**HISTORIC BRICK WALL AT THE SWAN INN
SWAN STREET
SIBLE HEDINGHAM
ESSEX**

BUILDING SURVEY AND RECORD

JULY 2011

FAU Project No.: 2436

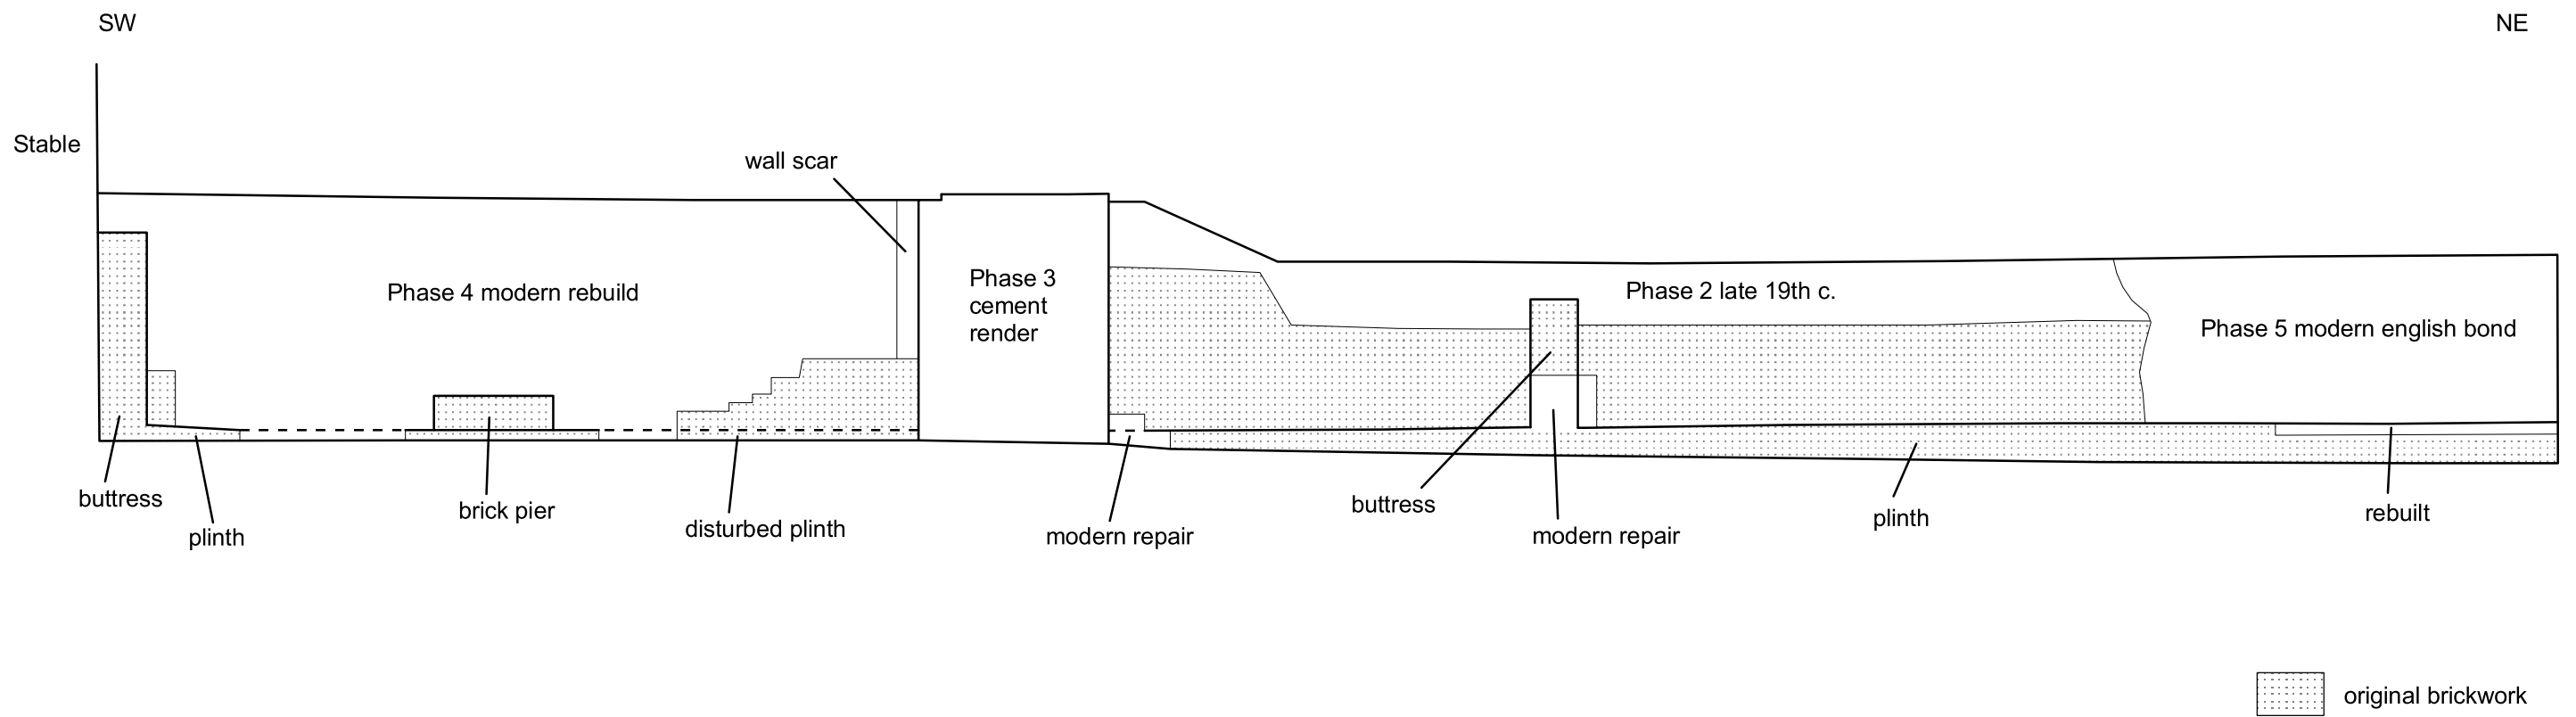
Fig.6. South east elevation of wall

Above the plinth, the wall is built in Flemish bond. Two early buttresses survive, one by the stable (plate 4) and the other roughly central (fig. 6 & plate 6). It is likely there was originally

The upper 4-5 courses of the north-eastern half of the wall were rebuilt around the late 19th century, capped with bricks on edge. These bricks are harder and more regular in size, like standard later 19th and 20th century bricks, and bonded in a hard lime mortar that has been re-pointed in cement, which has now largely blown. Only the area above the central buttress has remained since the other two ends were rebuilt in the modern period (phases 4 and 5 in fig. 6).

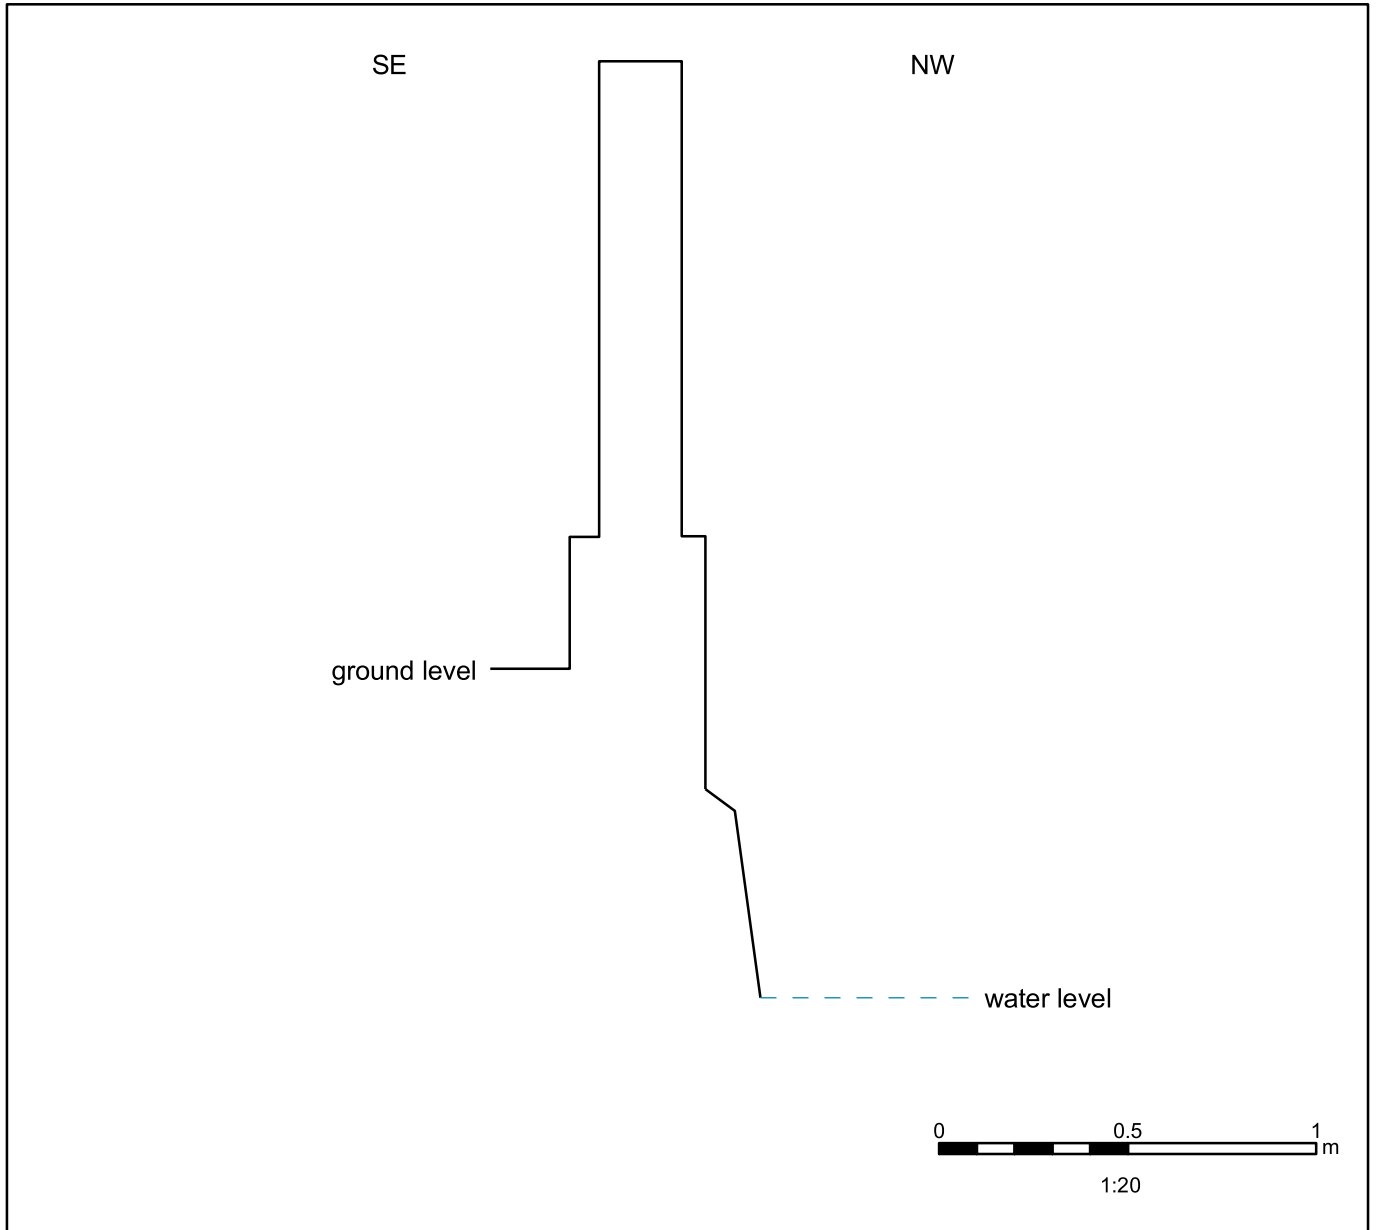
Fig.7. Section through wall

At the base of the wall is a brick plinth at 45.21m OD, built in header bond. Towards the south-west only the top course is exposed, which survives only partially due to later rebuilds and general deterioration (plates 4 & 5). As the ground level decreases, up to four courses of the plinth are revealed whose survival and condition varies from good to poor (plate 6-8). The plinth is 14 inches or 360mm wide and drops a further 660mm on the north-west side, before battering out into the brook (fig.7).

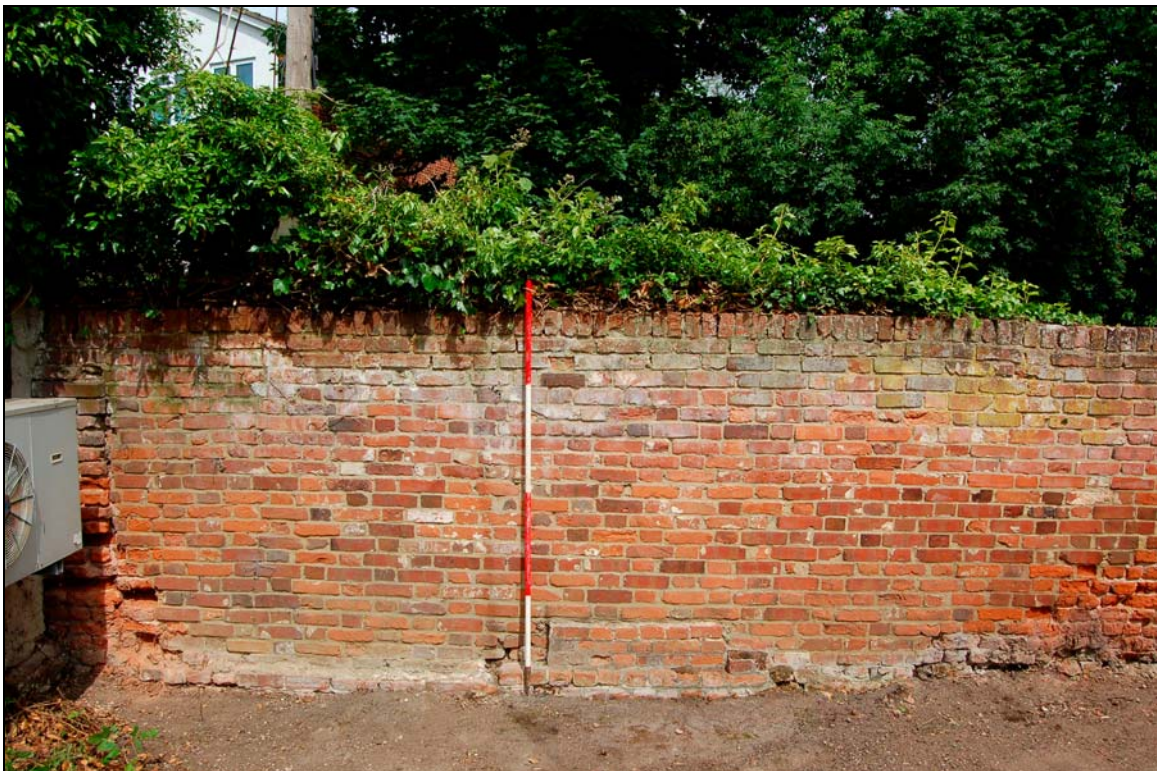
a third at the north-east end of the wall, which has been rebuilt removing any trace of it. There are the remains of a brick pier close to the stable (plate 4, beside base of scale), though its phasing and purpose are unclear. Other features have less historic interest: the cement-rendered rear wall of one of the utility buildings and evidence for an early 20th century single-skin wall between the boundary wall and pub (plate 5). The top of the wall has brick on-edge coping.

The south-western part of the wall was rebuilt using a mixture of new and old bricks in a buff-coloured gritty cement (plate 4). The new bricks are hard 8¾-inch reds with sharp arrises and diagonal kiss marks, between wide mortar joints. The upper courses have been discoloured through contact with ivy that was removed before the survey began, but is prolific on the side of the wall and stable.

Plate 4 South-west historic buttress, pier base and modern phase 4 rebuild (2m scale)

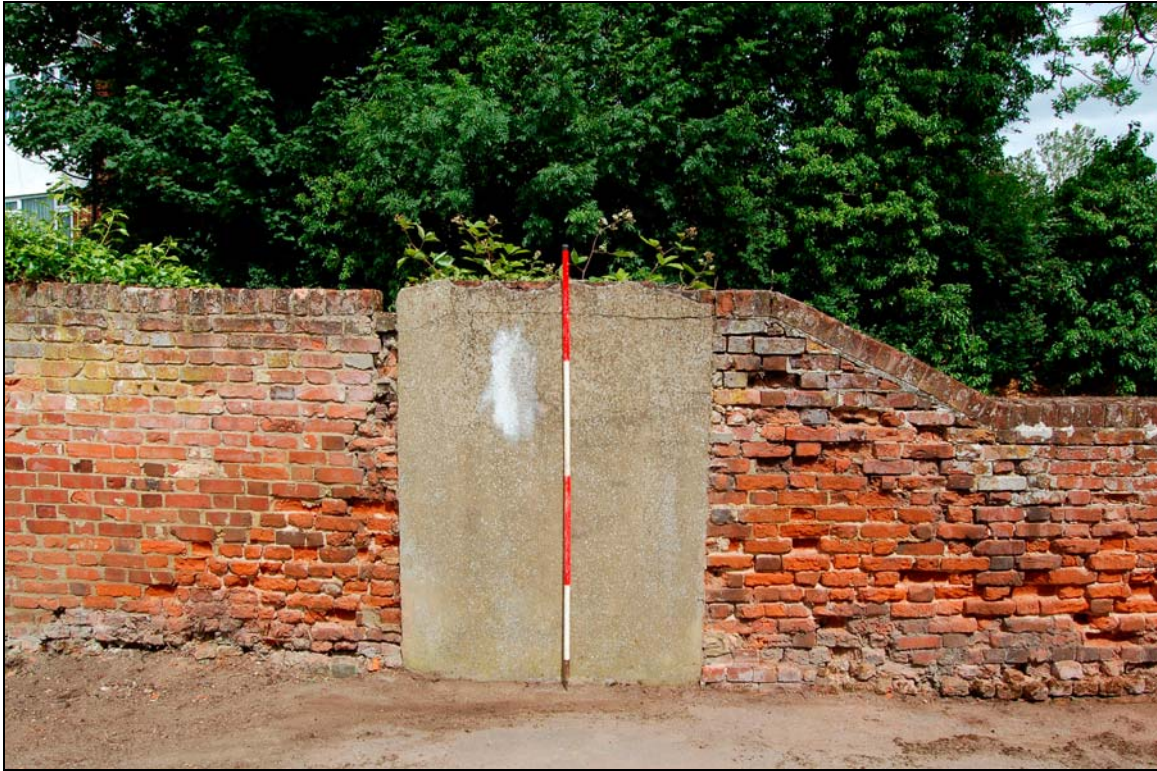
An area of cement render represents the later rear wall of one of three minor structures built onto the wall in the mid-late 19th century (1840-76). By the 1920s the structure had been demolished but a single-skin brick wall had been built across the driveway on its north-western side, represented by a scar in the brickwork cement (fig. 6). No sign of the other buildings are visible today and it is therefore likely they were either timber structures that left no mark on the wall or independent structures that were not 'tied-in'.

Plate 5 Evidence of phase 3 structure and modern wall across driveway (2m scale)

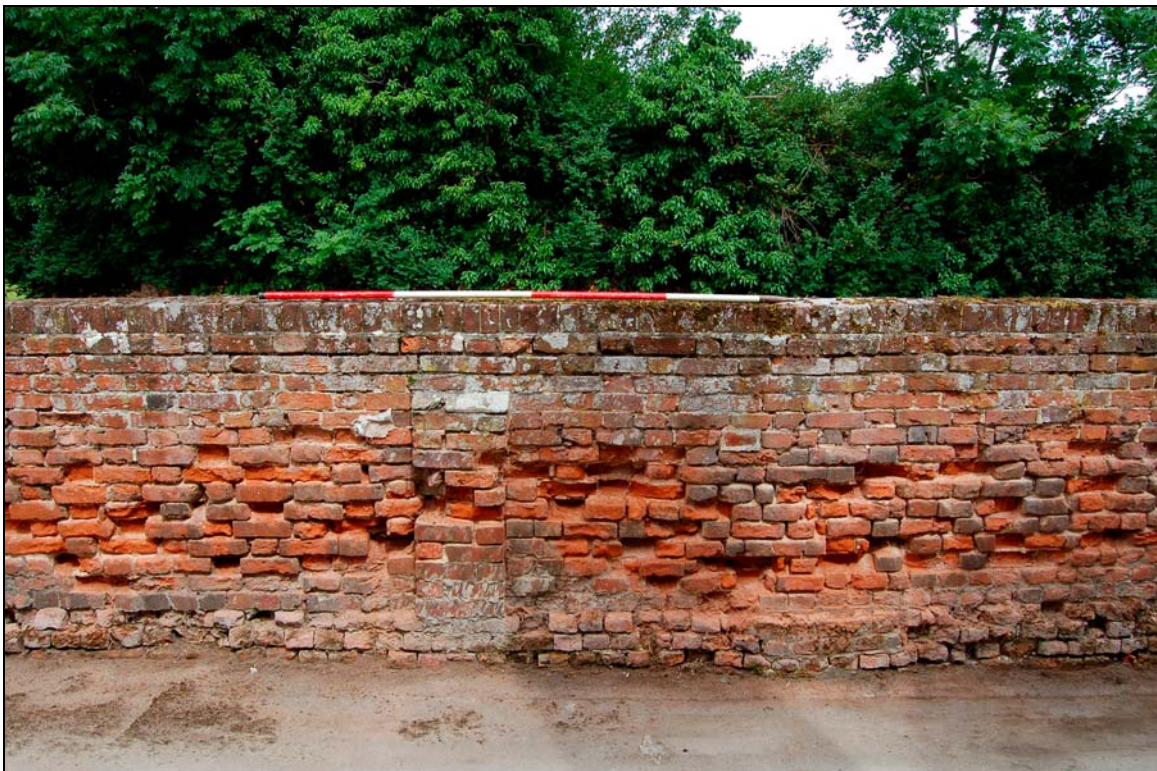
Plate 6 Historic phase 1 wall and central buttress below phase 2 rebuild (2m scale)

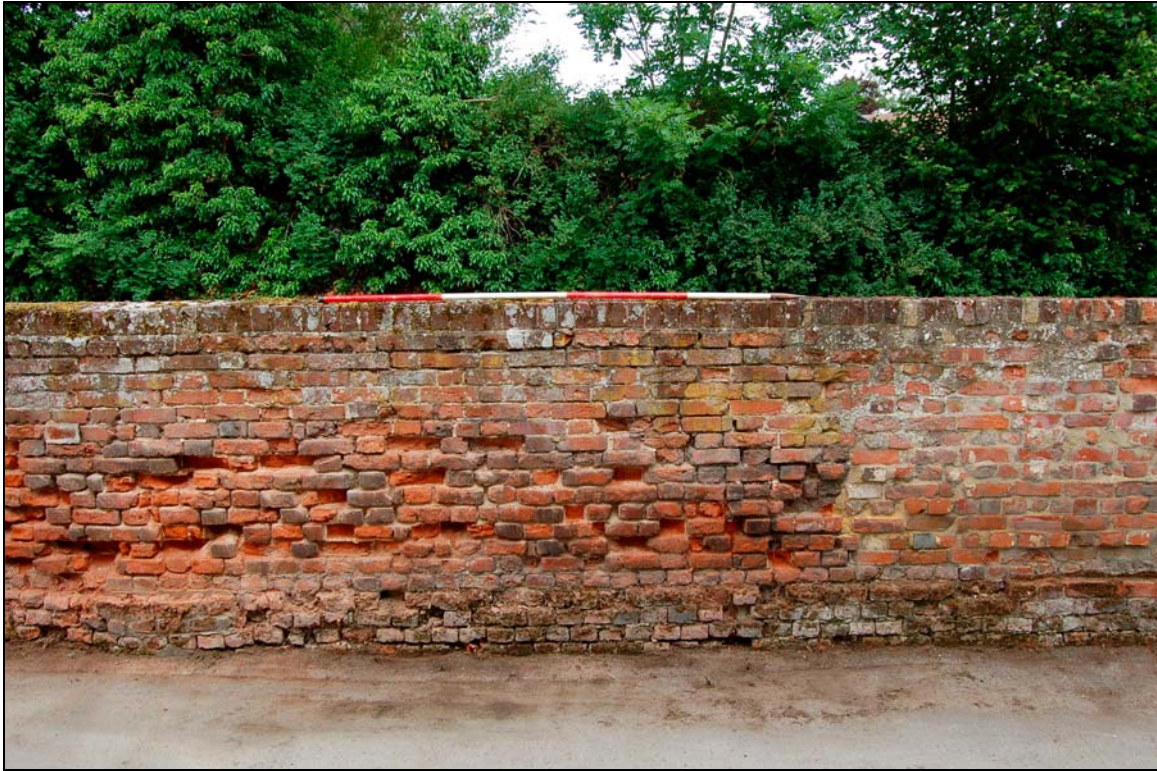
The north-eastern end of the wall has a similar mixture of bricks to the phase 4 build but these are laid in English rather than Flemish bond (plates 7 & 8). Most of the bricks are hard reds but there are some phase 1 bricks included as well as odd half bricks and brick fragments, heavily surrounded by a thick sandy-buff cement. Part of the top course of the plinth has been rebuilt as stretchers (plate 8).

Plate 7 Historic wall and modern (phase 5) rebuild (2m scale)

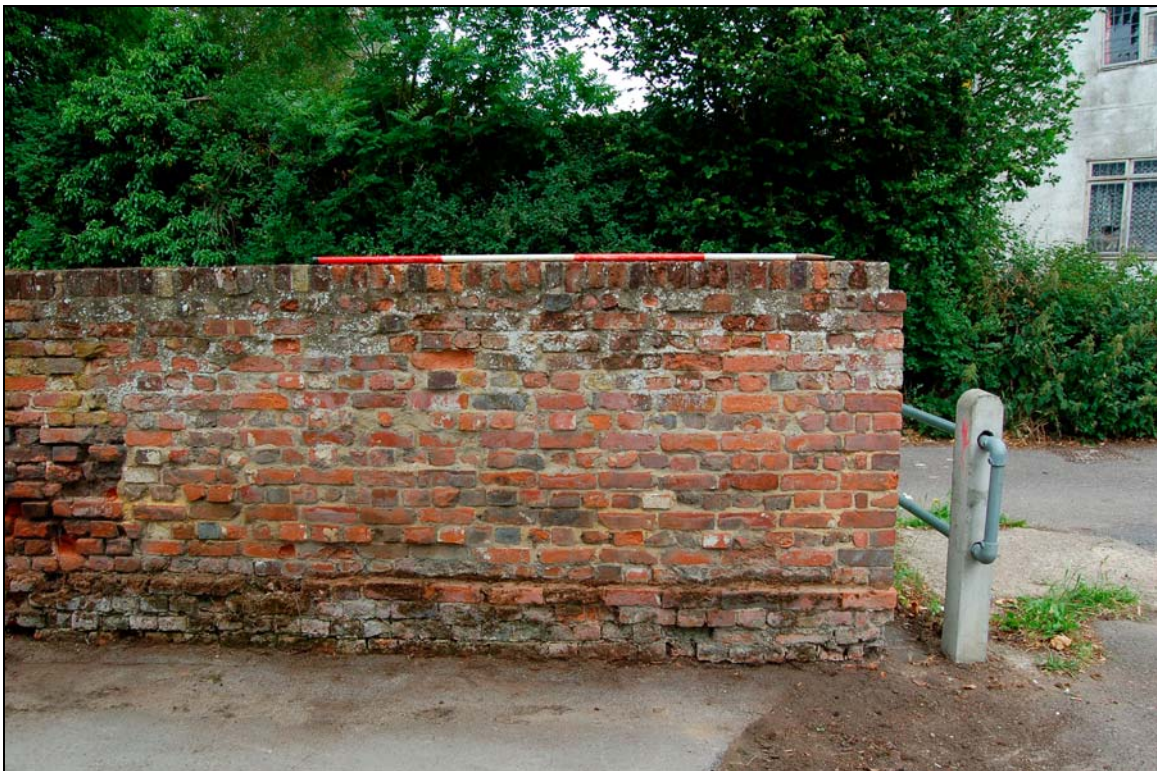
Plate 8 Phase 5 rebuild at north-east end (2m scale)
