**THE PARKWAY CENTRE (FORMER PARKWAY SCHOOL)
WELWYN GARDEN CITY
HERTFORDSHIRE**

LEVEL III HISTORIC BUILDING SURVEY

December 2011

Document Ref.	2484repV2
Report Issue Date	7 th December 2011
Circulation	CgMs Consulting
	HCC Historic Environment Unit
	HCC Historic Environment Record

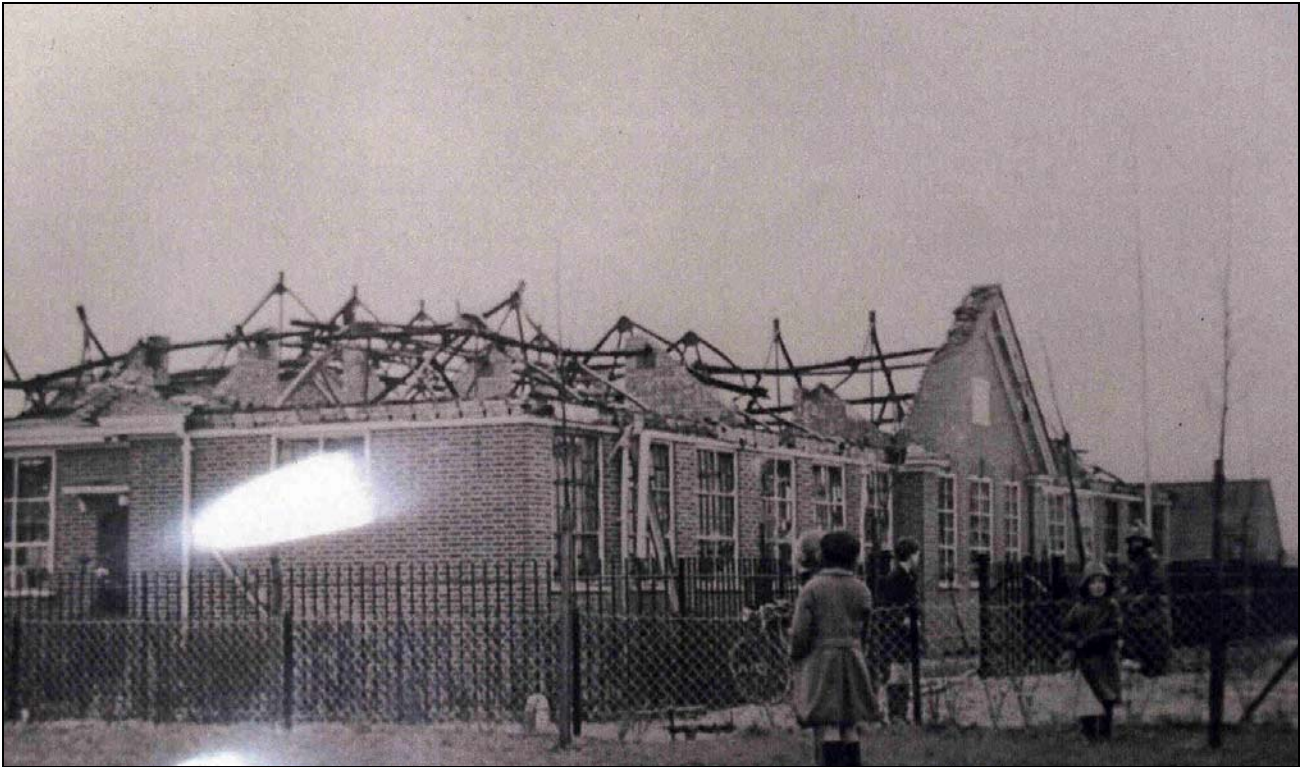
Fig. 2 Photograph of the front of the school and part of the north range taken after the 1939 fire

Based upon contemporary accounts, the most affected areas were the west and south ranges and figure 2 shows the north range shortly after the fire, its roof destroyed, leaving only the outer walls.

Although it was not possible to observe the roof space during the survey, it is unlikely to differ from the roof shown in the 1939 photograph, which shows bolted angled iron trusses in a strong king post strut form, with iron purlins passing either side through the tops of the load-bearing walls (fig. 2).

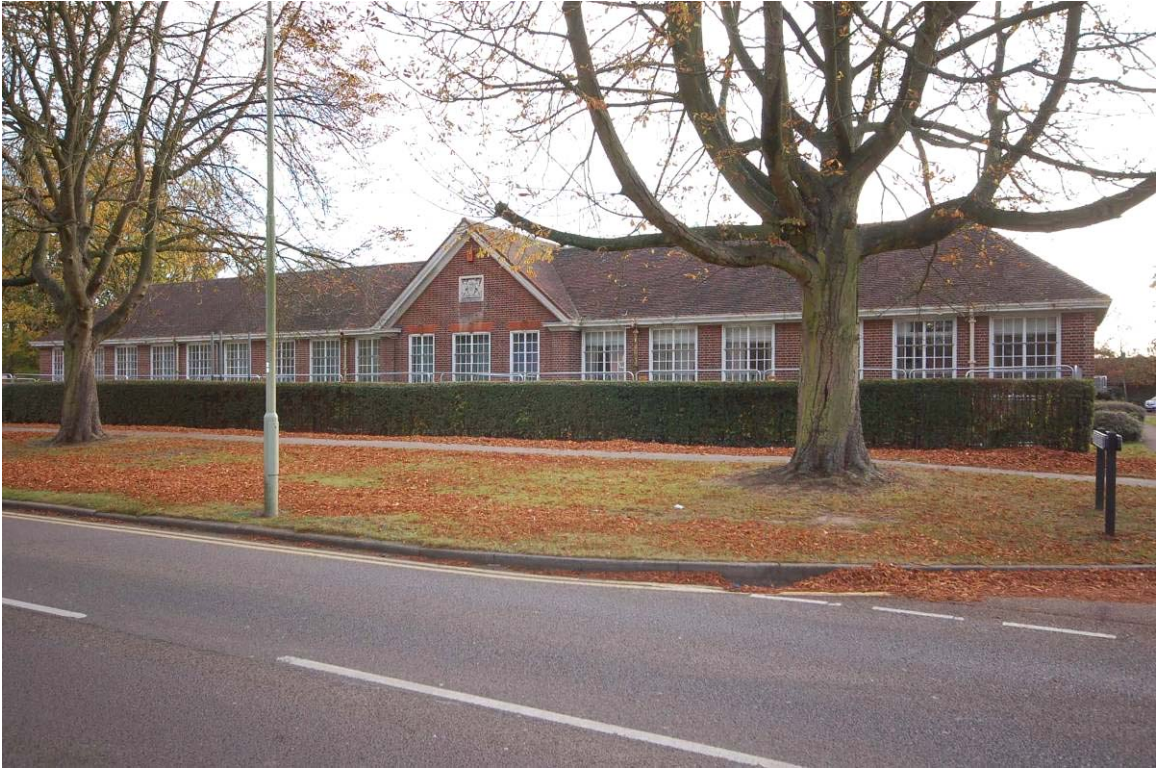
Plate 1 Main elevation viewed to north-east

The **western elevation** forms the main façade, containing five classrooms fronted by a long, heavily fenestrated frontage either side of a central broken pediment and hipped roof either end (plate 1). Originally there were six bays either side of the pediment but after the 1939/40 rebuild the northern end was increased to nine. The windows, which are the same as those used on all of the surviving outer walls, are in a multi-paned (36 panes each), neo-Georgian style, suiting the pediment above, and have wooden sills. Each window is divided into three

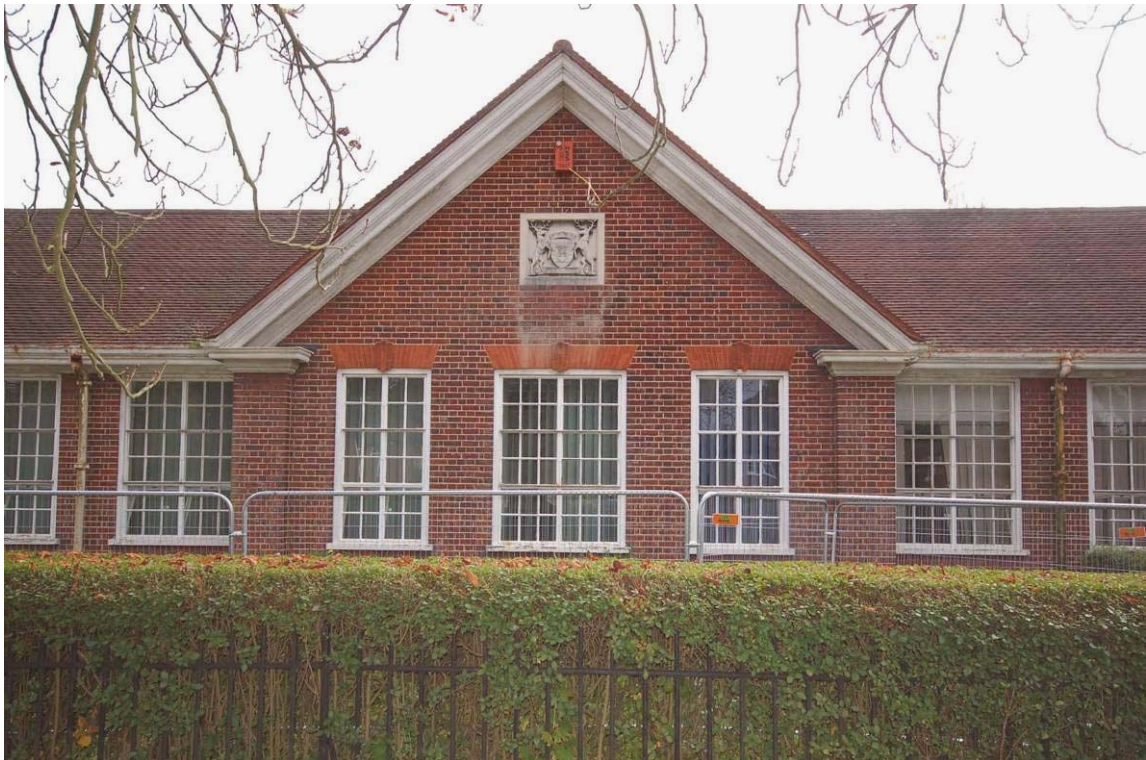
Plate 2 Central pediment

A central pediment encloses a three-window range with narrower 24-pane windows either side of a central, larger, 36-pane window, in the same combination as those either side. Each is topped with flat gauged brick heads and stepped brickwork keystones (plate 2). The pediment is raised on brick piers and carries the same mouldings as the cornice either side. Inside is a cast stone or concrete plaque depicting the county arms of Hertfordshire.

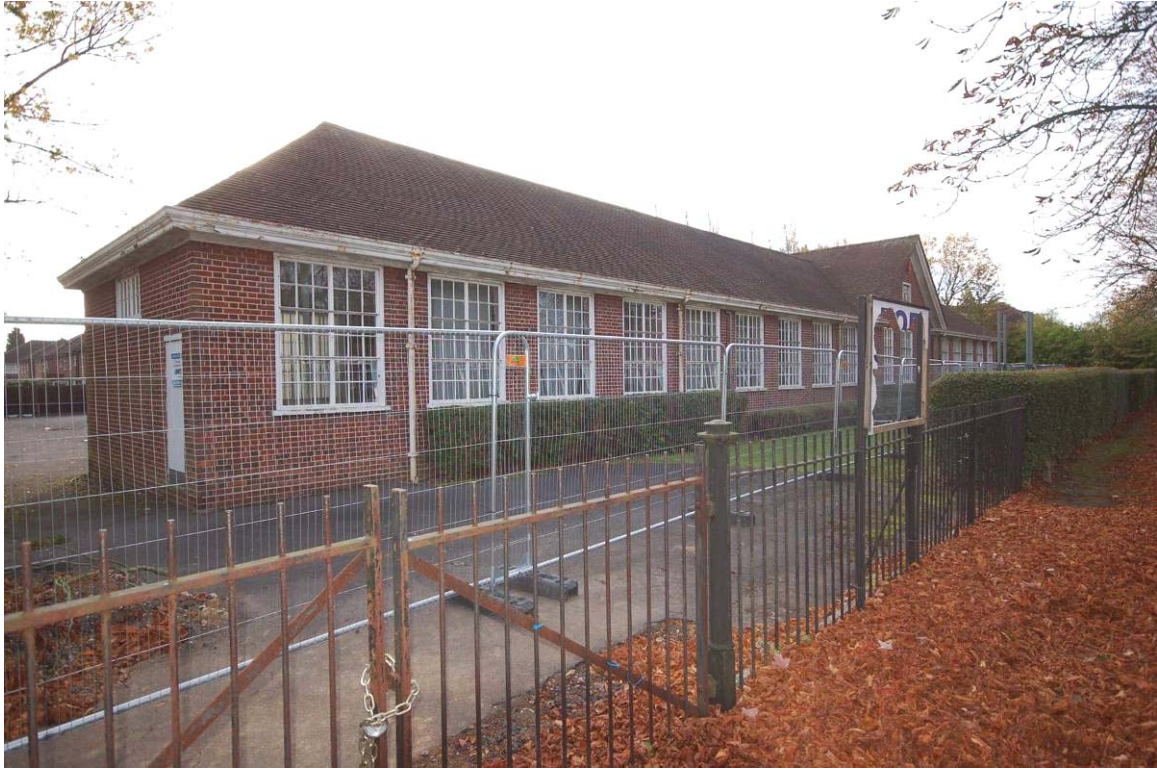
Plate 3 Western range viewed to south-east

The **north elevation** contains few features apart from a high tilting window just below the eaves and an inserted modern fire door (plate 3). The **south elevation** (plate 4) has been rebuilt and the only feature is a pair of modern semi-glazed fire doors similar to those on the OT store, with the same soldier brick heads. Originally this end was probably fenestrated the same as the north end, with a high, tilting window (plate 3).

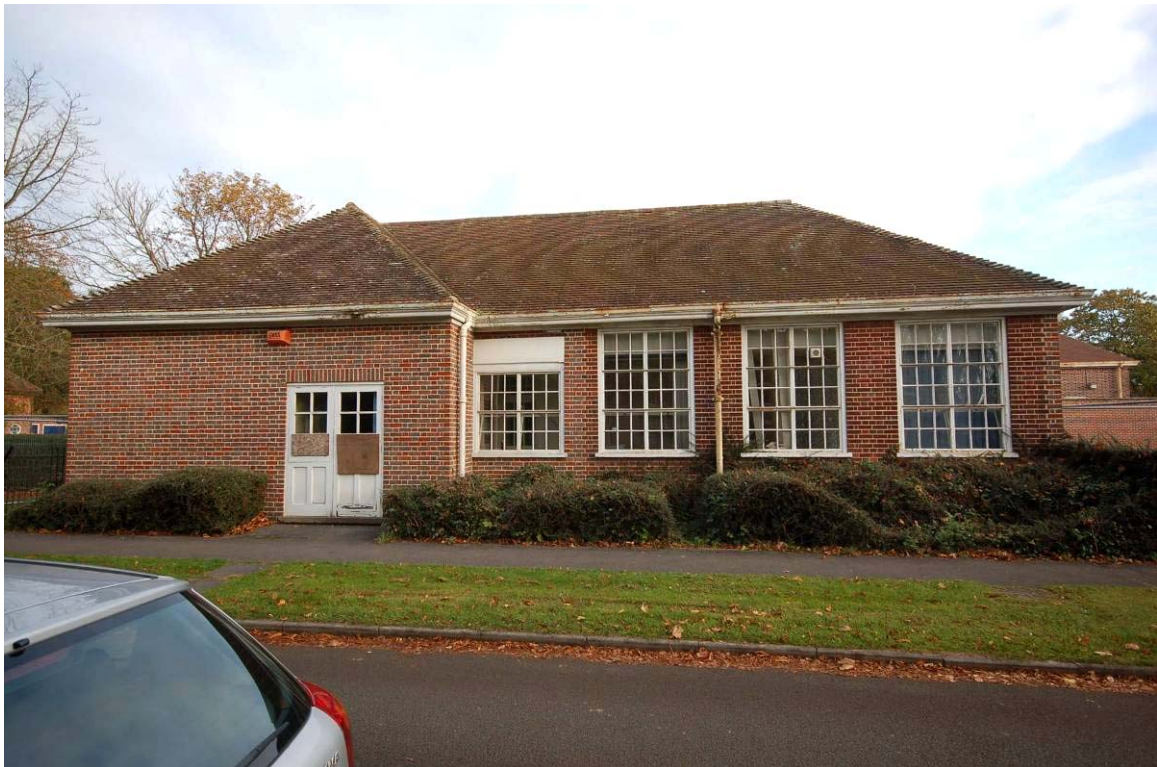
Plate 4 South elevation from road

On the opposite side of the corridor is the **assembly hall**. Both former entrances off the western corridor originally held double doors but have been reduced in width to accommodate single ones (fig. 4). The interior is amply lit by high windows set above the flat roofed western corridor and at either end that are now partially hidden by a suspended ceiling (plate 19). Room partitions, ceilings and carpet are all modern, but the skirting boards are contemporary with the school and it is interesting to note how they curve around the rounded corners of the walls (plate 19). The southern wall has been cut through to create a visitor's room beside the modern reception area (plate 4).

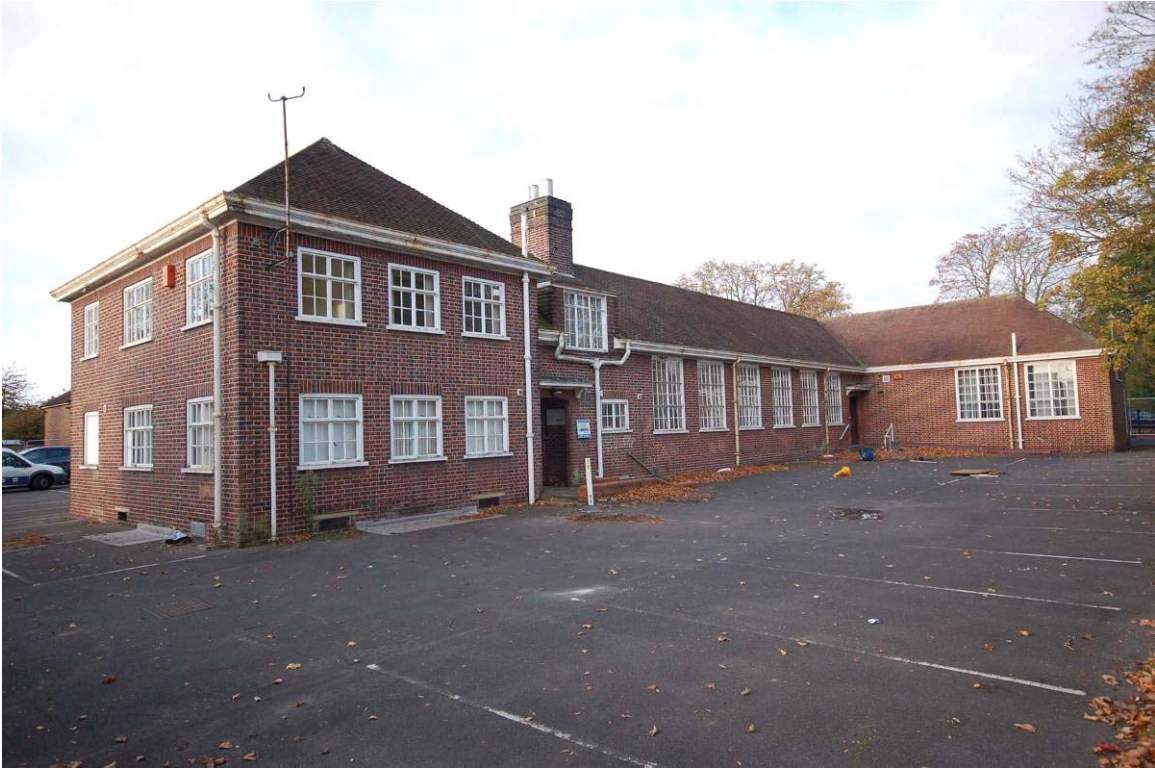
Plate 5 School viewed to south-west with staff block in foreground

Most of the **eastern elevation** of the west range is hidden by the hall and the two side ranges. At the extended north end (plate 5) the windows are in the same positions as those on the main façade with the omission of the window nearest the north range, whose location would have been too close to the entrance porch

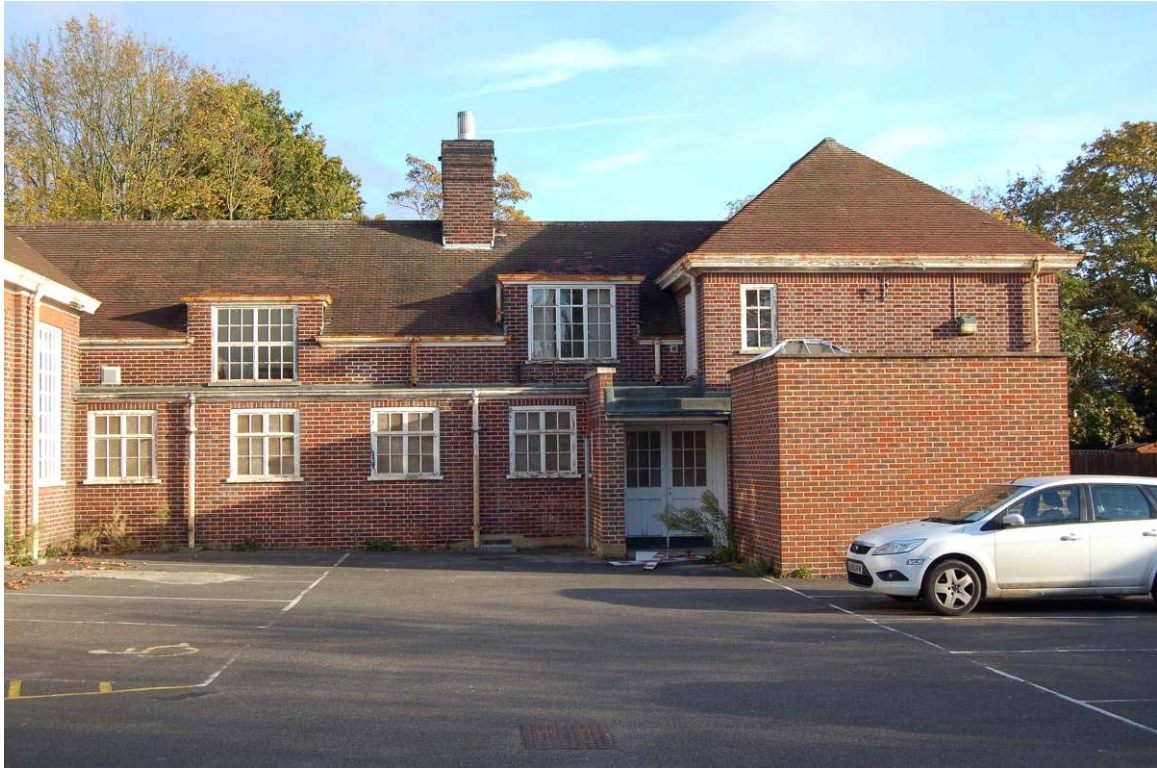
Plate 7 Northern range and remains of eastern range viewed to north

The northern classroom range stands between the western range and a two-storey staff block and originally contained two classrooms and an unidentified room, perhaps a reception/office area based on its location near to the entrance. Its character is the same as the western range, with good use of windows on the **north elevation** to light the classroom interiors (plate 5). The main features of this elevation are the two entrances at either end. Identical in form, each is open-fronted with moulded brick sides and segmental brick arches behind a flat-roofed moulded canopy. The doors themselves are set back from the wall line and comprise a pair of twin-panelled semi-glazed doors (with later safety glass) below three-light rectangular fanlights (plate 6). The door panels are chamfered on the inside, which is a common theme to all original doors throughout the school. To the side of the eastern doorway is a small soldier-arched casement window lighting the current kitchen, perhaps the former reception/admin area. The brickwork below the window has been rebuilt, suggesting there was a lower window here previously. Above is the former staff room, signified by a steel casement window embedded in a hanging tiled surround (plate 5). Another steel casement lights the staff room on the **south elevation**, above the flat-roofed corridor (plate

7). Further to the west, two slightly lower dormer windows provide additional light to classrooms 1 and 2 below. The ground floor window range comprises steel-framed casements. Unusually, this elevation is built in stretcher bond. To rear, a plain flat-roofed entrance porch towards the east end is fitted with the same semi-glazed doors seen on the other entrance points, but here represents the cut-back former east range corridor (fig. 4 & plate 7).

The eastern range survives as a small store, the staff toilet and a second car park entrance into the Parkway Centre, which is the truncated remains of the former corridor (plate 7). This was a narrower flat-roofed range, more suited to a service function and it was here that the toilets and kitchens of the old school were probably located. The OT store in front of it is constructed in similar style but is late 1990s's in date as is not depicted on the current OS map (fig. 1) and there is a clear, straight joint in the brickwork between it and the adjacent store (fig. 4). It has the same flat concrete slab roof and soldier-headed doorway as the open store next to it (plate 7), which appears to be part of the old range.

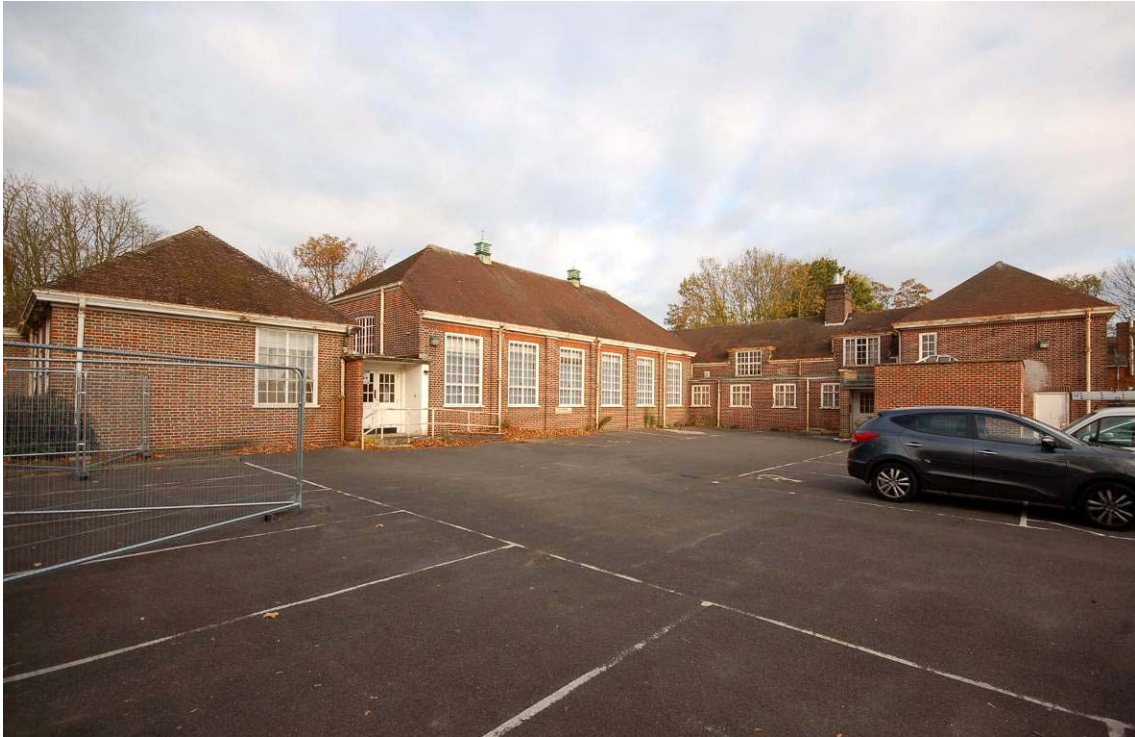
Plate 9 Rear of school viewed to north

This may be regarded as a separate structure attached to the rear of the main range (fig. 1), which displays a slightly higher architectural detail than the main ranges (plate 9). The hall would have been used for school assembly, PE classes and a dining room at lunchtimes.

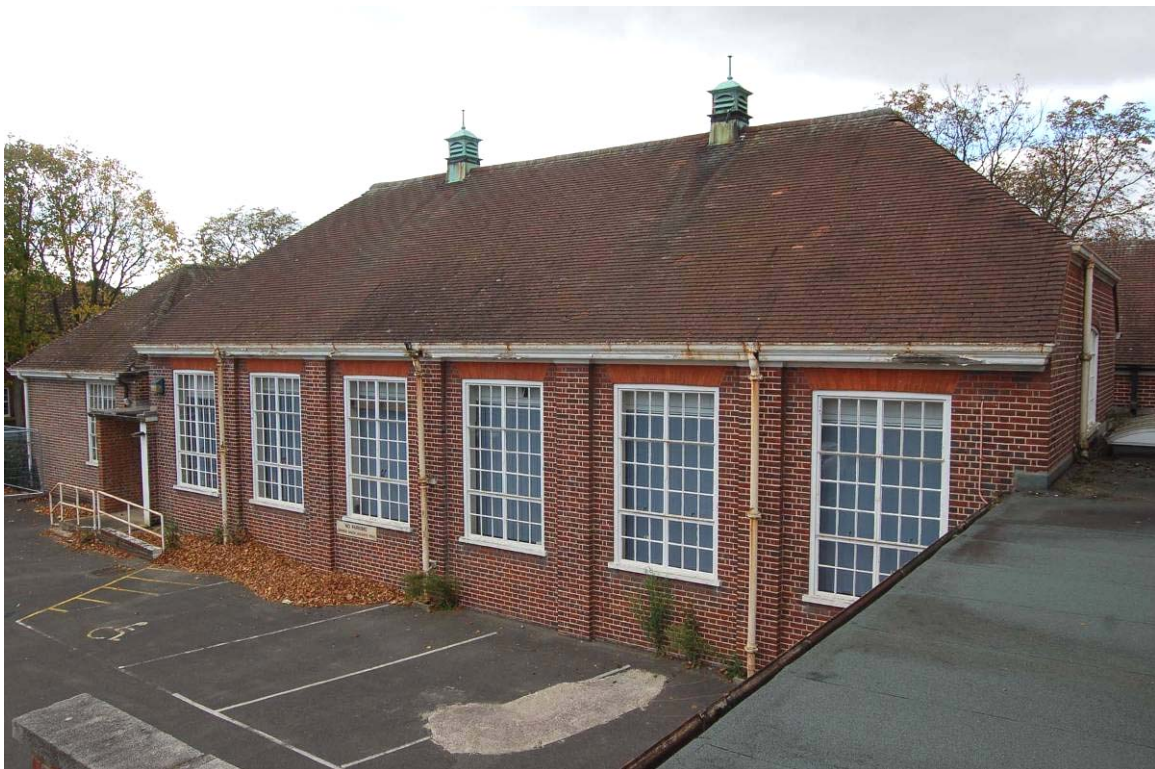
Plate 10 Assembly hall viewed to south-west from north corridor roof

Like those on the pediment at the front, they have flat gauged brick heads (plate 10). The roof is half hipped, ending with high, slightly arched windows either end (north and south), that have segmental arched heads (plate 9). One of the more interesting features is an ornate pair of copper roof vents along the ridge (plate 11).

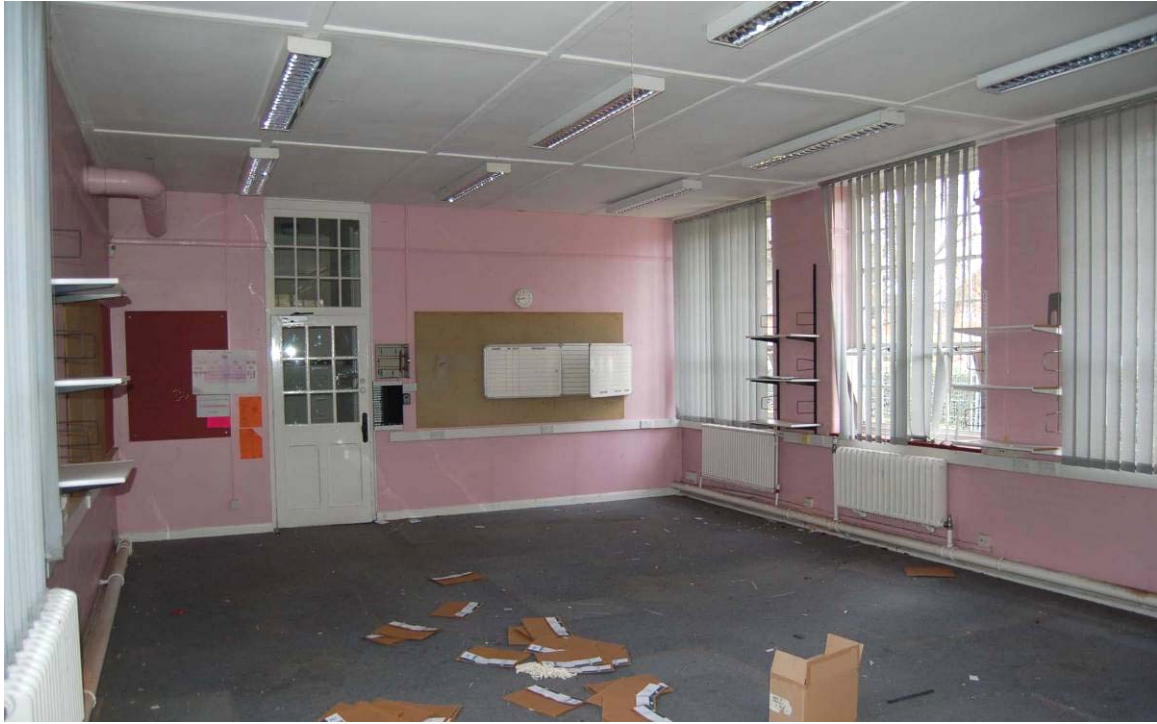
Plate 17 Classroom 3 viewed to east

Before the fire, it is probable that **classroom 3** was the mirror image of classroom 7 at the opposite end of the corridor (fig. 4). However, after the 1939/40 rebuild, the north end was extended by three extra bays, creating the largest classroom in the school and the two bays to the south of the classroom were used for storage, and still are. The doorway into classroom 3 is contained within the inserted 1930/40 wall (fig. 4) and is typical of the semi-glazed form throughout the school. The square door light above it is a substitute for the more

common dormer windows (plate 17). Interior detail survives well here, though only as minor embellishments such as plain 3½ inch skirting boards, slightly-moulded cornice and exposed boarded ceiling, fitted to the underside of the joists by wooden battens (plate 17). Like all the other classrooms, the brick walls are painted rather than plastered. This is perhaps the best example of a typical classroom, as it is less affected by later developments.

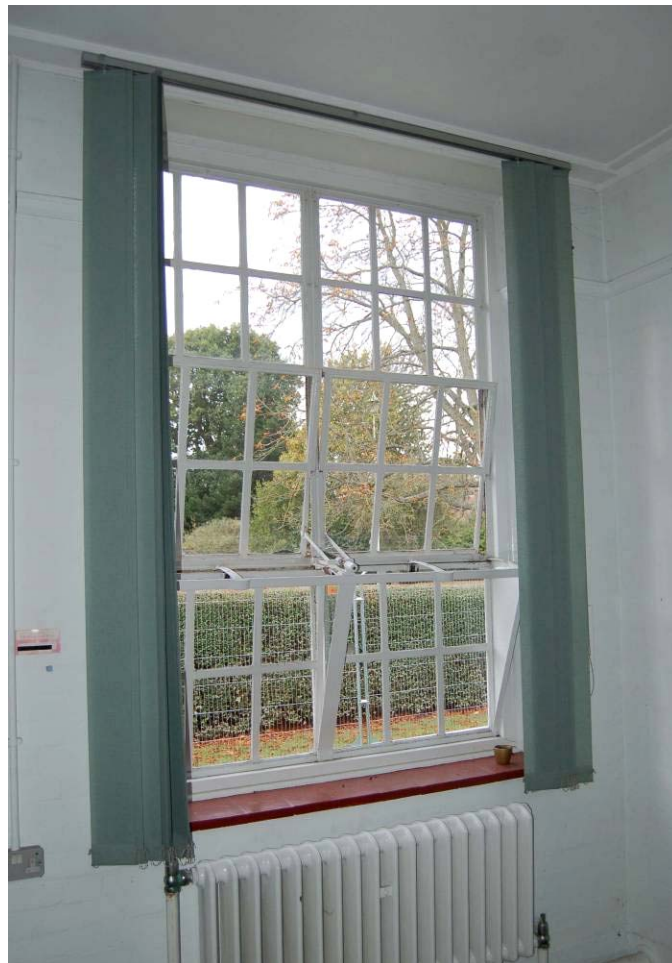
Plate 18 Typical classroom window

registers, one above the other, comprising paired 6-pane lights, giving 12 panes to each register, divided by a central glazing bar. The bottom pair are hopper windows and the two pairs above are tilting windows (see plate 18 for internal view).

Beyond the stores is **classroom 4**, which retains the same fixtures and fittings as classroom 3 but has a suspended ceiling. A detail photograph of the front window is included as plate 18 and is representative of all the external classroom windows. It shows the two hopper windows at the bottom, the central screw-operated tilting windows partly open and a set of closed cord-operated tilting windows above. The sill is tiled.

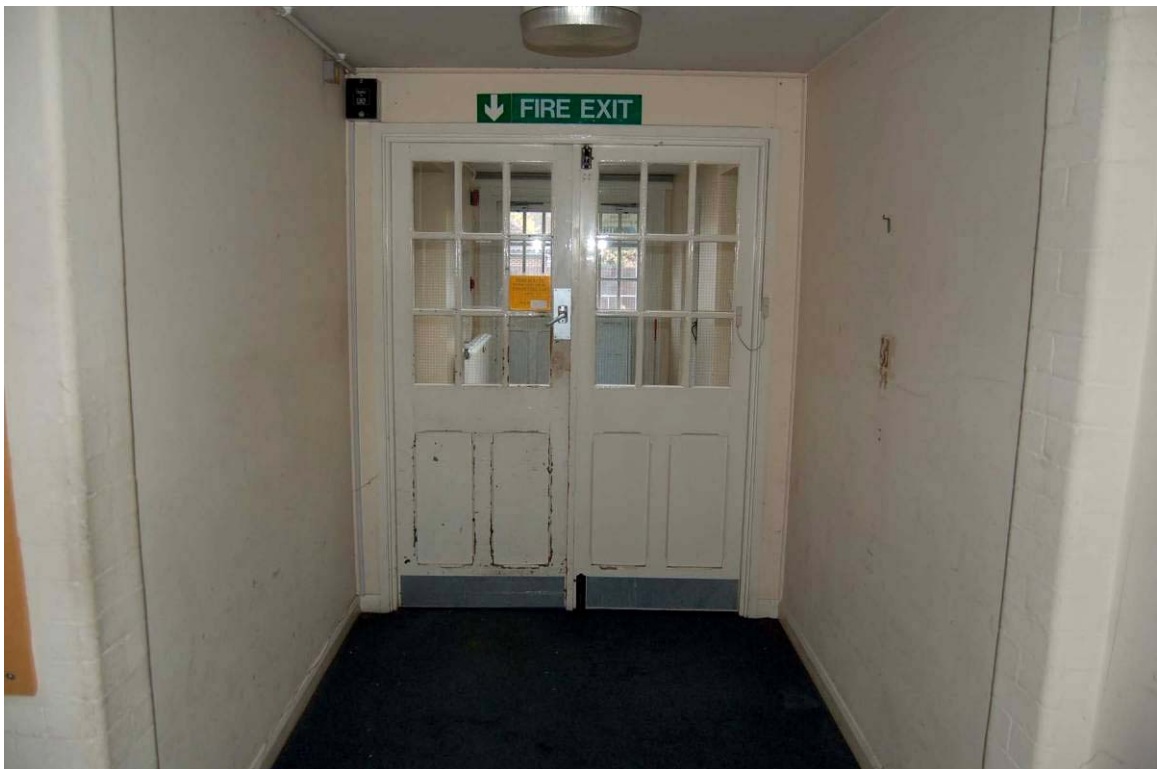
Plate 20 Corridor of former south range viewed to east

Classroom 8 and the corridor next to it are all that remains of the southern range, which probably mirrored the northern range with the exception of the staff block. The walls of the **corridor** are plastered (probably a later development), as well as the ceiling. Original skirting remains against the modern carpet. A pair of 1939/40 firedoors provides a good example of

type (plate 20). Beyond these to the east are modern inserted doorways (fig. 4) and similar fire doors at the other end, recessed within a short porch, to provide a modern entry point when the original corridor was demolished (plate 9). At the eastern end of the corridor is the original entrance into **classroom 8**, whose interior has been divided up into modern toilets, offices and interview rooms; no original décor remains. Its eastern wall was rebuilt flush with the rear doorway after the south range was demolished and incorporates a reused window.
