**GYPSY CORNER FARM  
PARK LANE  
LITTLE CHISHILL**

**HISTORIC BUILDING RECORD**

May 2012

Prepared by: Andrew Letch Position: Project Officer	Signature: Date: 8th May 2012
Approved by: Mark Atkinson Position: Project Manager	Signature: Date: 8th May 2012

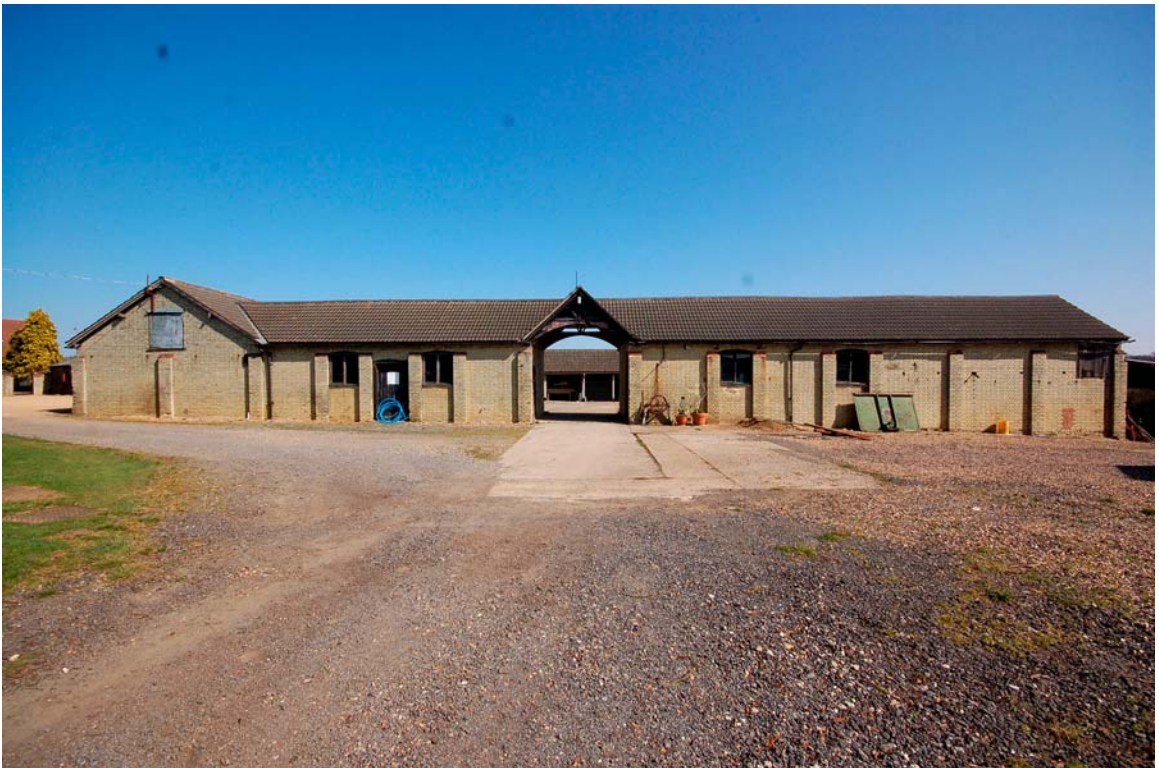
Plate 2 South range viewed to north-east

The main **south range** (plate 2) faces onto the road and comprises the gable end of the west range and a long 13-bay range (fig. 4). The covered entrance is located centrally and features a slightly steeper (45°) roof built onto a relatively elaborate exposed timber roof frame that comprises a pegged king post and collar purlins, plus curved collar brackets and struts (plates 2 & 8). Originally there were wooden gates but these were damaged on occasions by the wind and removed (Mr Bates pers comm.). On the second and fourth bays either side are modern casement windows inserted into earlier apertures, probably once accommodating wooden air vents. The window bays are decidedly narrower and do not reflect the location of trusses inside. A replaced cattle doorway is positioned to the left of the entrance in the central bay between the two window bays (plate 2).

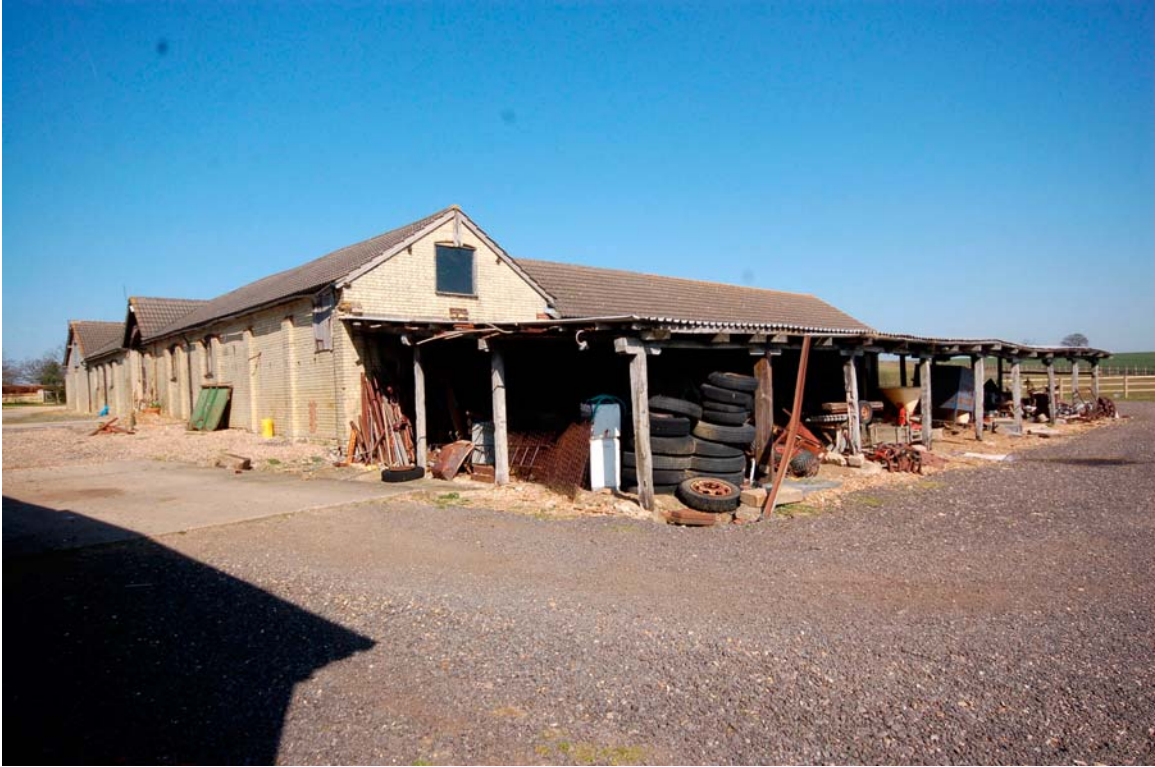
Plate 3 South and east ranges viewed to north

At the west end is the gable end of the two-bay west range, the gable window of which is sealed with metal sheeting. At the opposite end, where the south range finishes in a hipped roof, is a first floor hatch, connected to the first floor of the milling room (plate 3). It is possible

The **east range** (plate 3) is obscured largely by modern open sheep shed 12, that was constructed sometime before 1981. This elevation forms the rear of the former mill room, bull ring and pig sheds and retains its original form and appearance including a half-heck stable-type door at the south-west end (fig. 4 & plate 4), and no other features. The elevation is divided neatly into nine bays.

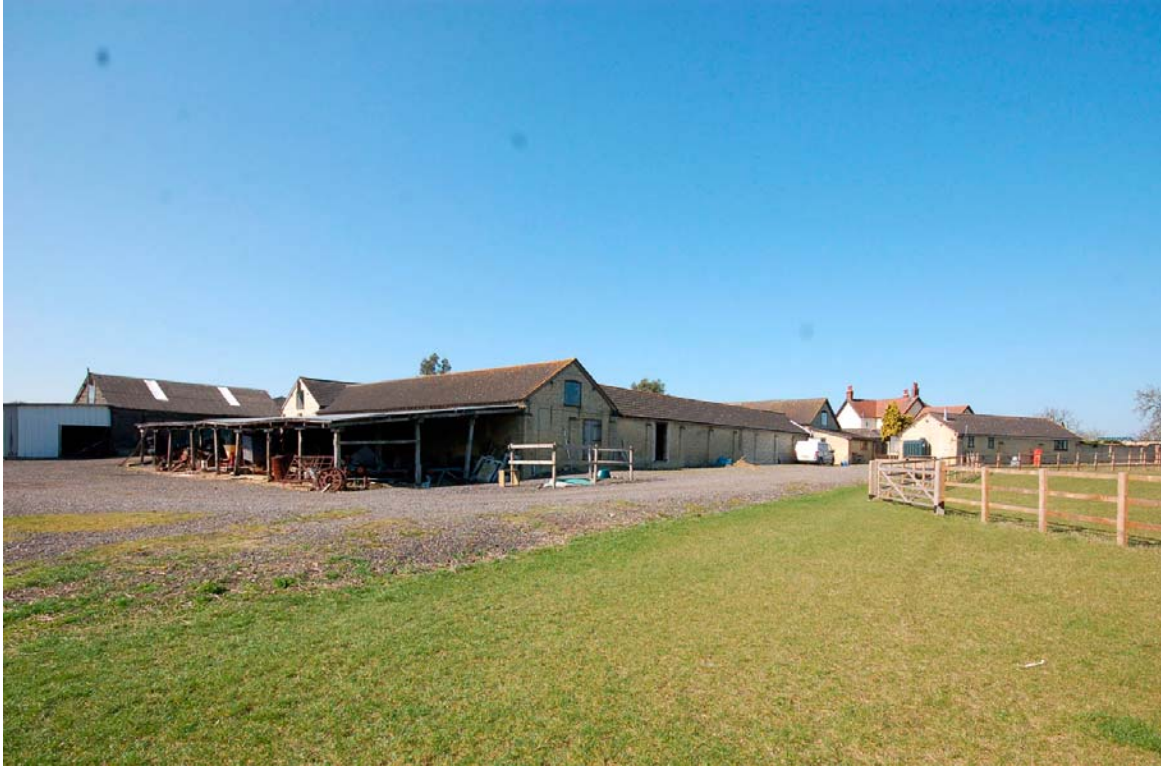
Plate 5 East and north ranges viewed to west

The **north range** (plate 5) faces onto a paddock and former grazing land. The gable at the eastern end (pig shed) contains an early door set on later T-hinges and above it is a modern gable window inserted into a previous opening. The main eight-bay shelter shed range contains an adapted doorway on the second bay (fig. 4). The rear wall of bays 5-7 has been rebuilt recently to counteract the lean of the existing wall (fig. 4). At the western end, the gable end of the west range contains a small lean-to brick structure, likely to be part of the original complex. Modern windows have been inserted into the lean-to and within the gable, the latter to light an inserted first floor office.

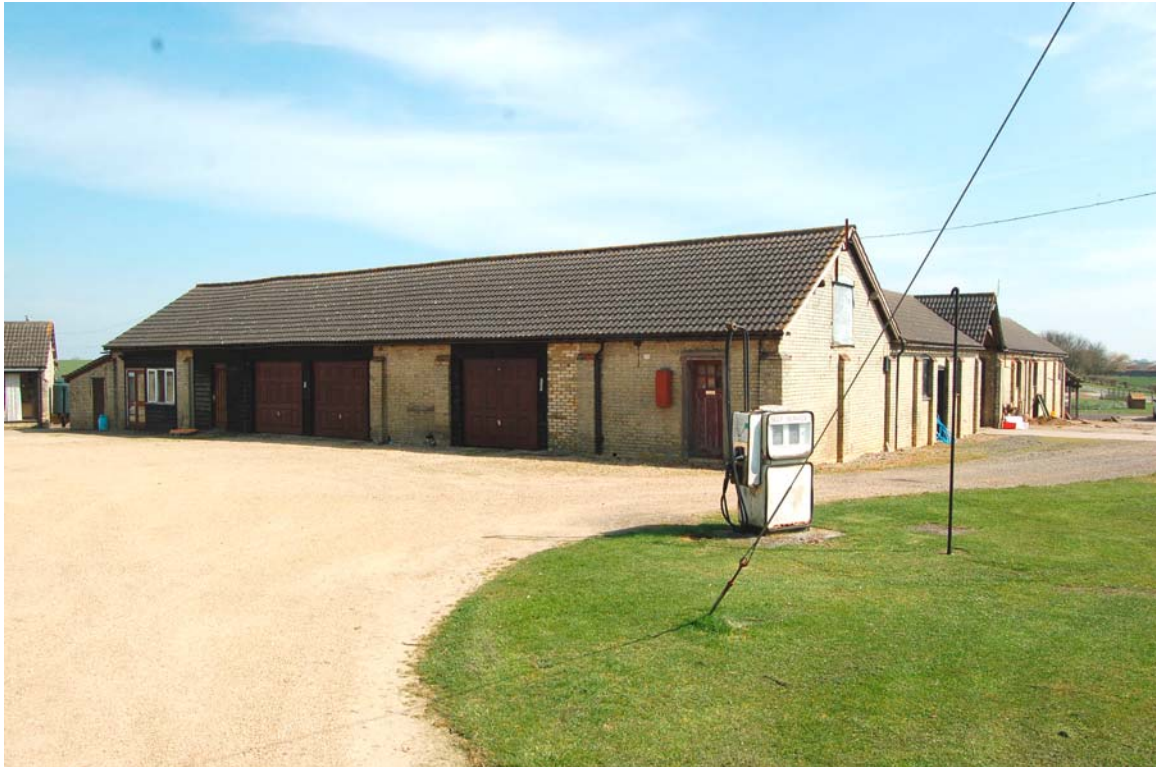
Plate 6 West and south ranges viewed to east

The **west range** (plate 6) faces the farm house and some later structures that are not included in the conversion plans (fig. 1). This range was converted some time ago into offices/kitchens for a catering business for Mrs Bates and as a garage, which is still in use by the owner. The garage is to be retained by the farmhouse and was therefore not recorded in the survey other than externally since it is part of the planned farm. Although converted and containing modern windows and doors, a section of modern weatherboarding in the middle bays bears comparison with the open-sided cart shed in the 1921 OS map (fig. 2). Some modern brickwork was observed further to the south around the single garage door, but this does not relate to any known original opening here (plate 6).

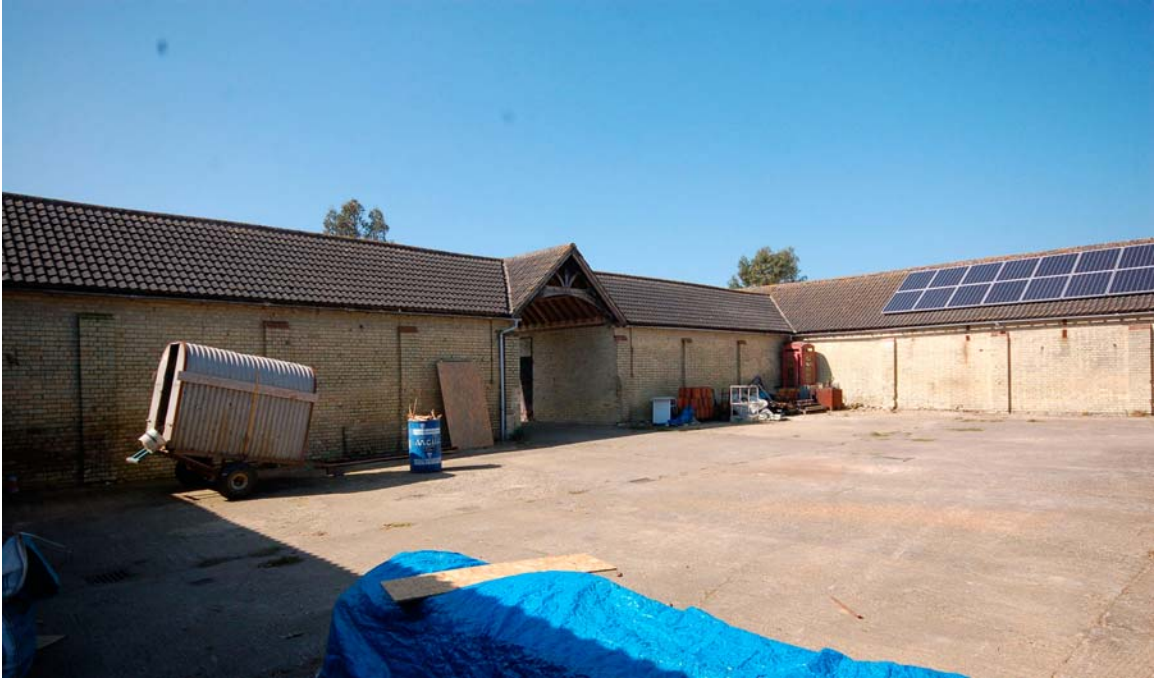
Plate 7 South and west ranges viewed from yard

The main **south range** (plate 7) remains unaffected by later developments and contains the covered entrance on the fifth bay which is an interesting feature best viewed from this side (plate 8). Within the entrance are two original half-heck doors leading into the cattle houses either side (plate 8 and section 5.2).

The **west range** (plates 7 & 10) contains a blank wall divided up into four bays externally. Square iron plates indicate the location of roof trusses reconfigured to suit the modern room layouts within. Photovoltaic panels are a recent addition to the roof.

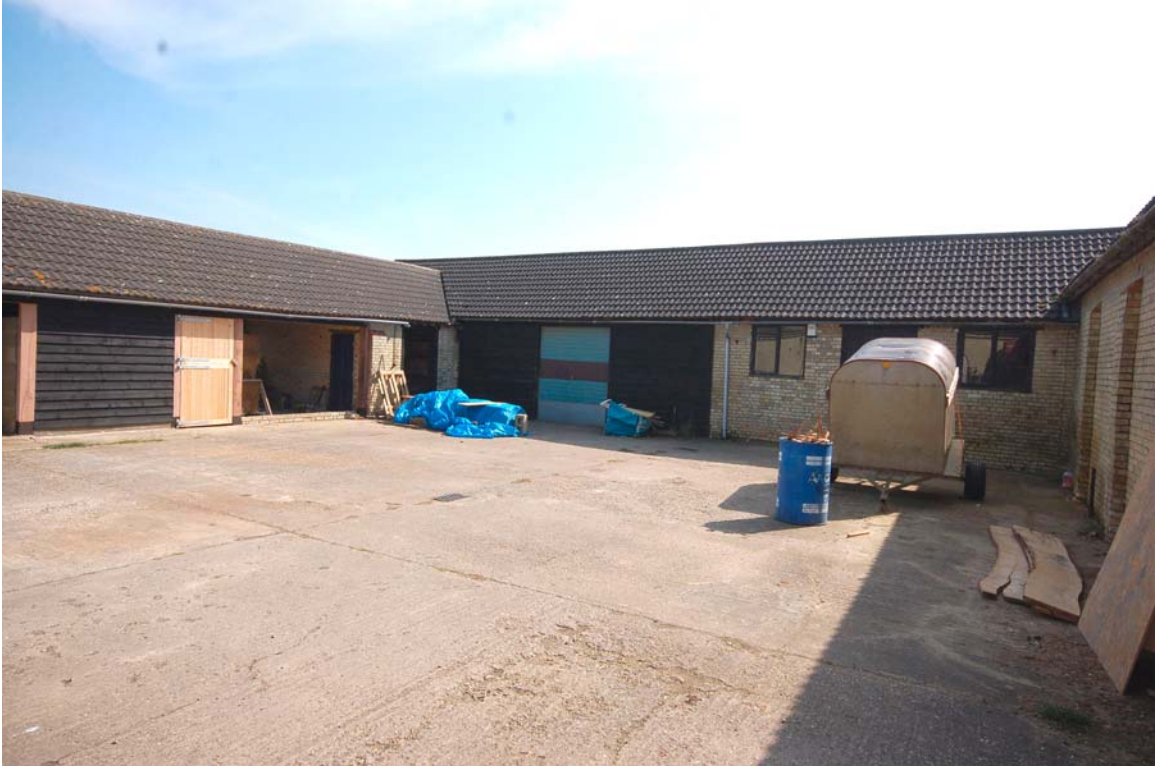
Plate 9 East and north ranges viewed from yard

The **east range** (plate 9) has been significantly altered in recent years. The former bull ring, occupying the brick-built bays, lost part of its wall when it was opened up for tractors but thereafter the wall was rebuilt and refurbished as an office/meeting room. The wall facing the

yard is thicker here, constructed in 14-inch English-bonded brickwork, to contain the bulls. The open-sided pig shed that forms the north half of the elevation has been enclosed with weatherboarding and a central garage door to become a carpentry workshop (plate 9).

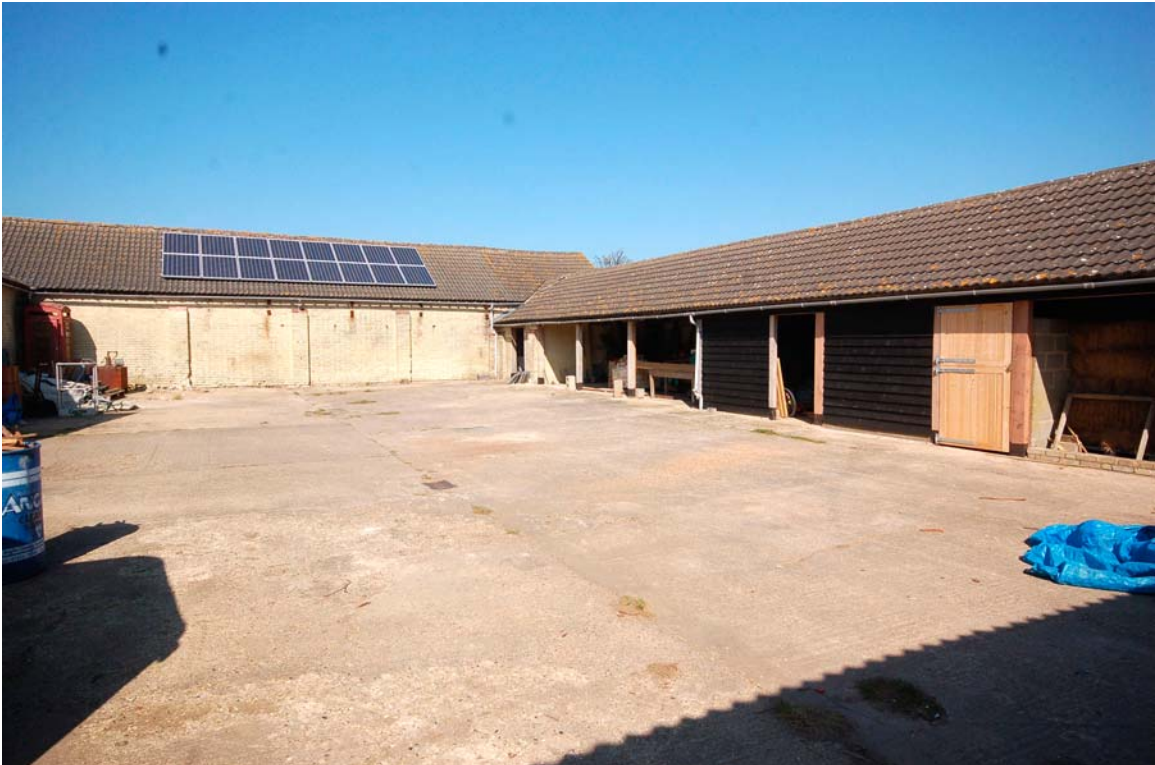
Plate 10 North and west ranges viewed from yard

The **north range** (plates 9 & 10) has been refurbished as stables, replacing the bay posts and enclosing two bays of the open-sided shelter shed in black-painted weatherboarding to create three stalls (fig. 4). The doorways into the loose boxes either end have been refurbished and no longer retain doors (fig. 4).

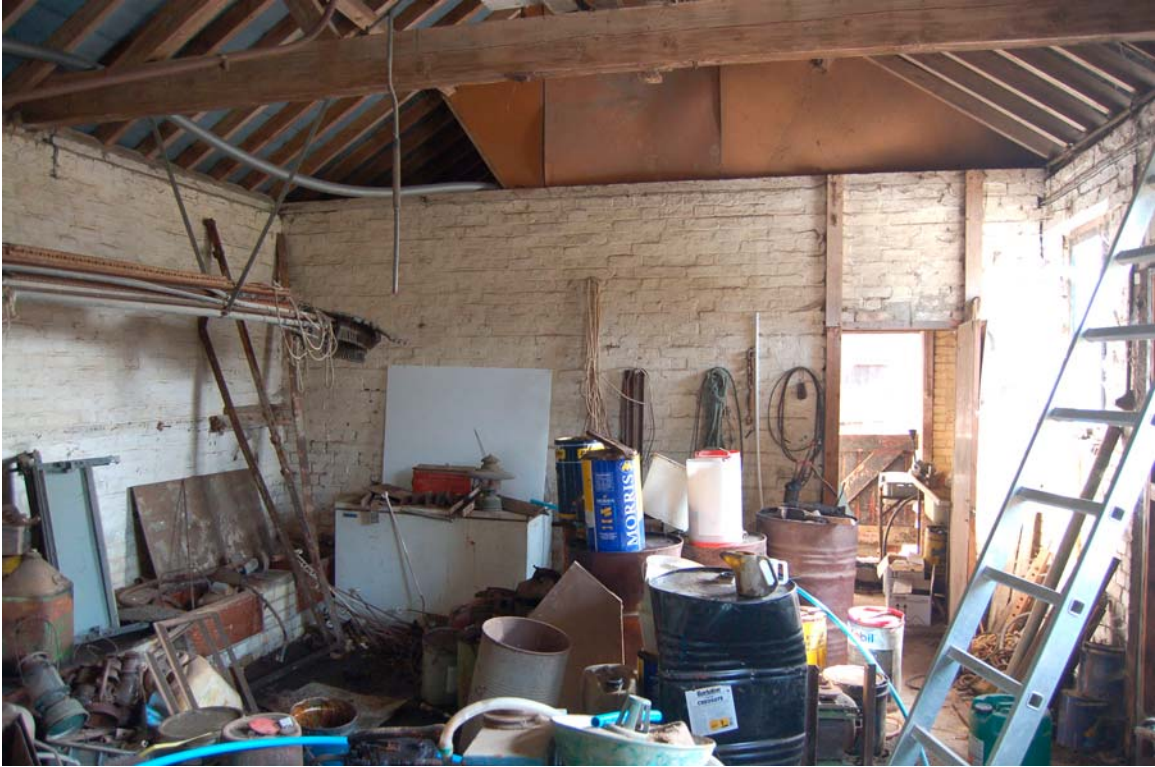
Plate 11 Interior of cow house 1 viewed to south-east

Cow house 1 traditionally kept the dairy herd, but has more recently been used as a chemical store and for general storage purposes. It has a four-bay layout, comprising the cow house and a fourth bay at the end for cattle feed (fig. 4). Entry points are located within the covered entrance and along the south elevation (fig. 4), both of which are wider at 1.2m to cater for the animals. The entrance within the covered entranceway retains its original half-heck door with its cast iron strap hinges and top vent, though the latter is now boarded up (plate 6). Upon entry on this side is the chemical store, refurbished but likely to represent the former feed store. A well-worn doorway leads from the feed store into the main area, which is used for storage purposes and at the time of the survey was full of junk (oil drums, engine parts, etc) spread over the floor and on metal racks at the north-western end. The floor is laid to concrete and has a waste gully along its centre (fig. 4), behind where the cattle stood. There are no internal partitions and the bare brick walls are whitewashed and open to the roof (plate 11). Along the north-east wall is a row of four 'Doulton' ceramic feeding/water troughs set within a low brick wall, five courses high (plate 12) and above are the remains of wall rails to former hay-feeders (plate 11, left).

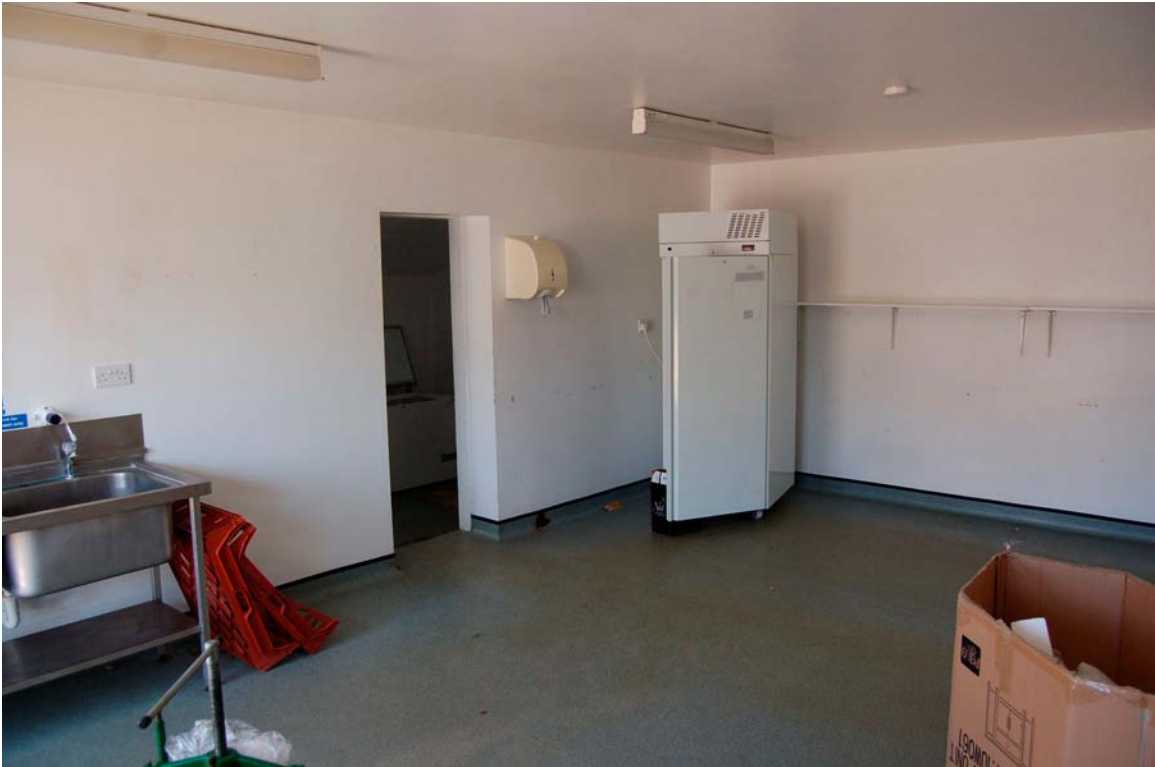
Plate 18 Interior of workshop 7

Internal inspection of the catering area showed complete refurbishment of all areas and no exposed historic fabric or features. Workshop 7 (plate 18) was last used as a preparation area and the lean-to next door was used as a freezer room. The former open side of the cart shed has been enclosed and now contains stairs to an office area above the former workshop, divided from the garages to the south-west by a likely modern wall (fig. 4). All doors and windows are modern, including the external ones into the lean-to (fig. 4). The garages were not entered during the survey.

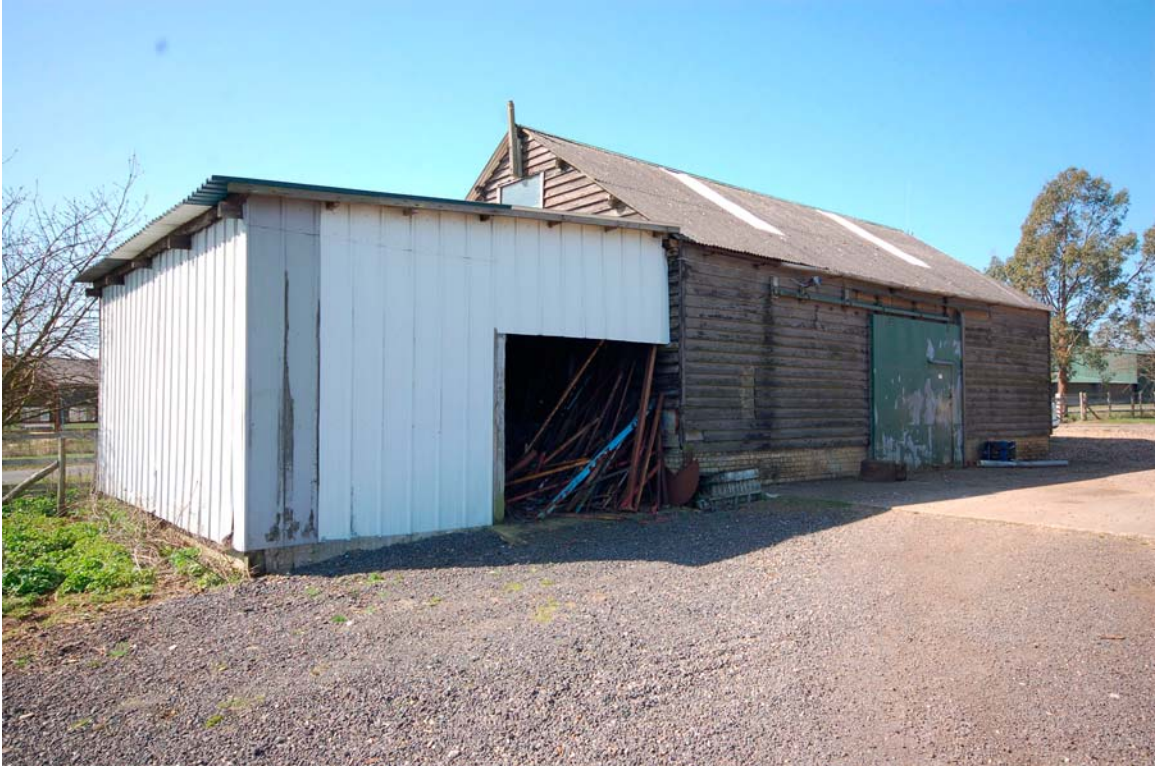
Plate 19 Meal shed 10 viewed to south-west

A modern structure is attached by a high wooden rail bolted to the eastern wall of the meal shed (plate 19). Its construction is similar to modern sheep shed 11. Internally, square-cut wooden posts are bolted to the rafters by wooden 'pillows' or caps and there are long rails and rafters to hold pre-formed light steel panels that constitute the walls and also the shallow-pitched roof.

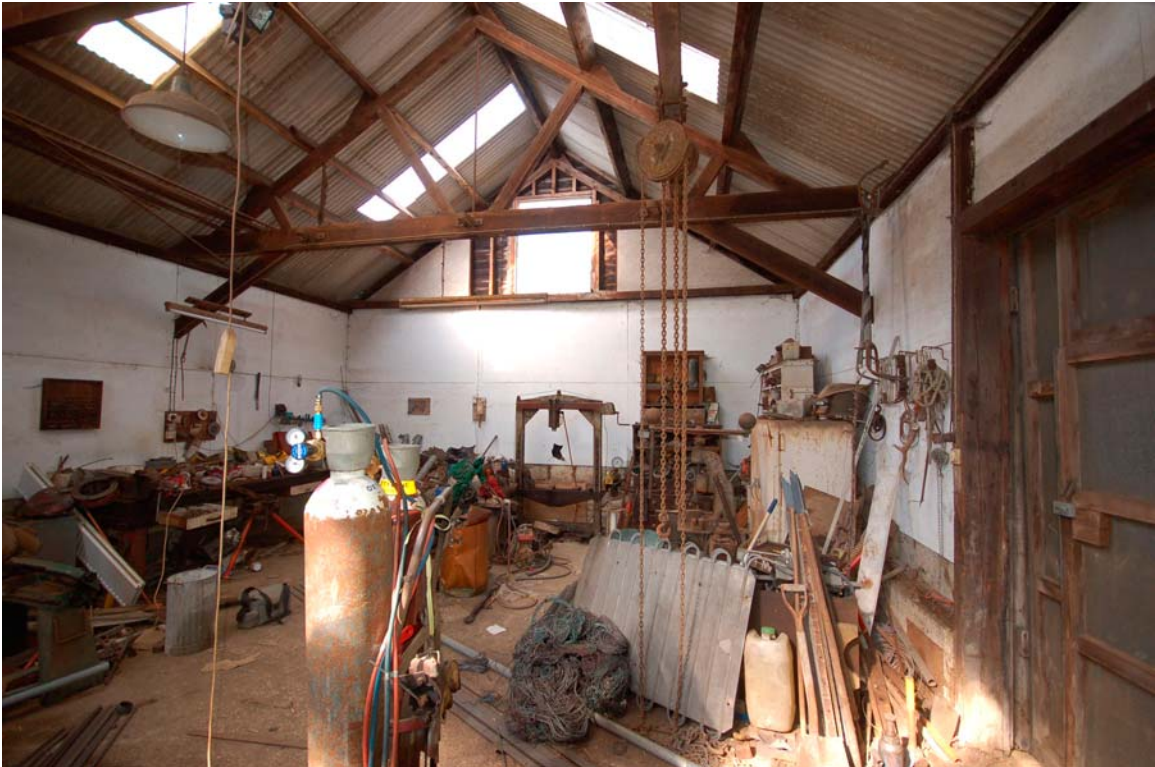
Plate 20 Interior of meal shed viewed to north-west

As a workshop, the interior is filled with metal lathes, welding equipment and shelving for various metal articles (plate 20). Beside the doorway is a 'Hercules' chain hoist (made in the USA) attached to a 4-inch iron girder, used to unload heavy items inside the workshop. No internal fixtures or fittings remain. The floor is laid to concrete and much of the timber wall-framing is hidden behind white modern wall panels. A small gap all the way round between the plinth and panels reveals a primary-braced frame made from 2-inch wide studs and 4-inch bay posts, using machine-sawn timbers.

Roof construction is the same as seen in the main part of the farm, though slightly larger, i.e. the bolted iron king rod form with raking struts and, here at least, triangular braces against the walls to cope with the greater span (plate 20).

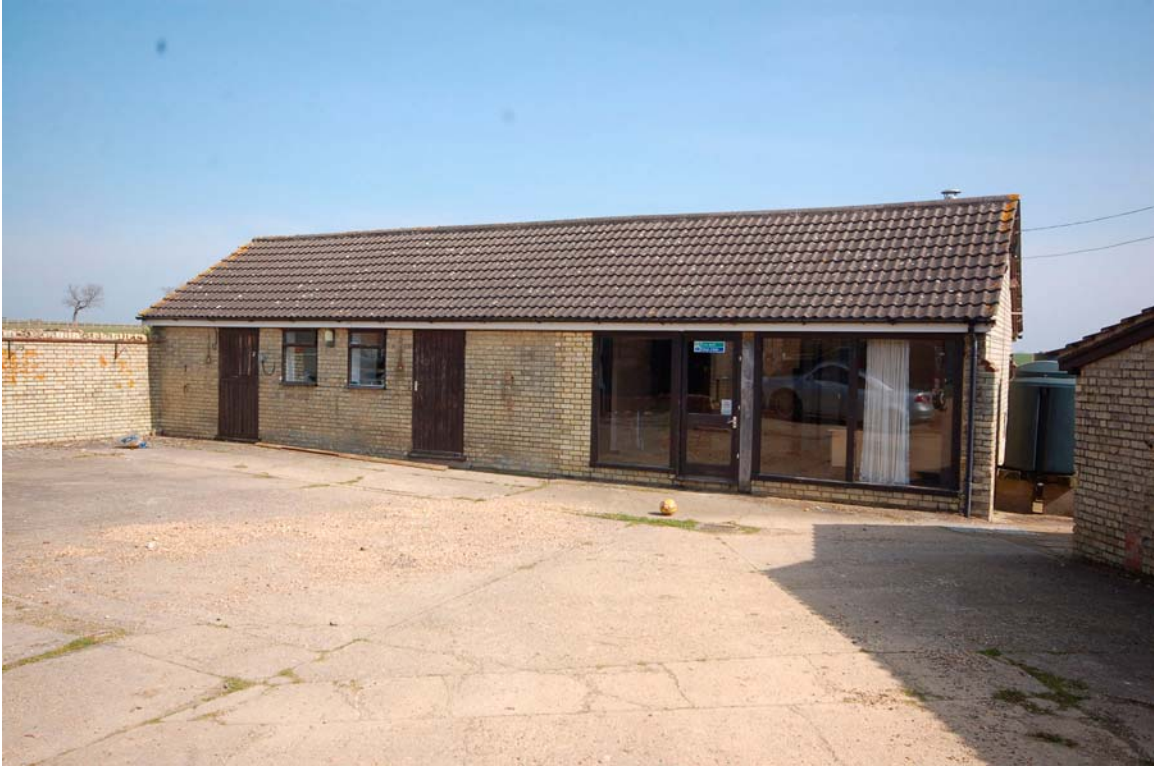
Plate 21 Stable and cart shed 11 viewed to north-east

kitchen area for the catering business. Externally it is clear that the office glazing on the western elevation (plate 21) has been inserted into the former cart shed opening and that the locations of the two doorways into the stables further to the north are probably original, even though the doors themselves are not. Modern windows have been inserted into the eastern elevation that was probably featureless apart from the brick buttresses that continue in the wall surrounding the farmhouse (plate 5, right).

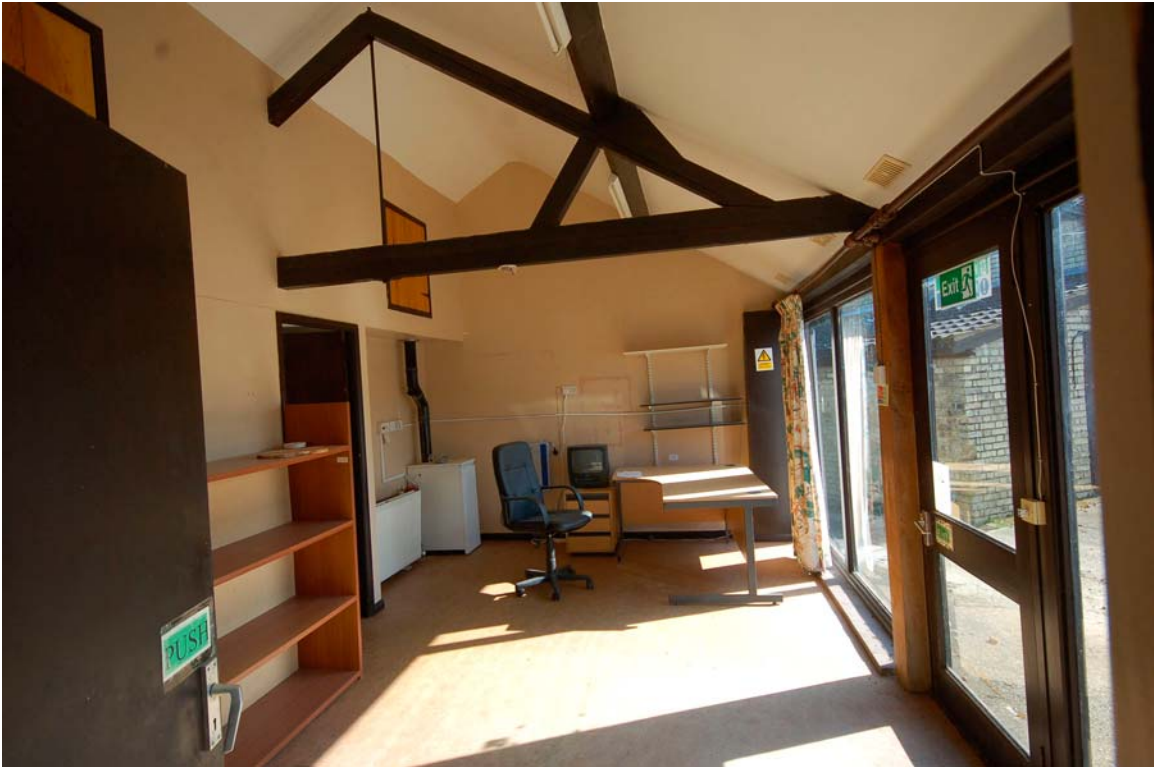
Plate 22 Interior of cart shed

Inside, the roof trusses have been used in a prominent way in the refurbished areas but there are no other exposed historic features (plate 22).
