**ALTERATION WORKS AT  
CHURCH OF ST MARY THE VIRGIN  
WIDDINGTON, ESSEX**

**ARCHAEOLOGICAL MONITORING & RECORDING**

Essex County Council  
Field Archaeology Unit

November 2012

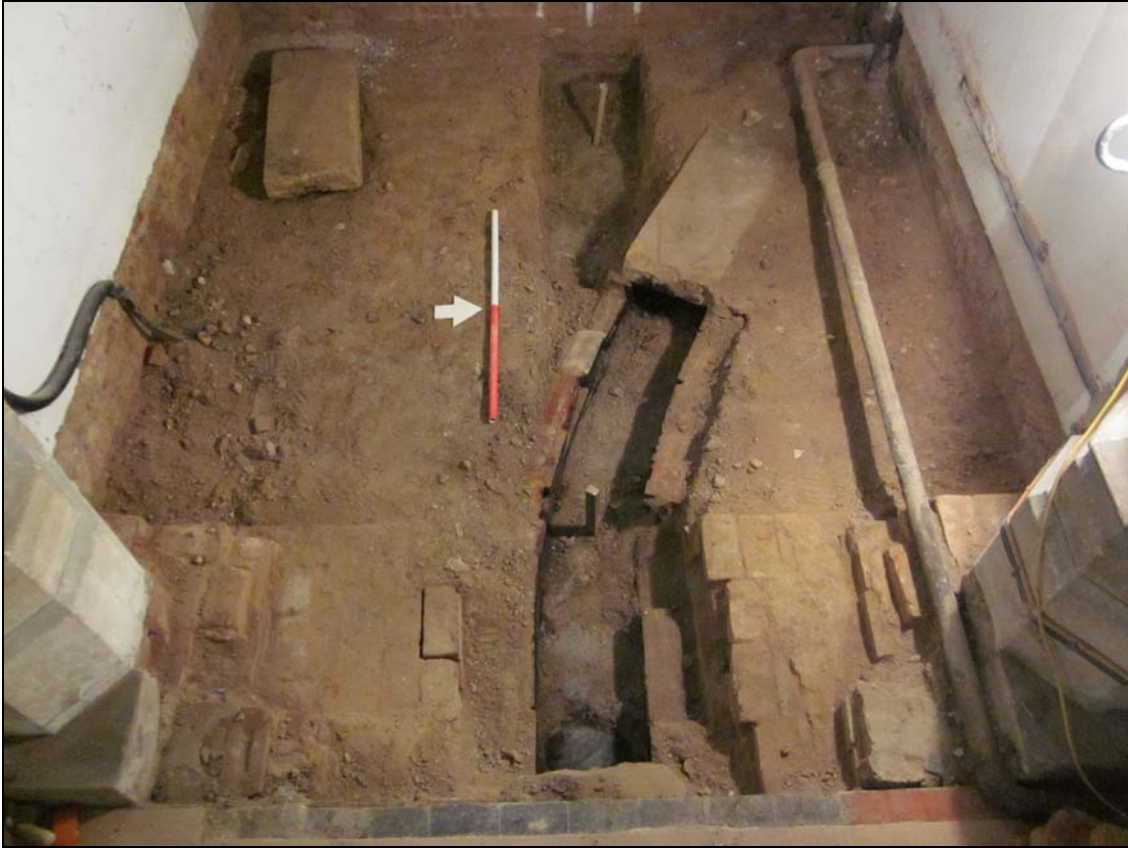
Plate 1. Tower floor, showing heating duct and brick foundations (1m scale)

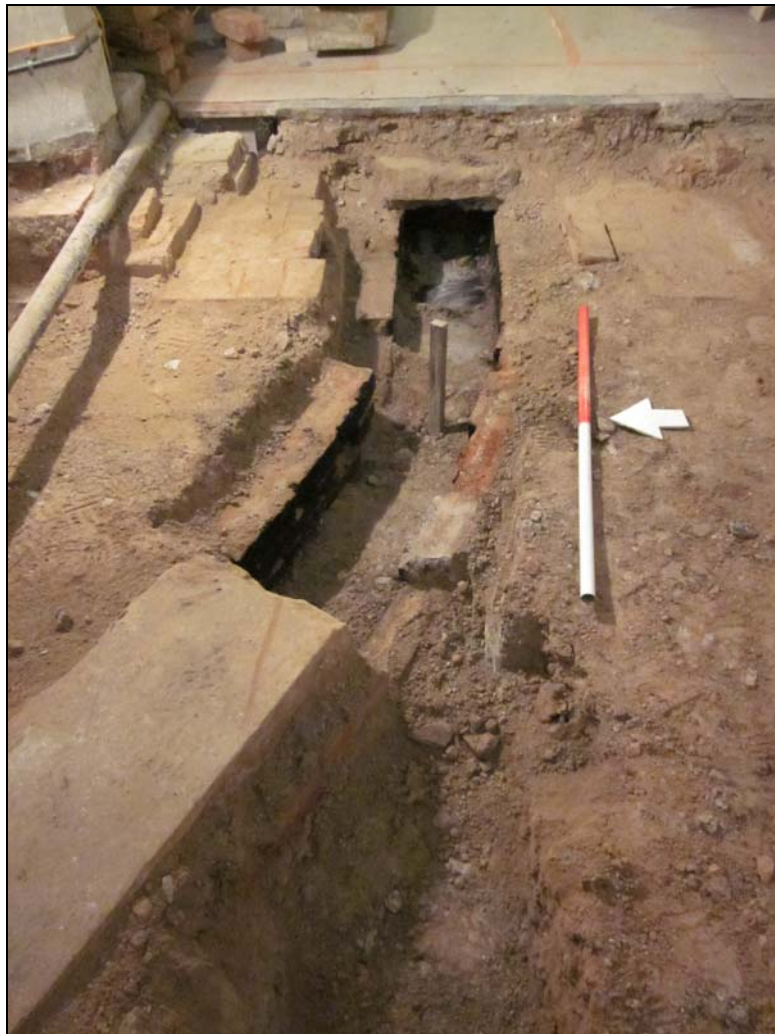
Plate 2. Heating duct detail, looking toward Nave (1m scale)

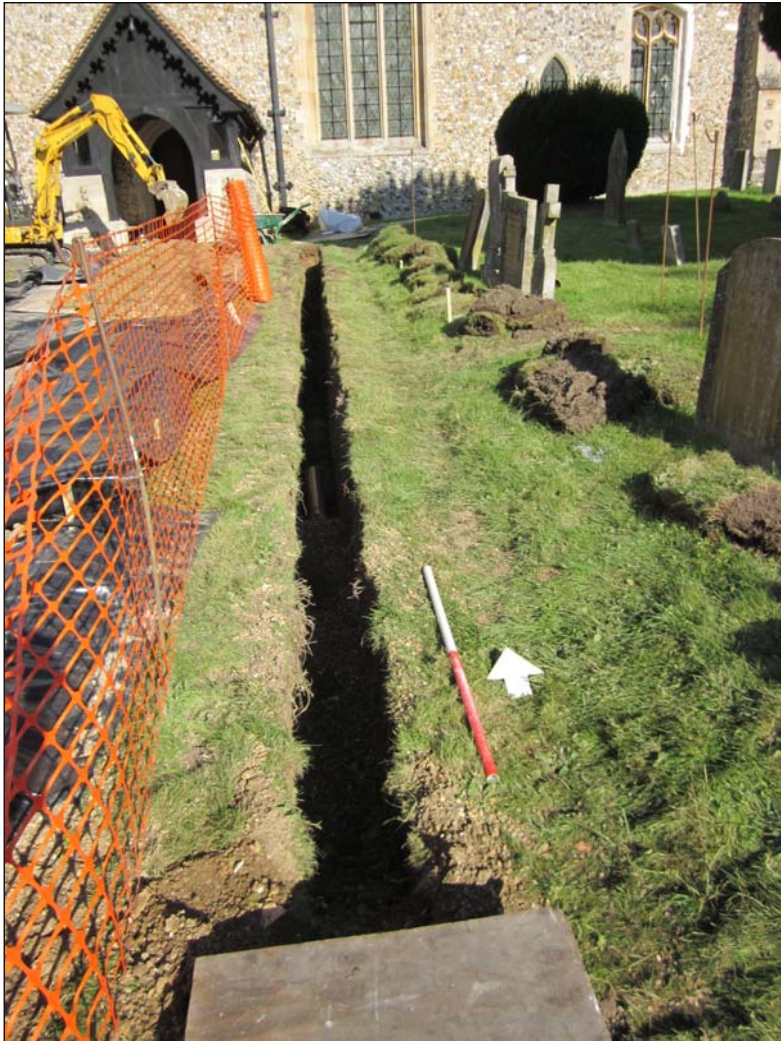
Plate 3. Sewer trench, looking north (1m scale)

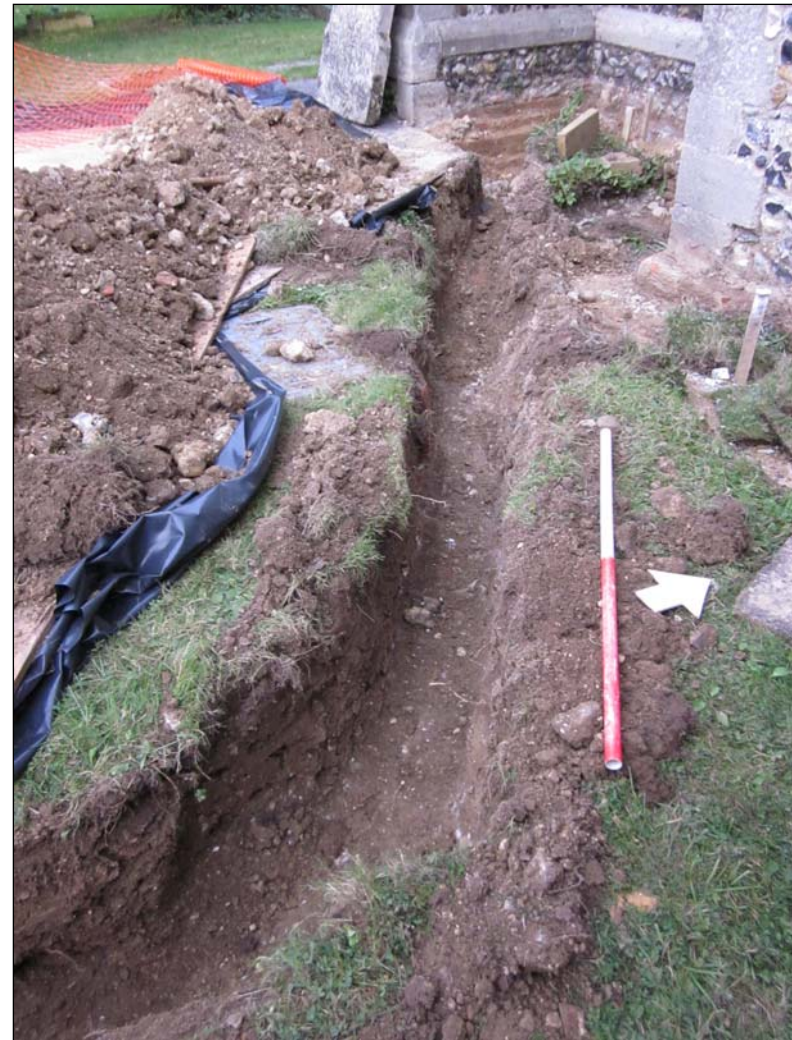
Plate 4. Sewer trench, at base of Tower, looking NW (1m scale)
