**FARM OUTBUILDING RANGE AT SWAYNES HALL  
MOLE HALL LANE  
WIDDINGTON  
ESSEX**

**HISTORIC BUILDING RECORD**

April 2013

**FAU Project No.:** 2663

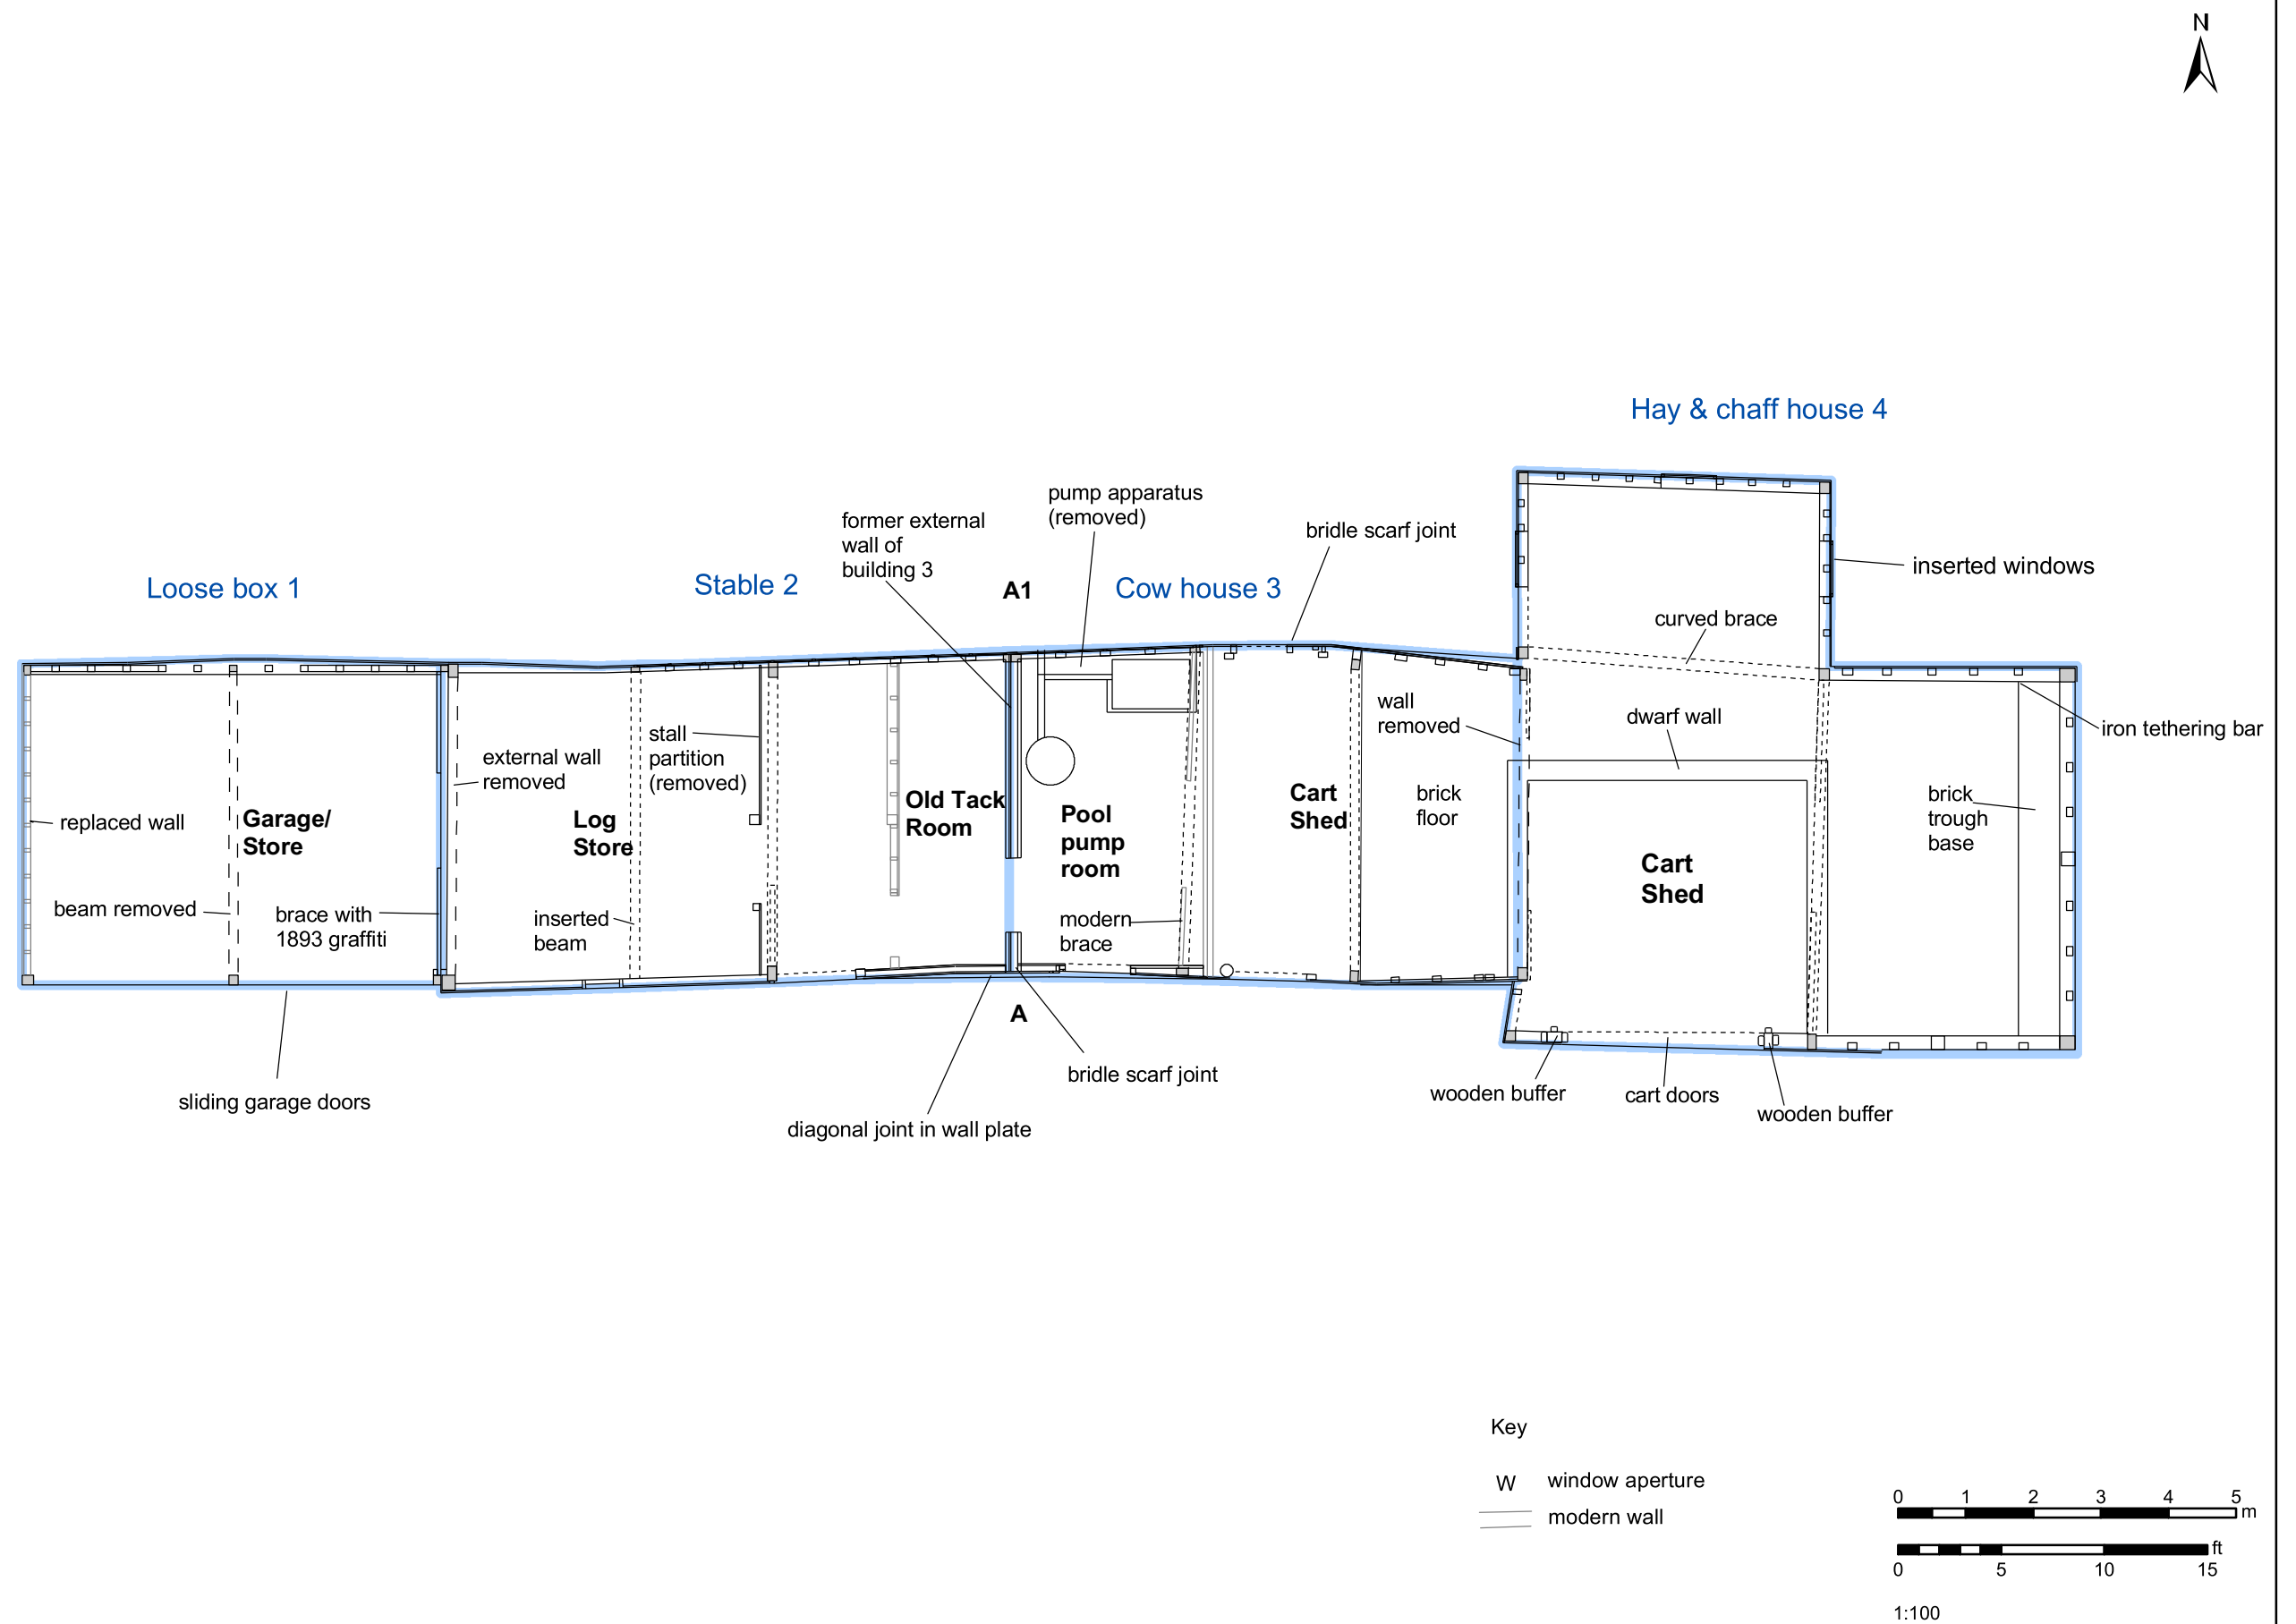
Fig.6. Floor plan of outbuilding range

The outbuildings form a linear structure measuring 30.5m by 5m with a small 2.7m long porch facing the swimming pool on the north side (fig. 5). The main part, which is thatched, is 5m high with a steep roof pitch of 50°, while the garage/store (1) on the west side, with its rebuilt pantile-clad roof, stands to only 4m and has a shallow 35° pitch. The ends of the roofs are gabled apart from the east end and north end of the porch, which are hipped.

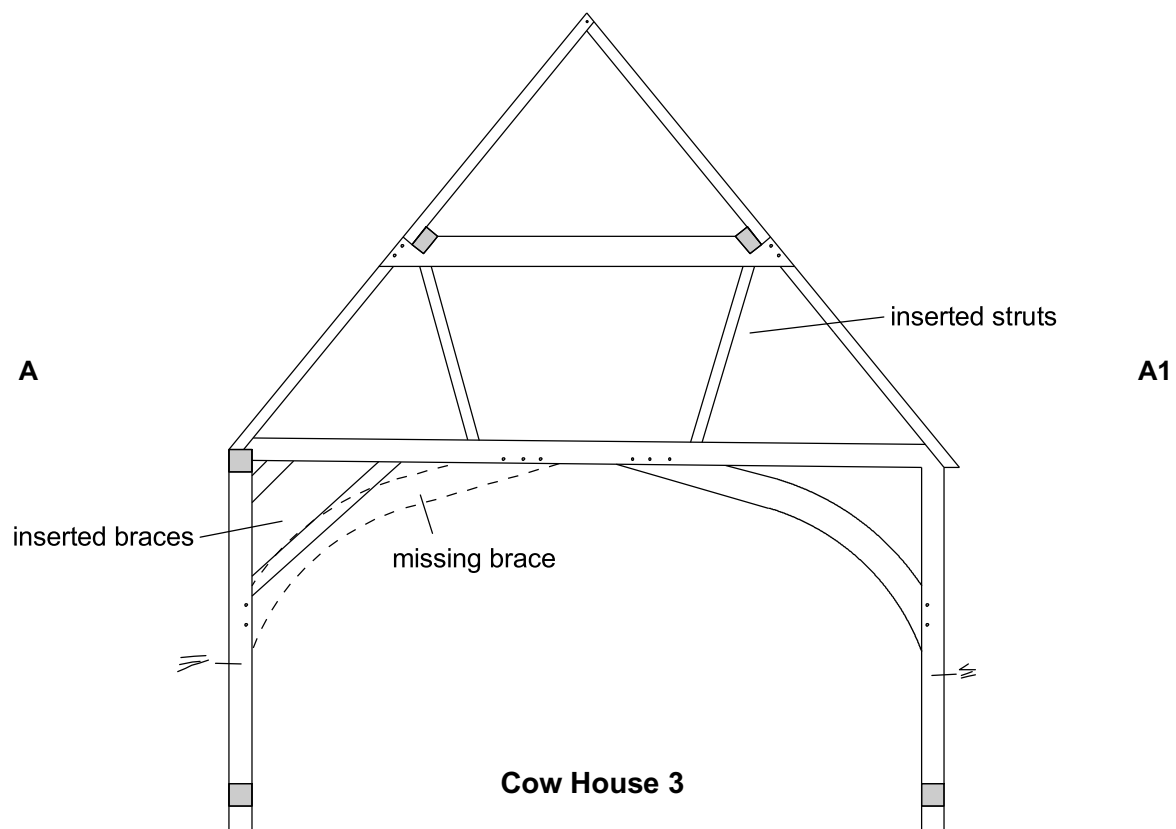
Fig.7. Cross section A - A1 through building 3

Main framing tends to comprise jowled bay posts. The only braced tie beam is the one dividing the central and east bays and drawn as section A-A1 (fig. 7 & plate 15). The surviving brace on the north side is curved and pegged twice to the post and three times to the beam. Scored carpenter's marks were observed on the two bay posts indicating the numbers 3 and 7 (fig. 7).

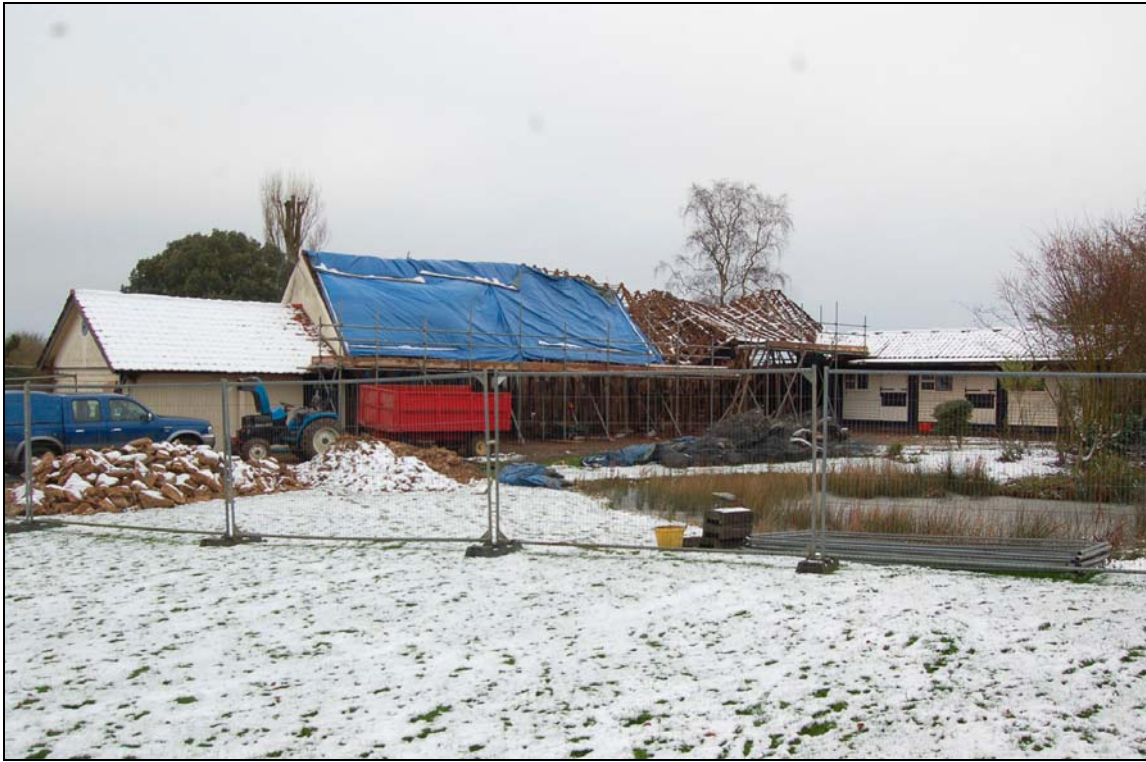
The main elevation comprises garage/store 1 at the west end, whose front has been replaced with sliding doors (plates 1 & 3). Beyond this is the log store/old tack room (building 2), which has a single off-centre half-heck door leading from the former stalls inside and a window/vent on the first bay (plate 3). Further to the east is the former cow-house (pool pump room and part of the cart shed 3) with its half-heck doors, now removed, on the first and second bays (plate 4). These doors were 1.10m-wide and of traditional ledged, braced and boarded form, fitted with cast iron strap hinges and were intended for animal access onto the yard. The cart doors at the east end leading into cart shed 4 had the same fixtures and were set below a quite shallow flat-topped hood (plate 4).

Plate 1 Outbuilding range and modern stable block viewed to north-east

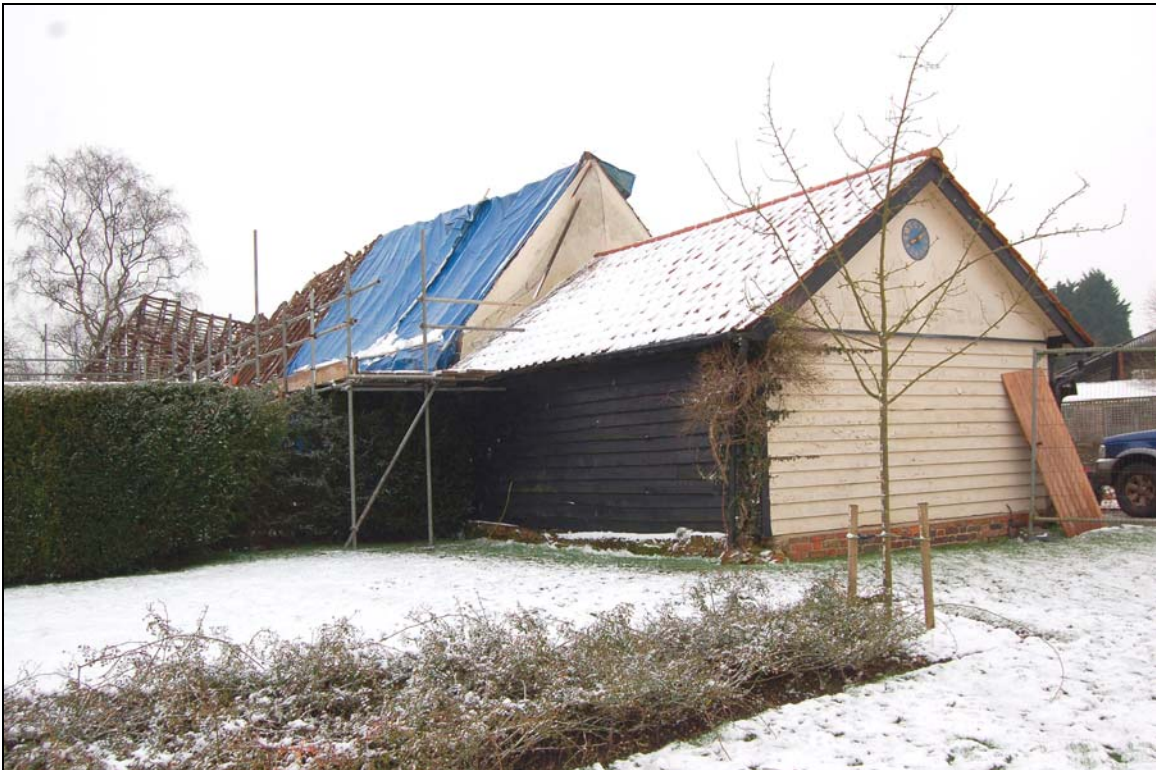
The boarding on this side continues up to the rear door at the west end of the cartshed (central bay of building 3) but there after, up to the western end bay of the log store, the upper panels are exposed and reinforced plastic sheeting placed behind (plate 6), either replacing plastered panels or wooden vents to the rear of the stable and cow house. From this point onwards the full weather-boarding resumes up to the end of the garage (plate 2).

Plate 2 Rear of outbuilding range viewed to south-east

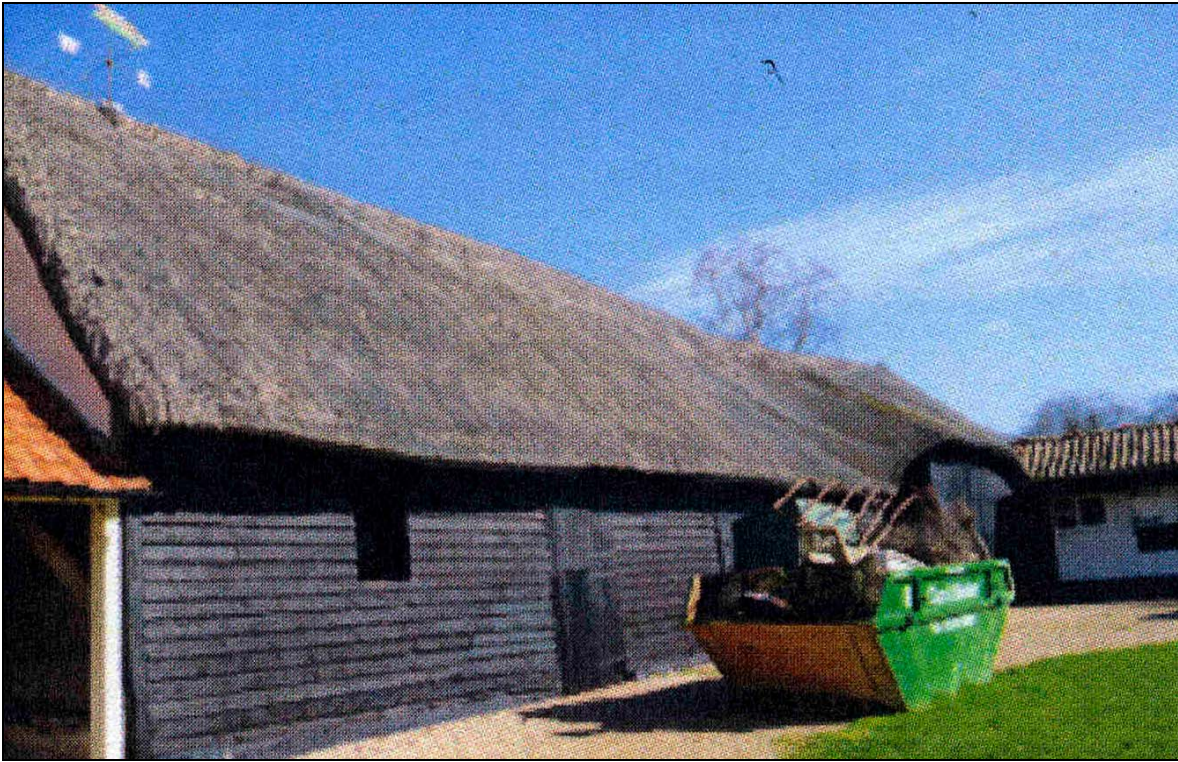
Plate 3 South elevation showing log store and tack room (SJ 2012)

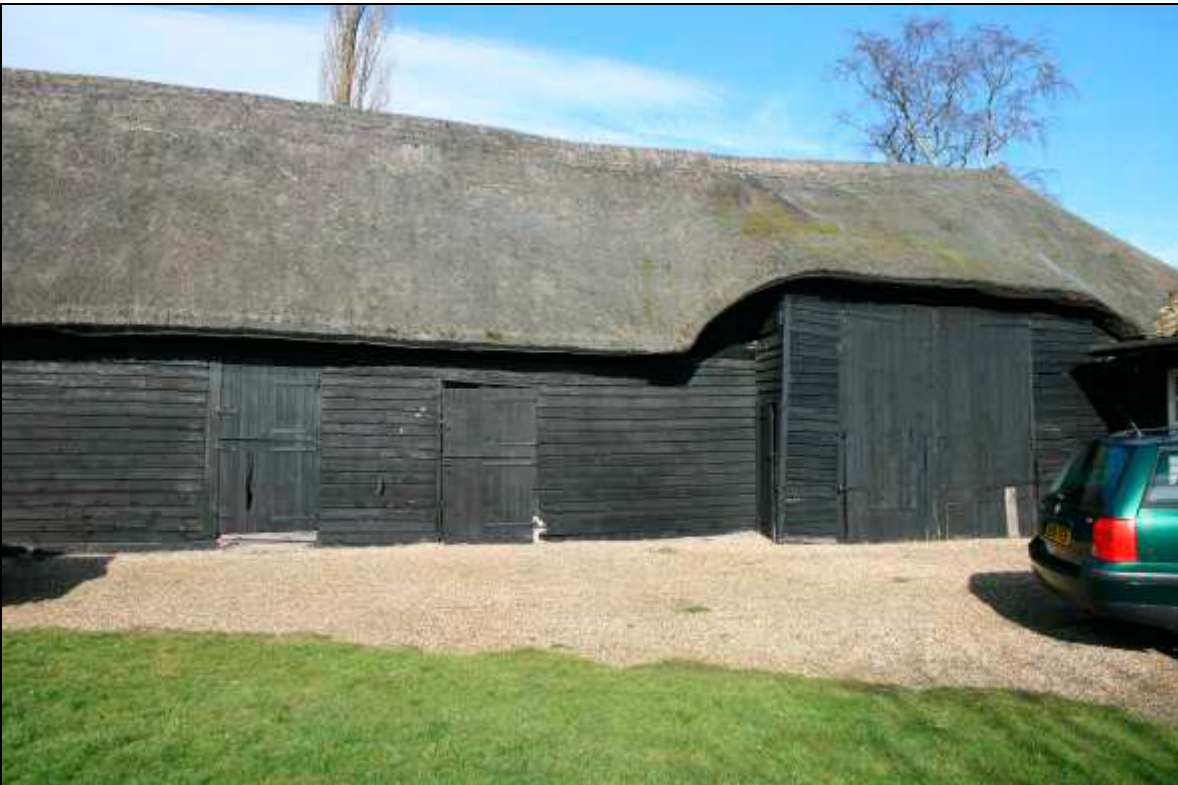
Plate 4 South elevation showing pool pump room and cart shed (EP 2012)

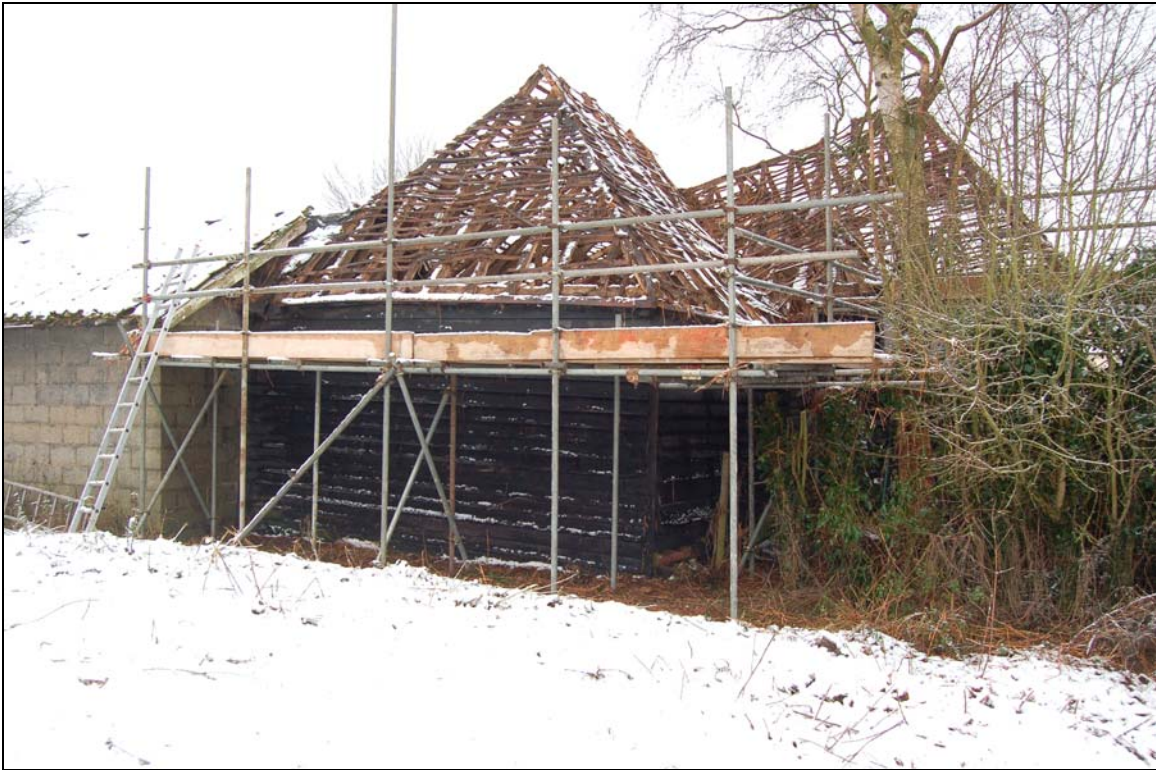
The east elevation (plate 5) faces onto rough ground at the back. It is fully-boarded underneath a hipped roof. The only feature is on the east side of the porch in the form of an inserted window below the eaves, which simply comprises panes of glass inserted between the exposed studs (fig. 5 & plate 22, internal).

Plate 5 Outbuilding range viewed to south-west

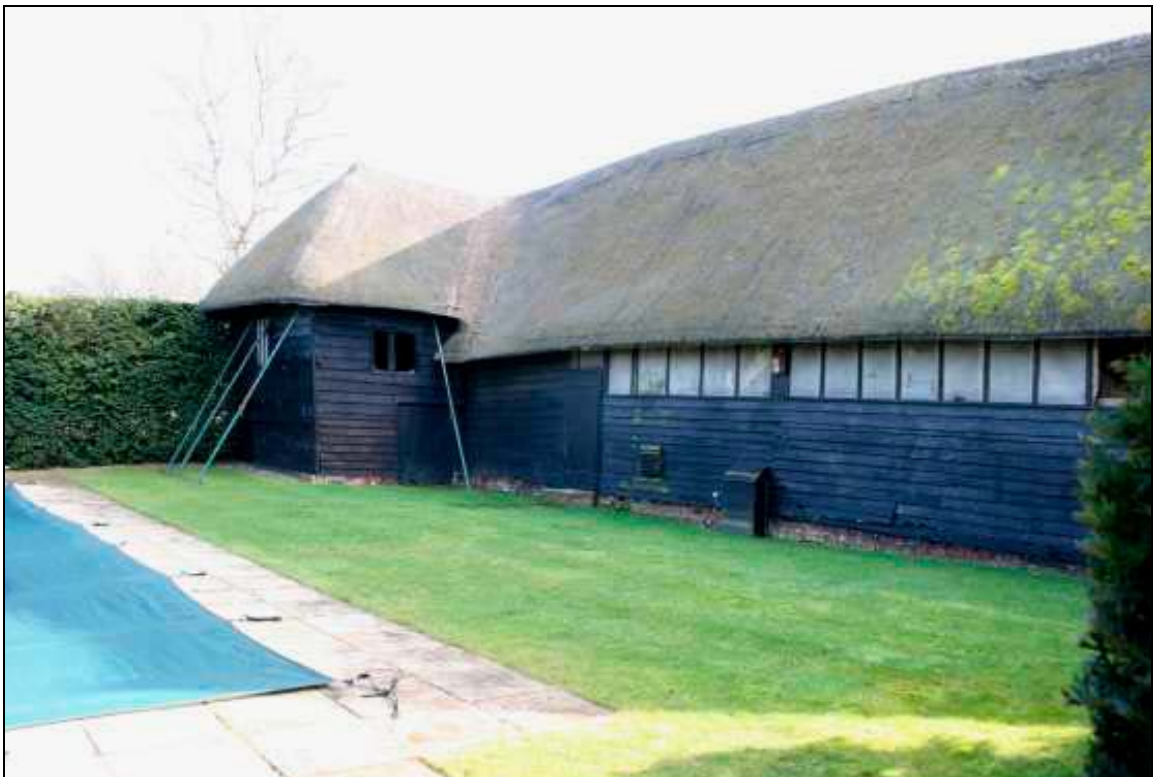
The north elevation stands behind the swimming pool in an exposed position and much of its historic fabric remained apart from the roof (plates 2 & 6). The short porch at the back of the cart shed, at the east end, was propped up with scaffold poles prior to conversion work beginning (plate 6). This part is fully-boarded apart from an inserted window. A small ledged, braced and battened door with long strap hinges and original closing fixtures is located on the west side of the porch and was the only door to remain *in-situ* at the time of the survey (plate 7). An inserted window as per that on the east side of the porch is located above it.

Plate 6 Outbuilding range viewed to south-east (EP 2012)

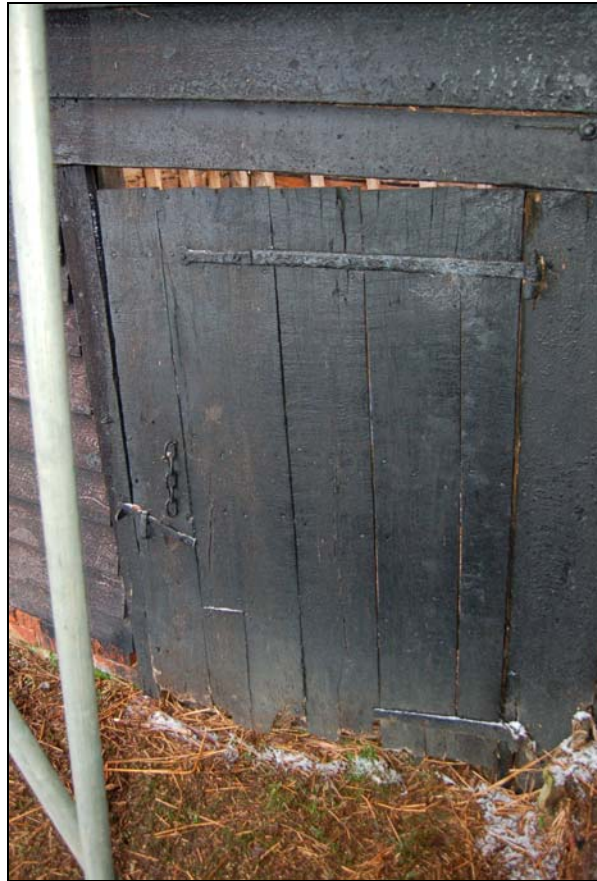
Plate 7 West door of porch

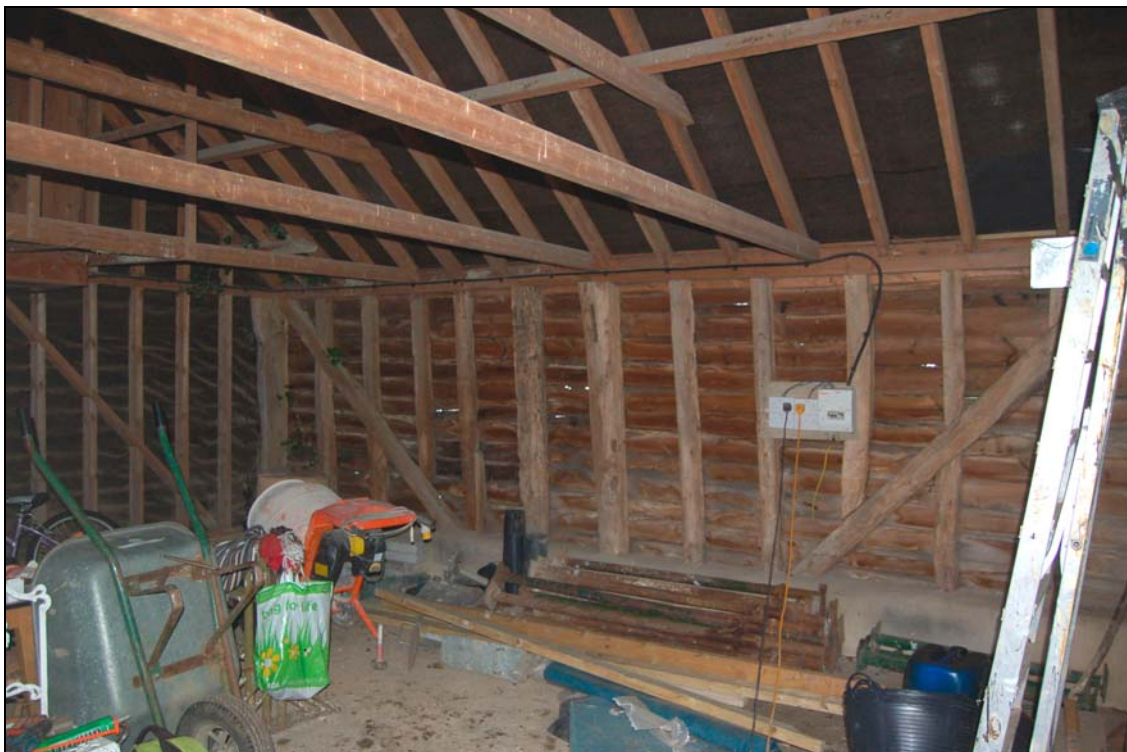
Original studwork comprises c.12cm by 10cm-wide studs (c.5 by 4-inch), five per bay, spaced at c.40cm intervals (plate 8). Again, the timbers are cut down suggesting the height of the building was reduced during the garage conversion from that of the rest of the range. It is uncertain whether the sill plate is original or not, since it is rendered over in cement. The studs have slightly uneven scantling and are divided by diagonal primary braces of equal size. Primary-bracing is where the brace is inserted first and the studwork nailed onto it and was used from the 16th-century throughout the post-medieval period.

Plate 8 Interior of garage viewed to north-west

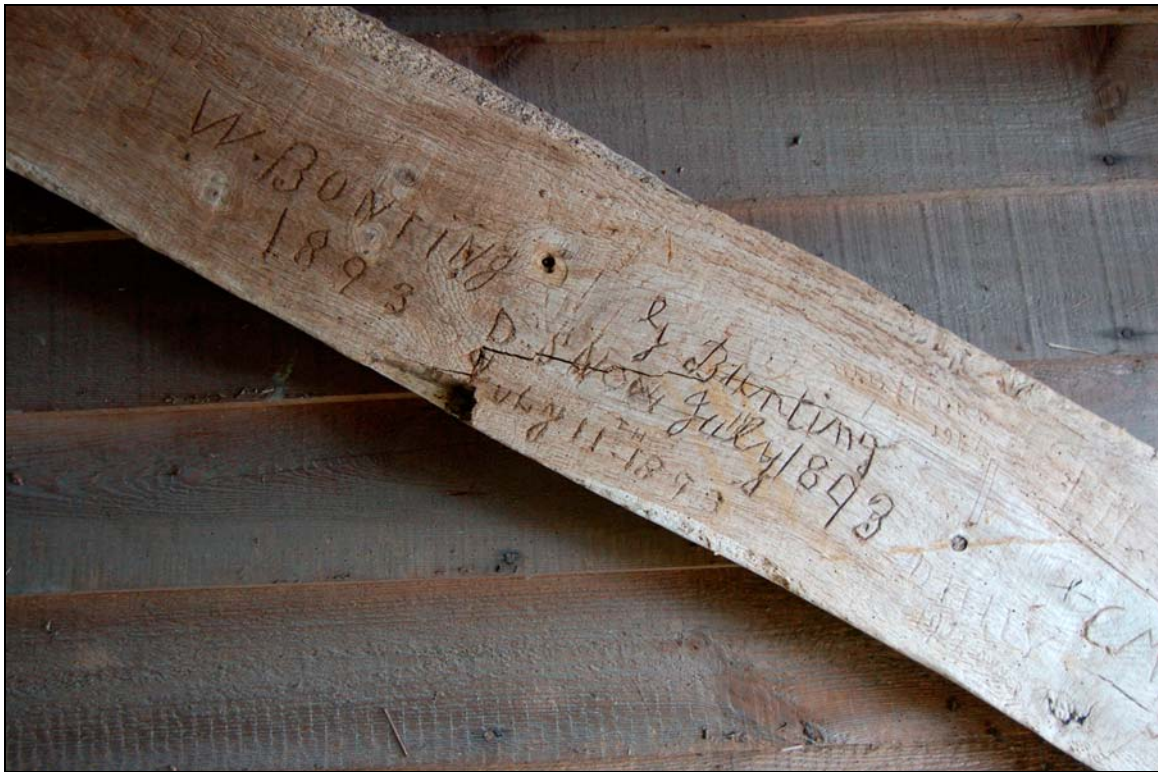
Plate 9 Craved graffiti on collar inside garage

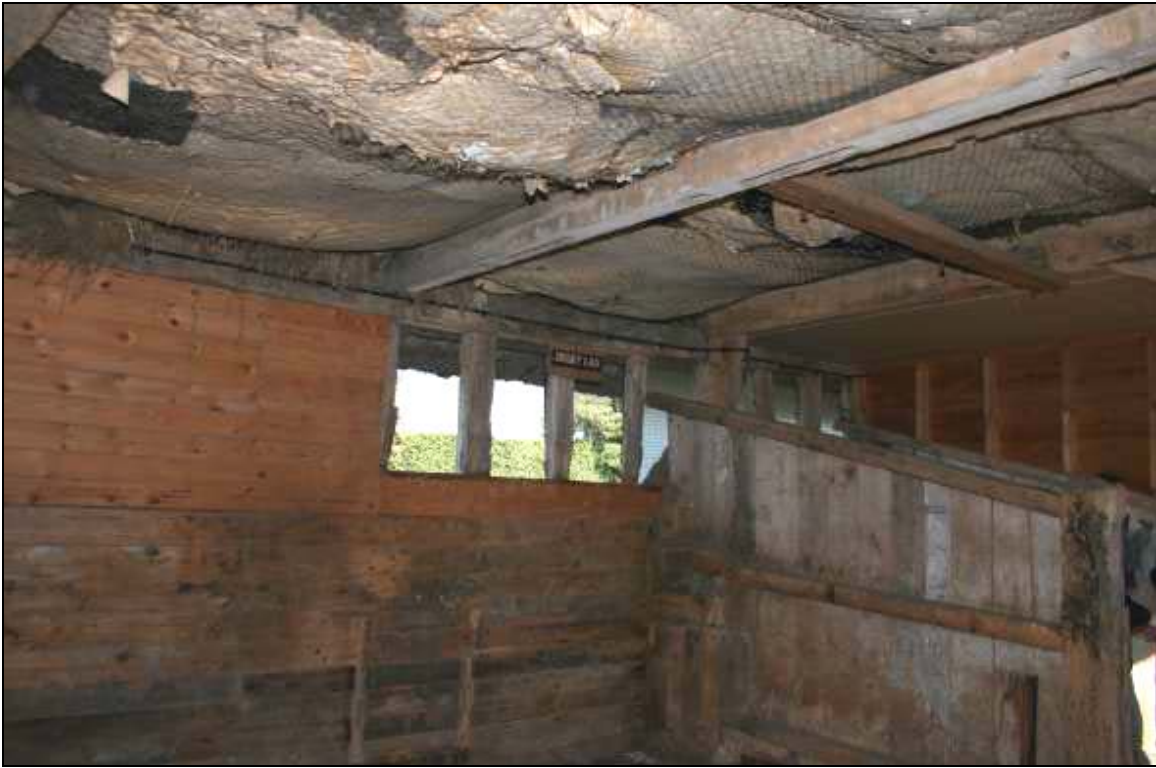
which was removed prior to the survey. The existing concrete floor was being broken out at the time of the survey and no earlier floor surfaces were apparent. Plate 11 depicts modern boarding on the upper half of the walls that appears to confirm this side was either vented or plastered in the historic period.

Plate 11 Stall inside tack room, viewed to north-east

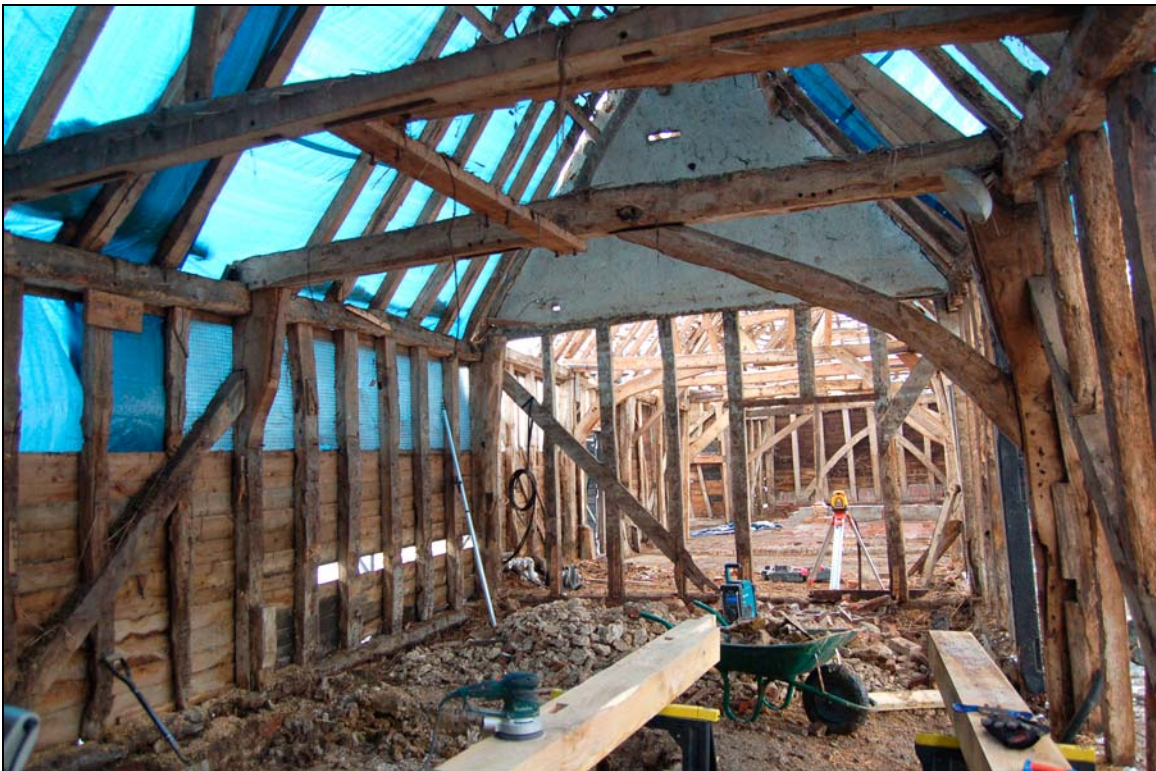
The second bay is narrower at 3.6m and built in un-braced studwork of similar-sized scantling to the first but with smaller gaps, commonly 32-35cm (plate 12).

Plate 12 Building 2 viewed to east (outer wall of building 3)

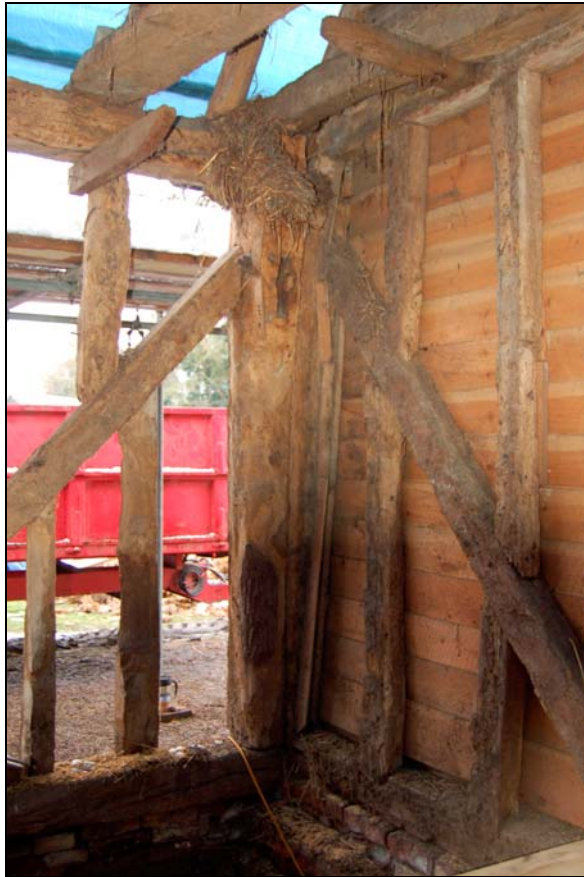
There are no scarf joints to the wall plates and the sills had rotted. The wall plate of building 2 is attached to building 3 (the pool pump room) by an un-pegged crude diagonal joint (fig. 5). Therefore the east wall represents the external west wall of building 3, which is the earliest of the structures. It is interesting to note the lath and plastered external gable, with the regularity and number of nail holes on the wall below it suggesting this end was plastered too in its original form (plate 12). Wooden harness racks are located in the north-east corner, where the posts of the two buildings join (plate 13).

Plate 13 Harness racks in former stable (top)

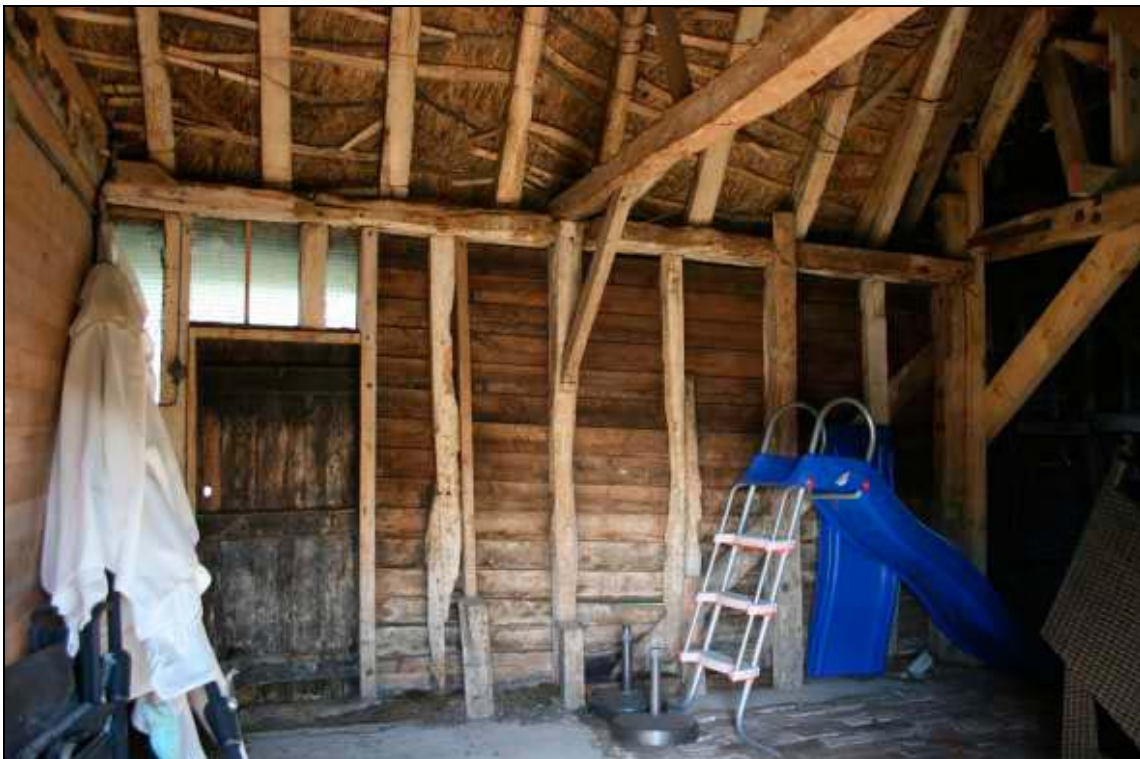
Plate 14 Central bay of building 3 viewed to north (EP 2012)

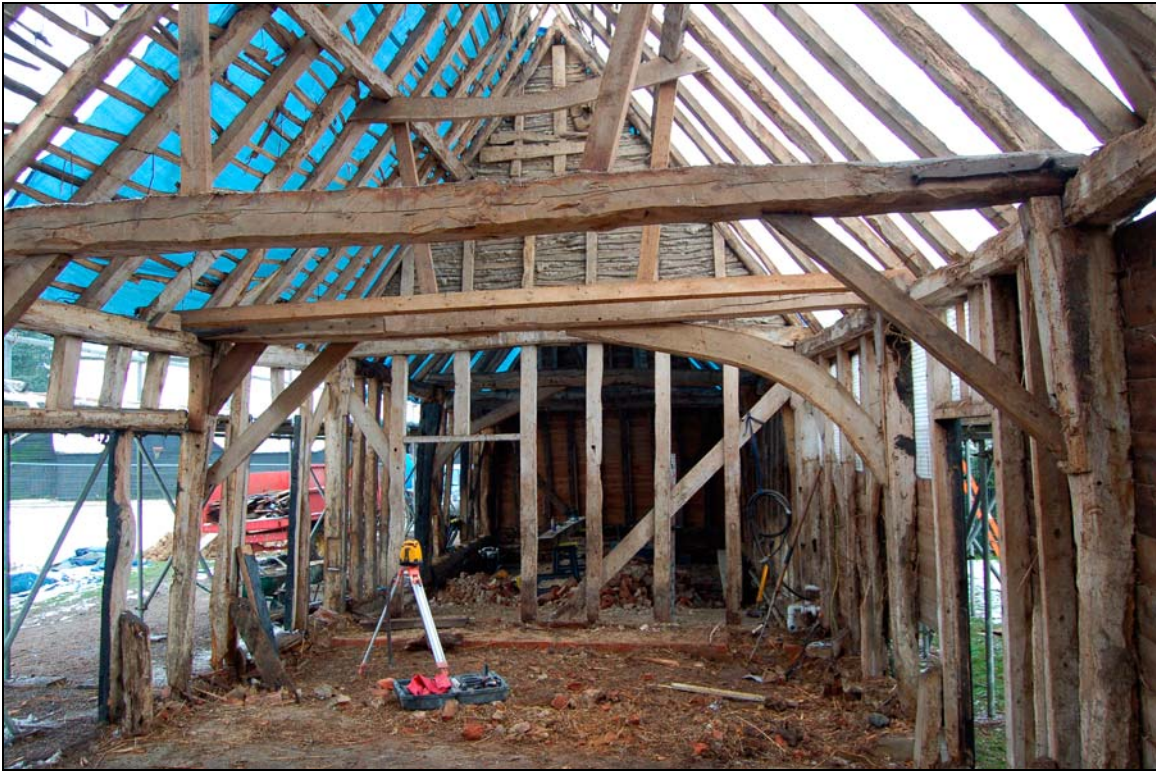
The original layout had three narrow 2.5m-wide bays, with animal doorways located on the south and west sides and a smaller entrance along the north wall (fig. 5 & plate 15). The east end wall was removed after building 4 was added and the brick floor in the east bay (plate 16) is more likely to be Victorian in date, possibly a milking area.

The roof frame is the same collar clasped purlin roof as building 2, but with later raking struts added below the purlins to counteract the sagging of the roof (fig. 5 & plate 15). Diagonal wind braces are nailed to the rafters at either end on both sides, a feature only found in building 3 (plate 18).

Plate 15 Building 3 viewed to west (former stable)

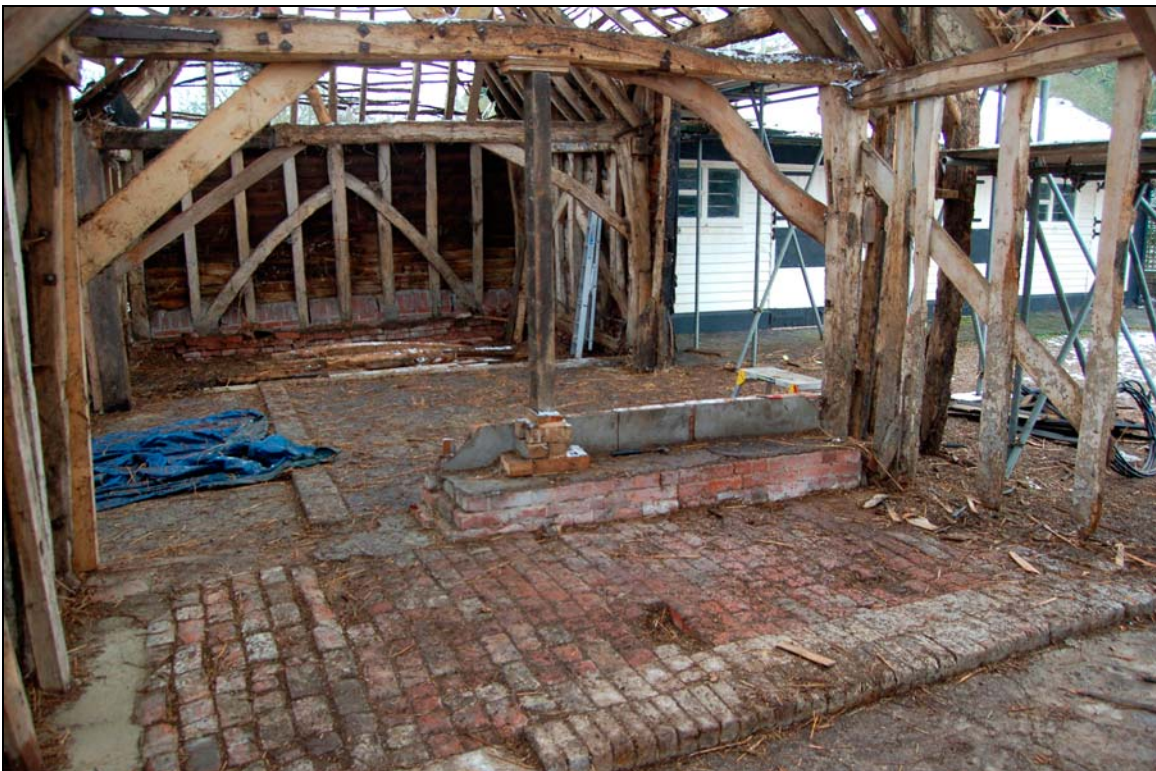
Plate 16 Interior of buildings 3 and 4 viewed to east

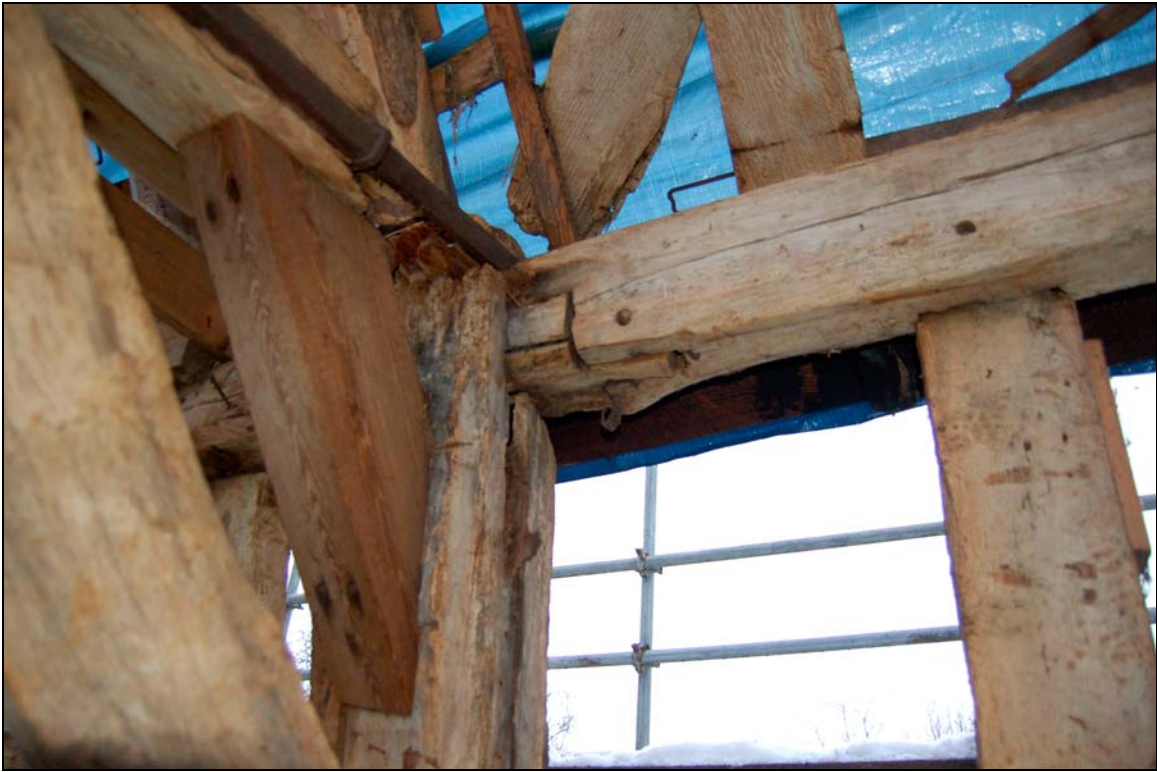
Edge-halved and bridled scarf joints connect the wall plates on the north and south sides of the building (fig. 5), which is a medieval and early post-medieval joinery form (fig. 5 & plate 17). The last recorded in Essex dates to 1650 (Hewett 1969). In the Swaynes Hall case the bridles are short, inferring a later date.

Plate 17 Bladed scarf joint in southern wall plate of building 3

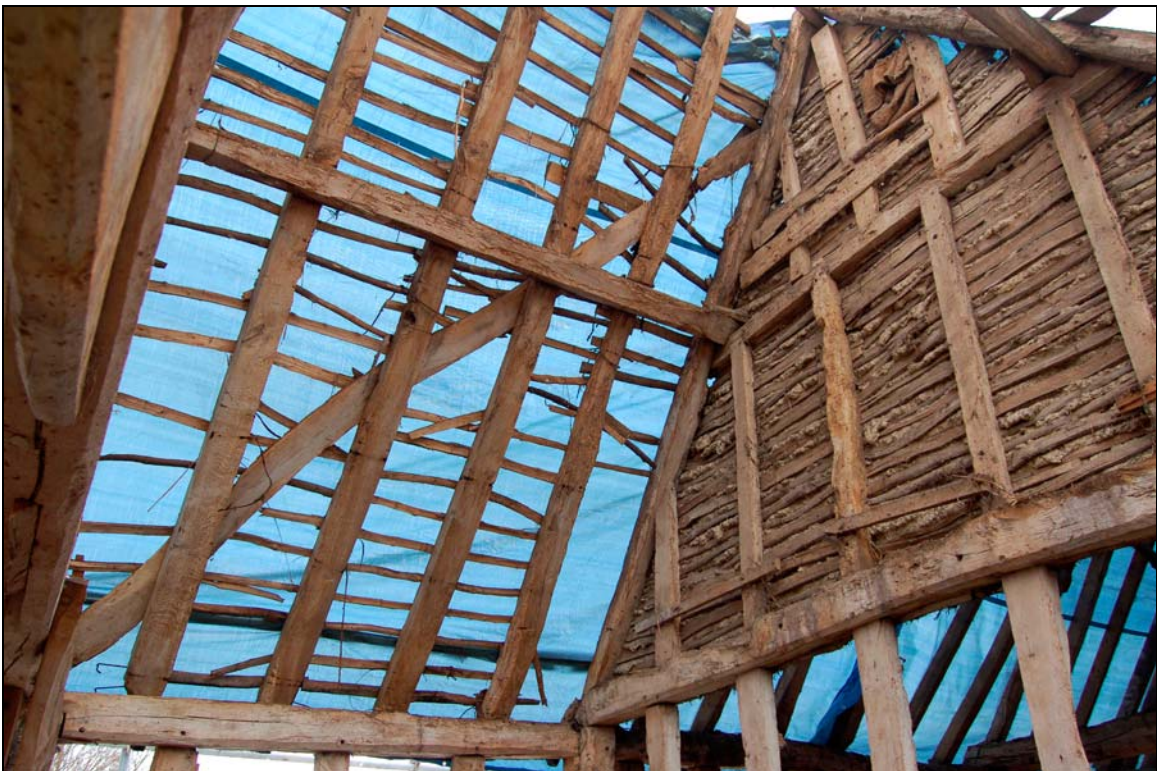
Plate 18 Wind-brace in roof of building 3

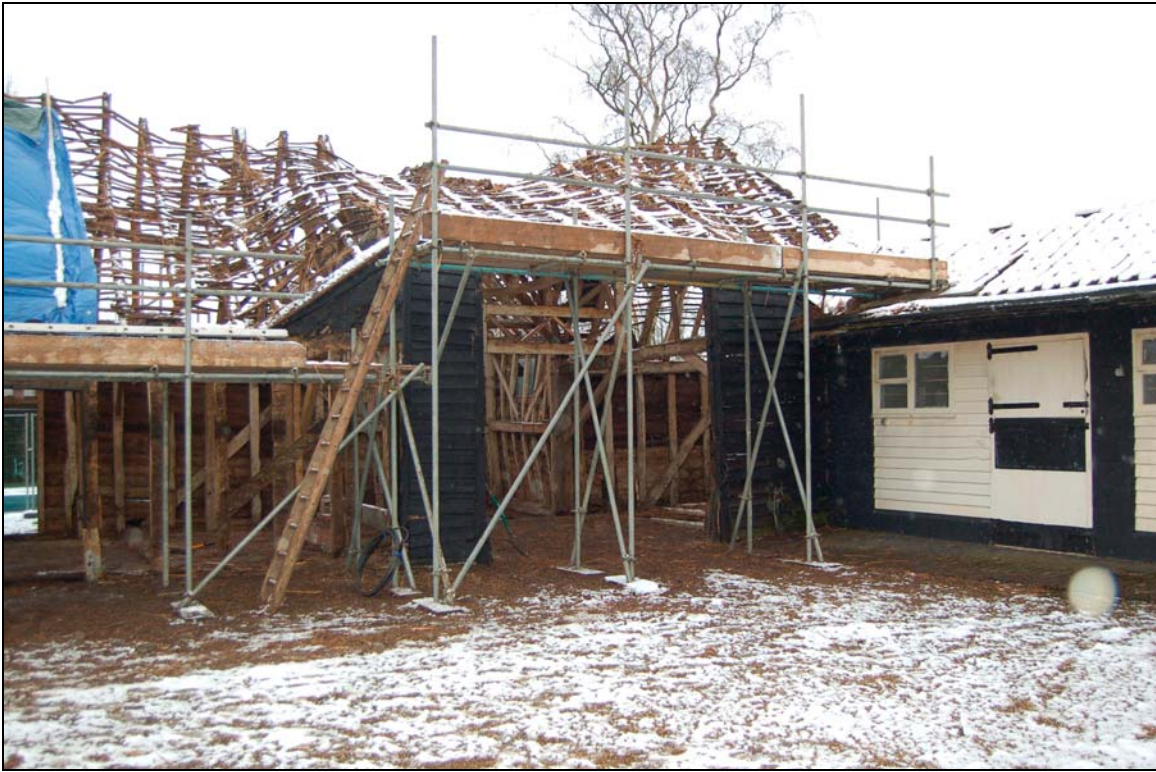
The central bay (plate 19) is the widest of the three, at 4.2m, to admit carts for unloading. No studwork remains of the former east wall of building 3 to which this is joined and it is unclear when this was removed. The former east end of building 3 has a secondary serpentine brace nailed onto the south side. The post and brace on the north end of the wall were replaced in the modern period to counteract the lean of the porch (plate 20). The cart doors were set slightly higher than the rest of the building and the base of the door jambs are protected from wear and tear on three sides by wooden wheel buffers (fig. 5). The cart entrance is clearly built over the end of building 3 and bolted onto it.

The roof frame is the same double-pegged collar clasped purlin roof seen in buildings 2 and 3 with additional raking posts supporting the purlins, again a later feature. The roof at this end of the building has failed and several repairs to the frame have been made in modern times, primarily a section of cross-framing over the central bay to support a sagging purlin (plate 21) and bolted V-shaped bracing against the adjoining wall with building 3 to strengthen this end (plate 19).

Plate 19 Cart shed entrance

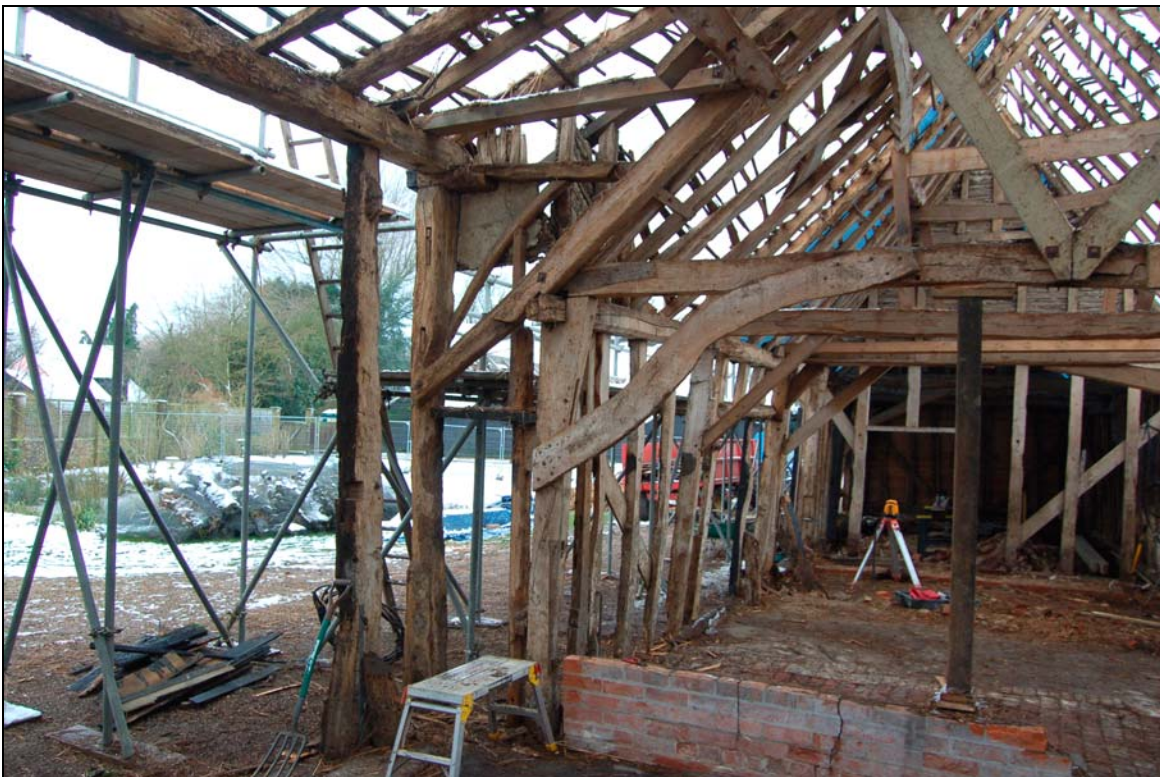
Plate 20 Detail of cart door construction
