**FARM OUTBUILDING RANGE AT SWAYNES HALL  
MOLE HALL LANE  
WIDDINGTON  
ESSEX**

**HISTORIC BUILDING RECORD**

April 2013

**FAU Project No.:** 2663

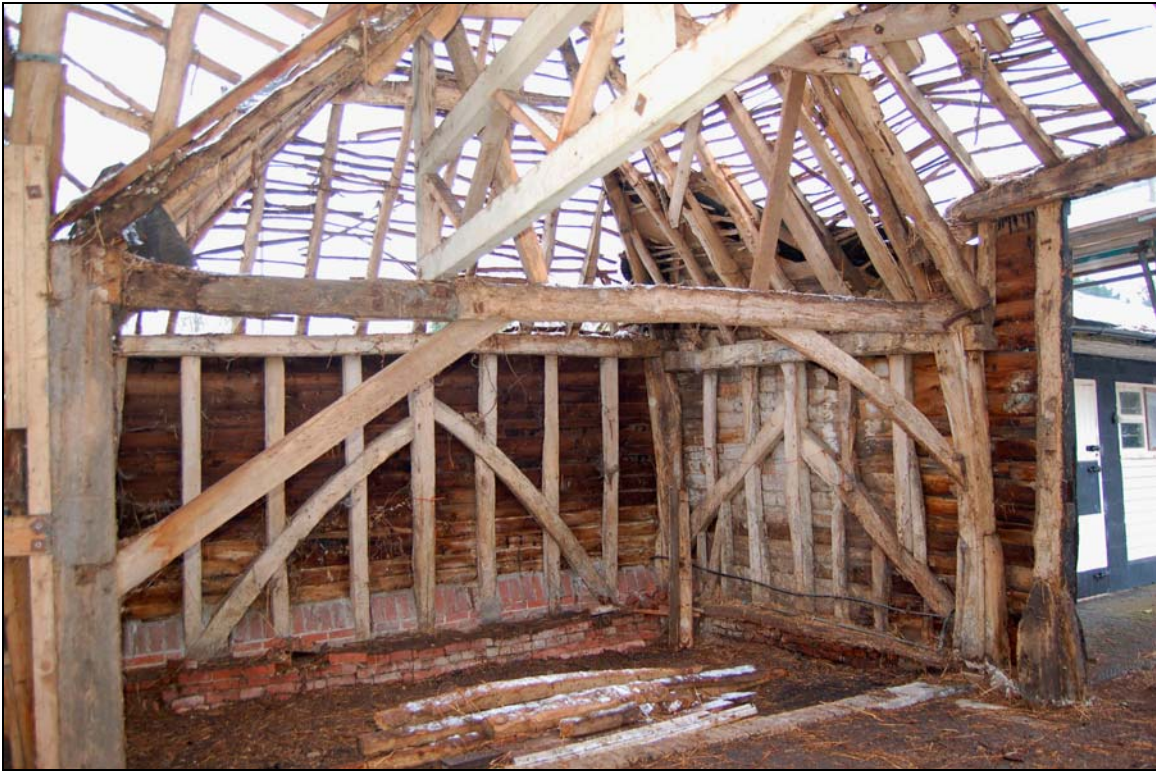
Plate 21 East bay of cart shed

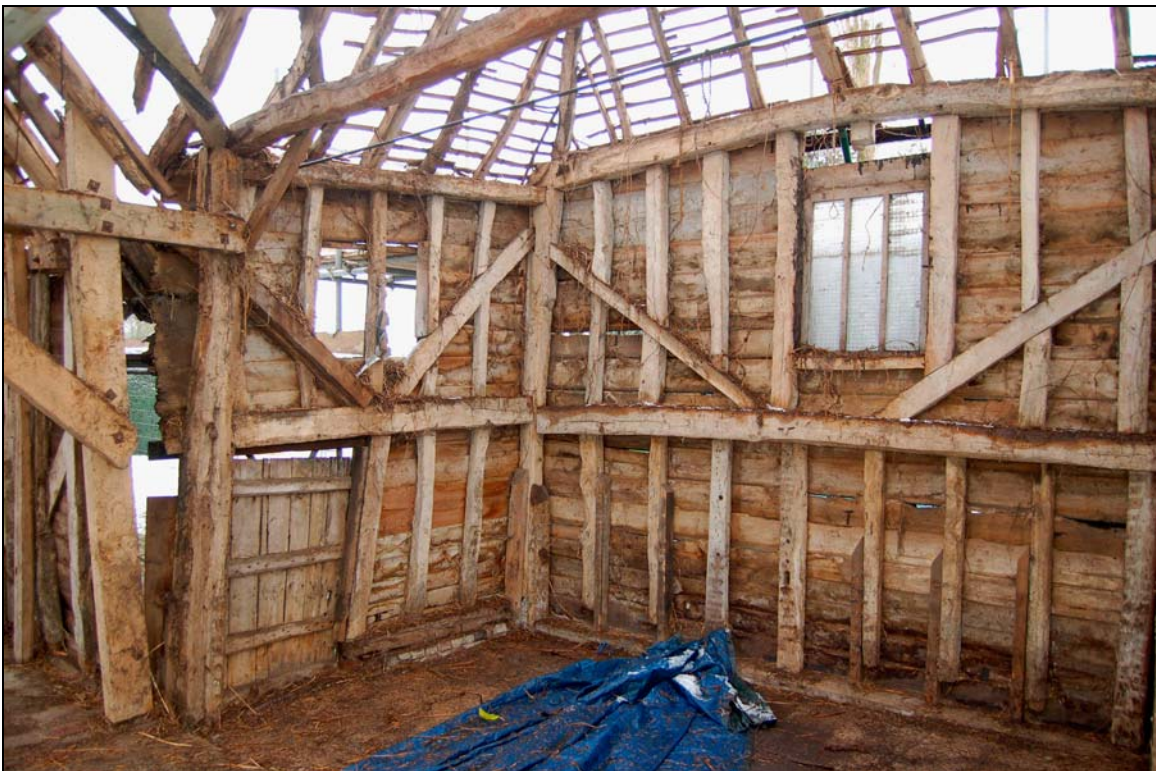
The east elevation (plate 5) faces onto rough ground at the back. It is fully-boarded underneath a hipped roof. The only feature is on the east side of the porch in the form of an inserted window below the eaves, which simply comprises panes of glass inserted between the exposed studs (fig. 5 & plate 22, internal).

Plate 22 Cart shed porch viewed to north-west
