**CHURCH OF ST GERMAIN, BOBBINGWORTH, ESSEX
REPLACEMENT FLOOR TO VESTRY**

ARCHAEOLOGICAL MONITORING AND RECORDING

**Essex County Council
Field Archaeology Unit**

APRIL 2013

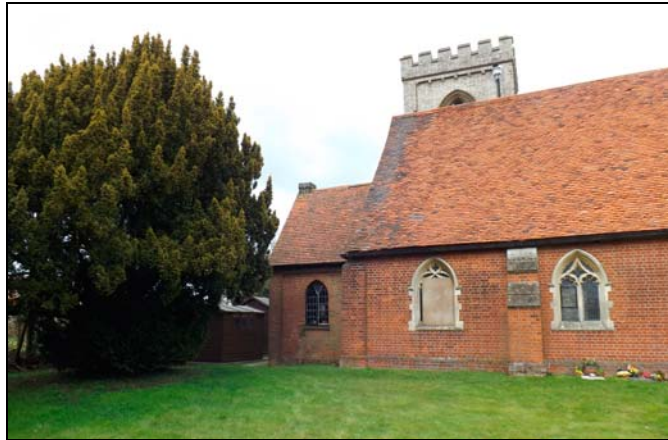
Plate 1: Vestry location at the west end of the nave, looking north.

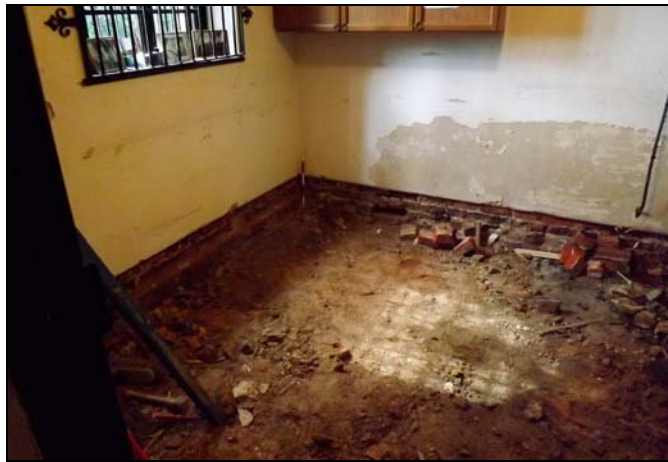
Plate 2: Vestry interior after the removal of existing timber flooring, looking west.

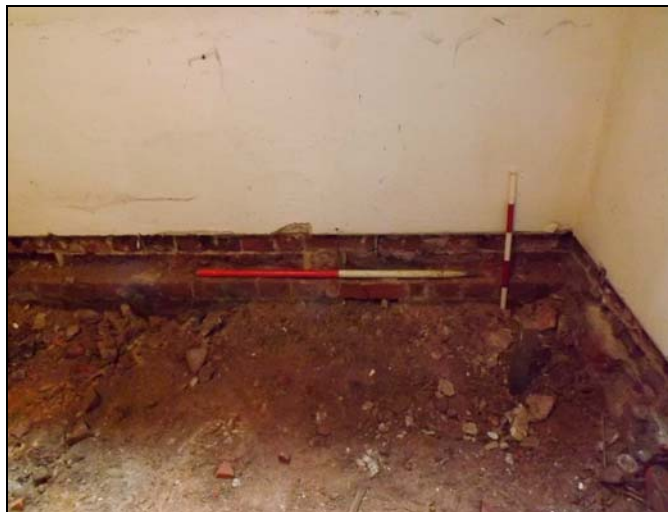
Plate 3: Detail showing depth of cavity beneath timber flooring, looking south.
(1 and 0.5m scale).
