**BURY FARM, BURY LANE, EPPING UPLAND
ESSEX**

HISTORIC BUILDING RECORDING

FAU Project No.: 1499

Site Code: EPBF 05

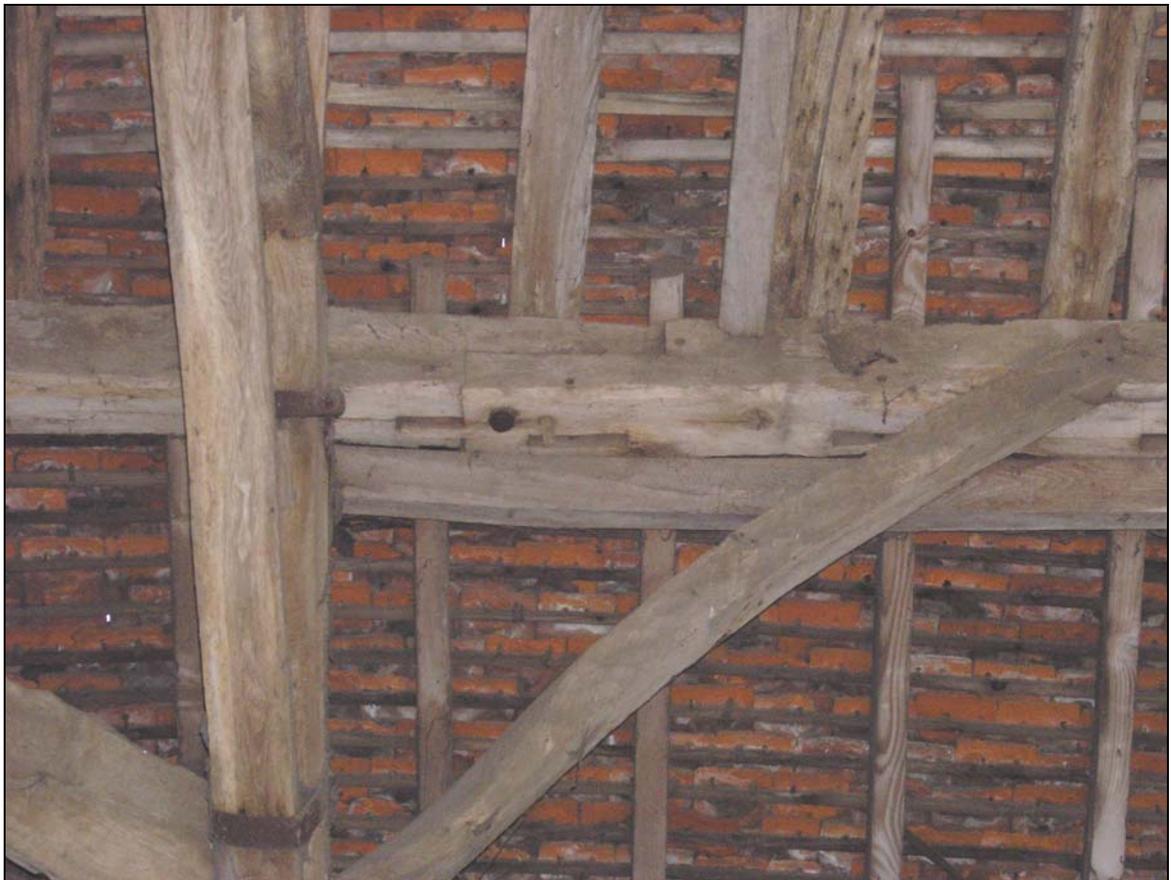
probably later in date (described as 'archaic' in Appendix 1). Empty stud mortices on the south-west aisle plate soffit indicate the earlier studded rear wall that presumably pre-dated the rear porch/lean-to (plates 6 & 7 (partly obscured in 7)). Unless the porch was original and those mortices on the plate on the south-west of the midstrey belong to an earlier structure. No structural evidence of a rear porch was found in the survey. Either way, the shallow, unpegged, mortices represent wall framing largely consistent with the north-east wall that contains reused medieval studwork. Empty mortices on the tie beam between bays 2 and 3 (fig. 6), allied with facing mid rail mortices on the arcade posts either side, indicate a former dividing wall between bays 2 and 3 (fig. plate 7); useful to keep animals separate or store different crops.

Plate 6 Archaic bridle scarf joint in south-west arcade plate

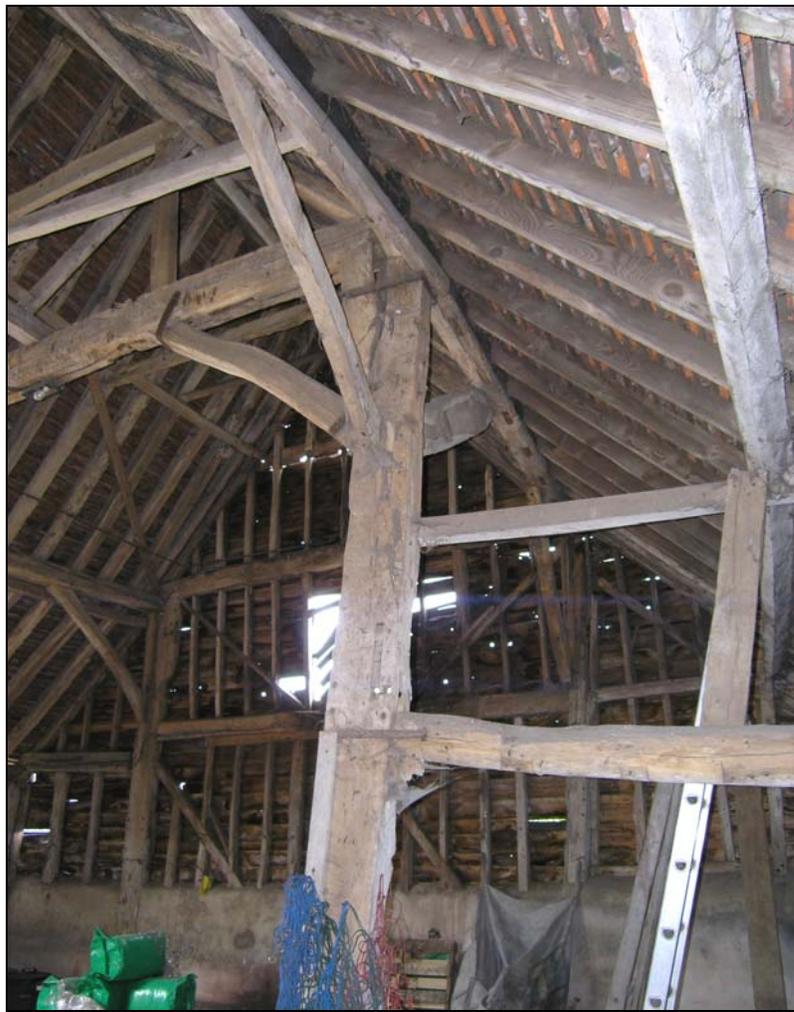
Plate 7 Empty mortices for midrail and studs for original south-west (rear) wall

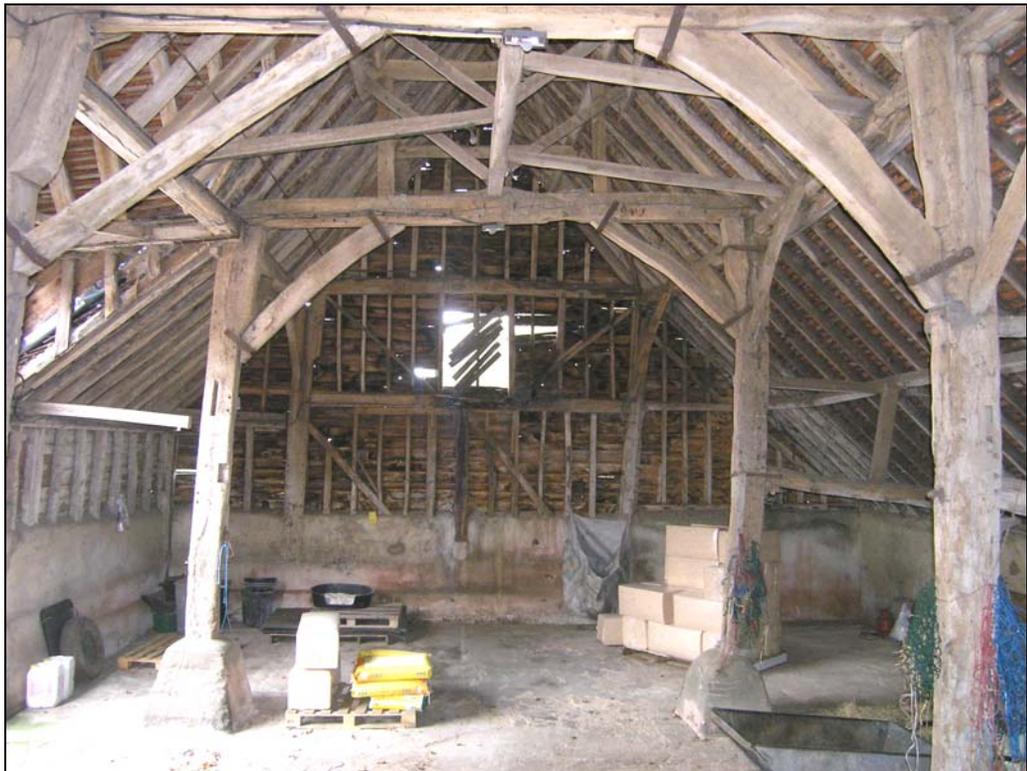
Wall framing on the opposing south-east wall (plate 8) again comprises late primary bracing and a replaced, formerly jowled, post, fitted contemporary with the rear aisle. Empty pegged mortices on the inside of the south-east arcade post suggest the mid rail was heightened when the rear aisle was constructed, or may simply show that the building from which the posts were reused had a lower aisle. There are some machine-sawn 19th-century studs at this and the other end; the product of ongoing maintenance to the barn. Such timbers are positioned either side of the louvred windows, indicating a contemporary insertion.

Plate 8 Barn 1 viewed to south-east end

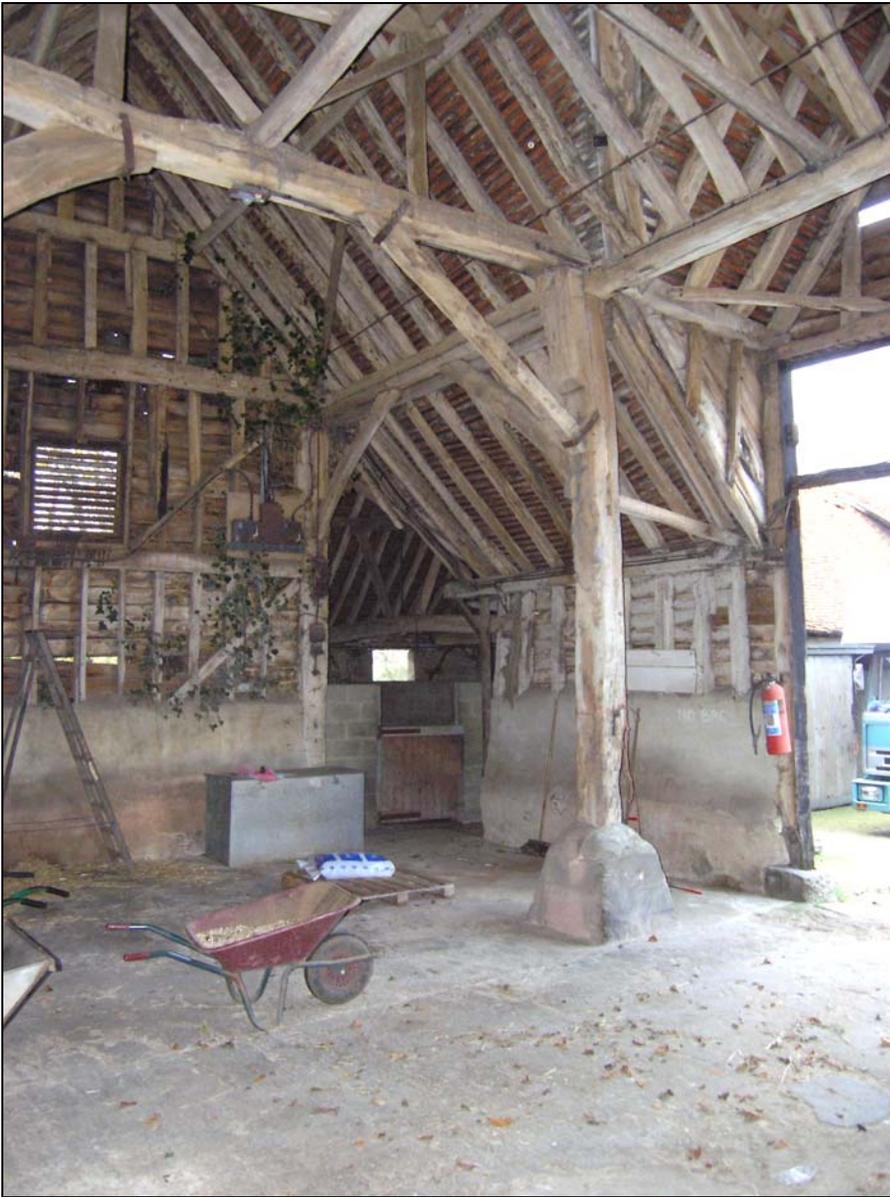
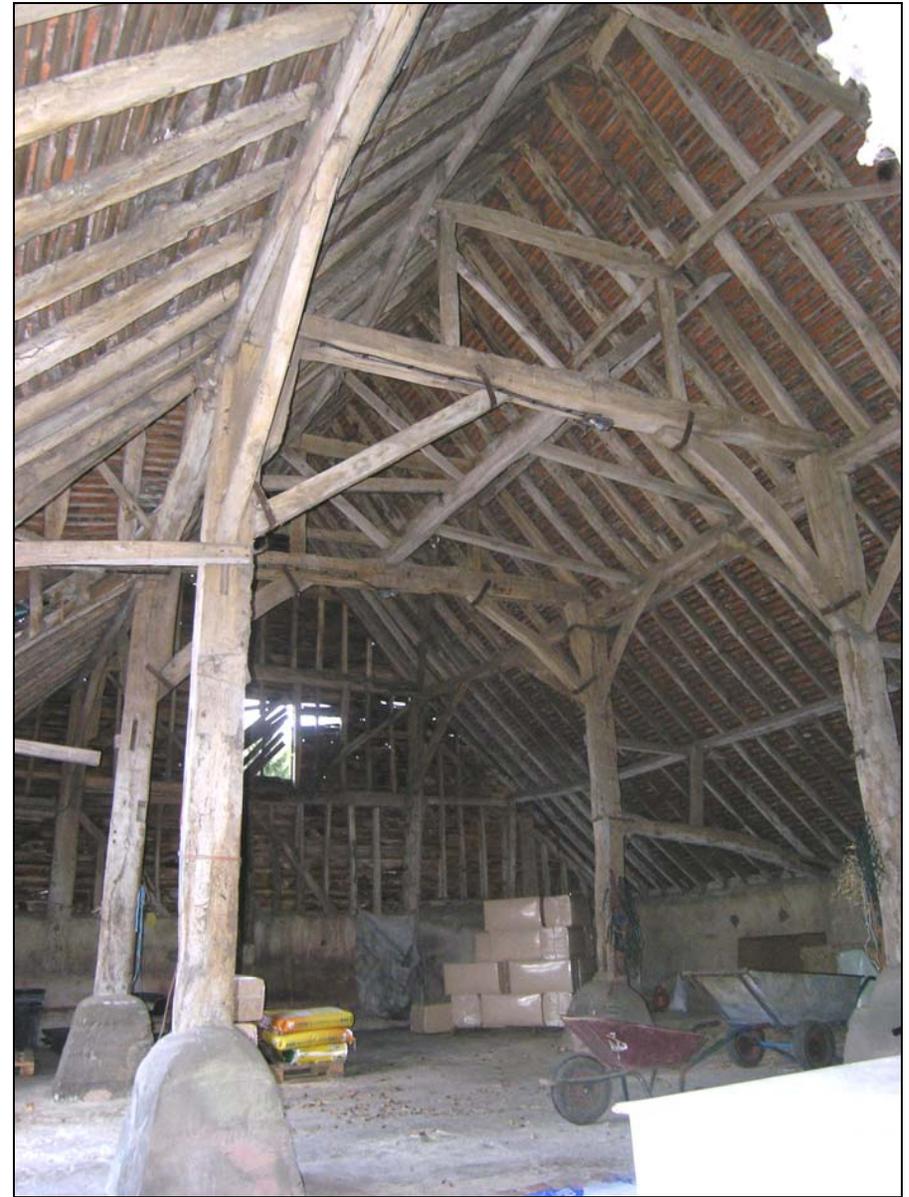
Plate 9 Reused medieval studs in north east frame and removed north corner

Plate 10 Truss detail showing soot-blackened rafters in Barn 1

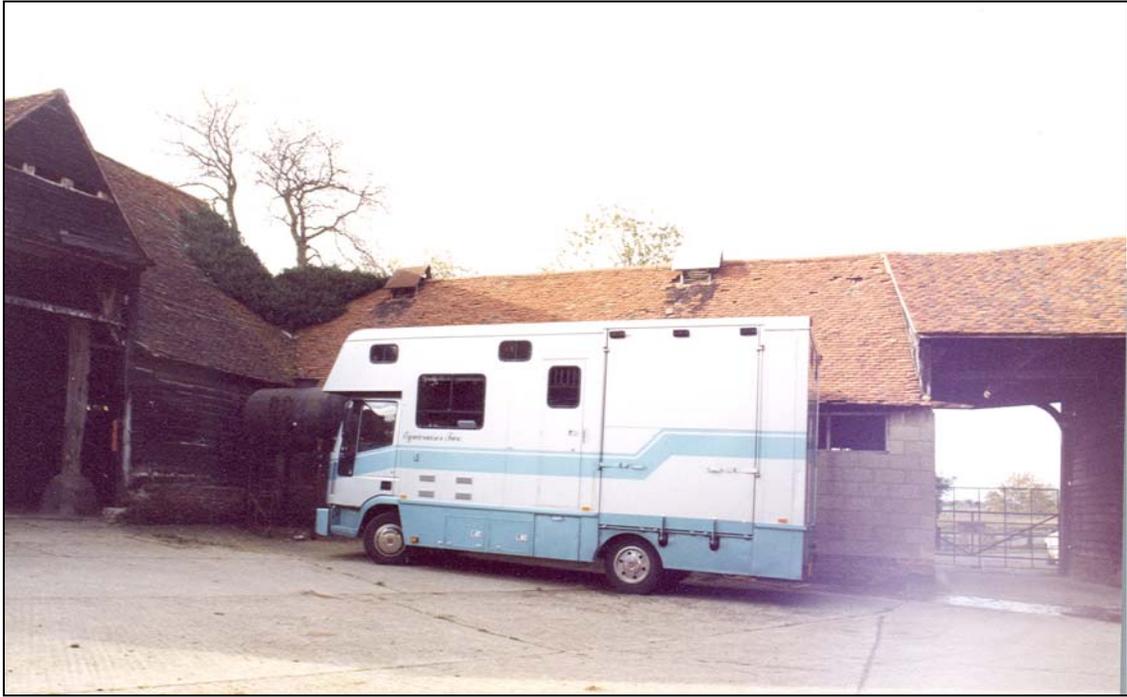
The south-east elevation is also formed from concrete blockwork. Plate 13 shows a diesel tank in the west corner, where the range is built into the barn forming a valley, partly obscured by a modern horse transporter. Further along the elevation, the block walling is broken up by four high 0.7m deep plastic/iron-meshed thin wood framed vents, located below the eaves (fig. 6). A modern corrugated sliding door and internal ramp creates animal access from the third bay onto the yard (fig. 6). A large infilled area on the north-east gable may signify a blocked modern entry point out into the covered entranceway. However, this is not apparent internally.

Plate 13 Stock House 2 and Entrance Porch 3 viewed from inside yard

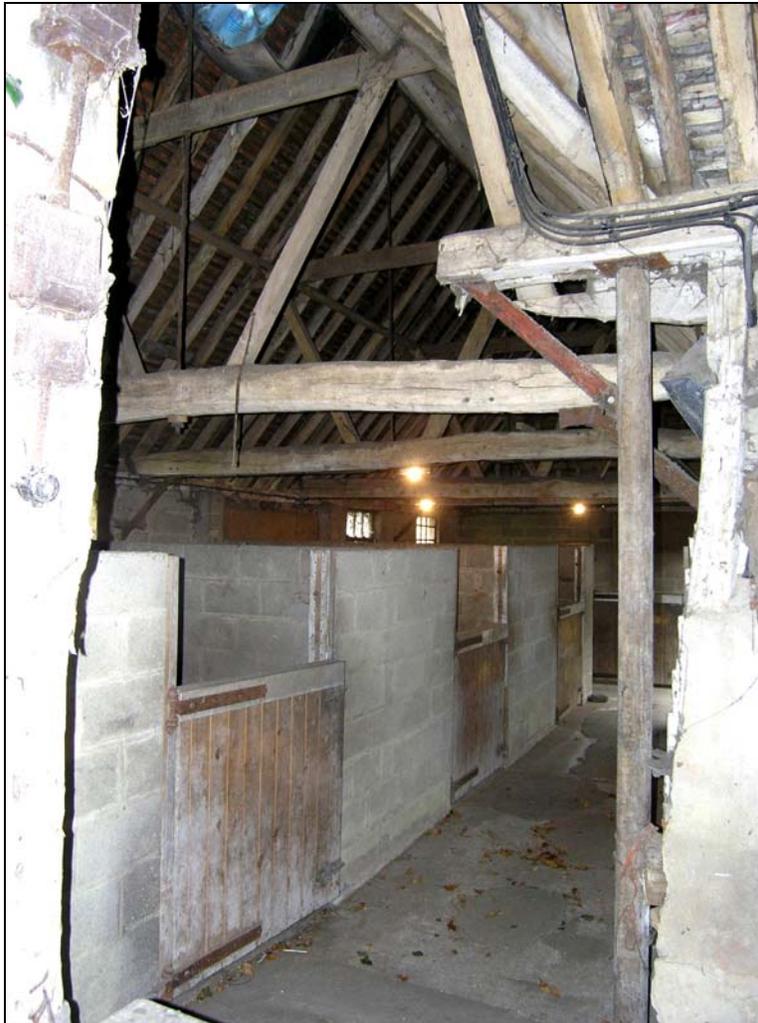
the barn, the weatherboarding and aisle wall plate have been cut through and the latter supported on a plain cast iron column and bolted angle iron bracing (plate 14). Since the concrete block rebuild, similar iron brackets act as replacement braces to the tie beams. All bays are roughly equal in width at c. 3m, except the south east bay which is shorter at only 2m. Reused oak tie beams are used throughout, accompanied by empty mortices and peg holes for braces and queen posts. The ties are supported on oak and elm wall plates joined by short, face halved and bladed scarf joints (Watkin 2005) indicative of a post-medieval date. The current trusses comprise raking struts (some of which are machine-sawn) tenoned to the tie beams, trenched and nailed to the collar and cut to allow the purlin to pass (fig. 9). The purlins are splay scarf-jointed where the sections meet and the whole is kept in tension by an iron rod screwed into a ridge boss at the top and down to the tie beam soffit where it is secured by a square nut (fig. 9).

Plate 14 Interior of Stock House 2 showing sawn off wall plate and weatherboarding to Barn 1

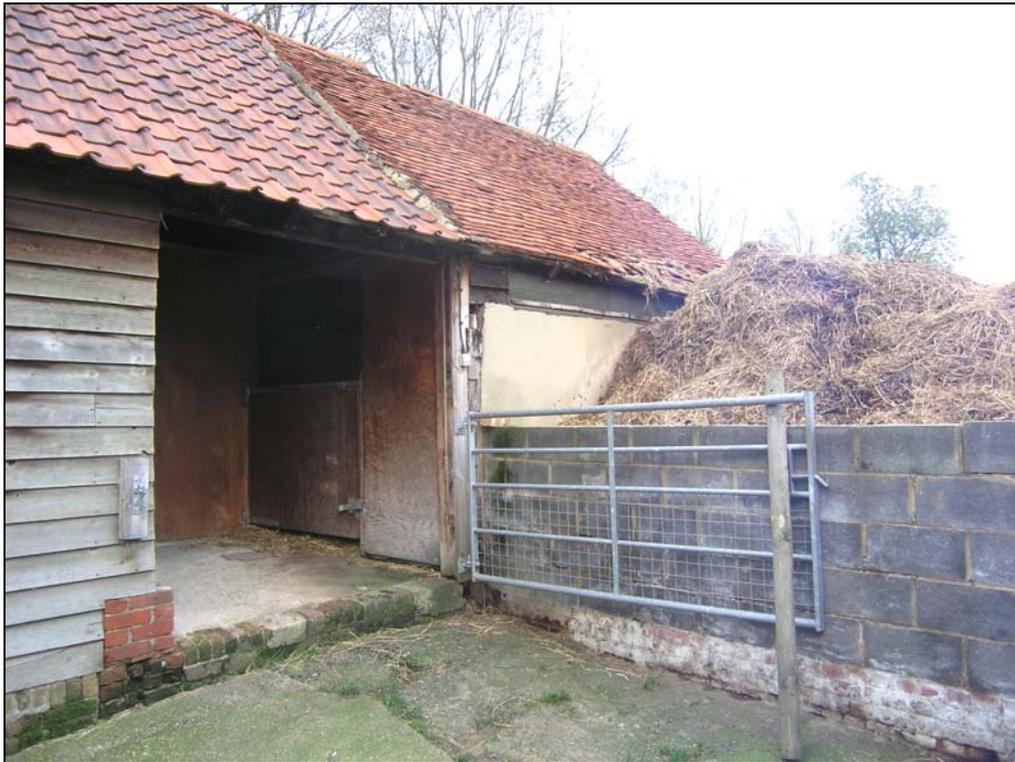
Plate 21 Inserted door into Loose Box 6 and plinth wall to late 19th-century south-east range

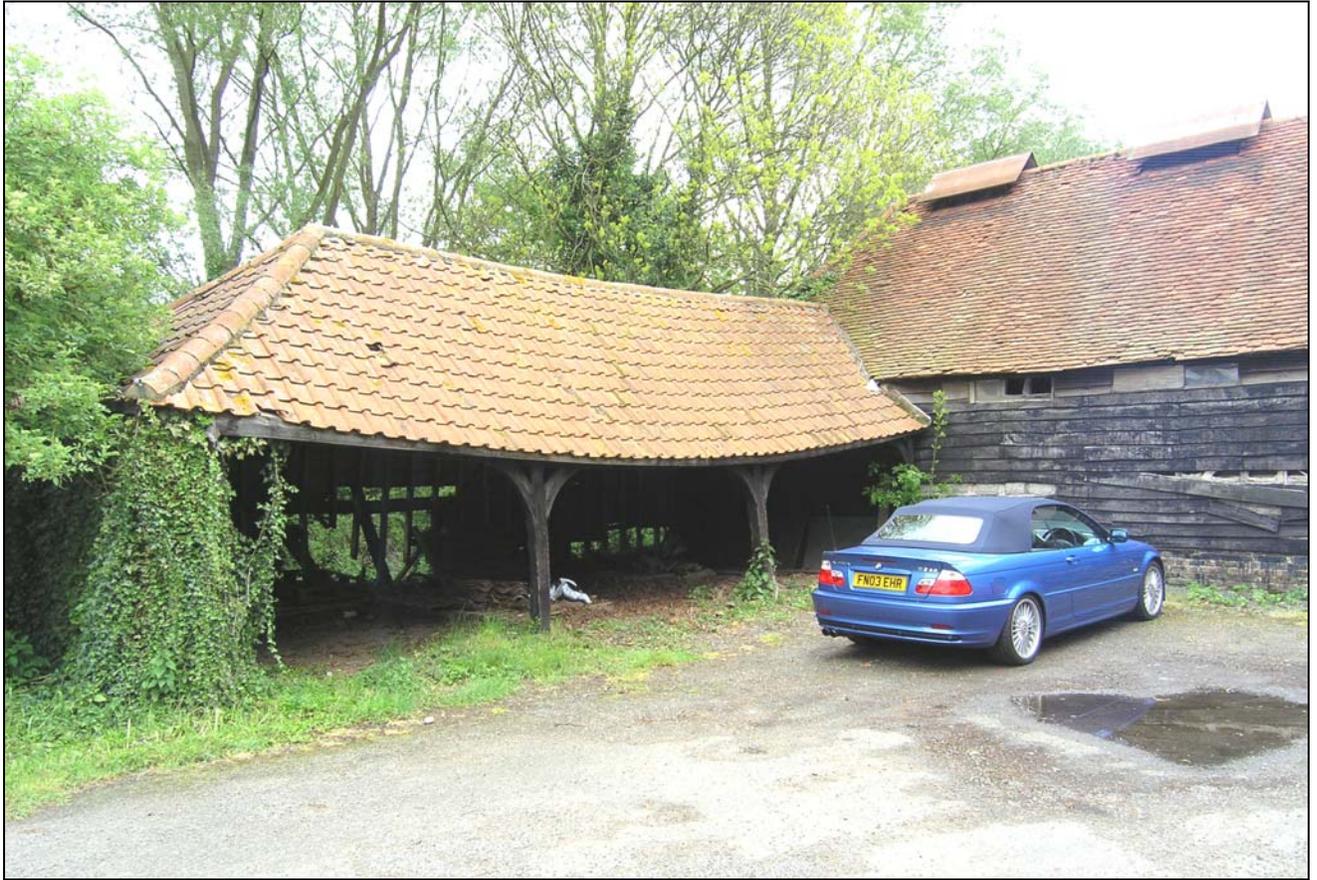
consequence, weatherboarding is missing from the rear wall leading to some studwork displacement. The front wall plate is sagging badly (plate 23) due to the weight of the tiles.

Plate 23 Cartlodge 7 viewed from west
