**PICCOTTS FARM BARN & OUTBUILDINGS
PICCOTTS LANE
GREAT SALING, ESSEX**

**HISTORIC BUILDING RECORDING
& ARCHAEOLOGICAL MONITORING**

December 2006

Document Ref.	1641rep
Report Issue Date	18th December 2006
Circulation	Pocknell Studios
	ECC Historic Environment Management
	Essex Historic Environment Record

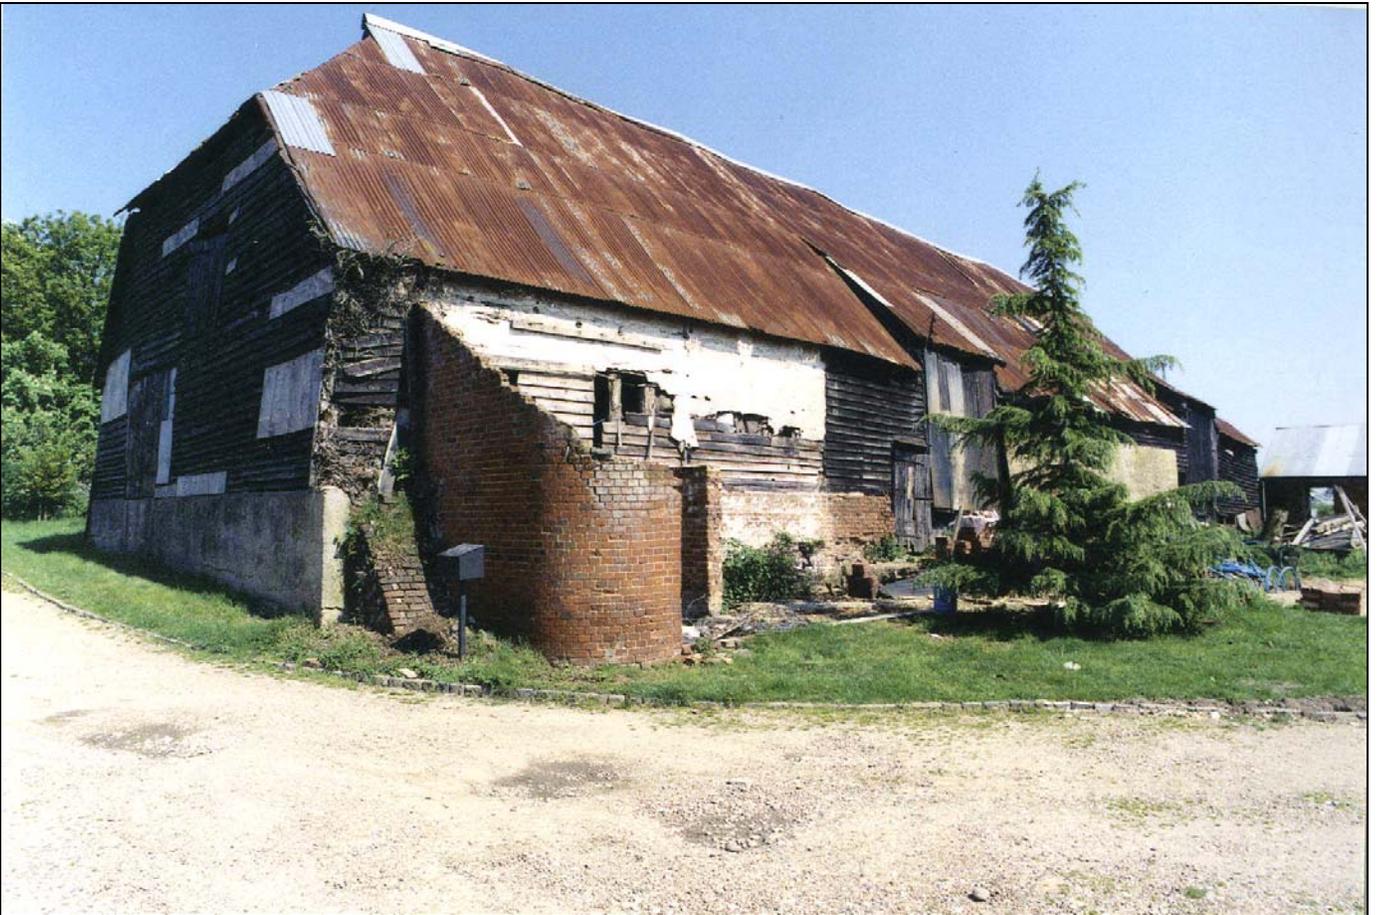
Plate 2 Barn viewed from south

The south-east elevation faces the farmyard and is furnished in a variety of materials where the weatherboarding has fallen off, or was in such poor condition through previous lack of maintenance. The former brick granary (1a) close to the south corner, retains an attractive curved header bonded outer wall, and a single partition wall (plate 2), but has lost its roof. The bricks are similar to those in the plinth in colour and dimension, but are clearly built onto and over the plinth making the granary later in date; an interpretation borne-out by the cartographic evidence which dates it between 1838 and 1875. The granary also uses a different brick bond (English) in its construction. Originally the granary occupied most of this side of the wagon doors, as evidenced by the remains of limewash and lath and plaster (to keep the grain clean and reduce loss) over the plinth and weatherboarding in plate 2. The surviving wall plate on top of the plinth shows the removed part of the structure was timber-framed. Adjacent to the header wall, a tumbling-in buttress has been added to support the corner of the barn against the slope (plate 2) that, in the 19th-century, defined the western side of the farmyards.

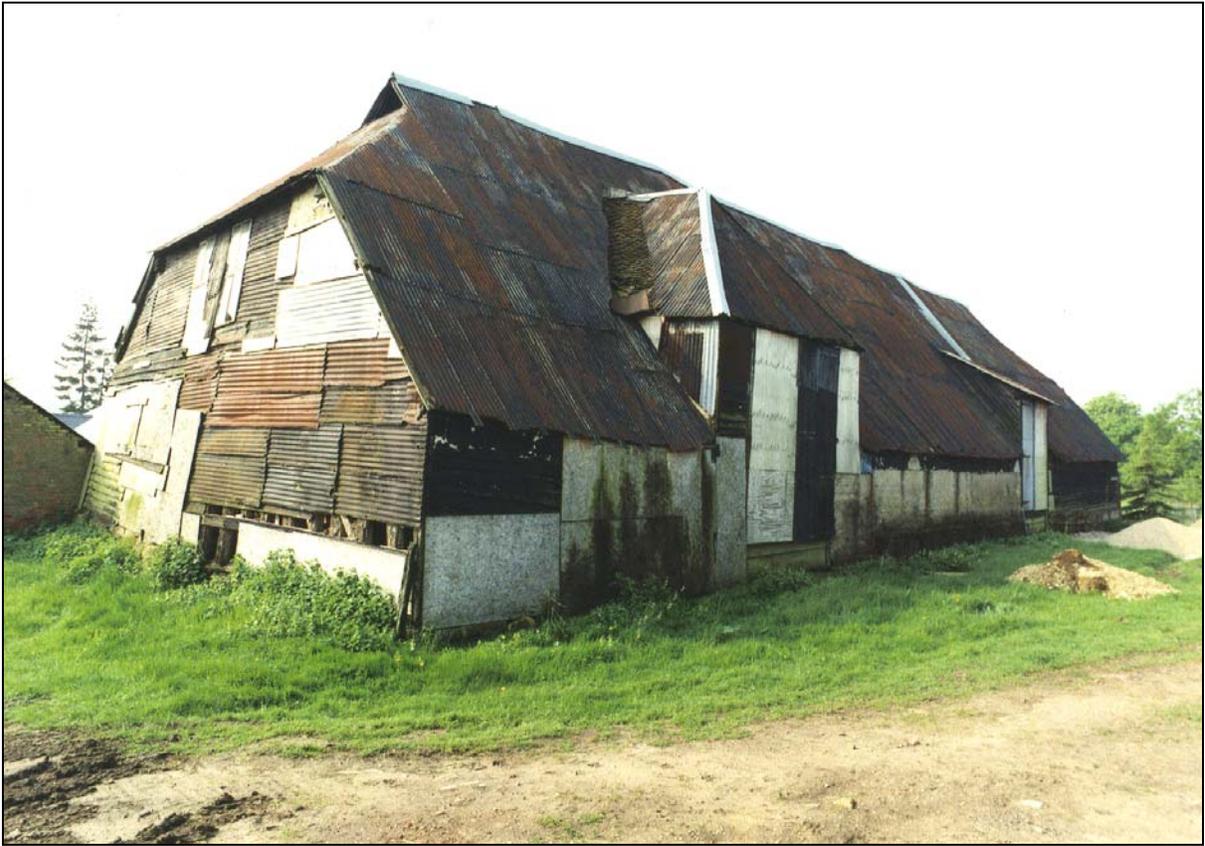
Plate 5 North-east and north-west elevations

Part of the lower clapboarding is missing and, due to the collapsing wall behind, there is a larger array of modern materials fixed onto the weatherboard (plate 5). Much of the plinth has collapsed and parts of the sill are sagging under the weight of the frame. A pair of high, fixed four-pane, windows are situated beneath the eaves; modern replacements for mullioned windows that, like their counterparts on the opposite end, were boarded over at a more recent stage, either when the plastered exterior was replaced by weatherboarding or in a re-cladding phase since. Their positions can still be recognised inside.

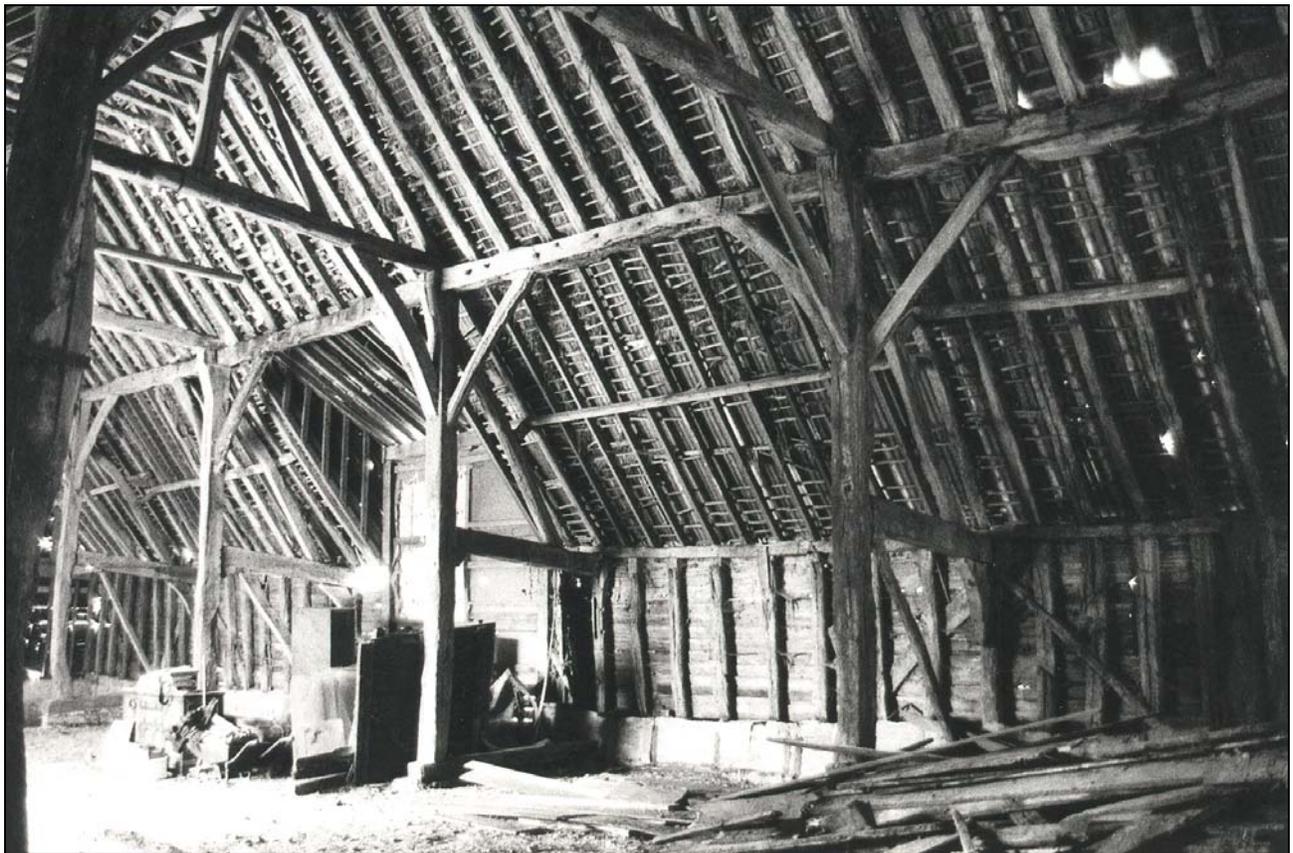
Plate 10 Comparison of external and primary braced framing on south-west wall to bays 3 and 4

Much of the original wall framing survives. A few bay walls were rebuilt in the post-medieval period and inevitably there are repaired areas, mainly in the gables from the Victorian and modern periods. The original build (plate 10, centre) comprises heavy c.16 x 13cm-thick studs (up to 22 x 13cm) with slightly curved external tension bracing. The braces are pegged as part of the original fabric. Each bay carries seven studs, pegged and c.50cm-apart, between 13 x 18cm mid-rails. The wall plates are fairly modest at c.13 x 18cm and connected by side-halved and bridled scarf joints, as are the arcade plates, which are locked-in with four vertical pegs. This type of scarf joint is used in constructions between

Lower rafters over the aisle have been replaced in many of the bays with slightly thinner or machine-sawn members (plate 10). Their shallower pitch means they are usually more vulnerable to damp (Padfield pers. comm.). Those in the nave appear to be original. Two types of purlin are visible in the aisle roof. One set of purlins is pegged and cross-shaped, similar to the post and rail arrangement in the wall frames. The purlins in this instance are pegged to the central and principle rafters of each bay and retain substantial rafters like those in the nave. The second type is secondary, belonging to replaced rafters of narrower scantling and rougher build. These purlins are simply slotted through the middle rafter and pegged to the rafters either side. The butt ends are roughly-cut and overlap in the centre of the bay producing a joggled effect, whilst the remainder are pegged and morticed into the truss rafters. There is no wind bracing in the roof except for some primary bracing in bay 2, which has been rebuilt.

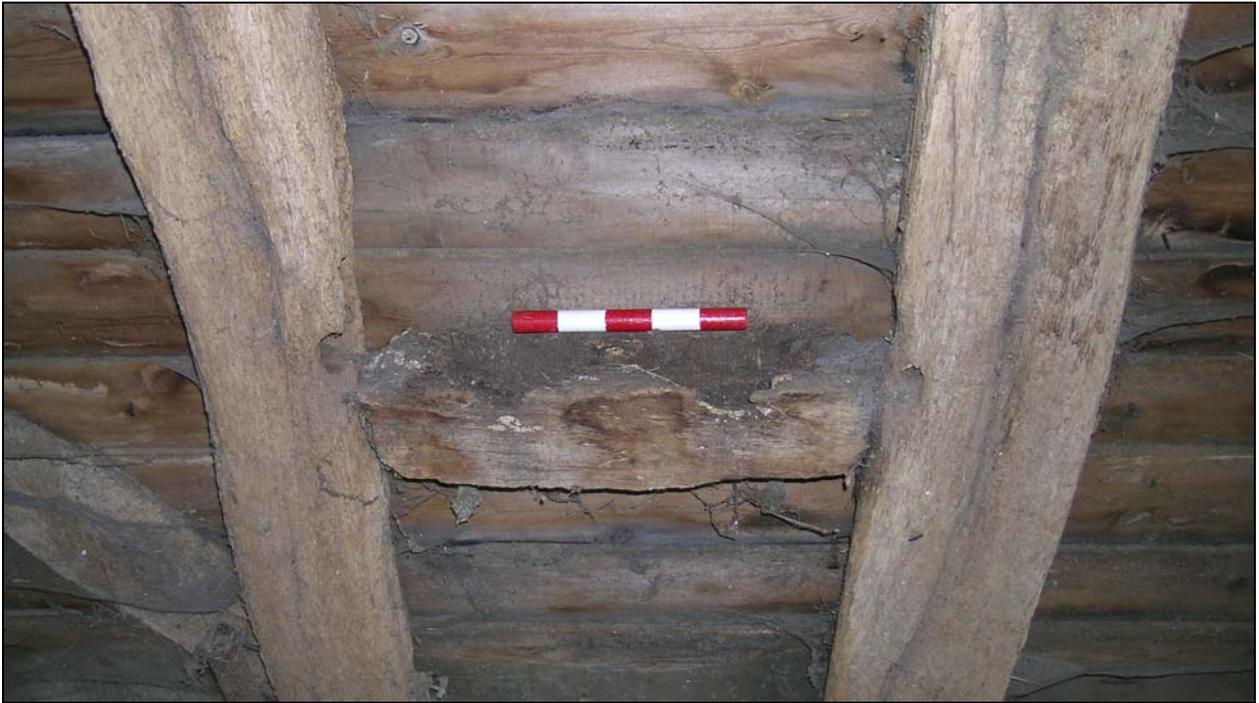
Plate 17 Remaining sill to medieval side window containing rotted diamond mullion recesses

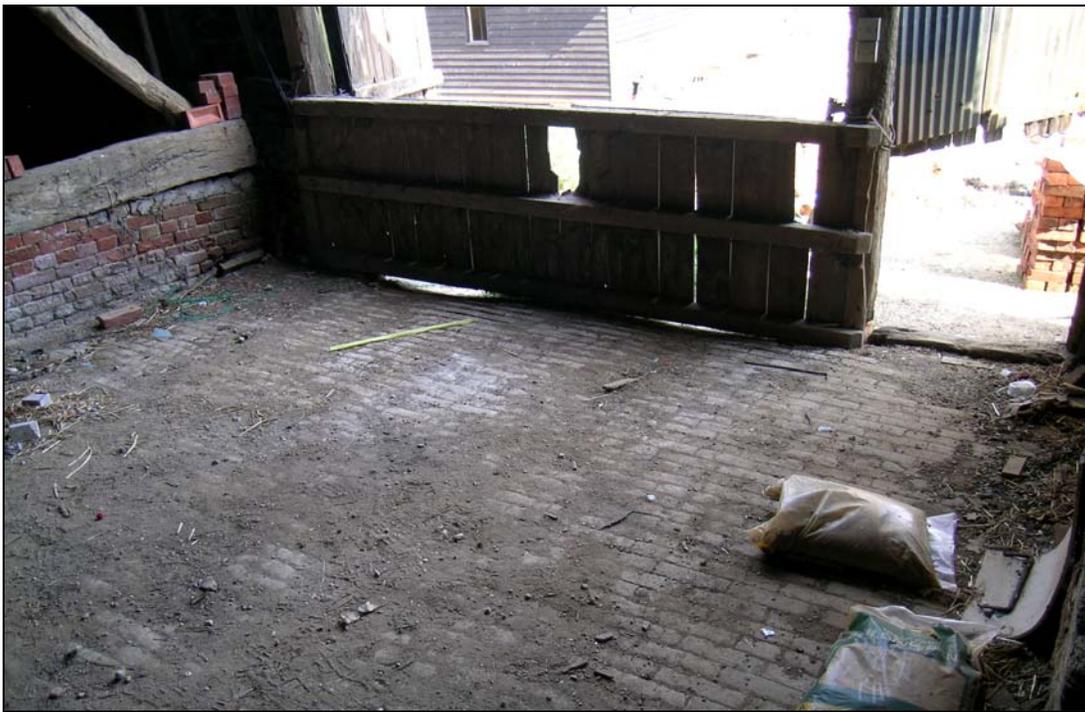
Plate 20 Brick threshing floor viewed to main yard

The brick floor in bay 5 (B5 in fig. 6), which is worn and uneven (plate 20), is made from un-mortared whole, half and quarter bricks, of similar size (24 x 7cm) to those found elsewhere on the farm. A carved date of 1839 on an aisle strut beside the south-east wagon door (fig. 6, plate 22) may indicate when it was constructed.
