**HISTORIC BUILDING RECORDING OF BARN & OUTBUILDINGS
AT
LITTLE WARLEY HALL FARM
LITTLE WARLEY
ESSEX**

February 2007

FAU Project No.: 1709

Site Code: WARW 06

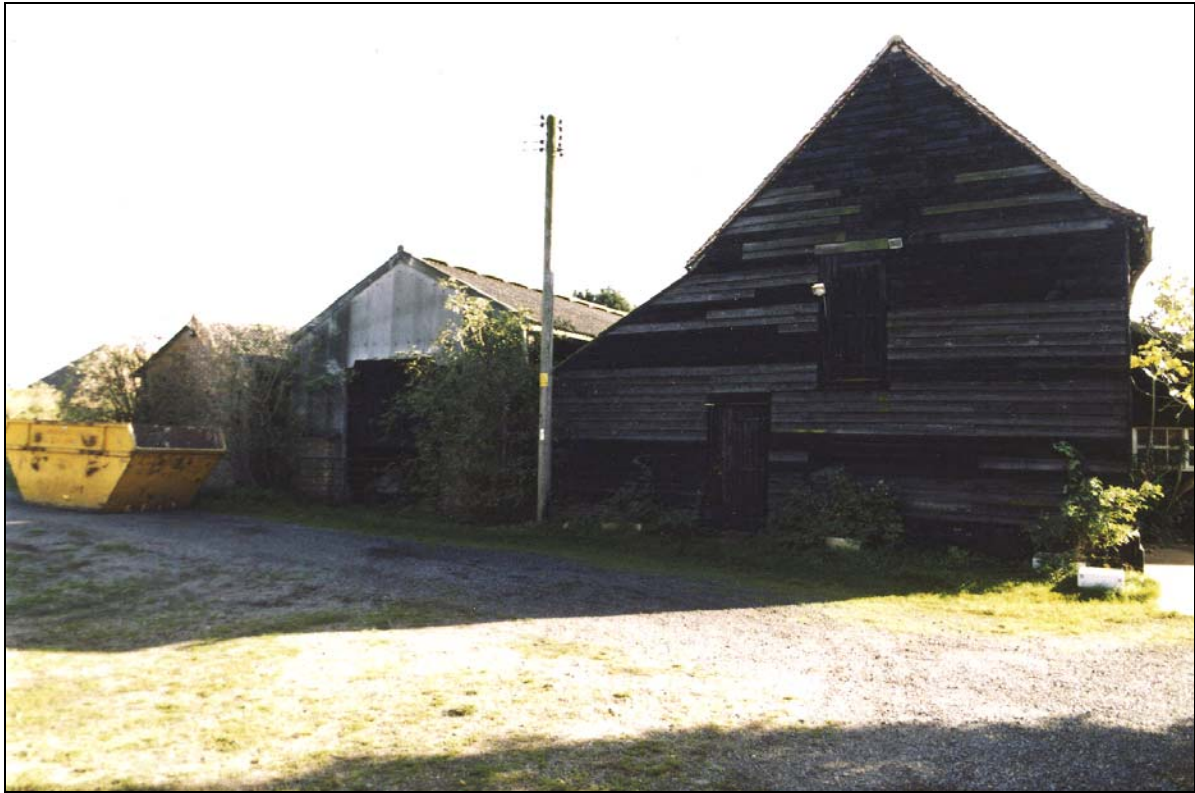
Plate 3 Barn and Covered Yard viewed from north-west

Clapboarding on the north gable elevation crosses from the barn to stables 3 (plate 3), perhaps indicating the last time the barn was clad; probably in the 1950s when other structures were erected in the same material. The cladding has a somewhat mottled appearance from patching in fresher boards to the faded earlier ones. A door leads into the barn at ground floor level, whose wrought iron strap hinges are of some age, though are more likely to be 19th than 16th-century date. Above it, positioned centrally up to eaves level,

is the 'pitching door', where hay or straw could be pitched into the barn from a cart outside (Peters 2003) to fill the final bay (fig.6, plate 3).

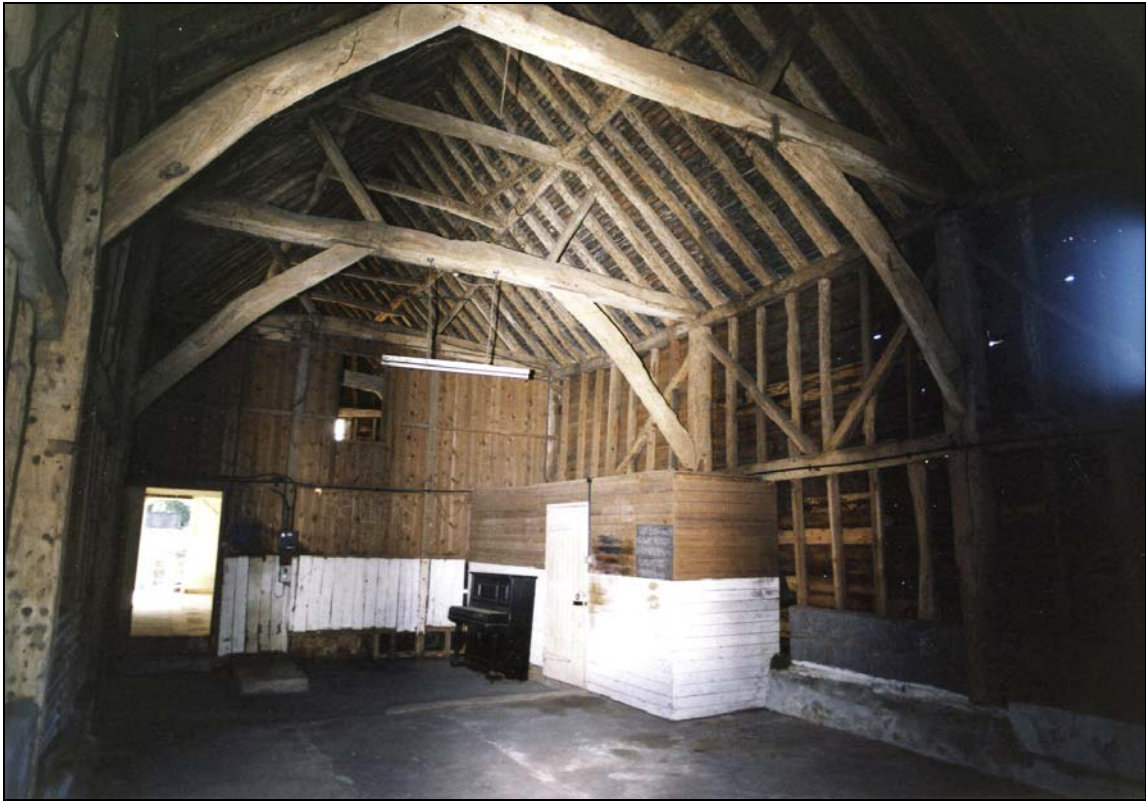
Plate 7 Interior of Barn viewed from north

The barn floor is made from concrete, probably laid in the post-war period. Many farms replaced the old threshing floors at this time which, unfortunately, accounts for their low survival. The plinth was rendered, covering the sill beam in many places. At the same time, the walls were lined-out in cement infill/concrete block work to a height of 1m, perhaps because livestock used the barn. This now obscures the base of the wall framing (plates 7 & 8).

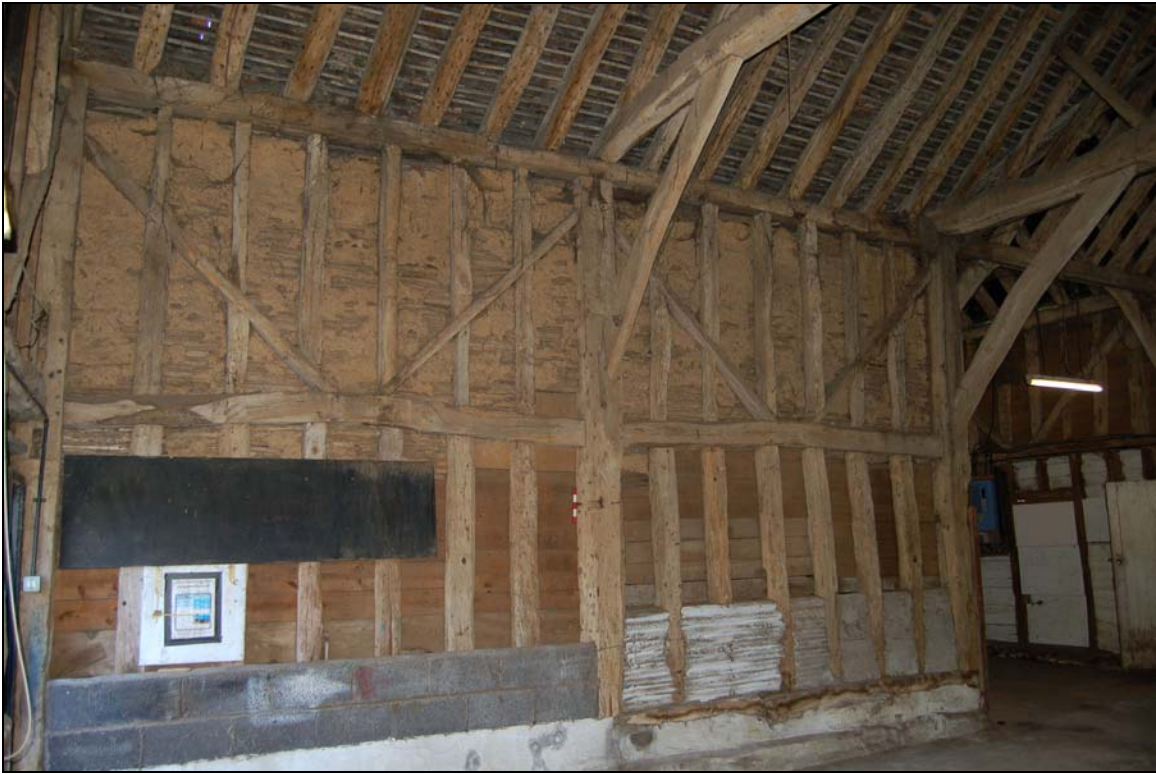
Plate 9 Variations in wall framing between upper and lower registers in bays 1 & 2 east

The main framing is oak and consistent below and above the midrail, even though there are marked differences between the timberwork in the upper and lower registers (plate 9). Heavy posts (c.20 x 24cm) divide the bays, double pegged to plates top and bottom with rails across the middle, of similar scantling. The posts are plainly carved, without jowls, suggestive of a 17th-century date. Wall plates are approximately one bay in length and are joined together by edge-halved and bladed scarf joints (plate 10), which were introduced in the mid 16th-century but became common in the next. The only exception to this is on an exposed part of sill plate on the east side of bay B2 where a short bridle scarf joint with squinted abutments was discovered (fig.6). This is a typical medieval ground sill joint (Hewett 1980) and is likely to be a reused timber. The face is over-lipped, to prevent water penetration (plate 11).

Structurally, the wall framing is formed from two distinct builds (plate 9). Much of the lower register is original close-studding, with wide (c.18 x 12cm) studs set between 27 and 35cm apart, six per bay. They are tenoned, but seldom pegged, indicative of later (16th-17th century) carpentry. Most have axe cuts on the sides to hold wattles, indicating that originally the barn had wattle and daub walling. The lower register contains several studs with rebates to hold trenched bracing. Unfortunately, many have been turned or swapped around so they do not form a pattern. It is possible that they are reused timbers from an earlier building, but there is no other evidence to suggest this. It is unclear whether the building was braced internally or externally, but identifying the bracing type would help in dating the structure.

The eastern walls of the two northern bays (B1 and B2, fig.6) contain daub render attached to laths nailed onto the exterior. Inside, the laths are partly hidden by a layer of daub between the studwork, which is failing (plate 9). More survives on the north wall of the porch. This mode of coverage is likely to be contemporary with the primary-braced rebuilding phase, which probably dates to the 18th-century.
