**STOKES HALL, ALTHORNE, ESSEX
HISTORIC BUILDING RECORDING
AND ARCHAEOLOGICAL MONITORING**

February 2007

STOKES HALL, ALTHORNE, ESSEX
HISTORIC BUILDING RECORDING
AND ARCHAEOLOGICAL MONITORING

FAU Project No.: 1620

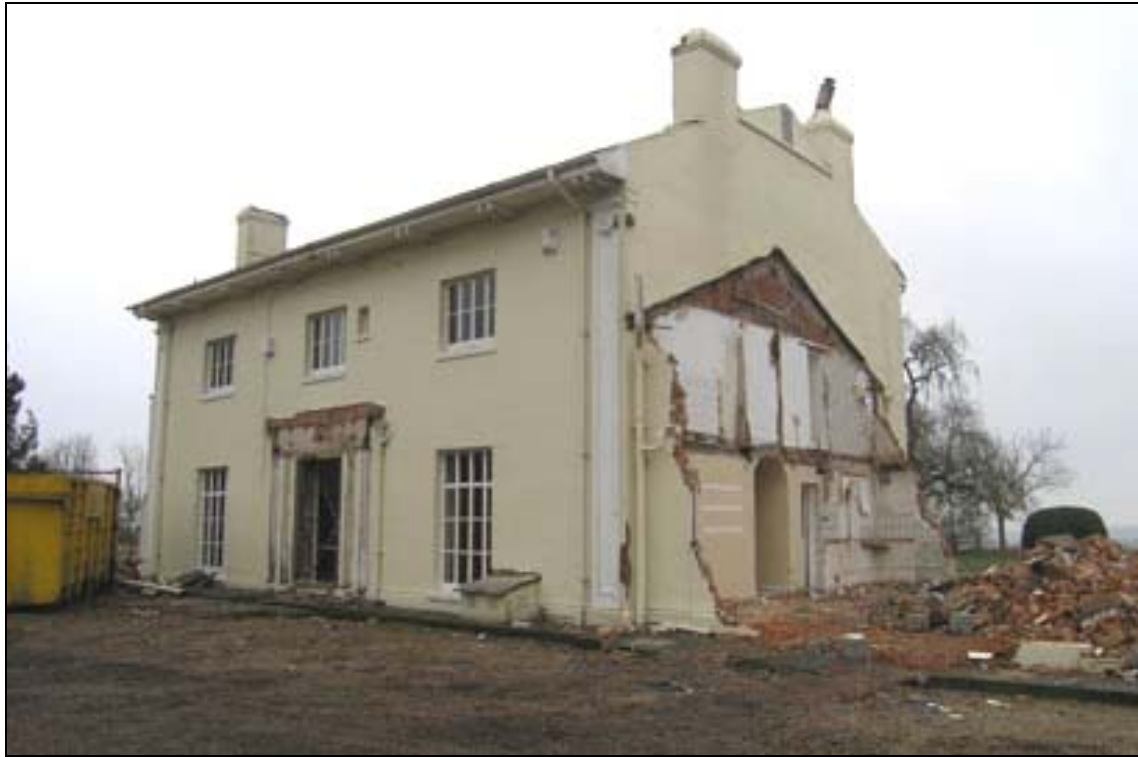
Plate 1 Main (north) elevation and demolished west wing

The box at the front (plate 1) provided ventilation to the cellar and a means of bringing foodstuffs in for storage. Tall square timber pilasters stand either end of the front with Greek motifs and a zoomorphic head carved into the top (plate 4).

The west wing (plate 1) is authentic and contemporary with the main house. The scar to a queen post strut roof truss can be seen in plate 1, as well as various doorways into the house, one of which, above the arched doorway on the ground floor (in plate 1) is sealed from the main house.

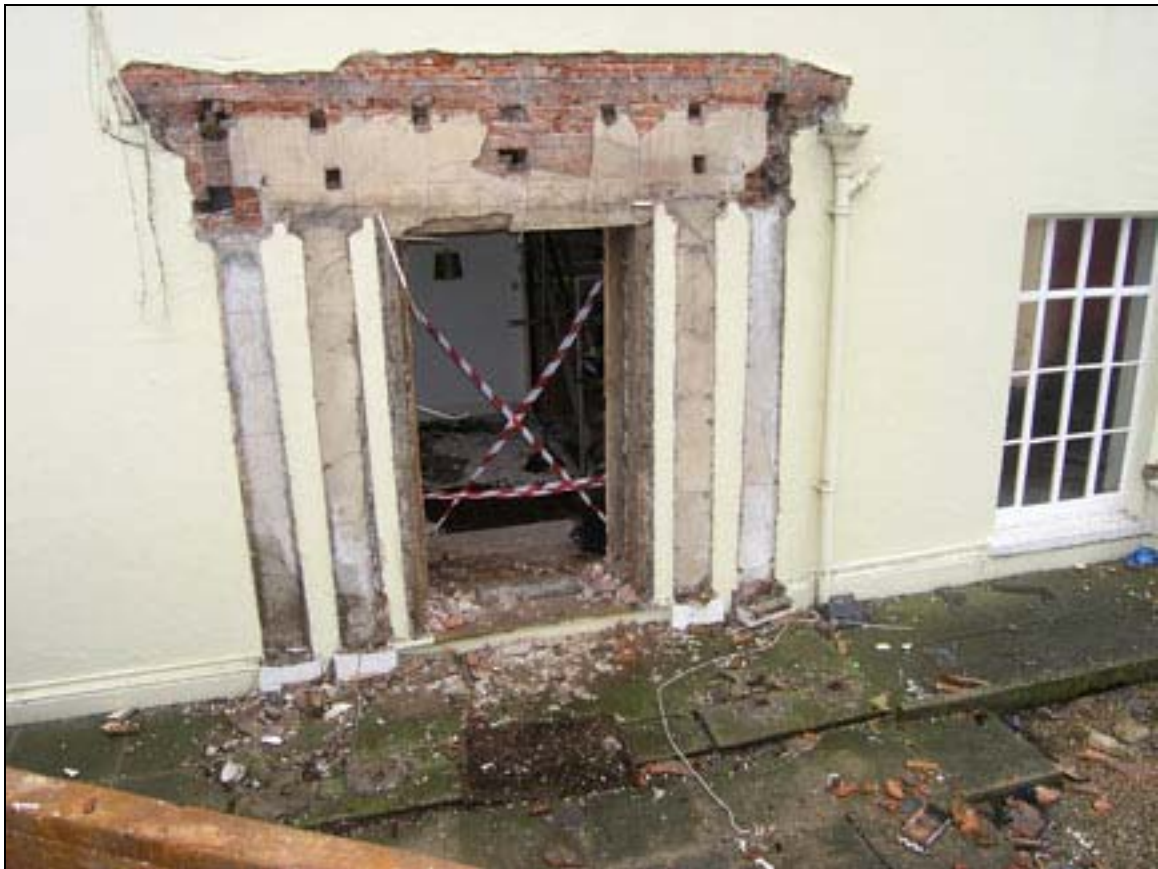
Plate 2 Scar of removed portico on main elevation

The main entrance is set centrally to the front, with low steps leading to a paved area that lines this side of the house. The 19th-century portico and front door have been removed, and the scar to the former pilasters and entablature are clearly visible, as are the mortice holes that fixed the structure to the wall (plates 1 & 2). After dismantling, the portico was put to one side and recorded photographically during the survey (plate 3). It was noted that the timber columns at the front of the feature were fluted and had stucco bases to add weight. They stood in line with the wall pilasters, two each side of the entrance. Mortice holes indicate their positions in the paving.

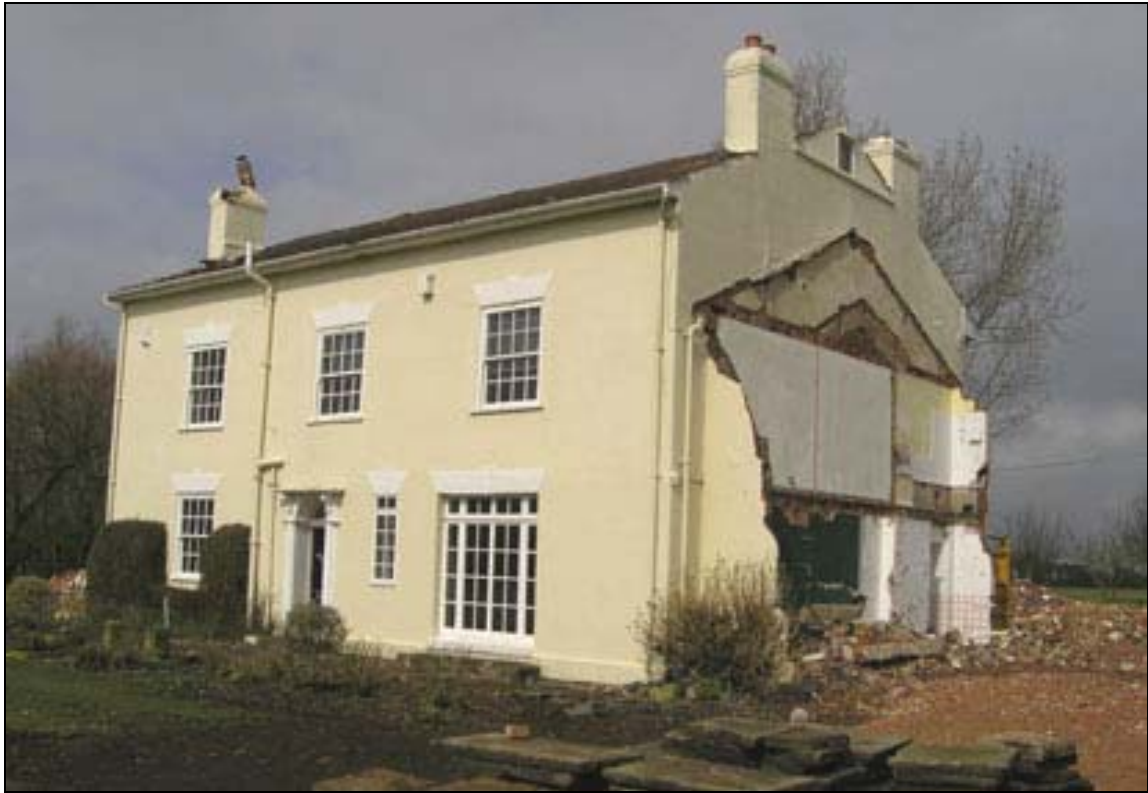
Plate 5 South elevation and demolished east wing

The ordering of the windows and door is similar to the main façade, but with more variety, style and embellishment (plate 5). Proportions are not as good this side. The rear entrance is placed slightly off-centre within its own door case. Either side are diminishing square columns, a moulded lintel and carved brackets supporting a flat, lead-lined canopy. Set above the door is a fanlight, a typical aspect of Georgian architecture. Windows on this side are mainly 16-pane vertically sliding hung sash windows with thin glazing bars (1 inch) and horns, suggesting a post-1830s/40s date, with flat plastered heads and keystones. French windows light the eastern room, which again are centrally-opening like the windows on the main façade. Next to it, the narrow top-vented window seems slightly out of place (plate 5).

Despite its old-fashioned appearance on the front cover, the east wing (plate 5) has clearly been rebuilt in the modern period. Probably when the whole house was 'restored', though exactly when this was is difficult to say without more evidence. The walls have been constructed one brick skin thick, with a breezeblock skin behind and plastered over on the inside. The bricks are bonded in cement and are a mixture of reds and yellow stocks, some of which may well have been reused from the original east wing.

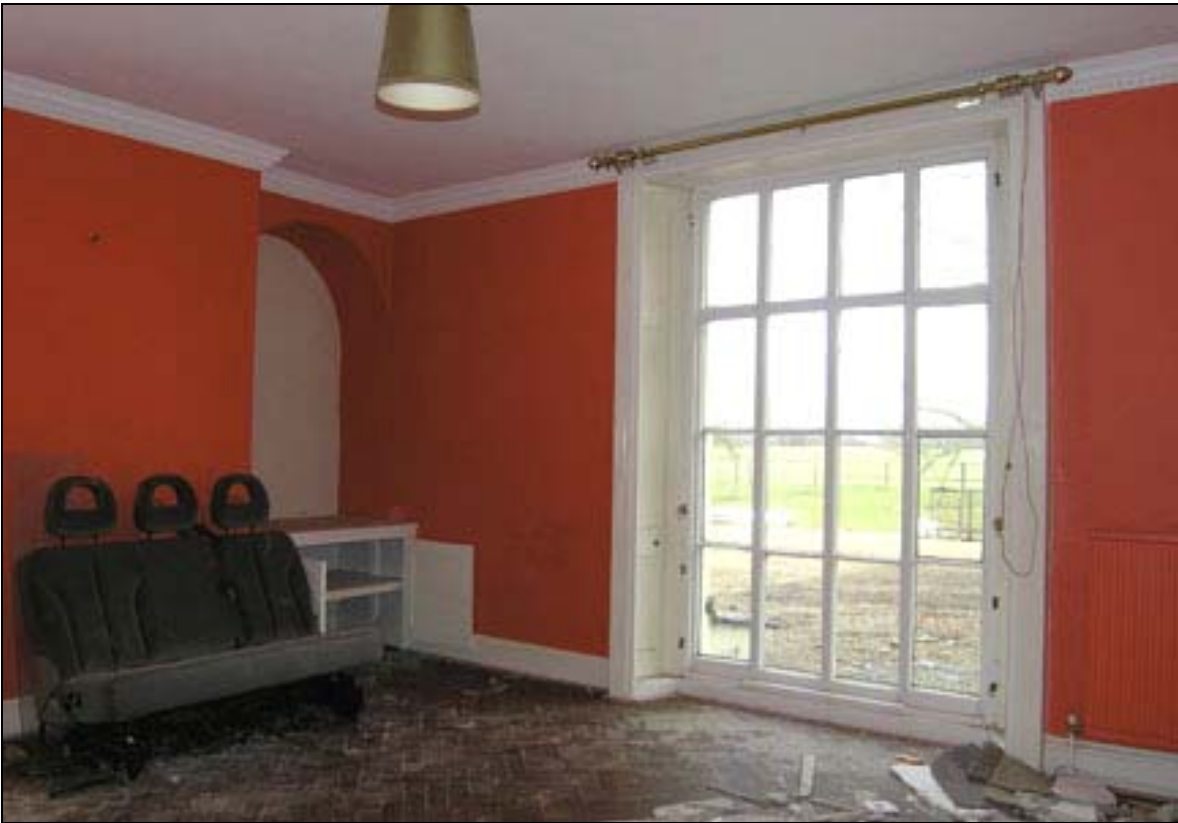
Plate 6 Room 1 at front of house

The large folding windows in rooms 1 (plate 6) and 3 on the main elevation and the French windows in room 4 (plate 7) have some modern fixtures, but are probably original. Shutters have been removed from the end cases that once folded into the gaps beneath the Greek-style carved wooden frames (plate 7). Classical fluted door cases mark the major entry points between rooms 3 and 4 that formerly housed double doors (plate 8). Some neat naturalistic carving festoons the alcoves either side of the fireplace in room 4 (plate 7). However, there are some fittings that bring the authenticity of these features into doubt. The dentilled cornice in rooms 1 and 6 are definitely false. To illustrate this, the cornice in room 1 (plate 6) is fitted over the wallpaper!

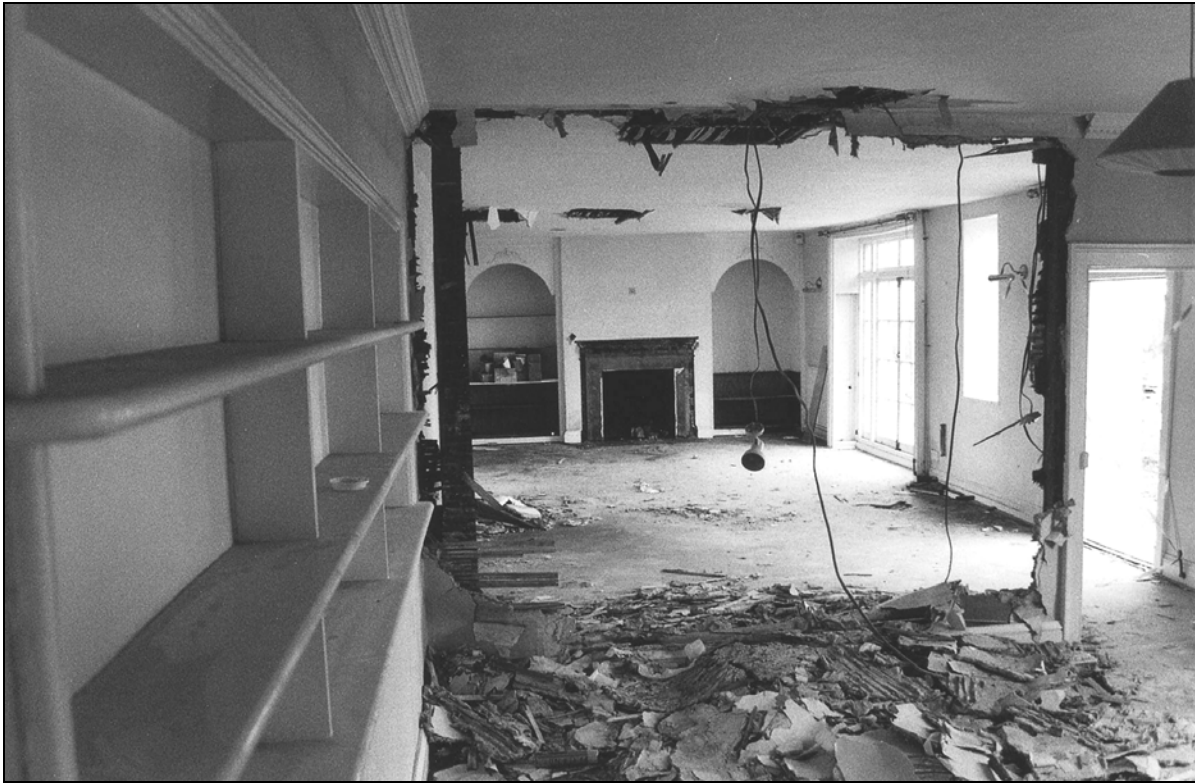
Plate 9 View from room 6 to room 4

Various cupboards and shelving units are utilitarian in aspect and show no Georgian embellishment, yet are attractive in their simple design (plate 9, left). Other fixtures include a beaded skirting.

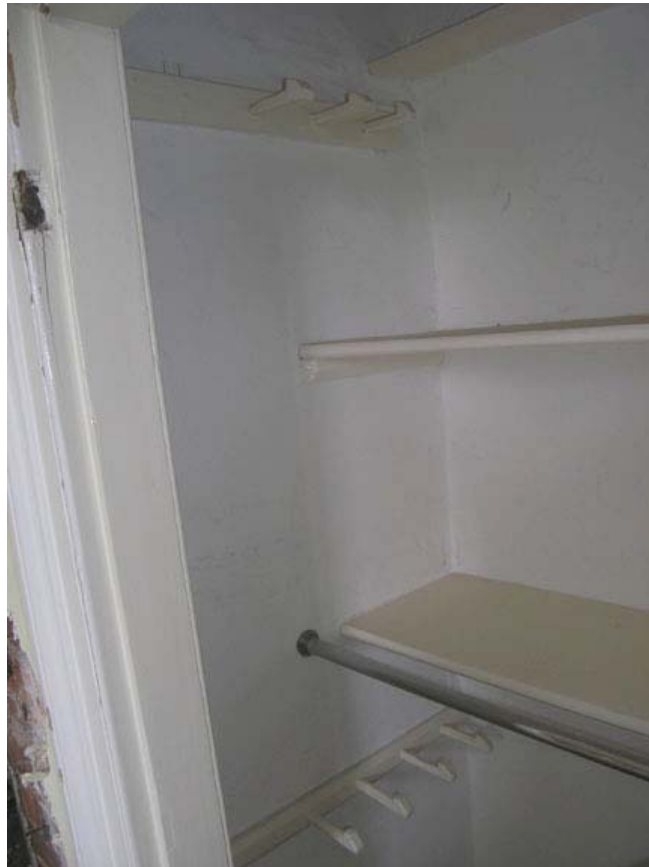
Plate 12 Carved wooden cupboard hooks in bedroom 7

Each of the four bedrooms is laid out with cupboard space at the back (fig. 6). Inside are basic shelving and hand-carved clothes hooks of a style common in domestic and utilitarian scenarios throughout the 19th-century (plate 12). Plates 10-12 show the general condition of the first floor.

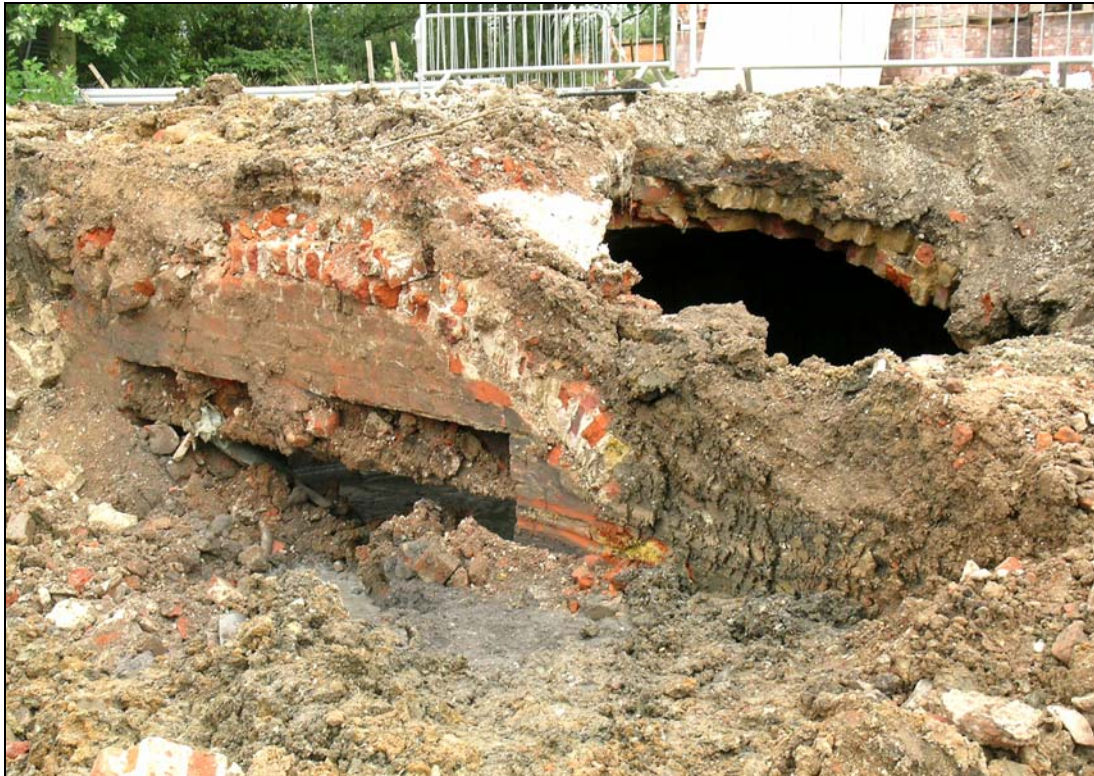
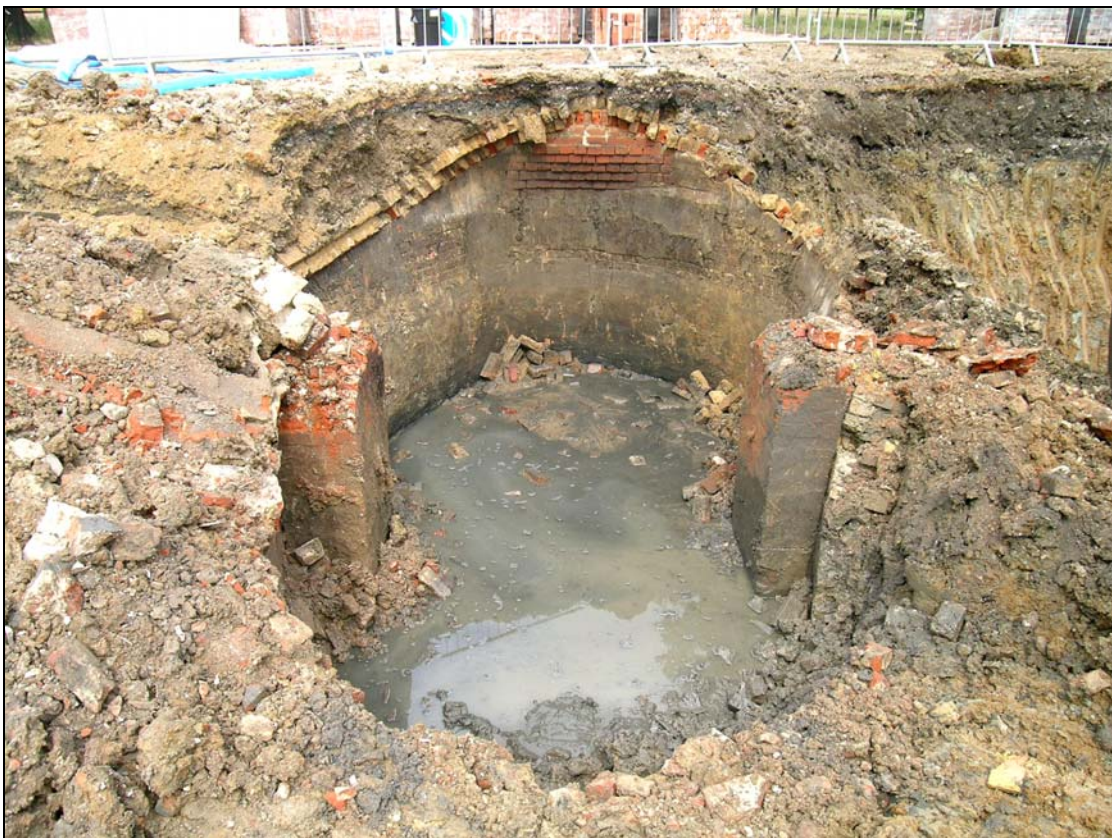
An underground brick-built chamber, measuring approximately 4 x 6m, was discovered in the north-west corner of the excavation, close to the former west wing. It lay directly beneath a tarmac surface (plates 15 & 16). Either side was a layer of dark grey modern clay made ground laid for the tarmac. The chamber was ovoid in shape with a domed roof that had collapsed on the south side. The feature was built in red frogged bricks and yellow stock bricks laid within a very sandy lime mortar. The inner walls were lined in plaster inside the structure was filled with water and rubble. It post-dates the hall, and is more likely to have been built in the later part of the 19th-century, perhaps when general improvements were made to the house. The south end of the arch had been partly blocked to form a square opening, either side of two inserted (cemented) brick piers, not bonded into the main brickwork, with an iron joint spanning the width (plate 16). This was probably a repair made after the southern section, which is very disturbed, collapsed in the modern period. Away to the south, the suggestion of a brick drainage channel was observed, but was badly-disturbed.

The position of the feature close to the west wing suggests a service use. No fixtures or fixings were seen inside and the walls inside were plastered. It is too near to ground level to be an ice house and no entrance was apparent. The likely function was perhaps as it does now, to hold water. The front cover picture shows a hand pump outside the entrance to the outbuildings and the chamber is near by, even if its position is approximate. Perhaps it was a rainwater well for household use. It is worth remembering that water level is very low on the site.
