**HISTORIC BUILDING RECORDING OF BARN & OUTBUILDINGS
AT
CHURCH FARM, ALRESFORD
ESSEX**

HISTORIC BUILDING RECORDING OF BARN & OUTBUILDINGS
AT
CHURCH FARM, ALRESFORD
ESSEX

Document Ref.	1721rep
Report Issue Date	16th March 2007
Circulation	Mr. E. Daniels
	ECC Historic Environment Management
	Essex Historic Environment Record

FAU Project No.: 1721

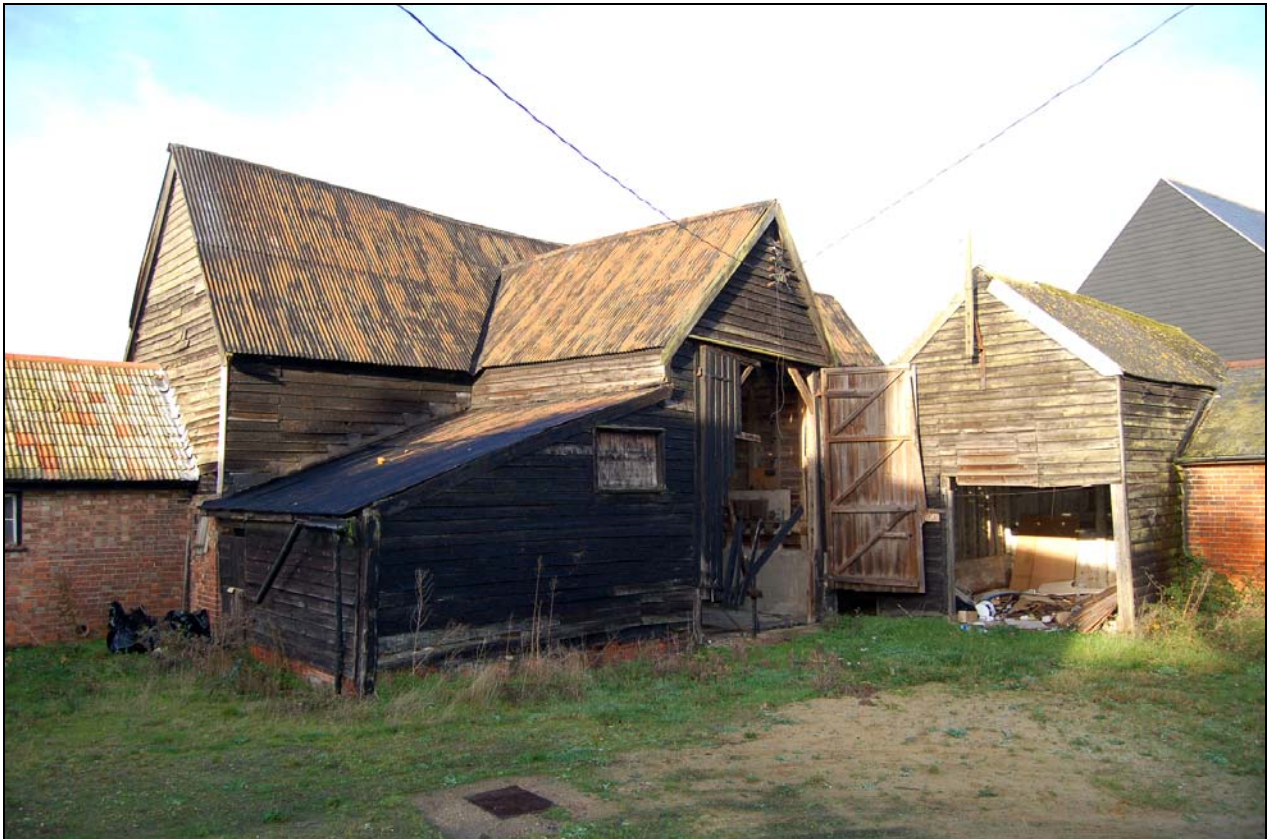
The barn stands on the west side of the yard, with its porch facing the east side (plate 2). Part of the east elevation is obscured by pole barn 3 and the south elevation by stables 6

Plate 2 Barn viewed from yard

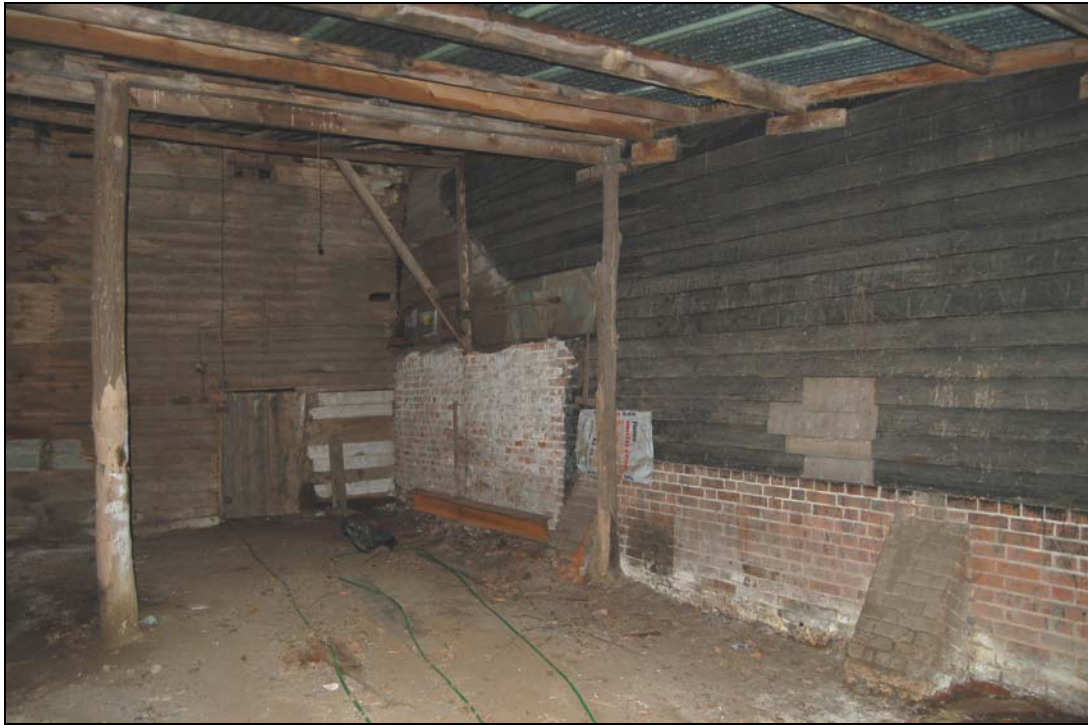
That part of the east elevation hidden by the loose box has an internal doorway and whitewashed weatherboarding (for animal hygiene), but no features. On the other hand, the same elevation on the opposite side of the porch is very different. Here is evidence for the original cowhouse or shed, replaced when cowhouse 5 was built, whose roof scar can be

seen in the untreated weatherboarding of the barn (plate 3). The shed was clearly brick-built, occupying the north bay on this side, and open to the north. The brickwork here rises to 1.8m, the height of the midrail on the inside, and is plastered in lime. The brick bond cannot be discerned beneath the plaster. There are no other walls remaining and no distinction between the builds to plinth and wall, suggesting that they were added at the same time to the existing barn.

A straight brick joint separates the two phases of barn construction. On the newer side, also hidden by the pole barn, the plinth is higher than the original, at 13 courses. The brickwork is noticeably neater and cleaner and the red bricks slightly shorter in length and height to the main build. The bond is more explicit, a crisp Flemish bond, and tumbling-in buttresses are built as part of the plinth on each bay (plate 3).

Plate 3 Barn extension and evidence for former cowhouse viewed inside pole barn

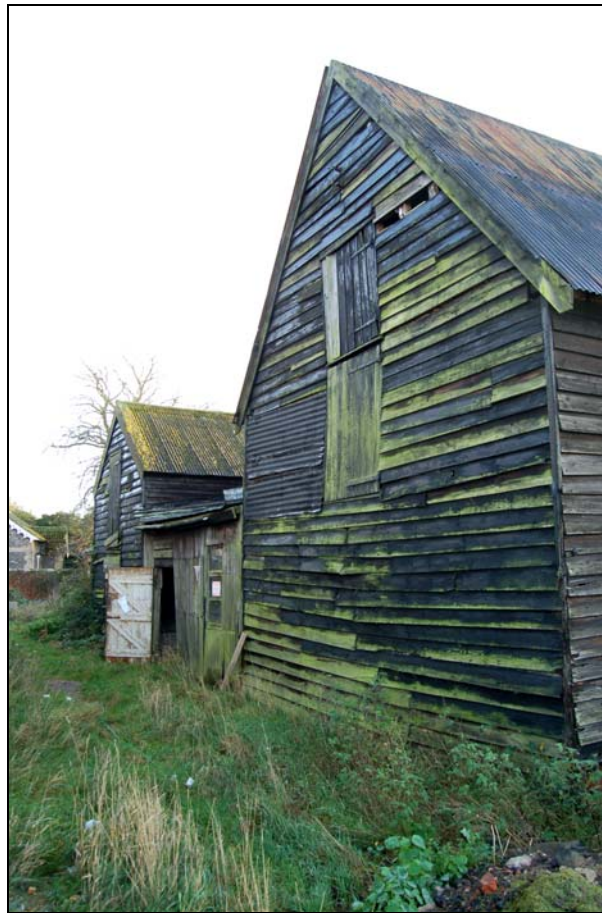
The north elevation is part of the secondary build (1a) but is actually the north end of barn 1, rebuilt. Two pitching hatches are located above and below the wall plate inside, suggesting there was once a hay loft (fig.6, plate 4). However, no evidence for this was found inside. The weatherboarding to the barn is covered in algae on the damp north side. Part has been replaced in corrugated tin, to the left of the bottom pitching door (plate 4).

Plate 4 North elevation of barn with pole barn and granary to left

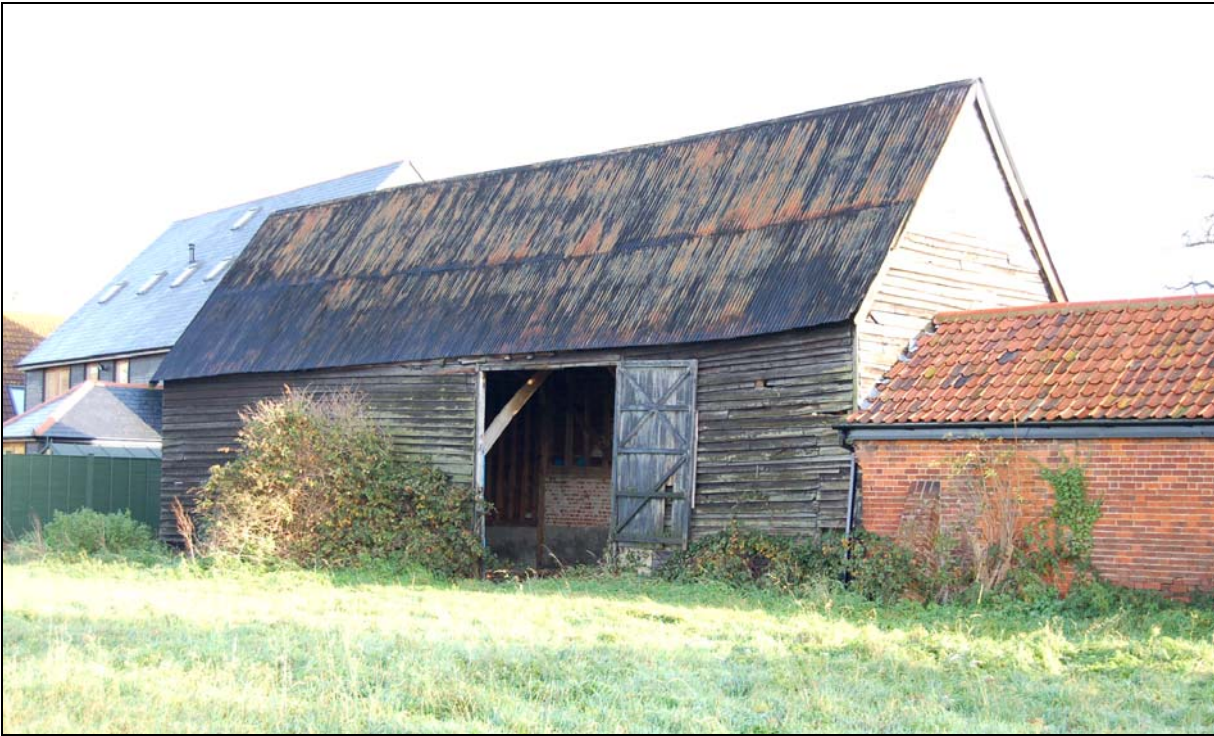
Weatherboarding on the west elevation (plate 5) is dry and bramble bushes obscure the plinth and other parts. As there is no scar where the barn extension was added, it is clear the barn was re-clad after the extension was built. Only one cart door remains.

Plate 5 West elevation of barn

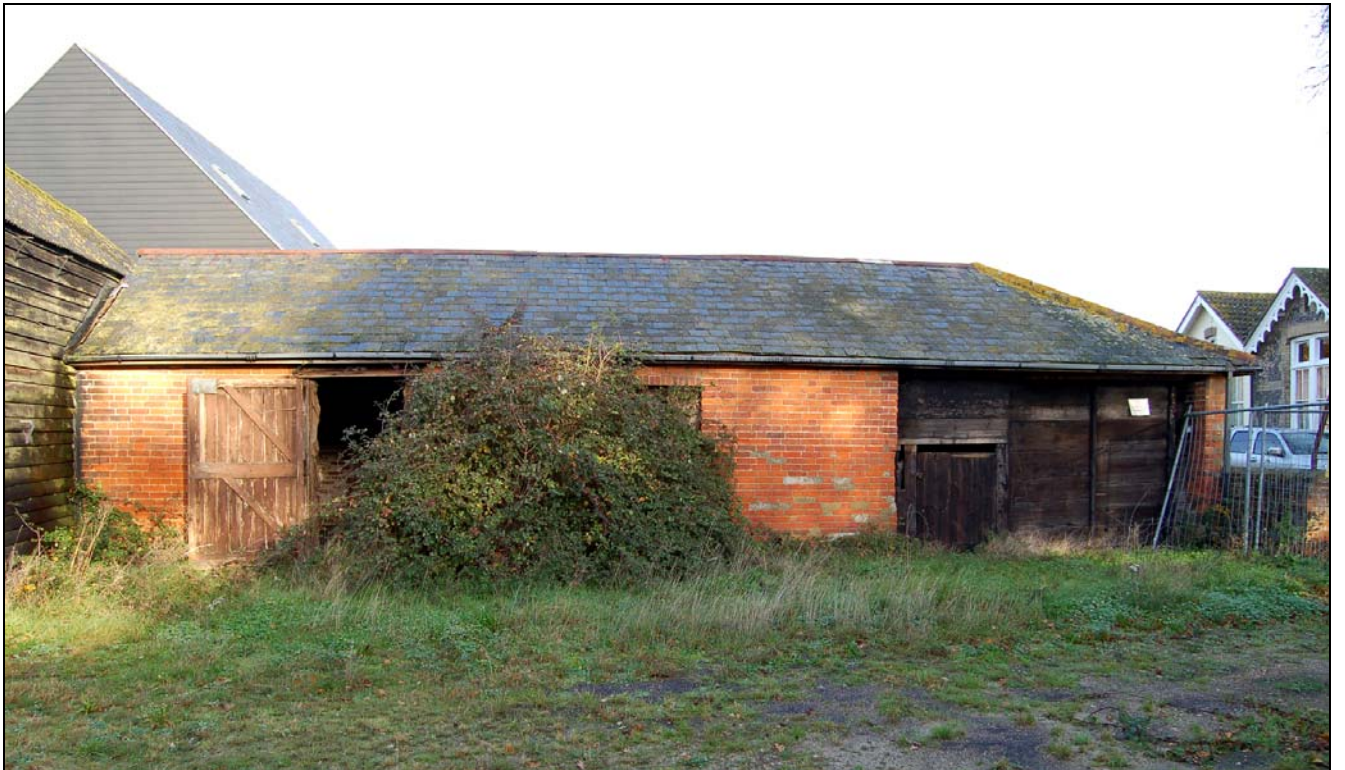
Much of the south elevation (plate 16) is brick-built, with a contemporary cow door and a boarded iron and wood-framed casement window (one side of which is clearly replaced) partly obscured by a bramble bush. The eastern third, beneath the roof hip, is a boarded (on this side) loose box contemporary with the main cowhouse. A low door with probable locking

Plate 16 South elevation of cowhouse 5

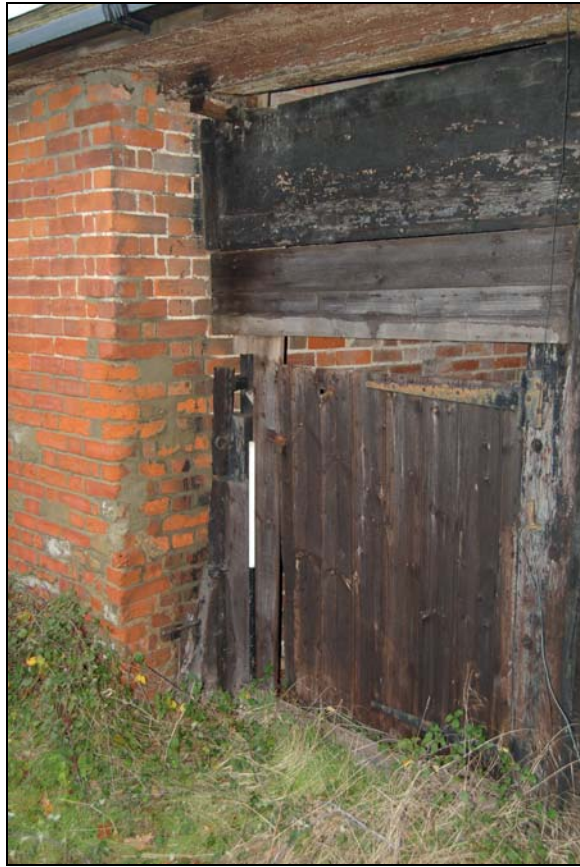
loops (plate 17) suggests this may have housed a bull. Damaged/rebuilt brickwork in the corner shows rough treatment.

Plate 17 Entrance to loose box 5a

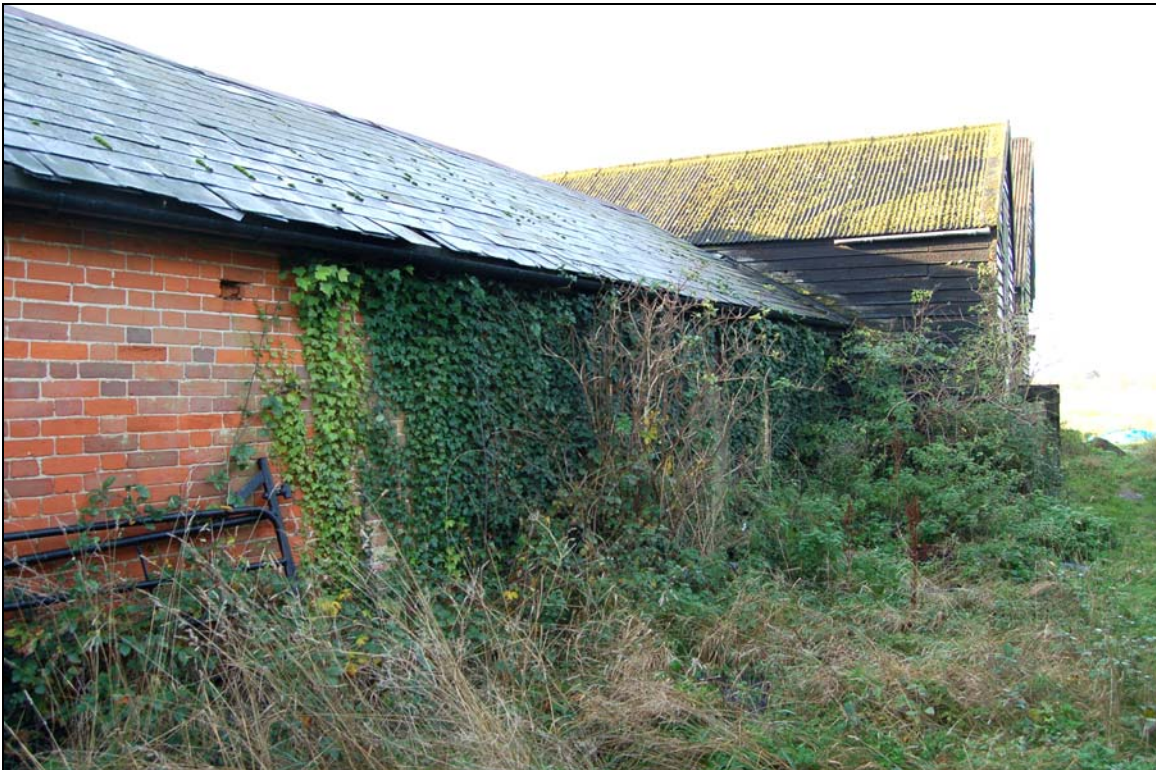
The rear (north) elevation has double half-heck cow doors largely covered in ivy (plate 18) and no other features. Conversely the bullnose bricks on the north-west corner wall, inside the granary, show no wear, proving the granary was laid out with the main farm structures.

Plate 18 Rear of cowhouse 5 and overgrown cow doors

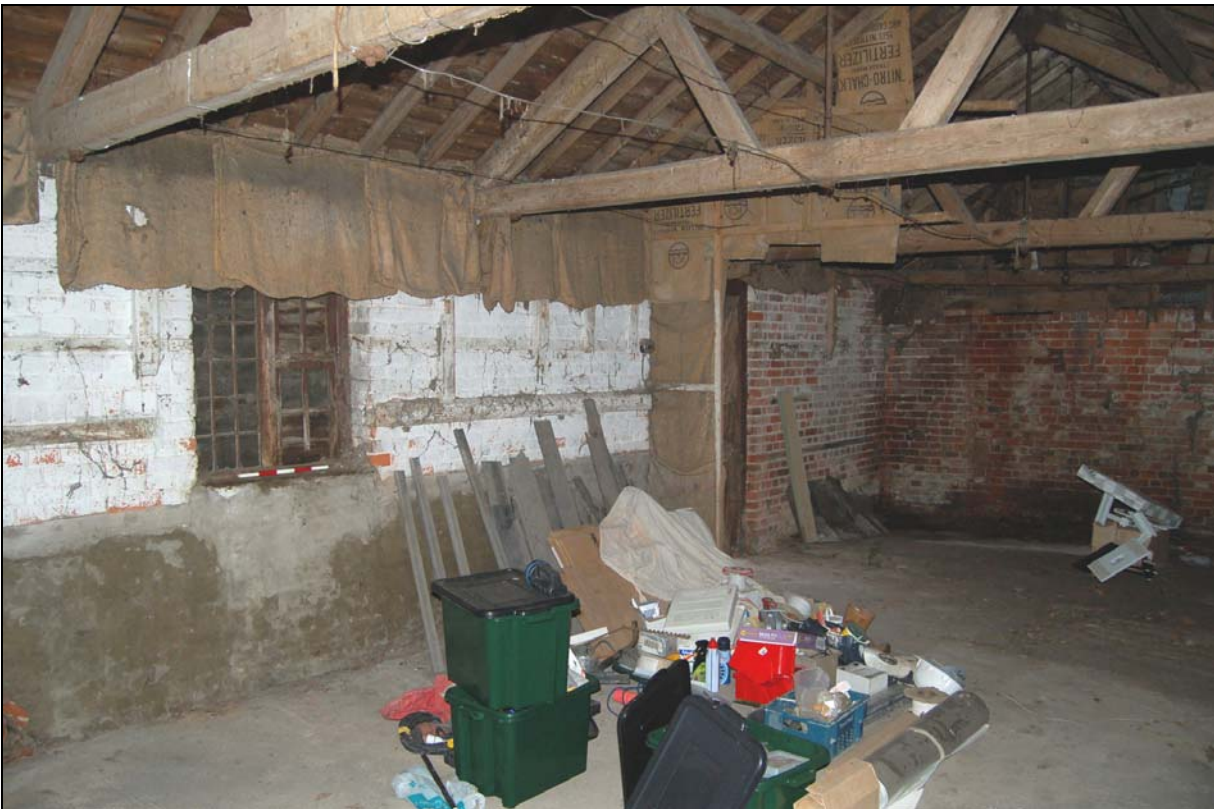
The interior is open-plan of five bays, divided at the east end by a partition wall from the cowhouse into loose box 5a (fig.6). The main part has whitewashed walls. Part of the original brick floor has remained exposed within the concrete floor by the double doors (fig.6, plate 19). Further modern additions are the pipe drains inserted at the wall bases on the long sides (plate 19) and concrete render partly up the southern wall between door and partition wall to the bull house. Here also is a wooden rail and brackets to a possible hay feeder above the render (plate 20), since removed.

Plate 20 Interior of cowhouse 5 showing removed hay rack

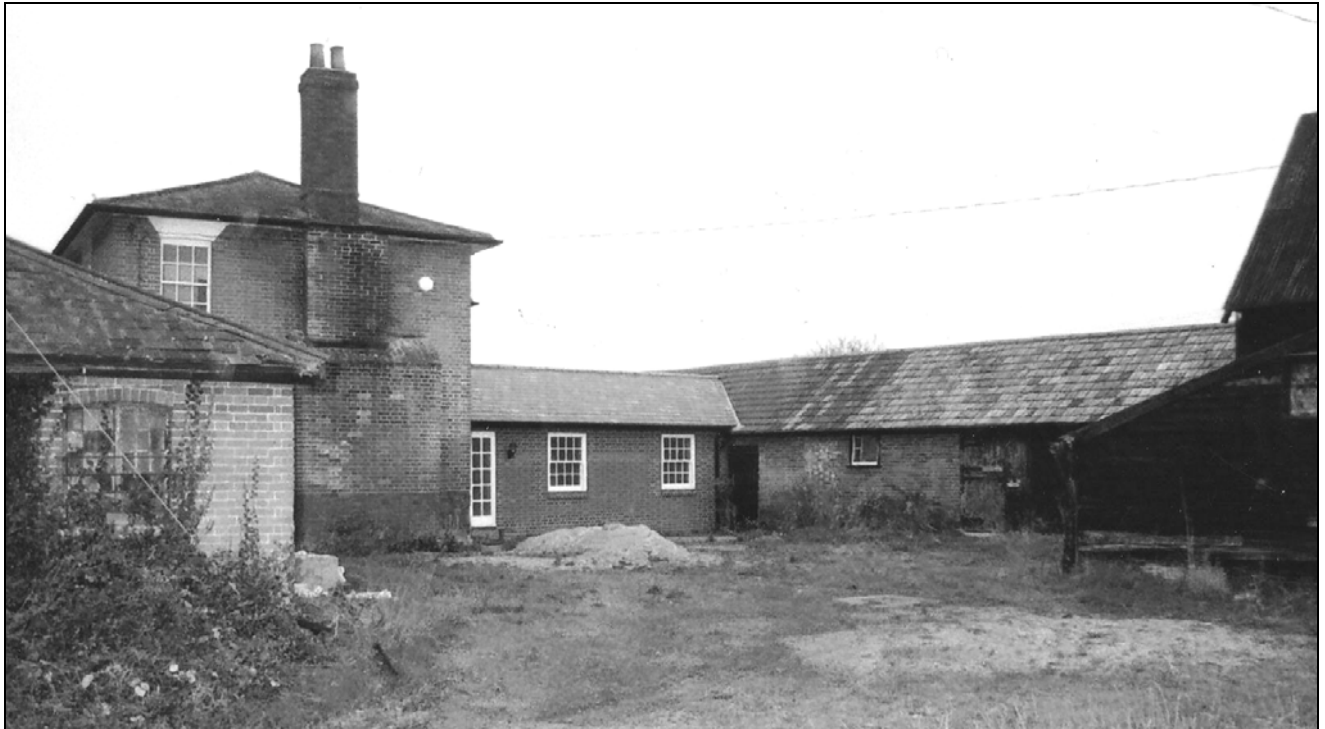
On the main elevation facing the yard (plate 21) there is a replaced double (?cow) door. A second doorway has been blocked in Fletton bricks (fig.6), as has the area on the north side of the cow door that formerly opened out into the (removed) shelter shed against loose box 2. An original central-tilting window has been inserted in the later brickwork (plate 22), identical to another towards the south. The window probably came out from the blocked partition wall between the cowhouse and washhouse (buildings 6 and 6a, fig.6). The opposite elevation, on the west side (plate 23), has a fairly uniform appearance with a central half-heck doorway to the main area out to the fields. There is no scar for the former 'porch' that stood here in the 1897 map (fig.5).

Plate 21 Cowhouse 6, house and modern extension viewed from north-east

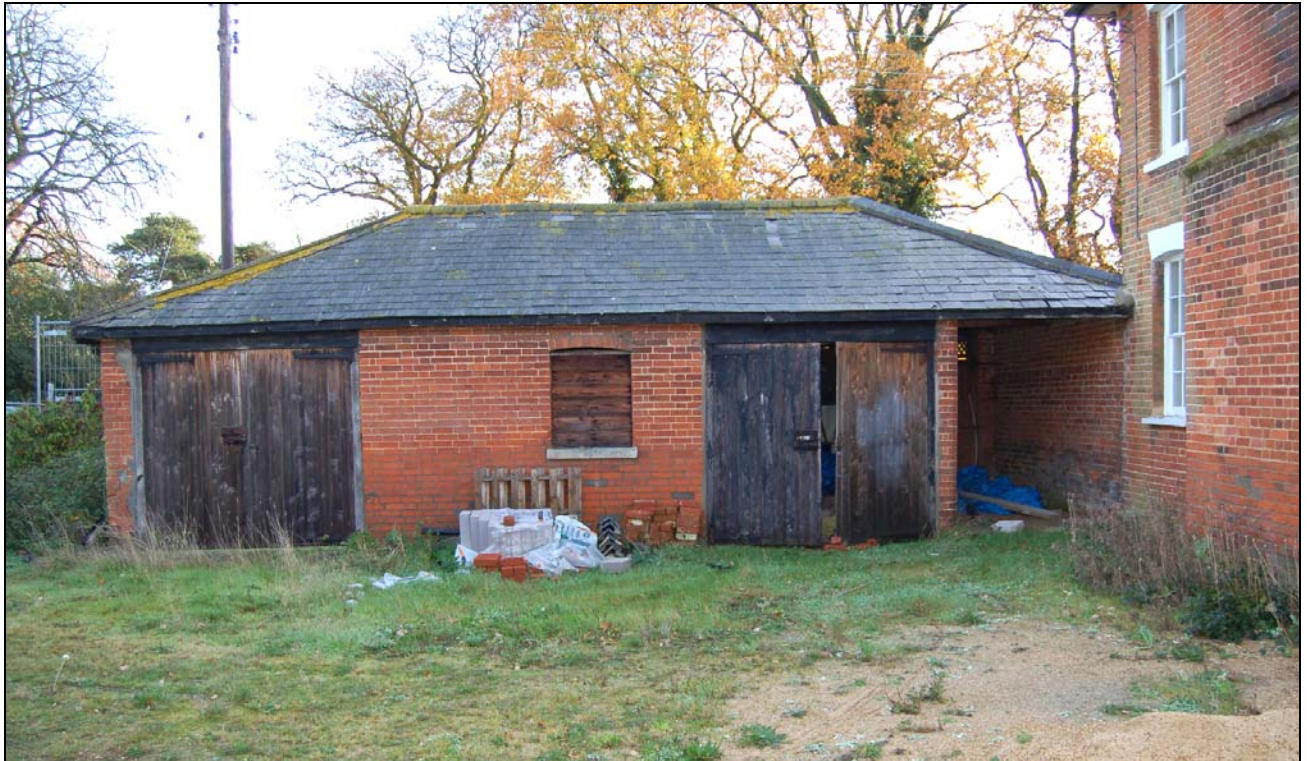
The cart doors on the west elevation, facing the yard (plate 26), appear to be modern replacements cut into the existing wall fabric. Those on the opposite side are original and, in their prominent position facing the road, designed to be on show. Here the cart doors and stable door are ledged with diagonal battens (plate 27). A third, behind the stores on the south end (fig.6), is more basic with vertical battens, but the attractive ventilation grille above continues the diagonal theme in slatted timber strips (plate 27a or 28). Fenestration in the building is limited, and found only on the west and north elevations. The windows are thin iron 15-light twin fixed paned, set within wooden frames inside segmental brick heads (plate 26) and would have provided little in the way of ventilation inside.

Plate 26 West elevation of wagon house/stables
