**STUBBLES FARM, TYE GREEN, CRESSING  
ESSEX**

**HISTORIC BUILDING RECORD**

**Field Archaeology Unit**

**April 2007**

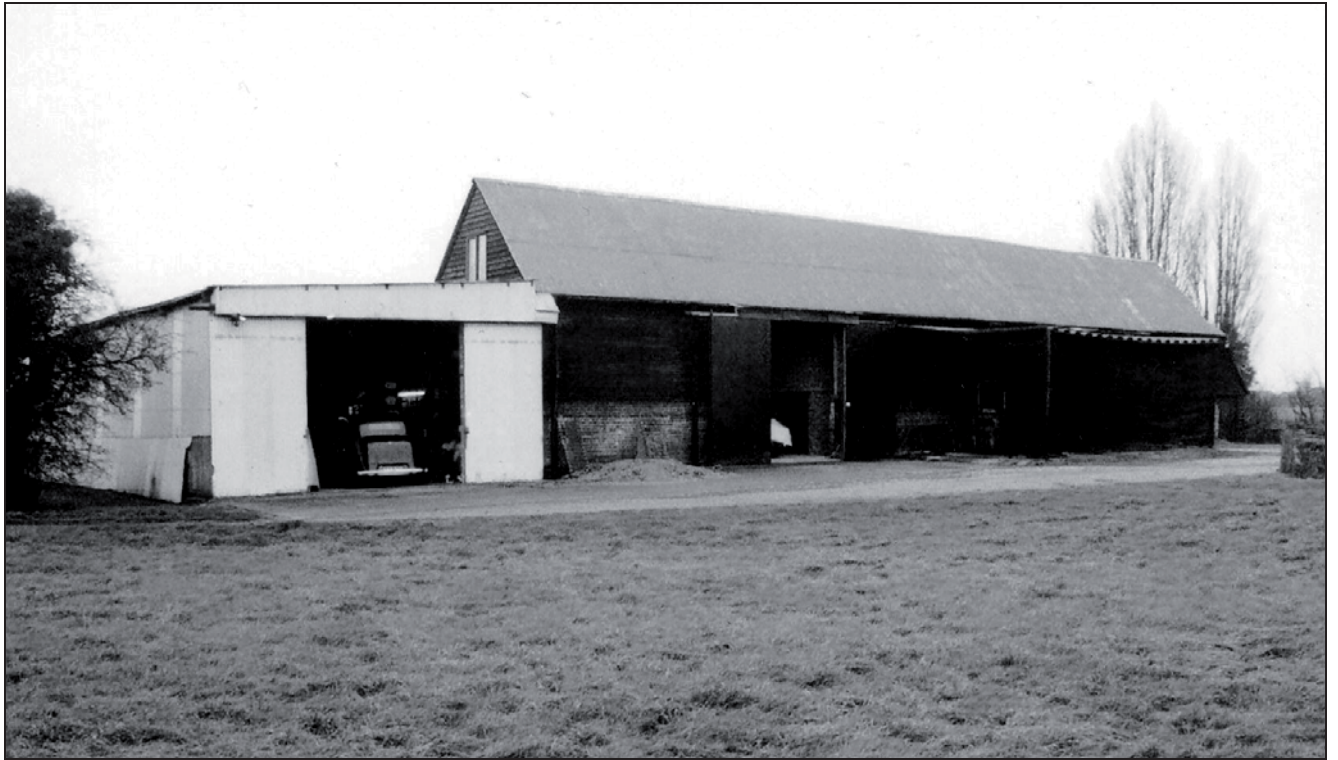
The eastern elevation (plate 1) fronts onto the gravel driveway and is relatively austere. Both pairs of cart doors have been replaced in the modern period by metal sliding doors hung from steel runners attached to telegraph poles. North of the doors is the blocked former transmission portal between steam engine and milling machinery inside this end of the barn (fig.6). Some rebuilding has been done around the north door that was damaged by a tractor (D. Nixon pers. comm.). The central part is taken up with the mid-20th-century shed 7 and tumbling-in buttresses support the plinth south of the doors (fig.6 and plate 1).

Plate 1 Barn and garage viewed towards west

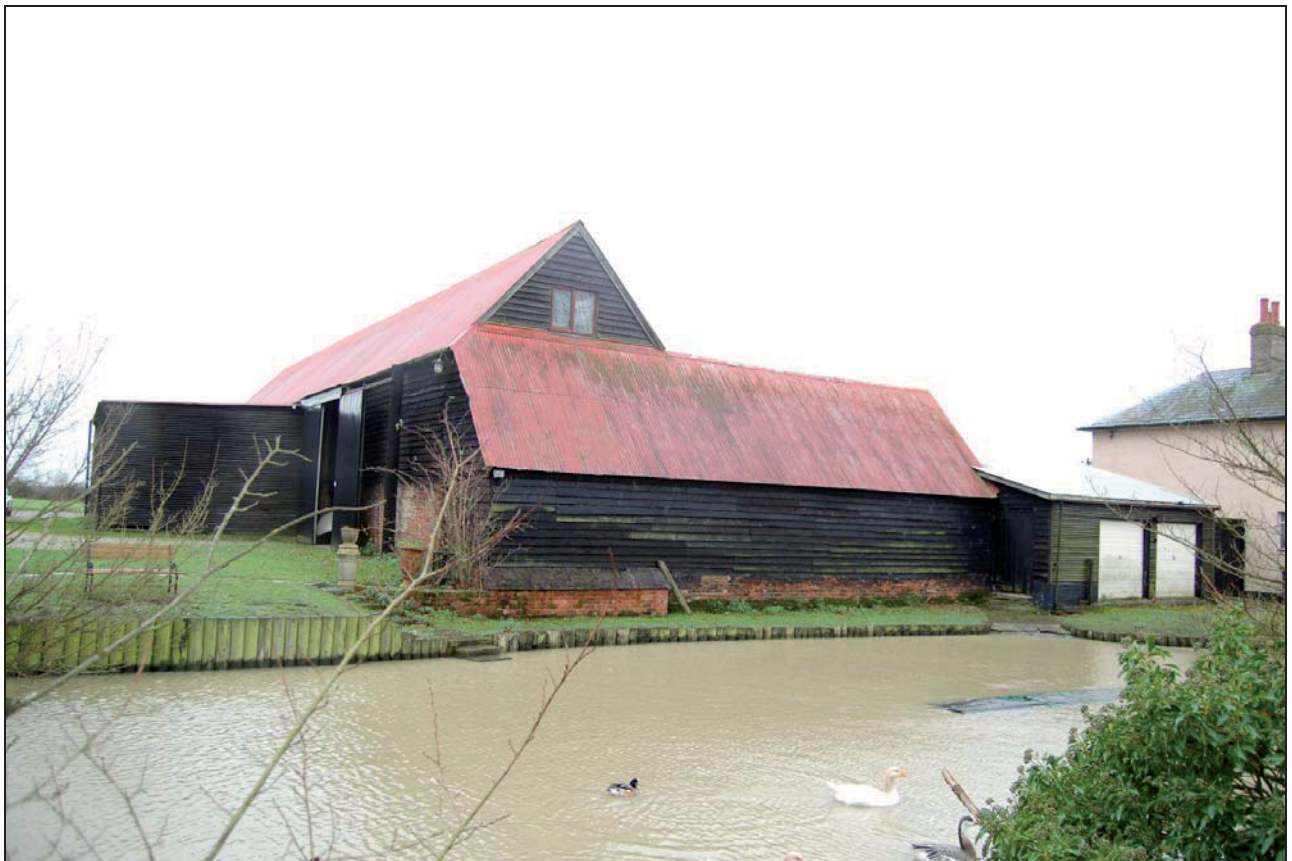
The shed (plates 1 & 2) is situated on the east side of the barn against the central bays (fig.1) and is open to the south. It is used to store numerous large vintage car spares (wings,

Plate 2 Barn, cowhouse and shed 7 viewed towards south

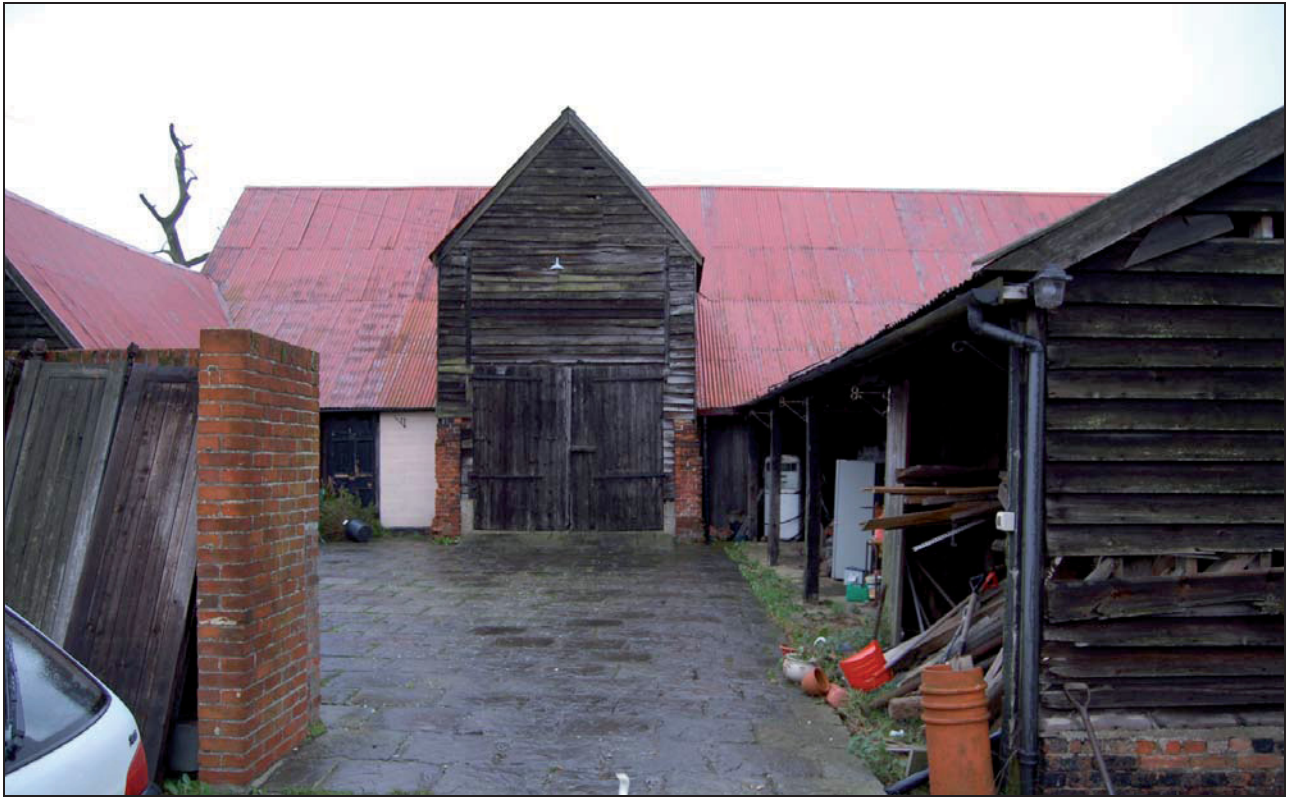
This structure (plates 3, 4, & 18) is the latest in date of the farm buildings, built sometime in the early 20th-century to house loose cattle. Since then, parts have been used for general and vehicle storage and as part of the 'Titanic Bar'.

Plate 3 Former yard surrounded by barn, shelter shed 4 and cowhouse

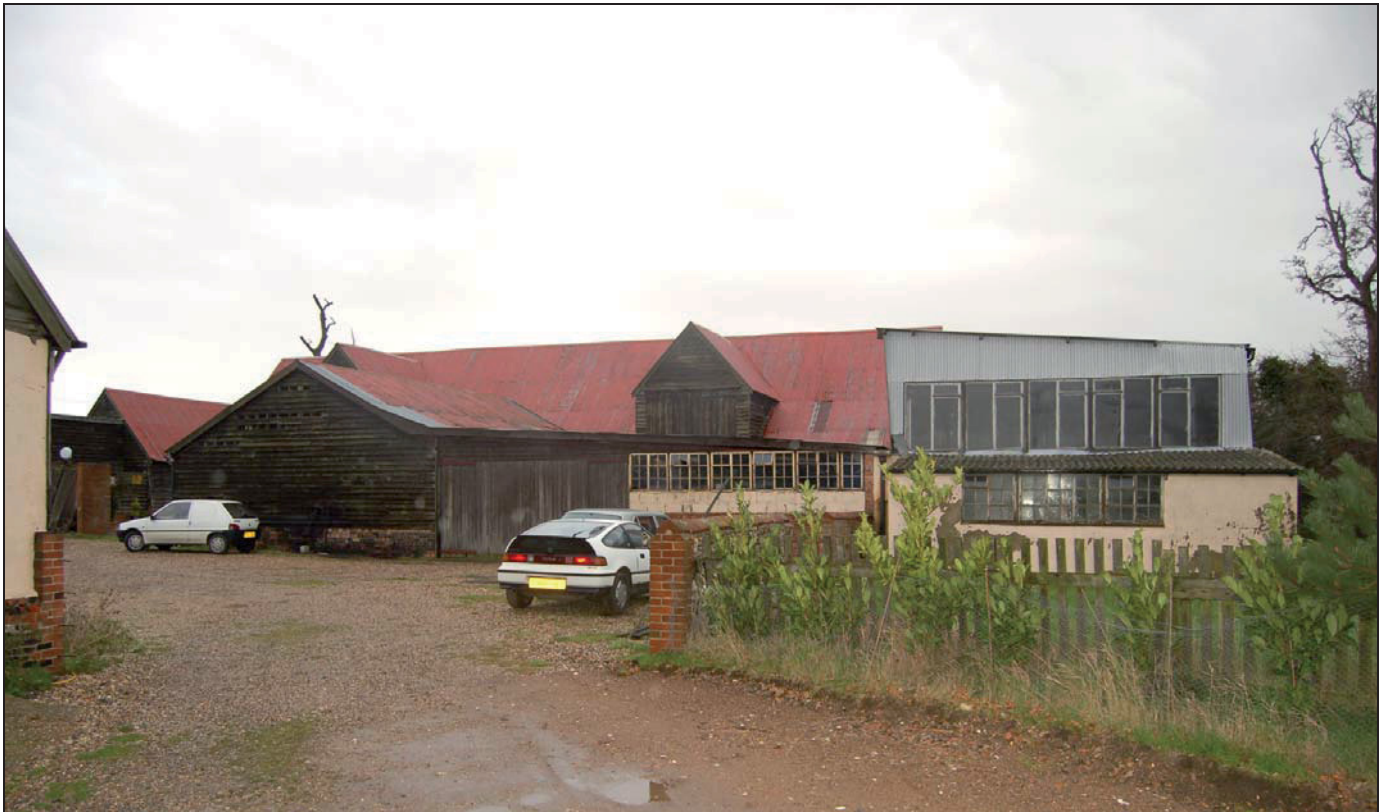
The garage (plate 4) is built from corrugated iron sheeting and concrete blockwork; adjacent to the south walls of the barn and pole shed. Iron Crittalls windows bring in light from the east from high up and in the projecting lower part. On the opposite side are large sliding doors to bring the cars in and out (plate 1). Construction-wise, buildings 5 and 6 are similar as they both have telegraph poles supporting the low-pitch roof and partial light timber-framing (plate 20).

Plate 4 Modern additions to barn

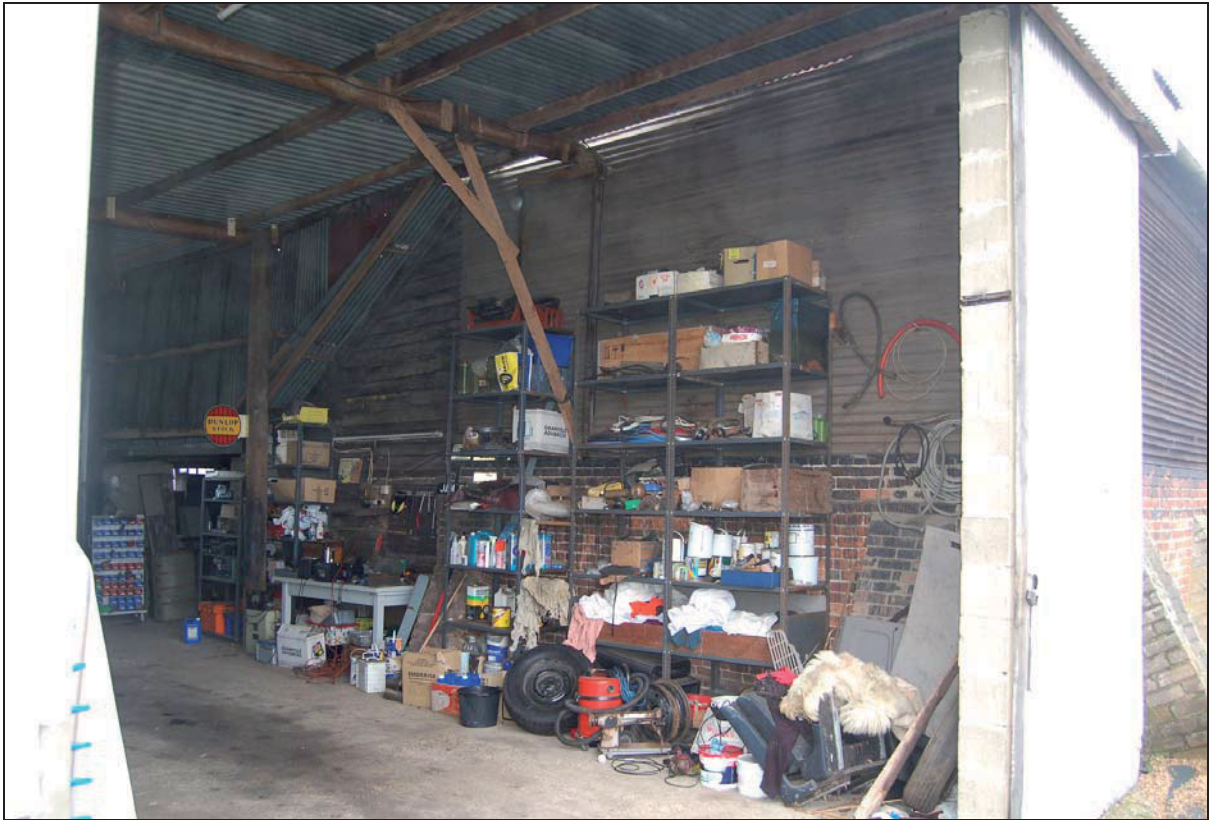
Again, the two short elevations are largely obscured by buildings, apart from their upper sections, and were recorded from inside other structures. Little has changed at the north end. However, the south end, inside the garage/workshop, was rebuilt in oak boarding after a storm (plate 5). Adjoining loose box 3c was unaffected.

Plate 5 Rebuilt south wall of barn inside garage

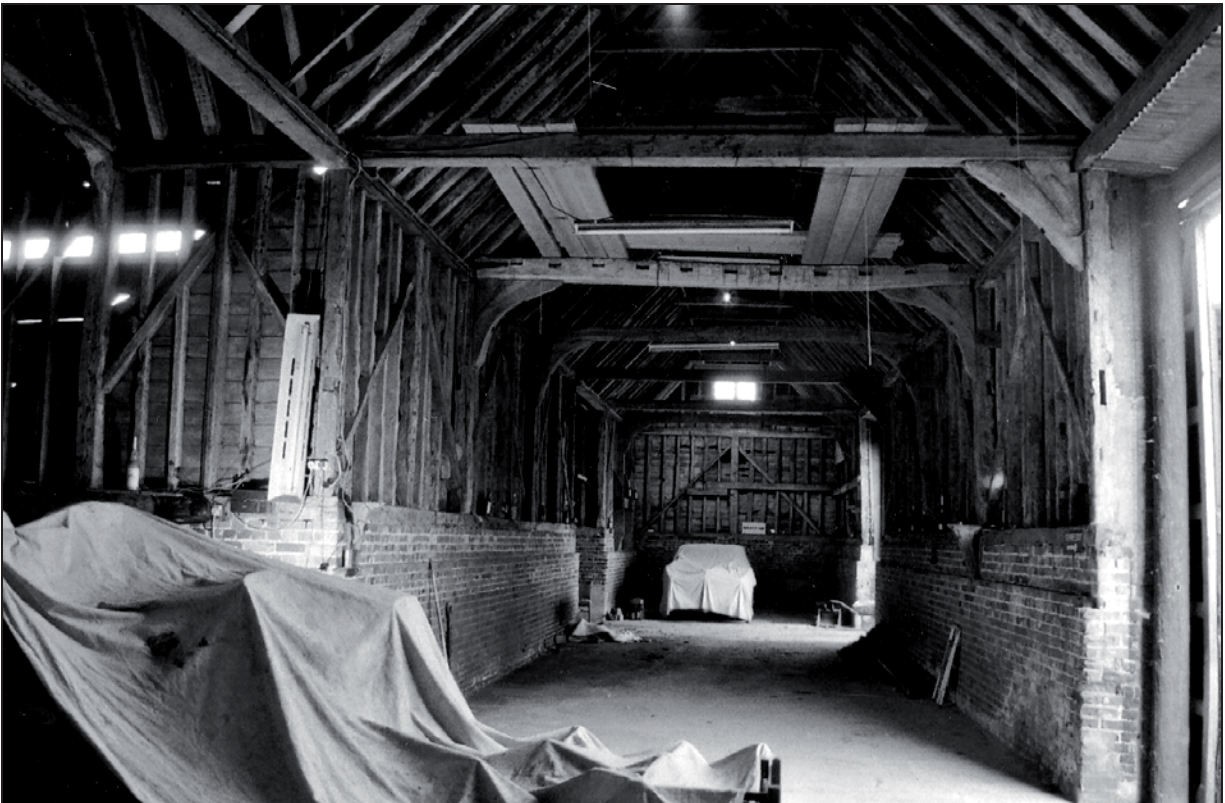
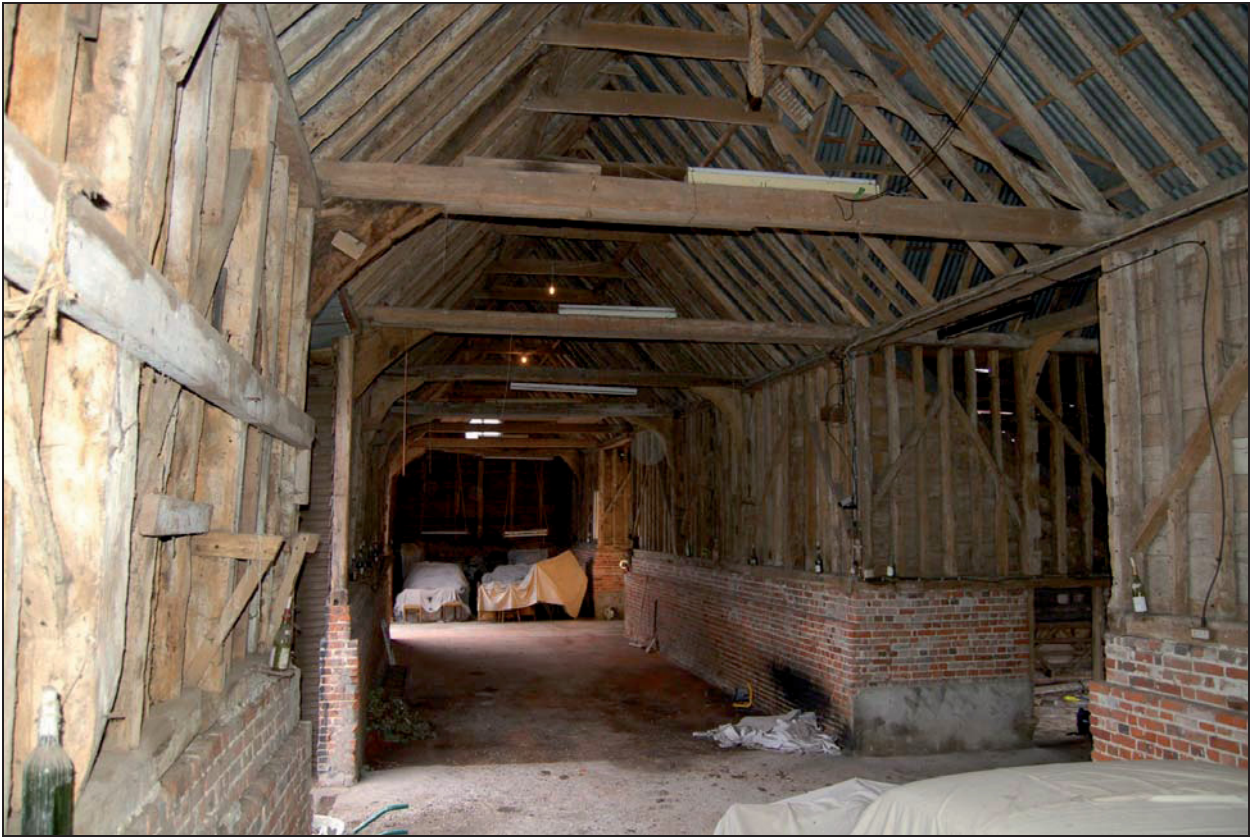
Inside the barn, the framing is primary-braced (plates 6 & 7). The nine bays vary between 3.2 and 3.7m-wide. Each bay has a central stud and either three or four normal studs either side, depending on the position of the bay. The central bays, between the wagon doors, are wider. The studs are long and slightly waney, tenoned to the plates and nailed to the bracing. Average width is 11cm, but the reused ones are thicker at around 13cm. The studs are set fairly close together, between 26 and 30cm.

Plate 6 Interior of barn viewed to north

Plate 7 Interior of barn viewed to south

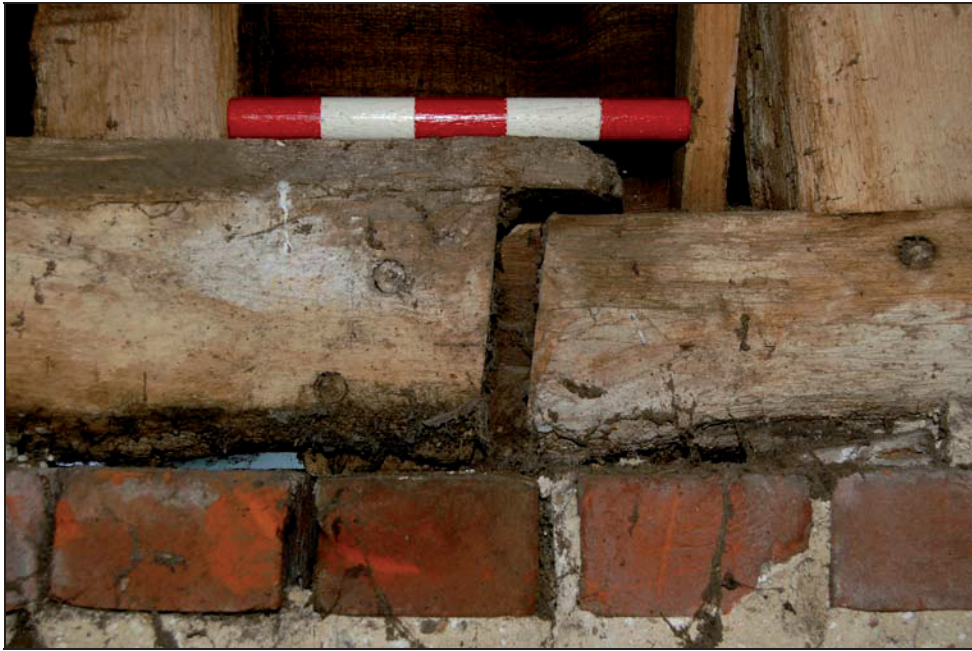
The main framing members are pegged together. Stout bay posts are on average around 22cm<sup>2</sup> or larger and are all reused. The wall plates (c.15 x 18cm dimensions) are contemporary with the barn (i.e. not reused) and come in long sections up to two bays in length. They are joined by face-halved and bladed scarf joints, typical of post-medieval construction but becoming obsolete during the 19th-century. The sill plates have identical scantling and are linked by over-lipped bridle scarf joints (plate 9).

Plate 9 Bridle joint with over-lipped face in sill

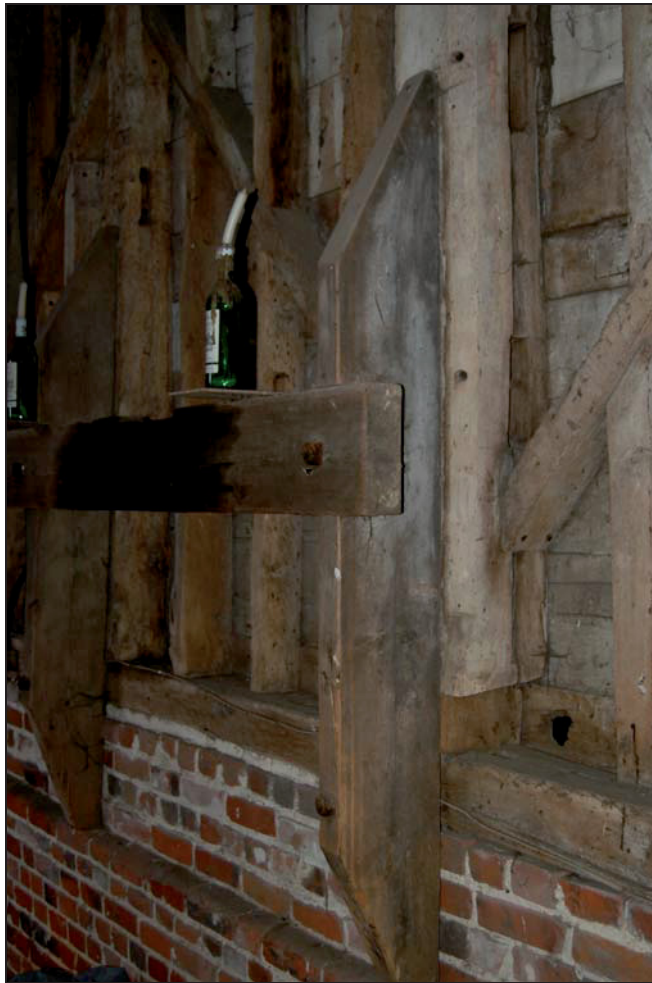
Although the milling machinery is no longer extant, some evidence of its superstructure remains, attached to the timber frame and in the roofspace. The original tie beam between the two northern bays has been 'doubled-up' to support the running gear and a bearing box bracket remains bolted to the framing on the western side (fig.6, plate 10).

Plate 10 Bearing box bracket for former milling machinery

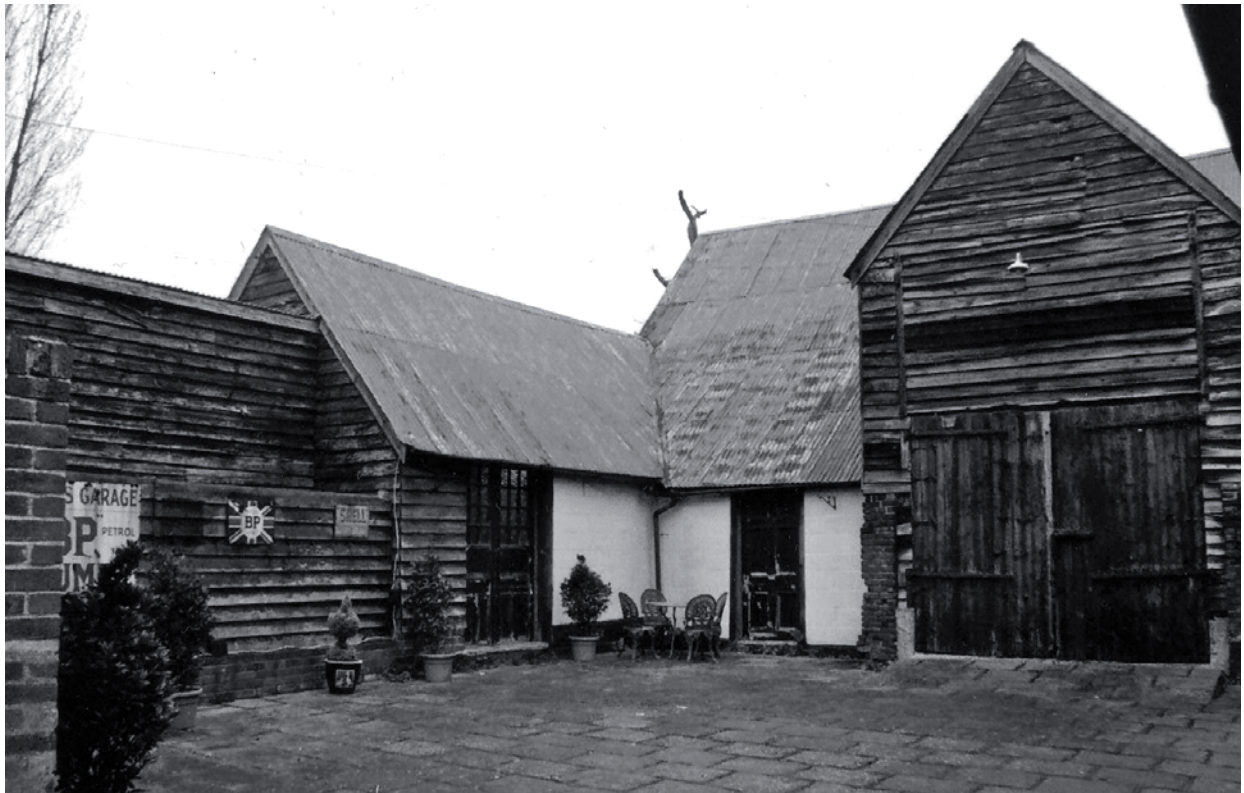
The main elevation of **loose box 3a** is built of blockwork with a modern house door set within (plate 11). Inside, are several reused timbers, including the wall plates to north and west (plate 14). Although there are no contemporary studwork mortices to show for sure there was a stud wall here, none of the maps show this structure as open-sided. Therefore it would appear that the existing mortices were reused when the shed was built.

Plate 11 Cowhouse and loose box 3a beside southern porch

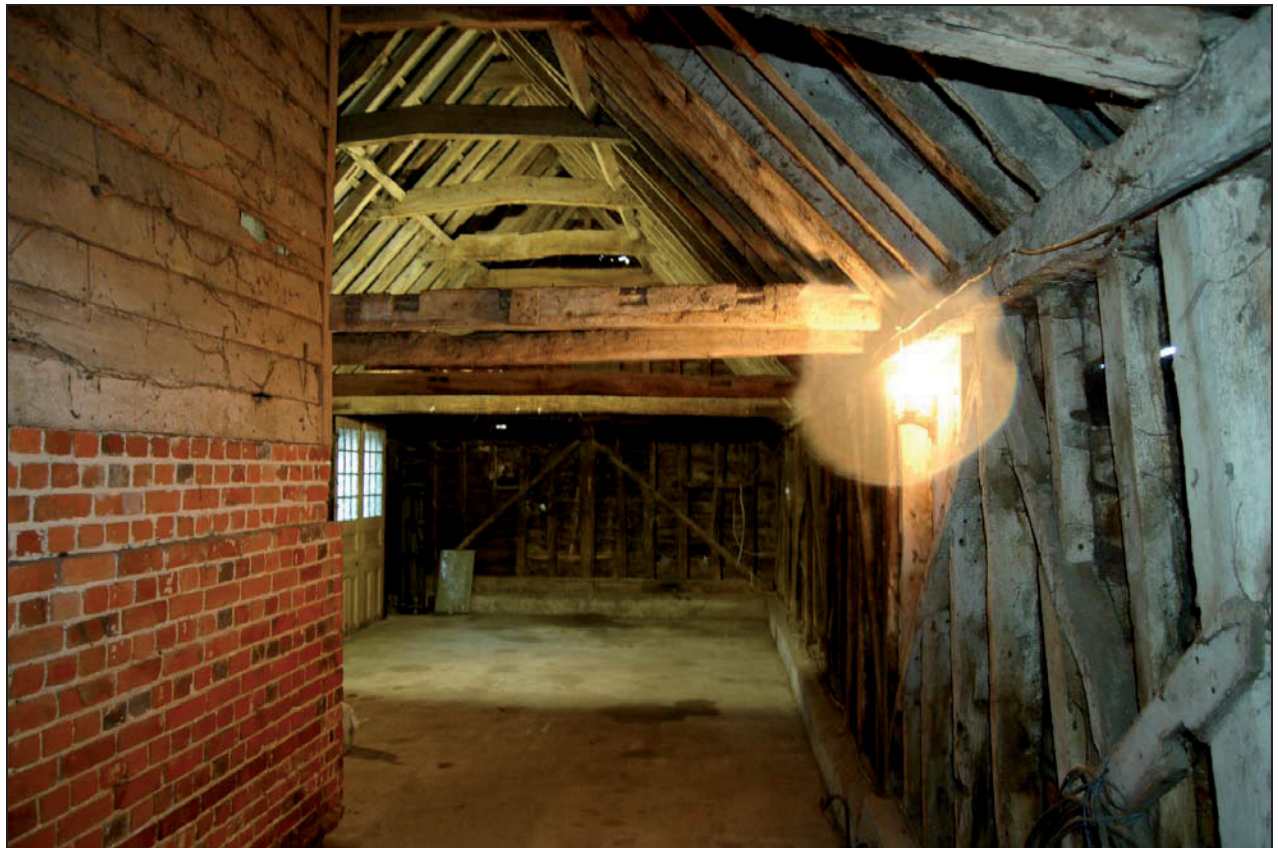
The roof framing is simple clasped collar purlin with no embellishment (plate 12). The tie beams that anchor the structure to the barn are nailed internally to the bay posts in the same way as the structures either side of the barn porches, included together as Building 3. No internal features associated with livestock (e.g. trough, hay feeders) remain, nor their positions recorded.

Plate 12 Interior of cowhouse viewed to west

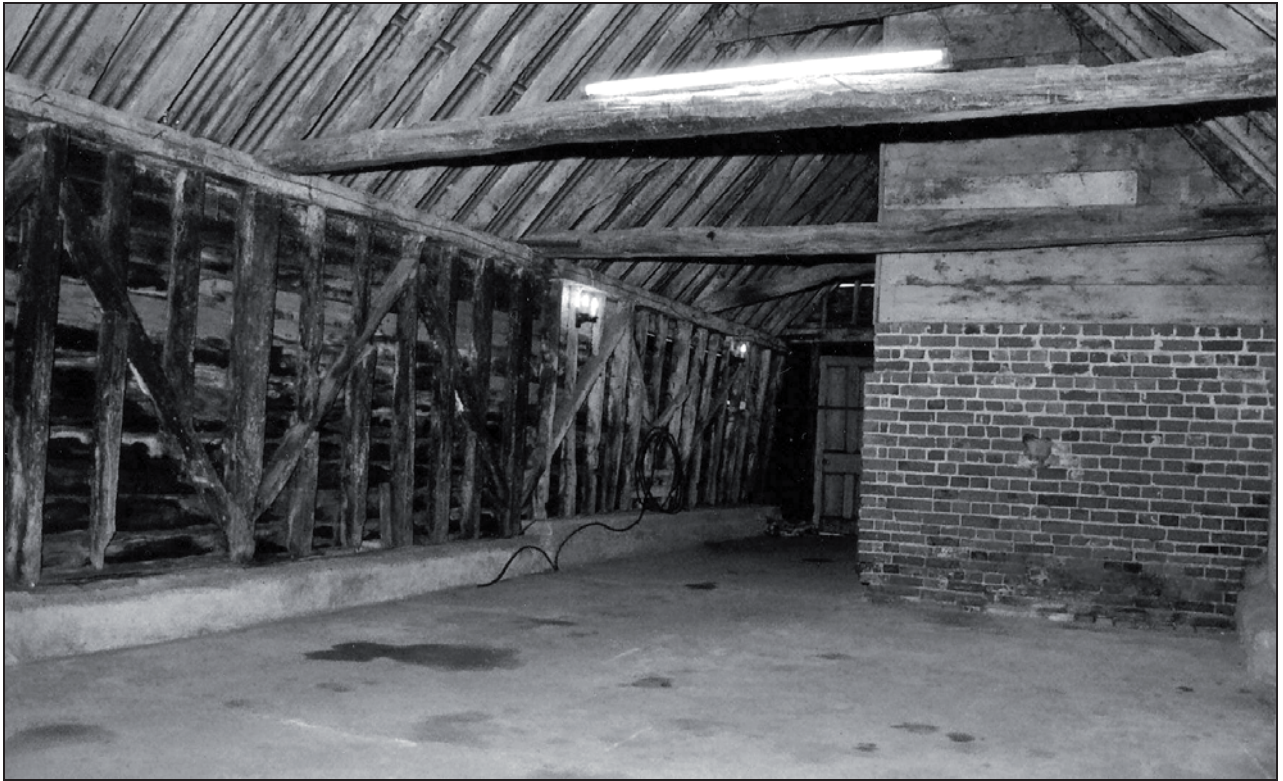
Inside (plates 12 & 13), the structure is five bays wide, each bay around 2.5m in width. The plinth is cement-rendered and the floor sloping towards the west. There are five studs per bay including the central one to hold the primary bracing either side (plate 13). Bay posts are thinner than the barn at around 16 x 12cm as the walls carry a lesser load. Studs are thinner too; at around 7 x 8cm. Reused timbers have been used as posts, sills and some studwork, again with wattle marks, probably from the same building. The most dramatic example is perhaps the sill plate on the west wall that contains mullion rebates, shutter groove and mortice holes for heavy studding, like in the barn (fig.6).

Plate 13 Interior of cowhouse viewed to north-east

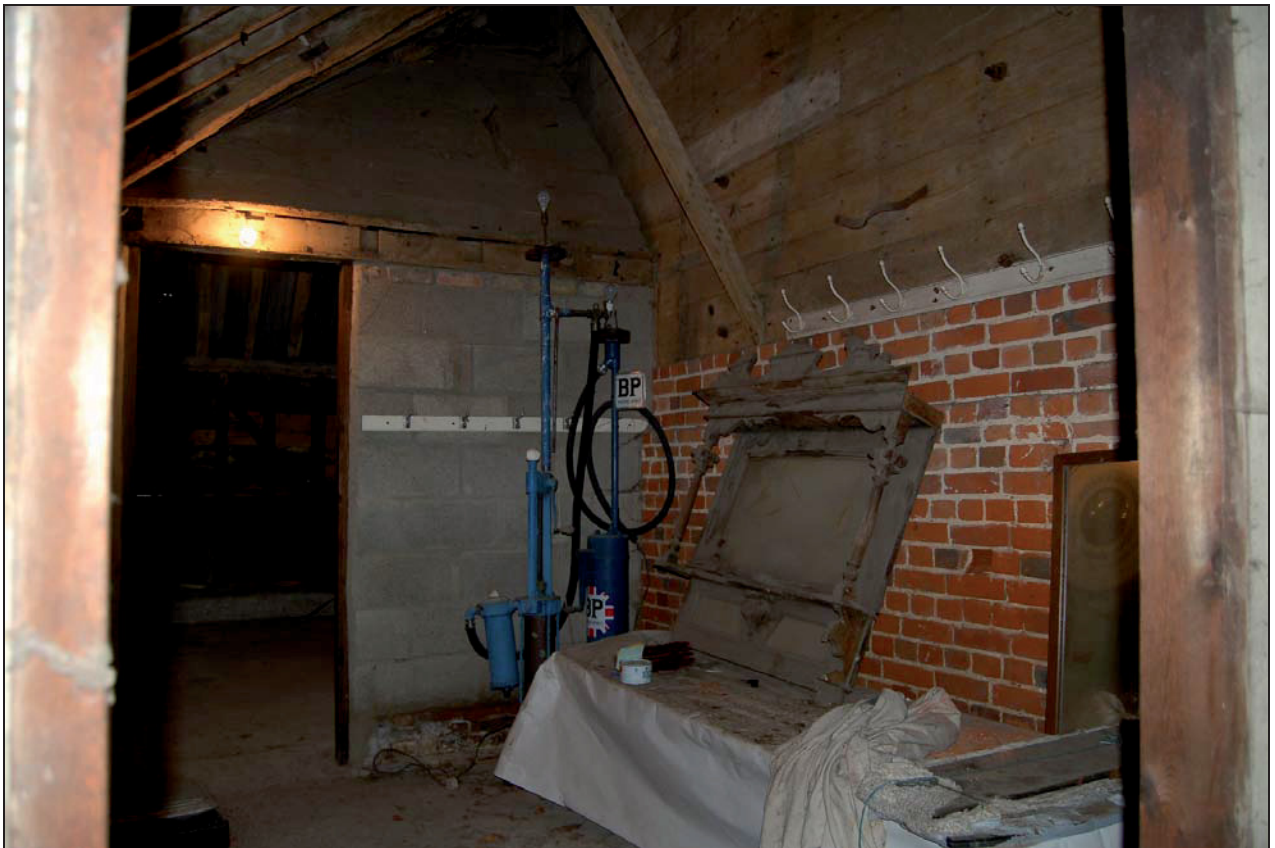
Plate 14 Interior of loose box 3a

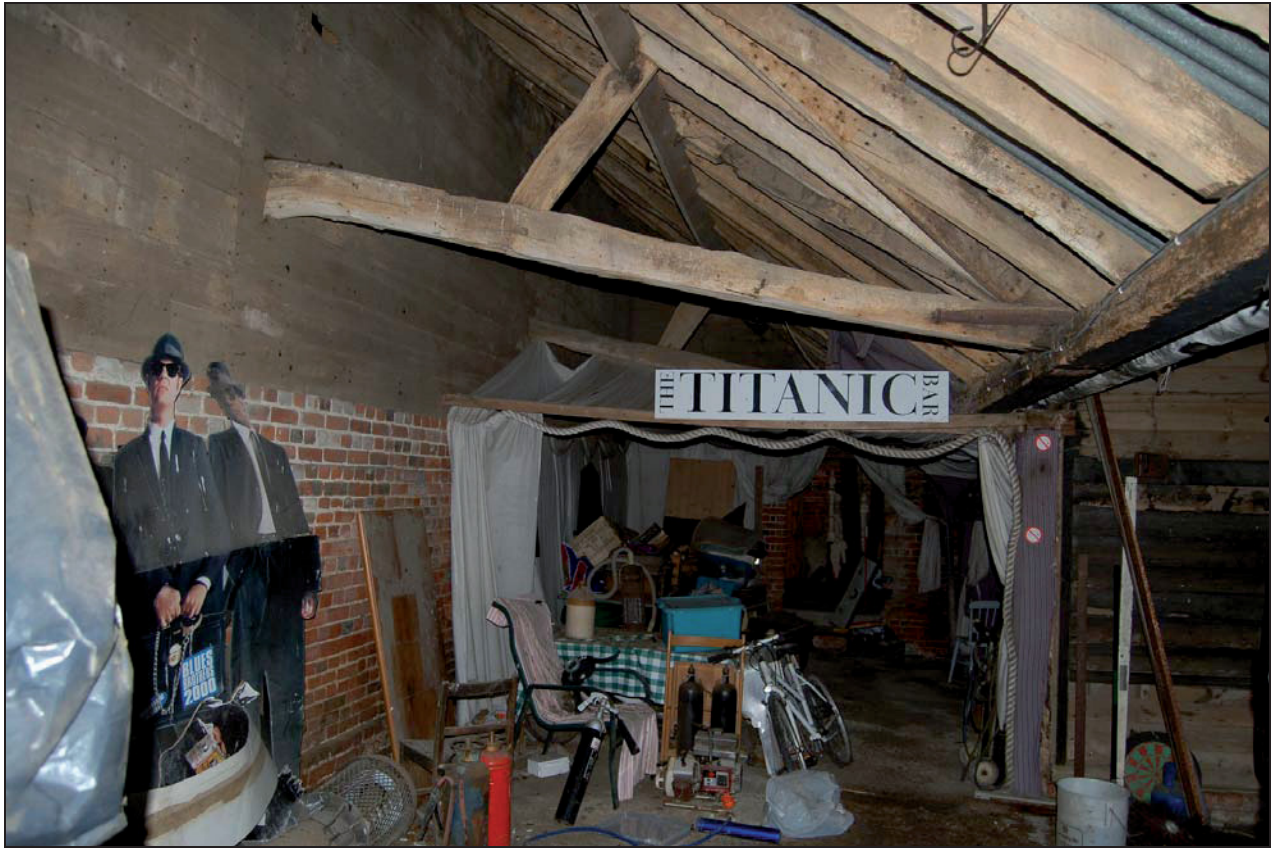
**Shelter shed 3b** was built open to the yard for loose cattle. Later on these facilities were increased by joining the large shelter shed onto it. In more recent times, the area has been used as a bar area for functions, nicknamed 'The Titanic Bar' (plate 15). The inside is divided into three bays and from here the coursing of late 17th-early 18th-century bricks may be seen (plate 15).

Plate 15 Interior of shelter shed 3b

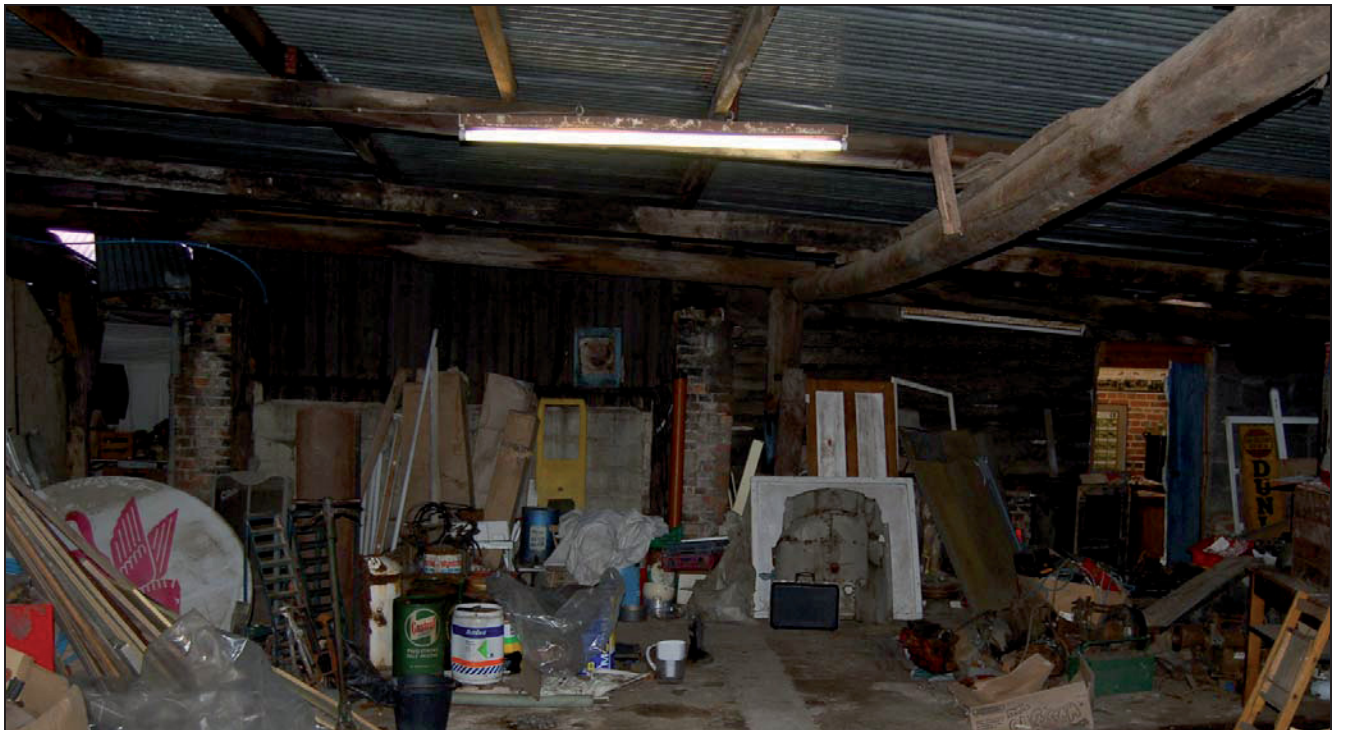
**Loose box 3c** is sited at the south end of the barn, but its main elevation (plate 16) was partly obscured by the items stored inside the pole barn. The interior has been nicely refurbished as an office for a wedding car business. The two bays were originally partitioned into loose boxes for a small amount of cattle, but the studwork below the tie beam has been removed (plate 17). Two doorways, one into the porch and the other out into the yard, provided entry into the boxes.

The barn has a low-pitch roof, sloping to the south. Inside, rafters span the width of the structure, held up by telegraph poles (plate 16). It is likely the corrugated iron roof was put on the same time as those on the more traditional buildings.

Plate 16 Southern porch and loose box 3c viewed from inside pole barn

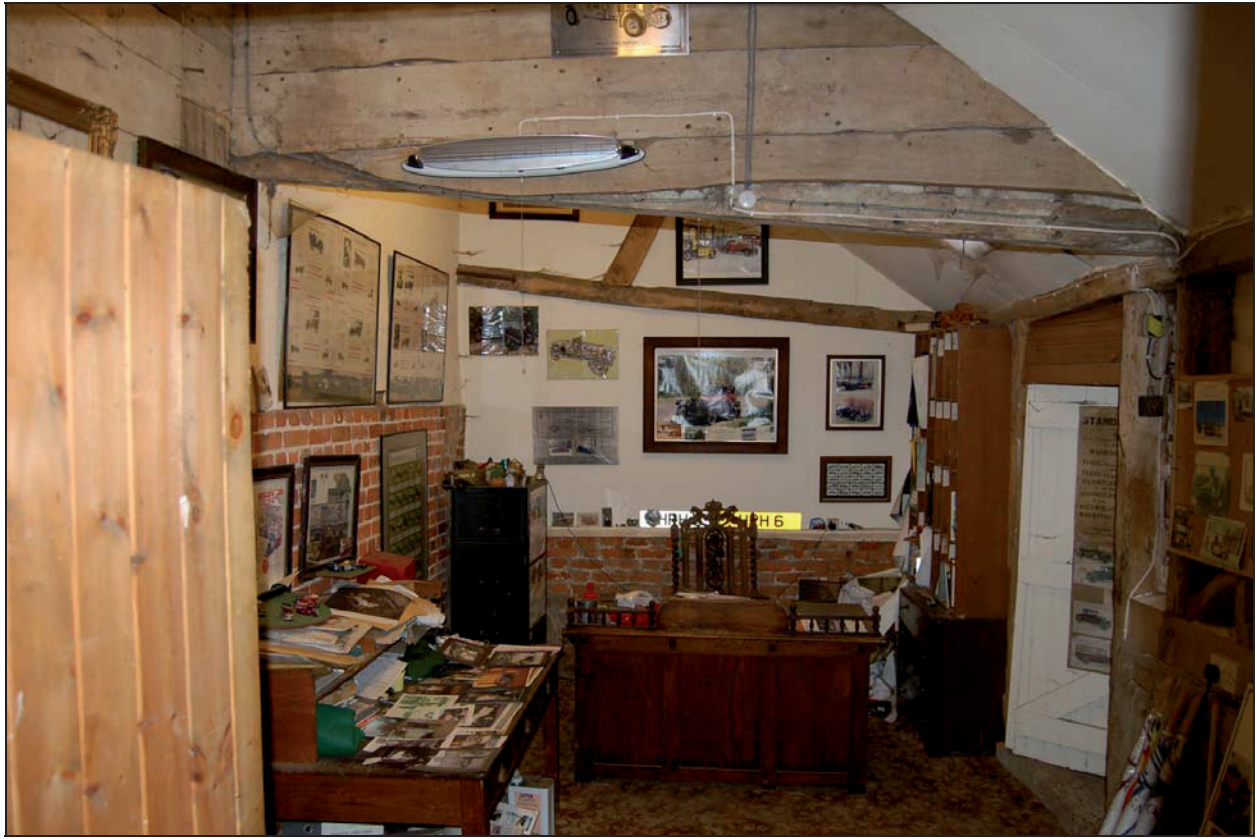
Plate 17 Interior of loose box 3c (office)

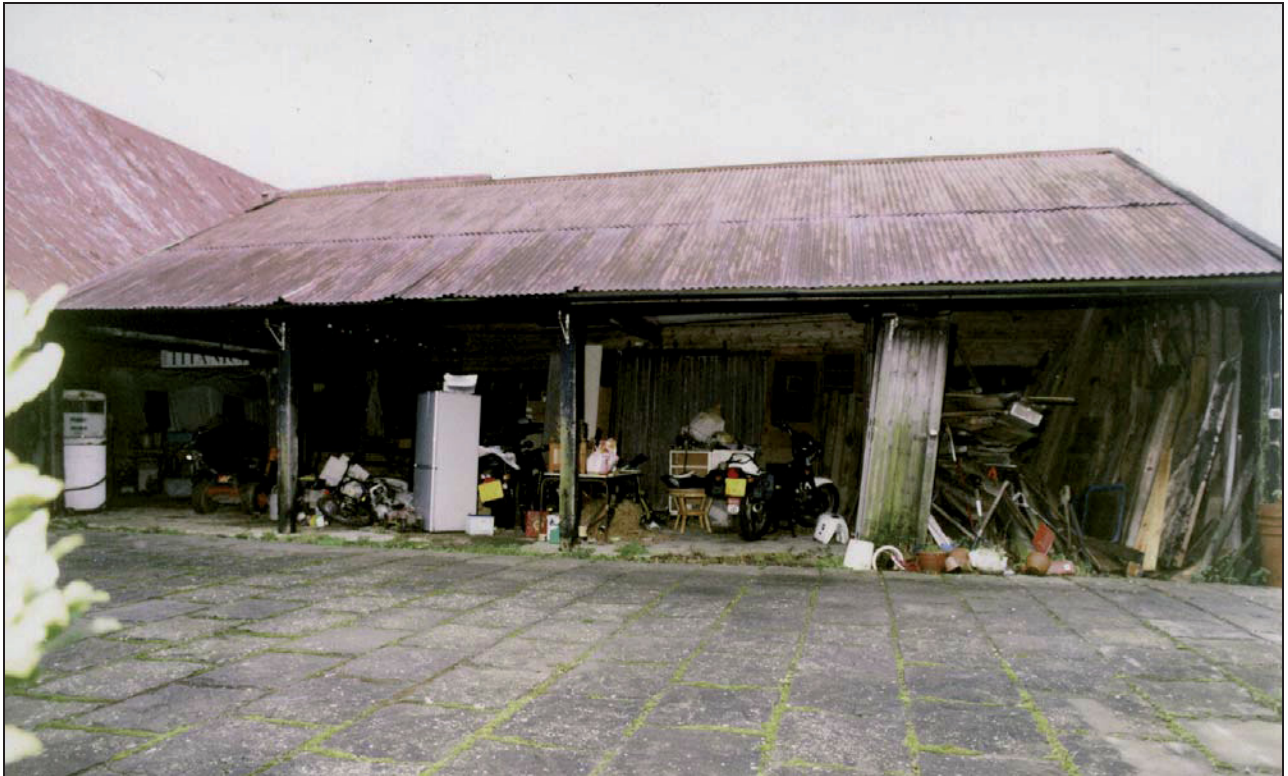
Plate 18 Shelter shed 4 viewed to south

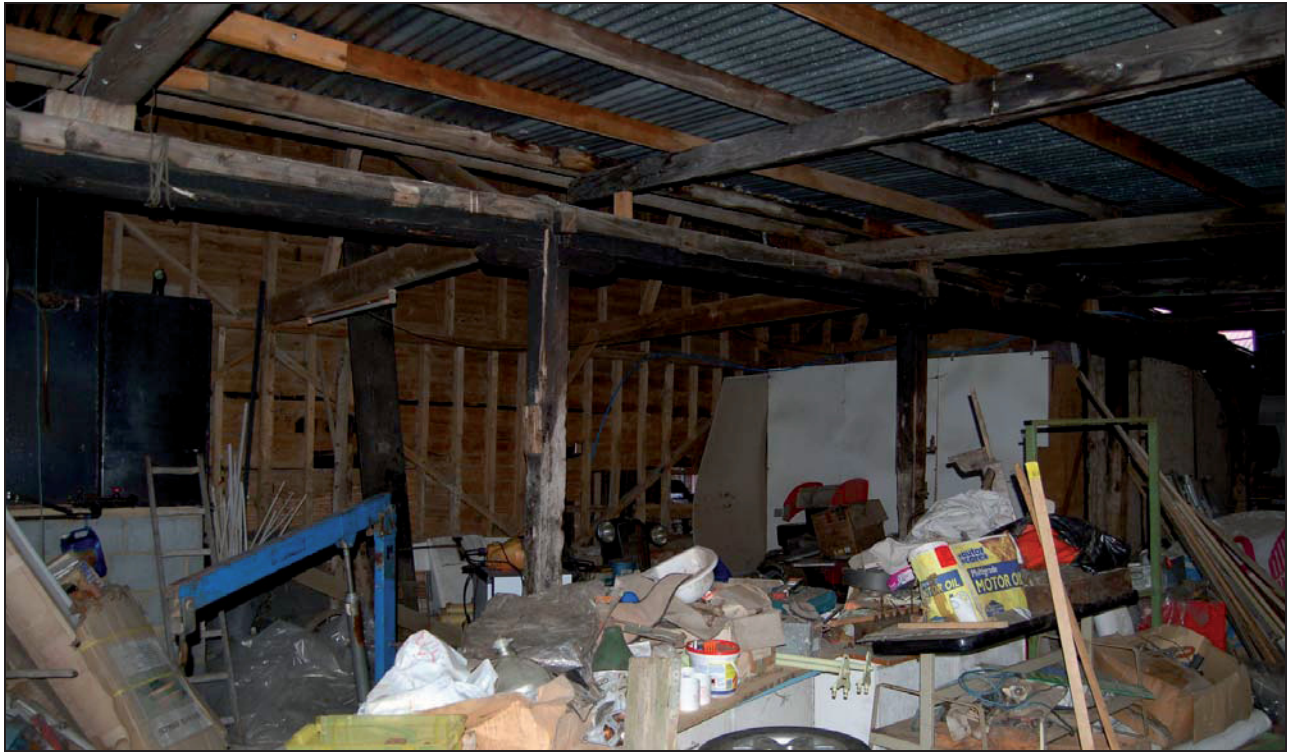
Inside, the two sides are divided by an axial spinal wall built from primary-braced machine-sawn timbers and weatherboarding (plate 19). There is a narrow vent running along the top for through-draft to either side. The long elevations are divided into four bays by square-cut 6" posts whose tie beams are connected to the roof purlins by simple splayed struts. Gate fixtures remain on the posts. The western bay is partitioned-off as a woodshed by a folding door a later adaptation (plate 18). The southern side opens out inside the pole barn whose roof is laid directly onto the cowhouse rafters (plate 19).

Plate 19 Southern side of shelter shed 4 from inside pole barn

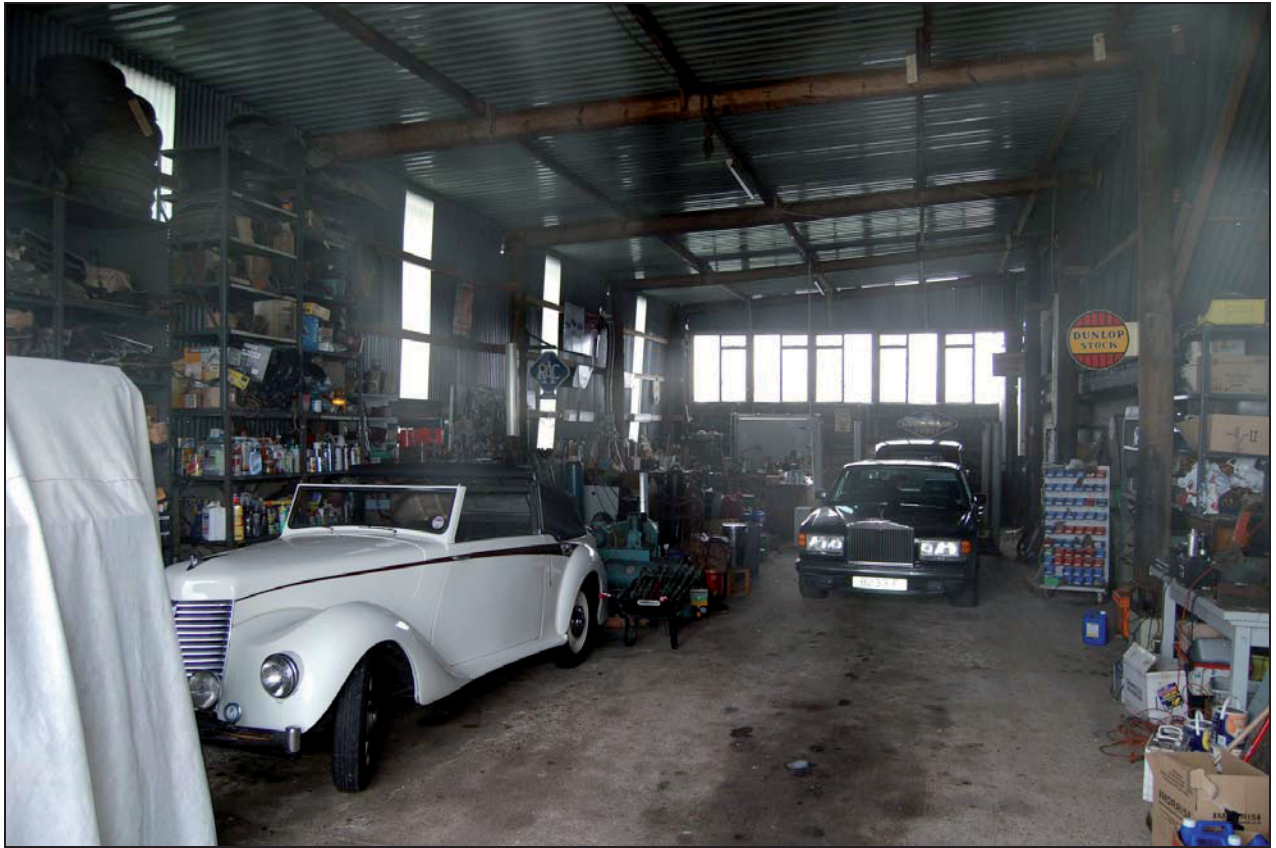
Plate 20 Garage interior
