**BARN AND OUTBUILDINGS ADJACENT TO THE TOWER ARMS
SOUTH WEALD
ESSEX**

**HISTORIC BUILDING RECORDING AND ARCHAEOLOGICAL
MONITORING**

Field Archaeology Unit

June 2007

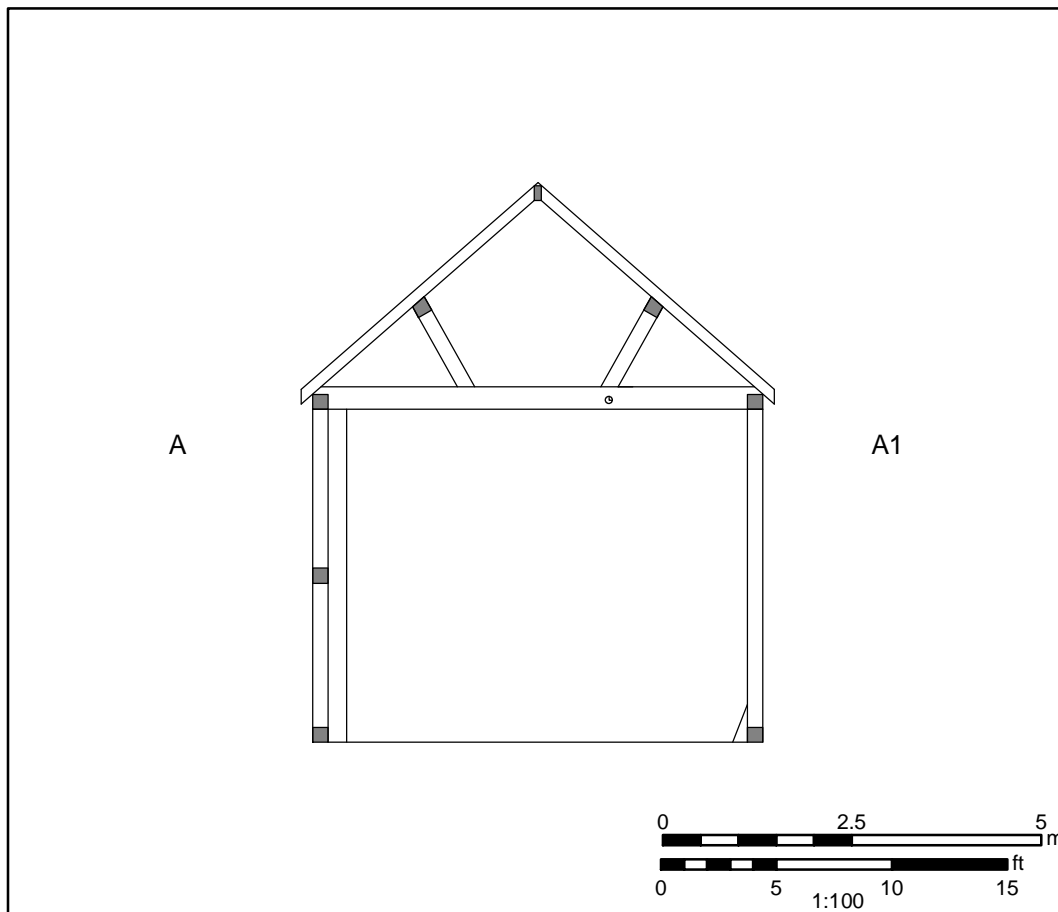
Fig.8. Section A - A1 through barn

Inside, there has been much altering and strengthening of the frame to give additional support to the structure. Sagging wall plates have been bolstered by adding fresh ones over the top with the new roof and the three bays have been further divided into five, by inserting secondary trusses. The gables and roof, including the porch, have been rebuilt in the late-19th or 20th-century using machine-sawn timber. Replaced elements mimic the original form. Struts, wind braces, collars and purlins to the queen post strut roof are all replacements. Only the tie beams are original. These are strapped to the wall plates like the later ones. Queen post struts are nailed to the purlins and overlap crudely on the outside (fig.8).

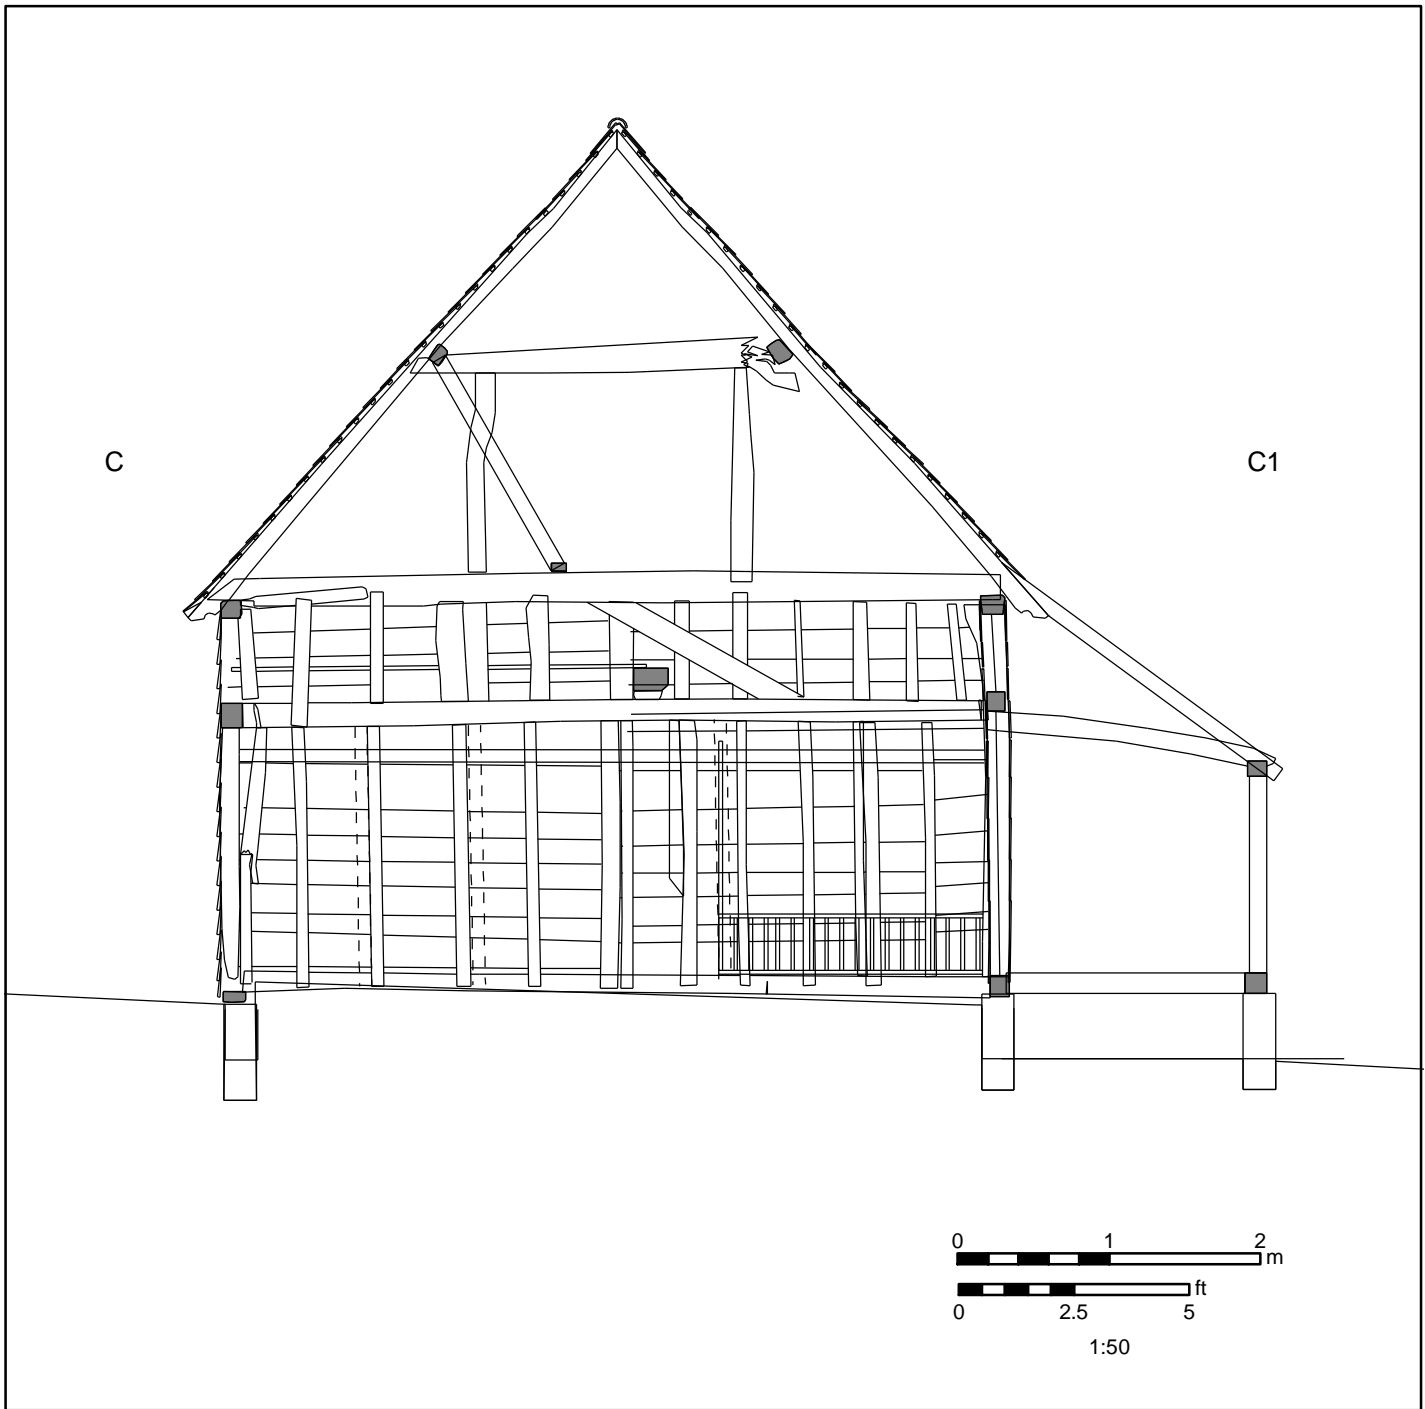
Fig.11. Section C - C1 through byre

There is only one roof truss (section C-C1) to divide the bays and it is now broken through the weight of the roof. Unusually it is in queen post construction (fig. 10, plate 22), especially as many of the rafters in the north bay at least have collar rebates and peg holes cut for a crown post roof (plate 23). Most have been turned at some stage and are not in their original positions. Some are sagging and spacers have been added between rafter and purlin or rafter and battens, which are all fairly new (i.e. the roof has been rebuilt at a later stage). All the rafters are pegged and tenoned at the ridge, though some have rotted and are held by an inserted ridge piece.

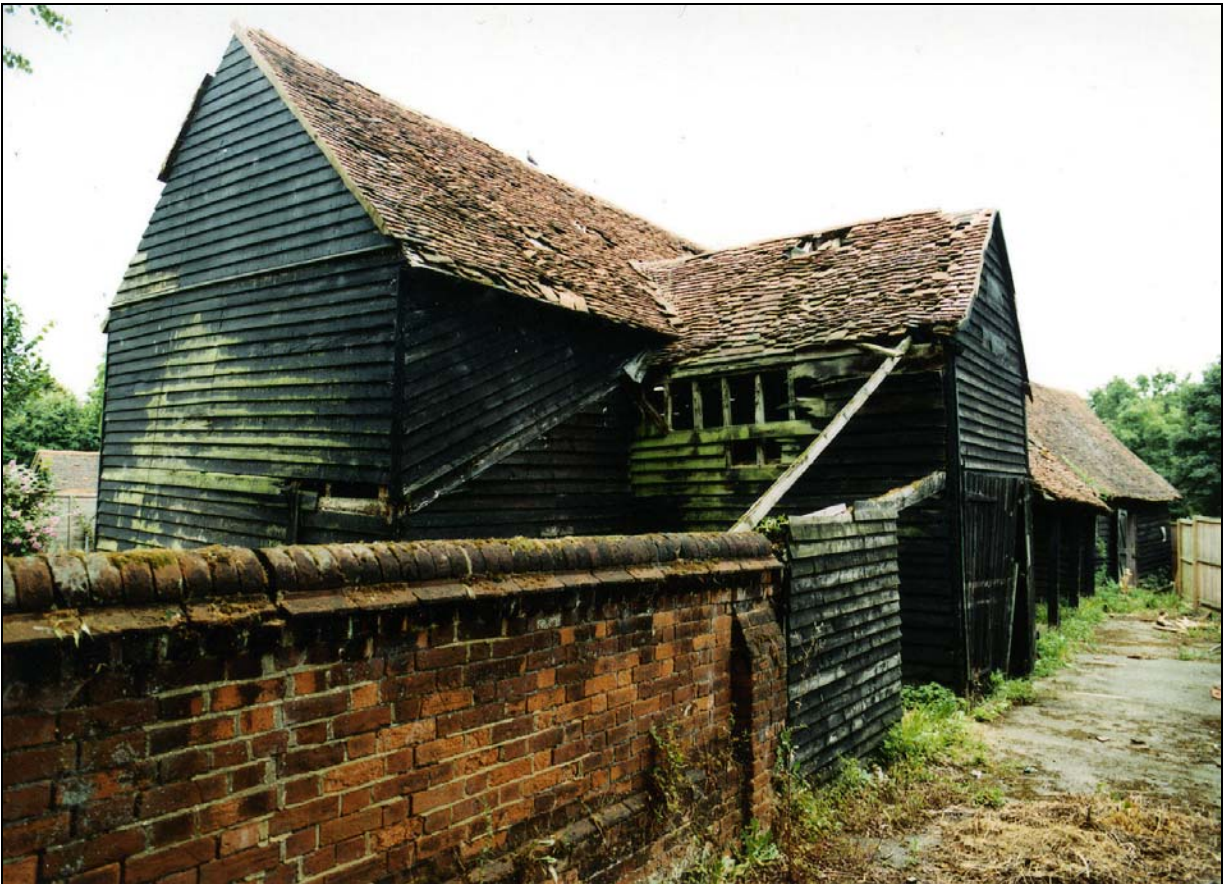
The lean-to on the north-west side against the porch is almost completely obliterated now (plate 2). It seems to have been a shed, open to the north, and built between 1838/9 and 1872, possibly contemporary with alterations carried out to the barn. The line of the lean-to roof may be seen by the slanted clapboard against the barn porch. This area was re-clad when the lean-to was built. It is built from machine-sawn softwood raised on a brick plinth of mixed reds and London stocks, all frogged and later in date than the main barn plinth.

Plate 2 Barn viewed from north-west

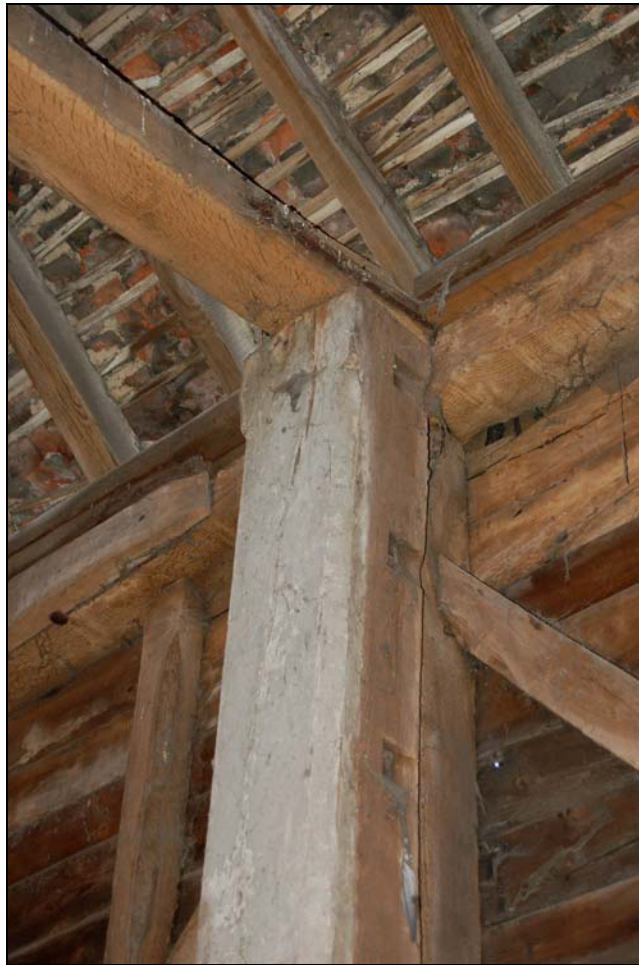
None of the bay posts (c.18 x 18cm) are jowled, indicating a post-medieval construction date. Two hefty oak posts are bolted to the posts by the east door to support the tie beams here. Both are reused. One, on the north side of the door, is a chamfered bay post with empty brace mortice while the other is a scroll-stopped chamfered bridging joist from a structure of some quality (plate 8). Wall plates are up to 1½ bays long and connected by short single-

Plate 8 Reused bridging joist to support tie beam by west door

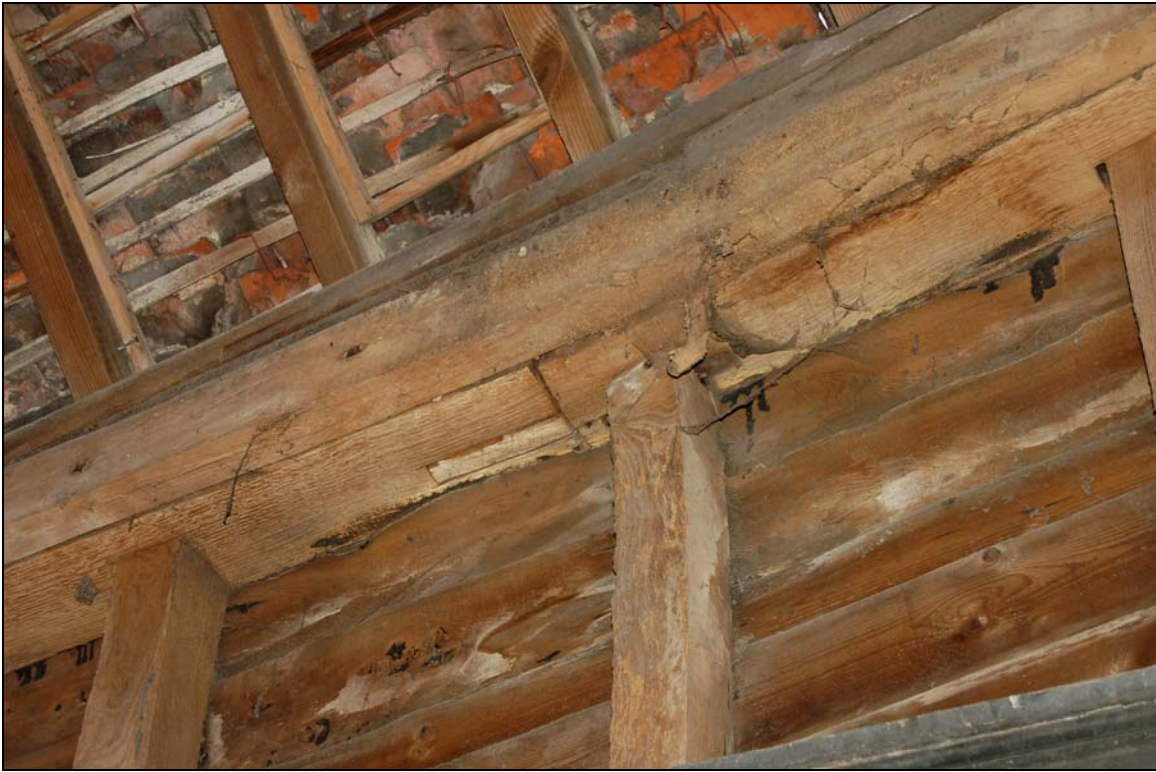
pegged bridle scarf joints with squinted abutments over the cart doors (plate 9). Both are obscured by planks attached to the face of the plates as a strengthening measure. Their locations are indicated on fig.6. Long scarf joints are a feature of good medieval carpentry but the short ones range in date from the medieval (Hewett 1980) to the 18th-century at least and there are many such examples in Essex barns. In many ways the angle of face cut appears similar to those in the byre which has an earlier and far different method of assembly.

Plate 9 Partly-observed bridge scarf joint with squinted abutments

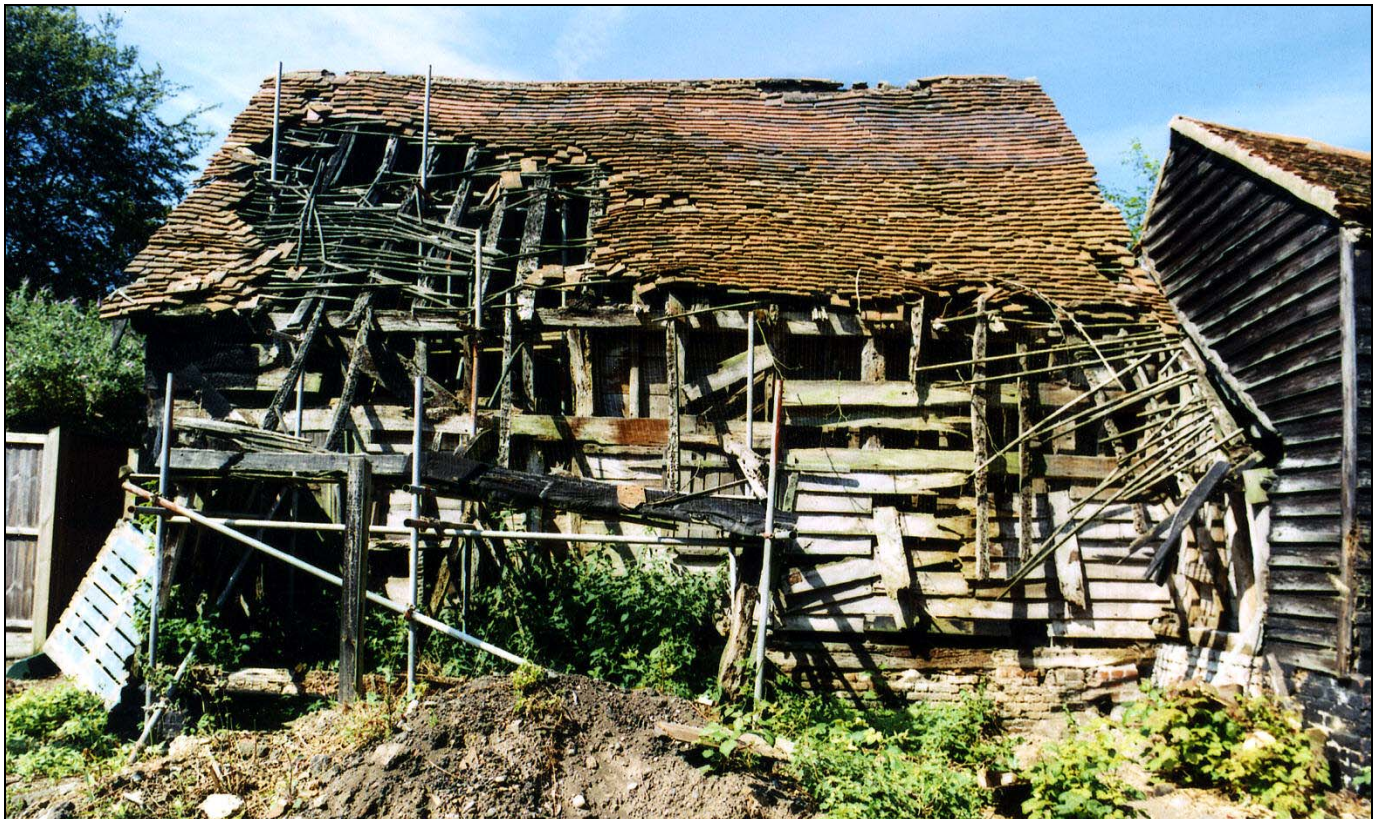
The oldest and most distinctive of the group is also the most deteriorated and quite rightly is included on the buildings at risk register, where it is described as '16th-century with 19th-century additions, latter linked to 18th/early 19th-century threshing barn' (ECC 2003). This is a small oblong timber-framed two-storied structure that has been much adapted. Its dimensions are 5.25 x 8.4m. Like the rest, this is clapboarded with a plain gabled tile roof pitched more steeply at 50°, probably to take thatch originally. Again, the brick plinth is the same as the barn and presumably added at the same time. Large sections of framing are exposed on the east side where boarding has disappeared through lack of maintenance (plate 14). The walls have not been tarred for a long time on this side. The west side facing the pub and gable end is in better condition (plate 13). Wall framing in other areas is hidden by boarding applied to the interior and exterior. An attempt was made to piece together the frame from the evidence viewed during the initial visits and added to the existing frame survey (fig.10). A partially open-fronted lean-to with later framing (pre-1872 and of similar primary bracing to the barn?) has largely disappeared. It had a long linear fixture, possibly the frame to a feeding trough or machinery (plate 15). The brick plinth on the closed side was built as piers, perhaps for ventilation. The southern end is in danger of collapse and has been propped-up with scaffolding that reaches inside to support the entire first floor as well. Netting hangs along the east side to contain falling timbers, mainly from the lean-to.

Plate 14 Dilapidated rear of byre viewed from east

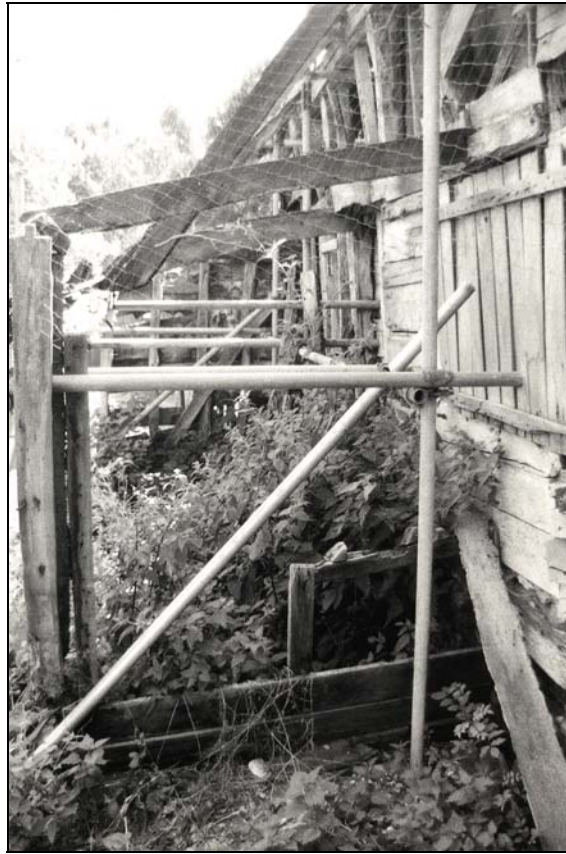
Plate 15 Remnants of attached shed to byre, viewed from north

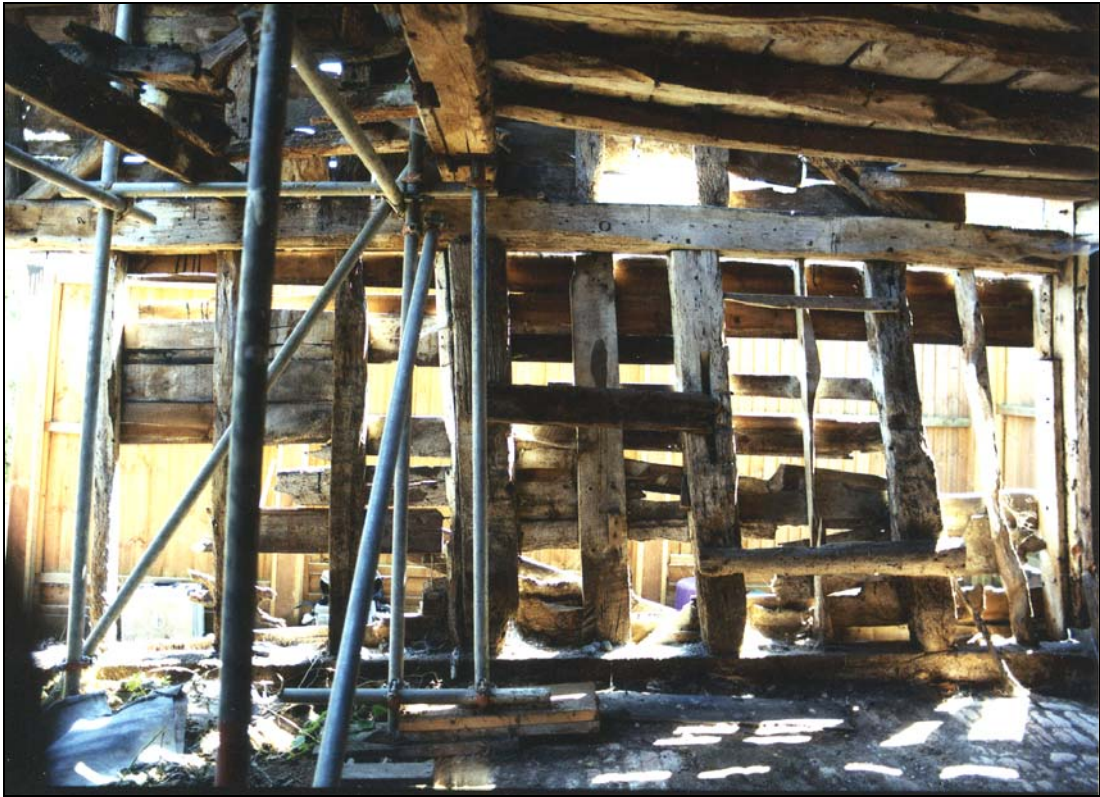
Replacement studs on both levels and elevations are characterised by a narrower scantling (c.10cm-wide) and closer proximity to one another (c.40cm, though varying). They are lapped and nailed onto the outer face of the midrail rather than tenoned like the others and are likely to belong to an early phase of repair.

Plate 21 Original studwork in south wall of byre

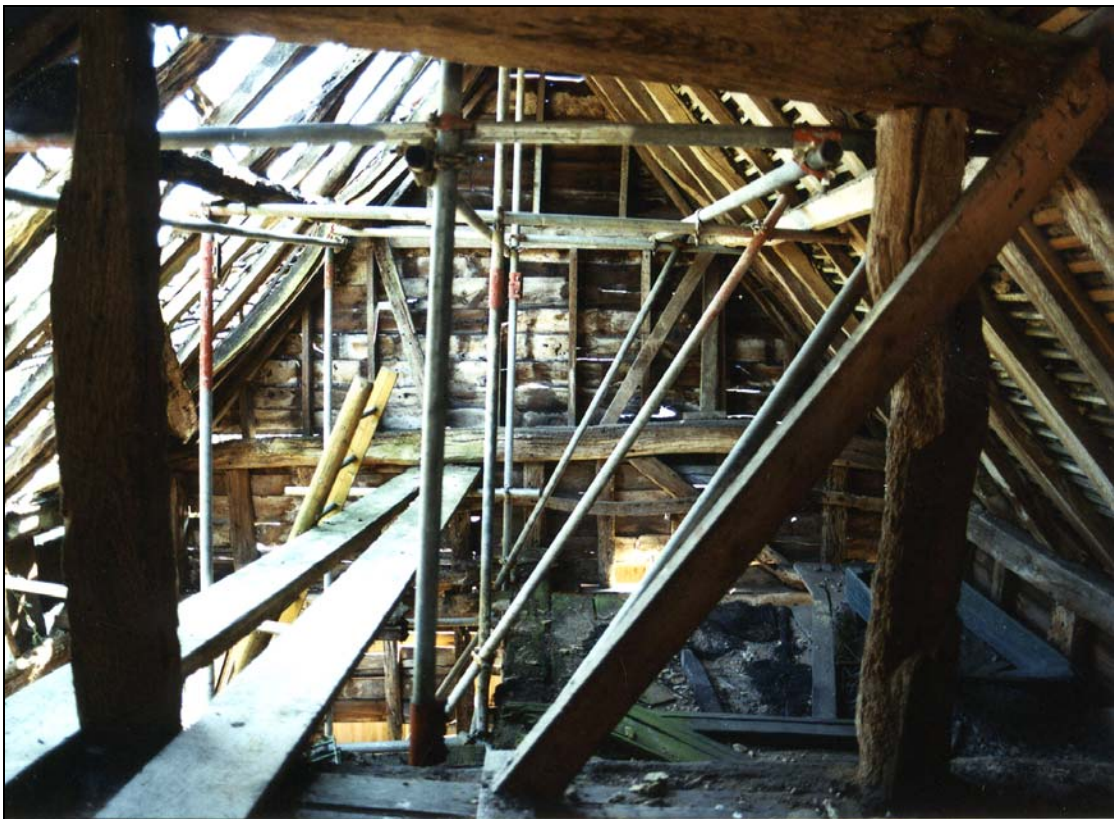
Plate 22 View through queen post truss across first floor of byre to rebuilt south gable

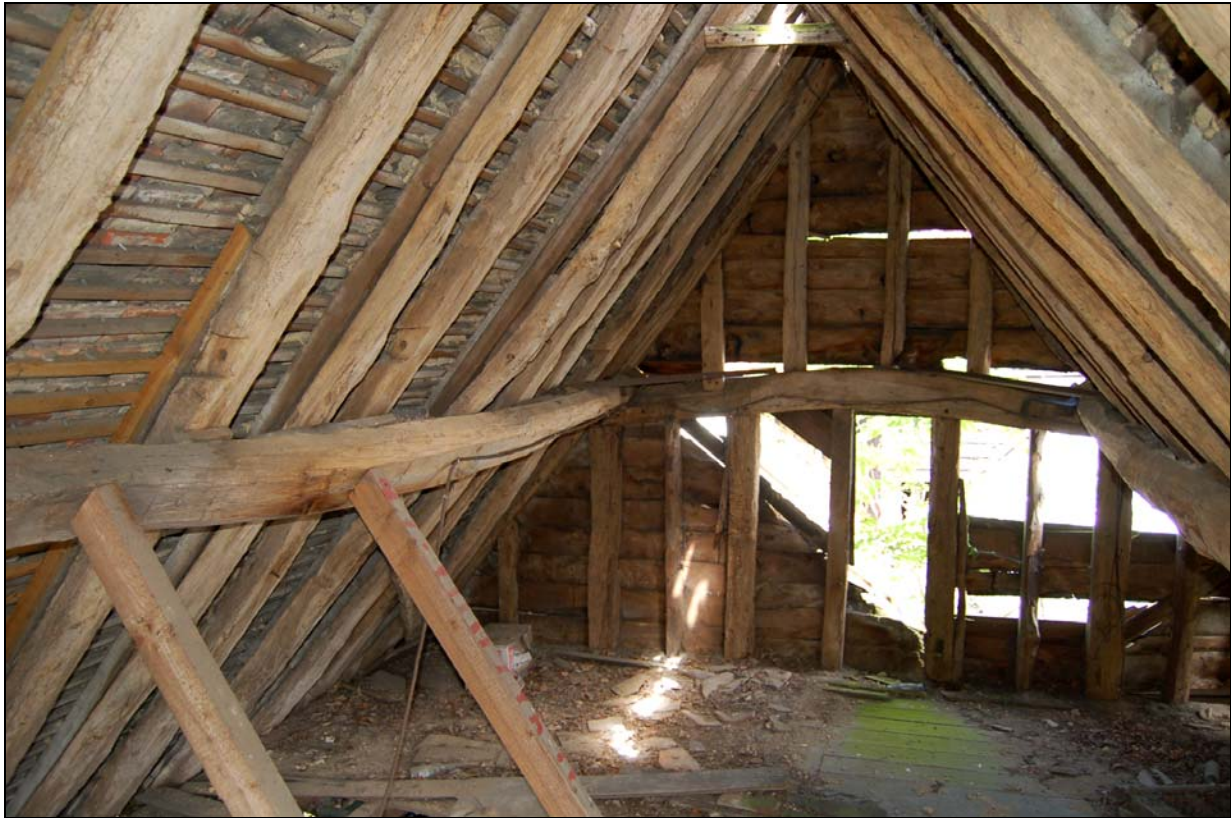
Plate 23 Propped purlin and original north wall of byre

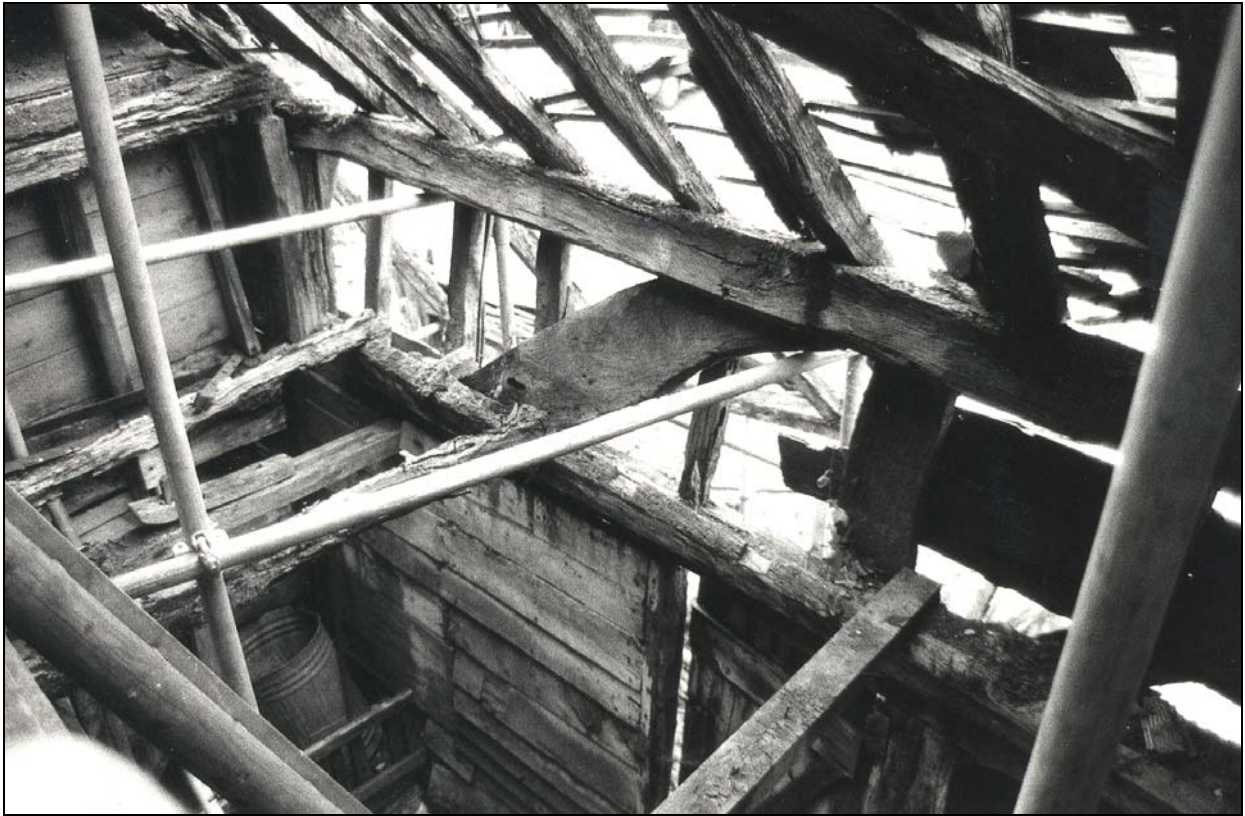
Plate 25 Heavy bracing member on east wall of byre
