**SHEERING HALL BARN, SHEERING  
ESSEX  
HISTORIC BUILDING RECORDING AND  
ARCHAEOLOGICAL MONITORING**

**November 2007**

**HISTORIC BUILDING RECORDING & ARCHAEOLOGICAL MONITORING AT  
SHEERING HALL BARNS, SHEERING  
ESSEX**

**FAU Project No.:** 1676

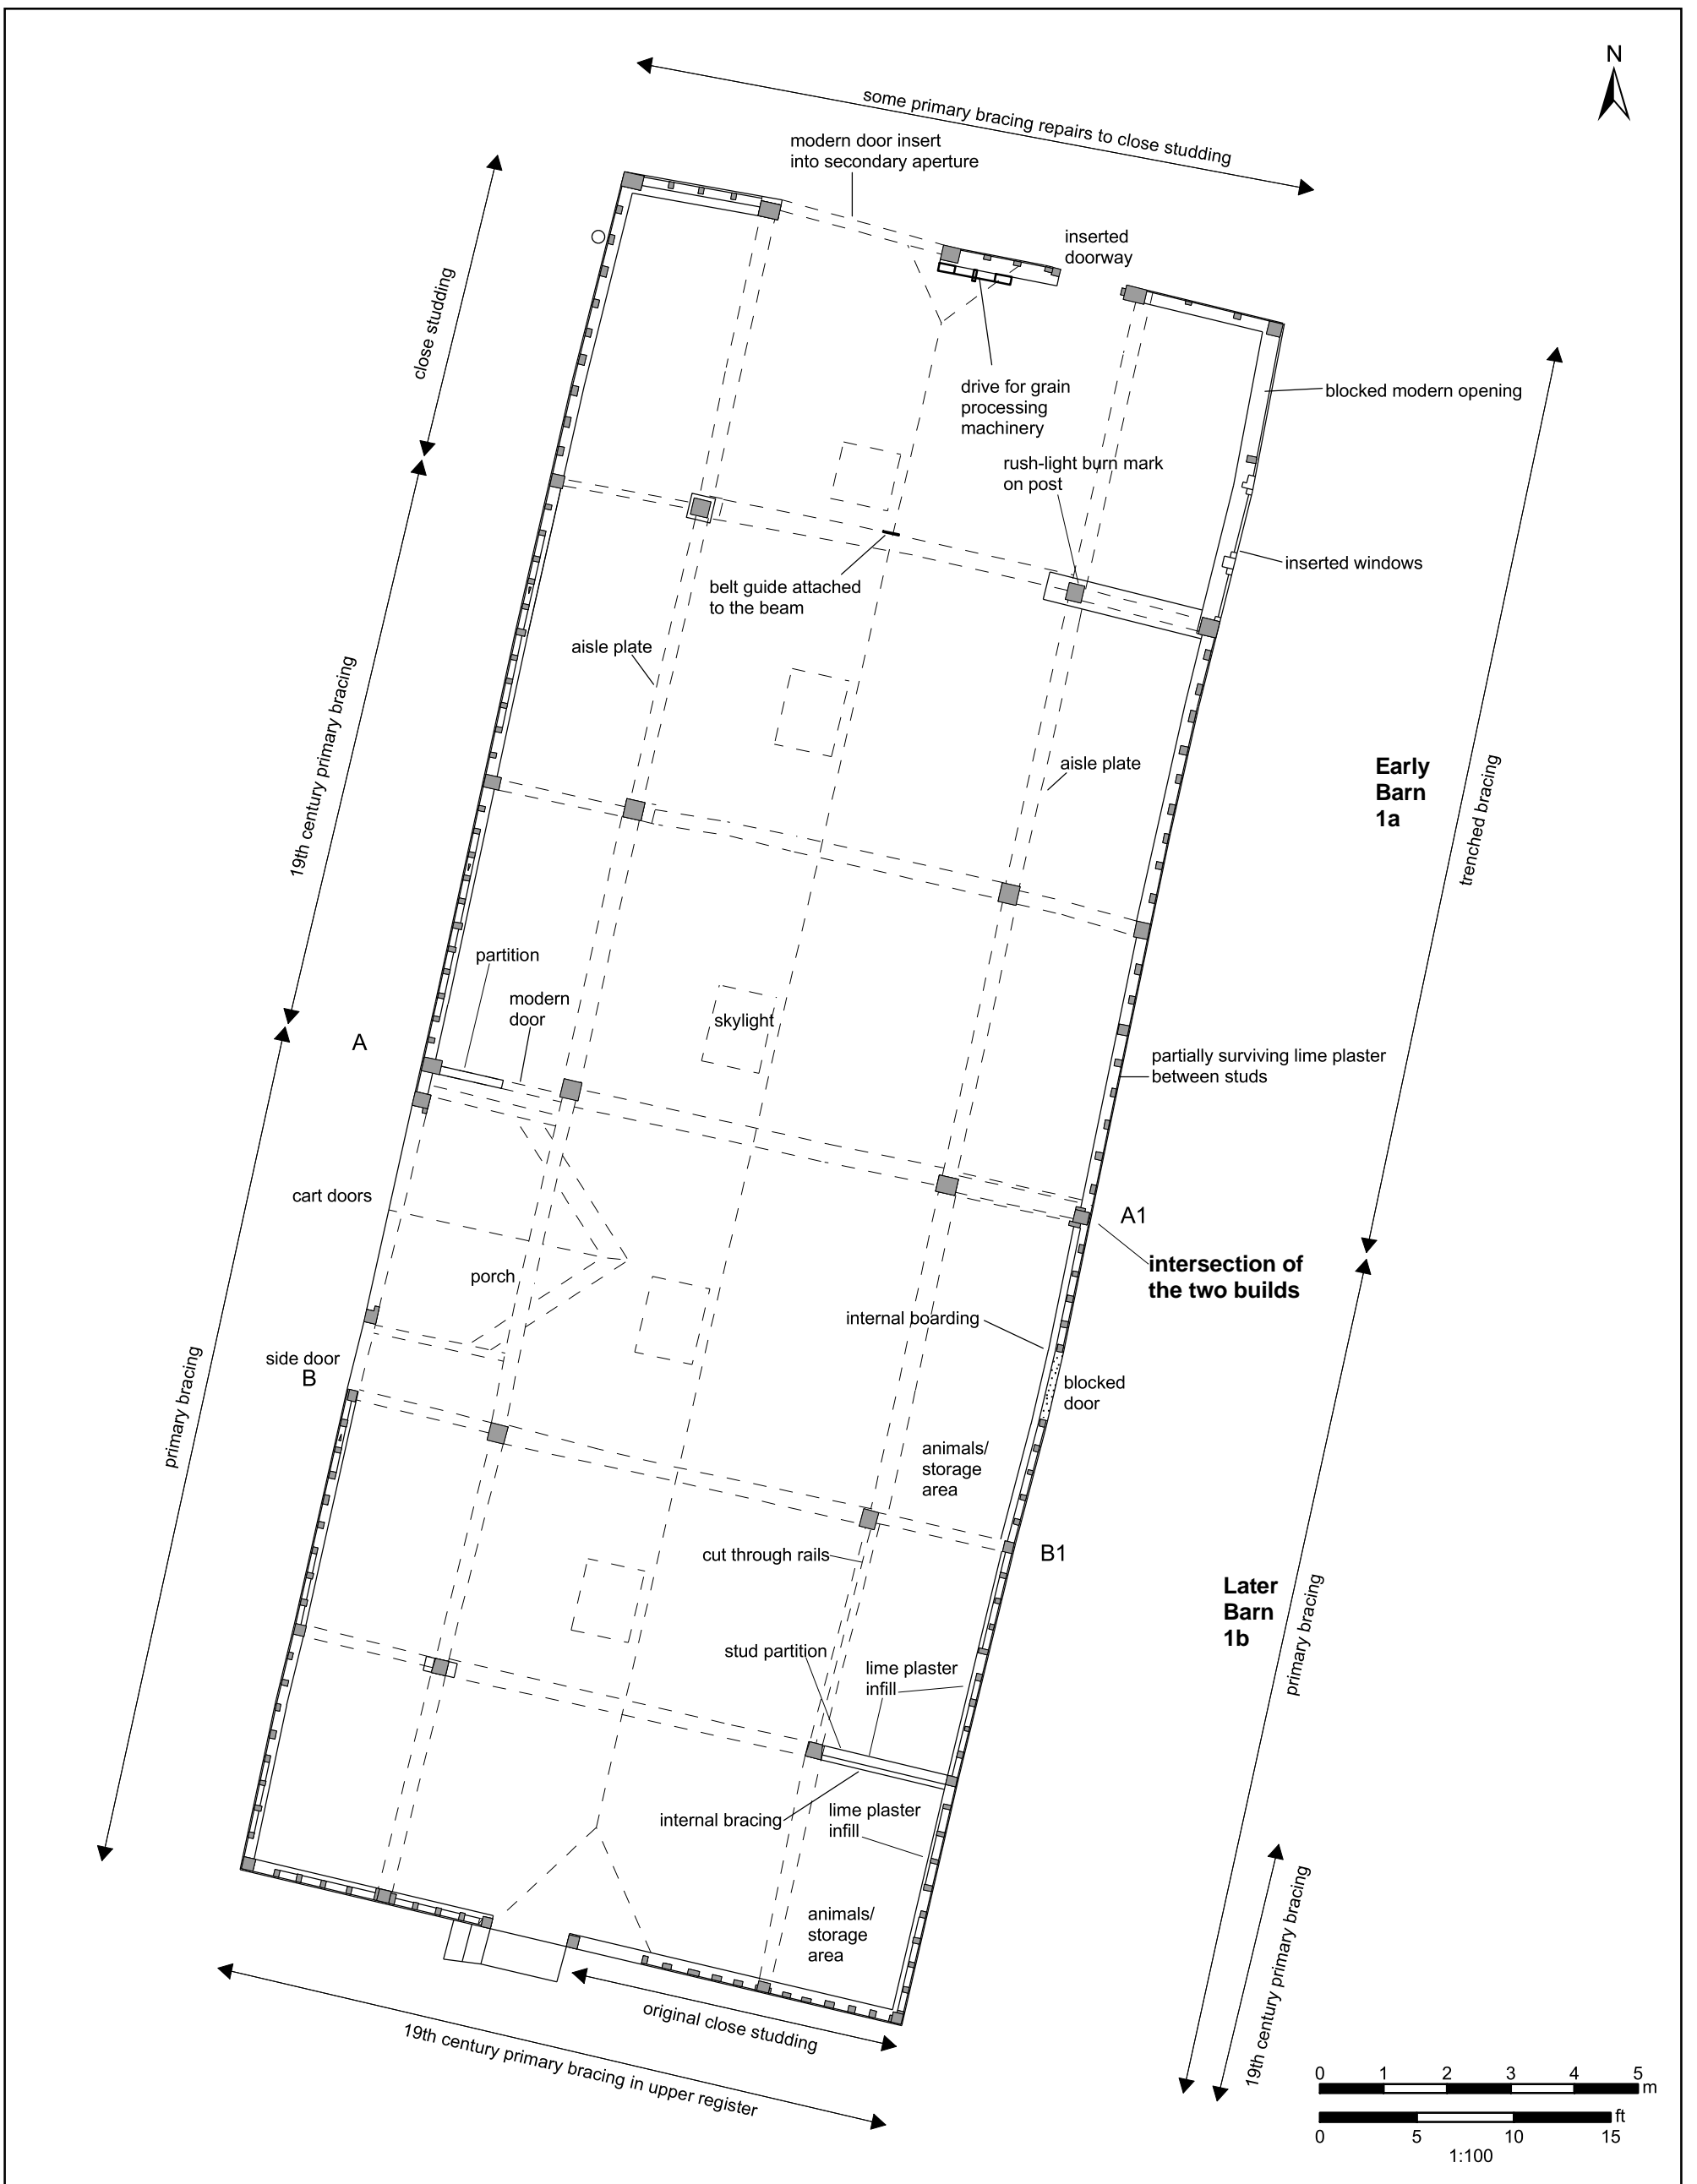
Fig.6. Barn 1 floor plan

internal evidence for windows or vents to light the huge area inside, though there are rush light burn marks on the north-easternmost aisle post (fig.6).

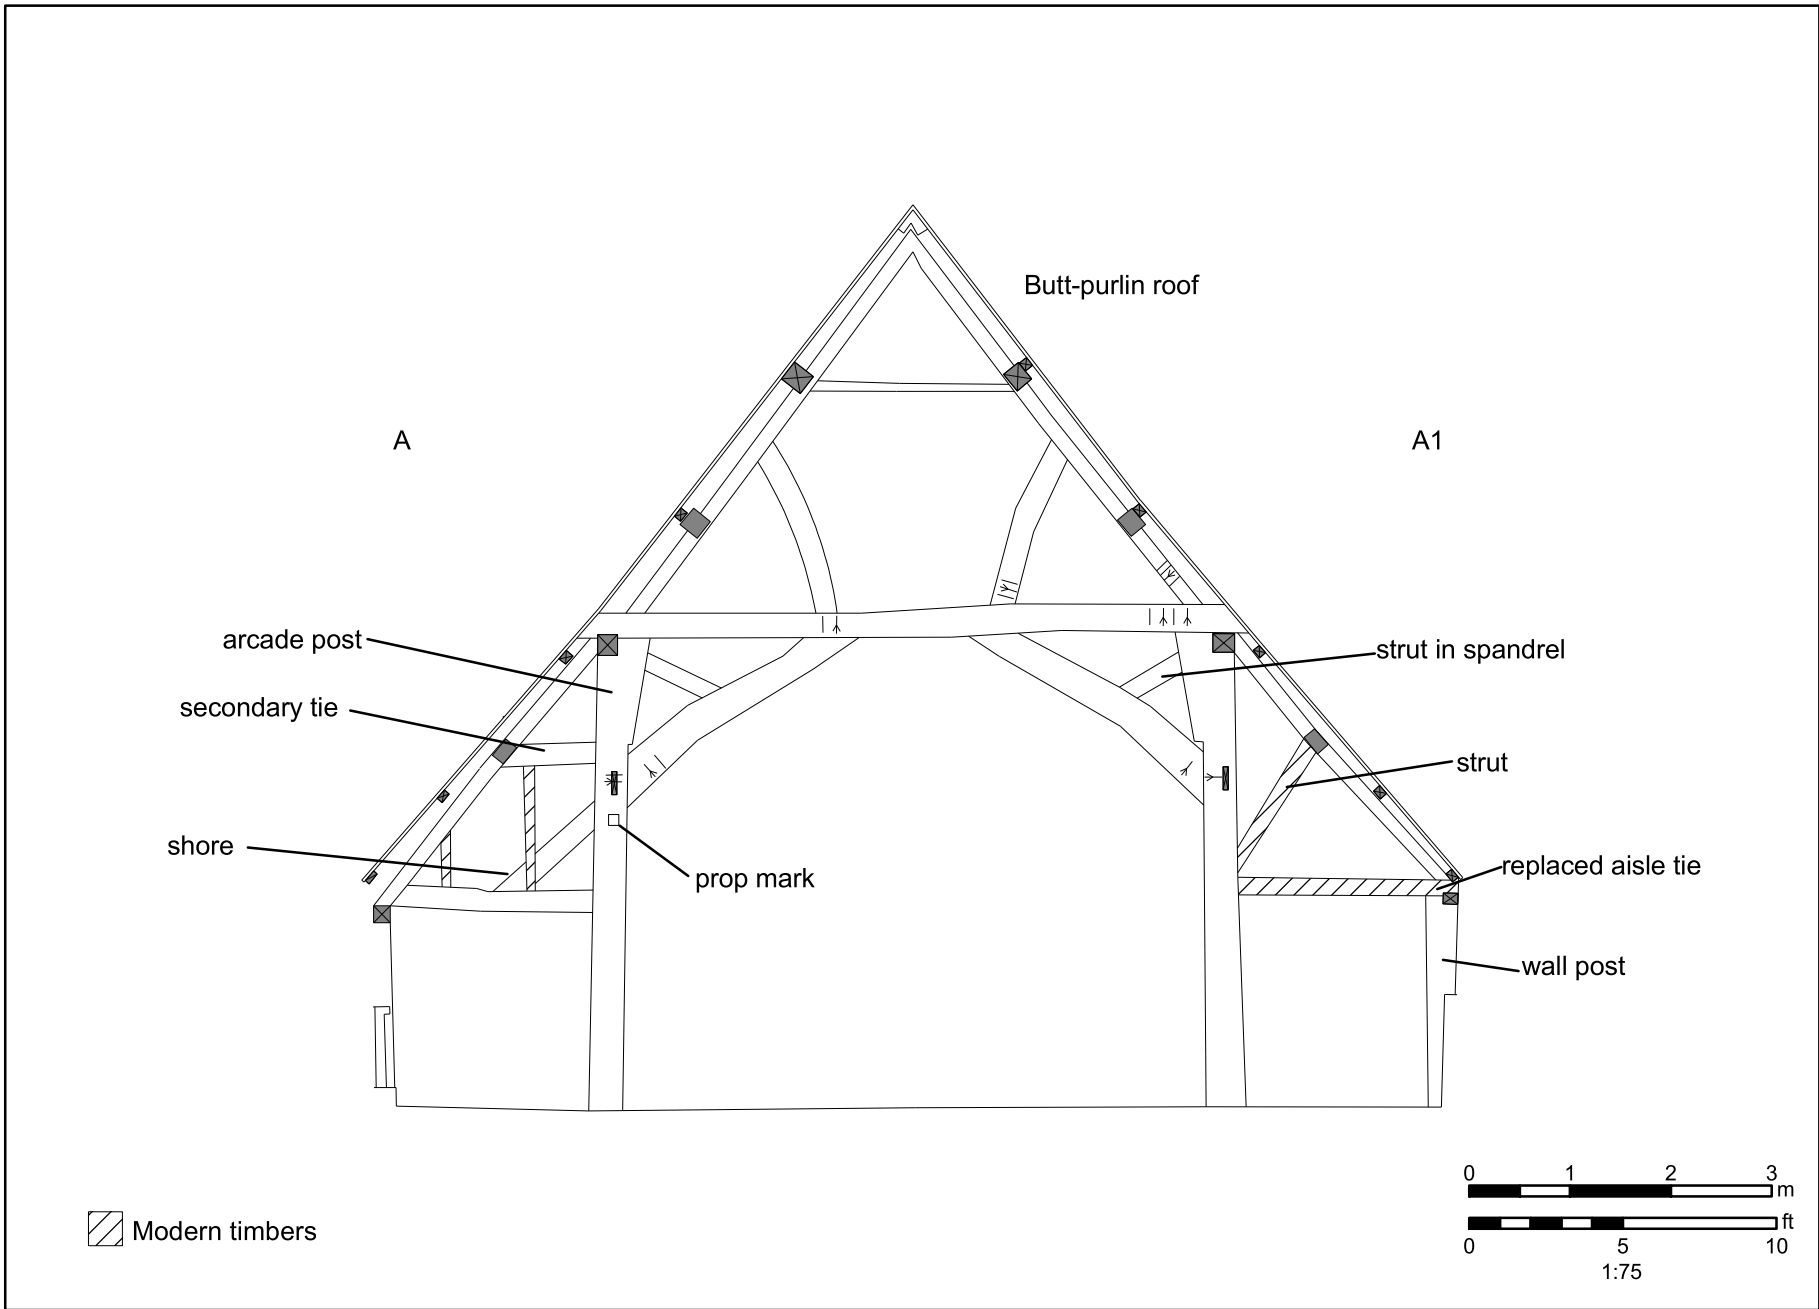
Fig.9. Section A - A1 across barn 1a

The jowled arcade posts connect to the arcade plates and tie beams through slightly curved arch bracing. In addition, there are struts in the spandrels of the trusses of barn 1a (fig.9). This is an original and unusual feature, but not, as far as is known, a typically medieval one. The arch bracing continues downwards from the arcade post, through the aisle tie and onto the wall plate by shores, parallel to the roof line (fig.10). Shores replaced the passing brace of early medieval aisled buildings. Many complete shore sections are either missing or have been replaced with smaller timbers. In some cases, later short horizontal struts link between aisle post and principle rafter (fig.9). Both parts of the barn have secondary aisle ties parallel and above the main tie to carry purlins (fig.10).

However, the roof-frames on each part are completely different. Barn 1a has a high quality medieval-style in-line tenoned-purlin roof (fig.9) while barn 1b has a simple clasped purlin roof (fig.10). The tenoned-purlin (also known as the butt-purlin) was used to prevent the rafters on large roofs, such as on aisled barns, from bowing by using heavy framing (similar to medieval wall-framing) to form the structure. Examples may be found in high-quality medieval structures in upland areas of England. Later on they are found in the lowland zones as an alternative to the clasped purlin roof (Harris 1993). In Essex therefore, they are seen as a post-medieval construction and Essex examples have staggered purlins, typical of the post-medieval period. The first known example is believed to be the re-built roof of the late 16th-century Cressing Temple granary, dated to 1623 (E. Watkin pers. comm.). In view of this the fact that barn 1a displays the in-line medieval form is highly unusual.

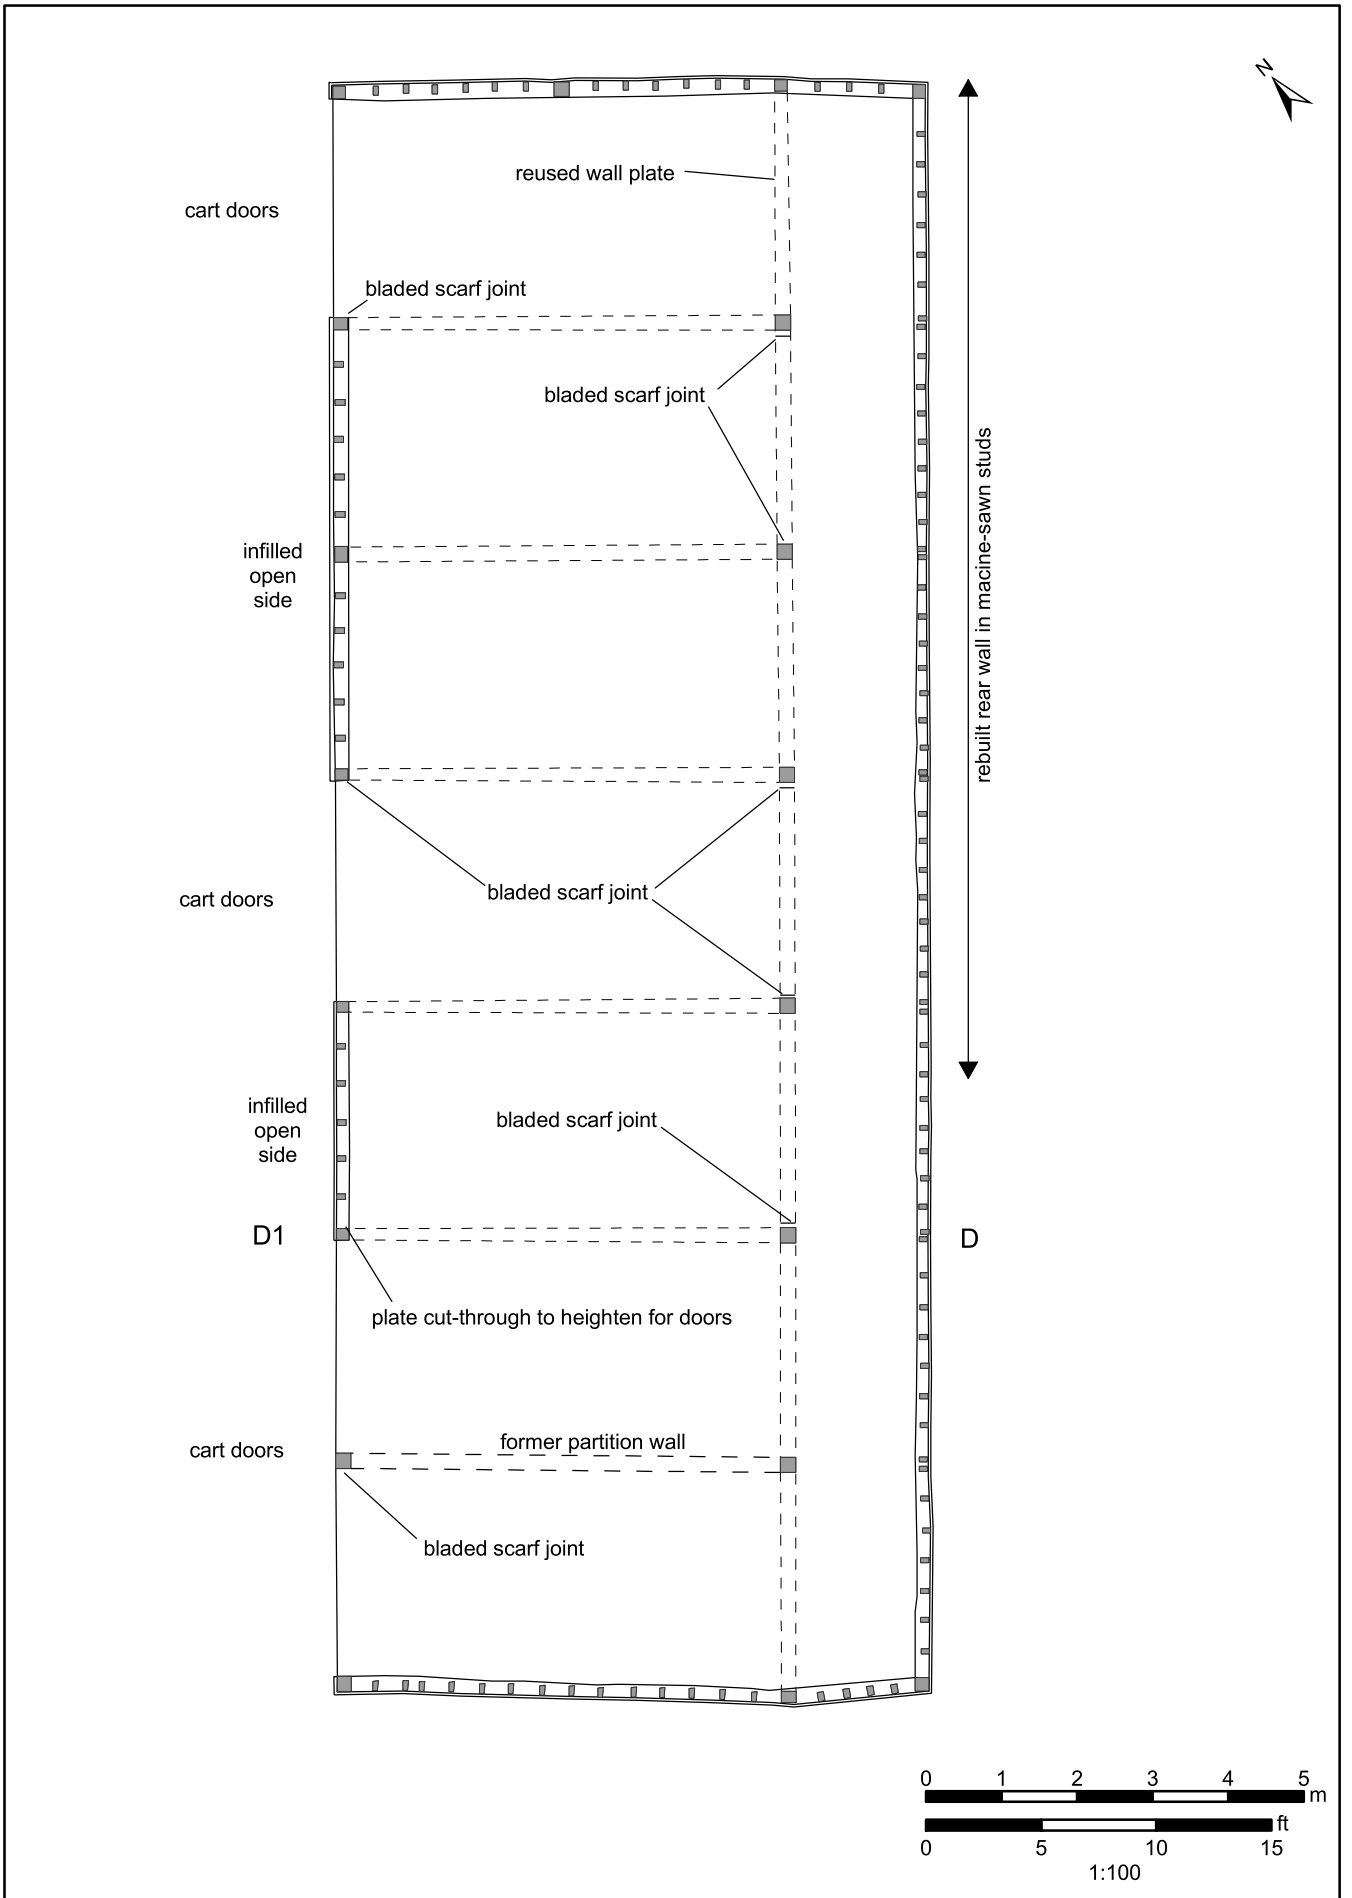
Fig.13. Wagon lodge floor plan

features were recorded, although it was noted that the aisle may have been a later addition, because the wall plate is more roughly-worked and crudely scarfed together and the walls taper inwards slightly (fig.13). However, there is evidence for an earlier rear wall, nor do maps show the rear as open-sided.

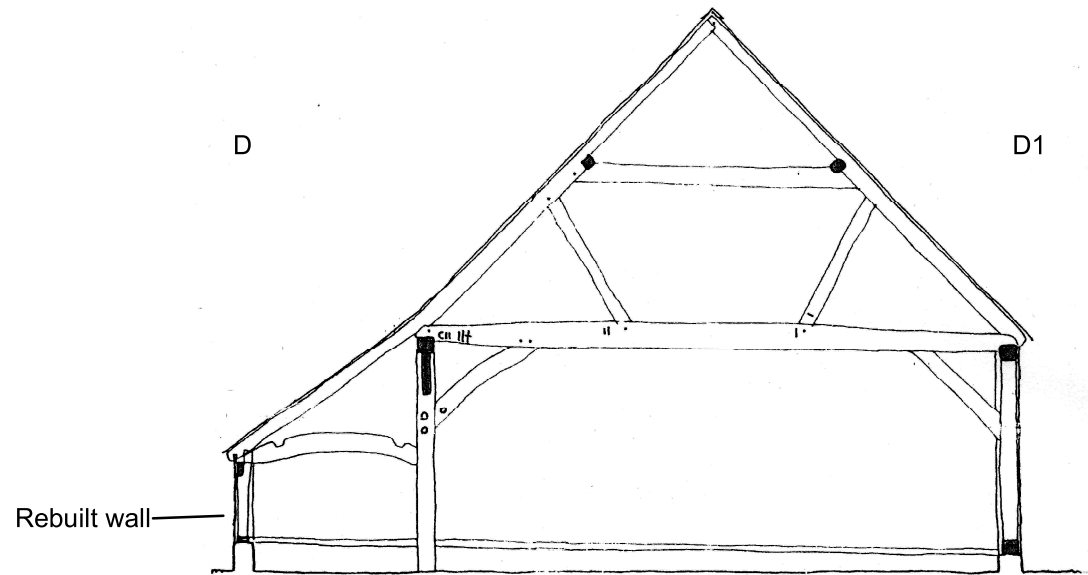
Fig.14. Section D - D1 through wagon lodge

Like the two barns, the roof is clasped purlin with queen strut trusses (fig.14). Some rafters and struts are replaced in machine-sawn timber, but most appear original.

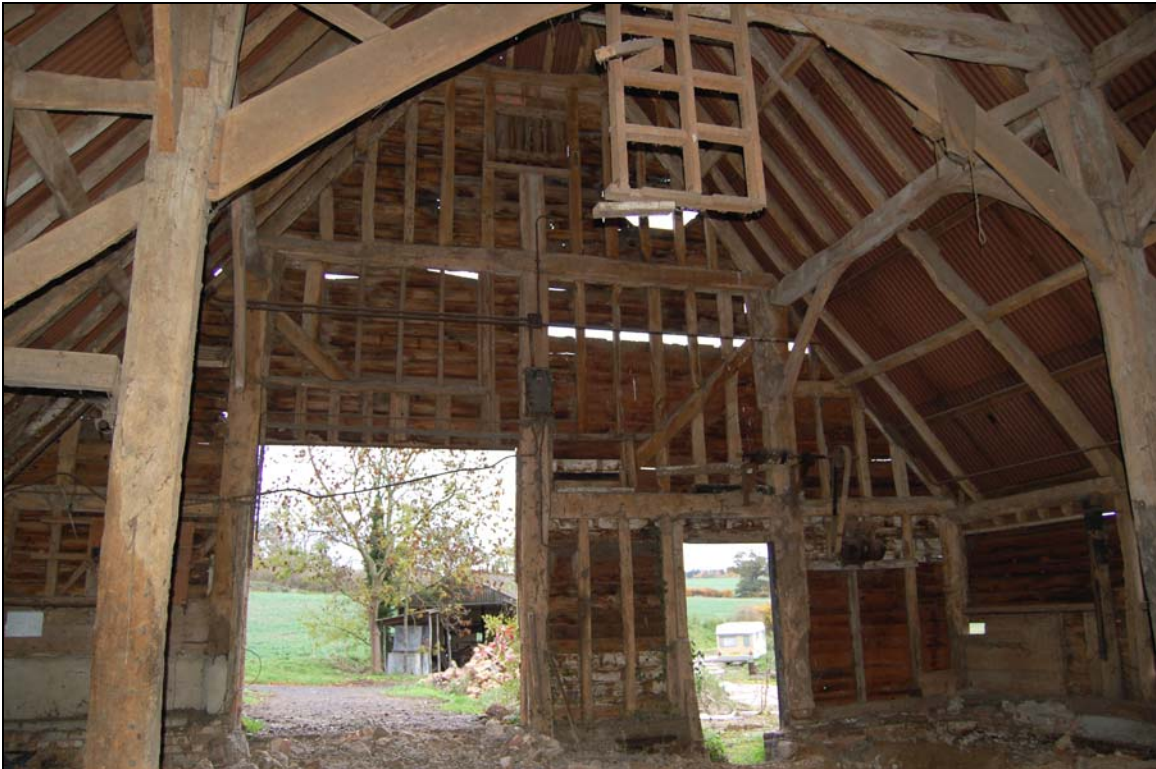
Plate 10 Partly rebuilt north wall in barn 1a

At the northern gable end, the crude jowls on the bay posts and primary bracing, amongst other things, show this wall was built with the later barn (plate 10). Again there is quite a lot of replaced studwork, some of which is nailed to the beam with a diagonal tongue that reaches behind onto the outer face. This method is seen in later barns where wall plates have rounded profiles because younger timber is being used. Often these are combined with weather-boarded exteriors where a flush exterior was needed for fixing, hence the development of these tongues on studs in these instances.

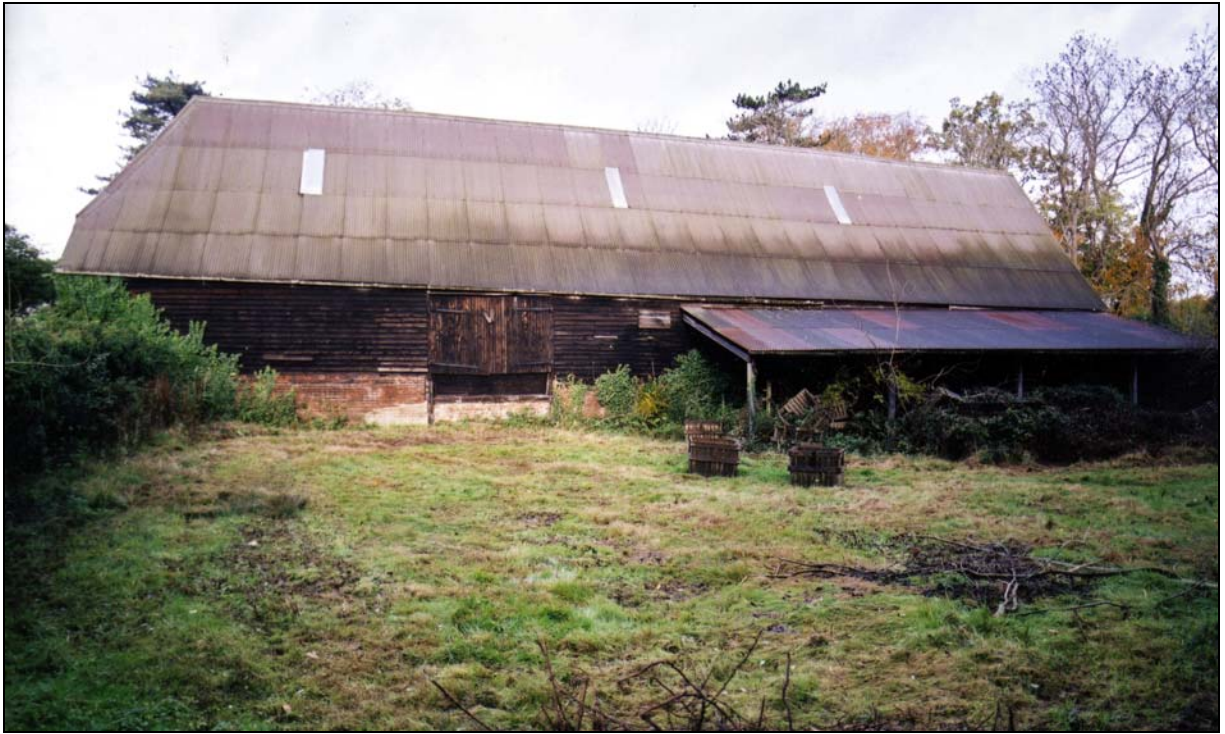
Plate 14 South-east elevation of barn 2

Perspex roof lights are inserted on the north-east elevation of the roof of the barn to catch the morning light (plate 14). The pitch is steeper than barn 1, at 55°, and the aisles either side more pronounced, on a slightly shallower pitch (fig.14). The plinth is high, at 1.4m, exposed through the wear and cleaning out inside the yard. Some lower parts are hidden behind cement render and overgrown ivy. The hard red bricks of the plinth appear to be shorter than in barn 1 but are the same in character. The main east door opens out onto the yard and is held on pintel hinges. Like barn 1 there is no porch. Underneath the door, the threshold has been raised on a bed of fletton bricks. There is a small hatch between the doors and crate shed. The crate shed is attached to a concrete block-built yard wall (plate 15) and is an open-sided four-bay structure with a corrugated plastic roof. The shed replaced a 19th-century range adjoining the two barns that fully enclosed the main stockyard here.

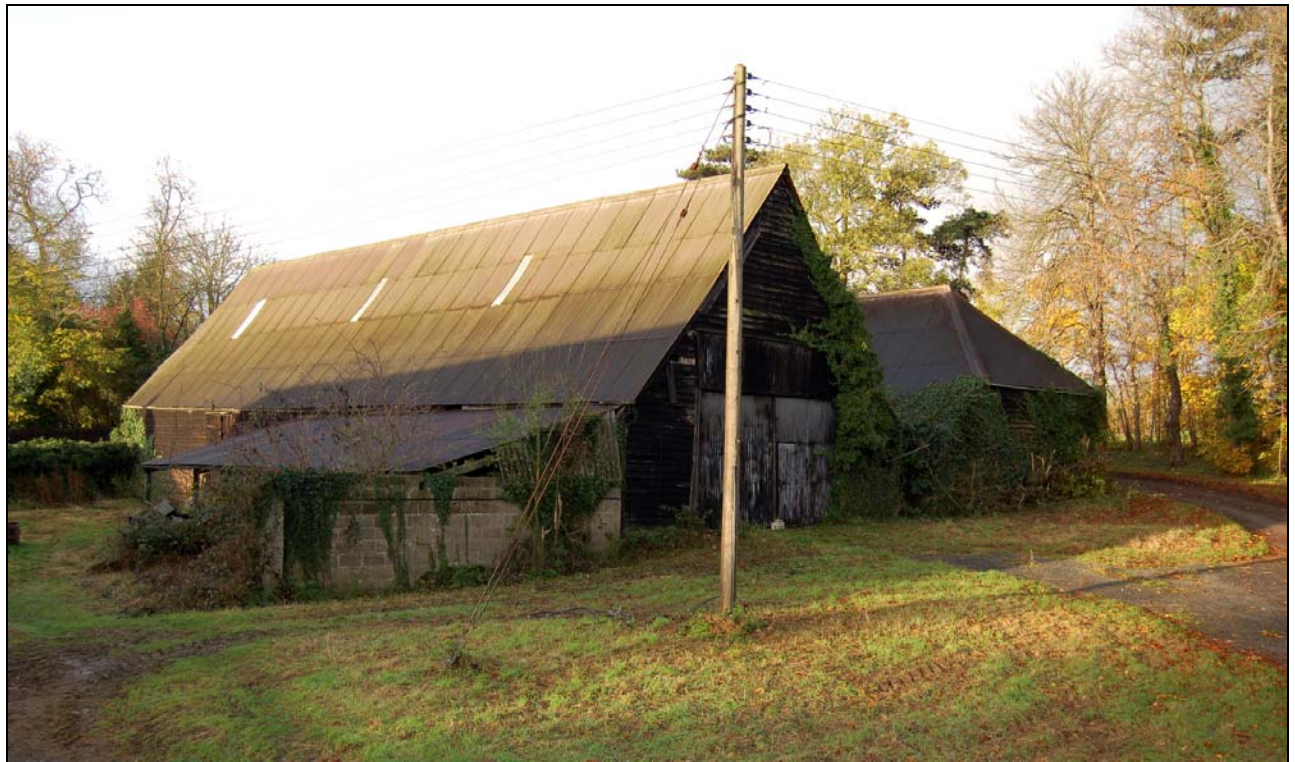
Plate 15 Barn 2 & wagon lodge viewed from east

On the north-east elevation (plate 15), heavy modern corrugated iron doors have replaced the former cart doors that are evidenced by infilling to the top section (plate 15). A second low cart door is located on the opposite south-west gable elevation (plate 16), facing onto the track to the hall. Above is a second door, perhaps a pitching door, and a vent made from wooden slats to bring the light in and circulate air inside.

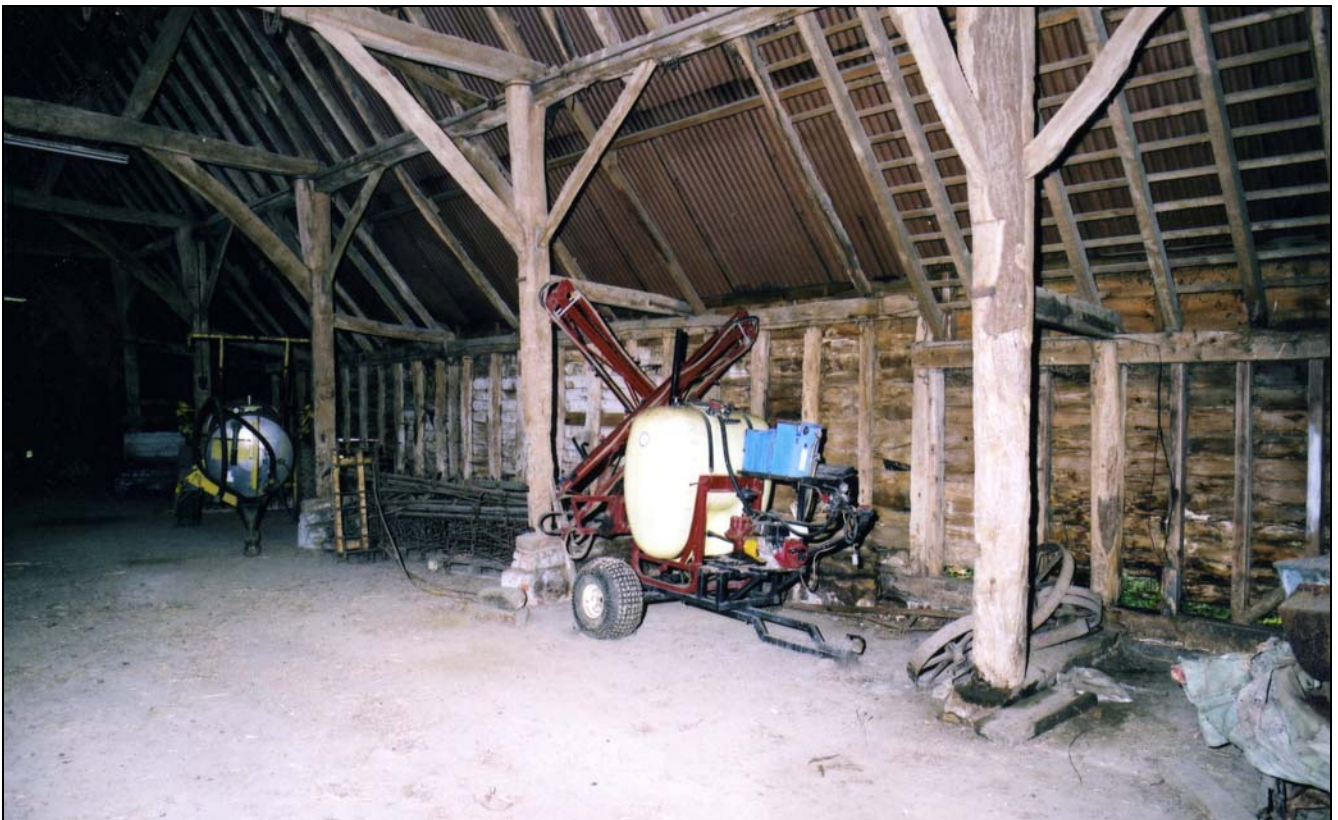
Plate 21 Comparison of two builds at intersection of barns 2a & b

One of the major differences between the two builds is the arrangements of the outer walls. The 2b extension is lower in height by 0.5m (plate 21) and was subsequently raised. It would therefore seem to be a complete reused section from an existing barn rather than a new build. Secondly, the aisle walling includes bay posts with swelling jowls (plate 21), completely absent in the main part of the barn. At the east end of the barn (2b, fig.13), both internal and external bracing was found, either side of the studs. On the west side the south bay has been replaced with machine-sawn primary-bracing (fig.11). The other bay is close-studded, presenting a rather disorganised picture, but typical of reuse. Studwork size is the same as the main part but the gap is narrower, between 28 and 35cm (c.1'). The wall plates are of similar size, though none of them have grooved soffits indicative of daub.
