**HISTORIC BUILDING RECORDING OF BARN & OUTBUILDINGS
AT
WALNUT TREE FARM, FANNER'S GREEN
GREAT WALTHAM
ESSEX**

Essex County Council

Field Archaeology Unit

September 2007

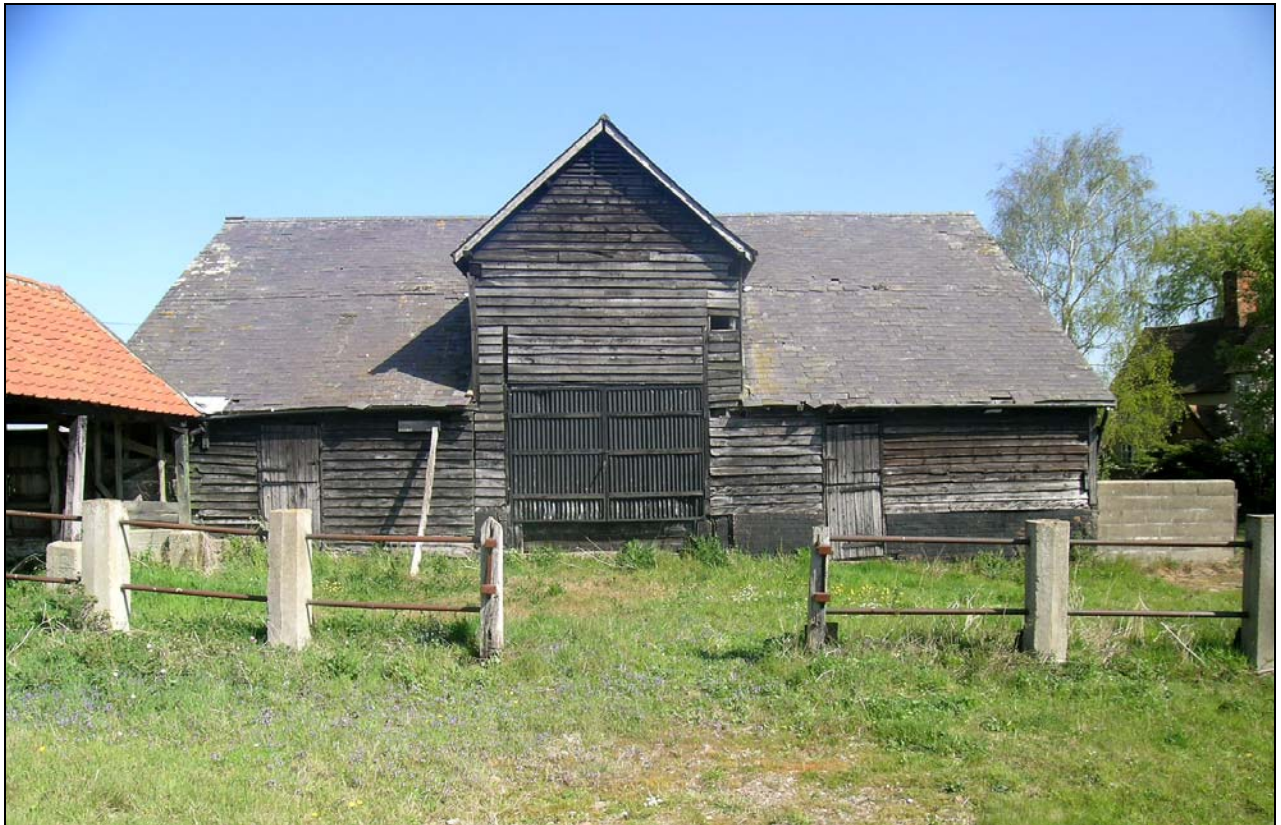
Plate 2 South elevation of barn

The main frontage (plate 2) faces onto the southern yard and the road, raised on a 1m-high tarred brick plinth and rendered in concrete on the western side of the porch. The main focus is the catslide roof over the side structures and the central porch that is set into it. The original high cartdoors have been replaced by lower corrugated iron ones, although their scar is evident in plate 3. The threshold leap (that contained the grain during threshing) remains below the porch doors. A slatted wooden vent provided ventilation at the apex of the porch roof, like those in the two short elevations, but is contemporary with the rebuild, as are those on the two short ends of the barn. Both exposed sides of the porch retain daub render (plate 3).

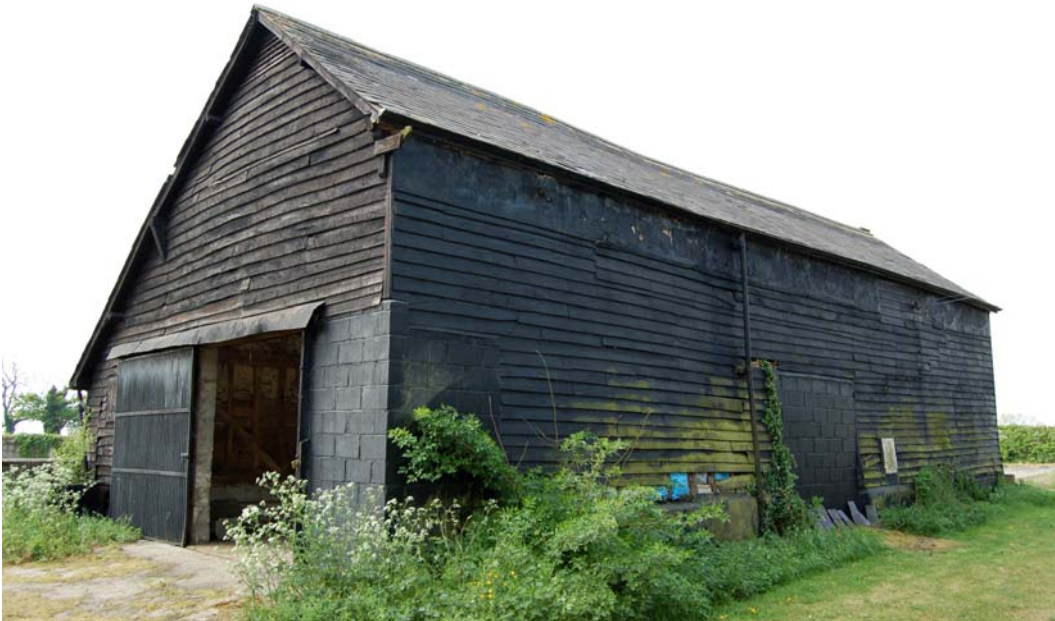
Plate 4 Barn viewed to south-west

The rear elevation has suffered from damp from lack of sun on this side and green algae is growing at the base. Areas of boarding have been patched-in, particularly on the west side where the mid-19th-century north yard cowshed once stood (figs.4 & 5). A few are missing on the other end. A central mass of blockwork infill indicates the location of the rear cartdoors (plate 4) which were lower than those at the front - for the empty carts returning to the fields. A frieze of daubed plaster has survived high up on the wall, protected by the eaves but unceremoniously tarred (plate 4).

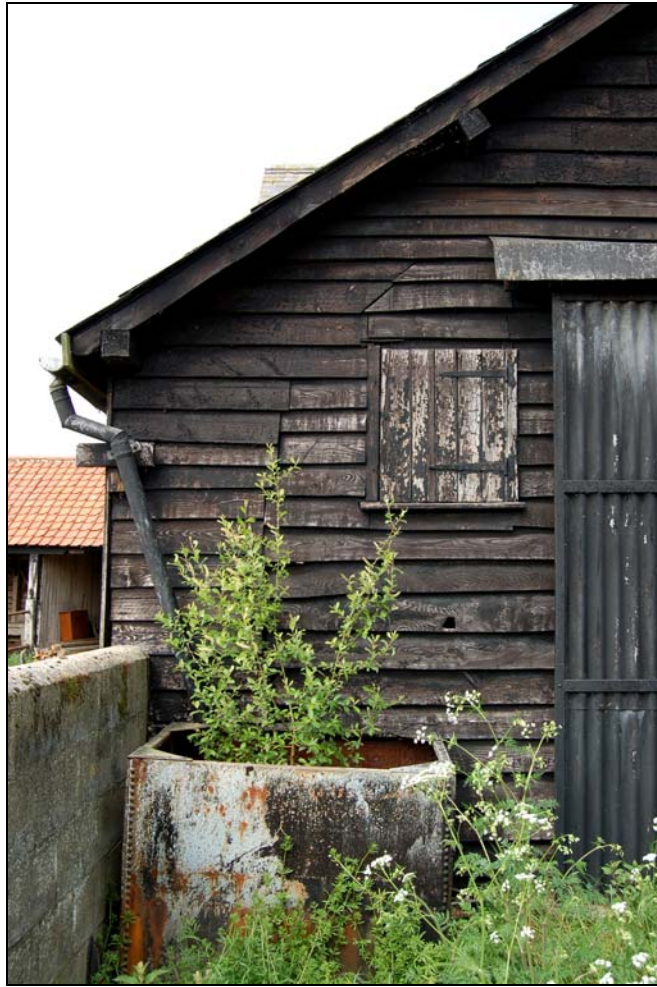
Plate 5 Scar to former roof line on east elevation

The full profile of the catslide roof may be seen in this and the west elevation. Unfortunately, the framing below midrail level has been cut out and replaced by concrete blockwork, which continues around the corner into the north elevation, to counteract the bowing wall frame caused by the spreading of the roof. A modern corrugated iron sliding door stands centrally (plate 4), accessed by a low concrete ramp from the encircling trackway. No such intrusions have been made into the wall fabric of building 1b. Here there is a small hatch set 1.5m off the ground (fig.6) and some scars in the external boarding above and to the left that would argue 1b has been extended at a later date by some 0.9m toward the farmyard (fig.6, plate 5). The scar above the top left corner of the hatch suggests the original roof was pitched at a

steeper angle of 42°, which is closer to the roof pitch of the contemporary east barn (Appendix 1).

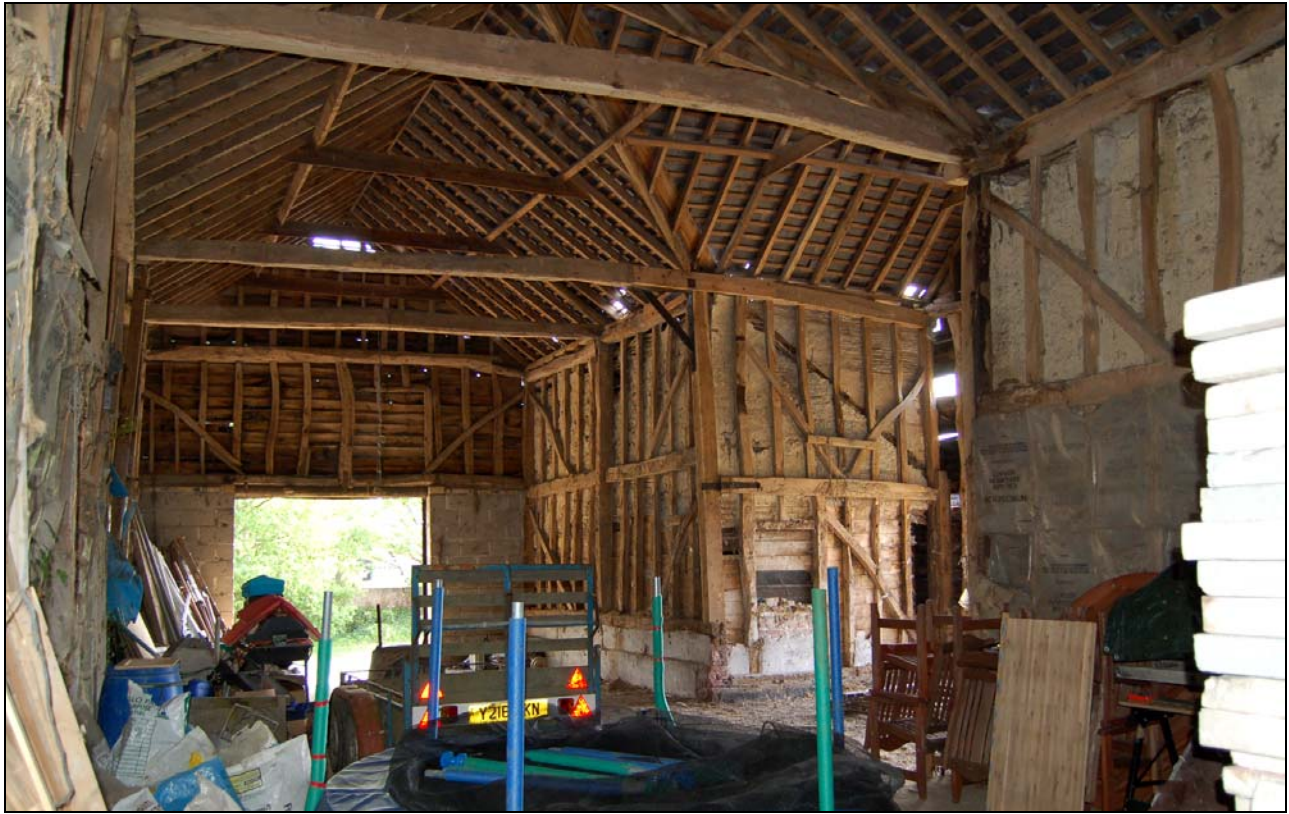
Plate 7 Interior of barn viewed to east, with porch to right

The walls are framed in elm with attractive, good quality primary bracing (plates 7 & 8). There are five studs per bay, apart from the midstrey. All the main timbers are pegged, and so are some of the studs. Bays are defined by tall 20 x 15cm posts that support tie beams spanning the floor below. None of the main timbers are braced, although an iron bracket has been added between the timbers on the north-west corner of the porch (plate 7). Long wall plates hold the barn in place longitudinally, joined by face-halved and bladed scarf joints, whose

positions are shown in fig.6. They are placed at roughly 1½ bay intervals on the north wall but are absent on the south wall. No such joints were seen in the base plate, which was rendered over when the concrete floor was added. Midrails are pegged to the posts, but parts of the studwork in the lower register, primarily on the gable ends, has been replaced with concrete blockwork. Clear plastic sheeting has been placed over the western bays, but less so to the east, part of which was removed during the survey. An inserted pitching hatch over the eastern door has been blocked (plate 7), probably when the modern door was fitted.

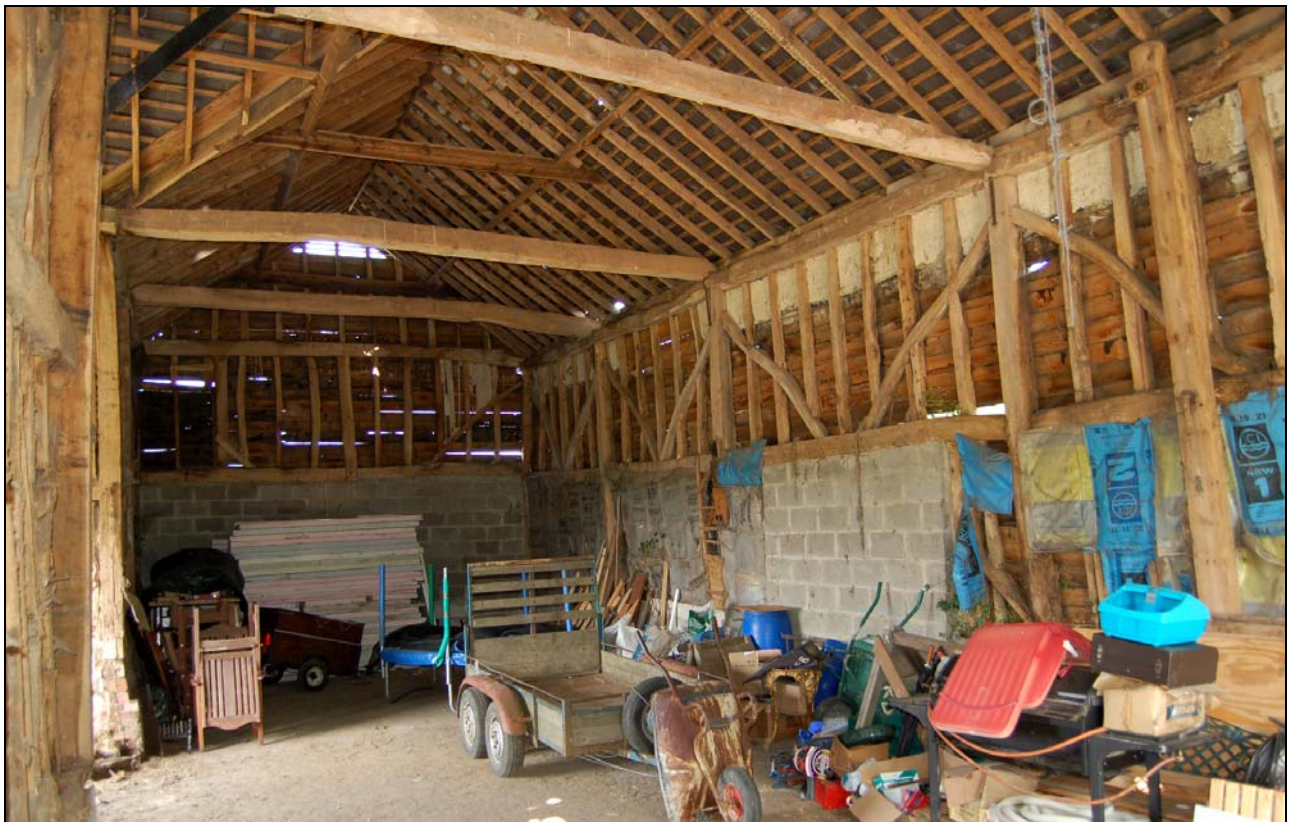
Plate 8 Interior of barn viewed to west

Nothing survives of the original barn roof. All was removed when it was totally rebuilt using machine-sawn timber, probably in the late 19th-century (fig.7, plate 8). The roof is carried on a secondary wall plate laid over the plate and tied into the existing structure on each bay by iron straps through the old plate and onto the post (plate 8). All elements to the collar purlin roof (fig.7) were fitted as new and none of the original rafters were reused. At the same time the cart doors were removed (or cut down) by approximately one third and the upper part of the opening blocked. Slatted wooden vents were built into the new gables. The roof pitch of the eastern barn (Appendix 1) is probably more typical of this barn before the roof was replaced.

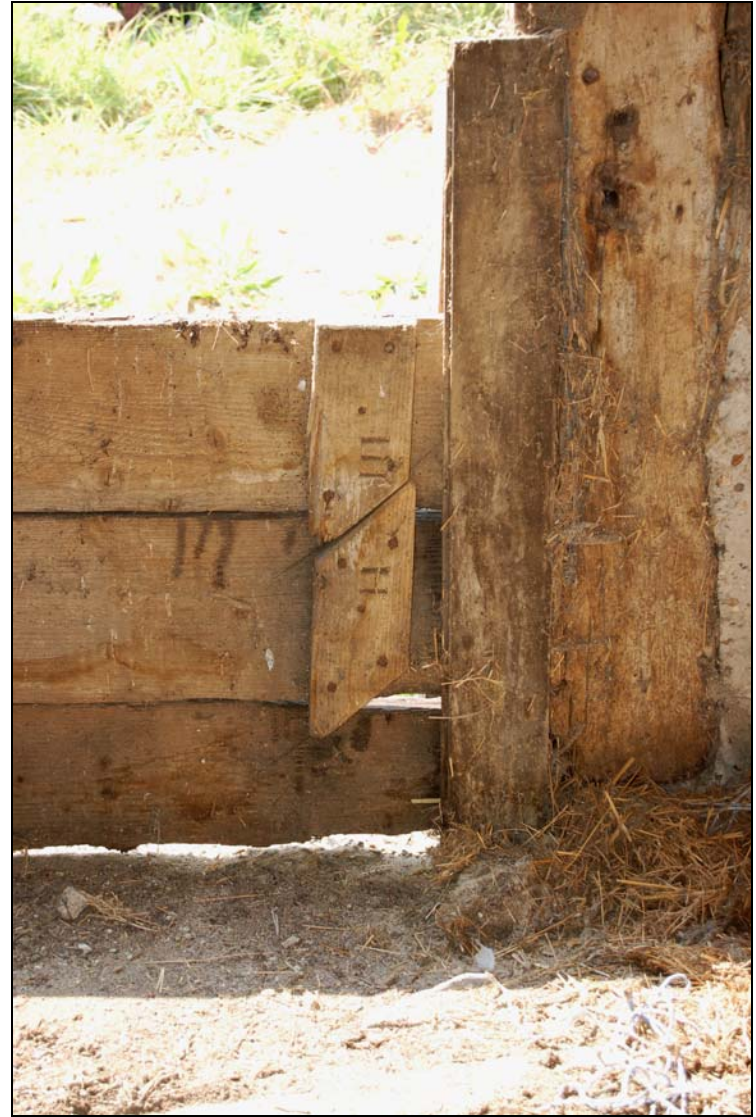
Plate 10 Detail of construction and markings to threshold leap

Slender pieces of timber are used for the studwork and primary bracing, commonly measuring approximately 10 x 8cm and spaced quite widely between 0.35 and 0.45cm. The braces have been especially chosen for their natural curves that, along the north wall in particular, have been arranged to resemble medieval-style arch bracing (plate 8). Extensive lath and daub panels remain between the studwork in the south wall, and in the top section of the north wall (plates 7 & 8). There is also some present on the porch walls (figs.7 & 9), as well as the laths that carry daub render to the external walls inside buildings 1a and 1b either side of the porch. A blocked doorway for farm workers exists on the west side of the porch (fig.6, plate 7) but there is none on the other side (plate 9). There is, however, a well-preserved leap, with three of the four boards *in situ*. They lock together in a particular way inside the grooved slots attached to the jambs, shown by diagonally cut planks on the inner face, with clearly-chiselled numerals (originally 1-4) indicating their order (plate 10).

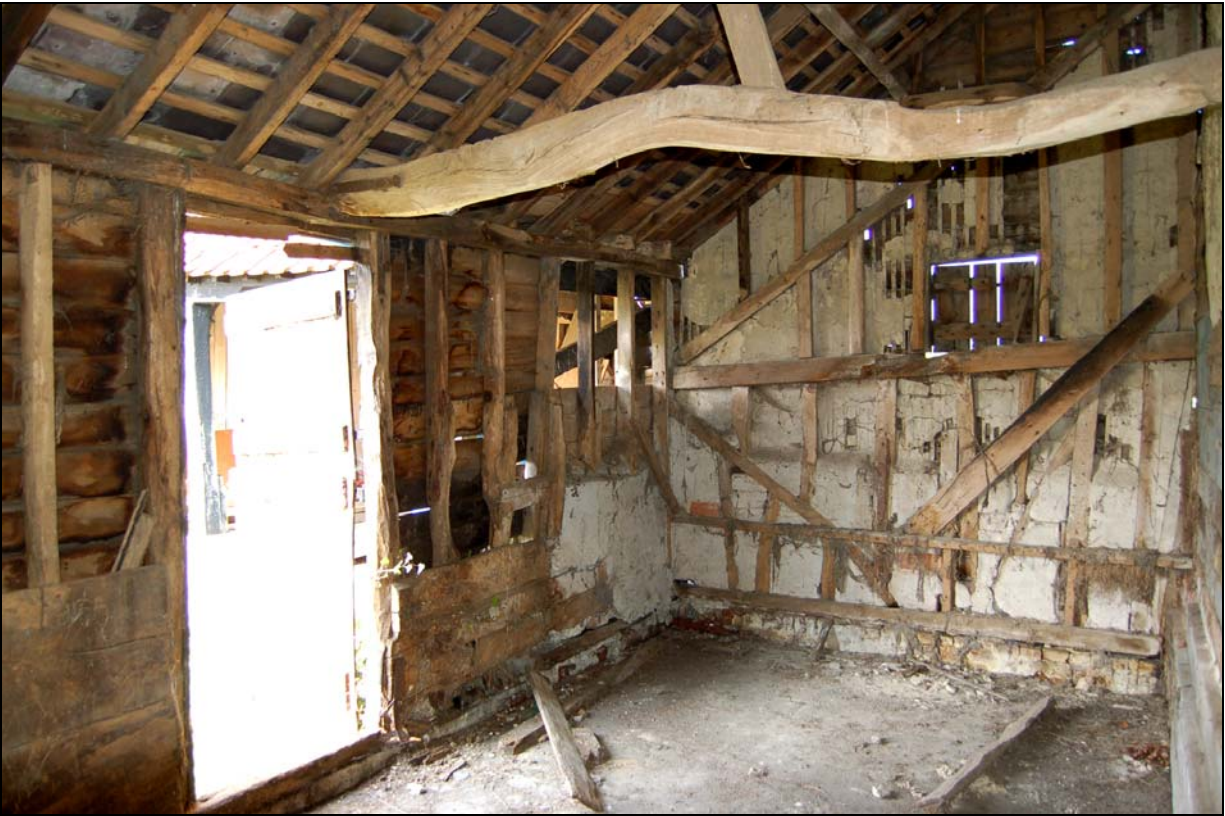
Plate 11 Interior of loose box 1a viewed to south-west

The dirty, worn stone floor appears to contain asphalt in its make-up. The outer walls of the barn/porch are half-boarded, with a daub-rendered upper section (corresponding to the midrail inside) indicating how the barn was originally built. Constructed with primary bracing of lower quality to the barn, but with appropriate-sized timbers, studwork is only exposed on the west and south wall (plate 11). The build is cruder than the barn and the studwork is joggled, which is not the case in the main building. Perhaps the scrap timber from the construction of the barn was used. Studwork above the plate forms the framing to the lean-to loose box roof, which appears to be a different building phase, containing, in general, better-cut timbers arranged more neatly. The studwork here is separated by a later diagonal midrail, parallel to the primary rafter/wall plate. Rather than an original roof line, it seems that the studs of the wall were cut down when the barn roof was rebuilt to the new pitch, the plate added and then built up with largely machine-sawn studs (plate 11). A hatch, shorter than that seen on the east elevation, can be clearly seen within the framing (plate 11).

The south wall is neater and partly boarded to 1m-high, fixed to close-studding. An opening has been made between this and the cow shed (fig.6). The roof is rebuilt and is contemporary with the re-roofing of the barn. A timber strut runs between the tie beam and roof purlin, linking old and new (plate 11).

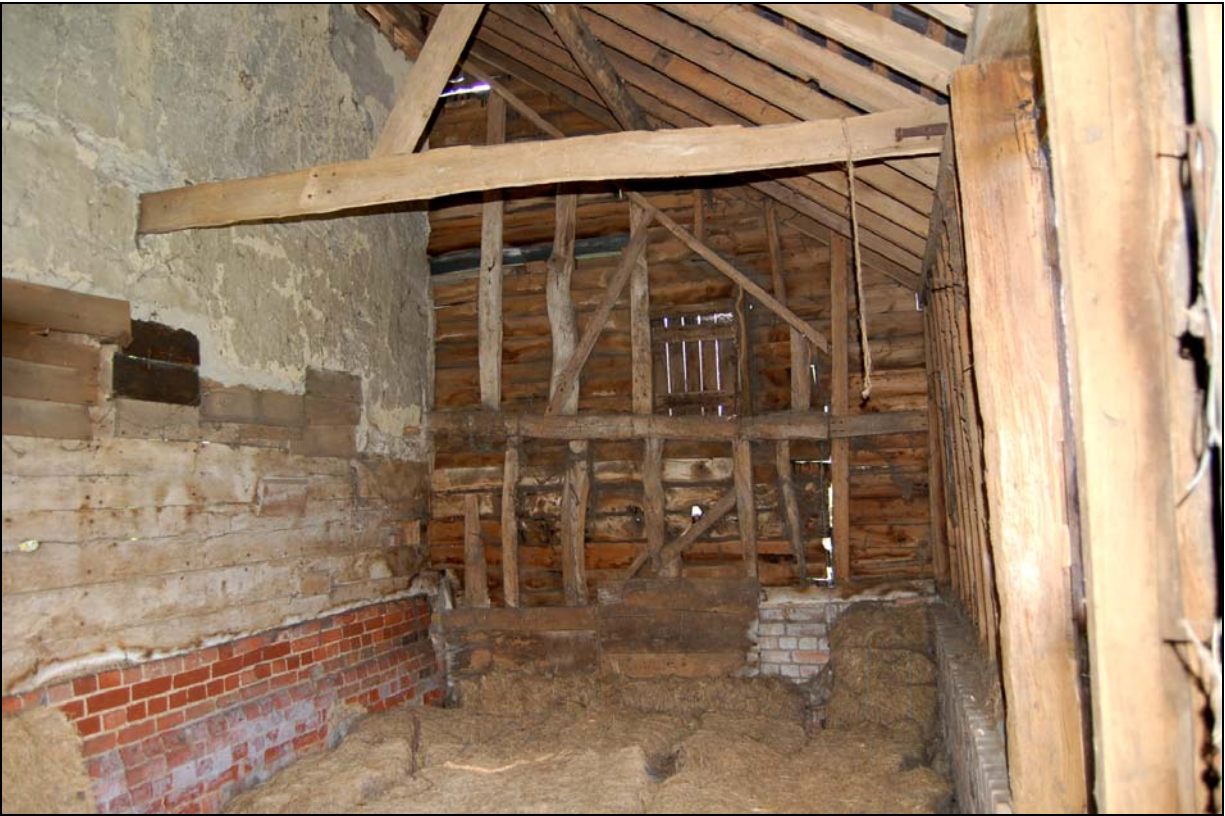
Plate 13 Extension & roof raise to shed 1b on eastern wall

The east wall (plate 13) has fairly sturdy studs and slender machine-sawn ones above that compare well with the wall scar on the east elevation discussed in section 5.1.1. Also, the midrail has been extended (by only 0.7m, fig.6) and fresh boarding added (plate 13). The south wall contains only machine-sawn and the odd reused timber but is set within a reused, probably original, wall and sill plates. This could mean that 1b was originally built as an open-sided shed to shelter animals around the yard and became a loose box when the new cowshed was built between 1875 and 1896, which is probably when the roof was rebuilt and slated.

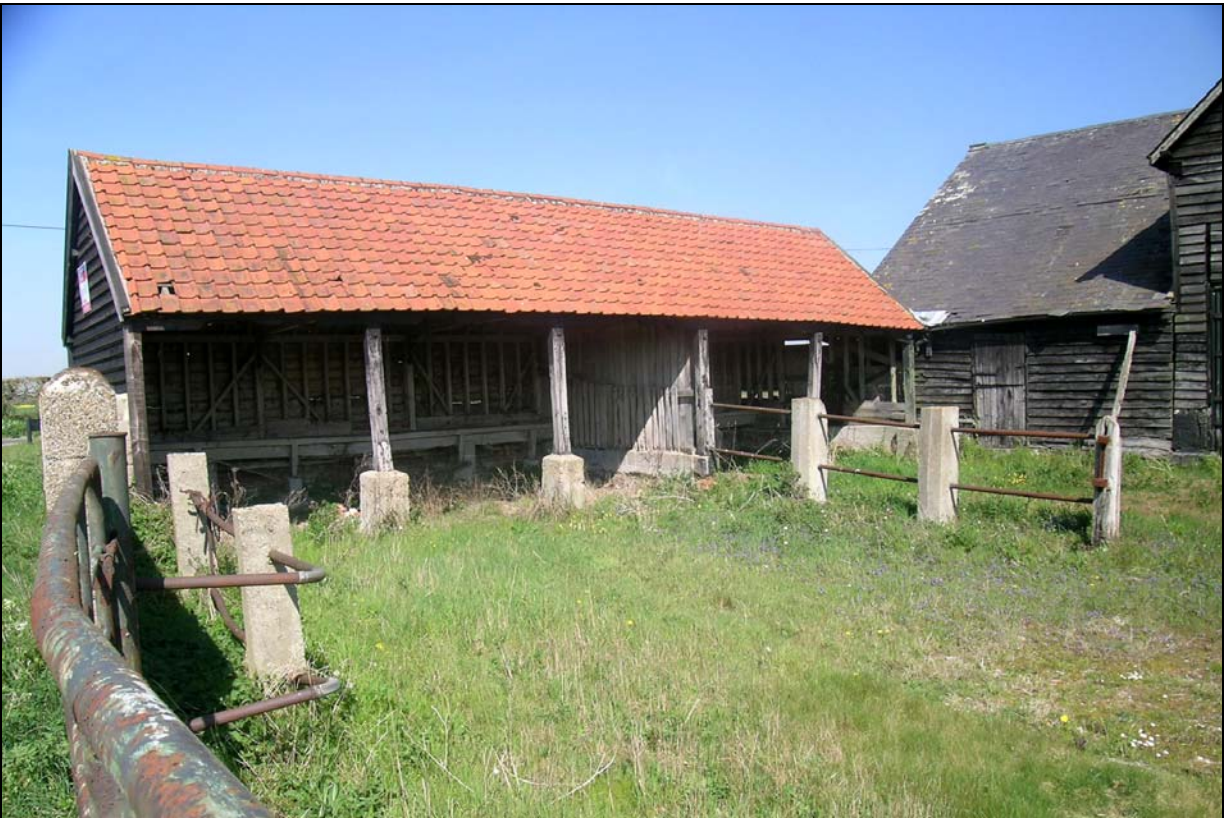
Plate 14 Eastern elevation of cowshed viewed across yard

The shed is rectangular in plan, timber-framed and open-sided to the east, with a clapboard exterior and a gabled pantile roof set on a shallow c.35° pitch (plate 14). A 50cm-high stepped plinth, comprised of c.9 x 4½ x 2½ red bricks, skirts the three sides. These are slightly larger than those in the barn plinth but like parts of the barn are arranged in various bonds. Some, but not all, are frogged.

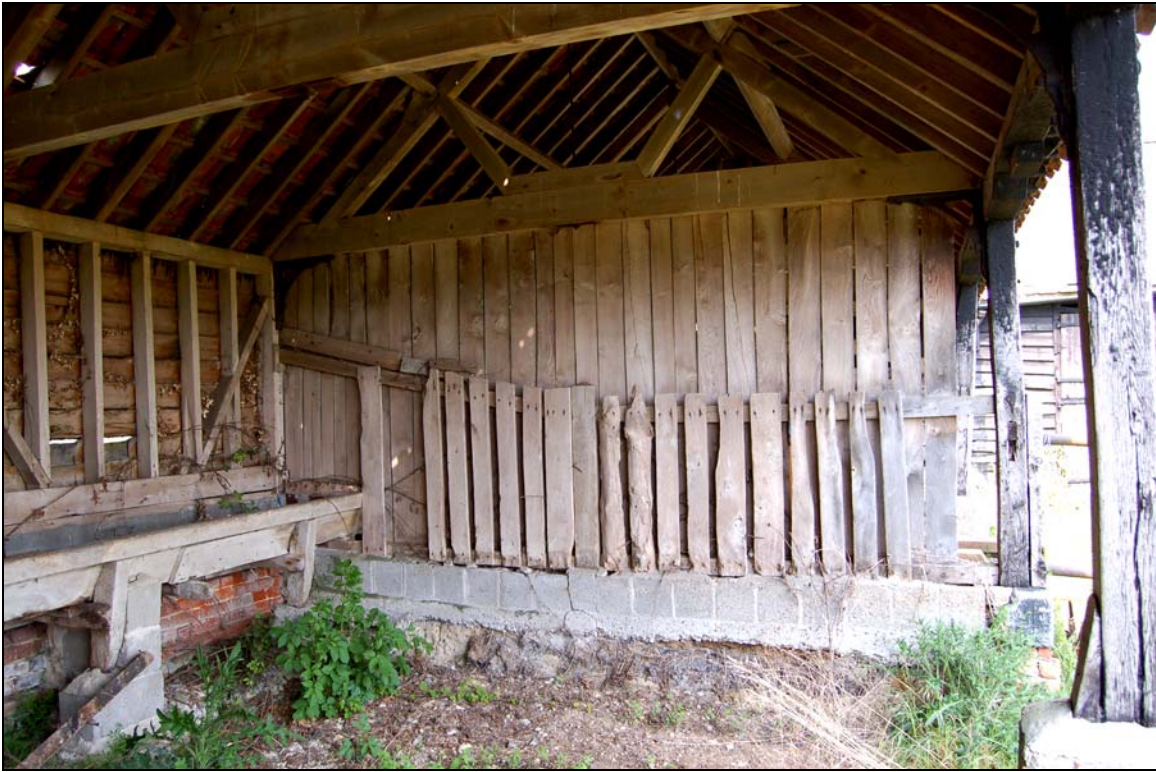
Plate 15 Cowshed partition

There are five bays, the end two of which, towards the north, are divided by a boarded partition built from vertical timbers (plate 15) either side of a middle rail. It is lower on the south side and is raised toward the trough end, like a stall partition. The partition conforms to the boundary of the south upper yard that came into being when the shed was built and is still represented by concrete and iron bar fencing today (plate 14). This part of the yard housed different animals – perhaps bullocks or calves. Because of wear to the floor, concrete blocks have been added to support the partition, on top of the original flint and crushed mortar floor (plate 15) that has been worn away in other parts of the shed.

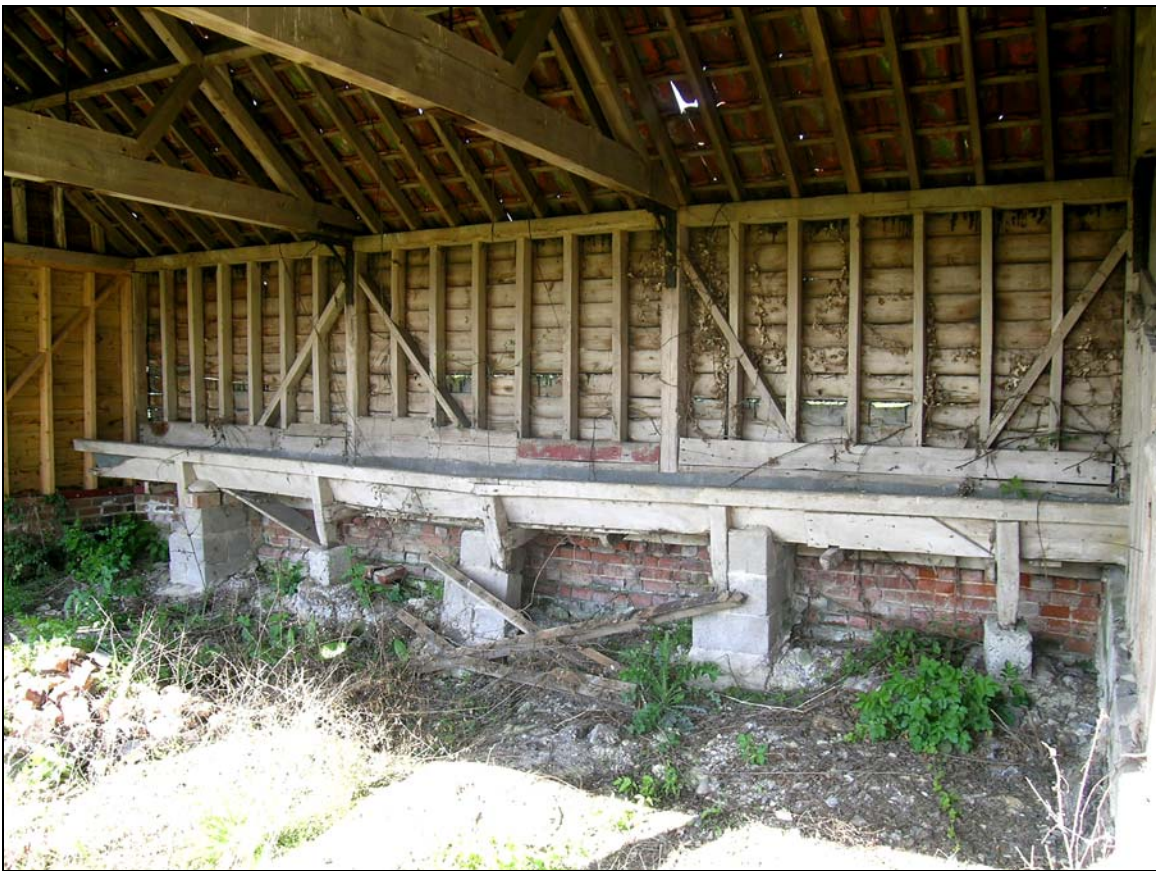
Plate 16 Feeding trough inside cowshed

Attached to the rear (west) wall of the shed is a feeding trough that runs from end to end (fig.6, plate 16). Like the area below the partition, the floor has worn down and concrete blocks have been inserted beneath. Originally, the height to the lip was approximately 80cm-high which would be tall enough for a standing cow. The crushed mortar and flint floor remains below the trough, away from the feet of the animals (fig.6).
