**HISTORIC BUILDING RECORDING
AT GRAYS FARM, GRAYS LANE
WETHERSFIELD
ESSEX**

Document Ref.	1742rep
Report Issue Date	21st September 2007
Circulation	Mr. D. Butler
	ECC Historic Environment Management
	Essex Historic Environment Record

FAU Project No.: 1742

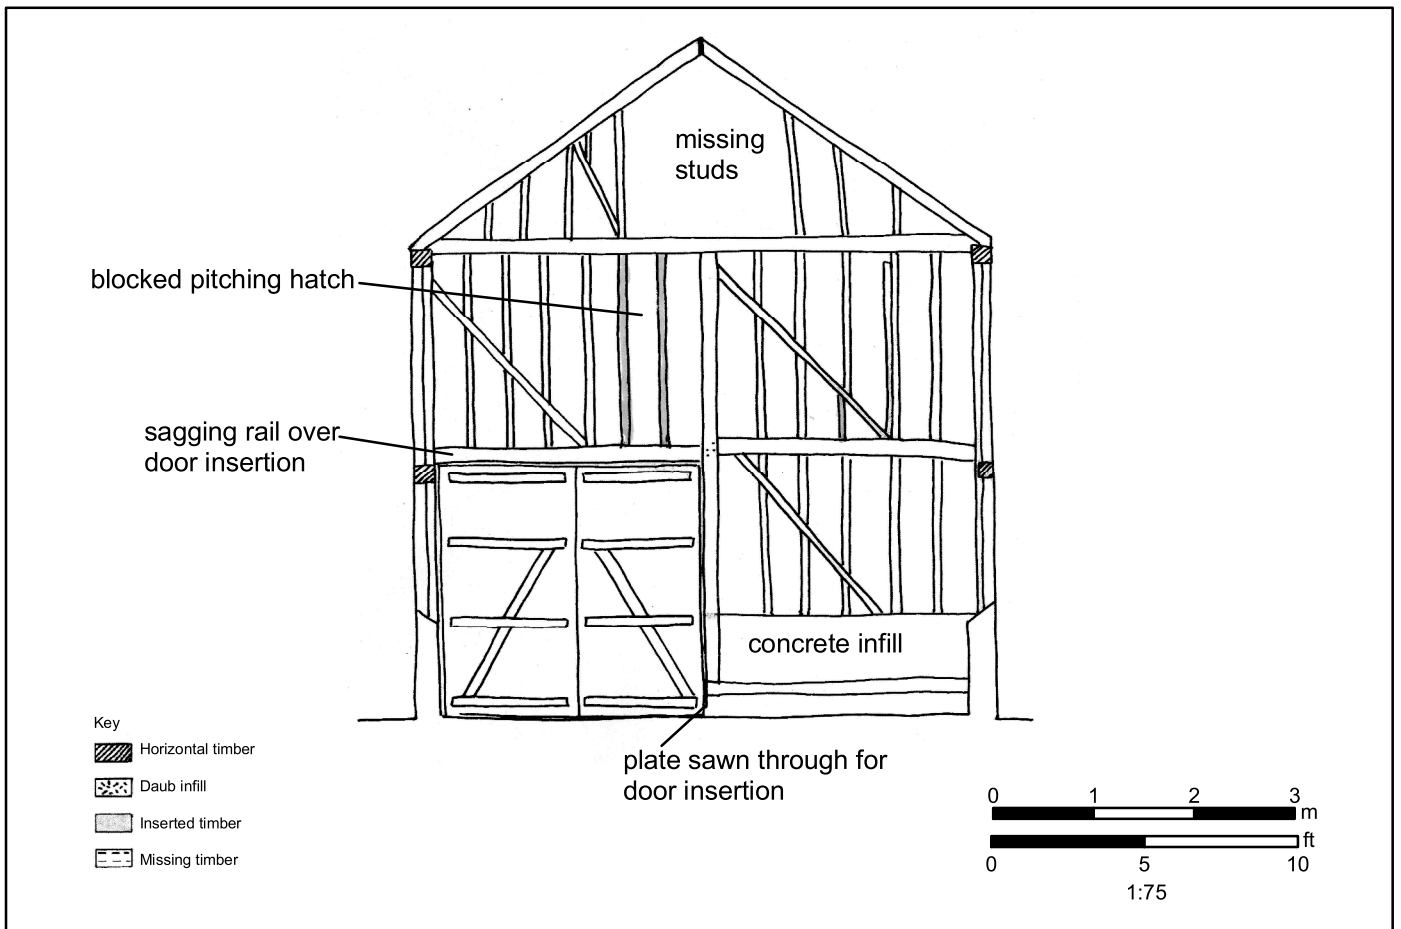
Fig.7c. Barn south gable

The north elevation (plate 9) retains its pitching hatch, although since the frame survey was produced, in March 2006, its door has fallen away (fig.7c). Above, the gable, which is partly rebuilt with the roof, is cement rendered. Much of the wall is engulfed by ivy, which extends into the building through gaps in the boarding.

Much of the original framing is intact. The few replacement studs are confined to the gable ends. Those at the southern end have largely been inserted to block the pitching hatch (fig.7c), while the north gable was largely rebuilt when the roof was replaced (fig.7d).

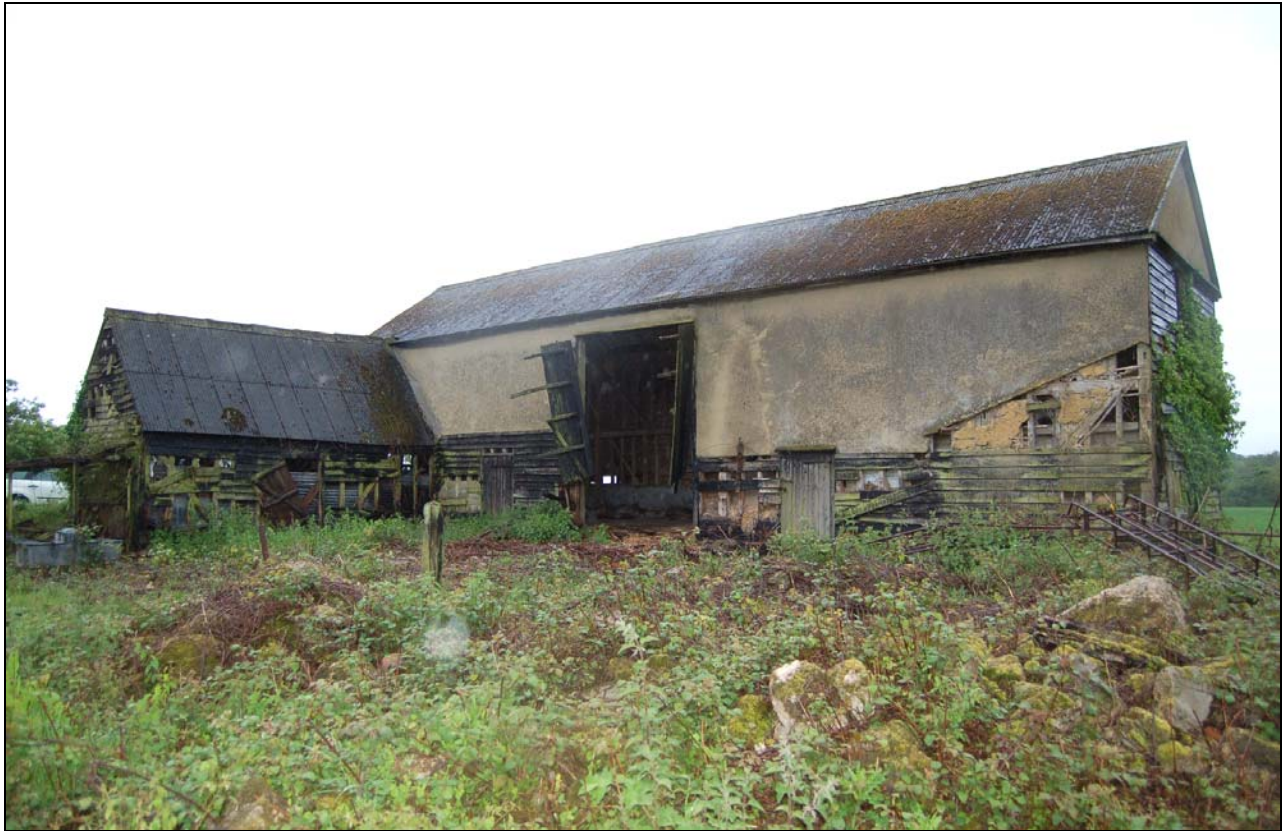
Plate 2 East elevation of barn and north elevation of byre

The main long elevation faces the yard to the east and is viewed on approach to the house. Contemporary byre 2 leads from the southern end. At least half the façade is coated in cement render above ancient 9 inch weatherboarding (plate 2). The high central wagon doors that lead onto the threshing floor inside are in poor condition. What remains is hanging off the pintels either side (plate 3). Below is a single low door threshold leap (plate 4), probably the precursor to the slotted plank leaps seen in Victorian barns and 19th-century upgrades, and quite rare. This controlled the grain when threshing was taking place and kept animals from wandering in from the yard. Then, when the grain was winnowed, they were opened to create a through draft across the threshing floor. All three doors are attached by large round-ended strap hinges, also present on the west elevation, on the opposite side of the threshing floor.

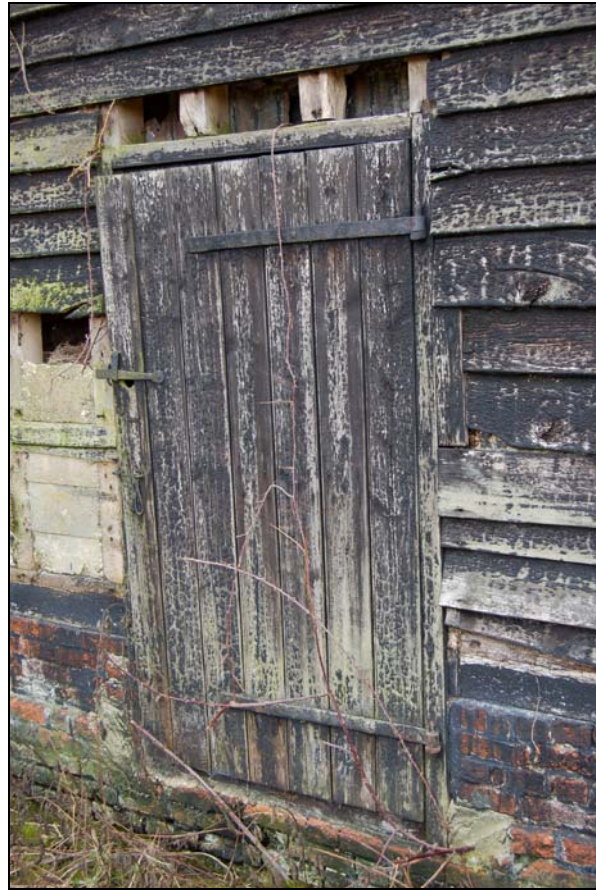
Plate 5 Detail of side door to barn

Either side of the cart doors are two ledge and batten side doors carried on plain strap hinges (plate 5). The wall/roof scar to the removed north range can clearly be seen from this side against the more durable cement walling of the barn. It appears to belong to a timber-built open-sided cattle shed (plate 6). Closer examination of the exposed area of barn walling reveals important information on its construction. The wattles are packed tightly together and tied to horizontal laths nailed to the timber frame. Further remains of original daub render exist on an area of half boarding on the south side of the elevation, hidden and protected by the byre (plate 24, section 5.3.2).

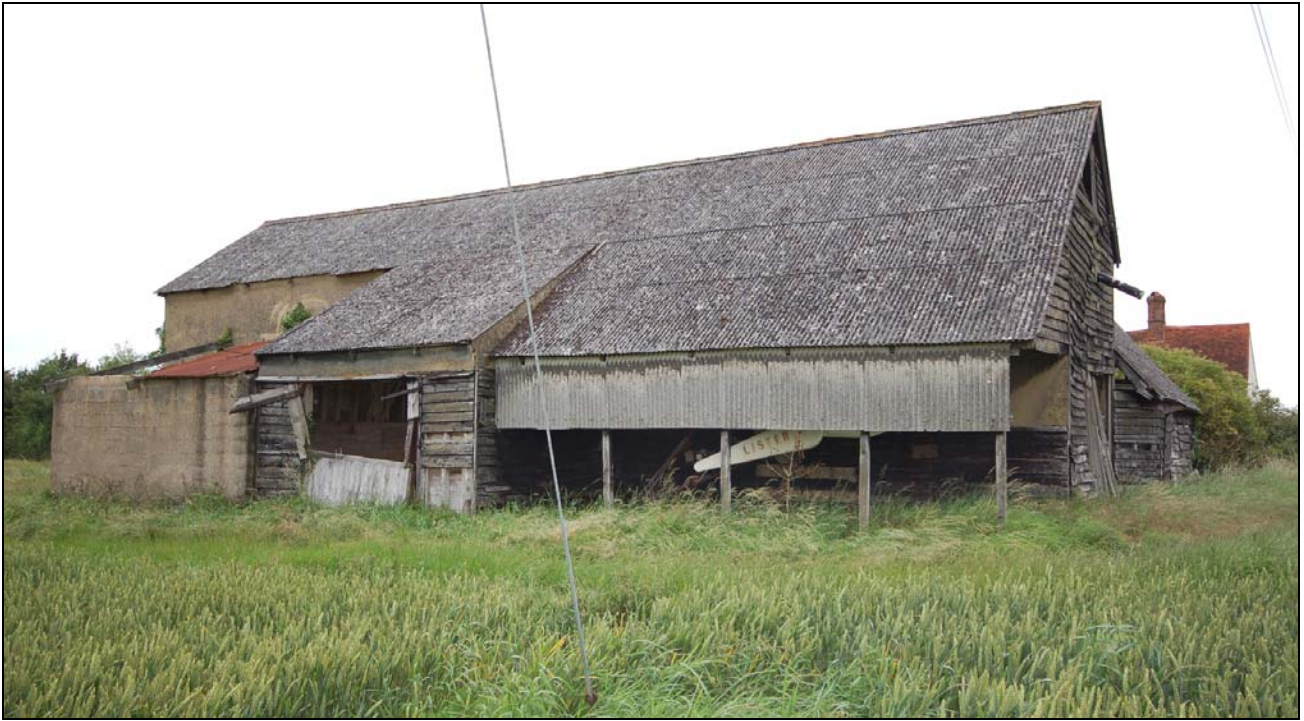
Plate 7 West elevation of barn

Changes carried out in the 1940s (D. Butler pers. comm.) have spoilt the more traditional aspect of the west elevation (plate 7), but have also been important in preserving vital historic remains. A low, lean-to central porch provides the main focus on this side, whose

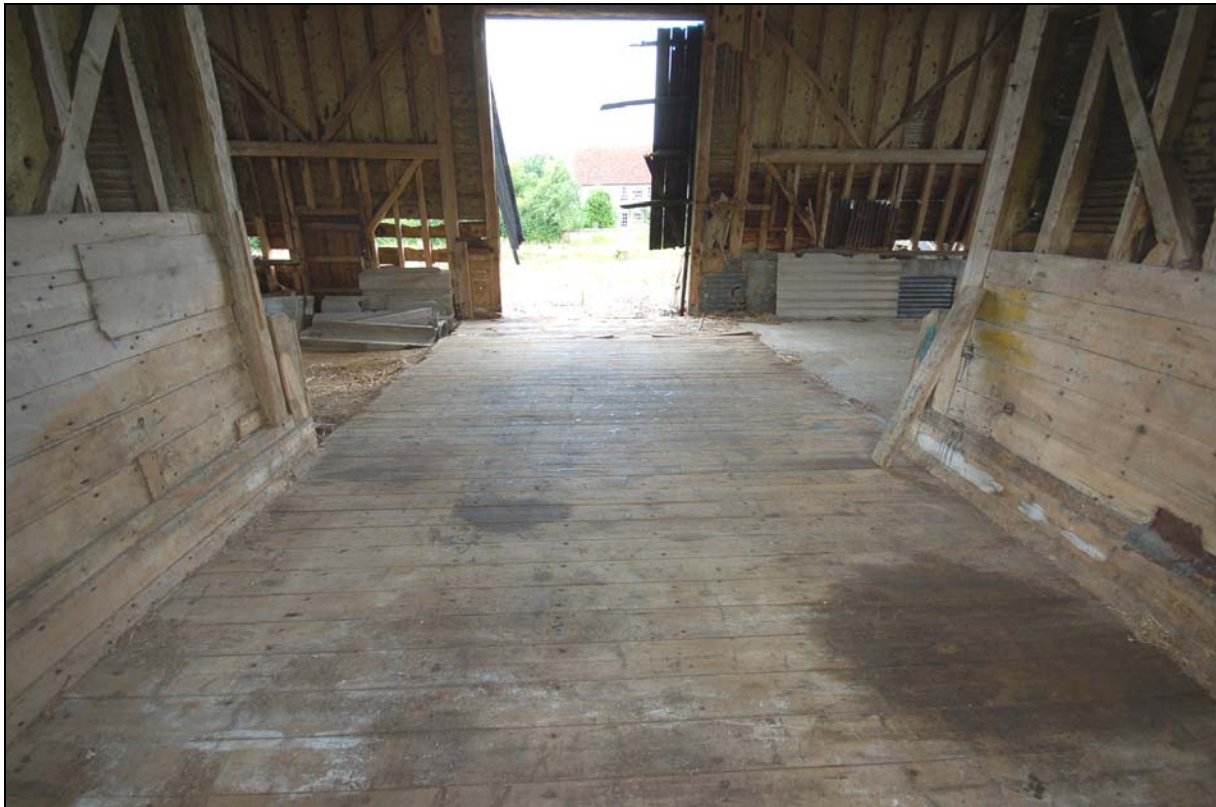
Plate 12 View across threshing floor to yard

The wooden threshing floor inside the midstrey (fig.6, plate 12) remains intact, which is rare as many were replaced with concrete flooring in the latter part of the 20th-century. It is constructed from 7 x 2½" nailed planks and extends into the porch (fig.6), though the ends of both sides have rotted from damp through the open cart doors. Inside the porch, a 1.4m-high 8" plank lining kept the timber frame clear of grain, whilst planks could be slotted inside grooved posts to a height of 1m in the main part of the barn (fig.7b, plate 16). The floor on

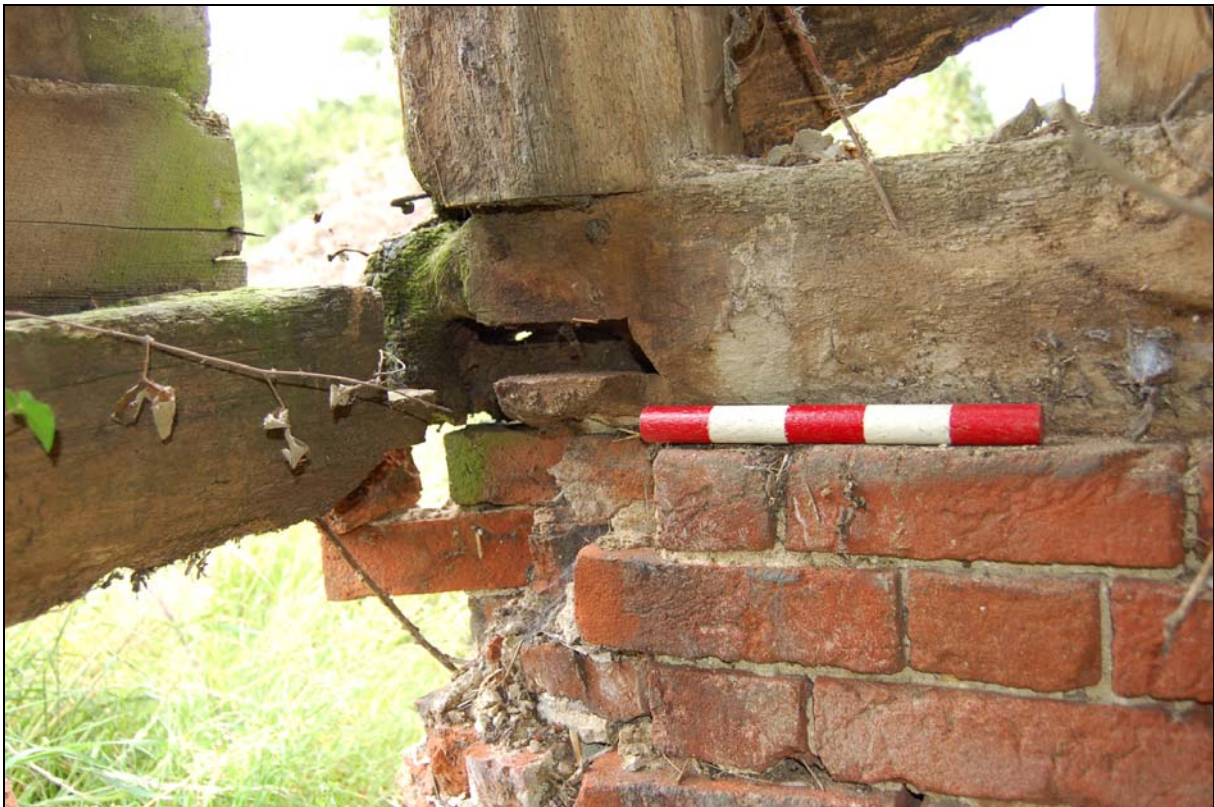
Plate 14 Detail of basic construction in north-east corner

A good idea of how the lower part of the barn was assembled is provided in the north-east corner, where the plinth has rolled, pulling the sill away from its housing and exposing the joint. As can be seen (plate 14), the two sill plates are joined by mortice and tenon the same width as the plate itself. This is pegged through from the top and then the corner post tenoned into the top and double-pegged vertically.

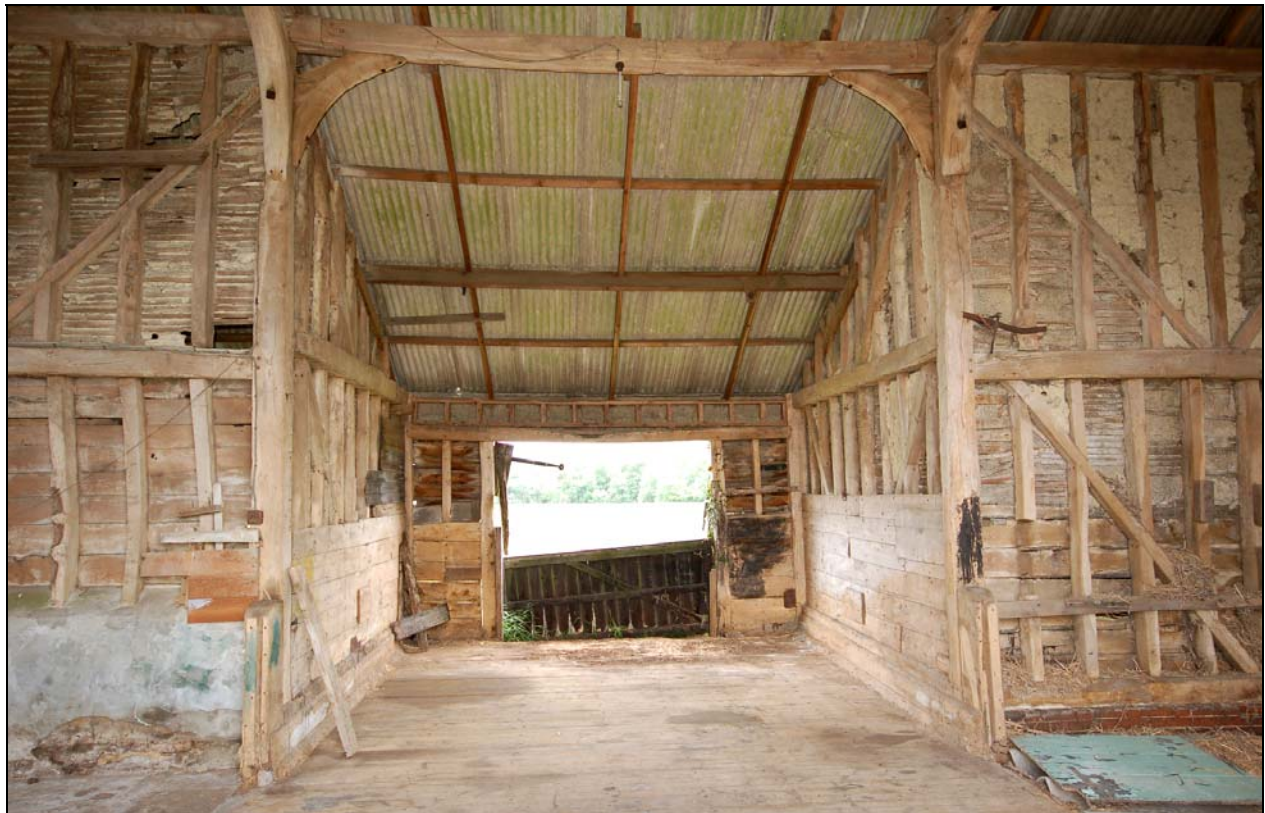
Plate 16 Detail of porch

The porch (plate 16) is integral to the barn and contemporary with its creation. However, it was altered significantly when the roof was rebuilt. The original roof would have been double-pitched like the existing roof on the main part of the barn (although it too has been replaced and this may not have been its original pitch), with the framing extending to the existing wall plate and original higher doors. Apart from the external evidence discussed earlier, there are also internal factors to suggest the porch has been altered. For instance, the end posts have been cut down and the wall plate is not pegged to the posts either side. The studs have been cut down and lapped internally over the new machine sawn diagonal plates, then nailed (plate 17). The western ends of the primary braces have been cut back substantially, along with the full frame, to make them practically useless as bracing.

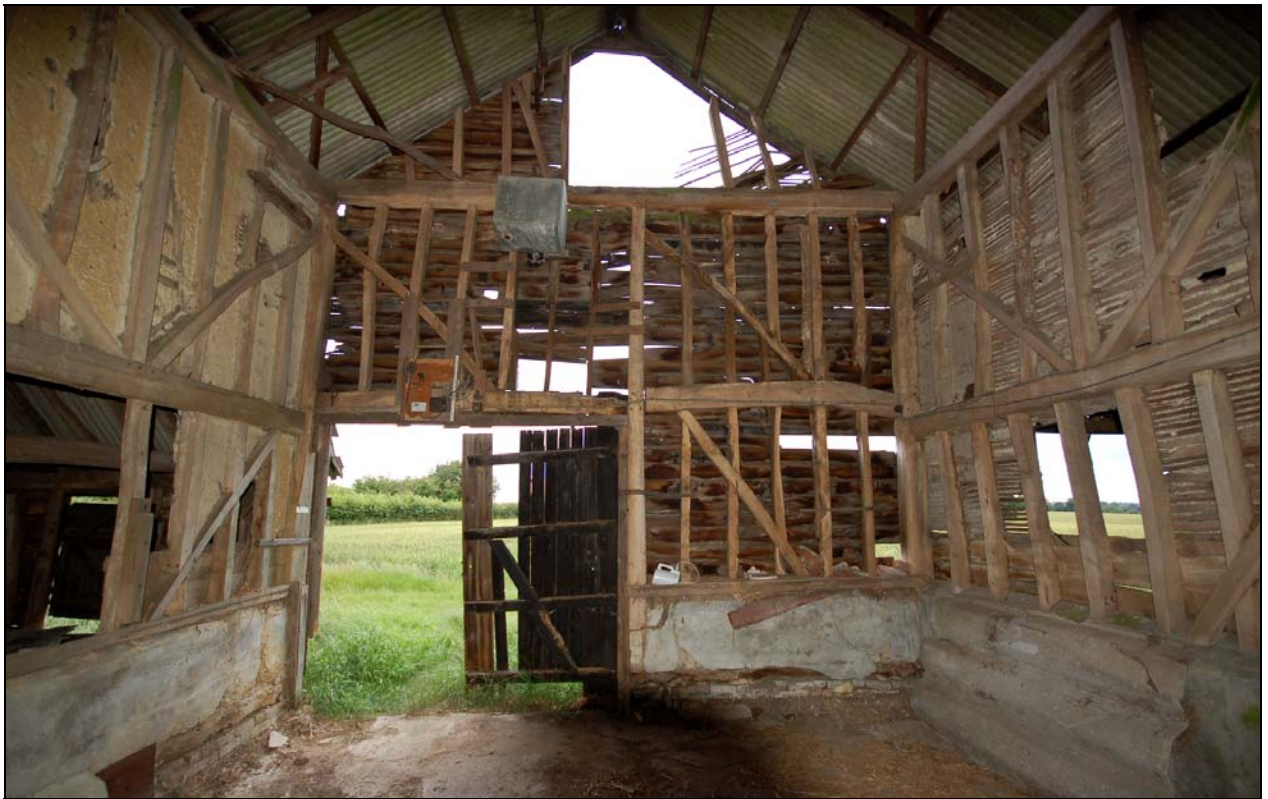
Plate 18 South gable of barn

Later usage for grain storage and processing is shown by a makeshift metal hopper attached to the framing on the east side (plate 18) that links to the grain chute outside (plate 7). The hopper was fed from above, probably by a vacuum hose lifted into place by means of a small hoist above. Other associated apparatus such as drying/processing machinery or grain silos may have formerly been located here too, either during or before bales were being stored here.

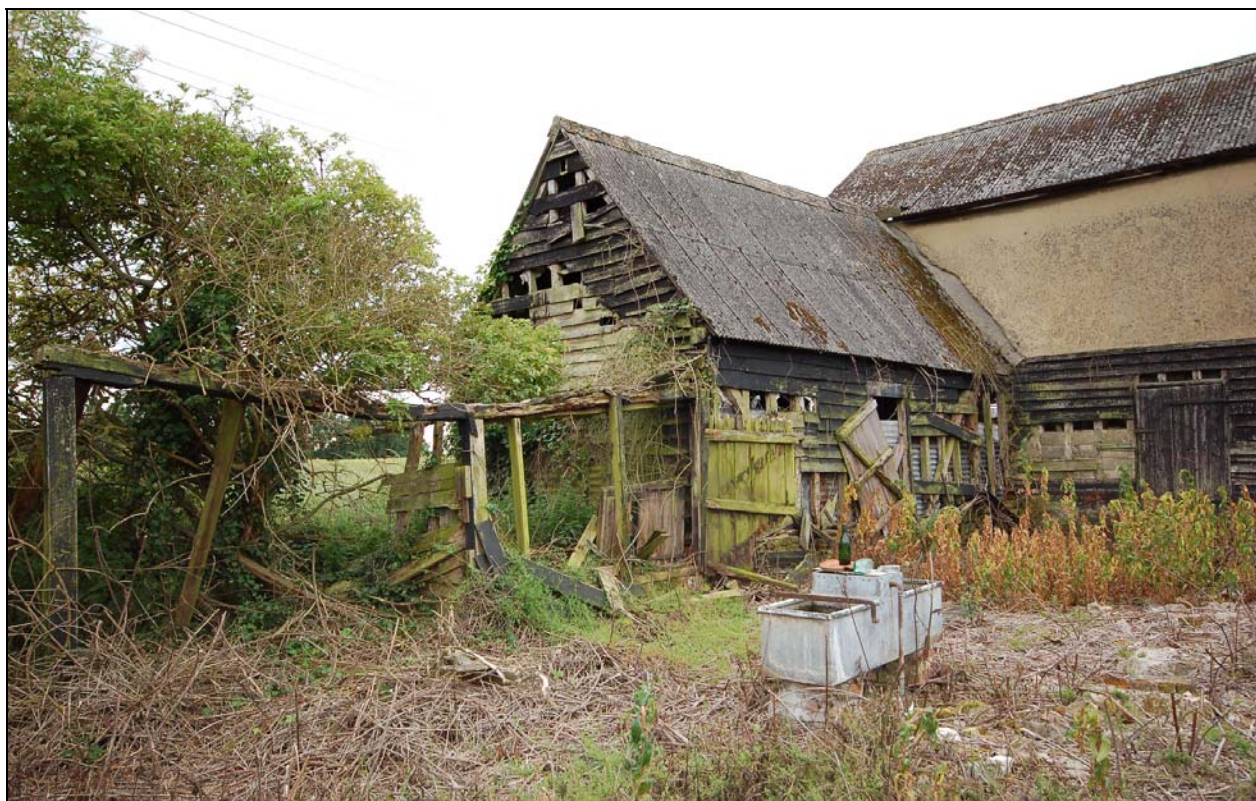
Plate 20 Byre viewed to south-west showing remains of south range

In terms of condition, the byre has suffered more than the barn, but not irreparably so. In particular, the north side, facing onto the yard is in poor condition, with the frame exposed and brick plinth either missing or replaced by concrete blockwork (fig. 9a, plate 19). The latter is also true of the east elevation. Its weatherboarding, which is the same as that on the barn, has faded on all sides. Decrepit wall plates and posts from the southern range adhere to the east end (plate 20).

The north elevation faces onto the yard. As has already been stated, it is in a poor state. At least half of the cladding has fallen away from the frame and parts of the plinth have rolled and been replaced or else left void. The central ledge and batten doorway is hanging off its hinges (plate 20).
