**HISTORIC BUILDING RECORDING AT WOLSEYS FARM
DUTON HILL, GREAT EASTON
ESSEX**

February 2008

HISTORIC BUILDING RECORD

FAU Project No.: 1821

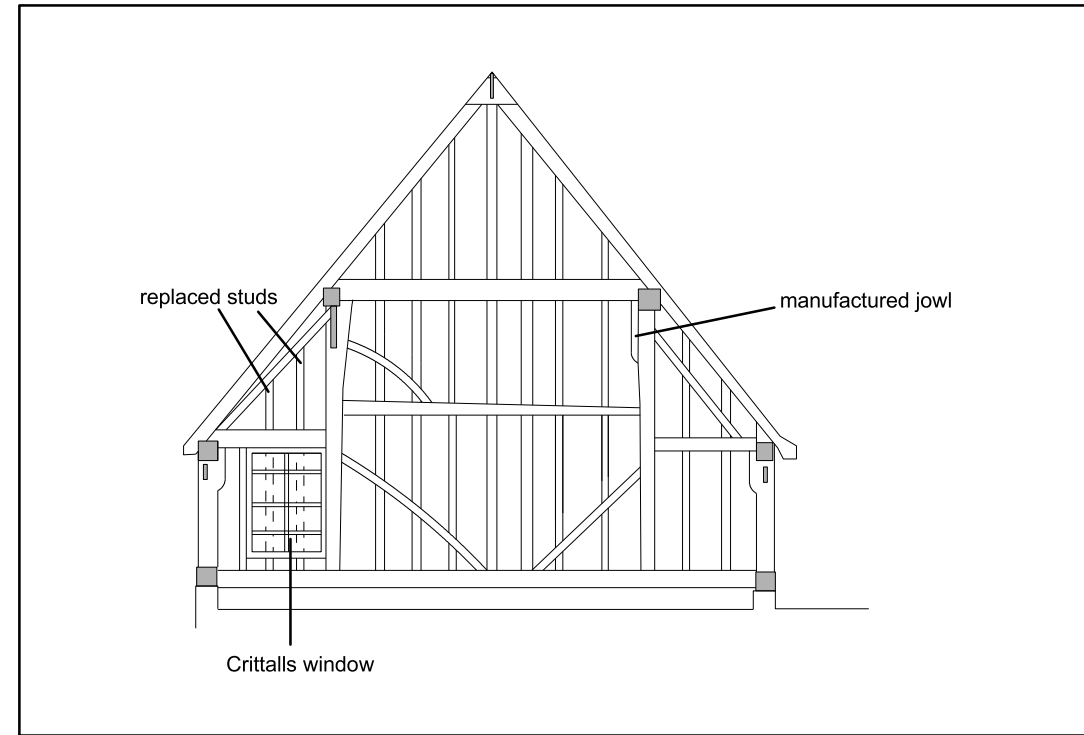
Fig.7b. East wall

Studs have been removed in the east wall to insert a Crittall window (fig.7b, plate 8). The aisle tie and corner post are reused. Two studs above the aisle plate are later replacements nailed to the shore. The main part is fully framed and pegged. Internal bracing is absent from the upper register (south) where the arcade post was not wide enough to form a jowl, and a manufactured jowl was fitted instead (fig.7b) that would not have had the strength if a brace was fitted.

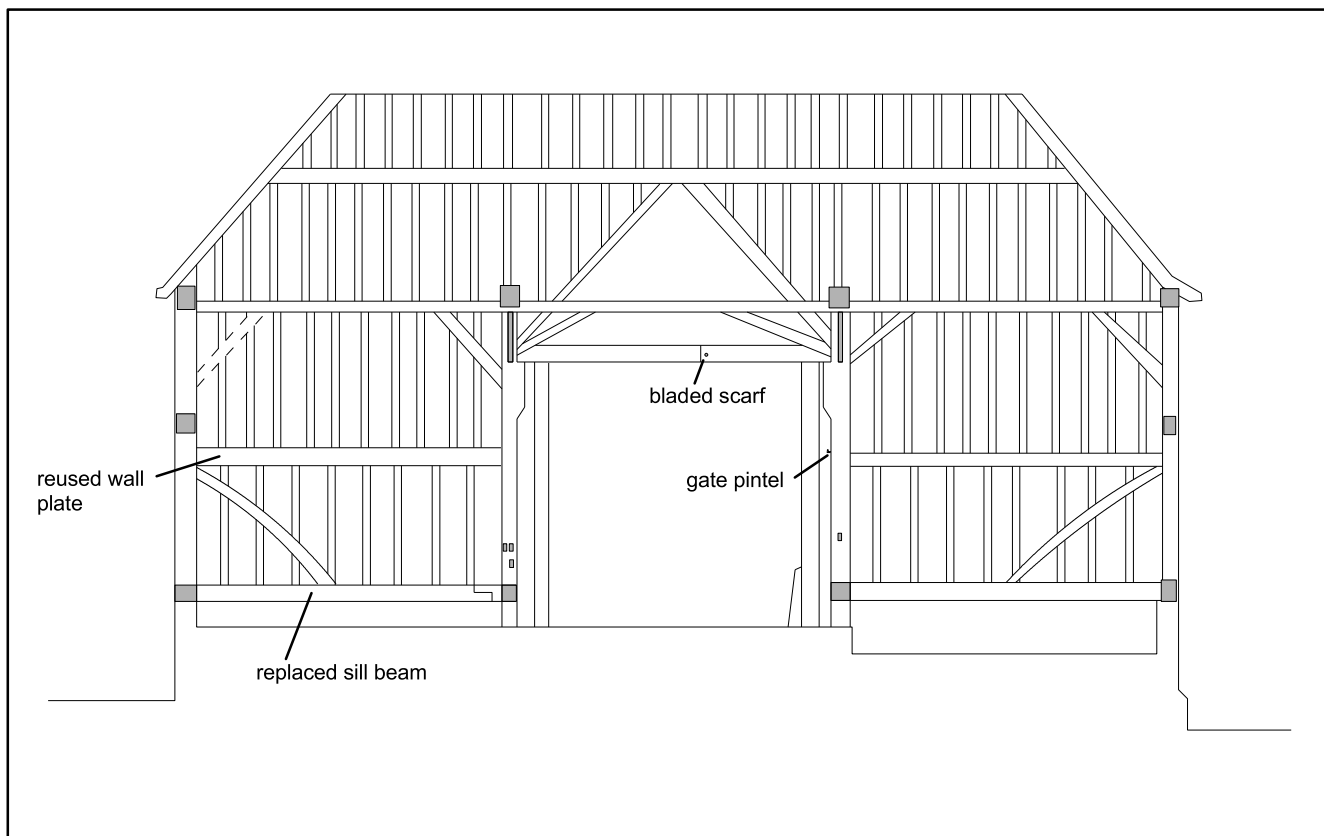
Fig.7c. South wall

On the south wall (fig.7c) there is a high proportion of re-used studs to the east of the midstrey, associated with a replaced sole plate, lapped rather than scarf-jointed. To the west, most studs are a mix of new and reused stood on a reused plate.

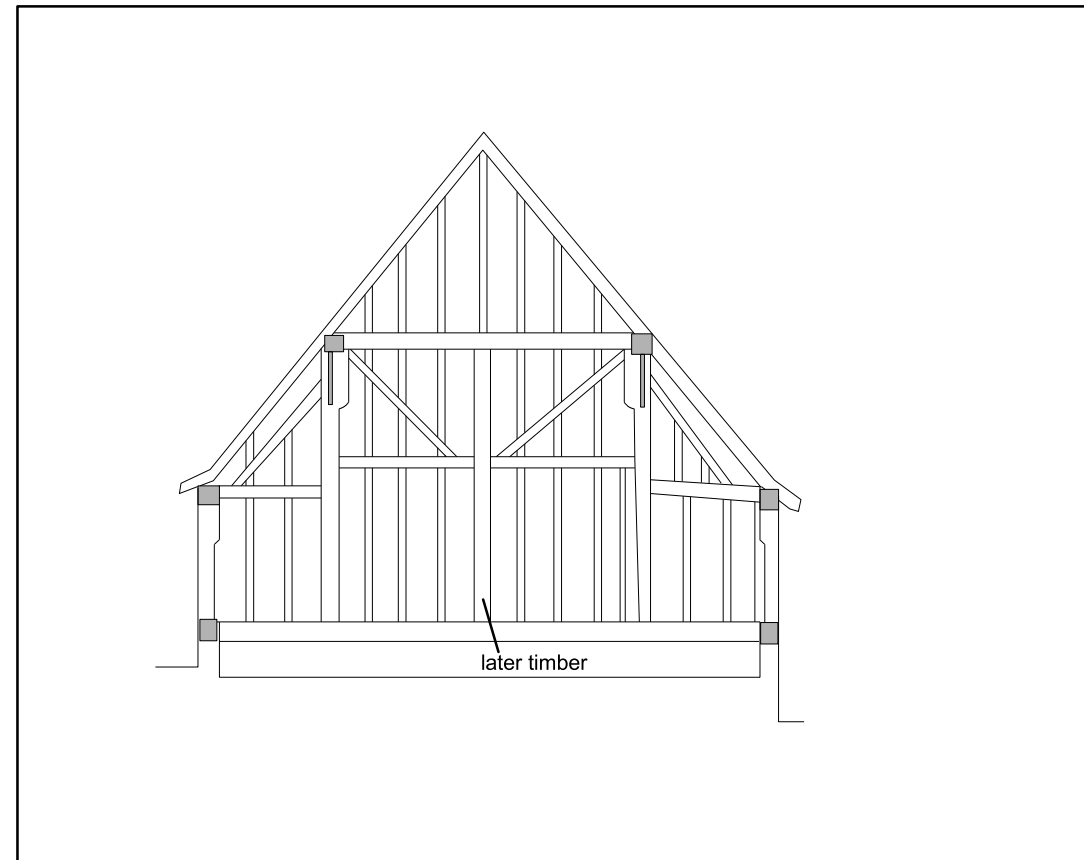
Fig.7d. West wall

The west wall (fig.7d) has late repairs to the sole plate and a second central post has been bolted to the original to provide greater strength. Stud bases have been reinforced by thin nailed timbers for better stability. Otherwise, much of the framing is complete and original.

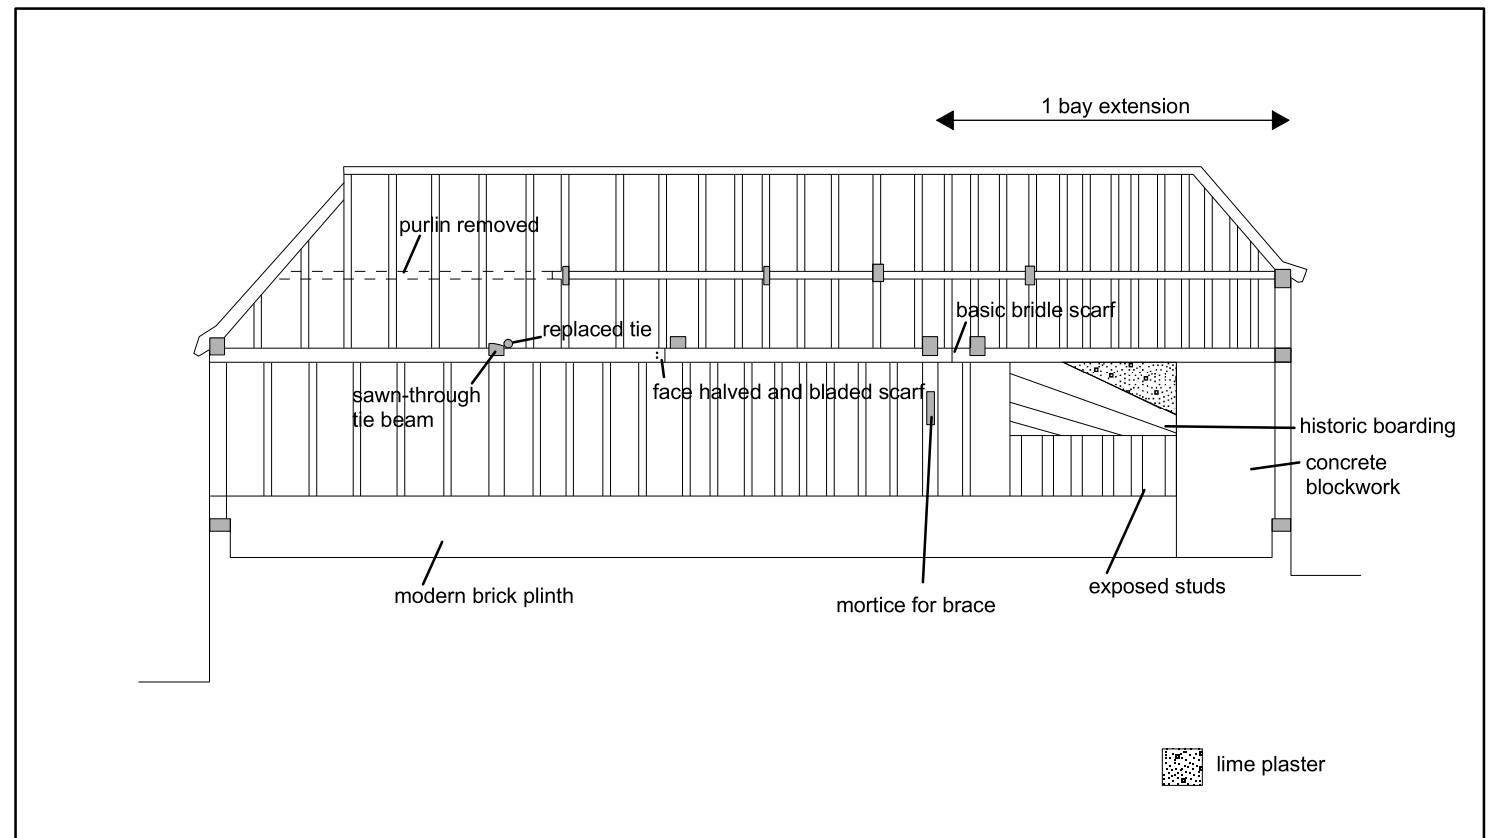
Fig.10b. East wall

Roof framing is pegged collar trenched purlin, except for the extension that has a birds-mouth collar. Purlins are lap-jointed together. One is missing on the east wall (fig.10b). Many of the paired roof rafters appear reused from an earlier building (Watkin & Watkin 2007) and those in the extension are closely-set. The floor at the north end is made of hardwearing 19th-century Staffordshire bricks (plate 22). The rest was concreted over stalls were added in

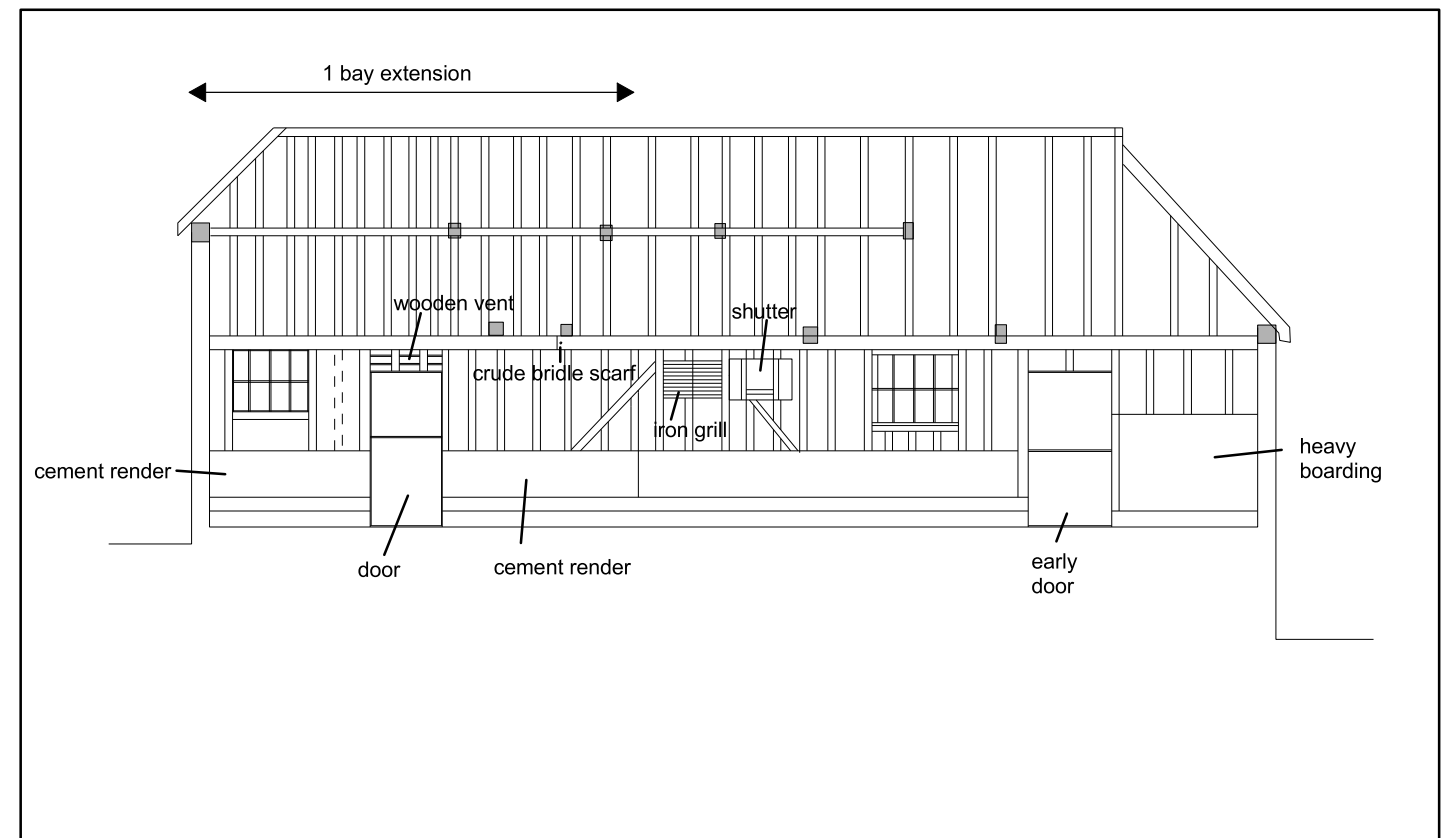
Fig.10d. West wall

The front elevation (plate 19) stands on a 1m-high brick plinth, consolidated at the base with concrete against the fall of the land. The main features are two fixed eight-pane Victorian windows either side, with half-heck doors to the left in both cases. The door to the north retains wooden latches (plate 20) that have been preserved through protection from shed 3. If this is an original feature, then this end was enclosed as a loose box, but a missing tie beam to this bay makes this hard to prove. The door further to the south has more common iron fixtures, with a wooden slatted vent above. Between the door and north window is an iron grilled vent, closed off on the inside by a wooden shutter (fig.10d), another sign of animal accommodation.

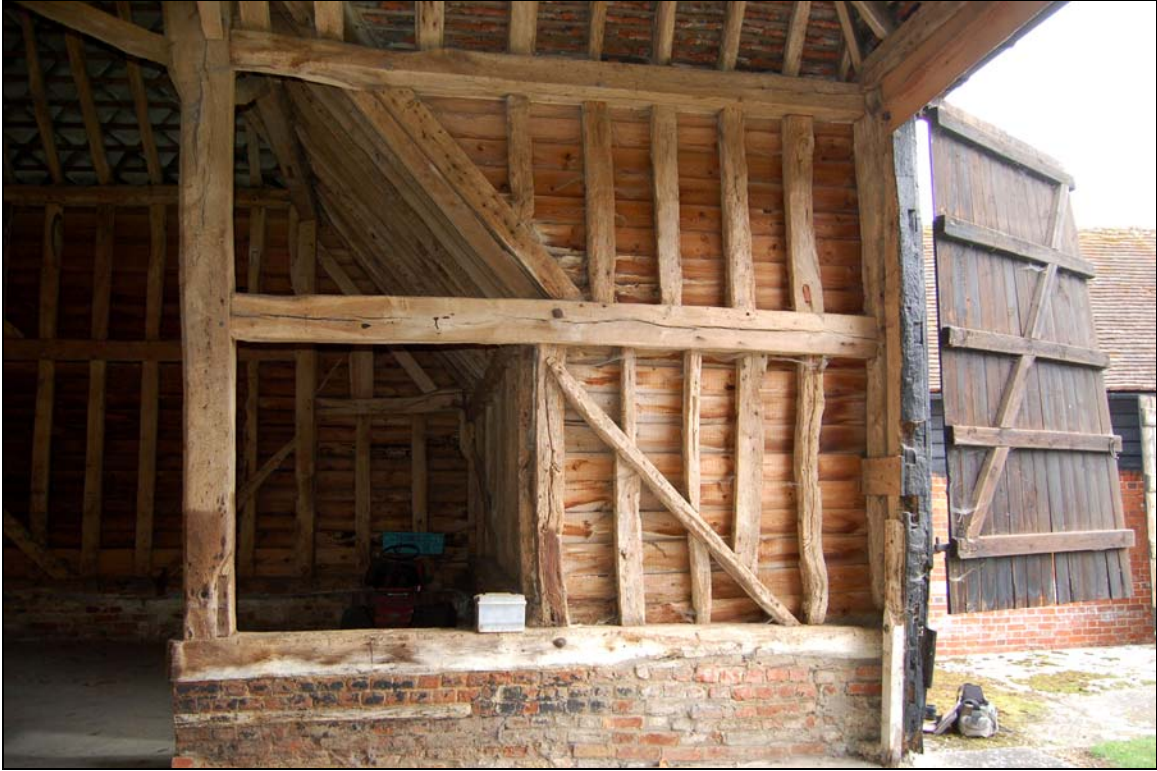
The east wall midrail is replaced and double pegged to the arcade and corner post, with a forelock bolt securing it to the aisle wall (plate 11). The wall plate, also replaced, has single-pegging. Studwork on the lower register is rarely pegged and primary-braced, but may include former members and the brace itself is nailed to the wall post. Above, the studs have alternate pegging. An empty mortice hole on the corner post above the midrail belongs to the removed brace.

Plate 11 Midstrey east wall in barn 1

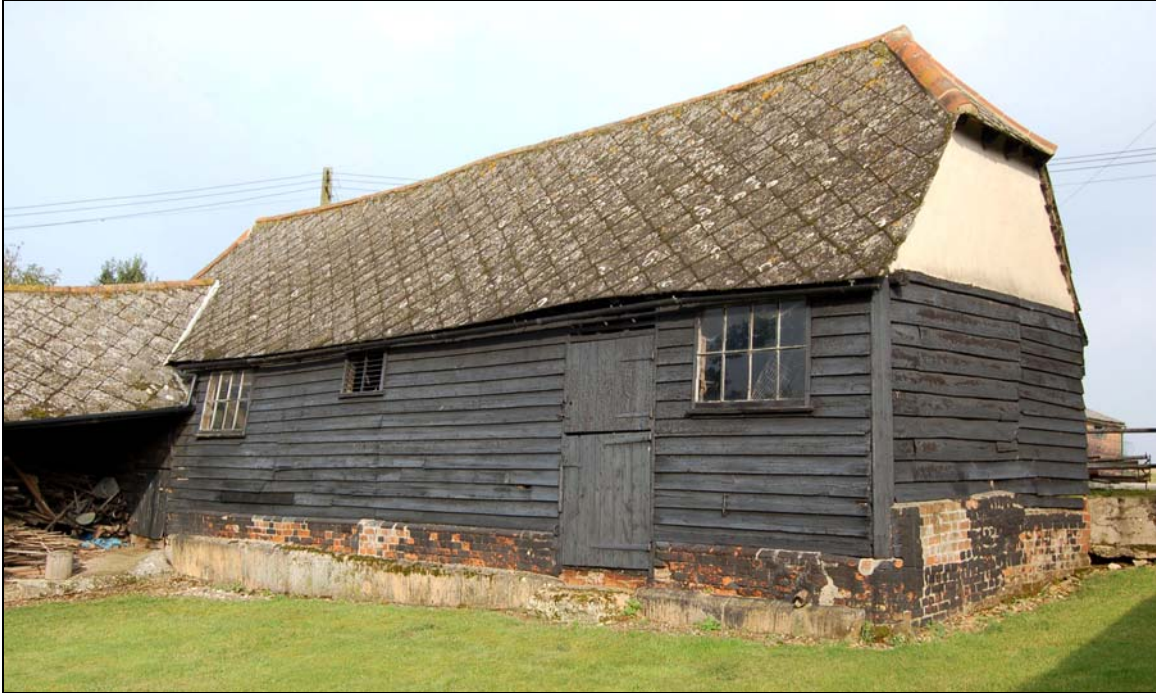
Plate 19 East elevation of byre 4

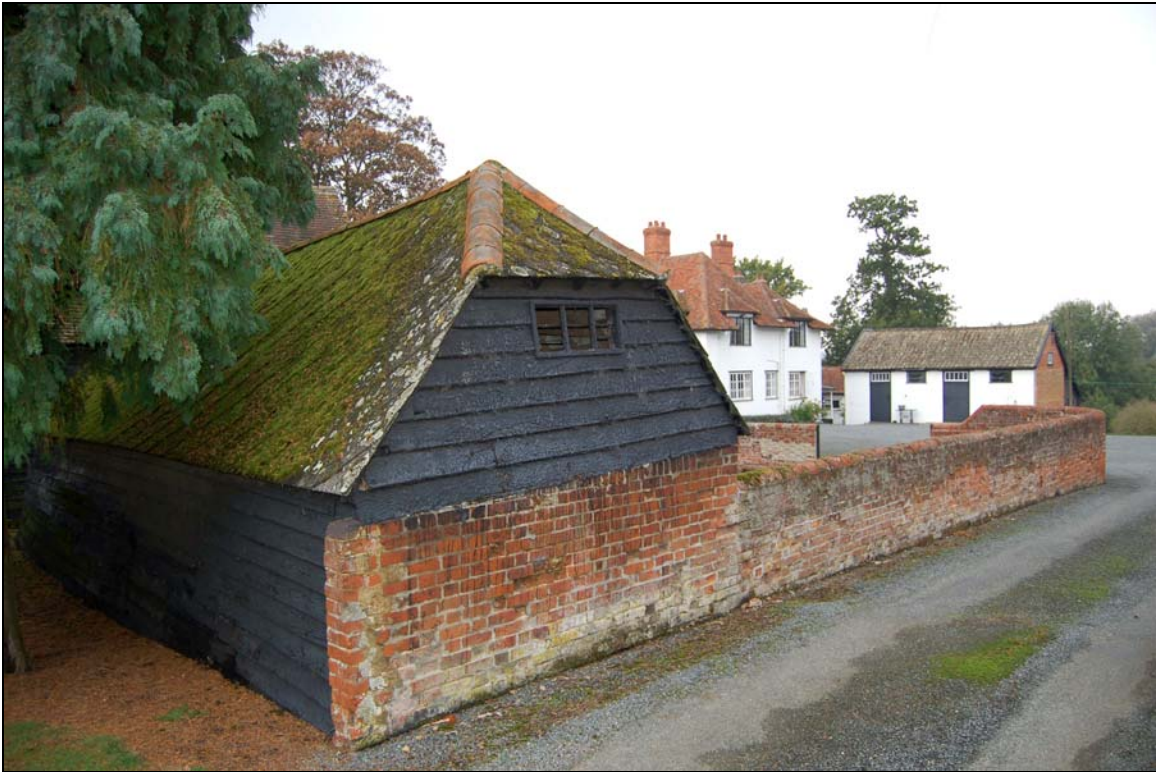
Plate 35 Under-built east wall of shelter shed 8 with stables 11 & farmhouse in background

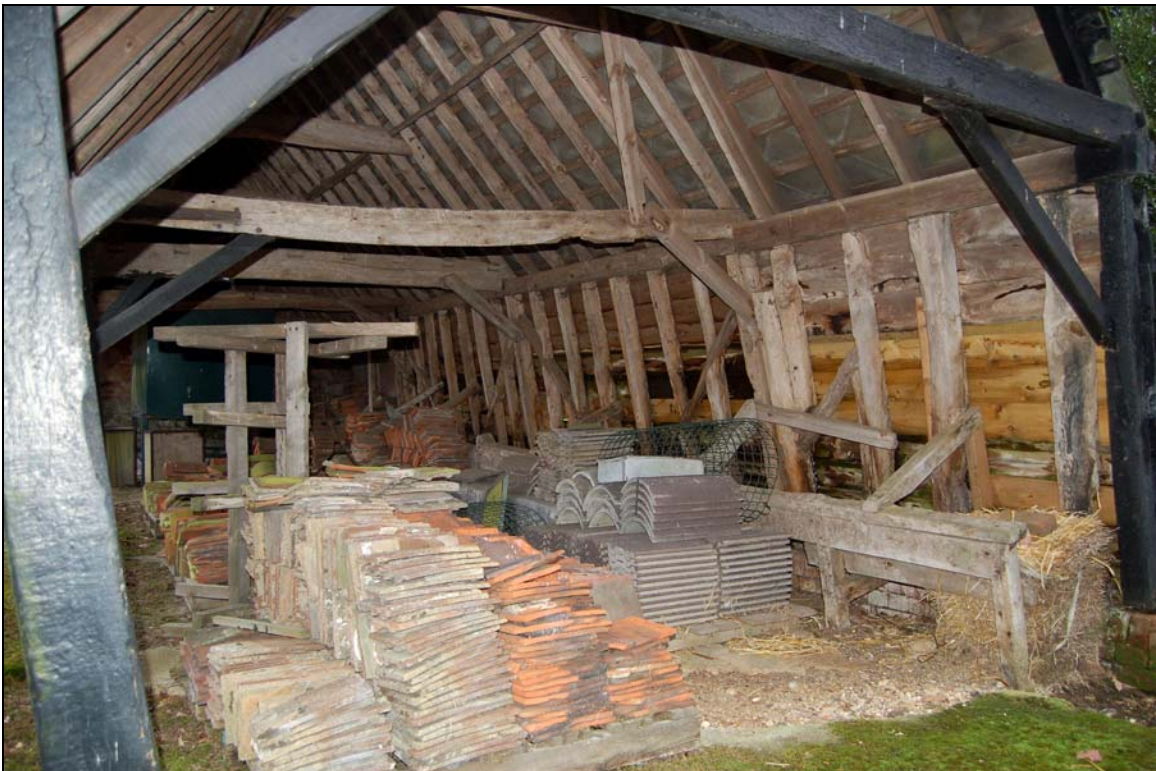
Inside, the main construction is different to the other sheds. The west bay was originally partitioned off, evidenced by empty mortices on the tie beam soffit, to form a separate stall or storage area. By 1920 the front had apparently been closed off, according to the OS map from this date (not illustrated), but there are no signs of this today. The concrete yard area extends inside into both areas. The main framing is basic, with strapped tie beams and pegged straight bracing, mainly replaced to the rear with nailed secondary bracing (fig.18a, plate 36). There is much reused timber, both in the main frame and exposed rear wall. High levels of reuse is a characteristic of the earlier farm buildings and it is possible this may date to the late 18th-century, but no earlier. Framing on the east bay is hidden by cock-bead boarding (Watkin & Watkin 2007) that would have also lined the partition wall. A low feed trough, suitable for cattle or sheep (Watkin & Watkin 2007) is located on the rear wall up to the partition, and was truncated on the west side when this bay was removed (fig.16 & plate 36).

Plate 36 Interior of shelter shed 8 viewed to east from missing bay

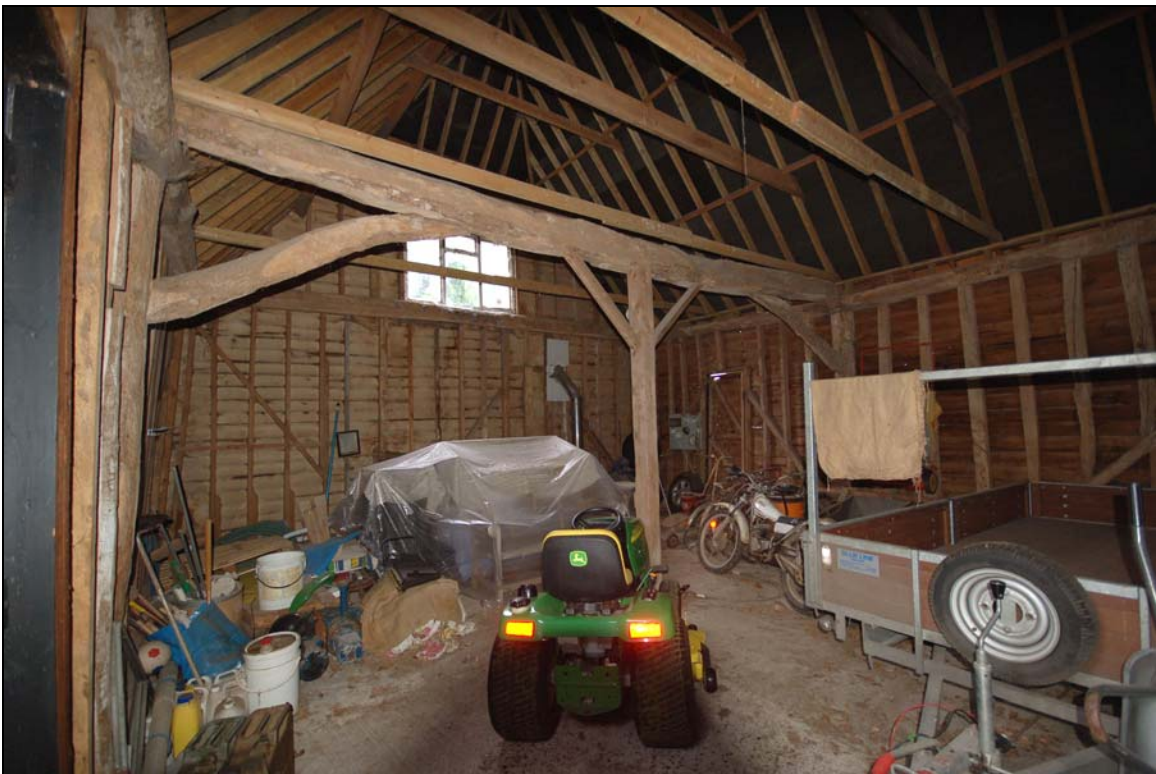
Plate 38 Interior of machine store 9 showing in-filled south wall

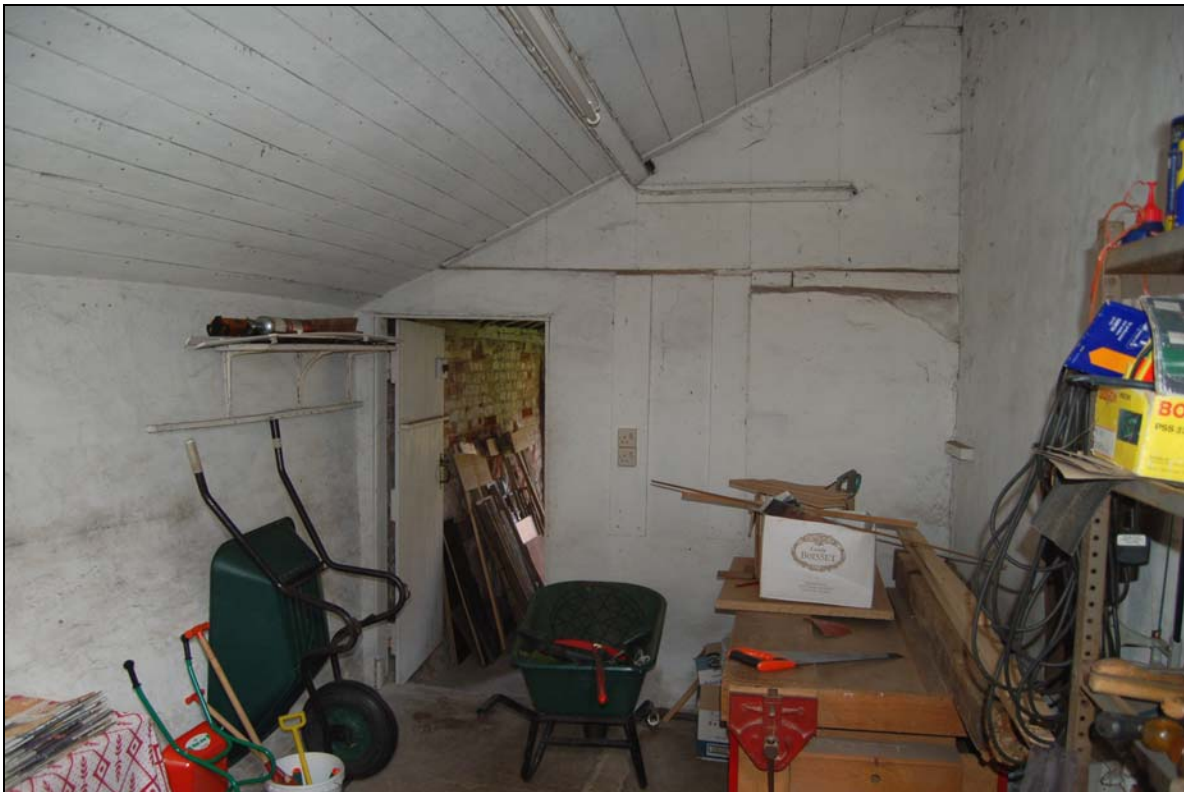
The interior of the outshot is also lime-washed. It is divided into two parts by a thin stud partition into stores on the east side and workshop to the west. The workshop is believed to have formerly been a dairy (plate 46), and there is an in-filled drainage channel running along the middle of its concrete floor and under the external door to perhaps corroborate this. Walls and ceilings are plastered and boarded. The wall on the opposite side (east) is later stud infill, suggesting this side was open below the wall plate (fig.19). The dividing door has a test-tube rack on the dairy side of the door and below the shelf beside it (plate 46) that would presumably have been used to hold milk samples.

Plate 46 Interior of former dairy viewed to east
