**HOE MILL BARN
WOODHAM WALTER
ESSEX**

HISTORIC BUILDING RECORD

May 2008

FAU Project No.: 1836

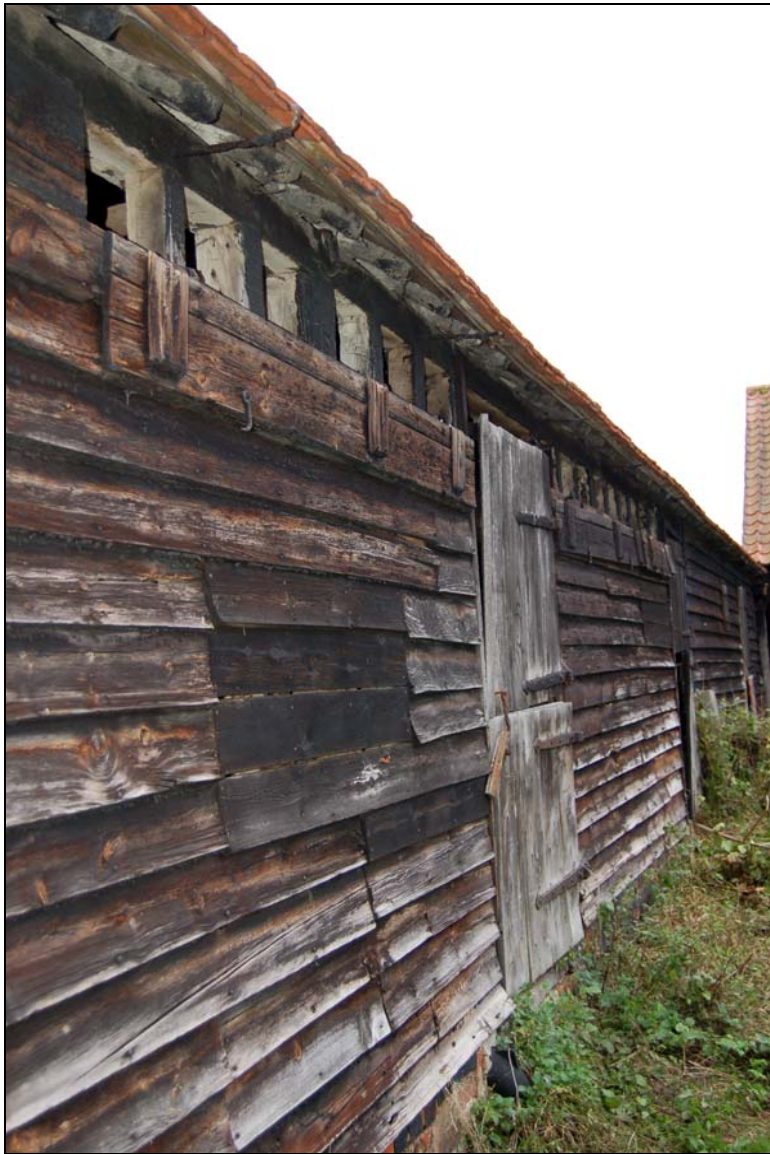
Half-heck ledged, braced and battened stable doors are located on the south elevation, facing onto the yards, one for each of the three stalls. They are held on round and spear-

headed wrought iron pintel hinges, common on all openings (vents and hatches), with looped barley-twist latches (plates 5 & 6). The only access point onto the road is a low (0.5m) door in the north-east corner of the aisle (fig.4), probably an easy way of bringing in food or bedding.

Plate 5 Detail of air vents on south elevation of stables

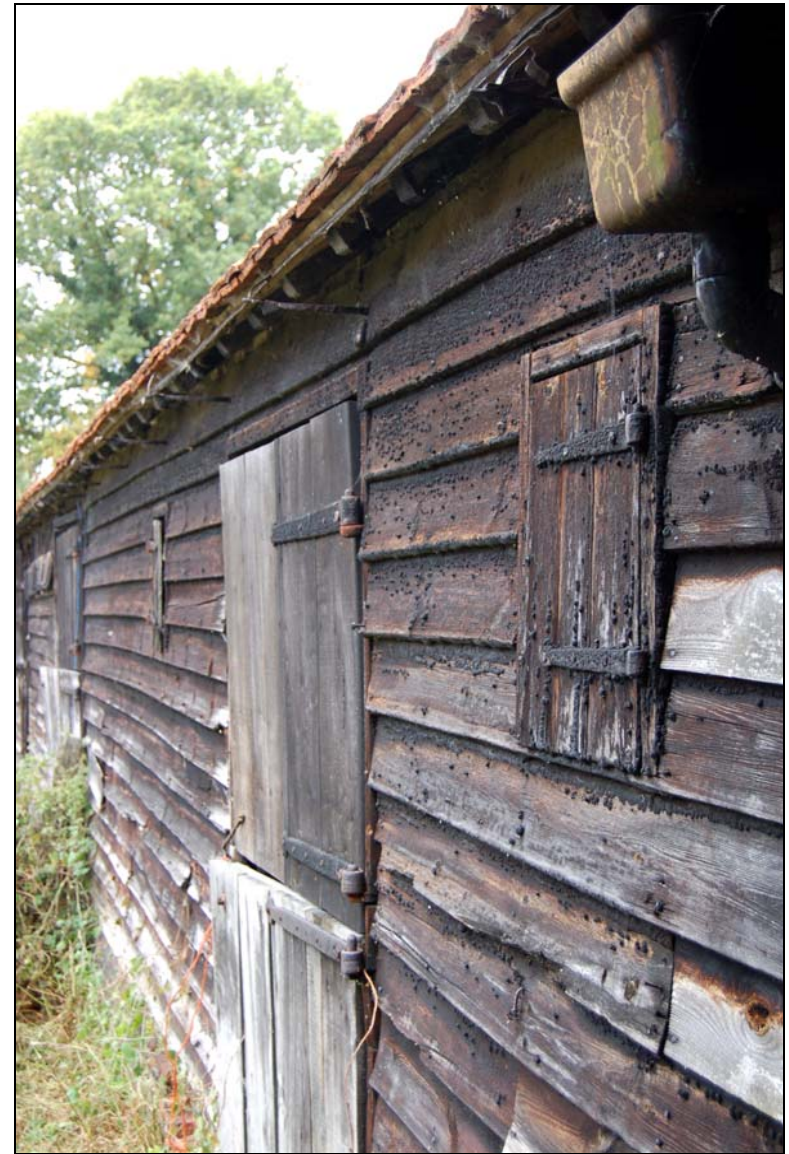
The main walls are timber-framed and primary braced, clad in 6" weather boarding. Only the main elements are pegged, i.e. posts and braces. Pitching hatches are set high up on the end gable walls, to west and east, and the porch, to toss in bedding straw and hay for the horses (plate 3). Along the long walls are vents under the eaves for each of the three main stalls inside (fig.4). They have narrow, hinged, boarded covers that could be raised to close-off the vents (plates 4 & 5) and are secured by hooked iron catches. Where there are no vents, there are small hatches instead (fig.4). Both features would have let air and light into the interior. Long spear-headed fixtures extend out from the wall plates at regular intervals, formerly to hold guttering linking to a surviving drain hopper and down pipe on the south-east corner of the building (plate 6).

Plate 6 Detail of hatches and door fixtures on south elevation of stables

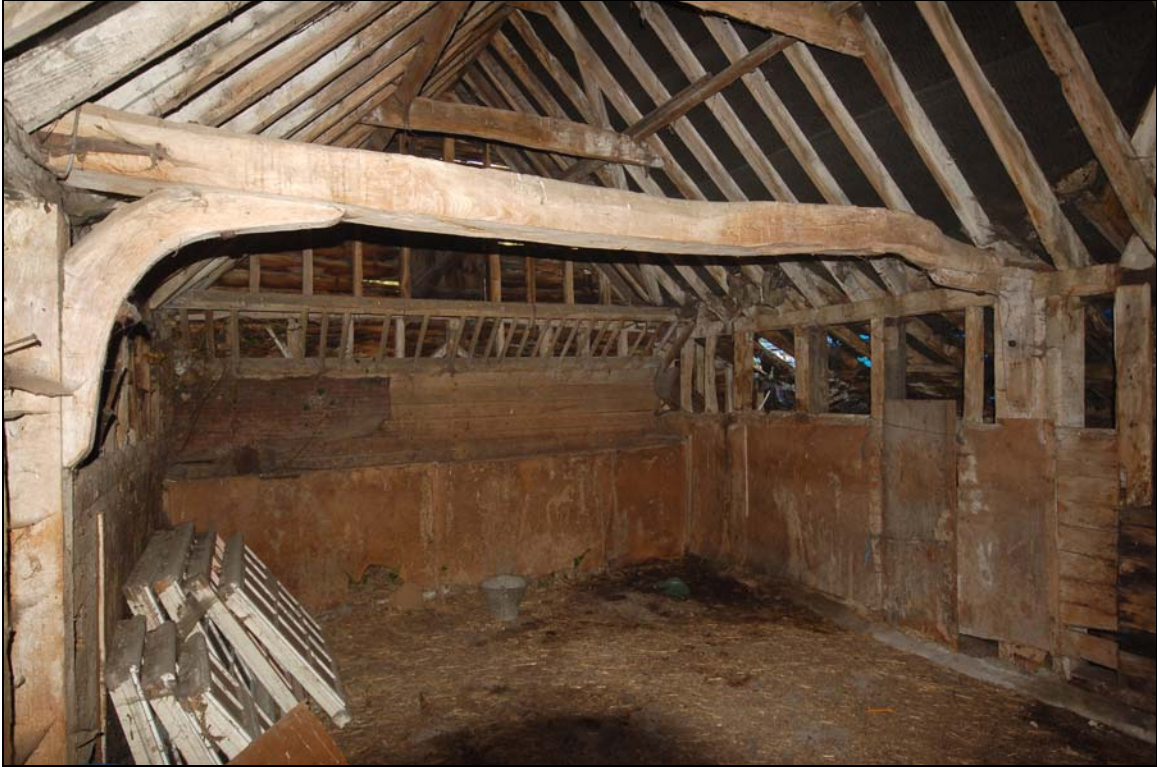
Stall A (plate 7) is the largest of the three. The trough and hay feeder stand on the west side, in front of the pitching hatch. On the north side is a blocked doorway into the west side of the aisle, where the ponies were probably kept. To the east of this is an original door into the porch (fig.4). The open framing above the panelling on this side would have been useful in circulating air, but only features in this stall. The porch frame is not jointed to the rafters of the main build, but in a small building like this it is not uncommon.

Plate 7 Interior of stall A viewed to west

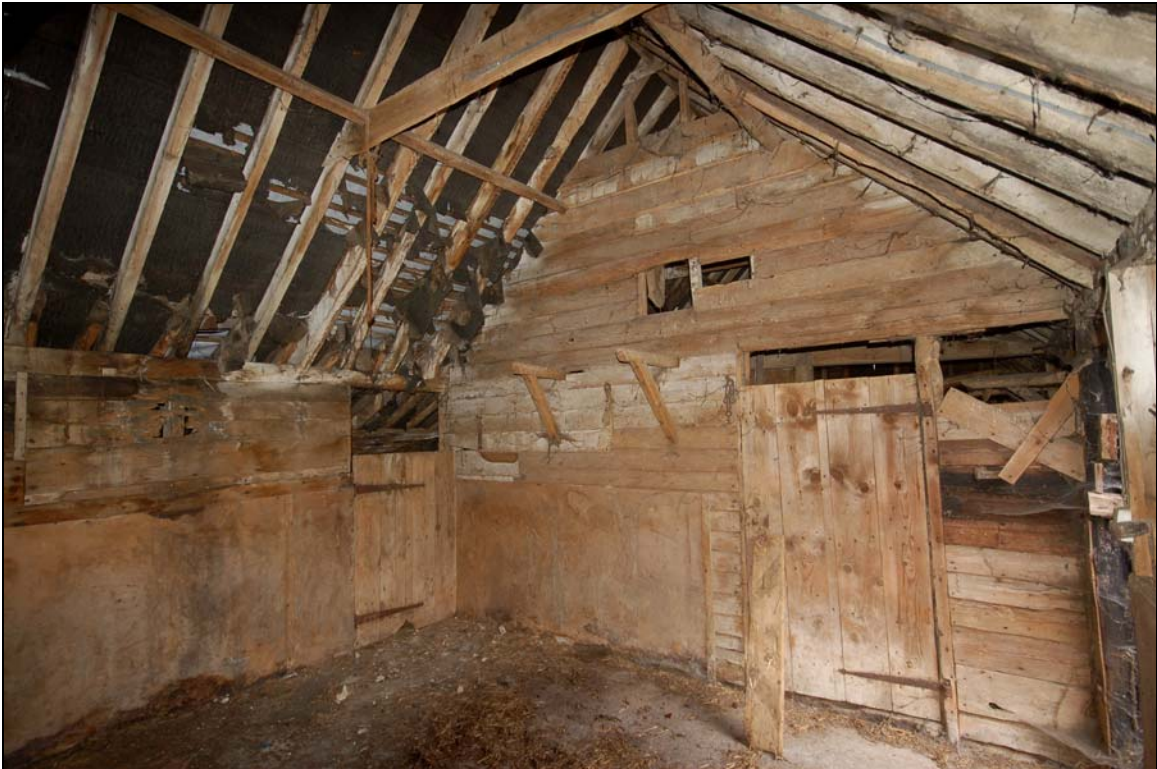
Stall B (plate 8) is the shorter central stall. It too has a feeder and trough on the west wall and a doorway into the eastern aisled area. A second doorway to the east leads into the

Plate 8 Interior of stall B viewed to east

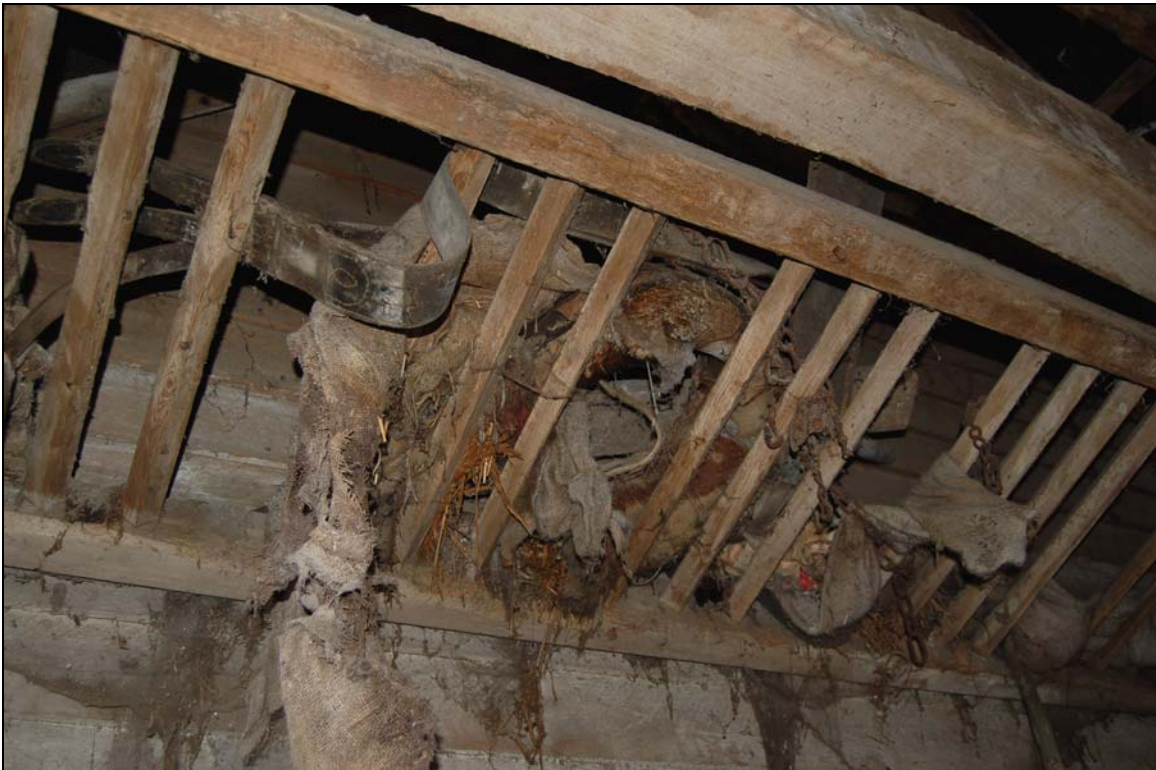
chaff/bedding store (plate 8). Both this and the opposing wall are weather-boarded. Two further saddle racks are placed on the east wall. Several items of tack (Zeuner 2004) have been left on the floor beside the trough and in the hay feeder. The first is a saddle from a shaft harness (plate 9) and the second is a badly decayed halter (that fitted around the horse's neck) stuffed with straw amidst various harness straps and chains (plate 10).

Plate 10 Degrading horse halter and harness straps and chains in stall B hay rack

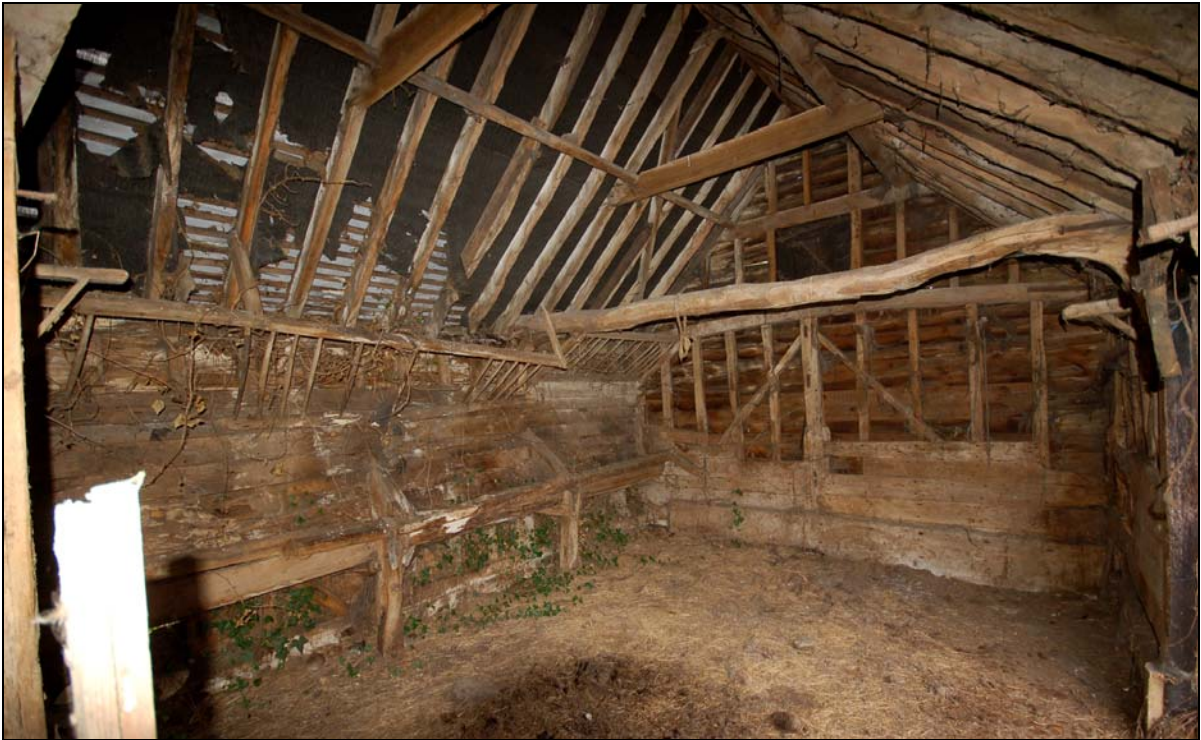
Stall C (plate 12) has a relatively low trough and hay rack on the north side. Both have suffered from damp coming through the stripped roof, at the aisle join. Two iron tethering rings are attached to the trough face and three saddle racks are located on the walls (fig.4). By the outside stable door is an area of exposed cobbled flooring that would have been common to the other stalls before being replaced with concrete.

Plate 12 Stall C viewed to north-east

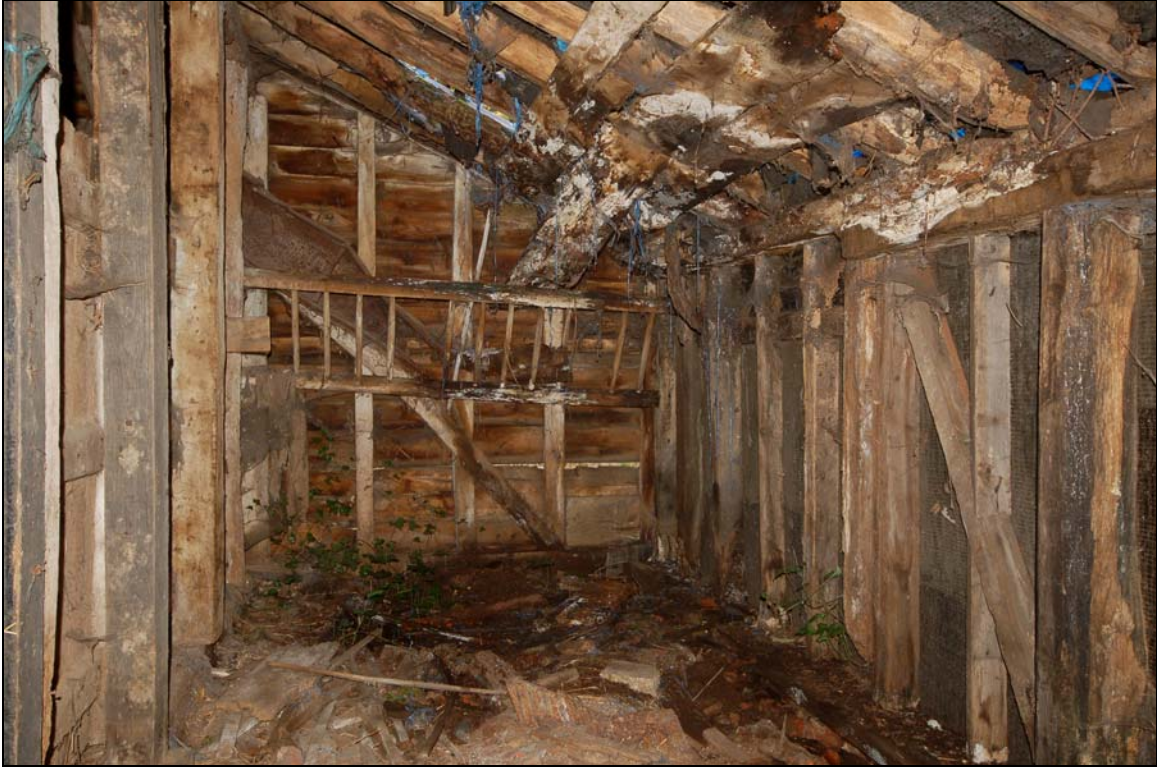
The western aisle (plate 13) is separated from the porch by an open-studded wall frame, with enough space for a door. Presumably this was once boarded like the other walls. The interior is damp and the timberwork rotting and falling away, making it unsafe to enter. The floor comprises bricks laid on-edge, with 1" gaps between them for drainage. Rotted 9" sarking boards litter the floor towards the west end, which have fallen away from the rafters. A low hay rack is located at the west end, standing half the height of those in the stalls at only 0.9m, and seemingly fed by a corroded iron chute (plate 13). Part of the north wall appears to have been rebuilt and the aisle roof felted at a later date.

Plate 13 Hay feeder set for ponies in western aisle of stable

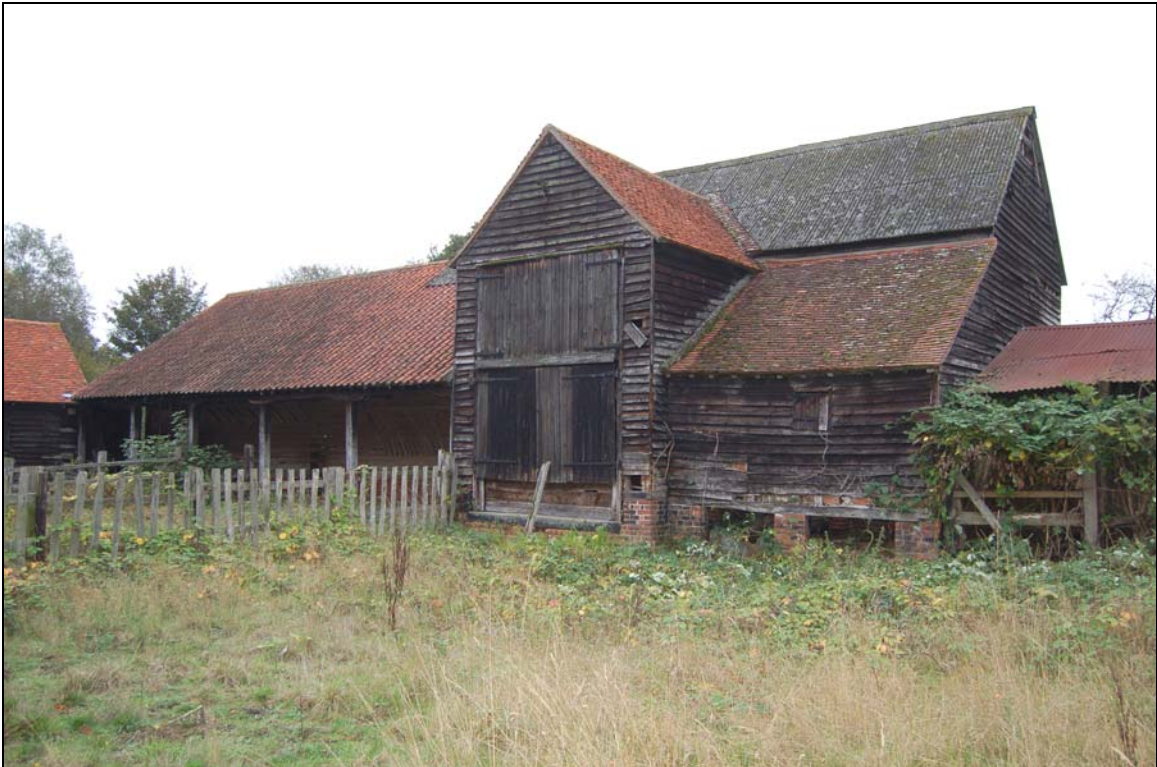
The barn is raised on a 0.7m-high 9-inch brick plinth that continues to the north, below the cowhouse, as part of an earlier building. Similarly, the weather-boarded exterior continues into the cowhouse at the back, showing the cladding has been replaced at least once since its construction. The roof is gabled to north and south at 45°, as is the porch. Corrugated asbestos sheeting now forms the main roofing material but previously plain tiles were used, some of which remain on the porch and granary (plate 16).

Plate 16 West elevations of cowshed and barn

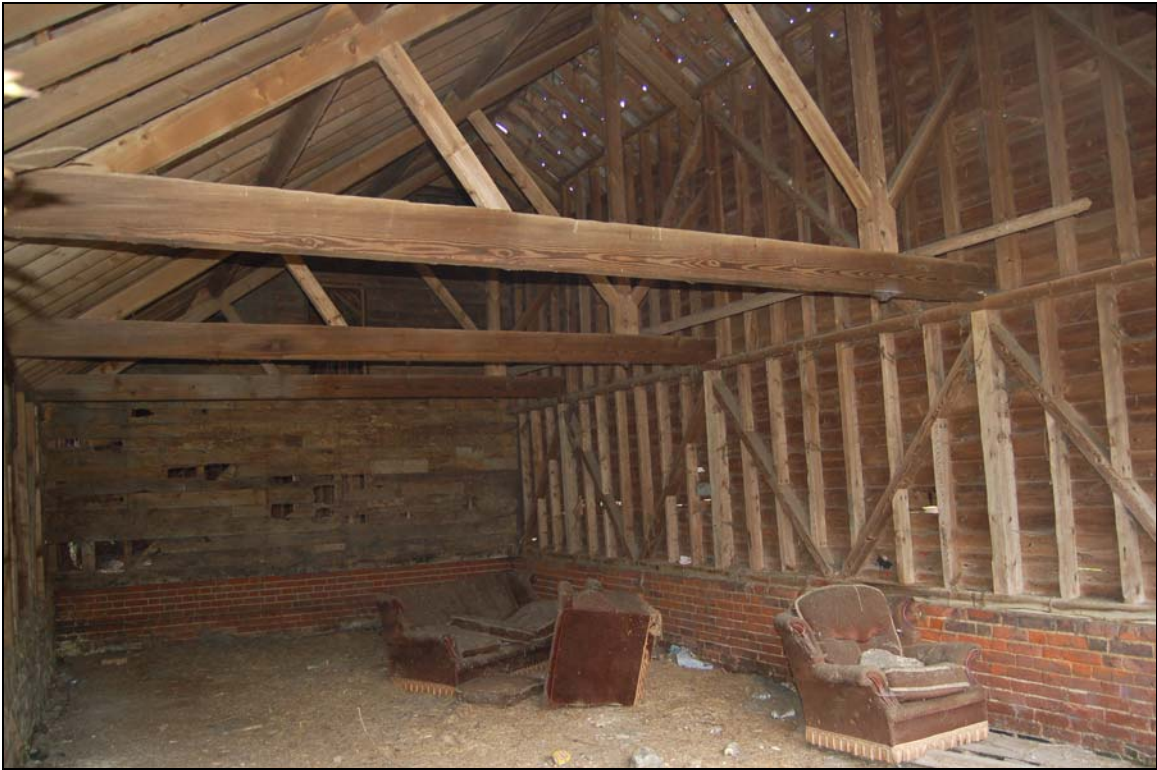
Inside, the structure consists of machine-sawn primary-braced softwood frame, rather than the quirky hand-sawn timbers observed in the stables and other buildings. Only the posts are pegged. There are 3½ bays, divided by king post strut trusses kept in vertical tension by bolted iron rods (plate 17).

Plate 17 Interior of cowhouse

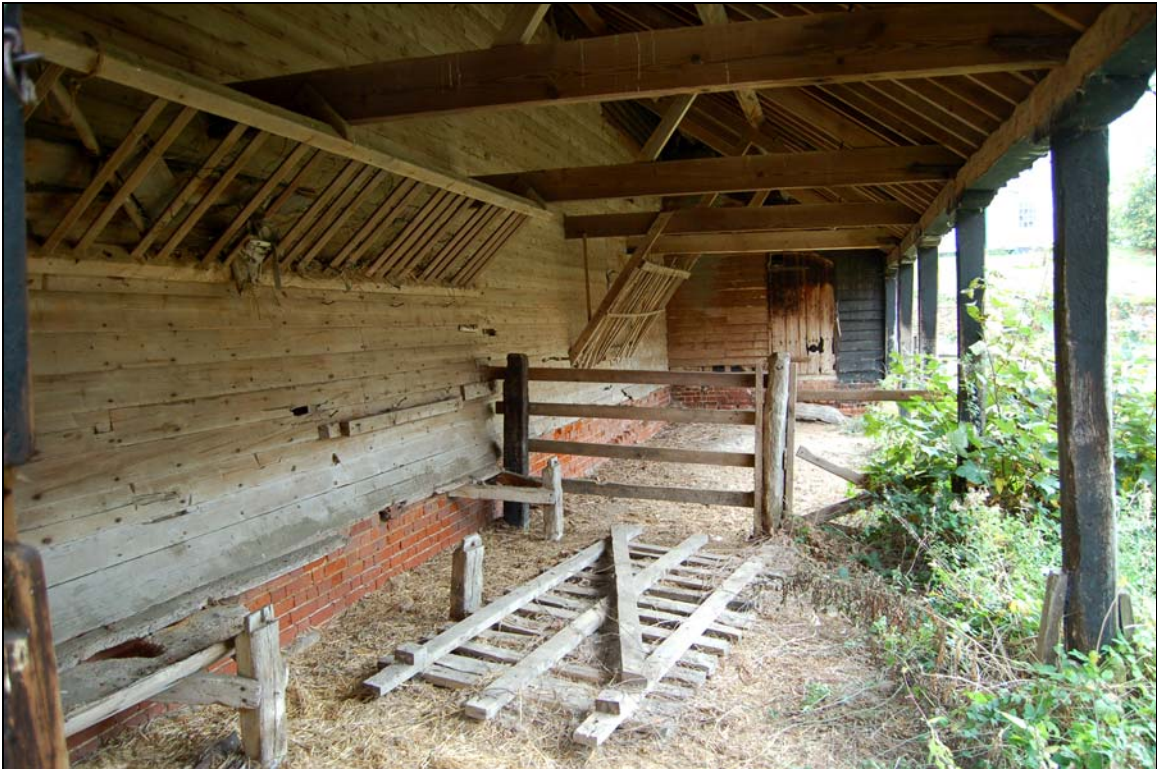
The cowshed has an open west side supported on earth-fast 6 inch-wide wooden posts, encased in modern concrete bases. The interior (plate 18) is linear in plan form and divided into five c.2.5m-wide bays by the wide trusses extending from the cowhouse and an extra short truss attached to the frame of the barn (fig.5). The two north bays are separated by a wooden fence that continues into the yard, to divide the two smaller yards facing the shed (fig.1). Both sides have hayracks, though the northern rack is set higher, with the southern one possibly set low for calves. The remains of the trough at this end are set quite low, again suggesting that it was set for cattle (plate 18). Only the rear part of the trough remains in

Plate 18 Interior of cowshed showing outline of former barn outshot

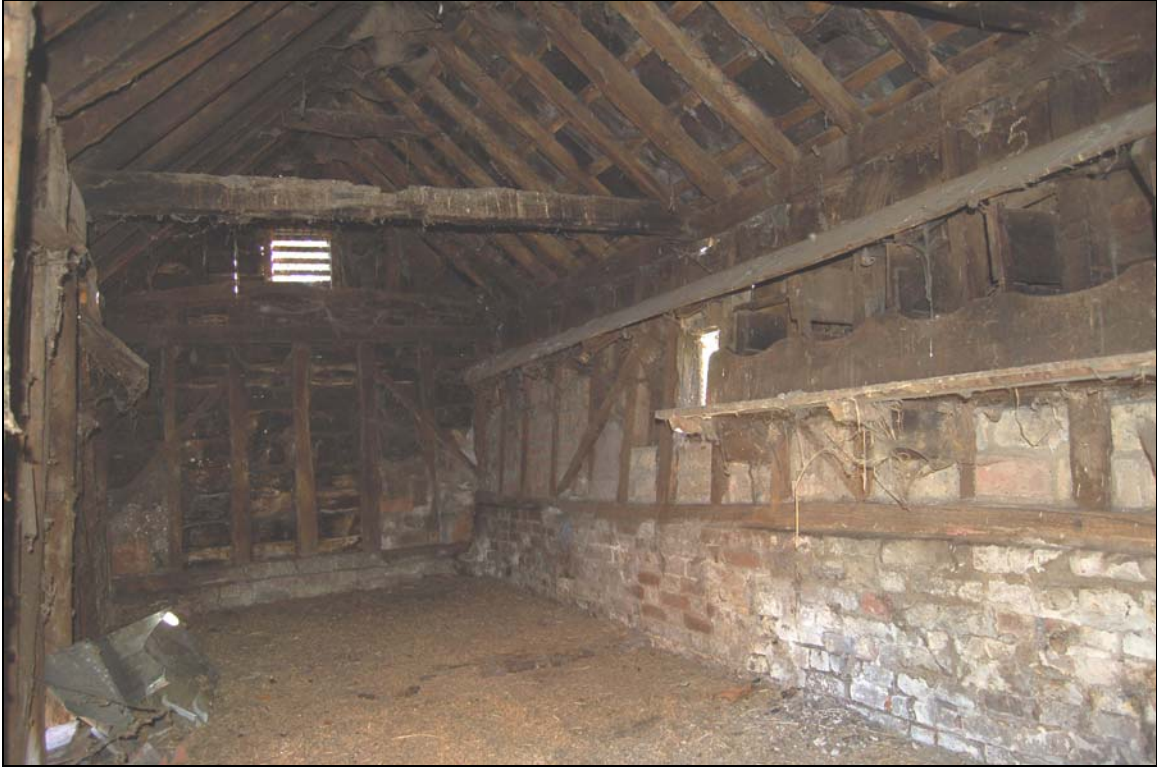
The interior (plate 25) has a brick floor covered with straw and wood chippings as chicken litter. Bricks have been mortared between the wall-framing, for security and insulation. Most posts are pegged to the wall plates but otherwise nailed and tenoned. All timbers are stained and the plinth lime-washed to help limit the spread of infection. Many of the timbers are

Plate 25 Interior of chicken coop viewed to east

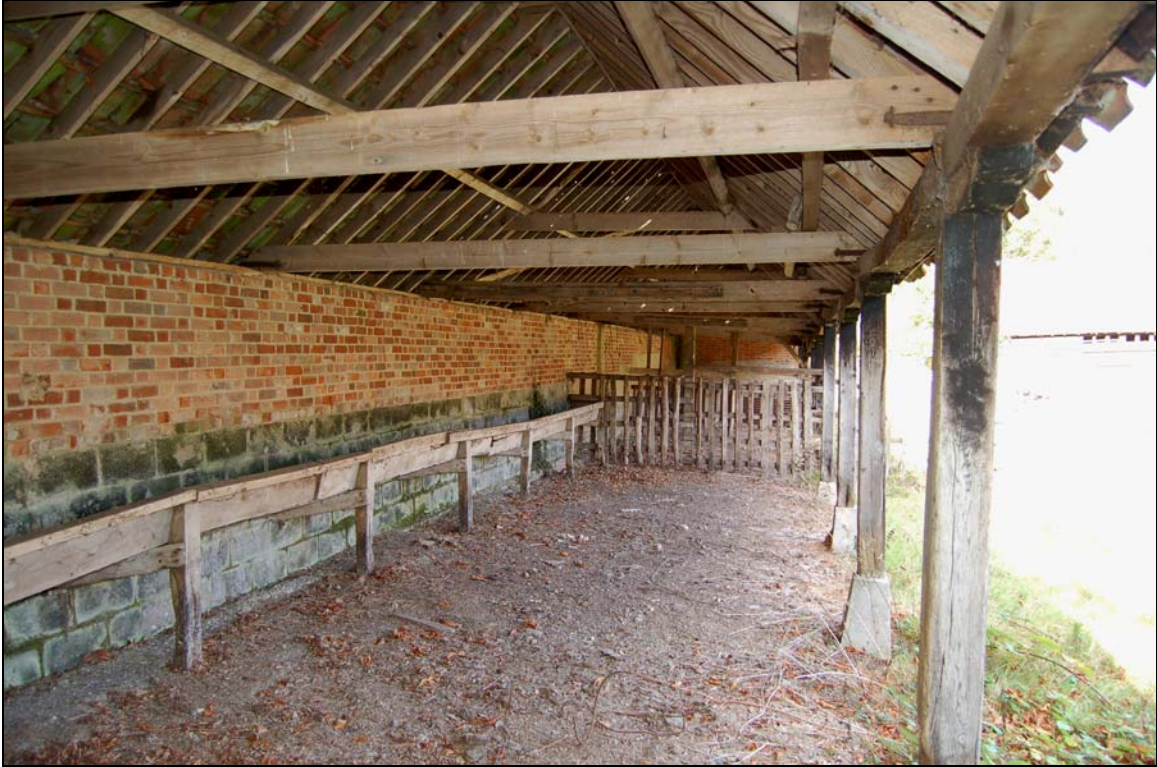
Inside, there is an earth floor and trough on the rear wall. A central partition continues beyond the shed as the main north-south yard division (fig.6, plate 27). The four bays to the north of this are further fenced-off into two, two-bay compartments, whose apparent lack of feeding apparatus suggests a different function, perhaps as cart sheds. The end bay is railed-off at the side and front (fig.6) to form a smaller enclosure. Here, the presence of a partial trough frame suggests this functioned as a loose box, away from the main herd at the southern end.

Parts of the roof are sagging at the front where the wall plate has failed due to the weight of the roof and weak connecting joints, which are lapped rather than properly scarfed together.

The pantiles currently cladding the 45° roof are later additions that probably replaced much lighter pegtiles.

Plate 27 Interior of shelter shed viewed to north
