**UNWINS FARM BARN, SPAINS HALL ROAD  
FINCHINGFIELD  
ESSEX**

**HISTORIC BUILDING RECORD**

**Essex County Council**  
Field Archaeology Unit

**August 2008**

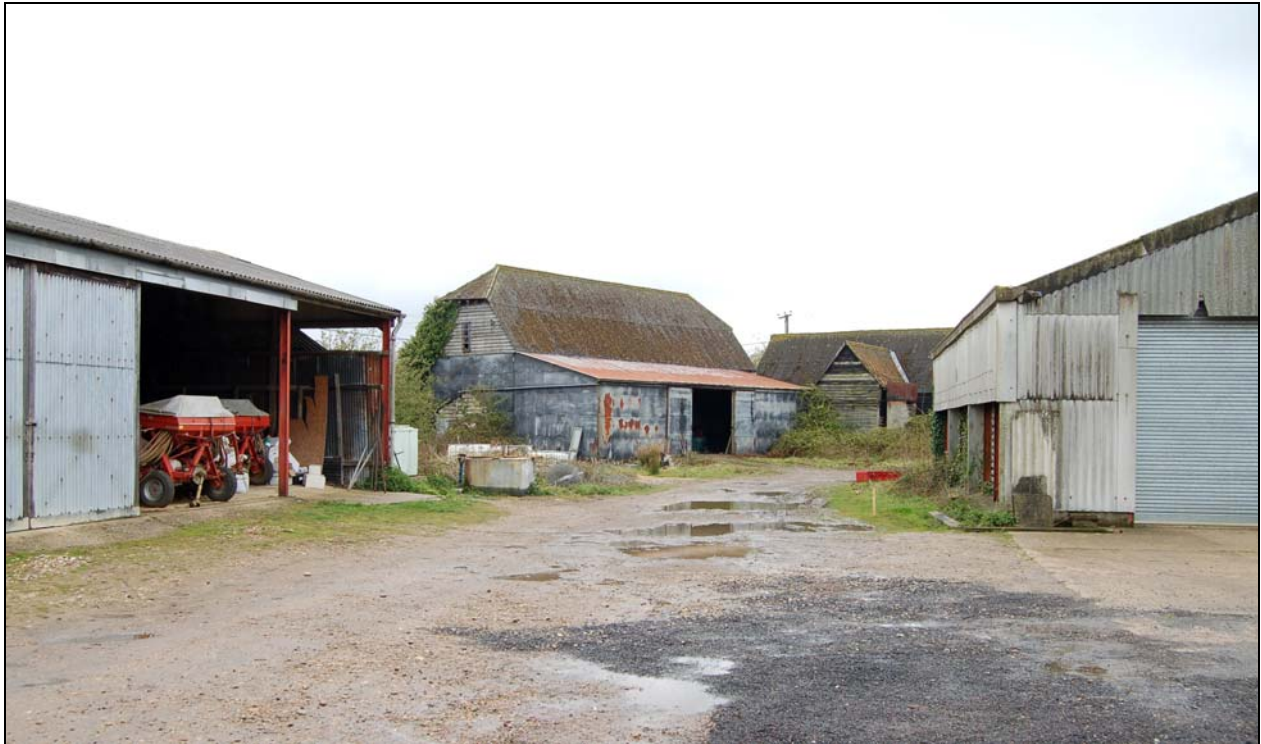
surrounds the outline of the former 19th-century shed (plate 1), confirming its relatively-recent demise. Above it is a modern steel window inserted into a former pitching hatch (fig.5).

Plate 1 Modern farmstead viewed from road

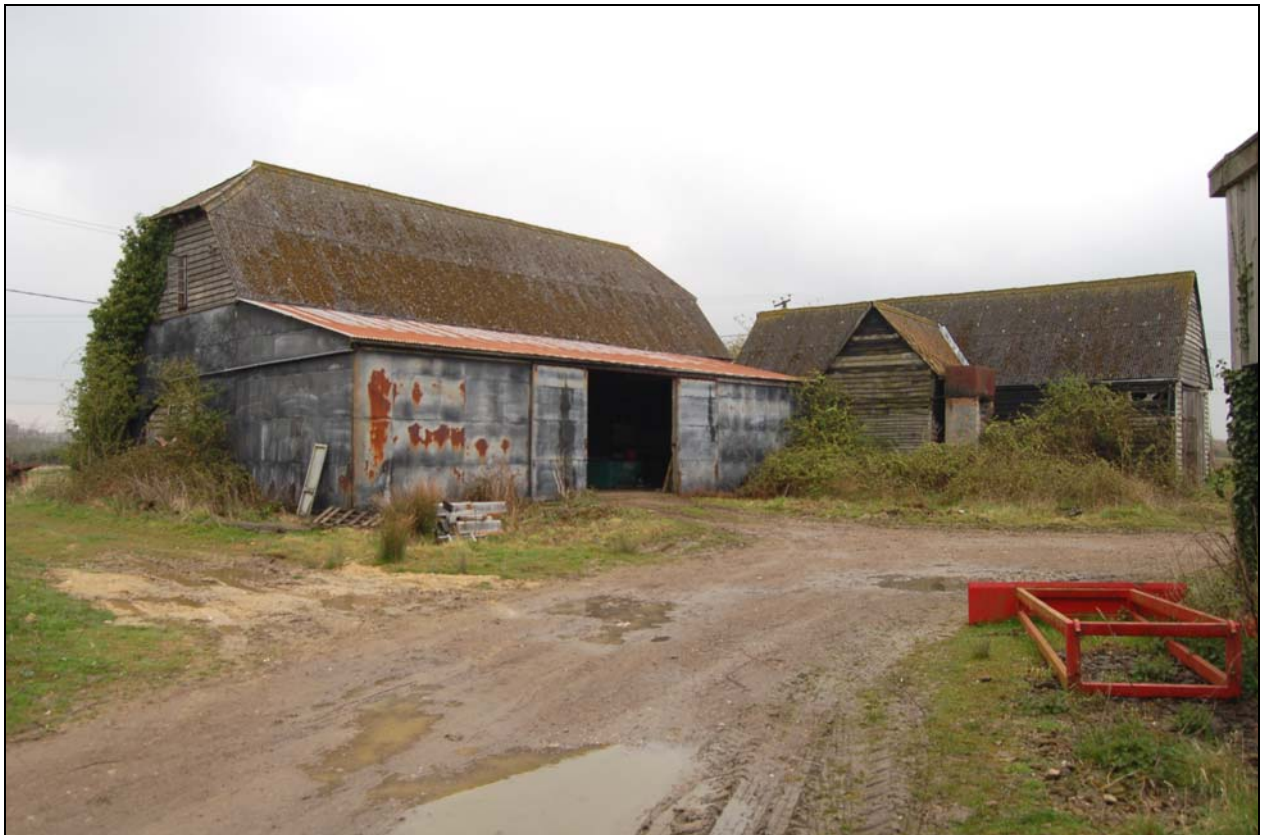
The two barns (plates 2 & 3) are joined by a large modern shed and overgrown with vegetation, mainly brambles and ivy. They have brick plinths, timber frames and degraded weatherboarded exteriors. Basic repairs have been carried out to the exteriors that have kept the insides in fairly good order, especially barn 1. The roofs are clad in ubiquitous corrugated asbestos sheeting, a common feature of modern farm buildings.

Modern shed 3 is built onto the barn and completely conceals its southern elevation (plate 2).

Plate 2 Barns around the traditional farmyard

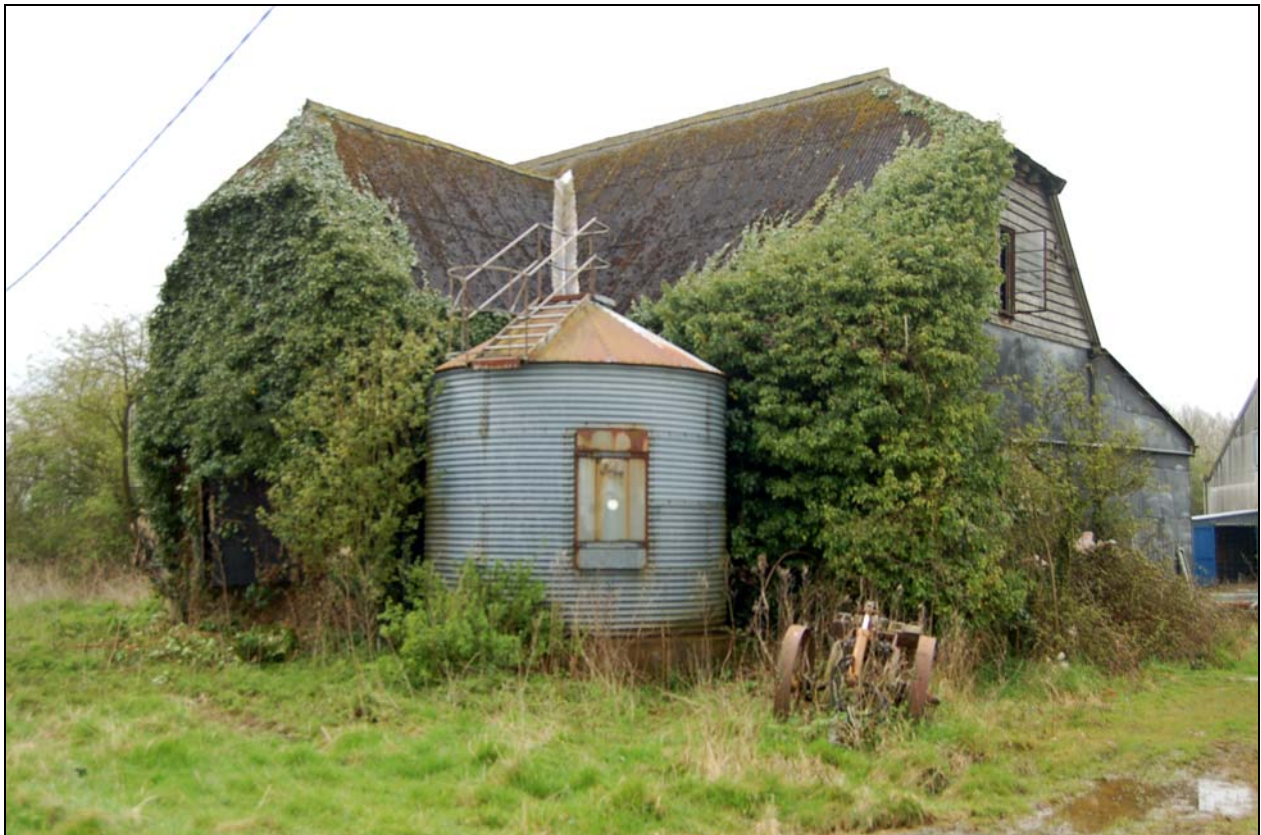
Ivy covers the porch and weatherboarding on the west side of the north elevation (plate 4). A cylindrical corrugated tin grain silo has been placed in front of the sealed side doorway into the porch (fig.5). The cart doors to the porch are set low on iron pintels and strap hinges and are typically ledged, braced and battened in their construction. This is the only intact door to survive. The threshold leap, used to create a through-draft for winnowing the grain, has been retained below and there are fixtures for door bars inside. Much of the weatherboarding on the other side of the porch is in a poor state and the lower part has been repaired in steel sheeting. Boards are missing above and openings have been cut through for modern air intakes (fans), hopper feeds and a steel window inserted between the studwork (plate 5).

Plate 4 Barn 1 viewed from north-west

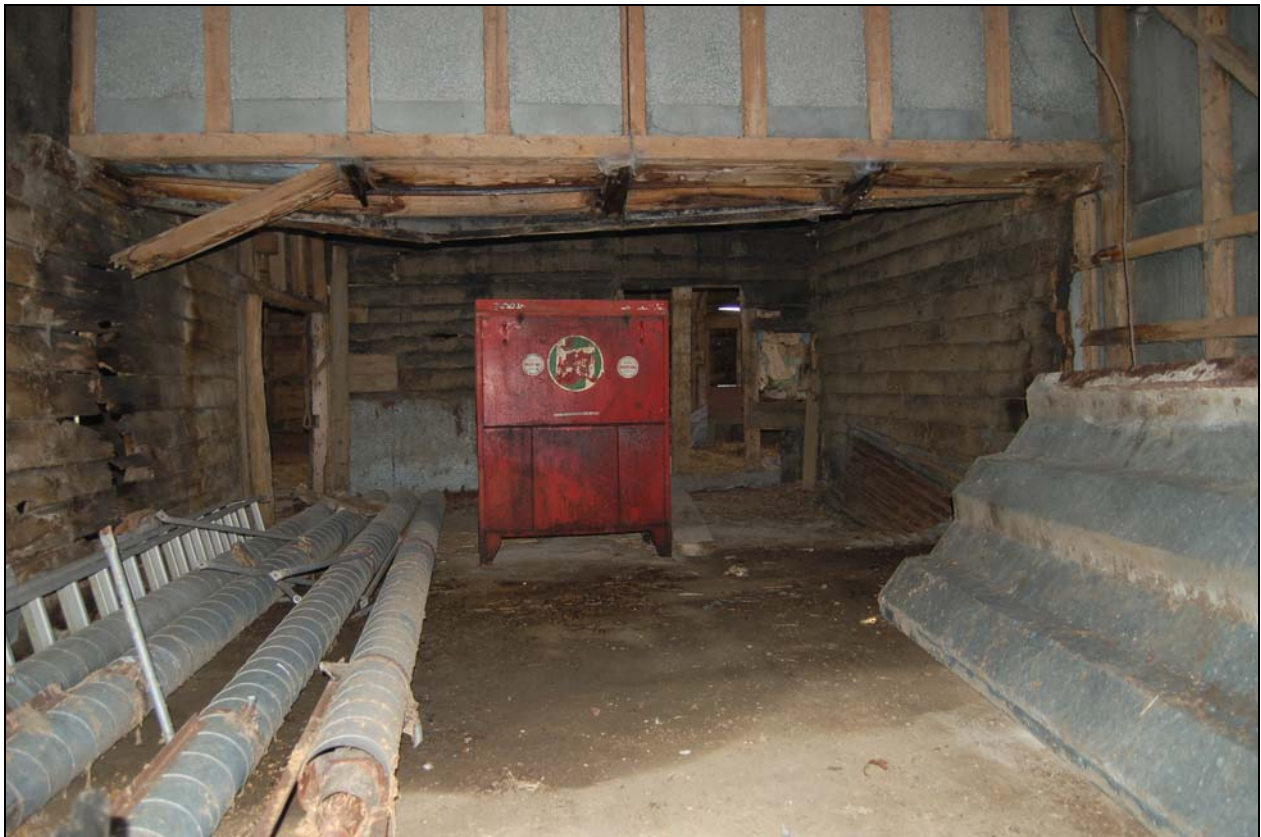
The unaltered eastern bay of the southern elevation (plate 7) has a connecting doorway into the threshing barn and a rotten wall plate to a possible former outshot shed to barn 2, on the north side of its porch, though there is no map evidence for this. This timber helps support part of the boxed-in area in shed 3 connected with grain storage or processing (plate 7).

The shed has been added during the past 10 years between the two historic barns to provide storage space for farm machinery and a sheltered entranceway into the grain processing area. It is built from steel sheets (same as those used to repair the barns) on a light timber frame, with a single-pitched corrugated tin roof that reaches across the front of barn 1 and to barn 2. Between the porch of barn 2 and facing wall of barn 1 an enclosed platform has been created, either to contain machinery or grain, whose timbers are suffering badly from damp (plate 7).

Plate 7 Interior of modern shed 3

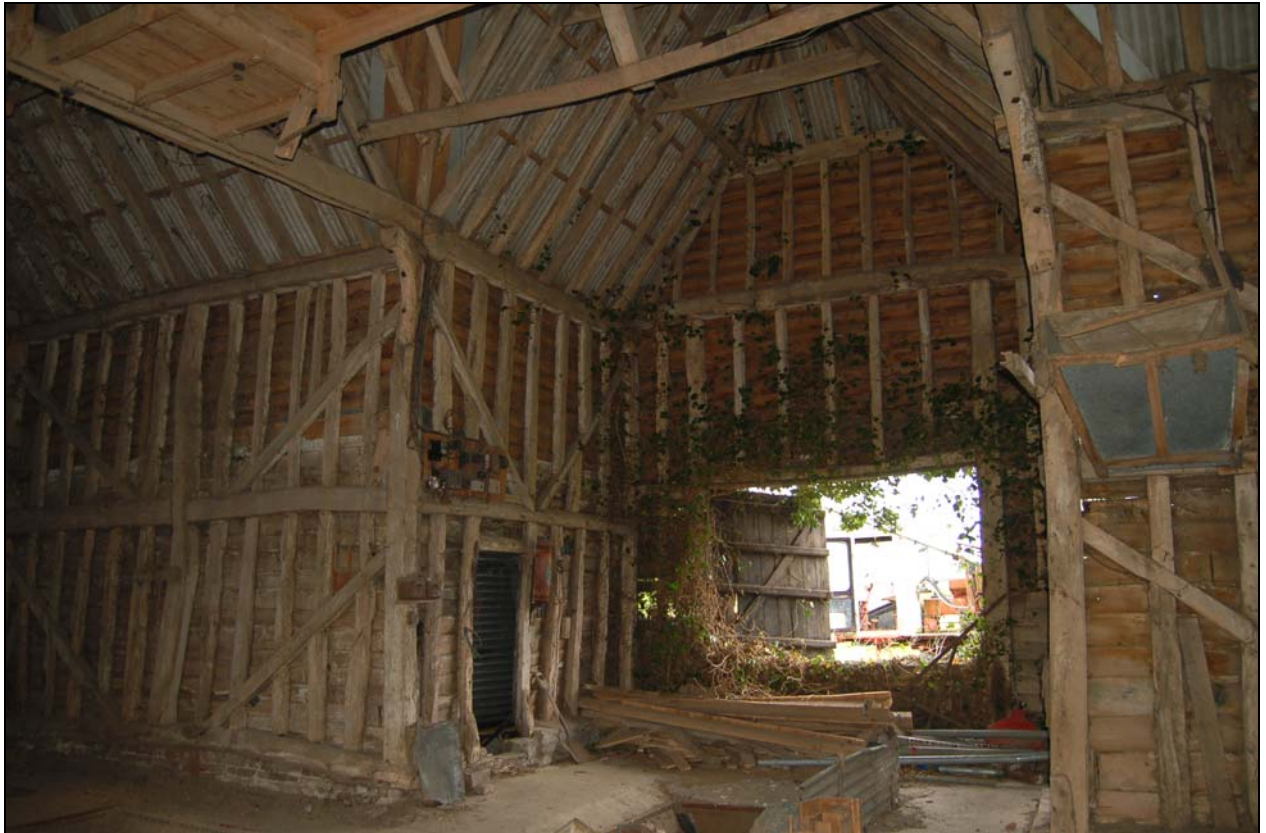
Porch framing is identical, but with single-pegged main timbers (plate 10). A chiselled assembly mark (XX) was found on the outer face of the north-east midstrey post (fig.5) where boarding has become displaced. Other marks will be exposed when the weatherboarding is removed, but no others were observed inside the building.

Plate 10 Barn 1 porch

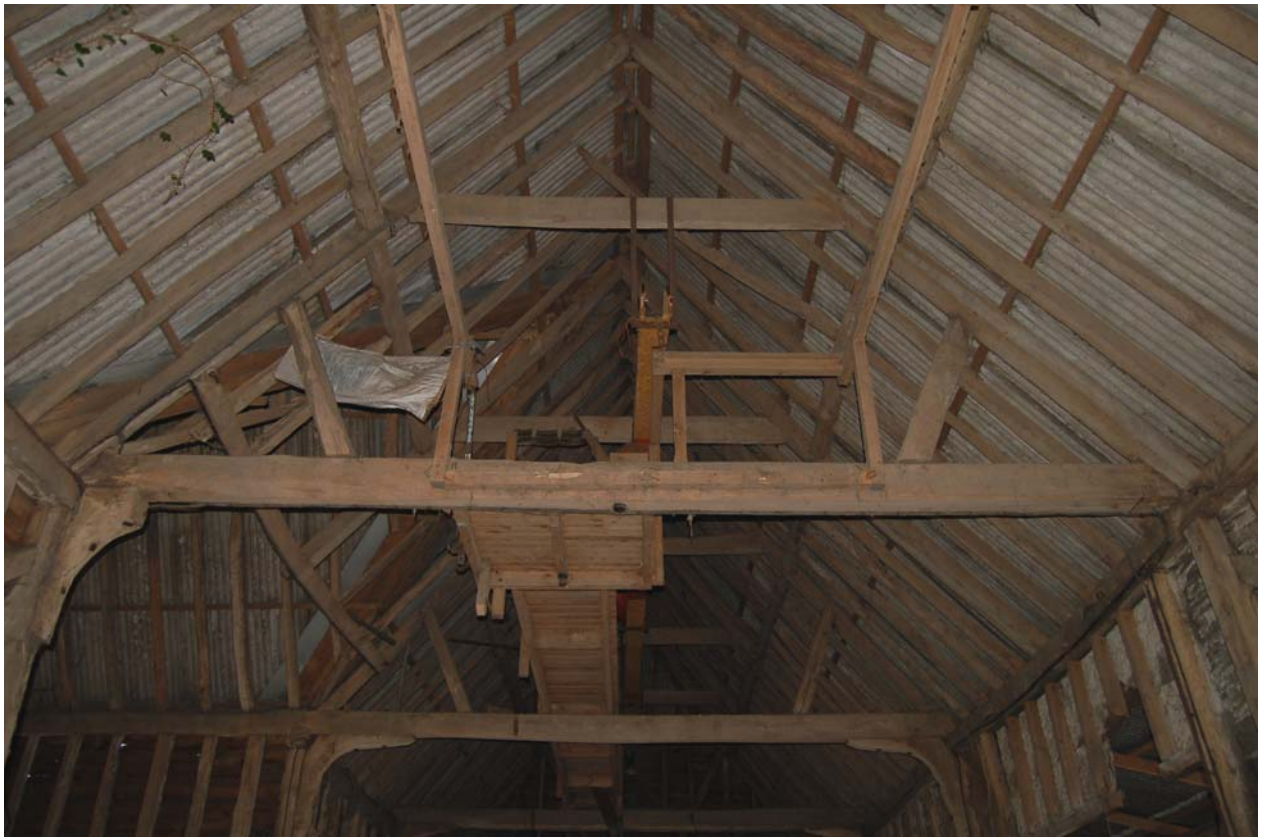
The roof is a butt-purlin type, developed in Essex in the 17th century but more common in the 18th (plate 11). There are wind-braces either end. The rafters are quite slender like most later butt-purlin roofs, but are tenoned to the purlins (or even notched) rather than individually pegged like in more impressive roofs. Running longitudinally along the tie beams are the remains of a dislocated overhead grain conveyor that transferred grain between the silos in the western bays, elevator in the porch and grain chute at the eastern end (plates 8 & 9).

Plate 11 Butt-purlin roof detail and grain conveyer inside barn 1

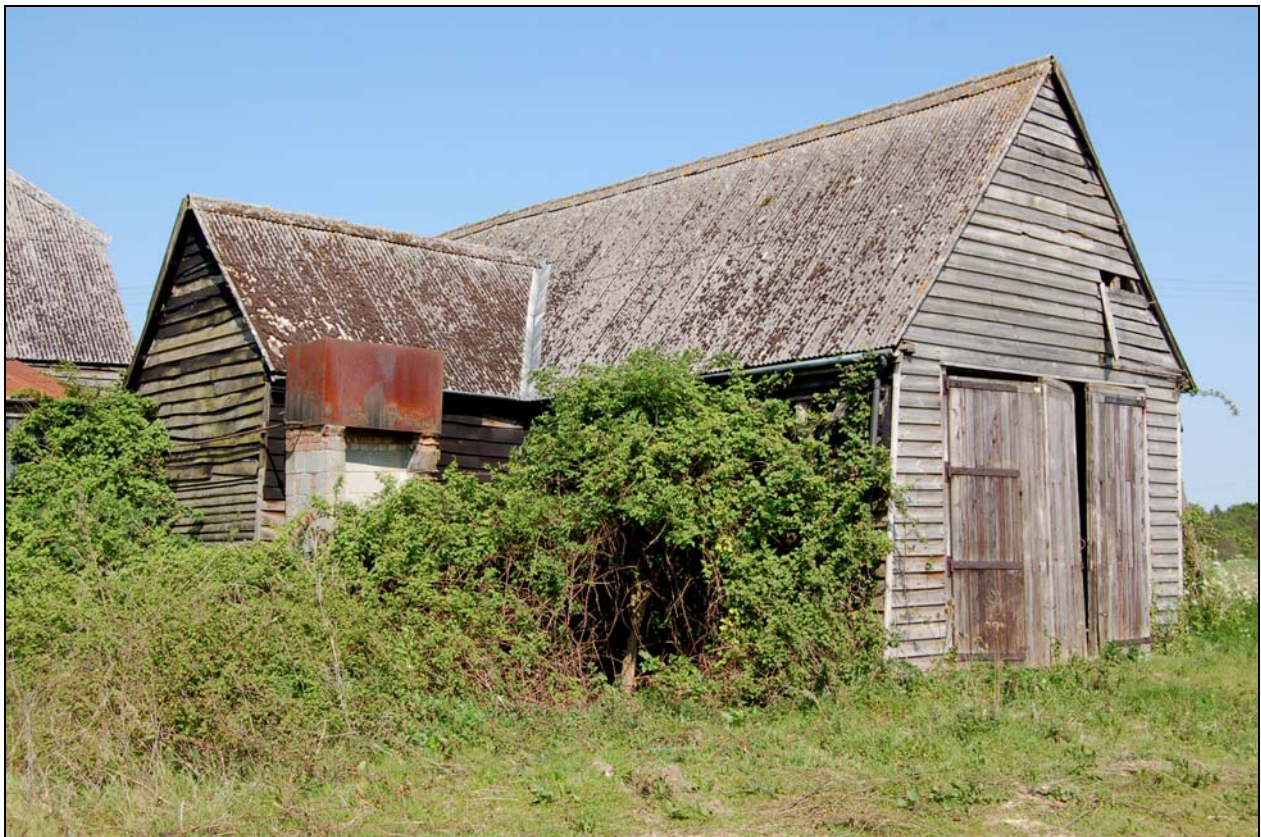
The western elevation (plate 12) is overgrown with brambles and partly obscured by shed 3 on the north side of the porch. Cartdoors to the porch have been removed and the opening sealed with modern studwork and boarding. A diesel tank stands in an elevated position, whose pipe runs into the upper studwork inside for filling farm vehicles. The two bays to the north are now enclosed in shed 3 (plate 7). The rotted wall plate to a possible outshot passes from the porch to barn 1 and part of its northern wall built up against barn 1 with a doorway between (plate 7, fig.5). A more recent opening has been formed by removing the boarding over two panels to form a crude doorway into shed 3 (fig.5, plate 7).

Much of the wall on the southern side of the porch is obscured by brambles (plate 12). The wall here is consolidated on a modern brick plinth, the former of which was probably damaged through past movement of the structure. The extent of this movement can be appreciated on the rebuilt southern gable elevation where the inserted folding door (to allow

Plate 12 Barn 2 viewed from south-west

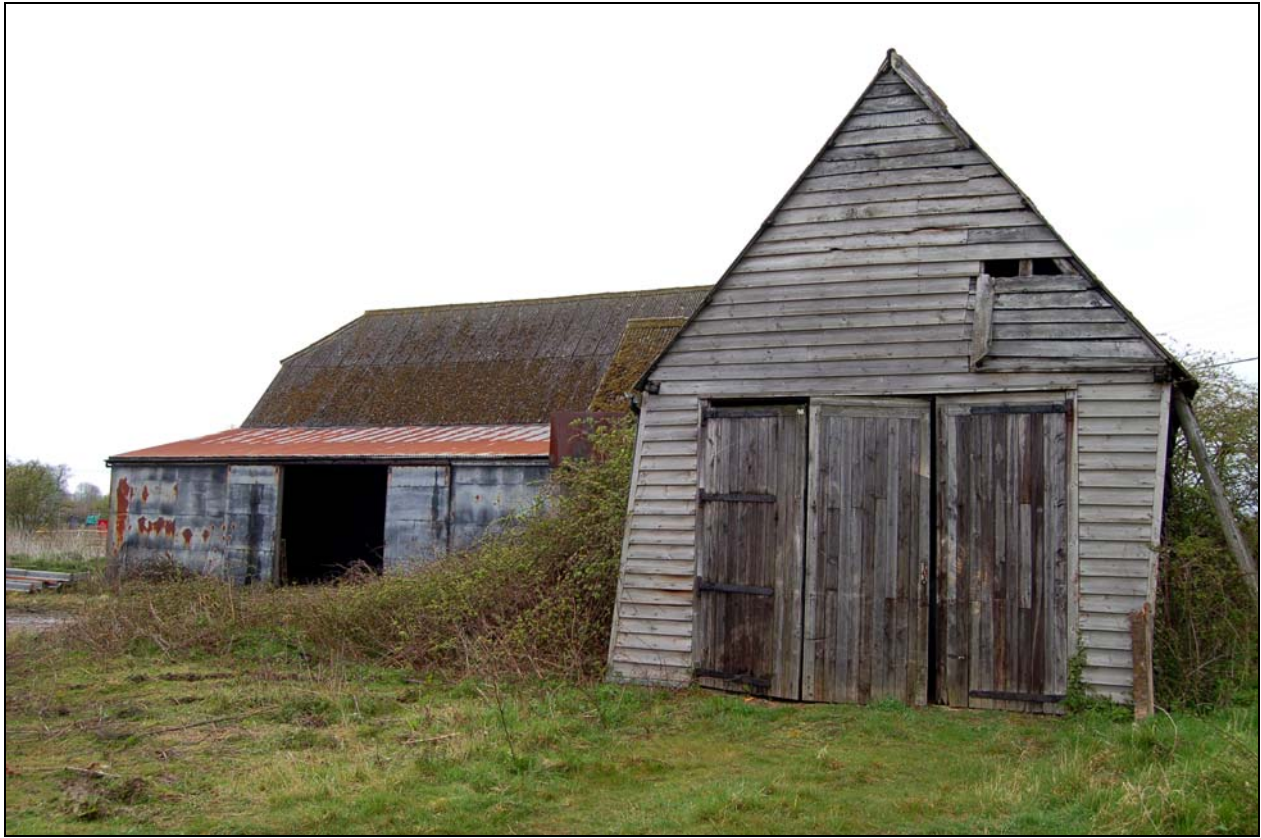
farm vehicles/machinery inside) is straight whilst the walls slope to the east (plate 13) In addition, a prop has been added under the eaves in the south-east corner.

Plate 13 Rebuilt western gable of barn 2 with shed 3 in background

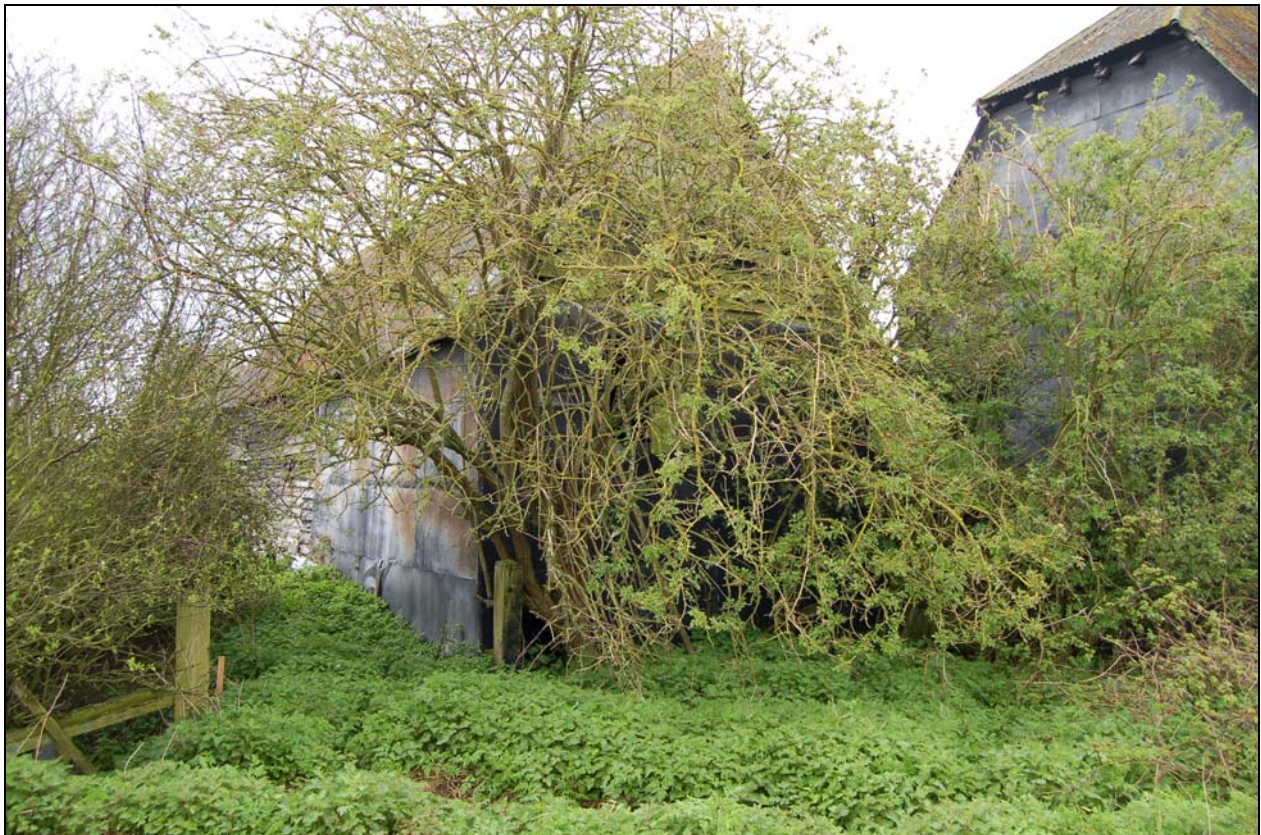
Parts of the eastern elevation have been re-clad in steel sheeting over the existing weatherboard (plate 14). Wooden stabilisers are original features fitted between the two north bays and one side of the filled-in former low cart door (fig.5). Stabilisers prevented damage by livestock and are often found on shelter shed posts. In this context, they suggest that cattle were being herded behind the barn and through the gateway to the north (fig.5).

The northern gable is virtually indistinguishable because of the surrounding vegetation (plate 14). Steel sheeting clads much of the elevation up to the eaves and the boards above are greenish in hue from damp and lack of sunlight. An off-centre pitching hatch has been retained, though it is better seen from the inside (fig.5, plate 15). Any evidence for a pitching hatch on the southern gable was lost in the rebuild.

Plate 14 North and east elevations of barn 2 disguised by vegetation
