**GREAT NUNTY'S FARM, NUNTY'S LANE
PATTISWICK
ESSEX**

HISTORIC BUILDING RECORD

November 2008

Document Ref.	1906
Report Issue Date	7th November 2008
Circulation	RED Investments c/o Graham Jones
	ECC Historic Environment Management
	Essex Historic Environment Record

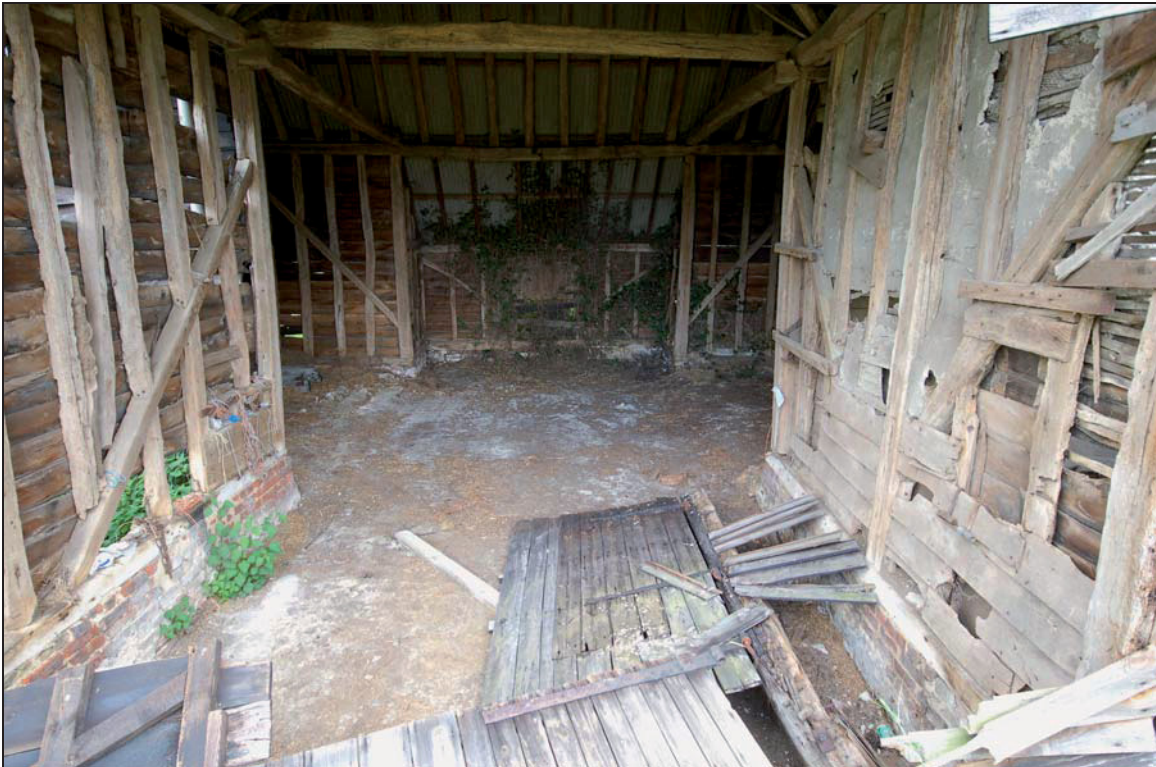
Plate 6 Collapsed cartdoors and plastered panels in barn 2 porch

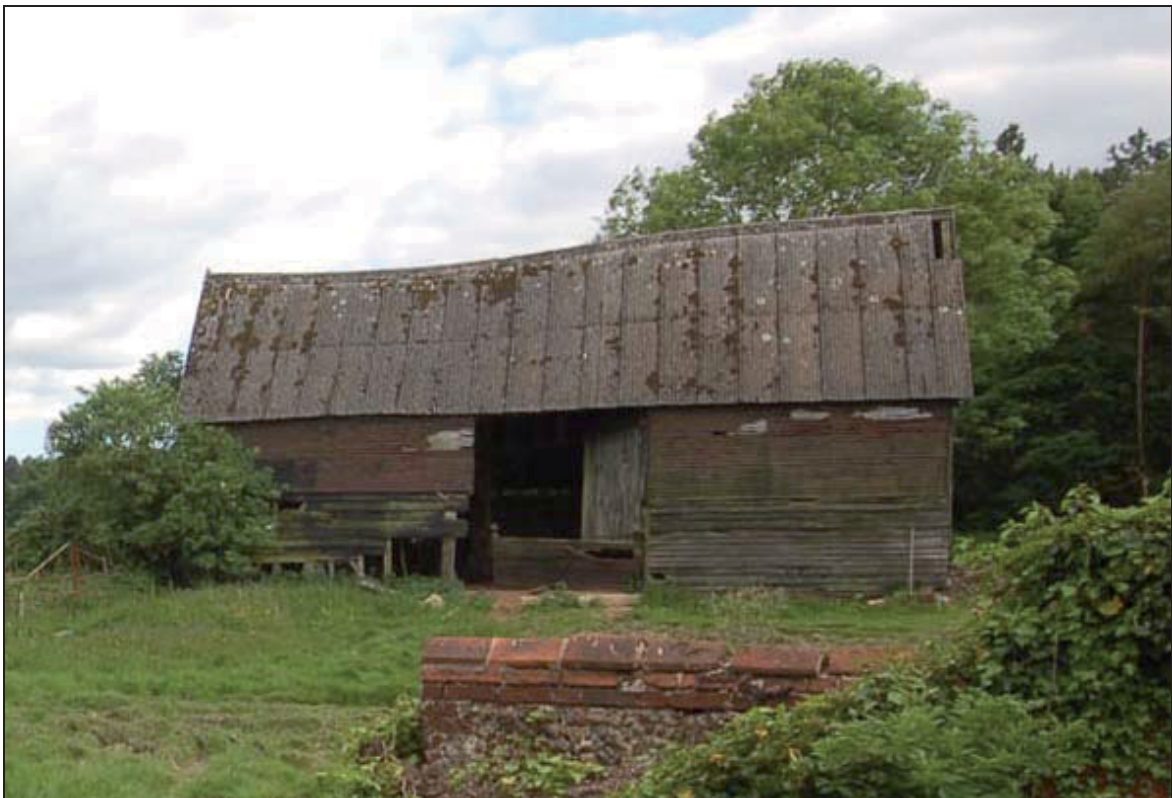
Plate 12 North elevation of barn 3

The current condition of the barn is by far the worst of all the structures surveyed. Corrugated tin sheets were fitted to the walls at some point in the past to steady the weak frame and the east wall is collapsing, causing the porch to 'kick up', pulling the roofline down on the east side (plate 12).

The main elevation fronts onto the former yard. Rusty corrugated iron sheeting hides much of the walls either side of the cartdoors, including areas of lath and plaster (plate 12), while the unprotected parts below have suffered and the weatherboarding has fallen away. The left-side cartdoor has collapsed into the building, but the right side still stands. The former leap gate is clad in corrugated tin (plate 12).

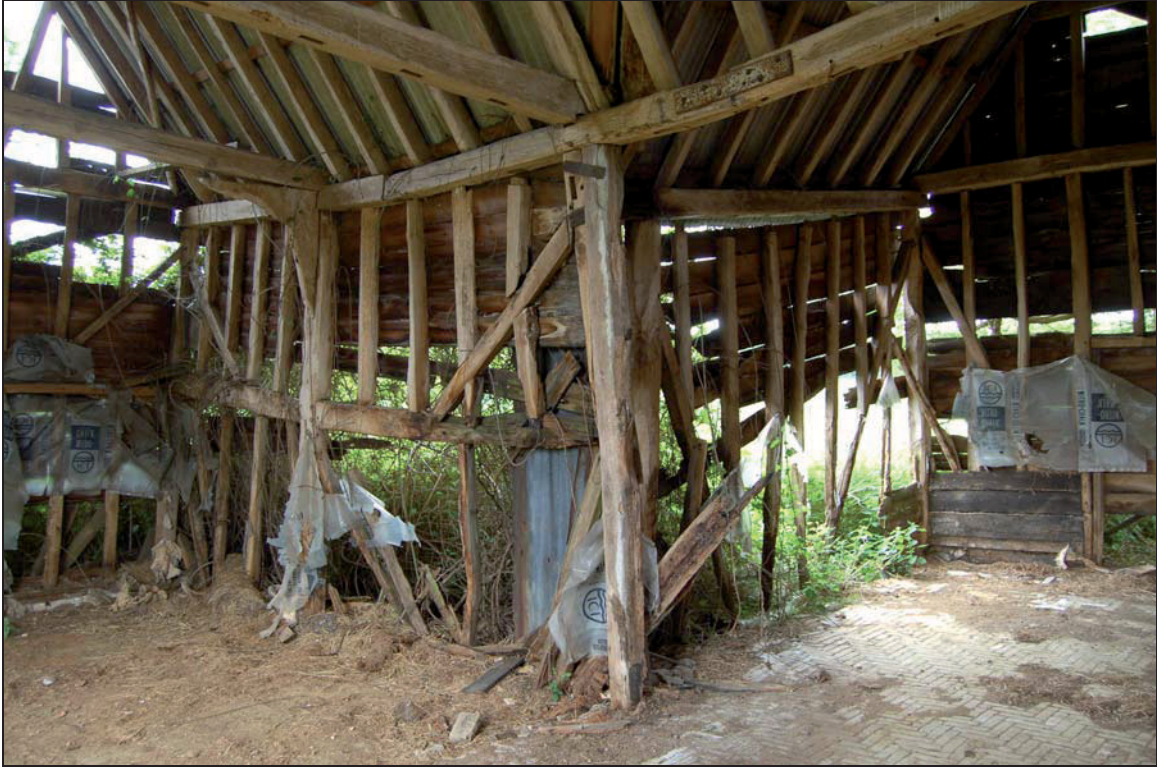
Plate 19 Dilapidated east end and porch in barn 3

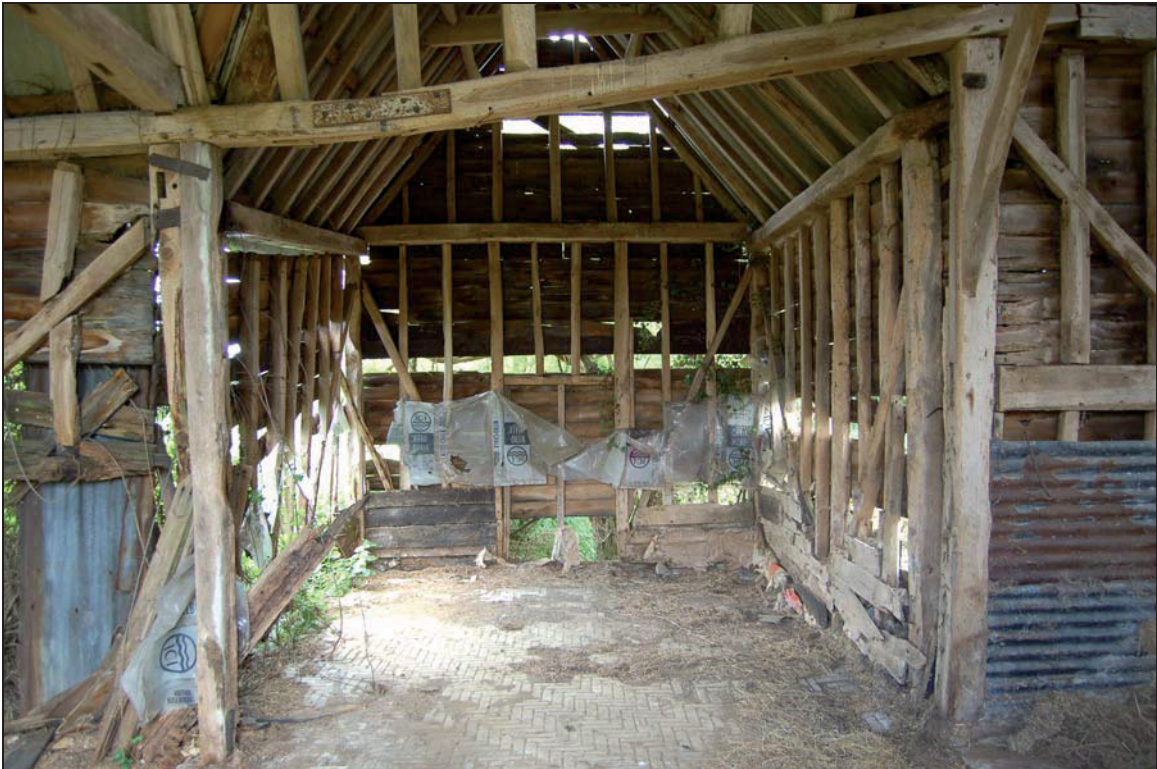
Plate 20 Porch and threshing floor in barn 3

The wall plate between the midstrey and porch is reused from a different building altogether, a close-studded structure predating the barn components. The empty stud sockets have regular pegging (plate 20), a less common practice by the 17th century. The plate is sloping down to the east side, with the movement in the building, loosening its purchase in the scarf joint on the west side of the porch (plate 20).

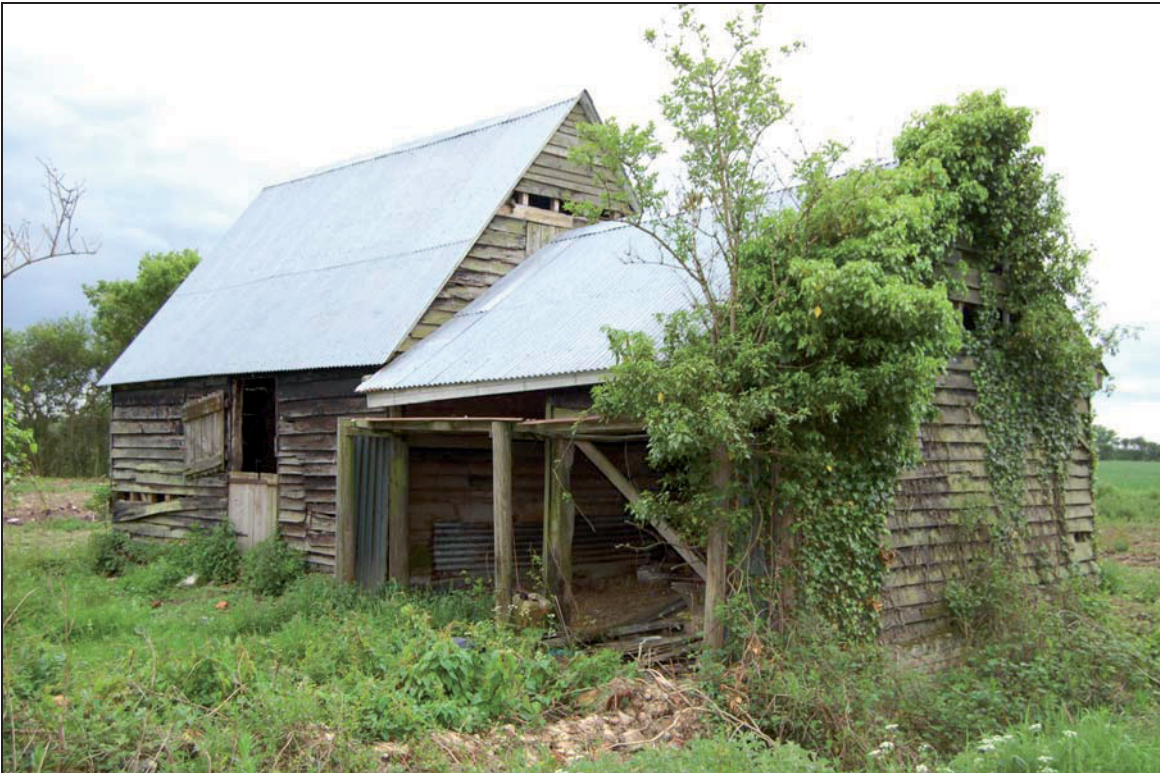
Plate 22 Stables and feeding shed viewed from north-east

Up in the weatherboarded north gable of the stable is the door into the former hay loft, now partly blocked by the re-built shed roof (plate 22). The north wall of the shed has been re-built to the lower roof pitch, while the elevations to the south (plate 22) and west (not shown) are in poor condition and show no features of interest.
