**ROE GREEN HOUSE, ROE GREEN
SANDON
HERTFORDSHIRE**

HISTORIC BUILDING RECORD & ARCHAEOLOGICAL MONITORING

December 2008

Document Ref.	1788rep
Report Issue Date	19th December 2008
Circulation	Mrs Lizzy Rudd
	Herts CC County Historic Environment Unit
	Herts Historic Environment Record

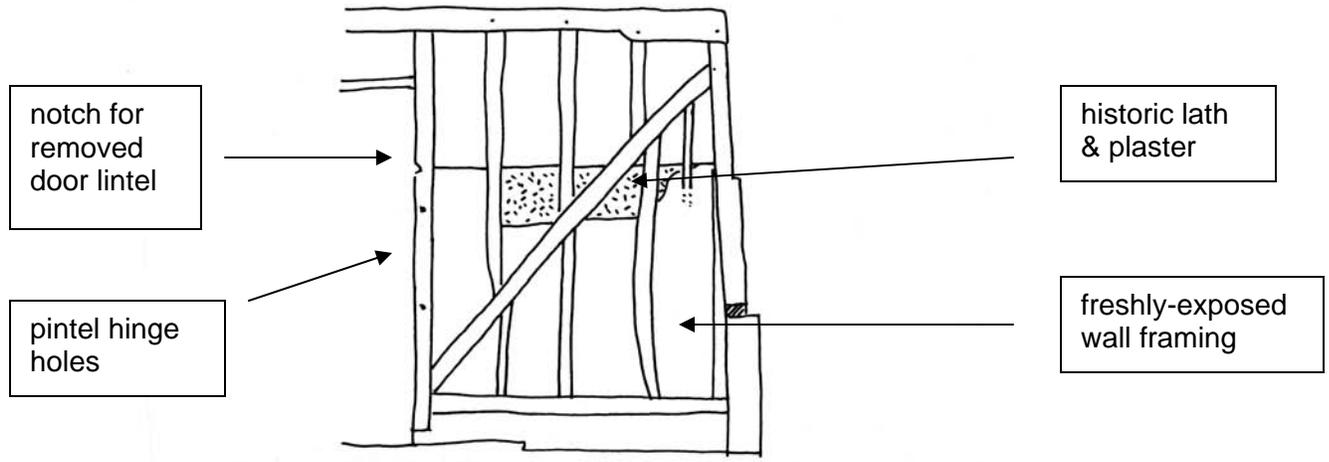
Fig. 8b South-west wall of utility room

A transverse three-bay two-storey cross wing was placed against the north-east end to provide a new 'high end' with a new kitchen wing and stack added at the opposite 'low end'. It is likely the attic was inserted in the main range in the same period. The exact sequence is unclear, but is likely to have been soon after the primary construction, around 1620 (Gibson 2007). Only the kitchen wing contains exposed stud walling to this phase, which is primary-braced like that of the original range (plate 13). It also has an in-filled diamond mullion window (fig. 8b).

The kitchen wing was built open to the rafters and has a primary-braced timber-frame (plates 18, 19 & 20) composed of studs of equal quality and scantling to those in the end wall of the phase 1 house. Much original timberwork is exposed within this room and during the current alterations more stud walling was revealed beneath modern plasterboard (drawn as fig. 8). This showed the gable frame had been cut and under-built in 14 courses of modern brick on a narrow timber sill (fig. 8a) and that the external doorway, leading out to the farm yard sits within a historic opening (fig. 8b). The figures also show that the studs are slightly narrower at times and more varied in size (10-13cm). Some are waney, more indicative of later framing and pegged to the mid rail but not to the wall plate above, rather than fully-pegged like those in the earlier range. Some narrow modern studs have been added to square up for windows, which are inserted above and below a blocked two-light diamond mullion window, mainly obscured by plaster (fig. 8a, plate 20). The wall plate above the window steps-up either side (plate 20) and has been interpreted as a cut-out for hinged shutters (Gibson 2007). A similar timber is found on the south-west wall that appears to be simply a decorative feature (fig. 8b).

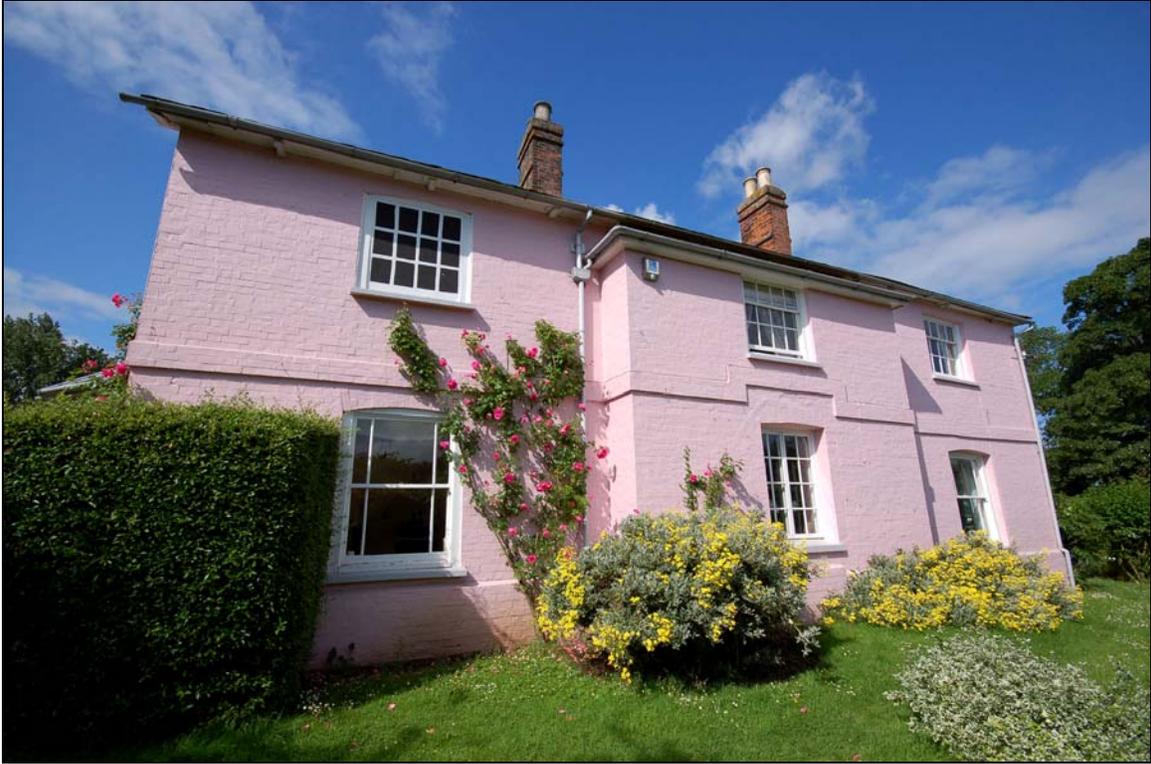
Plate 1 North-east façade

The symmetrical north-east elevation (plate 1) faces the road and provided the formal entrance to the 18th century house through the projecting central bay and former porch, now partly hidden by a hedge. Three bays/rooms are presented, divided by slender chimney shafts. Contained behind the façade is the 17th century cross wing, which has been re-faced in Flemish-bonded brickwork. The two bays either side have horned margin sash windows on the ground floor and 8:4 pane sash windows on the first floor, all recessed with cambered heads. The window on the south east bay is a dummy window (plate 1, left), perhaps replacing an earlier one (Gibson 2007). The two floors are separated by a three-course plat band that steps up in the centre porch (Listed Buildings Online) and continues around the refurbished cross wing (plates 2 & 3). In the central bay, the band frames an eight-paned casement window, set into the former porch, whose front doorway is indicated by a hood mould scar (plate 1). The head of the central sash window is held within the original eaves, which jut forward from the central bay, indicating the former eaves level and roof pitch, which was raised to present a more orderly frontage in the Regency period (plate 1).

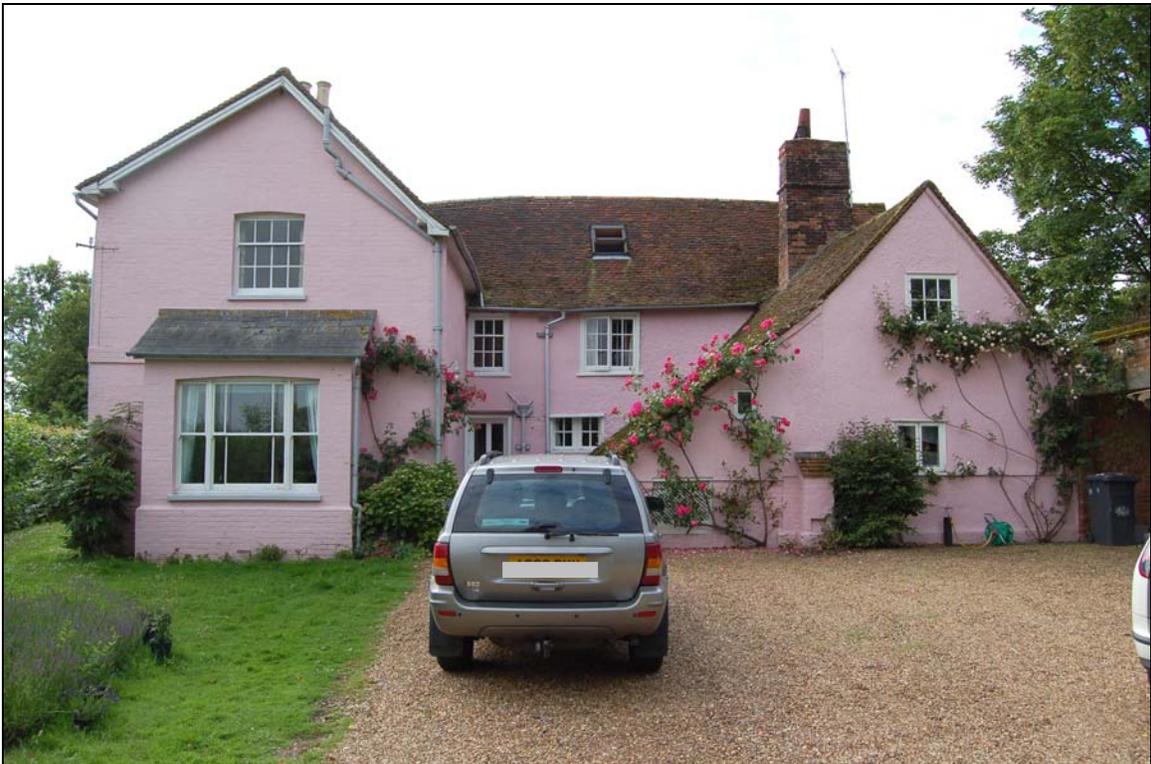
Plate 2 Driveway elevation (north-west)

The middle bay includes part of the original late 16th century range, the roof of which extends into the third bay, behind the utility room (plate 2). The timber wall frame is coated in cement render and the semi-glazed four panel front door belongs to the 19th century phase. A pair of four-pane casement windows are situated to the right hand side of the door, lighting the shower room and bedroom. A larger casement stands slightly set-back on the first floor, with a Victorian 3:6 sash to its left (plate 2). The beginning of the roof bow corresponds to the iwall plate viewed inside the first floor bathroom (fig. 6).

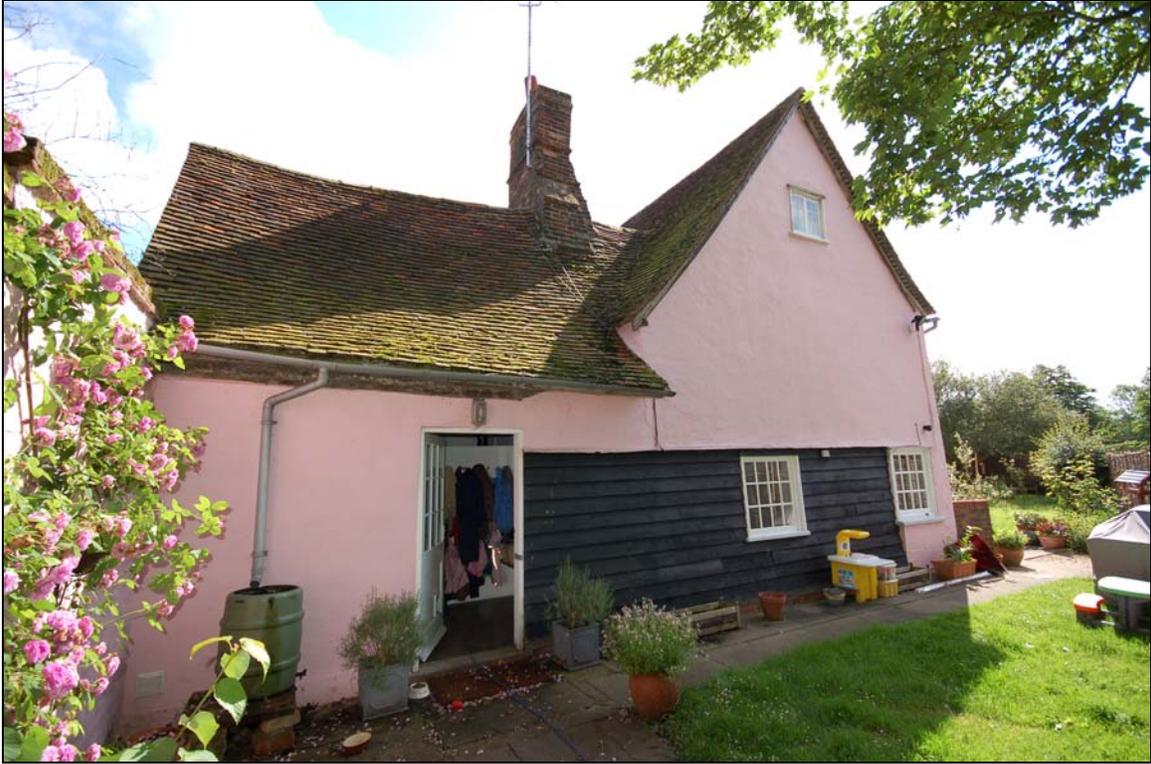
Plate 3 Rear elevation (south-west to farmstead)

The south-west elevation, formerly facing onto the farmyard, shows the relationship between the main part of the house and the low end with greater clarity and suggests the stack and kitchen wing are built onto the main range and therefore contemporary, (plate 3). This side of the house has a more sheltered position and retains an earlier lath and plaster coating, alongside timber boarding to the lower part (plate 3), which is also found on the old external wall of the snug, now inside the house (fig. 5). The door into the old service wing, currently the utility room, has modern fixtures but stands in the traditional frame. Fenestrating the gable end are 12-paned fixed windows on the ground floor, and six-light casements lighting the attic (plate 3).

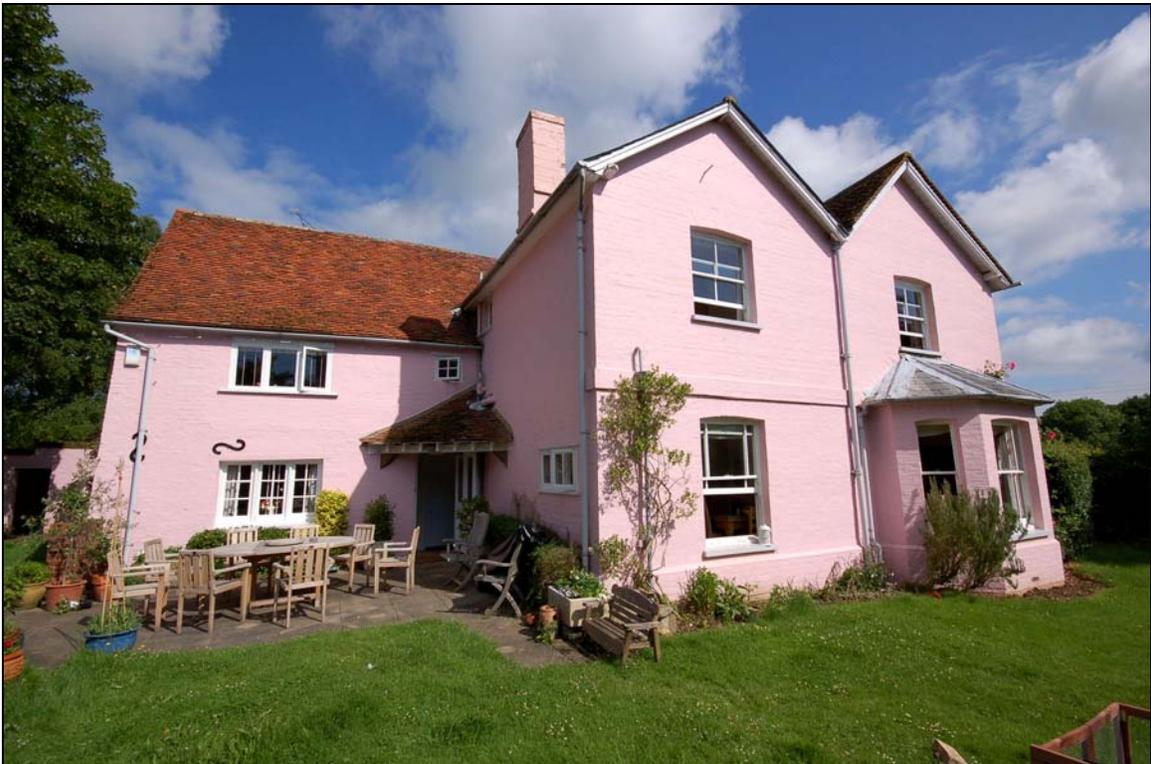
Plate 4 Garden elevation (south-east)

The remaining elevation, on the south-east side (plate 4), faces onto the back garden and comprises the 16th century range and two, rather bold, projecting 18th century gables, one of which wraps around the 17th century cross wing (fig. 4). Following round from the end gable described in the paragraph above, the older part of the house was bricked-in during the 18th century and re-fitted with contemporary spiral handled casement windows (Alcock & Hall 1994), lighting rooms on both levels. A charming four-pane casement lights the upstairs corridor above a triangular tile-clad open porch. There are similar, though smaller, casement windows on the porch side of the brick extension, where there is a fourth chimney supplying the cooking range in the 18th century/current kitchen (plate 4).

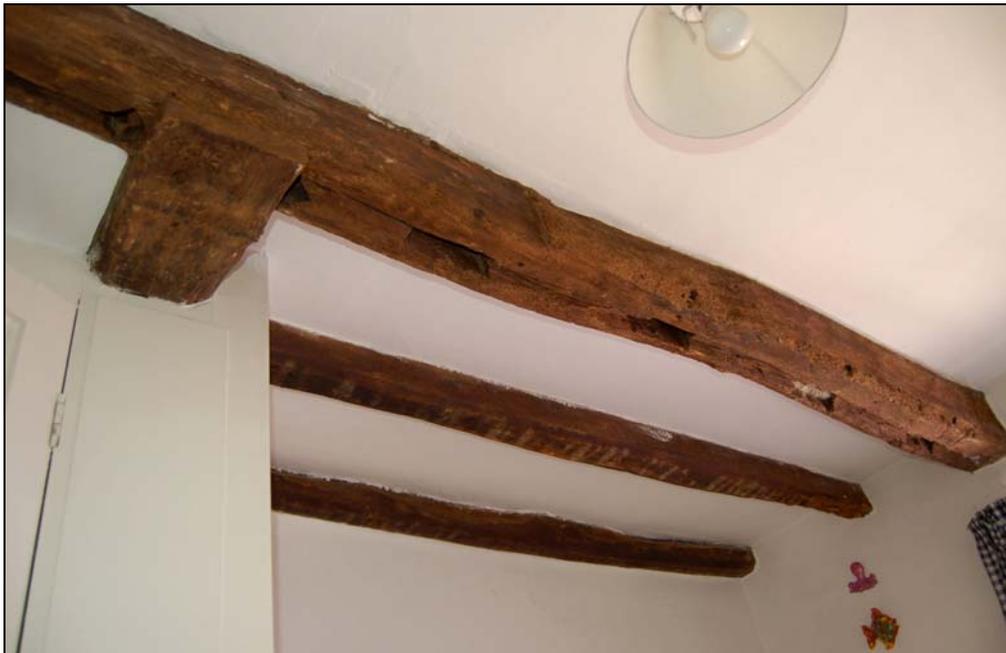
Plate 10 Detail of blocked mullion holes and pegged stud sockets to tie beam soffit

in the 17th century (Gibson 2007) (fig. 6, plate 10). The presence of an internal mullion window is unusual and suggests the beam was reused from another structure to create the partition wall. After all, if the wall was plastered over, the window would not be seen. Between the studs are grooves for wattles and a wide triple-peg mortice for a large brace on the south-west end (fig. 6), which is out of place with the primary-braced build, showing further evidence that this timber is reused.

A bridging joist is pegged to the tie beam soffit, over the mullion sockets (plate 10), which continues into the bedroom behind to support the attic floor (fig. 6). The joist has lambs tongue stops to either end, as do the exposed ceiling joists in the bathroom but not on the wall between the bathroom and bedroom, which is a later insertion. Attics were common features of 17th century Hertfordshire houses (Gibson 1994) and may have been included over the early range with the cross wing. As the bridging joist on the other side of the plate is not exposed and the ceiling here likely to be a later insertion, it is assumed the old service room kept its first open to the roof for longer.

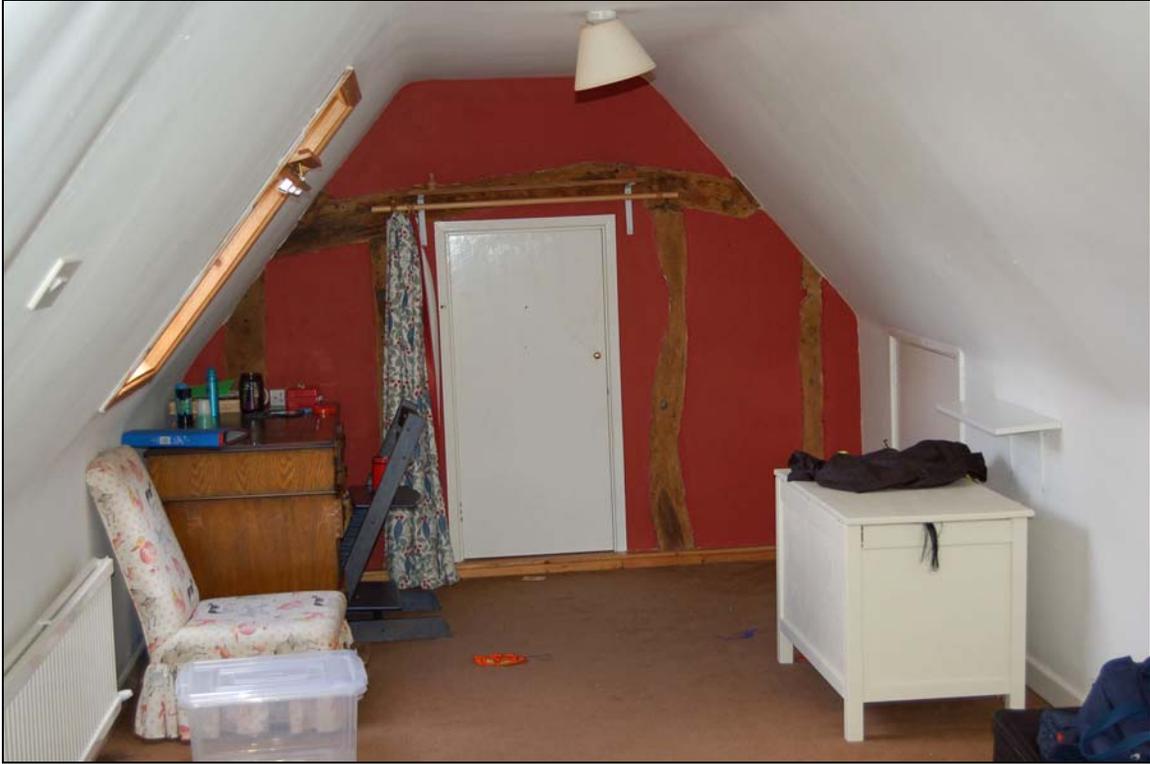
Plate 11 Continuation of partition walling into attic

The bathroom partition wall/service room partition continues into the second/attic floor where studs are arranged equally either side of an inserted modern cupboard entrance that has eliminated the central stud (plate 11). Although substantial timbers, at least one of the studs has a waney appearance and their spacing appears wider than those below, which again suggests the plate below is reused. There is a noticeable curve to the collar (plate 11).

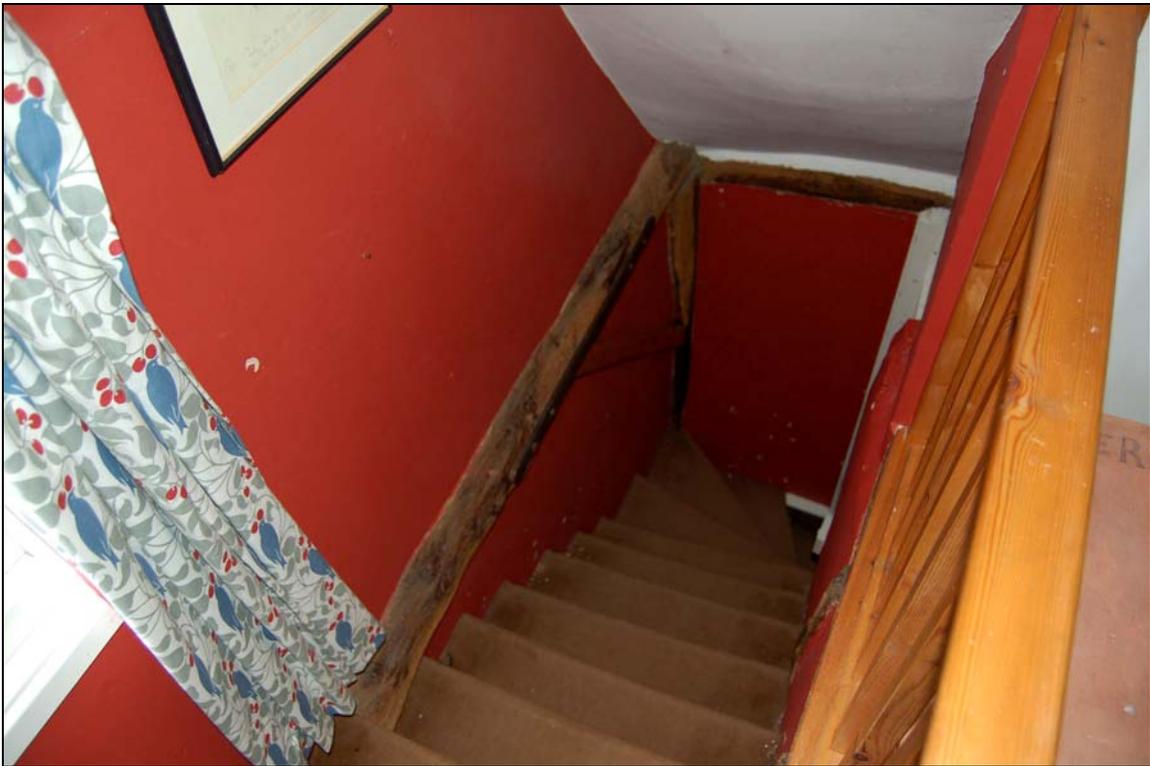
Plate 14 Back stair to attic

plate and its counterpart the other side are attached onto the bedroom wall plate (fig.6) by simple single-pegged face-halved scarf joints. They point to a fairly 'primitive' build, but without other contemporary examples to compare, it is difficult to tell how they fit in. An inserted floor clamp is nailed across the north-west plate to hold the ceiling joists and perhaps bolster the scarf joint on this side. A back stair leads from the playroom to the second floor, separated by a nailed stud partition clearly of some age, though not original. The staircase offers a rare opportunity to view two jowled bay posts, but unfortunately nothing of the frame (plate 14).

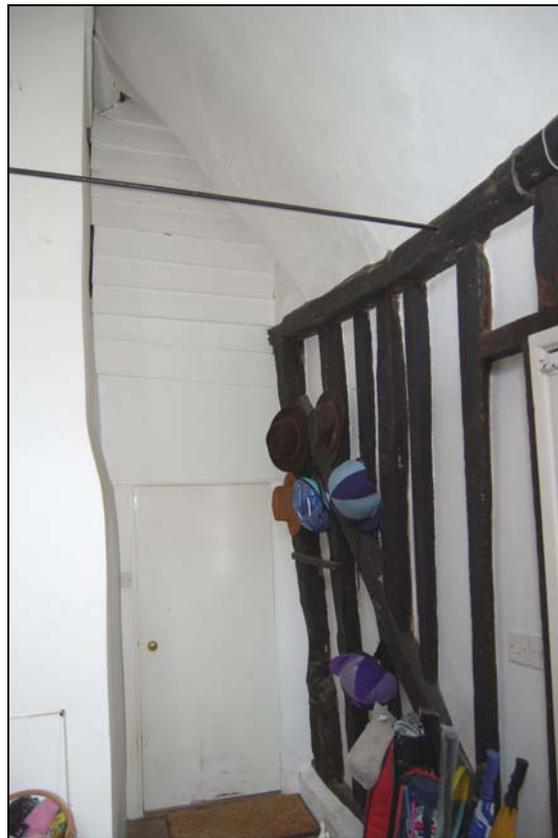
Plate 18 Trapped external boarding inside 17th century kitchen range

trapped under the kitchen roofline (plate 18), similar though earlier than that seen on the south-west wall which covers the join between the two builds.

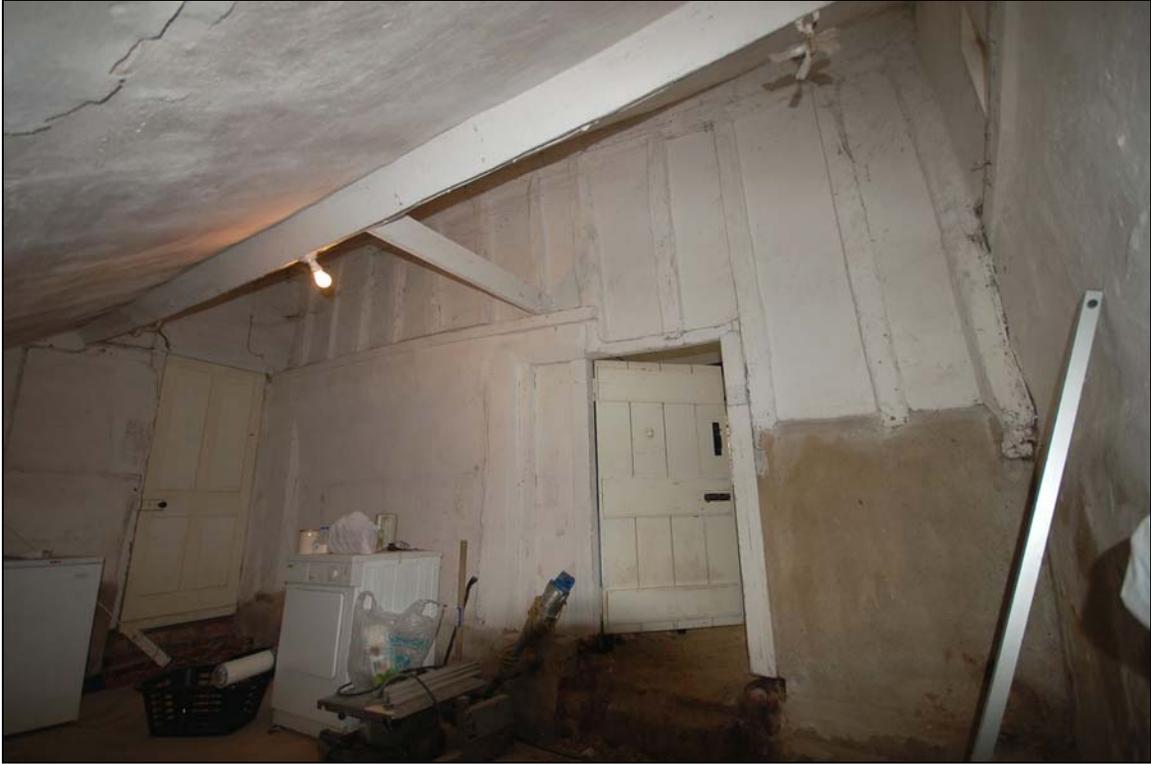
Plate 21 18th century cellar attached to kitchen range

Built almost 1m below ground level, the brick-built cellar (plate 21) would have been cool enough to store perishable commodities such as meat and cheese and may also have housed a well (Gibson 2007). A brick floor and gully, draining to the outside, meant it could be washed down easily (fig. 5 and). It is believed to have been built relatively soon after the kitchen as the two 'work together' as one unit (Gibson 2007), though the bricks suggest an 18th century date. Catslide-roofed dairy buildings were often added to existing service ranges, though usually as outshots on the rear wall (Gibson 1994).

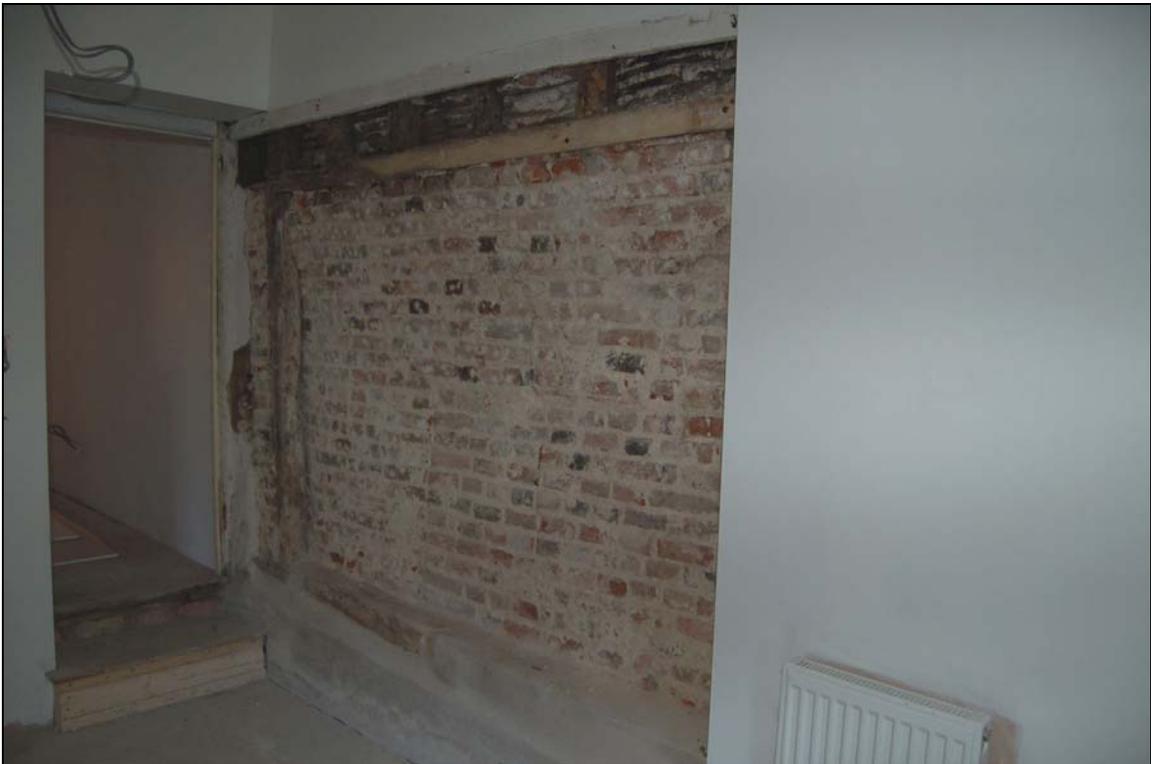
Plate 22 Stack wall in cellar exposed in building works

The two corner posts display a slight suggestion of jowling. Narrow wind braces have been added to the roof frame, which is plastered on the inside obscuring its construction. The large brick stack for what was once a big inglenook fireplace (Gibson 2007) extends out from the north-west side into the kitchen and it is clear from the way a brick stabilising wall has been built with the frame (plates 21 & 22) that the two are contemporary.

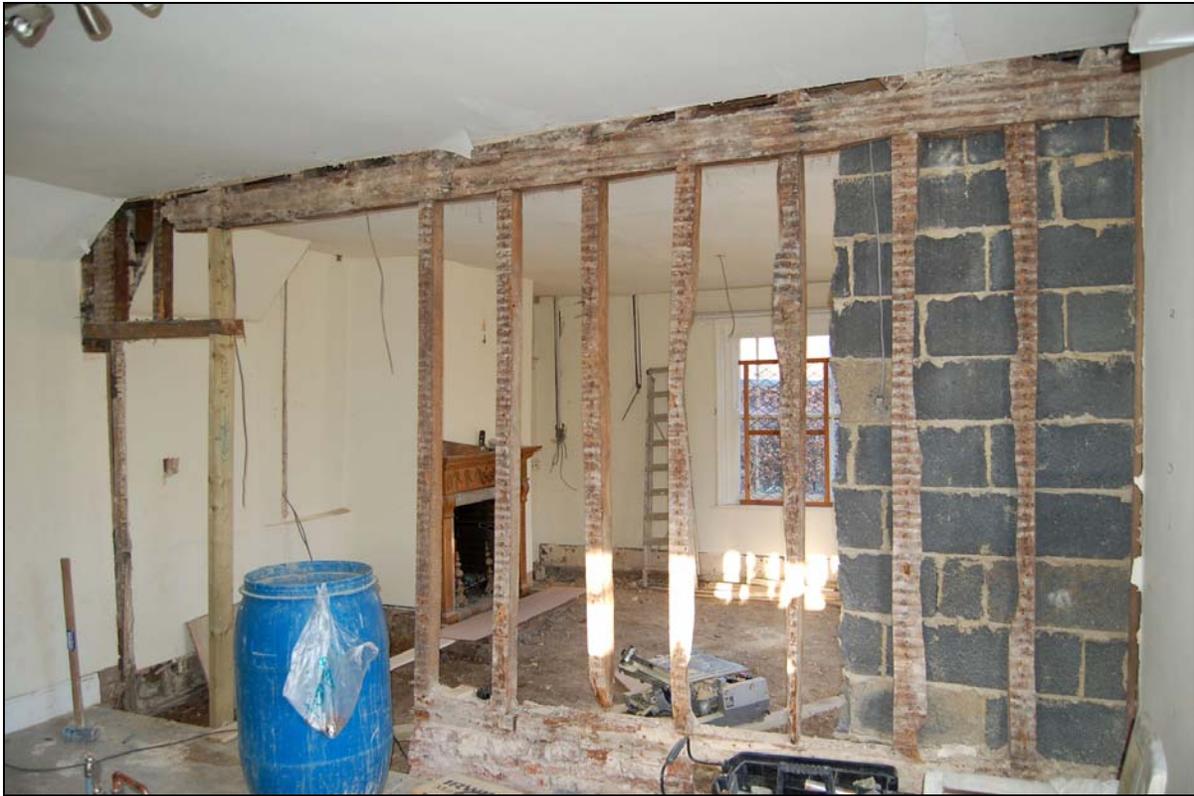
Plate 23 Typical 18th century stud walling between existing kitchen and dining room

Extensive alterations were carried out in the 18th century to the early 17th century cross wing. Upstairs there are partly-exposed wall plates that appear to be contemporary with 18th century stud walling, and replaced beams contemporary with the roof raise and rebuild, clearly seen in the north-west bedroom, where the inserted front wall plate is cut back to expose pegging for hidden narrow studwork (fig. 6, plate 17). Examples of 18th century stud walling were observed during building works on the rear of the north-west wing and between the present dining room and kitchen (plate 23), typically un-braced and built on brick plinths.

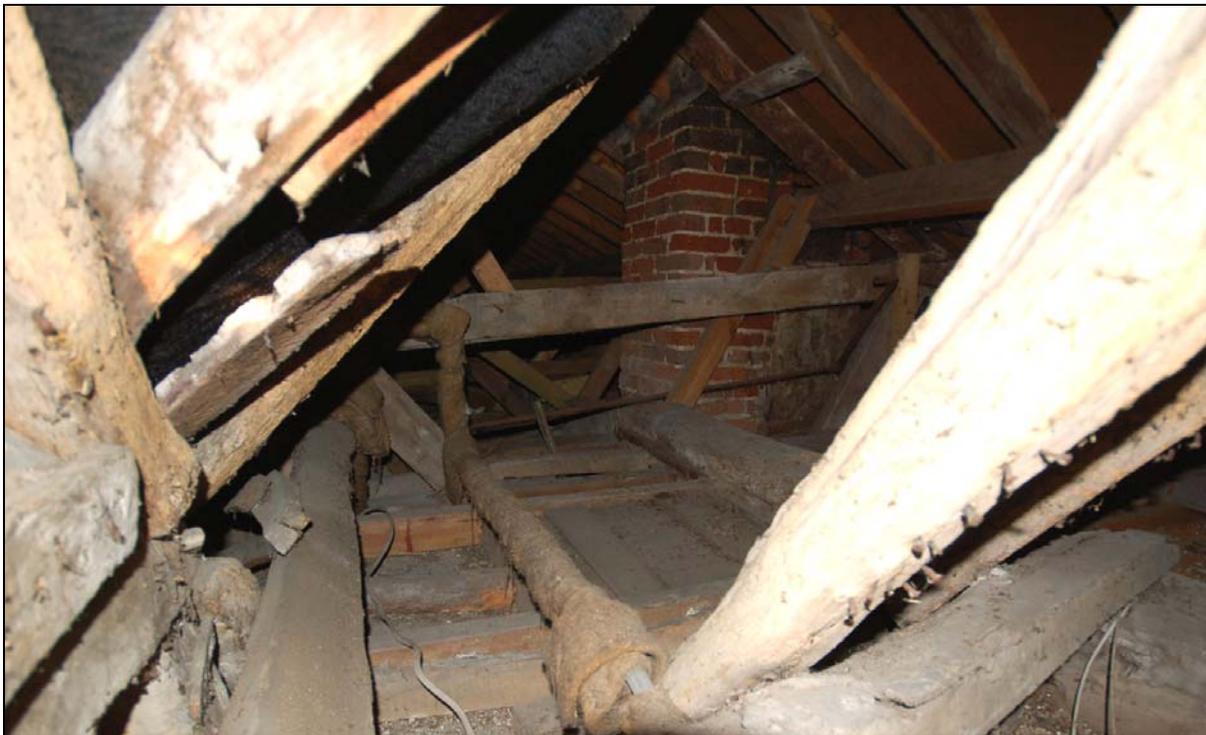
Plate 24 Rebuilt roof over cross wing

Observation was difficult, but over the old cross wing, the roof framing has inserted, nailed raking queen posts trusses and incorporates some early timbers on the south-west side, but apparently not on the opposite side (plate 24). The binding joist in plate 24 has been turned and new mortices made. The old mortices show it was exposed in the ceiling originally, like those in the main range.
