**GREAT NUNTY'S FARM, NUNTY'S LANE
PATTISWICK
ESSEX**

HISTORIC BUILDING RECORD

November 2008

Document Ref.	1906
Report Issue Date	7th November 2008
Circulation	RED Investments c/o Graham Jones
	ECC Historic Environment Management
	Essex Historic Environment Record

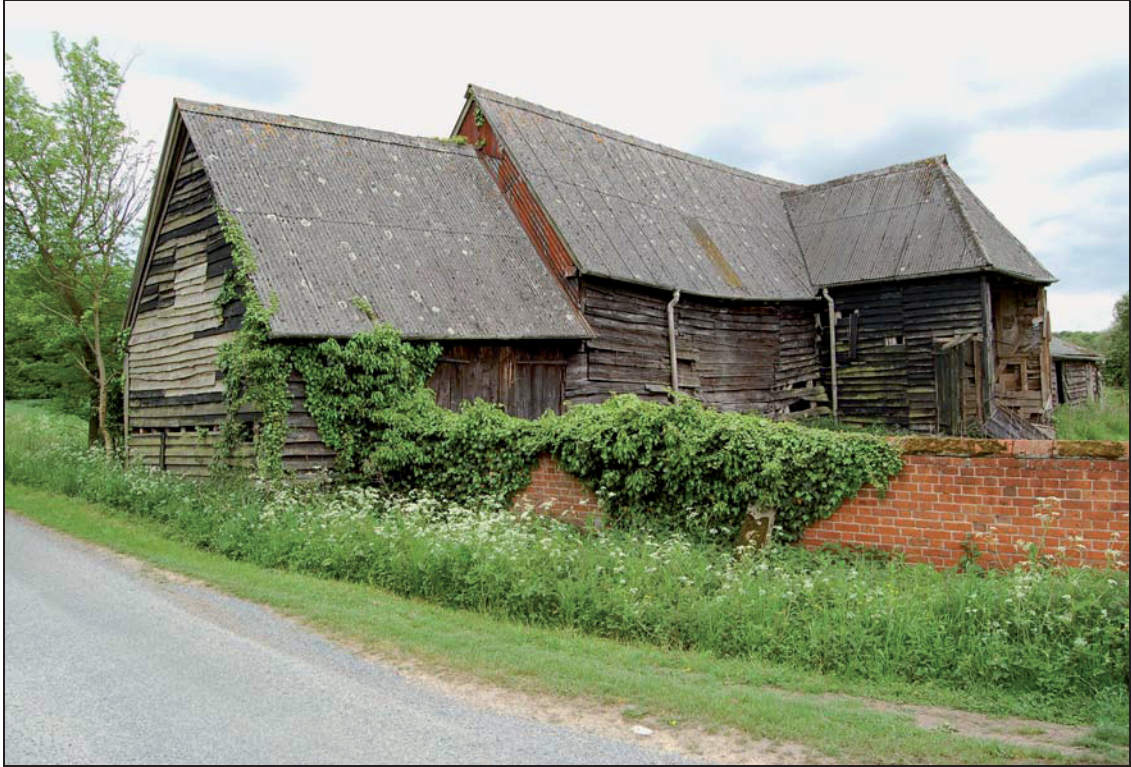
Plate 1 Byre and barn 2 viewed to south-east

The north end gable, facing the road, is less protected from the elements and the middle part has been replaced with un-tarred elm board. Above is the outline of a former pitching hatch (plate 1). The eastern or rear elevation (plate 2) which is now covered in ivy, once had a window or vent that has since been boarded over, but can still be seen on the inside (fig.6). The south wall also forms the end wall of barn 2, and is made of un-tarred weatherboarding, supporting the theory that the barn was built onto the existing byre. A pitching hatch between the two, perhaps to supply bedding into the byre, has been covered up.

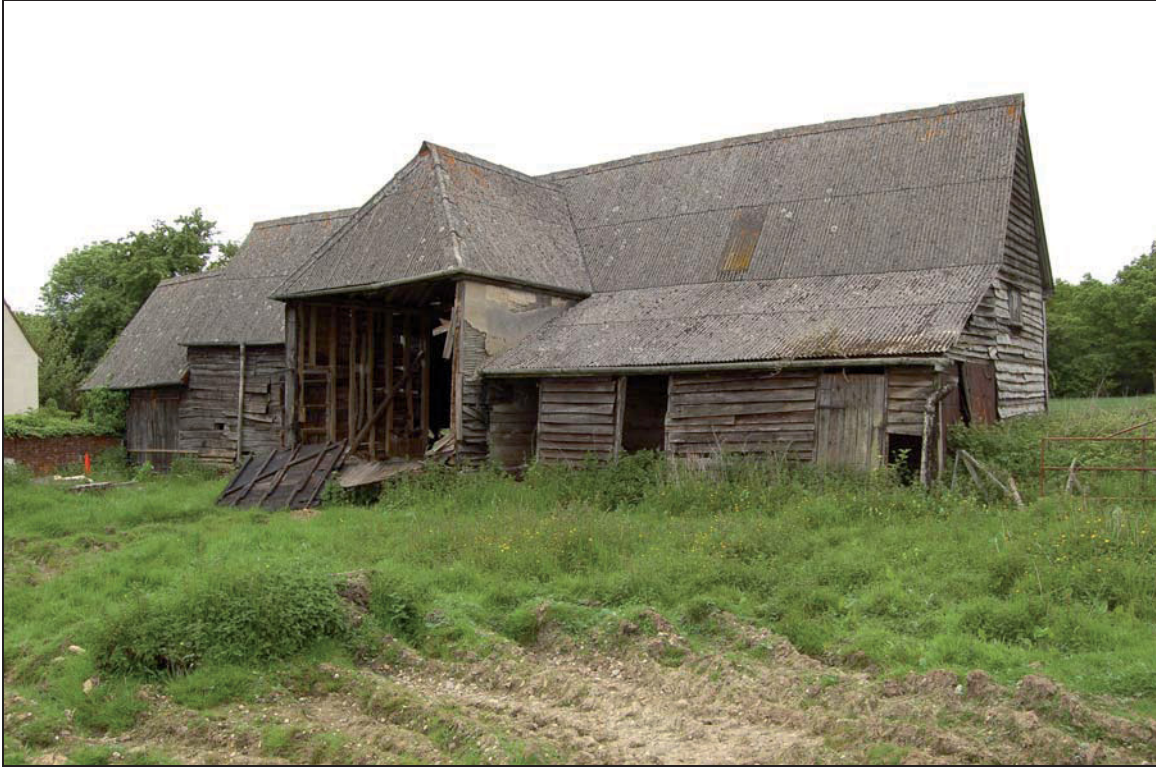
Plate 5 Barn 2 viewed to north-east

On the southern side, rusting early 20th-century corrugated iron doors have been inserted into the outshot, which led to the yard via a set of iron gates (plate 5). This area is now badly overgrown. A considerable amount of roughly-cut boarding has been used in the rebuilt gable end of the barn that also contains a contemporary narrow-paned window to light the southern end.

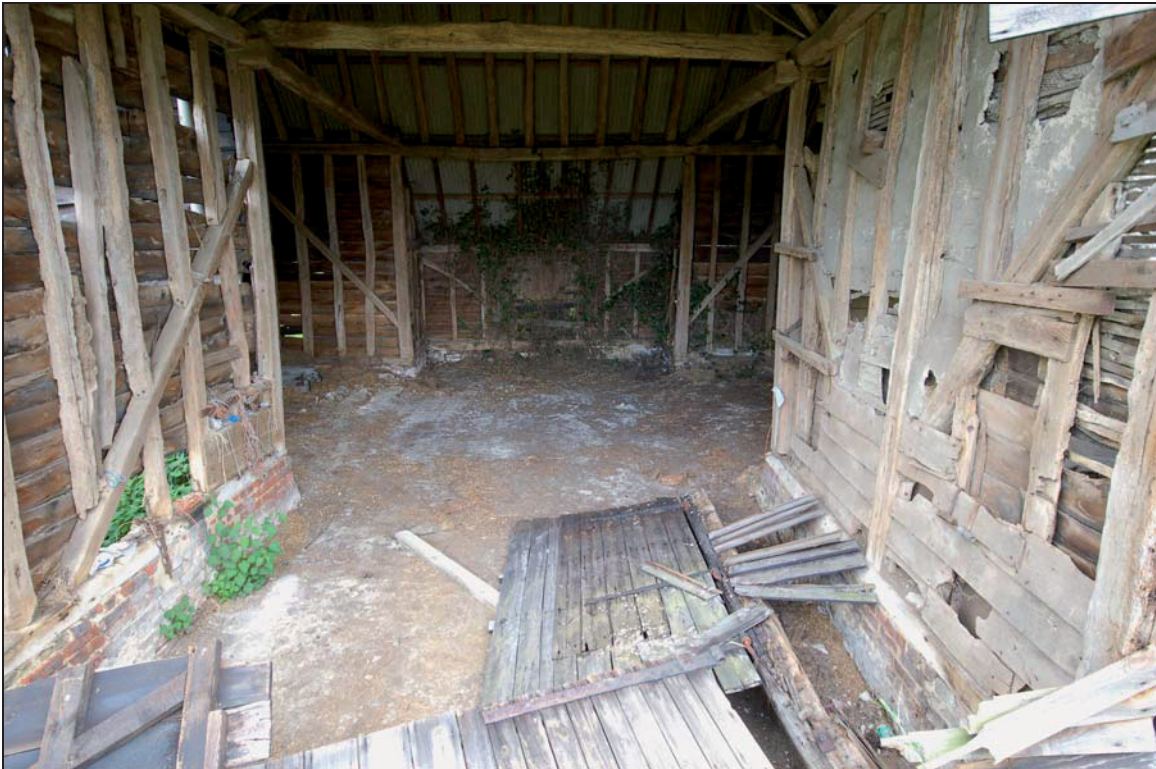
Plate 6 Collapsed cartdoors and plastered panels in barn 2 porch

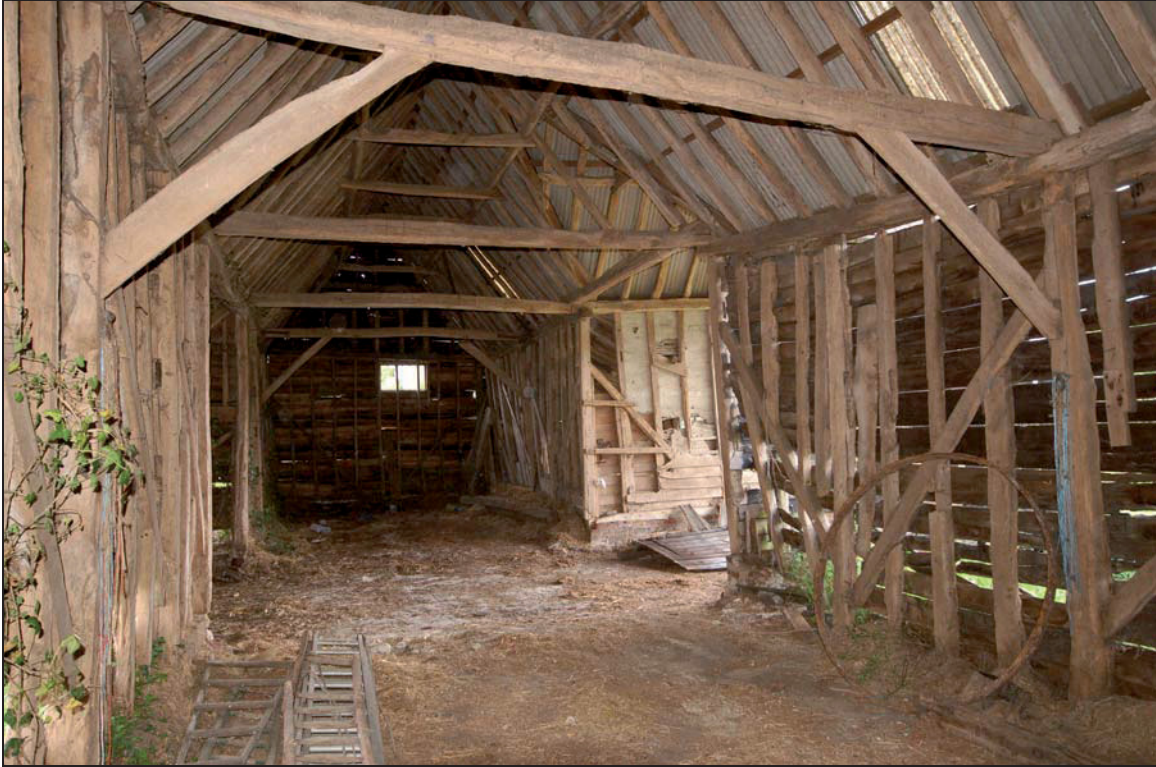
Plate 9 Interior of barn 2 viewed to rebuilt gable to south

Sill beams are generally in fair condition, although few have been replaced. The one in the penultimate north bay, west side, has rolled with the plinth (fig.6, plate 9), while on the same side in the southern bays the beam has spread outwards (plate 9), where the plinth has been undermined by burrowing in building 2a.

Wall-framing is divided into two sections per bay by a mid-post. Each part comprises 3 long studs tenoned, but not pegged, to plate and sill, except for the central eastern bay (with the short porch attached) which has no evidence for bracing, suggesting this is a reused plate (plate 11). The primary bracing falls steeply towards the central bay on each side except for the bays either side of the main porch. All studs and braces are straight and measure c.10 x 7cm. Framing in the porch is consistent with the rest of the barn. Few studs have been replaced in the barn, except for those in the southern gable, which has been rebuilt below the wall plate in machine-sawn timbers (plate 9).

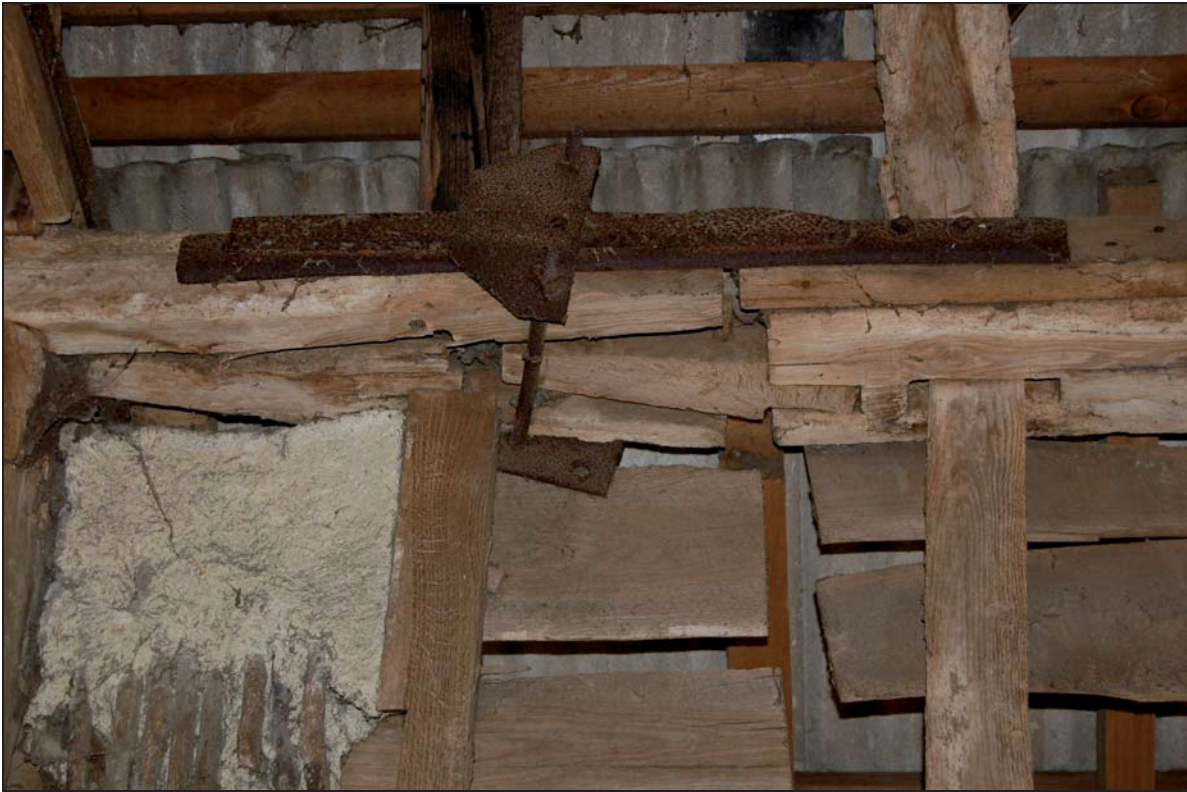
Plate 10 Crude un-halved bridle scarf joint inside barn 2 & remains of daub panel

Evidence of daub infill panels was found on the western side of the penultimate south bay, tied onto wattles (plate 10). Most of it has fallen away over time and hardly any now survives, and it is difficult to say whether it was originally present just on this side or throughout the barn. The daub has been replaced on the bottom section of walling against stalls 2a with brick infill. The main porch has lime plastered panels on laths rather than daub on wattles, surviving on the internal south wall (plate 6), and the frame below is boarded to ease the passage of carts (plates 6 & 9).

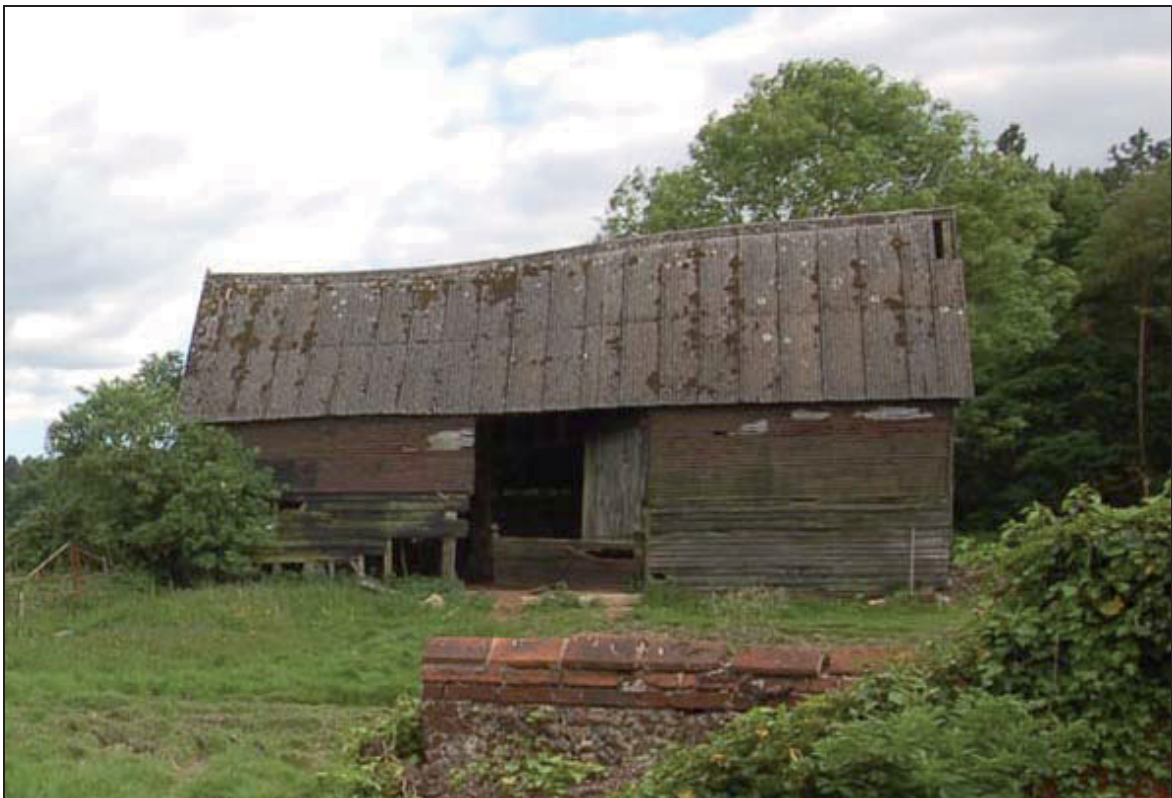
Plate 12 North elevation of barn 3

The current condition of the barn is by far the worst of all the structures surveyed. Corrugated tin sheets were fitted to the walls at some point in the past to steady the weak frame and the east wall is collapsing, causing the porch to 'kick up', pulling the roofline down on the east side (plate 12).

The main elevation fronts onto the former yard. Rusty corrugated iron sheeting hides much of the walls either side of the cartdoors, including areas of lath and plaster (plate 12), while the unprotected parts below have suffered and the weatherboarding has fallen away. The left-side cartdoor has collapsed into the building, but the right side still stands. The former leap gate is clad in corrugated tin (plate 12).

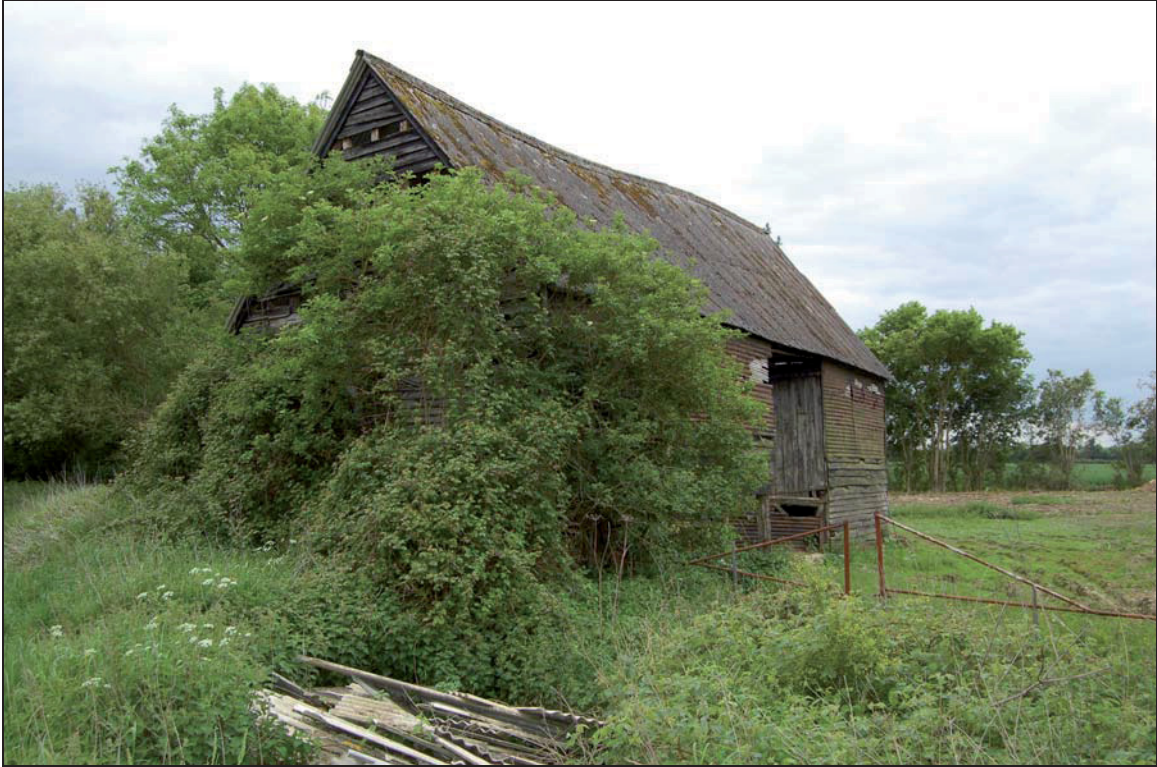
Plate 13 Barn 3 viewed from north-east

Brambles and elder hide the eastern gable and porch (plate 13) and boards are missing from the lower part of the frame. No remains of the formerly attached building seen in the 1842 map (fig. 3) are evident through the vegetation. The east side of the porch has no sign of a plinth and this has caused the sill to rot and the south-east bays and porch walls to collapse at the base, causing the distinctive bow in the roofline (plates 12 & 14). The western gable is in a much better state and has a Flemish bonded plinth of 7x 10 x 22cm frogged red bricks, likely to be of 19th-century origin (Ryan 1999) and therefore later than the barn/byre plinth. The plinth on the west side of the porch is more substantial and has been rebuilt around the pond here (plate 15).

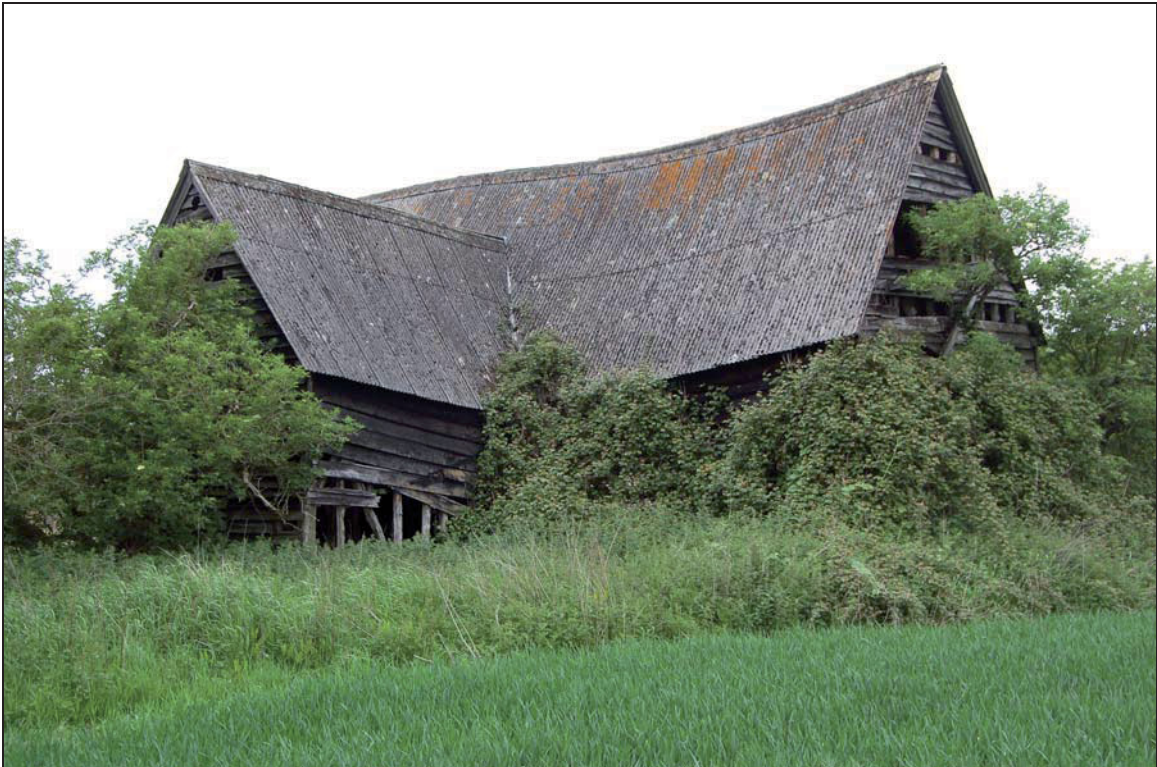
Plate 14 Collapsing barn 3 porch viewed from south-east

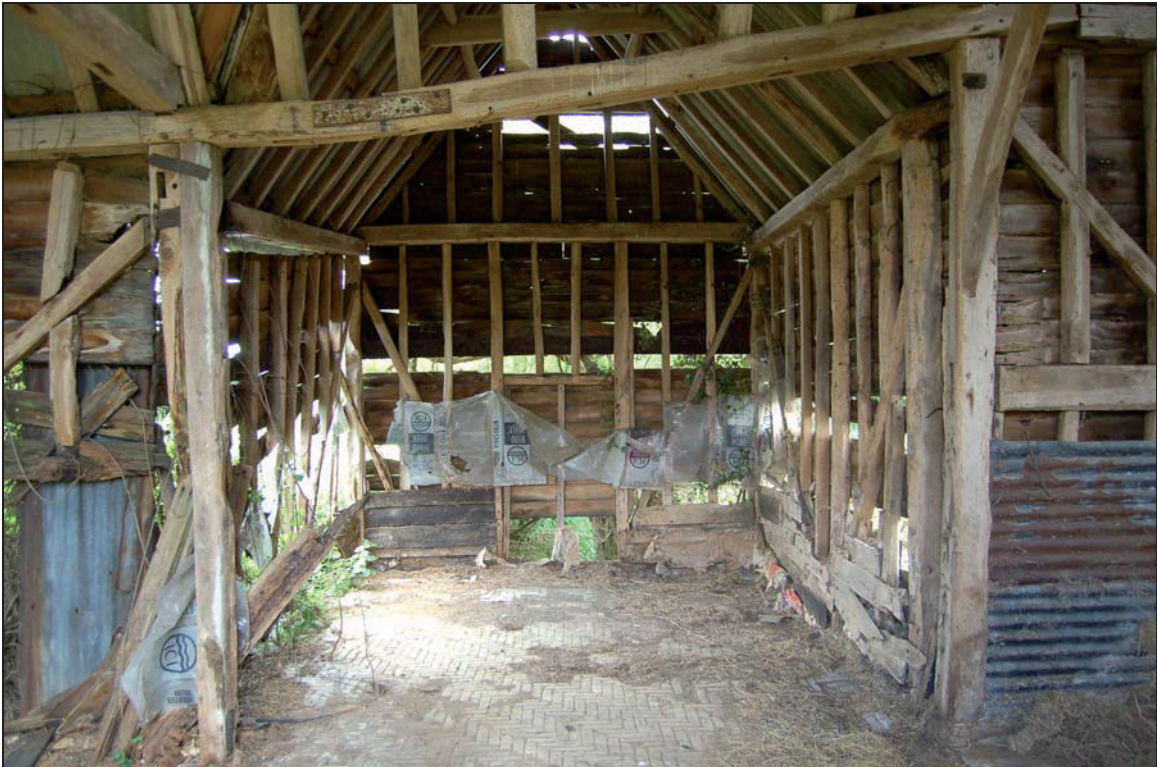
Plate 20 Porch and threshing floor in barn 3

The wall plate between the midstrey and porch is reused from a different building altogether, a close-studded structure predating the barn components. The empty stud sockets have regular pegging (plate 20), a less common practice by the 17th century. The plate is sloping down to the east side, with the movement in the building, loosening its purchase in the scarf joint on the west side of the porch (plate 20).

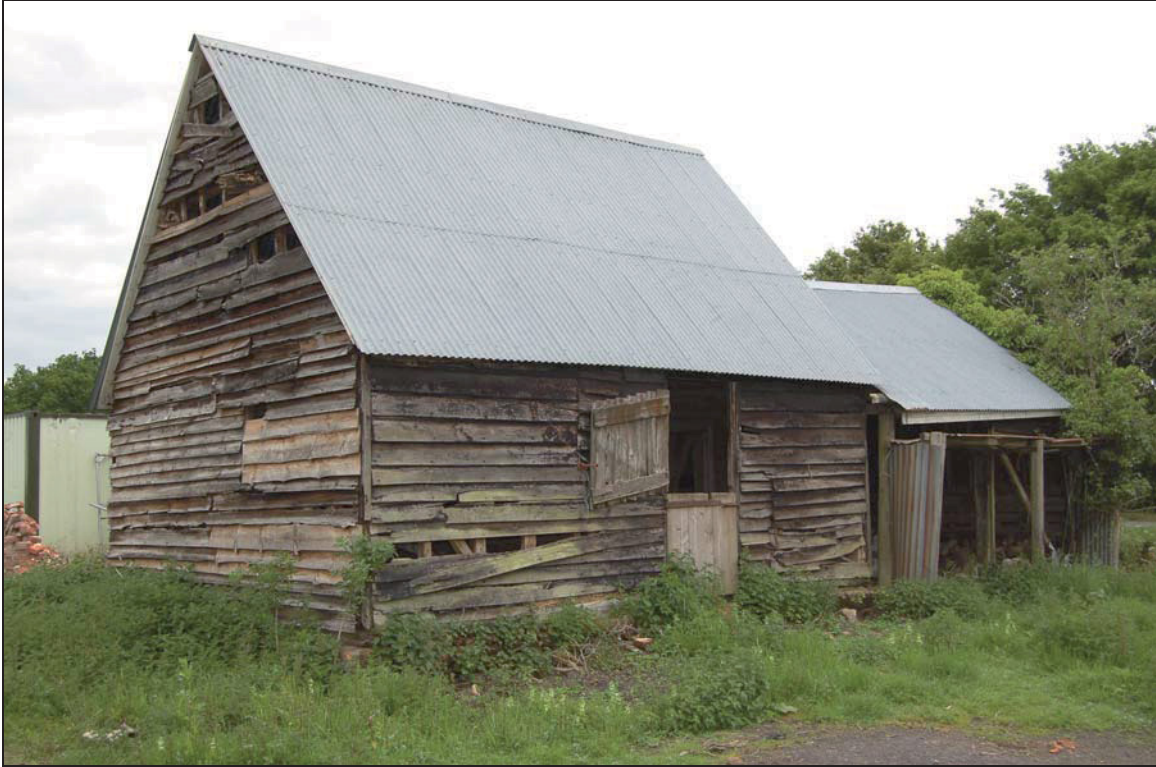
Plate 21 Stables and feeding shed viewed from yard (south-east)

The main eastern elevation contains a central half-heck door that provides entry into the stables (plate 21), above a worn brick threshold. The shed is open-sided and divided by a central post into two bays. A flat-roofed 'pole-porch' has been added at the front, with corrugated tin sides (plate 22).

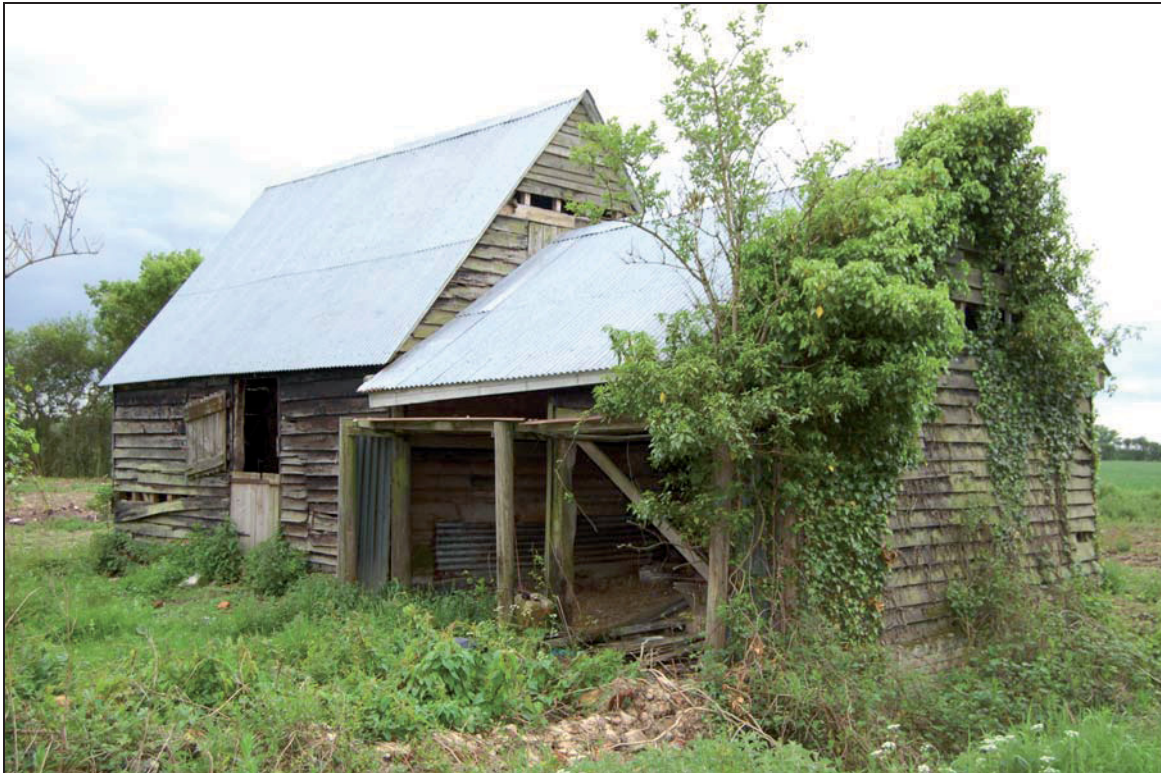
Plate 22 Stables and feeding shed viewed from north-east

Up in the weatherboarded north gable of the stable is the door into the former hay loft, now partly blocked by the re-built shed roof (plate 22). The north wall of the shed has been re-built to the lower roof pitch, while the elevations to the south (plate 22) and west (not shown) are in poor condition and show no features of interest.
