**HISTORIC BUILDING RECORDING & ARCHAEOLOGICAL
MONITORING ON FARM BUILDINGS AT FYFIELD HALL
WILLINGDALE ROAD, FYFIELD
ESSEX**

May 2009

Prepared By: Andrew Letch Position: Project Officer	Signature: Date: 14th May 2009
Approved By: Patrick Allen Position: Project Manager	Signature: Date: 14th May 2009

Document Ref.	1889rep
Report Issue Date	14th May 2009
Circulation	Integra Group Ltd
	ECC Historic Environment Management
	Essex Historic Environment Record

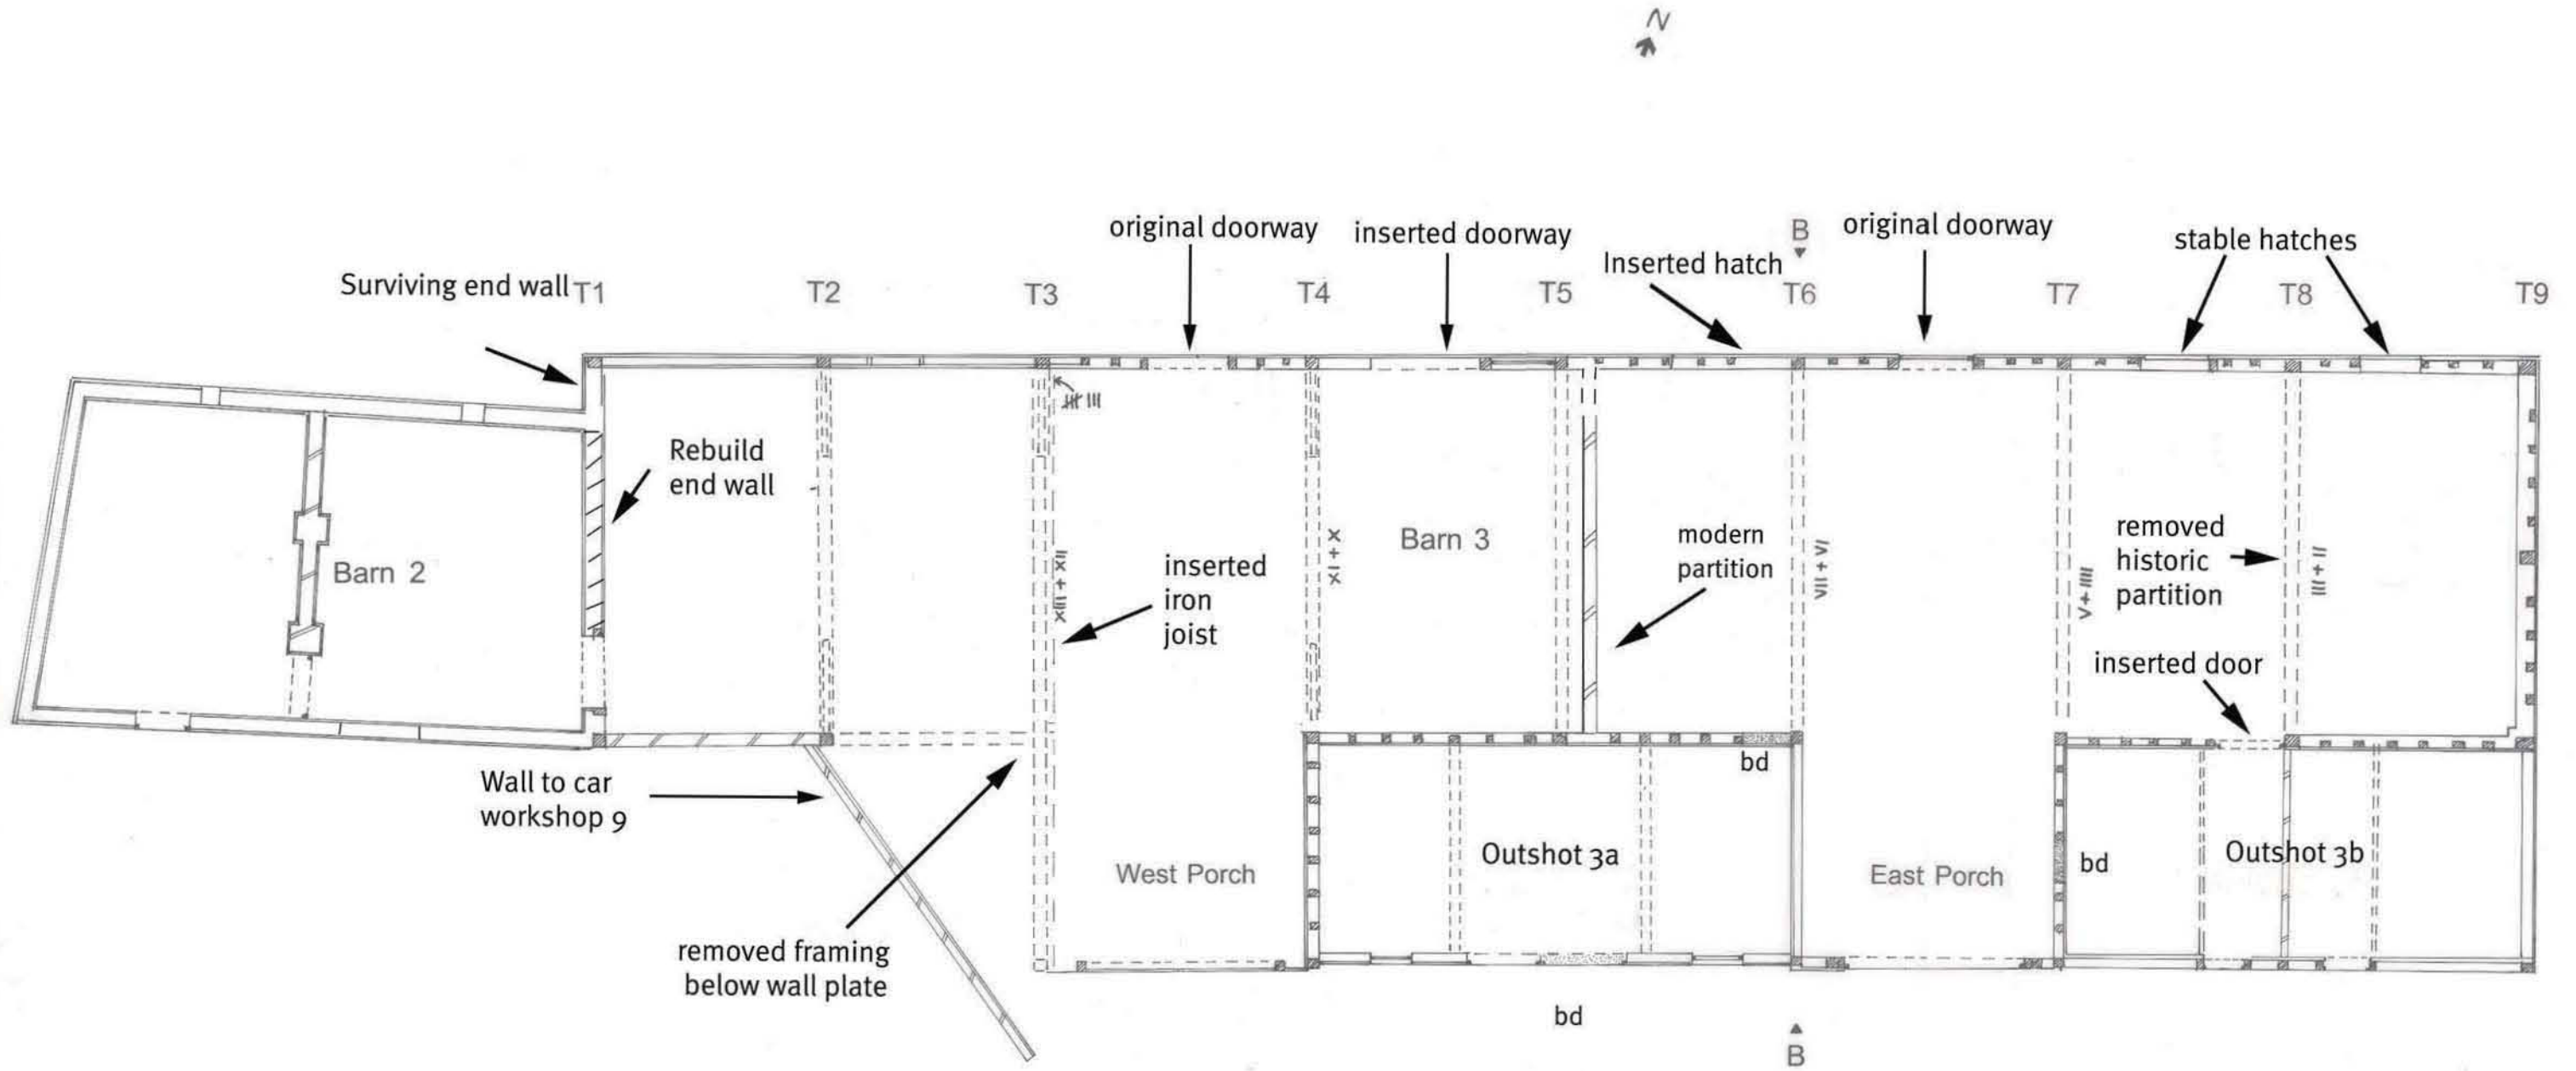
Fig. 11 Plan of Barns 2 and 3

The structural timbers are in good condition, though the end west wall against Barn 2 has been largely rebuilt and the front walls between Barn 2 and the east porch completely removed, along well as the porch wall on this side (fig. 11). Despite these alterations, much

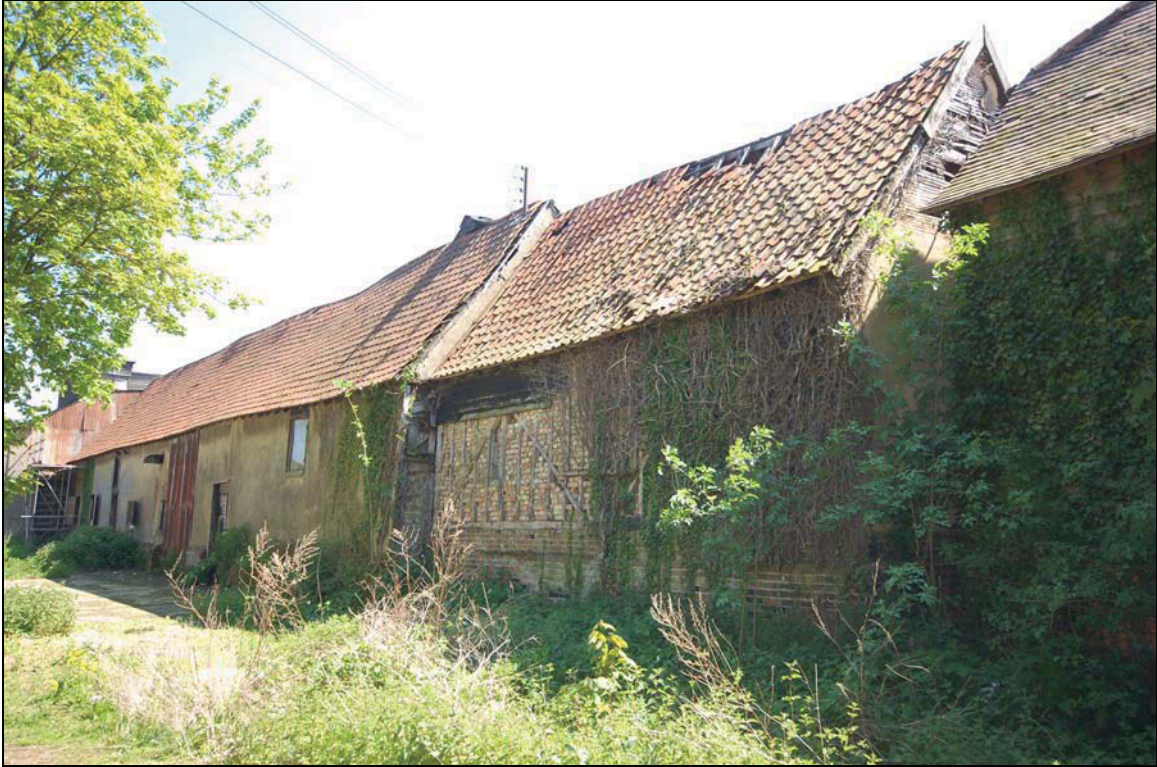
Plate 5 Barn 2 viewed to south east with Dovecote 1 and Barn 3 either side

The long sides are clad in weatherboarding which has largely fallen away or covered in ivy on the north side to expose a primary-braced machine-sawn timber frame with later brick-noggin infill (plate 5). Two small apertures exist midway on the north elevation, one in each bay, perhaps for grain feeds, but now blocked from the inside. Due to the southern elevation being enclosed behind Shed 9 this information was initially missing. However, once shed 9 had been demolished and the boarding stripped back, a similar pattern emerged, although it was clear the timberwork (studs, bracing and wall plate) was more substantial and comparable in size to Barn 3, perhaps being reused timbers (plate 6). A blocked window was discovered along with an original doorway only partly observed before. Perhaps the frame this side was exposed, which would match with the main barn.

In contrast, the end wall, the western gable, has a thick daub coating, applied on laths cracking and falling away at the top but relatively intact below thanks to its close proximity to the Dovecote (plates 5 & 6). It would be surprising if other walls were not treated the same originally.

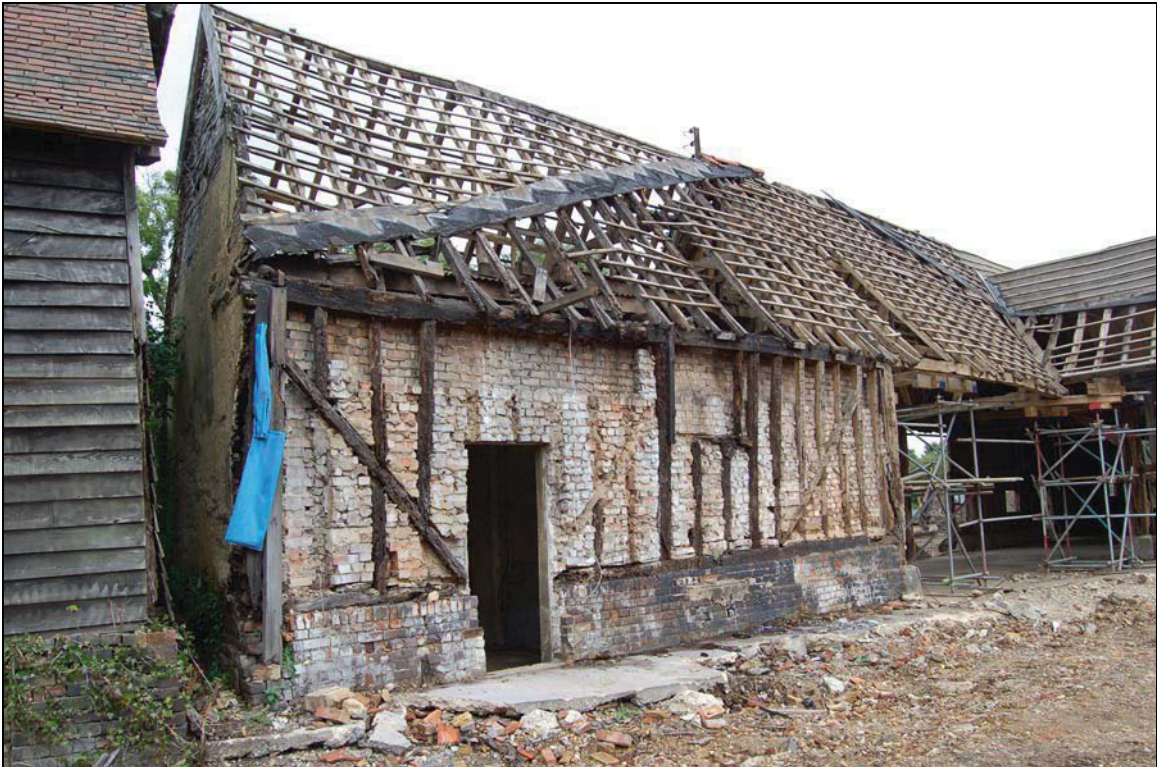
Plate 6 Barn 2 viewed to north-east after removal of Workshop 9

At the north end, Workshop 9 is built up against Barn 2 and their proximity has caused damp to be trapped within the older barn wall.

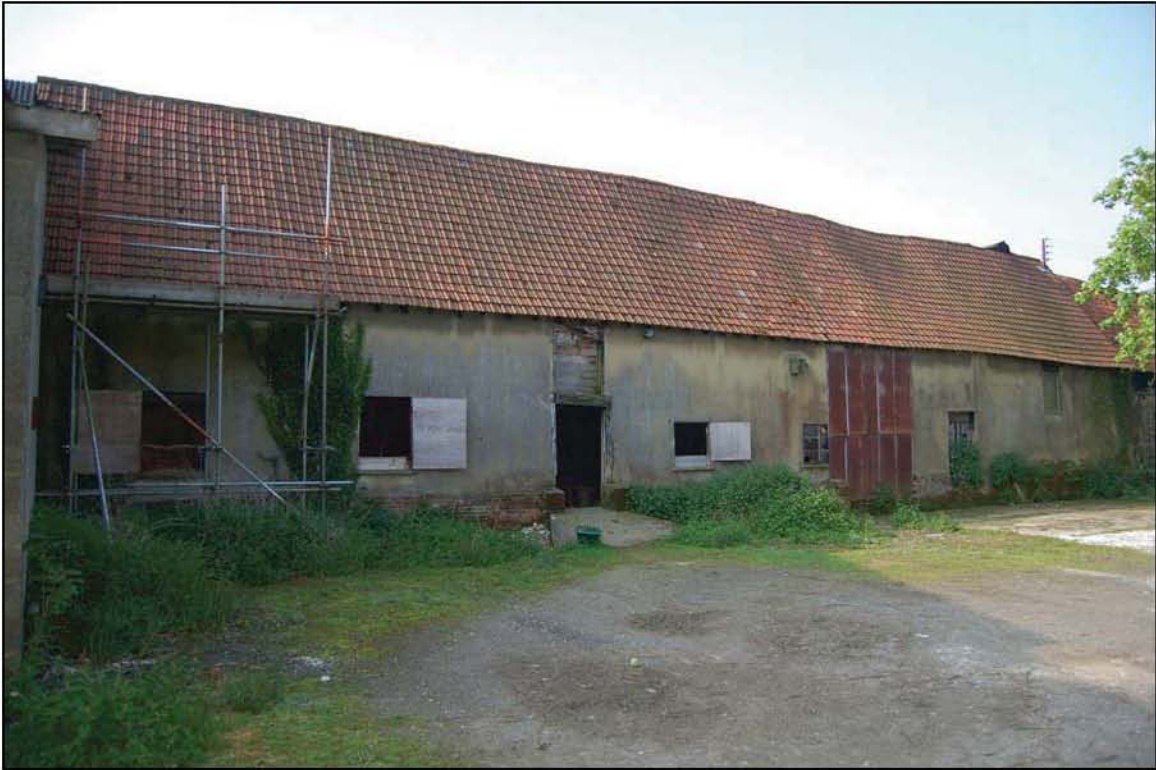
Plate 9 North elevation of Barn 3

The rear, or north elevation (plate 9), has a 0.80m high red brick plinth containing some reused brick and later Fletton repairs. All the weatherboarding has been removed on this side and cement render applied to the walls, hiding the frame, perhaps part of the 1975 refurbishment of the farm. The east end, which houses the stables, retains few identifiable early features apart from the doorway facing the east porch, remodelled with the insertion of a new frame and door and a blocked loading door above (fig. 10). The 'plywood' hatches on either side are inserted features, relating only to the former stables (Letch 2004), one per stall. The west side retains its porch-facing doorway which is now boarded over and was not constructed with a loading door above. A larger opening has been created in the next bay for vehicle access onto the hardstanding outside, but is now covered over with corrugated iron sheeting (plate 9). Otherwise, the only other features are inserted iron-framed utility windows.

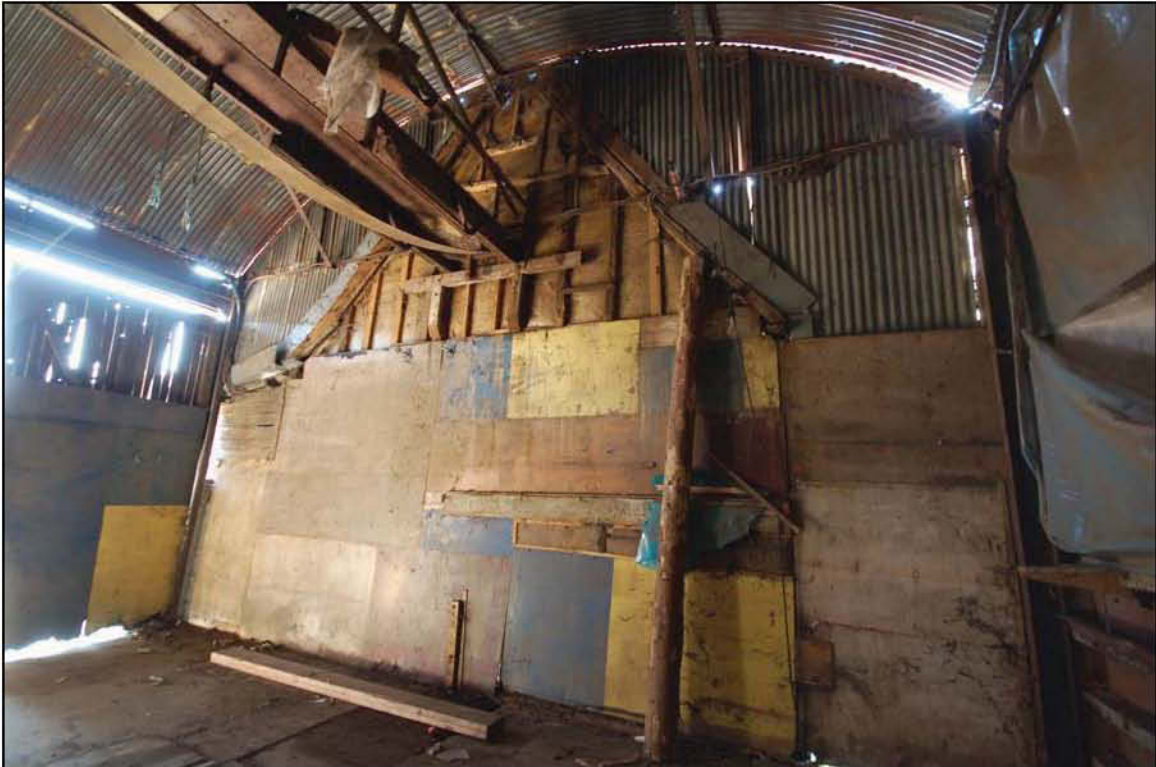
Plate 10 East wall of Barn 3 enclosed within Grain Store 13

While the western wall is rebuilt and clad in concrete, part of the east wall remains visible inside Grain Store 13 (plate 10) which is built onto it. It would seem that the weatherboarding this end has been replaced by a haphazard series of boards nailed to the frame. About half the studs remain in the gable but it is clear that the collar and other timbers were removed,

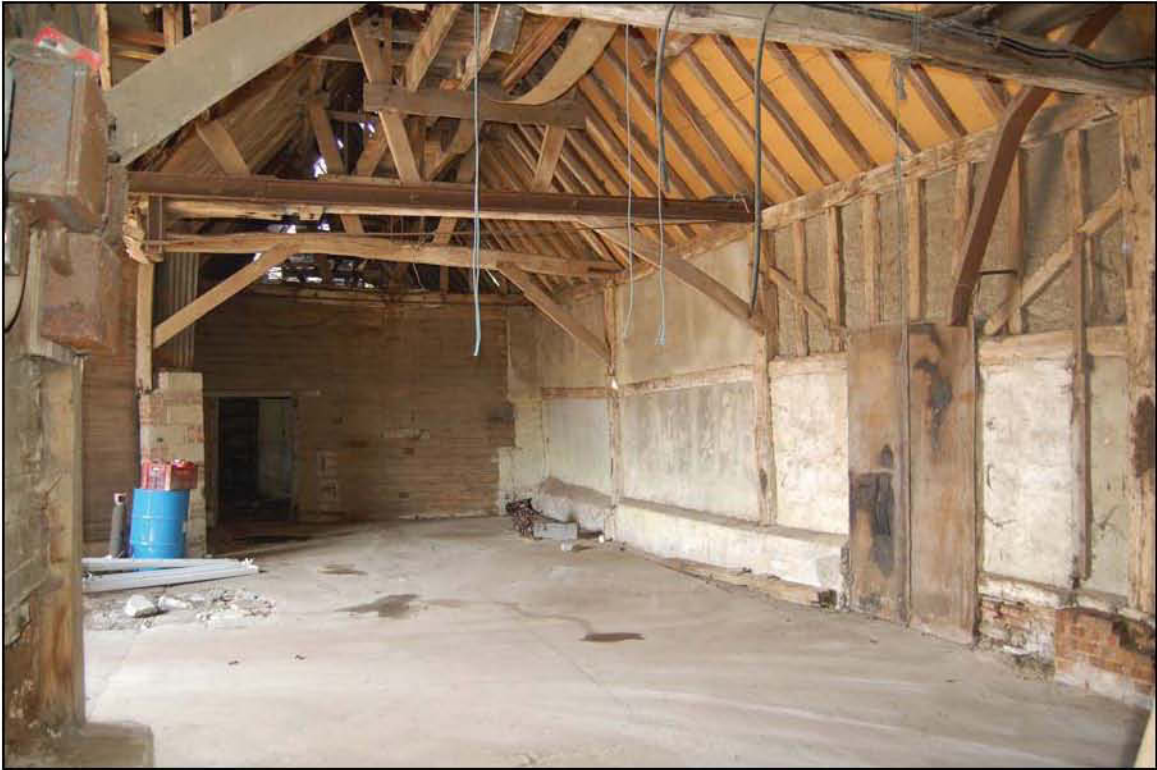
Plate 11 West side of Barn 3 viewed to west end

The west wall partially survives above the midrail where it is not attached to the rear of Barn 2 (plate 11). The outside formed the east wall of Barn 2 and has been lined out in brick and plastered over like the rest of the interior. It is unclear how much, if any, of this wall is original as limited inspection through boarding on the inside of Barn 3 found modern timber and injected concrete fill behind the boarding, viewed as contemporary with the building of Workshop 9.

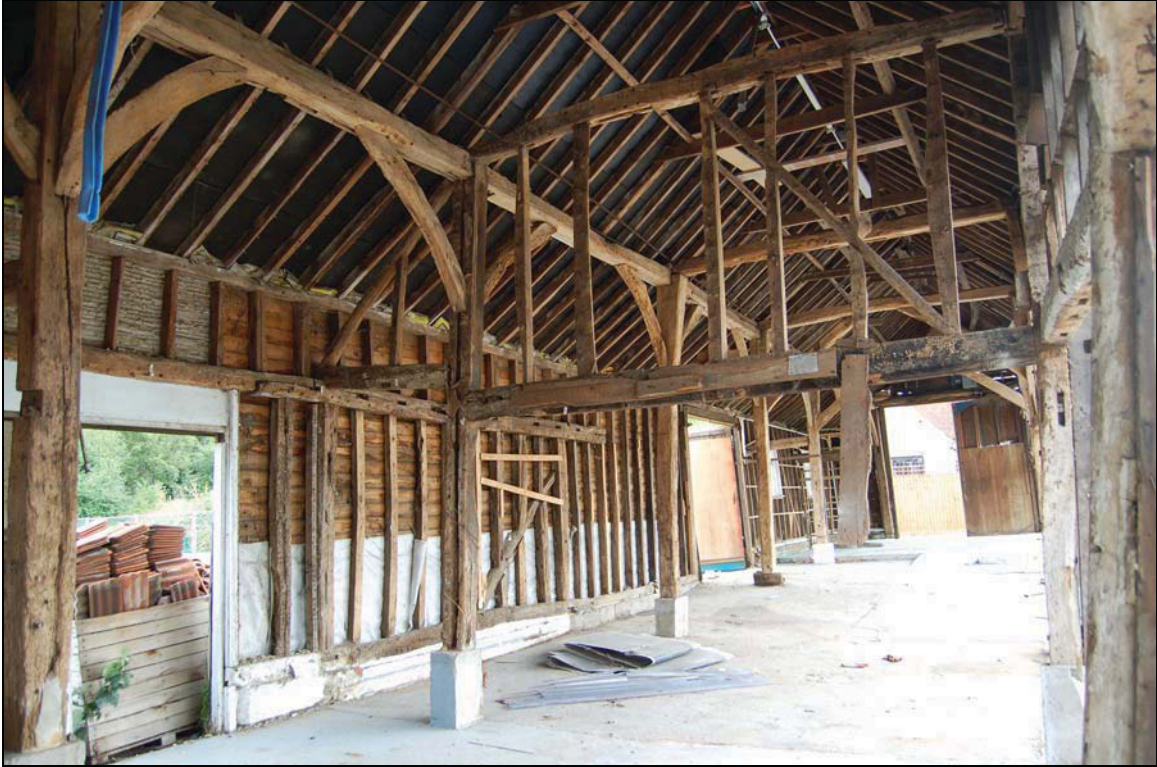
Plate 21 Partition and original aisle wall viewed to south in Barn 4

Within the aisle space, all except one of the aisle ties (T4) remain, most of which serve no structural purpose in the rebuild. The only ones still properly connected to wall plates are at the north end, T1-T3, which are slightly lodged over the plate (fig. 13, plate 21). A possible aisle sole plate is embedded in the concrete floor around the T7 post (plate 21) and elsewhere slots occur in the aisle wall plate where they are missing (plate 21).

Only the three northern bays along the eastern aisle wall are original (plate 21); the other bays were rebuilt when the aisle was raised by 0.7m with the addition of machine-sawn studs during the roof replacement phase. The remaining wall plate at the north end is crudely connected using an un-pegged lap joint (plate 21) rather than properly scarfed, which is unusual given the good quality joinery to the arcade plates.

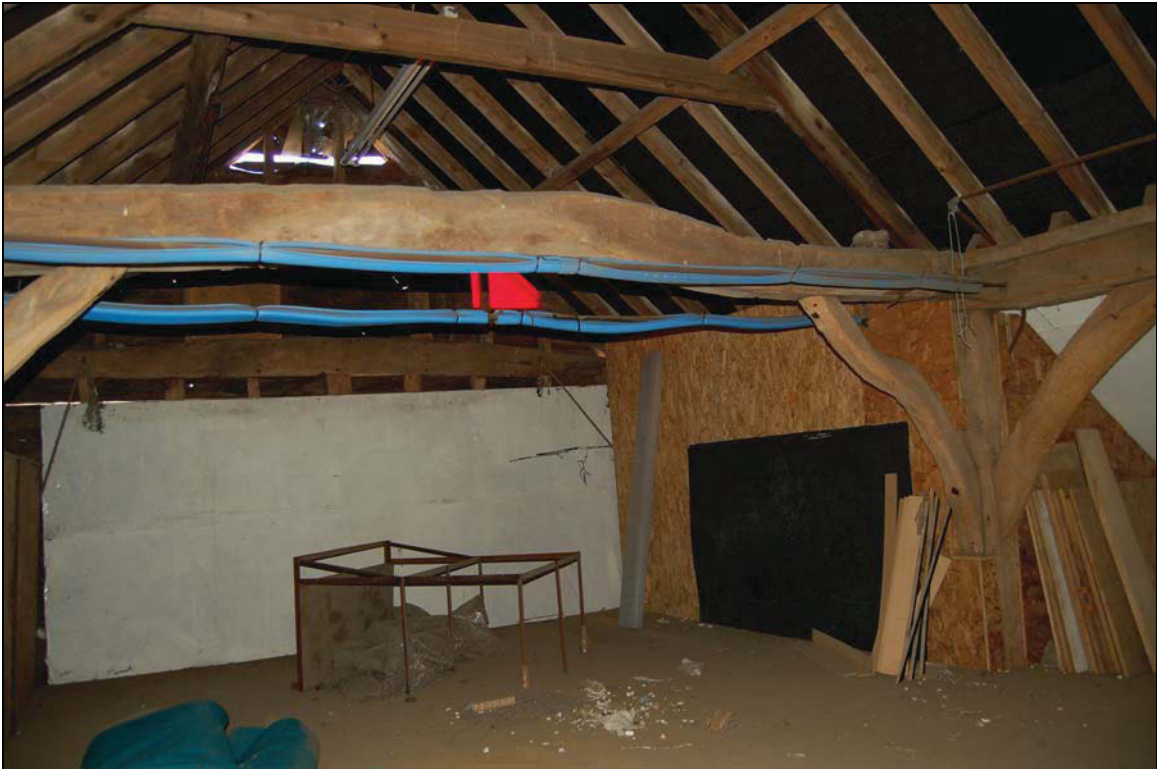
Plate 24 Crude bracing in northern bays

The main framing has c.18cm-wide bay posts with gradually-swelling jowls and slightly-curved braces double-pegged to the tie beams that are strapped to the wall plates (plates 20 & 22). To the north of the midstrey, the bracing has been removed and in T2 (fig. 13) replaced with cruder hedgerow-derived versions (plate 24, Appendix 1).

The N penultimate truss has a clearly replaced brace between arcade post and tie-beam as it is essentially a hedgerow misshapen member. More investigation might reveal further evidence in the barn but it is likely to have been severely reduced. The S end gable is all rebuilt in the C20 with a full-height 2-leaved door cut into the end wall.
