THE KING WILLIAM PUBLIC HOUSE CHURCH STREET BOCKING ESSEX

LEVEL II HISTORIC BUILDING RECORD

October 2009

Document Ref.	1979rep
Report Issue Date	9th October 2009
Circulation	Mr John Whitehead on behalf of
	Cambrils Ltd
	ECC Historic Environment Management
	Essex Historic Environment Record

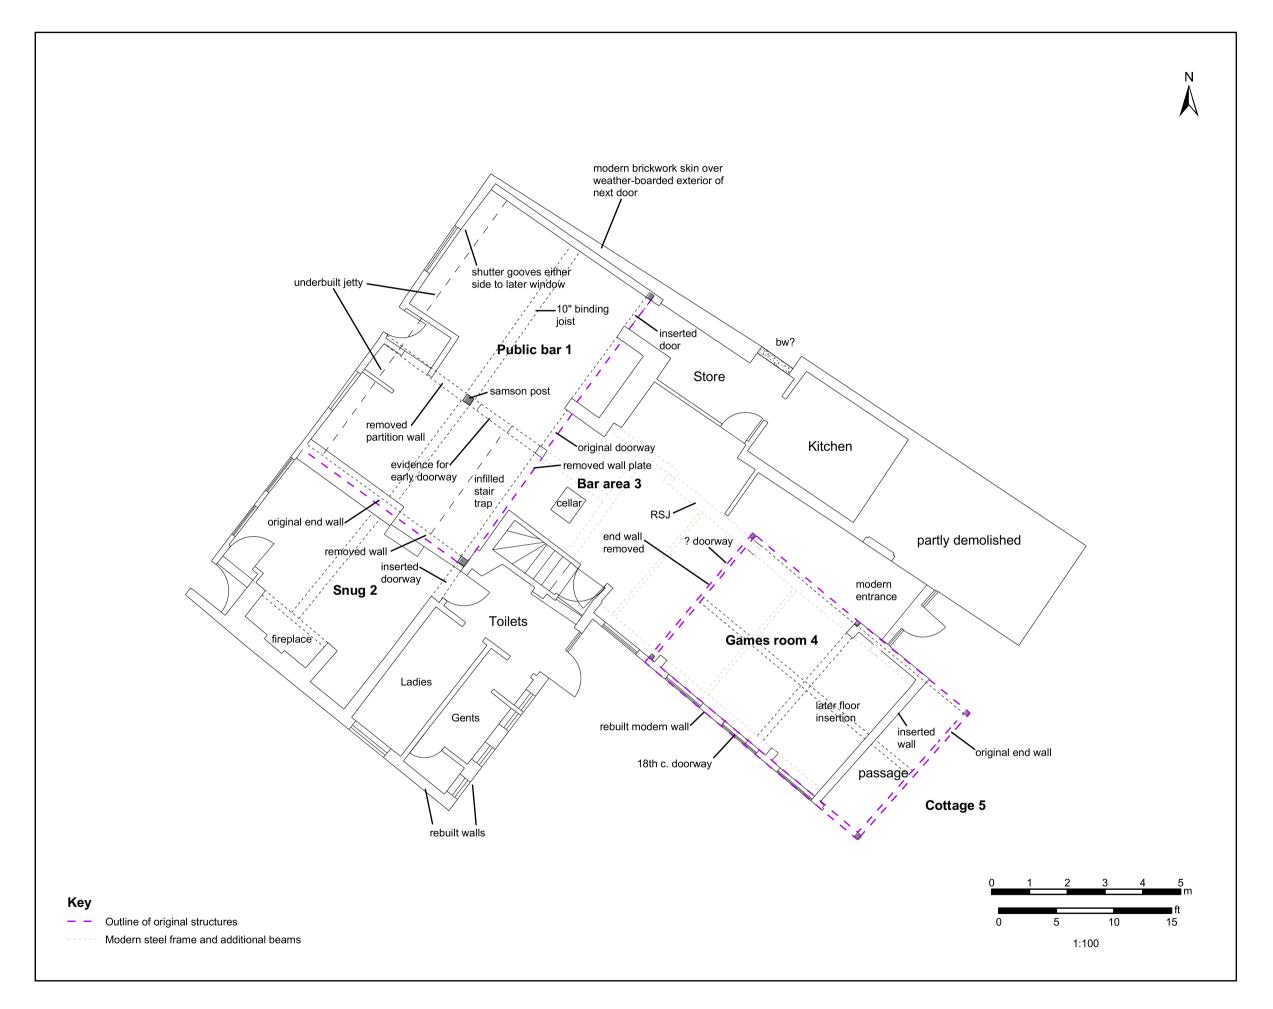
Fig.5. Ground floor plan of public house showing most recent room functions

The original building (public bar, fig. 5) consisted of two bays divided by a stud wall, forming two chambers. This was removed in the pub era and the ceiling beam propped up by a heavy Samson post (plate 7). A gap in the empty stud soffits of the beam indicates where the doorway into the adjoining room was located (fig. 5). A similar gap in the wall plate in the south-eastern (rear) elevation shows the position of the rear door, facing the main entrance at the front, in the old cross passage form. The doorway on the other side of the fireplace is a later, internal, insertion (fig. 5).

The wall between the bar and snug is the end wall of the original building, which is now hidden by modern walling either side (fig. 5). A large part of this wall was removed to create access into the snug when the two buildings were combined. A heavy bridging joist carries the ceiling across the snug to the brick fireplace at the other end of the room (plate 9). The ceiling here is 0.5m lower where the new end is terraced into the natural slope and built from thinner 5 inch joists. It would appear that the heavy brick chimney inclusive to the build has poor foundations as it is leaning towards the road and taking this end of the building with it.

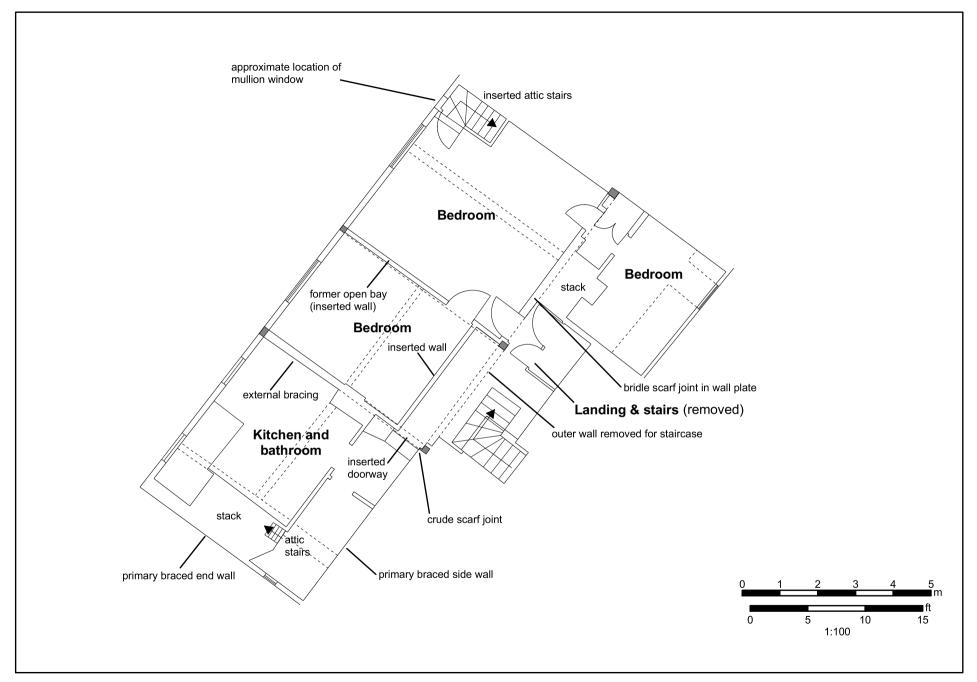
Fig.6. First floor plan of public house

A bridle scarf joint was recorded in the rear wall plate of the main chamber (fig. 6), a medieval form whose attitude shows the building was constructed from the south-west end. In contrast, the wall plates at the junction of the main build and building 2 are butted together rather than scarfed (fig. 6).

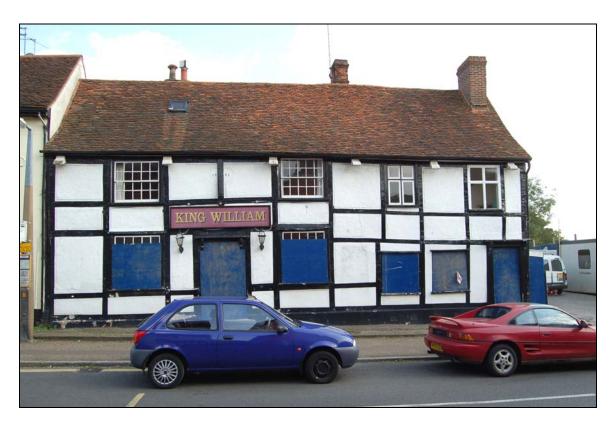
Plate 1 The King William from Church Street (main façade)

The main elevation faces the road and has a plastered front with painted mock square panelling in black and white in plaster/faux-timber (plate 1), though originally the timbers were fully-exposed (plate 2). The roof is tiled and gabled either end with plain chimney stacks.

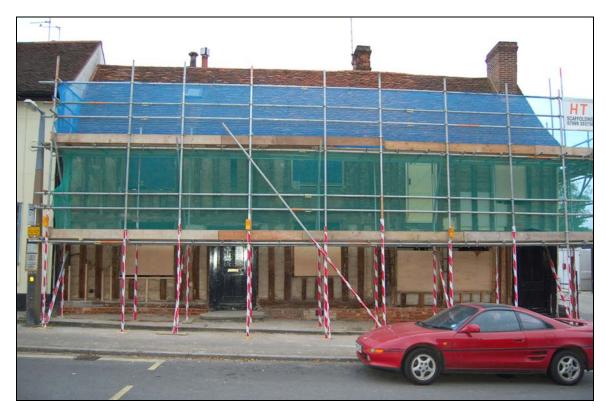
Plate 2 Framing exposed on the main façade

typical of late medieval and early post-medieval construction. Some of these features can be discerned in plate 2, through the green mesh after the front was stripped back to the frame, but better still in the original south-west end wall seen upstairs (plate 3). The 17th-century addition, with its catslide roof (plate 4), is mainly built from primary-braced framing with some evidence of reused timbers.

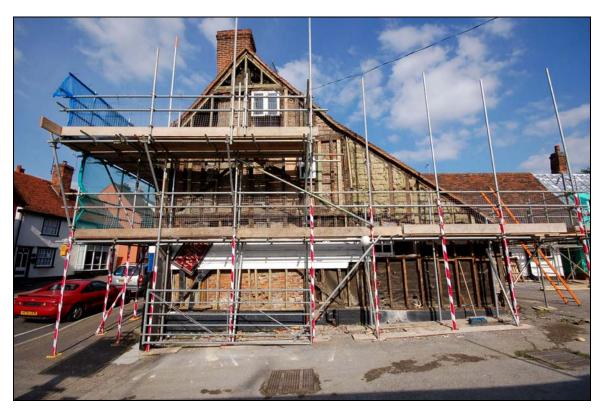
Plate 4 Stripped-back 17th century addition (south-east elevation)

Away from the street frontage, the south-western gable wall building 2 is weatherboarded over a primary-braced timber frame that was exposed during the works (plate 4). Small casement windows light the attic and first floor bathroom. A catslide roof leads off to the back which, although a contemporary feature with it, is entirely rebuilt (plate 6). Horizontal sliding sashes light the ladies toilets beneath the roof, where much of the lower register was underbuilt in modern timbers (plate 4) when the toilets were refurbished in recent years.

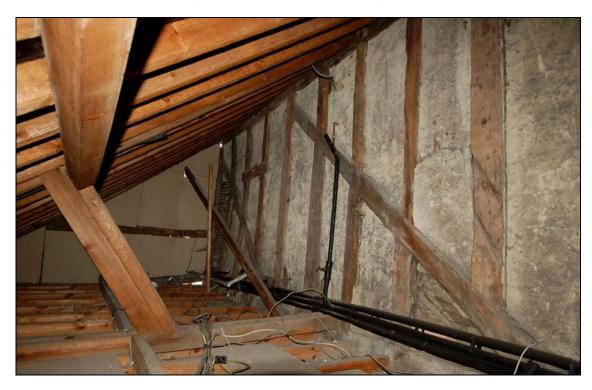
Plate 6 Primary-braced timbers behind the catslide roof

The rear elevation, below the catslide roof, is modern, although the fenestration to the gents toilets has a more 'period' feel. The door into the bar is modern too. A small horizontal sash window to the right of the roof lights the top landing (plate 5) and is likely to be 18th century date. The roof conceals good 17th-century primary-braced framing, containing some reused timbers (plate 6).

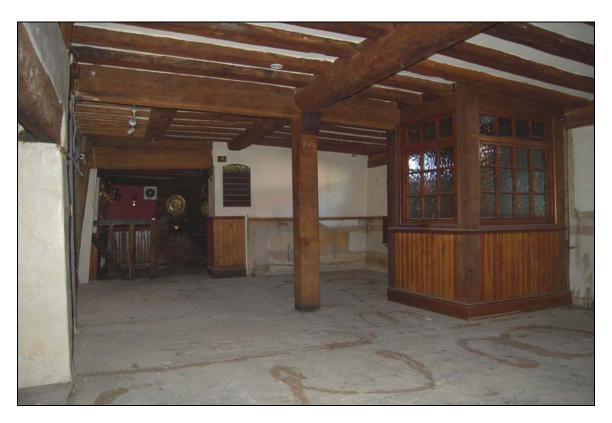
Plate 7 Interior of public bar viewed to south-west (snug)

The ceiling is built from substantial 7 inch-wide oak joists carried on a 10 inch-wide binding joist (plate 7), large but plainly decorated with crude chamfers and plain stops. The original stair trap is indicated by an area of inferior studwork on the second bay, close to the back wall (fig. 5, left hand side of plate 7), and would have led straight up into the hall above (R. Shackle pers. comm.).

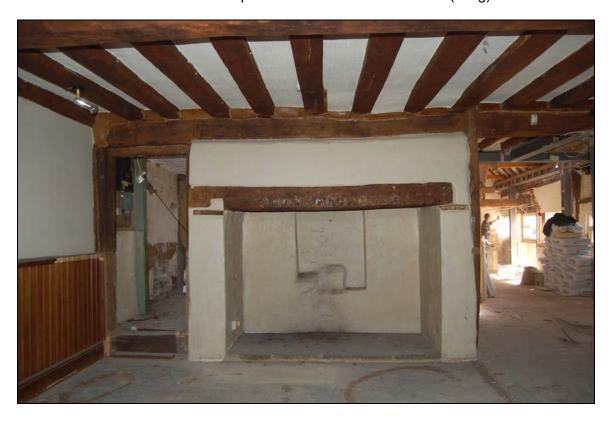
Plate 8 Inserted fireplace in public bar

The large inglenook fireplace is centrally located in the south-eastern wall of the main chamber. This is a later feature, perhaps of 16th or 17th century origin, inserted under the wall plate (plate 8), feeding into with an external stack (fig. 5).

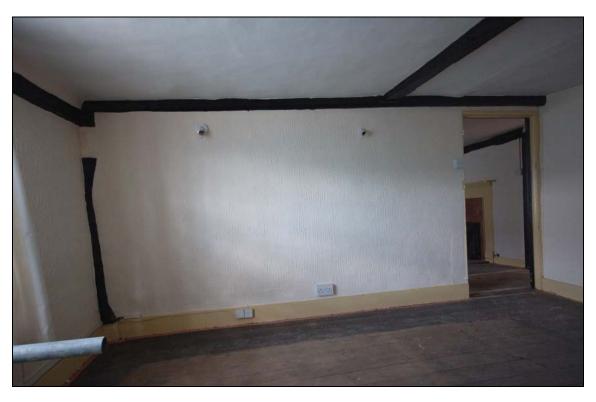
Plate 10 Inserted first floor partition wall

The original first floor held a single large chamber open to a crown post roof (R. Shackle pers. comm.). The open truss has been filled-in to create two rooms (fig. 6, plate 10) but large pegholes exist in the central bay posts for big braces of the sort needed to support a heavy crown post, which was removed when the attic was inserted.

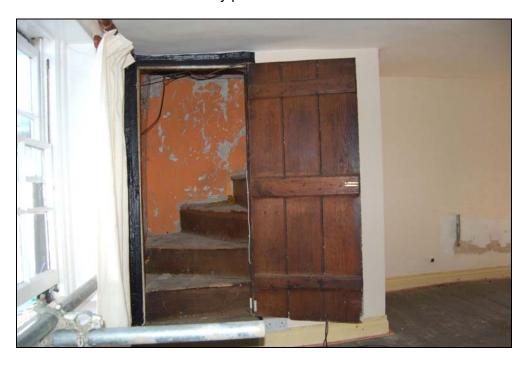
Plate 12 Attic stair (north-east end)

The attic is in two parts, divided by the gable end wall of the original structure. The attic over the main structure was probably introduced when the inn was established, as the boarded stair door and fixtures (plate 12) were common after 1790 (R. Shackle pers. comm.). The attic is divided in two rooms by a studwork/plaster partition constructed from waney timbers similar to those found in the 18th century cottage at the back. The first room has orange-painted hardboard covering the roof timbers but the second room retains a plaster coat and exposed wall framing amongst the modern pipework and water tanks (plate 14). Floor boards are as much as one foot wide (30cm) and underneath the voids between the joists have been filled with chaff husks for insulation (R. Shackle pers. comm.).

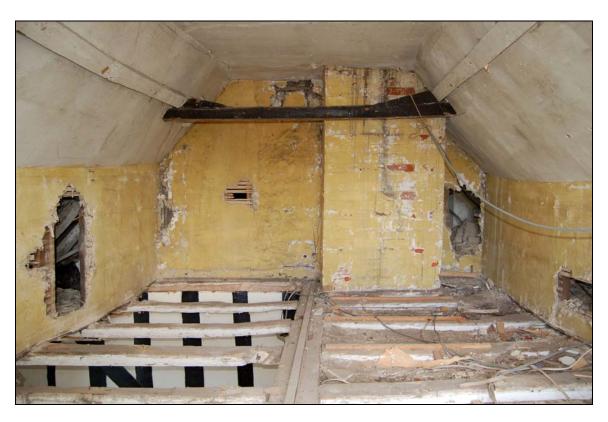
Plate 15 Attic of building 2

The approach to the attic in the 18th century part of the building is more rudimentary, lending support to the fact that this was built as a separate entity. A single flight of stairs leads to the attic, built from square-cut lumps of timber (plate 13); an unusual feature to survive. All of the attic floor has been taken-up to expose the joists, which are attached by bare-faced soffit tenons, indicative of a post-1650 date. The roof structure is rough, with exposed purlins resting on a wide collar braced by diagonal members (plate 15).

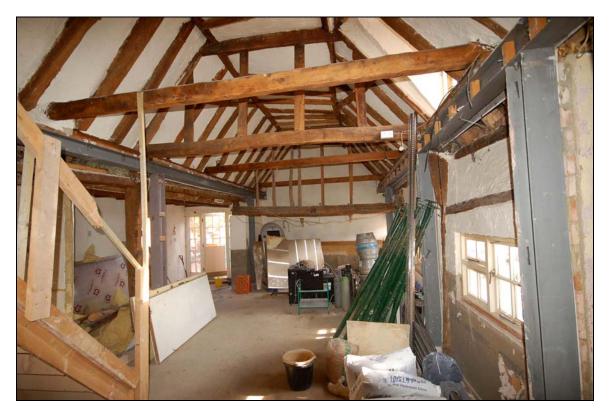
Plate 18 Rear wing viewed towards south-east

An internal steel frame now supports the timber main frame which comprises six jowled bay posts, similar to those in the main structure, plus wall plates. The wall plates show sockets for three widely-spaced studs at 0.75m intervals (plate 19). Only one original tie beam remains, on the south-east bay. This has been dropped from the top of the post and bolted further down to accommodate the 18th century floor over this bay, represented by an inserted bridging joist, waney-timbered partition and remains of a former doorway (plate 18, fig. 5).

Studwork has been removed from the lower part of the front gable (north-west side, plate 18). The studs were pegged and their spacing suggests there was once a doorway towards the north-east. No other features were identified apart from a possible 18th century doorway on the car park elevation (fig. 5).

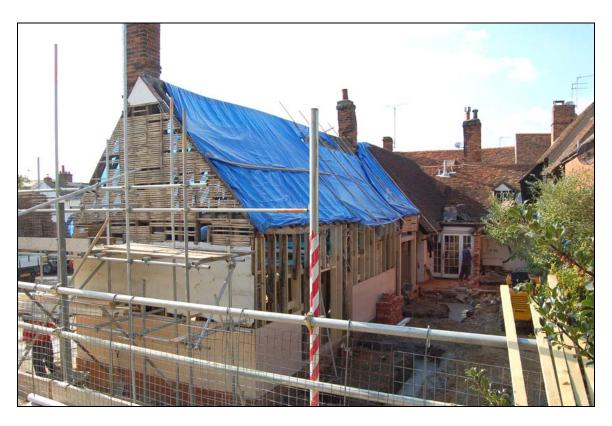
Plate 21 Cottages during refurbishment and rear of public house

The opposing long elevation and the south-east gable are pictured in plate 21, undergoing conversion. The existing floor plans show no openings at the back apart from a single doorway at the north-west end (fig. 7).

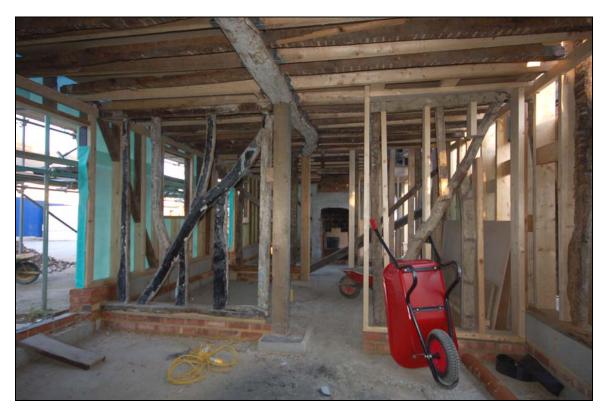
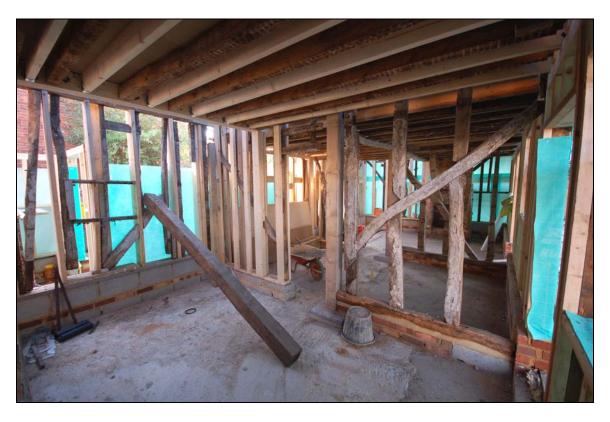
The cottages are built from rough hedgerow timbers and reused pieces. As part of the present refurbishment a new frame was integrated into the old (plates 22 & 23), but during the survey it was clear that parts of the frame had already been strengthened in the same way in the 19th century. There is a particularly crude binding joist in the south-east bay (ground floor fig. 7, plate 22). One original feature to survive was a small two light window on the ground floor (fig. 7, plate 23). The room layouts are identical for each property (fig. 7, but probably relate to later refurbishment (fireplaces, blocked doorways, etc) rather than the more general accommodation expected at an 18th century inn
