**BAKERS FARM, ROMAN ROAD
MOUNTNESSING
ESSEX**

HISTORIC BUILDING RECORD

Revision 1

October 2009

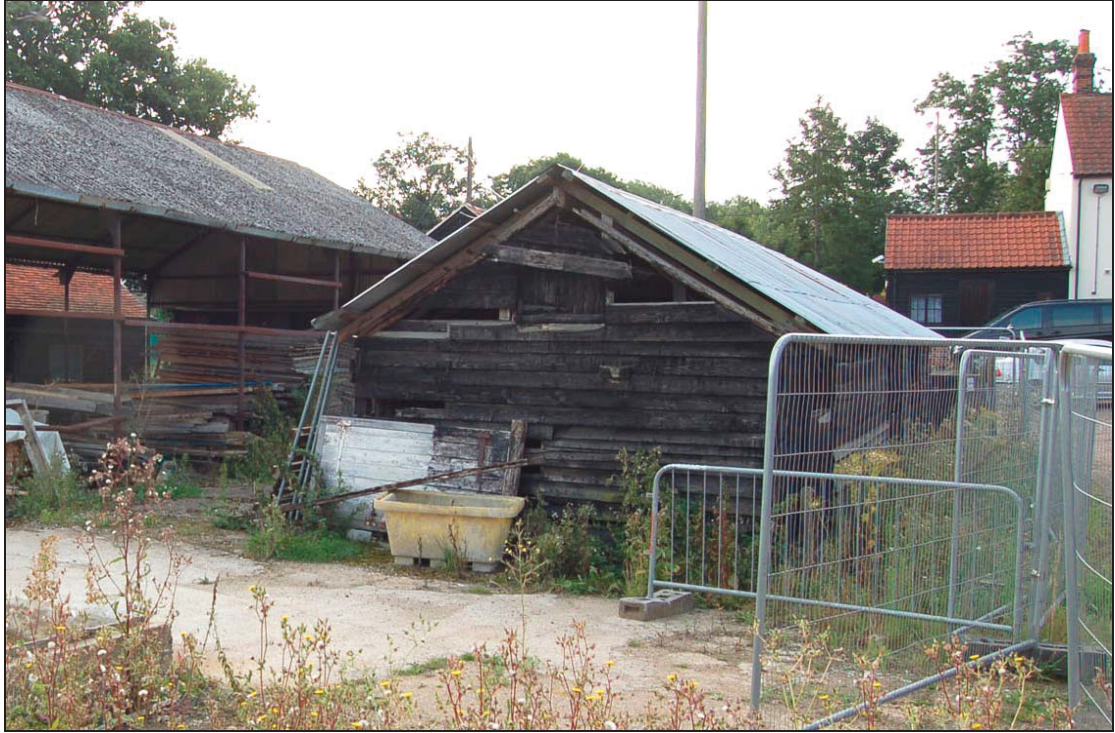
Plate 7 Nag stable viewed to south-east

This is a lightly-built rudimentary structure of four bays that stands in the centre of the yard (plates 7 & 8). It dates to the 19th century (pre-1874) but its low quality construction makes it unlikely to belong to the early 19th century phase. In fact the crudity of the structure makes it difficult to properly date. It is in very poor condition and has a pronounced 'lean' to the north-east. It has clearly been disused for some time. The bottom parts of the walls have rotted away and now rest on a concrete plinth. Much of the exterior is overgrown and fenced off from the yard in case of collapse.

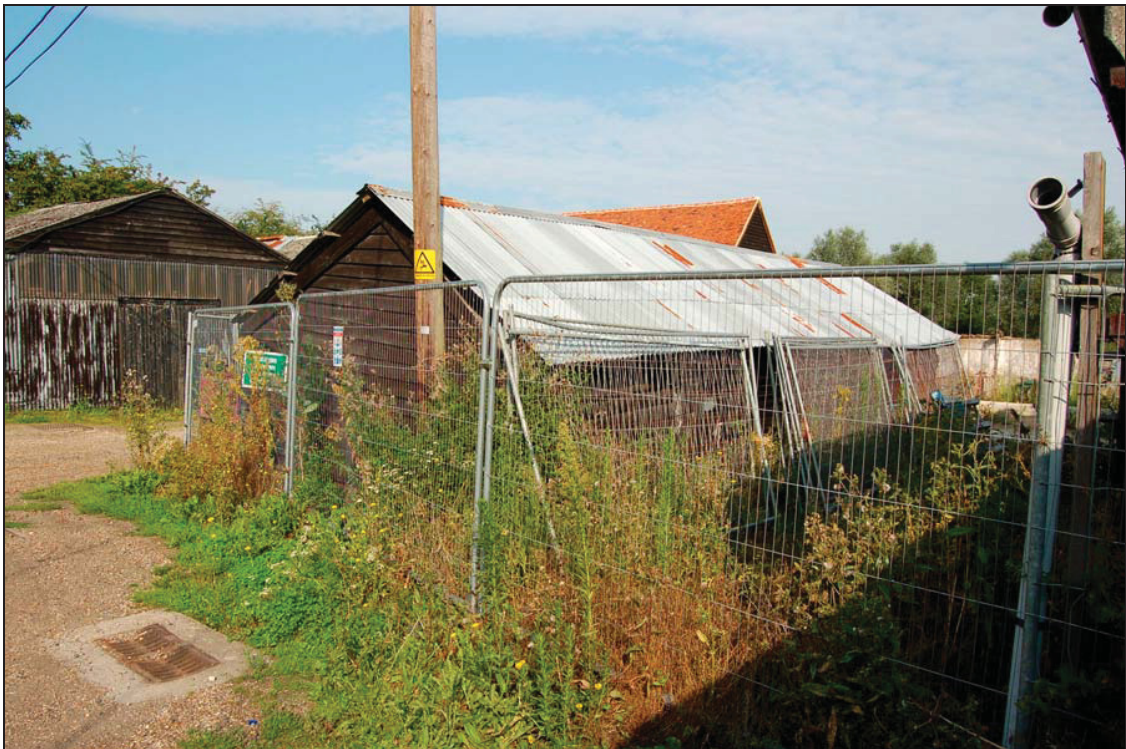
Plate 8 Nag stable viewed to west

In form it is a linear single-storey structure with dimensions of 11.5 by 4.2m, gabled either end and standing on a north-west to south-east alignment. Entry is to the south-west by three heck doors that lead into three stalls: a large two-bayed stall and two single-bayed ones (fig. 9). The old doors have replacement modern fixtures. A pitching hatch is located in the north-west gable (fig. 9, plate 7) but there are no other apertures. The roof is pitched at 35° and has a corrugated iron covering (plate 8).

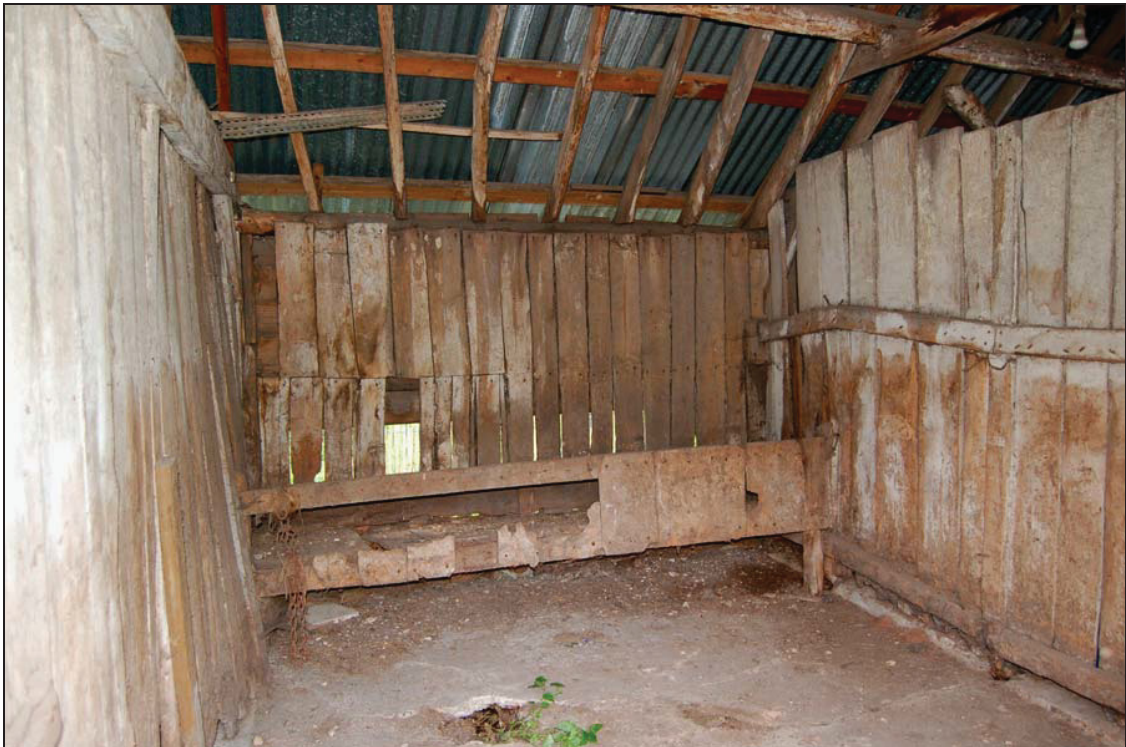
Plate 10 Feeding trough in central stall

The interior comprises a two-bayed stall at the north-west end and two single-bayed ones, each equipped with a feeding trough, though little remains of the trough in the main part. The walls are lined out in long 9 inch-wide planks to eaves level (plate 9) and so are the partitions, nailed to roughly-cut rails (plate 10). Where boarding is missing, it has been replaced with corrugated iron sheets. Each stall was originally equipped with wooden troughs, though only those in the one-bay stalls remain intact. They are constructed on a timber frame using the same boarding as the walls for the front and base (plate 10).

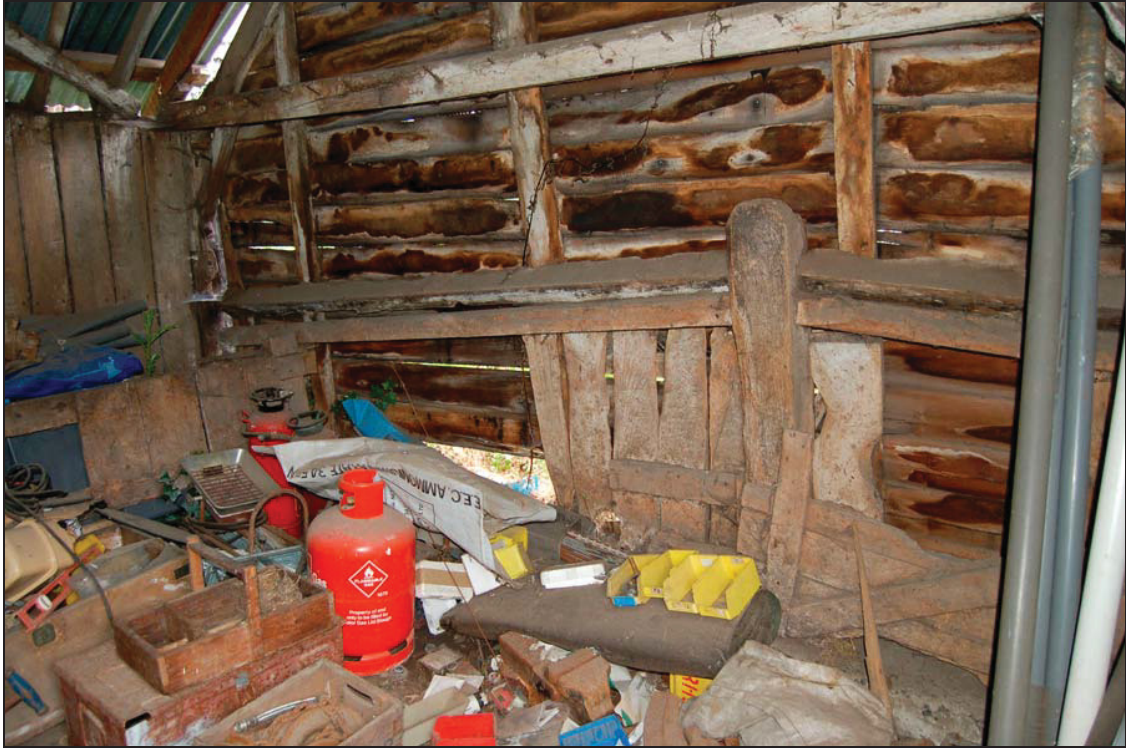
The main focus of the survey was the old nag stable (building 3). The low-quality of the build is in marked contrast to that of the barn and granary and also the fact that it is built onto the old stock fences indicates it was constructed after the existing farmstead was established. In this aspect it is an unusual feature in its unplanned origins and low-quality construction and this justifies the higher level of record required by the working brief. It is also the most vulnerable of the group. A visual inspection by MBP structural engineers reported the structure to be in very poor condition and that any attempt to refurbish it would compromise its historic value.

Plate 11 Nag stable wall built onto existing stock fence

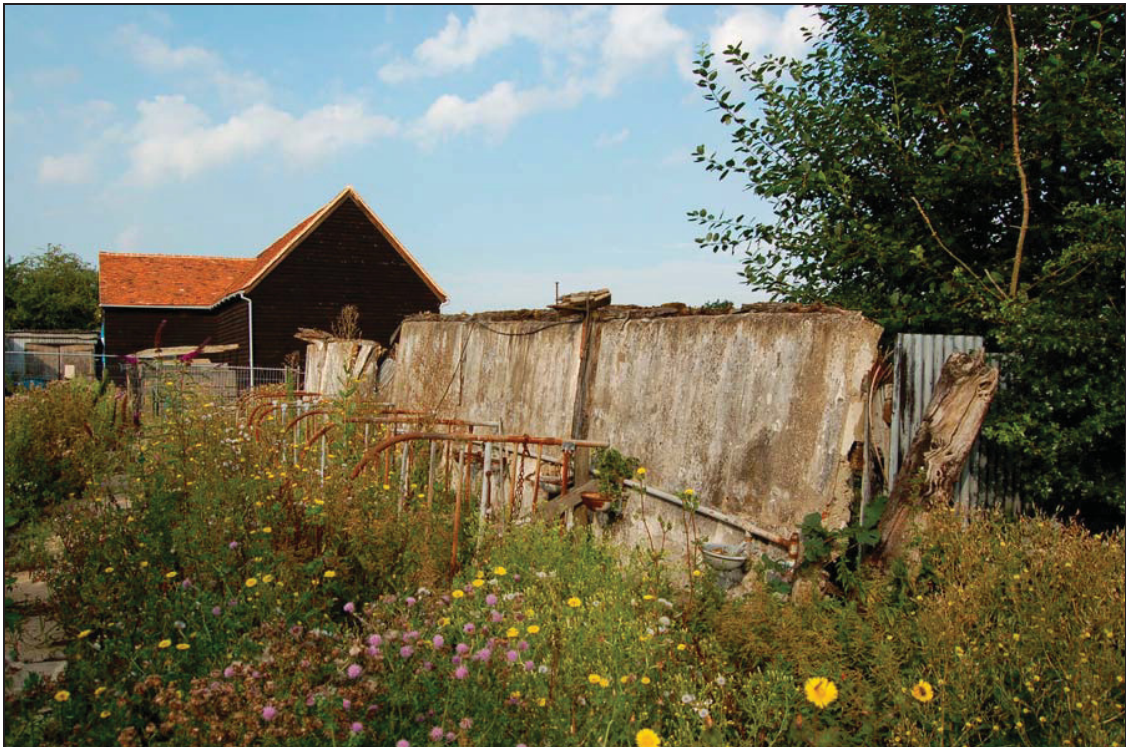
Plate 12 Derelict shelter shed viewed to west

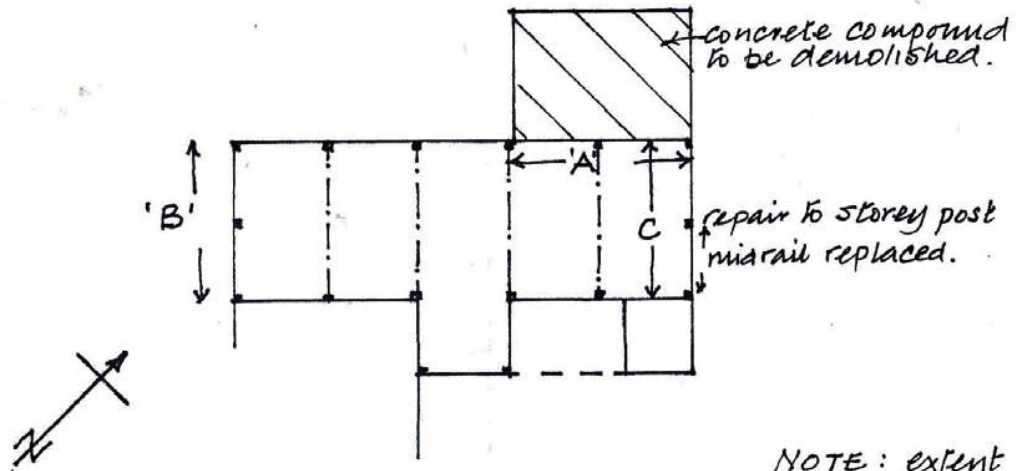
NOTE: extent of assessed once the compound has been

- Repair methodology:
1. repair storey post 'A'
 2. replace primary brace & framing.
 3. scarf & replace cill plate.
 4. rebuild brick plinth.

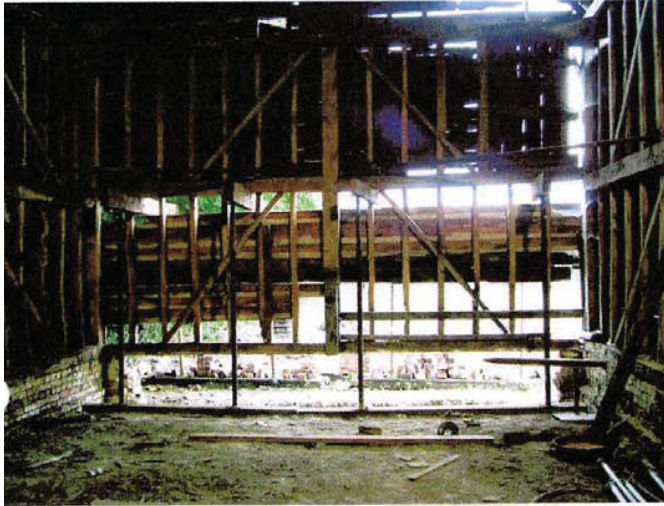
View to south end gable with plinth taken down and frame supported from mid rail.

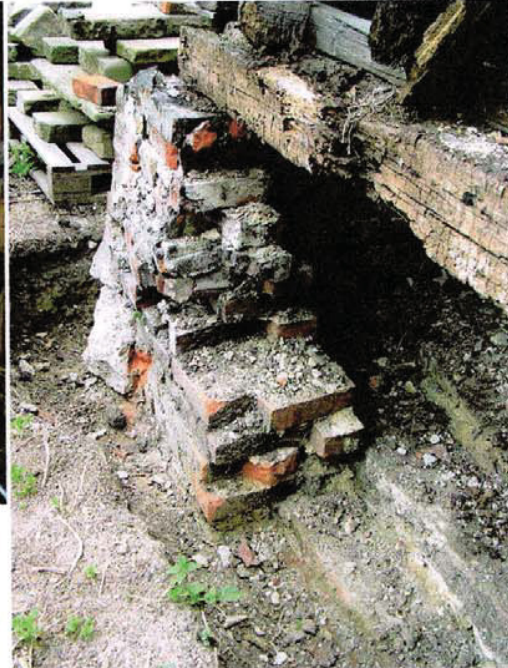
The first investigation was at the western end where the brick plinth was rolling out from the frame. Close investigation showed that this was mainly caused by a possible mistake in the original build that left the end gable wall of the barn supported on the outer edges of the plinth.

South-west corner showing plinth bearing on wall. This is the main cause of the plinth failure at this end.

The barn wall was supported by timber cross beams and the plinth carefully taken down. Below original floor level and inside the outer wall face were brick courses proving that they had to stretch the plinth to meet the timber frame leaving the outer face with little ground support. At this stage the Morton Partnership was consulted on the structural integrity of the end and what may be needed to provide a sound plinth structure. The outcome was a shallow bed of limecrete with long stainless steel reinforcing that would create a base that would accommodate any further ground movement that may occur. On this the plinth was rebuilt in the correct position to provide an even load from the end gable wall. As the sill plate of this wall was badly eroded along with the lower part of the main central post and the NW corner post, these were cut in and repaired as necessary with traditional scarf joints. The rest of the end frame infill was checked and one primary brace and some studs replaced. Replacement sections of the north and south sill plates were fitted at the same time. The wall frame was fully assembled and set back onto the plinth. This wall has now been boarded to provide structural stiffness to the frame while repairs continue along the main walls of the barn. The north-west wall timber frame has been repaired in a similar way. The only change to the original schedule was that the main intermediate storey post at the north-west end had to be replaced to full height. Replacement pieces of timber have been scarfed into the midrail to either side as necessary. The removal of the concrete slurry tank enabled a more detailed examination of this wall and the plinth has been partially rebuilt using the original bricks and the sill plate replaced. (This had been partially cut through and removed at an earlier change to the barn). The whole side has been boarded in readiness for new weatherboarding. Cladding of the southern gable is now taking place. The work schedule for 2007 is to repair the rest of the frame as necessary with a minimum replacement of original timber.

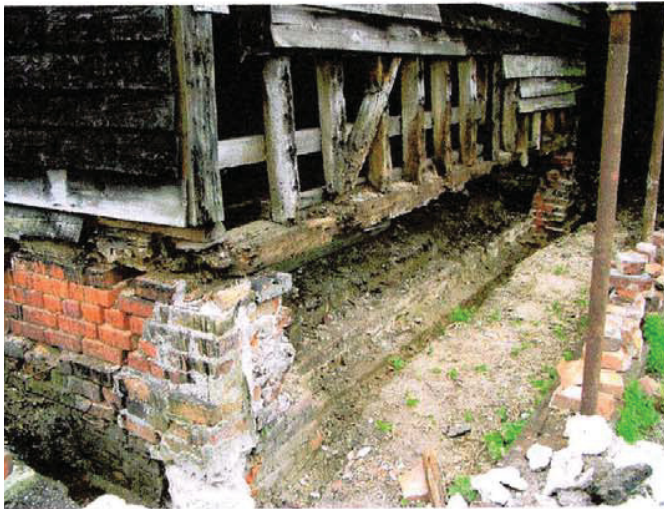
Outside view from the south-west showing full length of plinth wall and the badly eroded timber to sill plate and corner post.

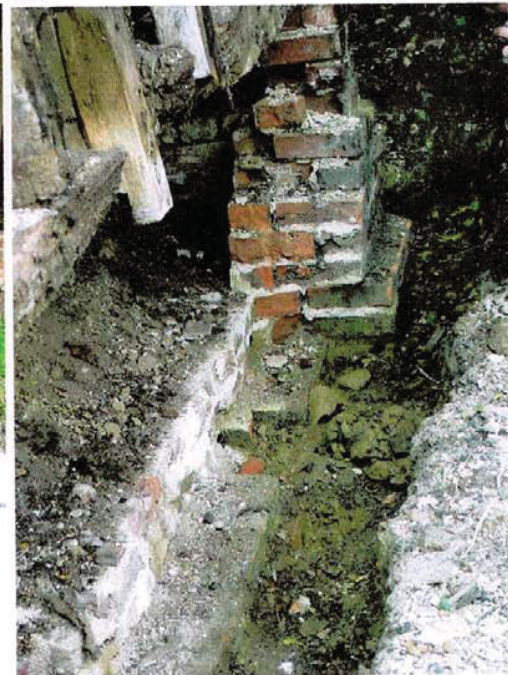
View to south corner showing plinth out of line with frame above.

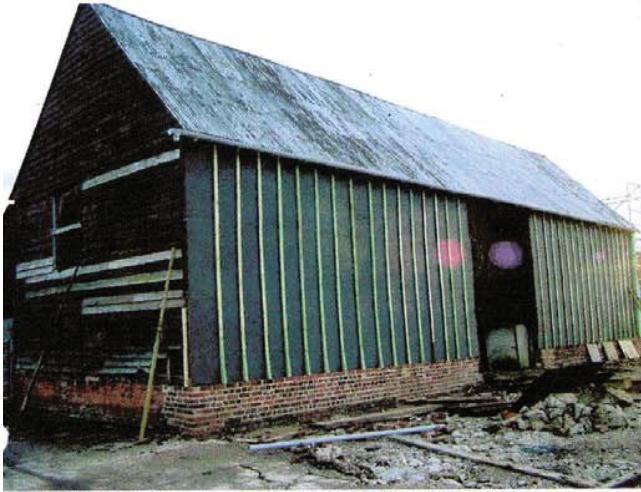
Outside view of north-west wall, repaired and boarded.

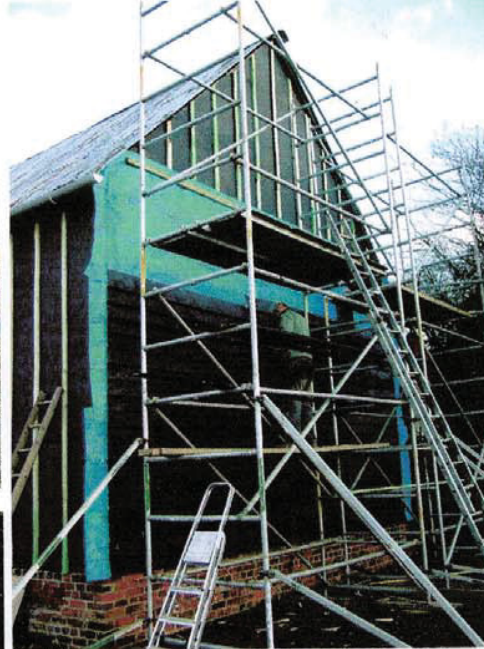
Southern gable having weather board applied.

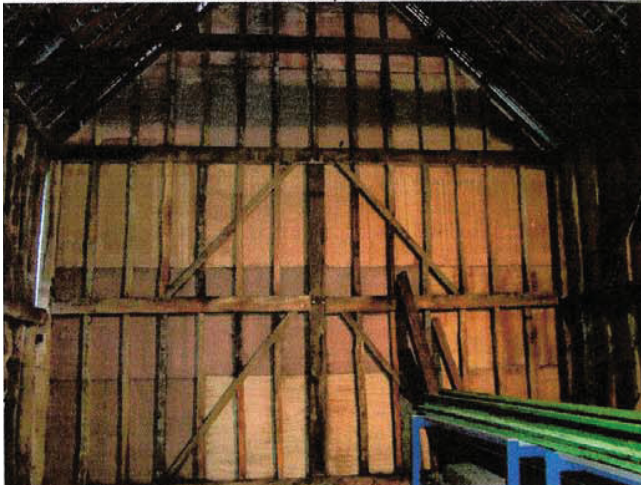
Internal view of repaired southern gable wall.

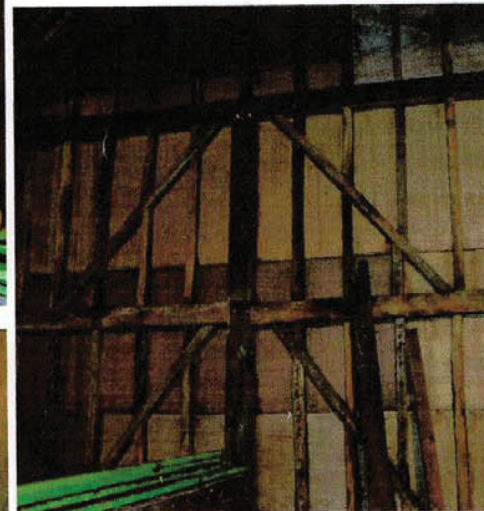
Detail of replacement central storey post at southern gable end.

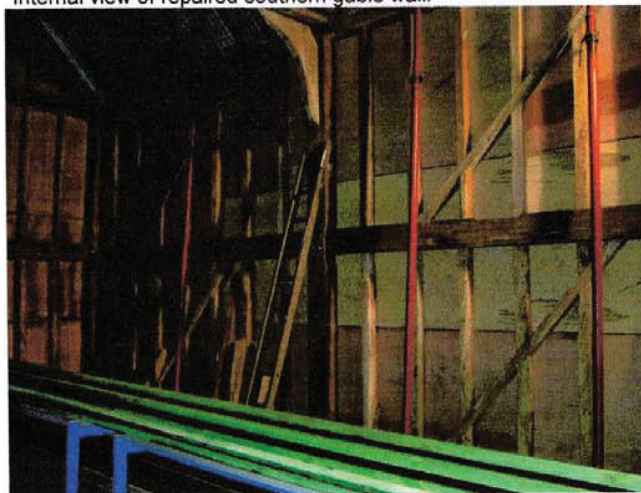
Inside view of repaired walling at western end.

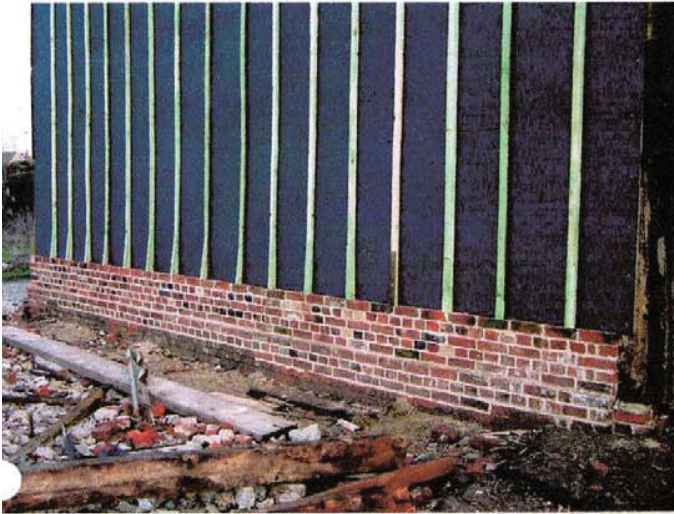
North-west corner plinth rebuilt from where slurry tank removed.

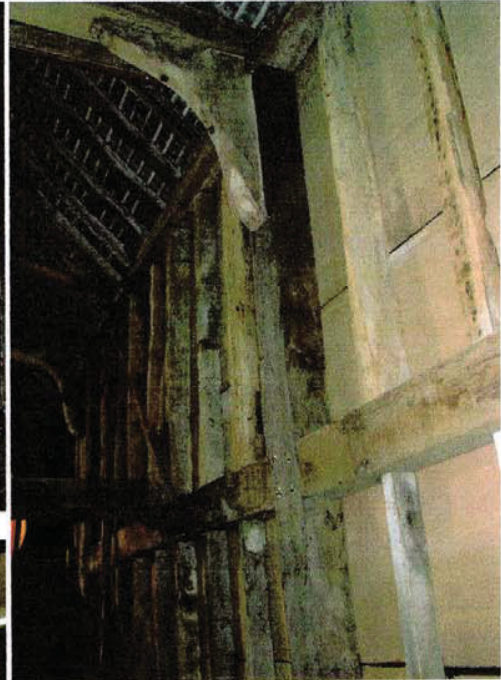
Inside on north-west wall showing storey post replaced to full height.

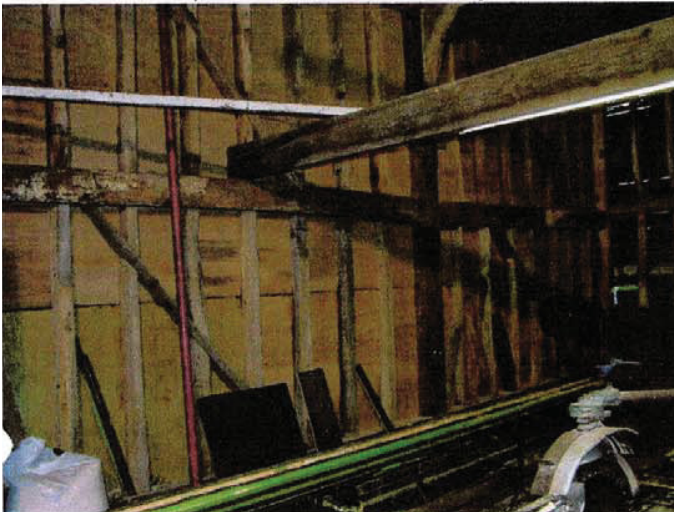
Inside view of north-west wall after repair.

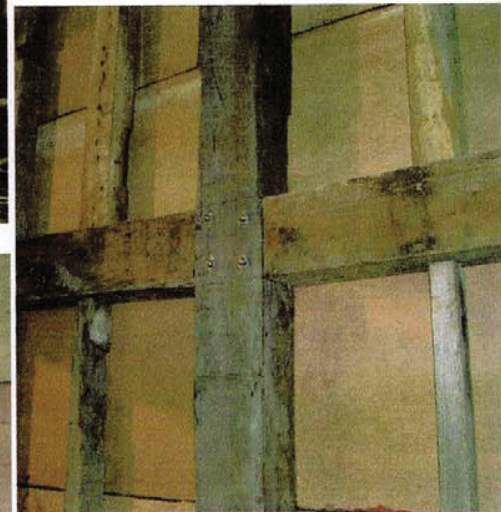
Detail of new junction of midrails into storey post.

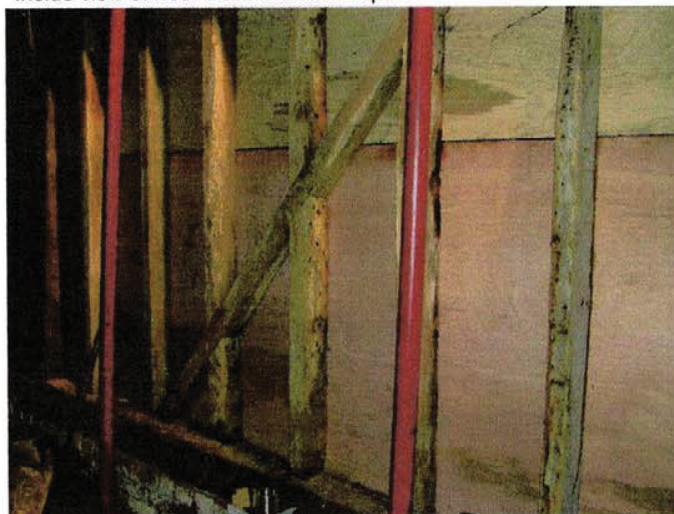
Detail of sill and primary brace replaced on north-west wall.
