**FARM BUILDINGS AT THE ELMS
BACON END
GREAT CANFIELD
ESSEX**

HISTORIC BUILDING RECORDING AND ARCHAEOLOGICAL MONITORING

**Essex County Council
Field Archaeology Unit**

April 2010

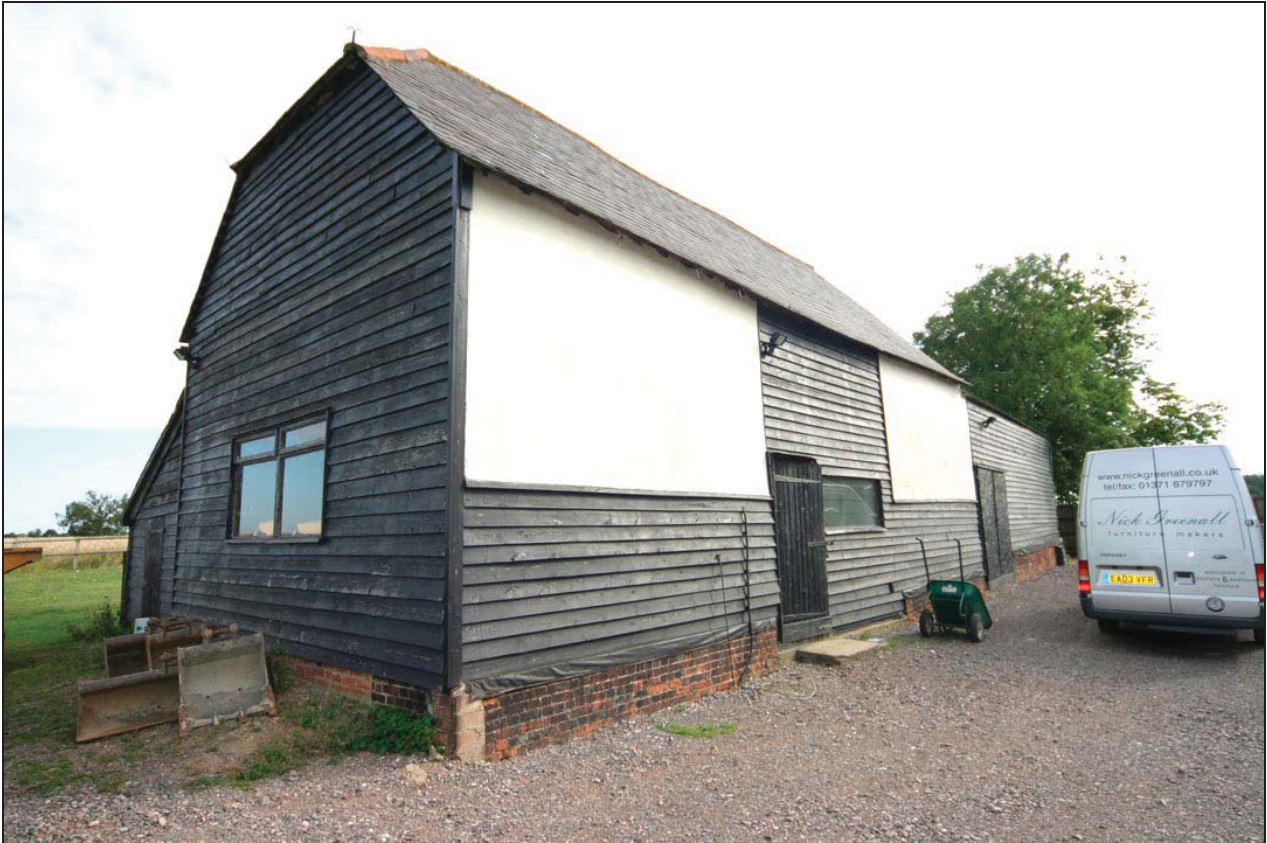
Plate 1 Barns 1 & 2 viewed to north

On the south (yard) elevation (plate 1) the exterior is boarded and cement-plastered either side of the main entrance. The cart doors have been replaced by a modern entrance and window, and the space above filled in with new studs and boards. The style of the opposite (north) elevation is much the same, but here there is a porch and lean-to (fig. 1). The porch was originally fitted with a low cartdoor, the opening of which now contains a modern window (plate 2). The two-bay lean-to (1a) is typical and probably built at the same time, though some maps do not show it. Until recently it was blocked-in (plate 2) but was opened-up during the conversion (plate 3). Such a small structure would probably be used for calves or bullocks before joining the herd, perhaps held in the field to the north (fig. 6). The open side was enclosed by a gate, indicated by the surviving old gate post (fig. 7, plate 3). No original fixtures or fittings or flooring remained inside the lean-to, but the simple roof structure survives. On the west side is a single planked ledged and battened door on pintel hinges, likely to be original (fig. 7).

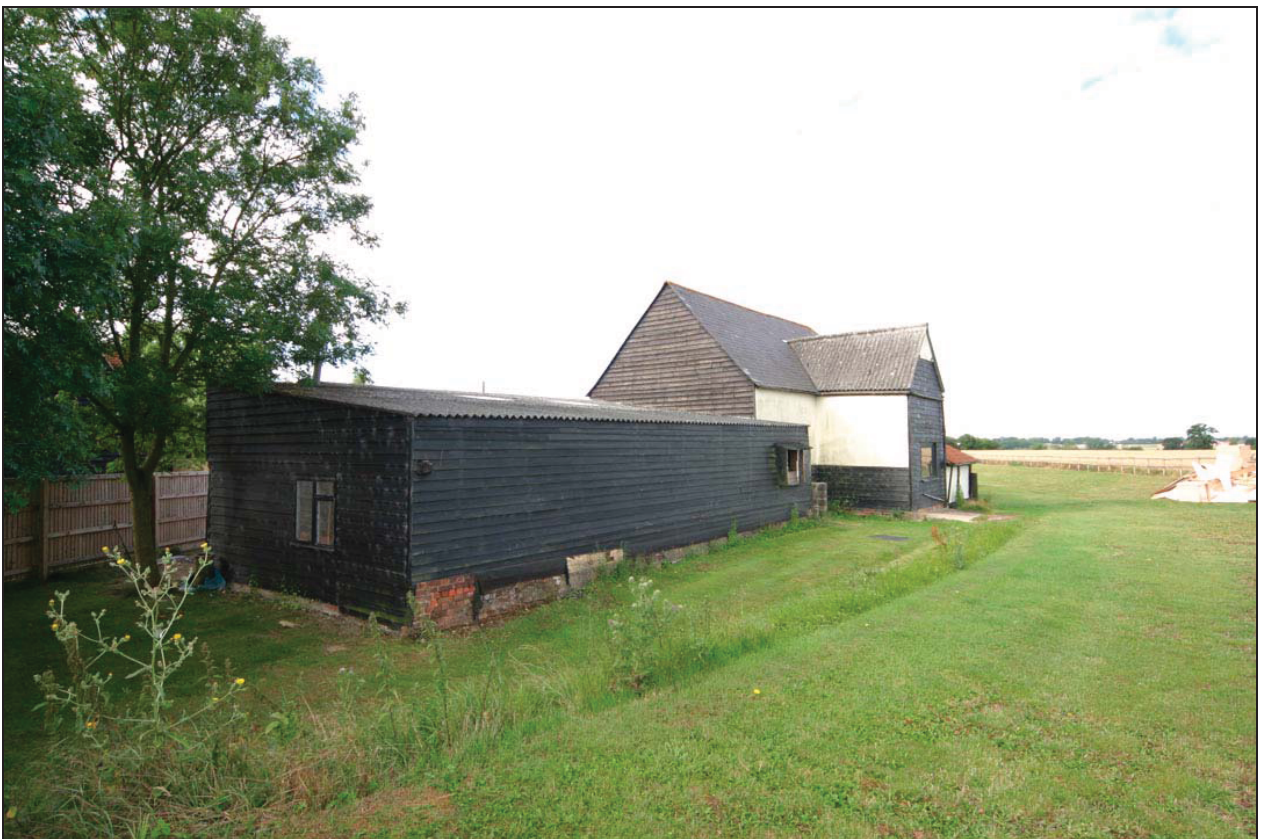
Plate 4 Barns 2 & 1 viewed to south-west

The exterior is plain and weatherboarded, and the single-pitched roof that slopes downwards to the north is clad in a modern corrugated material (plate 4). All windows and doorways are modern and associated with its most recent use, though it is possible the openings conform to earlier ones. In particular, infilling either end of the western bay (bay 1 in fig. 7) suggests there was an early midstrey, and hence a five-bay layout. The English-bonded red brick plinth appeared the same as the main barn and is likely to be contemporary with it.

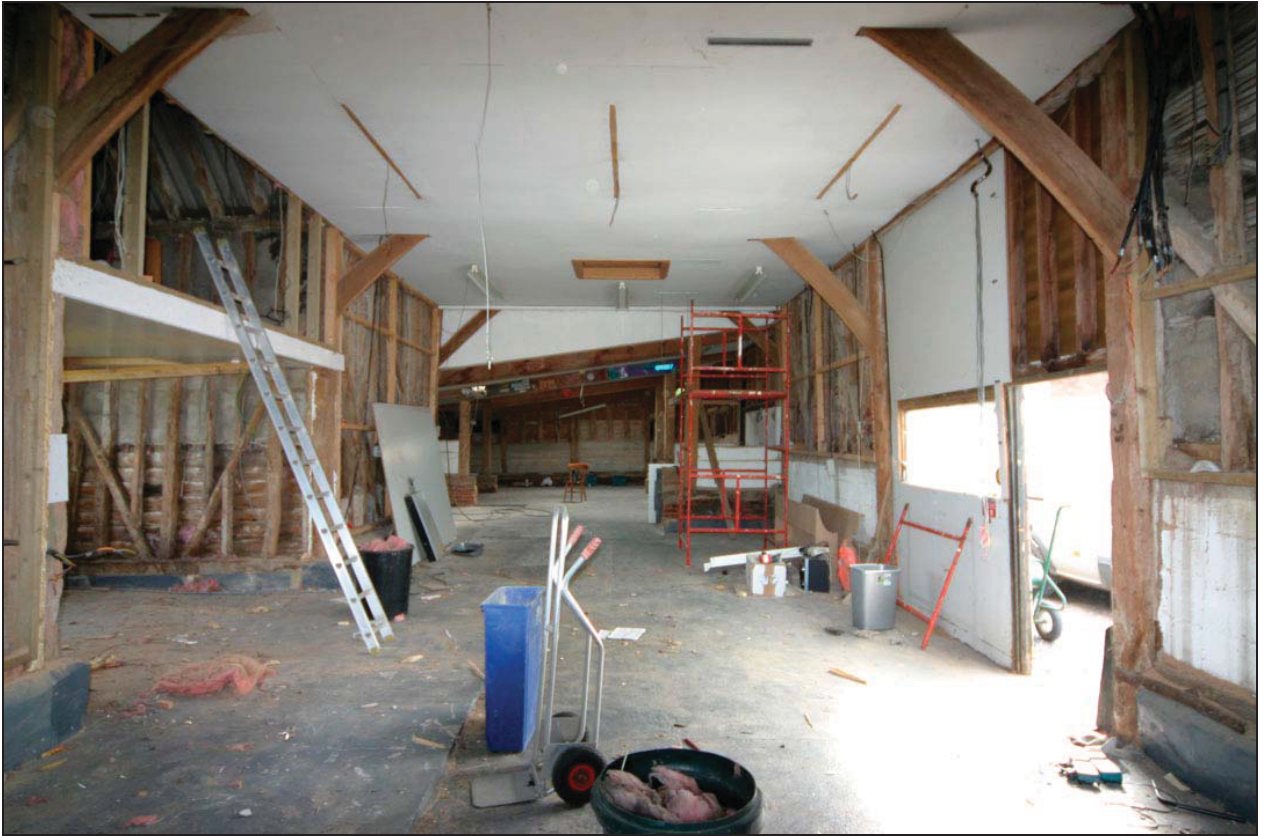
Plate 5 Interior of barn 1 viewed towards barn 2

A large entrance was cut through the west wall by the last farmer to get combines and other machinery into the barn (N. Greenall pers. comm.). The cladding on this side is replaced and there and a modern window has been inserted with the new framing (plate 1). The eastern end was previously open to barn 2 but after the fire the upper part was filled-in above the reduced roofline of barn 2 (plate 5).

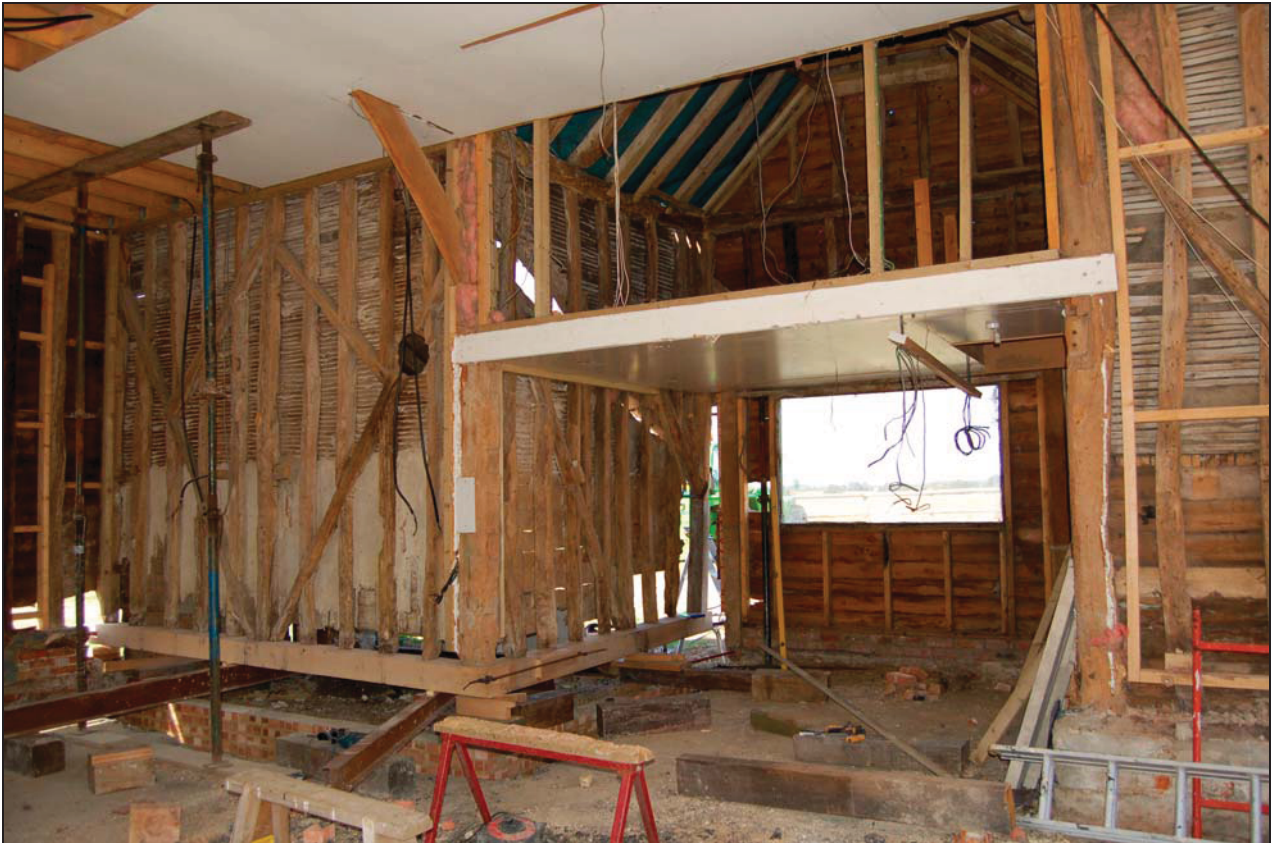
Plate 6 Porch and diamond-shaped bracing on north side of barn 1

Quite a lot of new timber is present in the porch (plate 6) and the wall plate on the east side is replaced, perhaps from the remnants of the old aisled barn, as the gaps between the stud mortice holes are similar. None of the studs are pegged in the porch but all are tenoned rather than lapped.

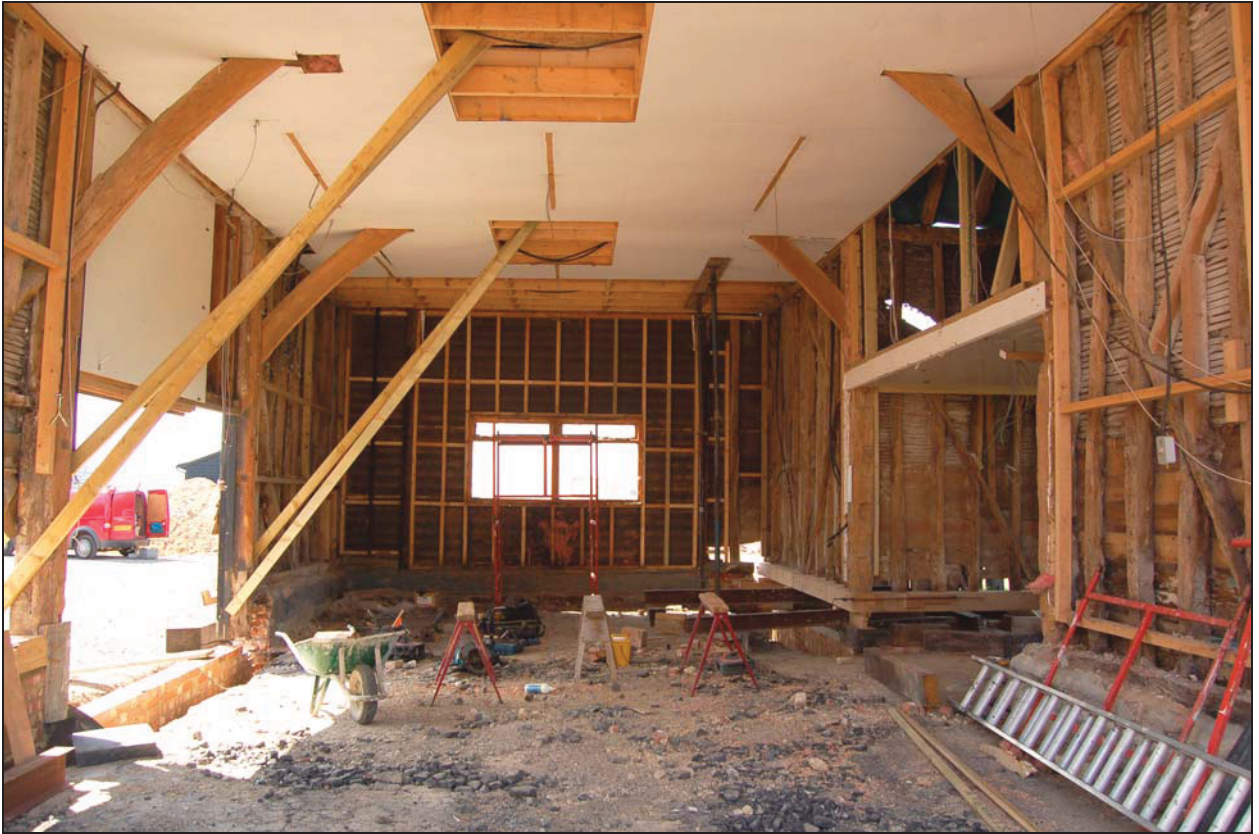
Plate 7 Barn 1 viewed to west

The west wall (plate 7) was completely rebuilt in the earlier workshop conversion to block the old combine entrance that the last farmer had made. Only one original wall stud remains. More fabric survives in the hipped gable, which is original. Here the studs are lapped rather than tenoned to the collar, another indicator of late build. Remnants of laths show the gable was plastered like the sides of the barn are today, though in a more traditional material. The east gable has been completely rebuilt since the fire and there is no indication on the tie beam that there was ever an end wall here, though there are sockets for a rail between the posts, perhaps as a low division.

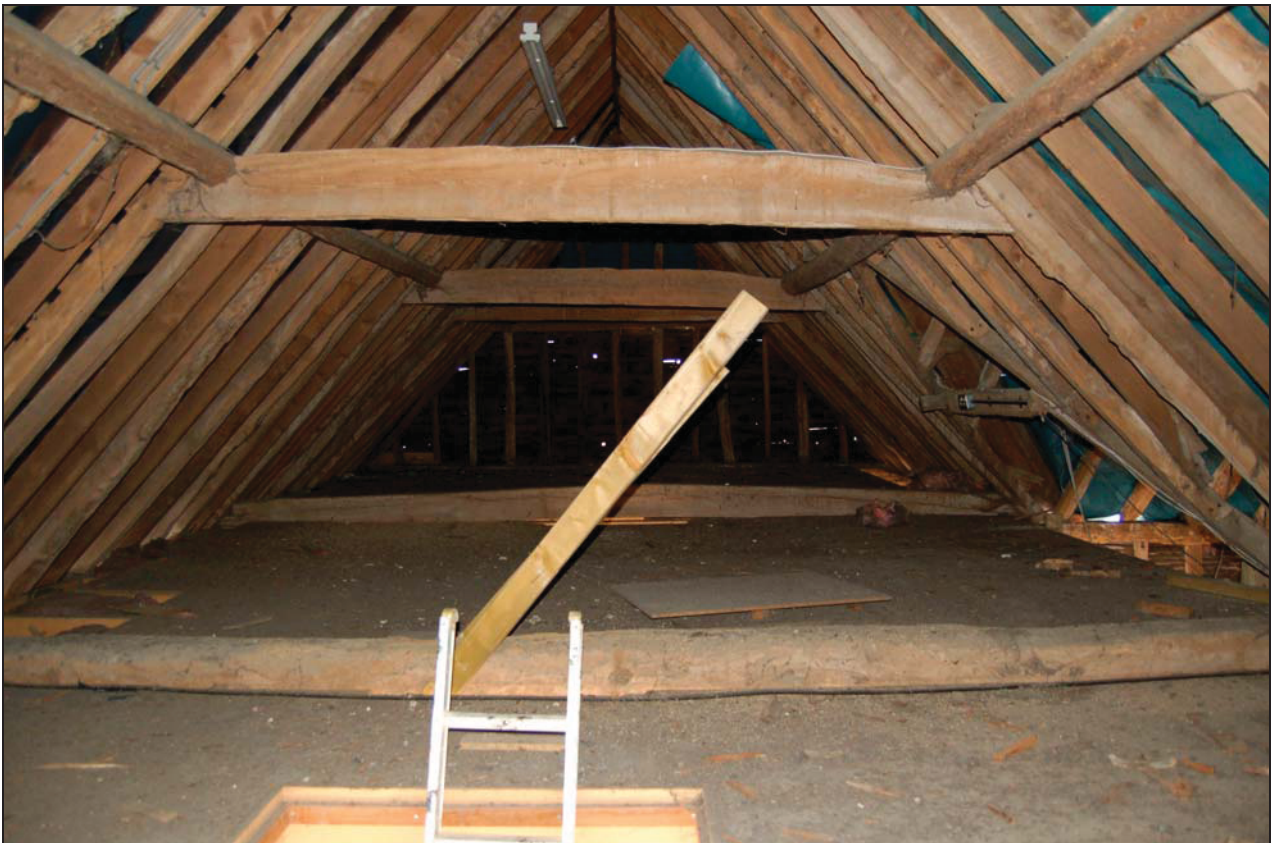
Plate 10 Roof frame in barn 1, viewed to west

The workshop ceiling was still in place during the survey but access was available to record the roof, which was rebuilt with replacement machine-sawn timbers and the surviving rafters cut back to accept a ridge piece when the slate roof was added. The main structure is dry and sound and has a typical pegged trenched collar purlin form (fig. 7, plate 10).

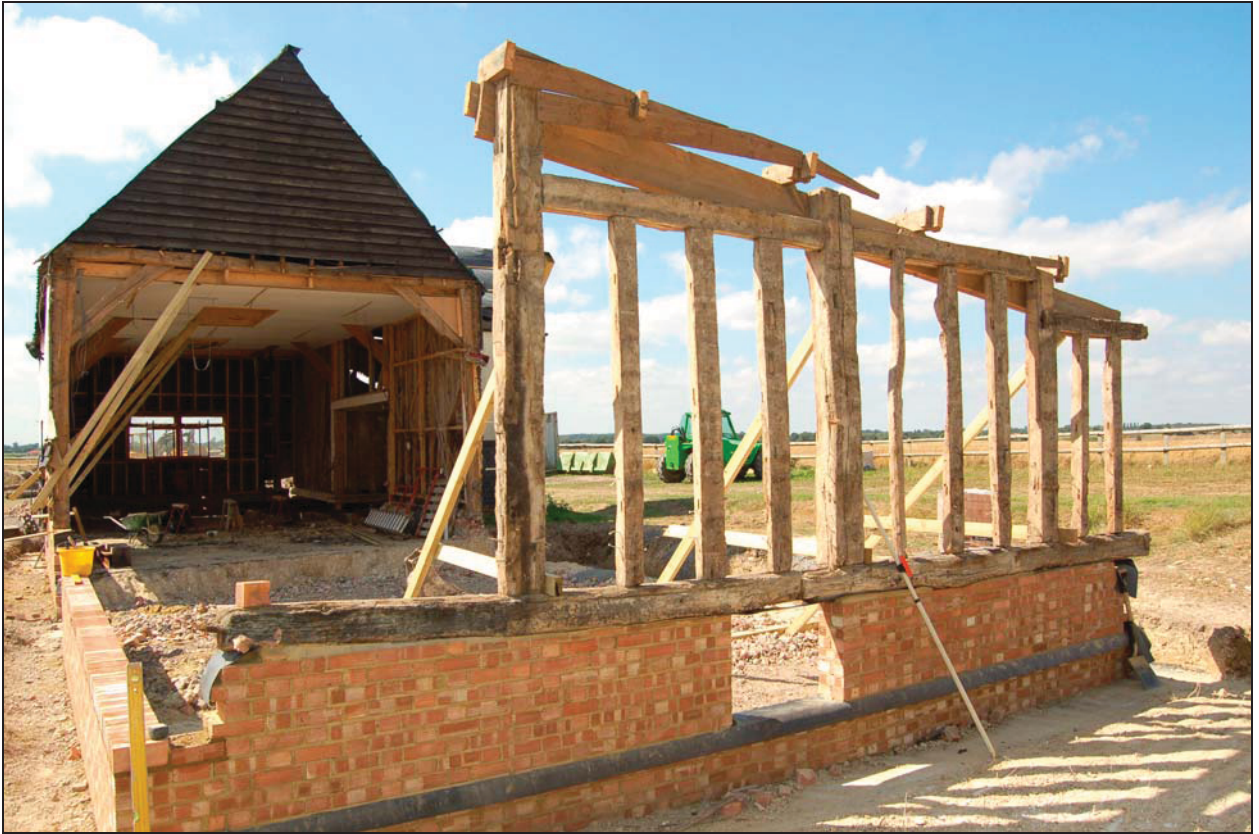
Plate 11 Extant east end of barn 2

It is speculated that this was originally a five-bay aisled barn with a central midstrey, whose western end was rebuilt in the form of barn 1 when the latter was added. Conversely, it could be that three bays of a disused barn were reassembled on this location as part of the construction of barn 1. Whatever the case, the earlier structure is built with better quality timber and craftsmanship, with heavy studwork and thick daub panels. Since the fire and the more recent conversion works, almost all of the original structure has disappeared apart from the east end wall (plate 11), upon which much of the interpretation is based.

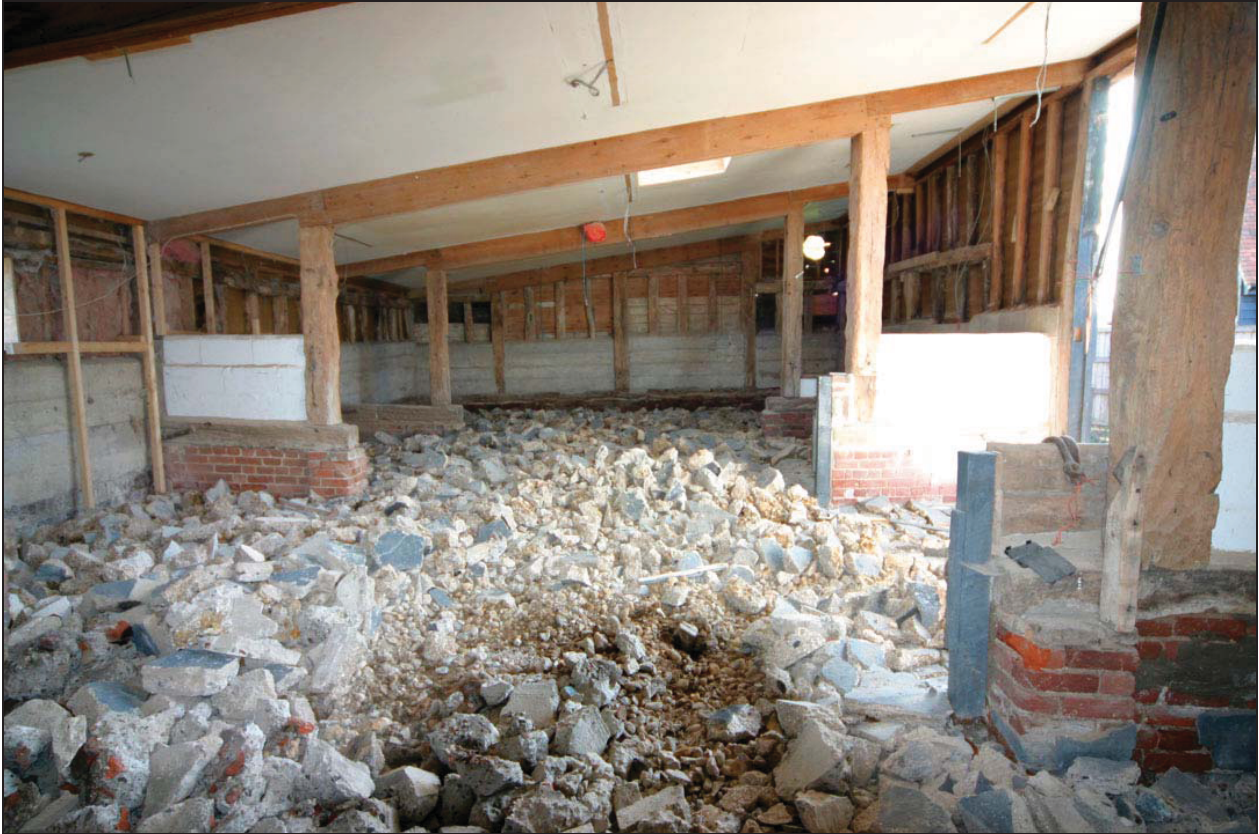
Plate 12 Pre-demolition photograph of barn 2 interior

Three bays survived of the aisled barn, each defined by heavy sole plates raised on brick piers and oak posts drastically reduced in height to carry the new lower roof (plate 12). It is likely the original layout was five bays, as each side of bay 1, according to the frame survey and earlier photographs, appears enclosed by modern studwork where the original cart doors (and perhaps a porch) were located. The bays are quite narrow, between 3 and 3.4m wide, and unusually the narrowest bay appears to be the midstrey (fig. 7). Midrail sockets suggest the eastern bay (bay 3) was partitioned-off (plate 13, right) perhaps for animals or to store a different crop.

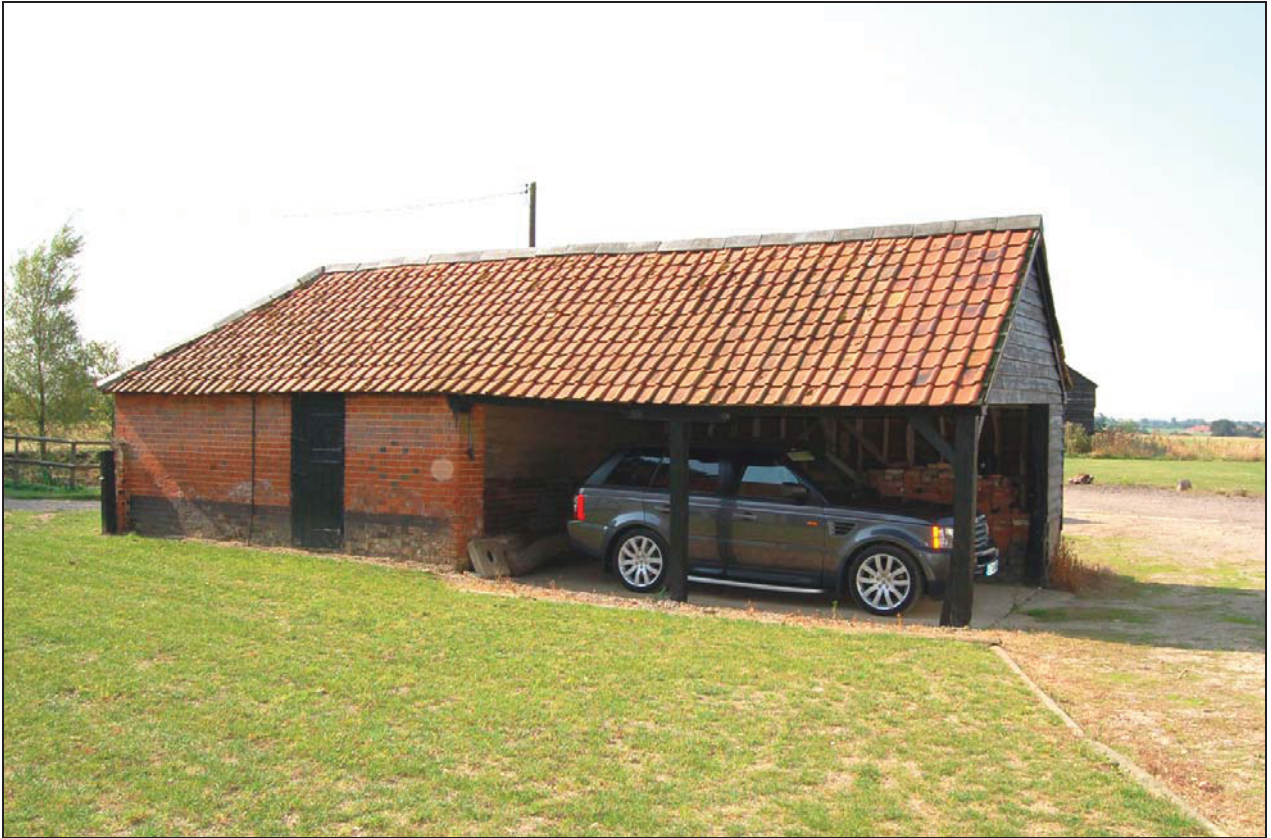
Plate 15 Loose box and shed viewed to west

Most of the western arm of the range reportedly fell down during the Great Storm of 1987 and was replaced with a single open-sided bay accommodating the diesel tank (fig. 10, plate 13). The main range had been divided into a chemical store by the previous farmer, and was being used as a mess room by the building contractors. The other part had become a timber store by the owner. The eastern arm, perhaps a later addition, is mainly timber-framed and contained two loose boxes and an open-sided shed, that may originally been used for livestock or carts, but is now a garage and log store (fig. 7, plate 15).

Within the former yard, the eastern arm of the range is timber-framed and boarded (fig. 10, plate 15). A tethering post and chain is located one third of the way down and there is access from the loose box on this side (fig. 10).

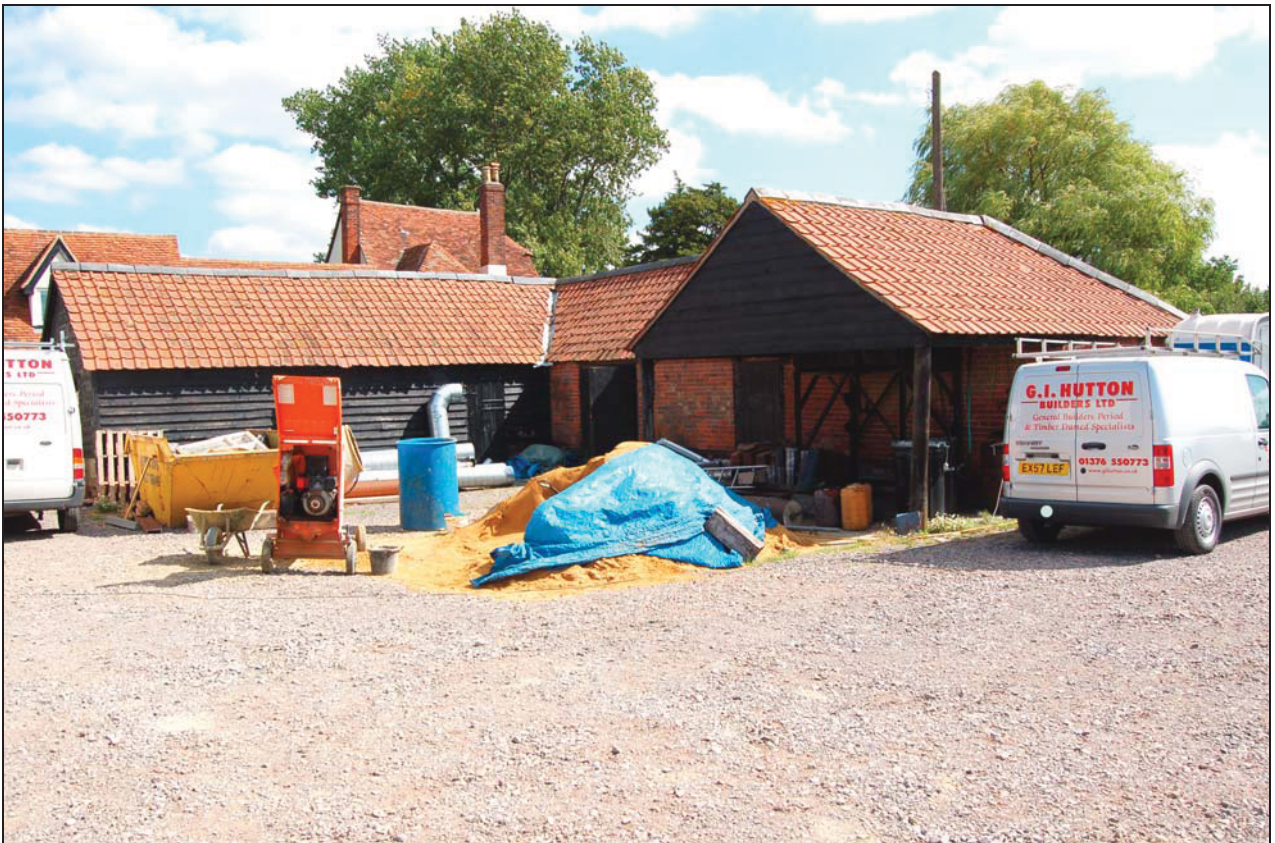
Plate 16 Range 3 viewed to south-east

The western arm of the range is pole-built with a modern boarded gable (plate 16). The wall between this and the chemical store appears to have been inserted, as the bricks are darker and laid in a much thicker mortar than the main build.

On the east side (plate 16) there is nothing to suggest that this is a later addition, as the brickwork and fixtures are the same as they are on the south side, which according to the maps is earlier. The only difference is an interesting piece of decorative brickwork, a diamond pattern made from burnt headers, between the door and open-sided end (plate 17). At the north end, the two open bays are divided at the front by stout wooden posts, the central post with a 'pillow' supporting the wall plate and the corner one with high straight bracing (plate 17).

In the centre, between the two projecting ranges, is the old cowhouse. This single stretch of brickwork contains plain modern double doors where the old cow doors were (plate 16), and an original half-heck door at the west end (fig. 10) There are no other features.

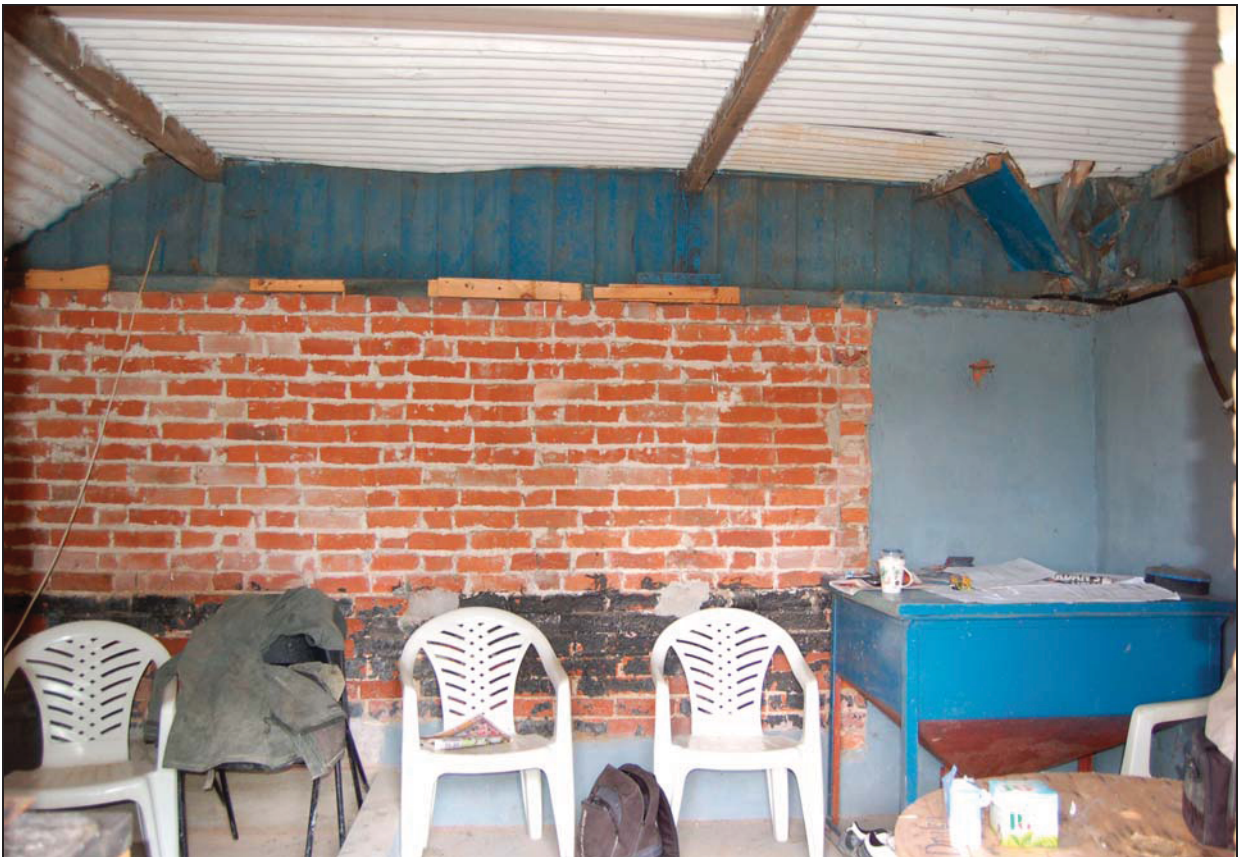
Plate 18 Interior of chemical store

The western end is post-1987 in date and houses a large diesel tank. The wall between this and the **chemical store** is inserted (plate 18), as is the adjoining wall with the old cow house (fig. 10). A corrugated tin ceiling has been added that obscures the roof structure.

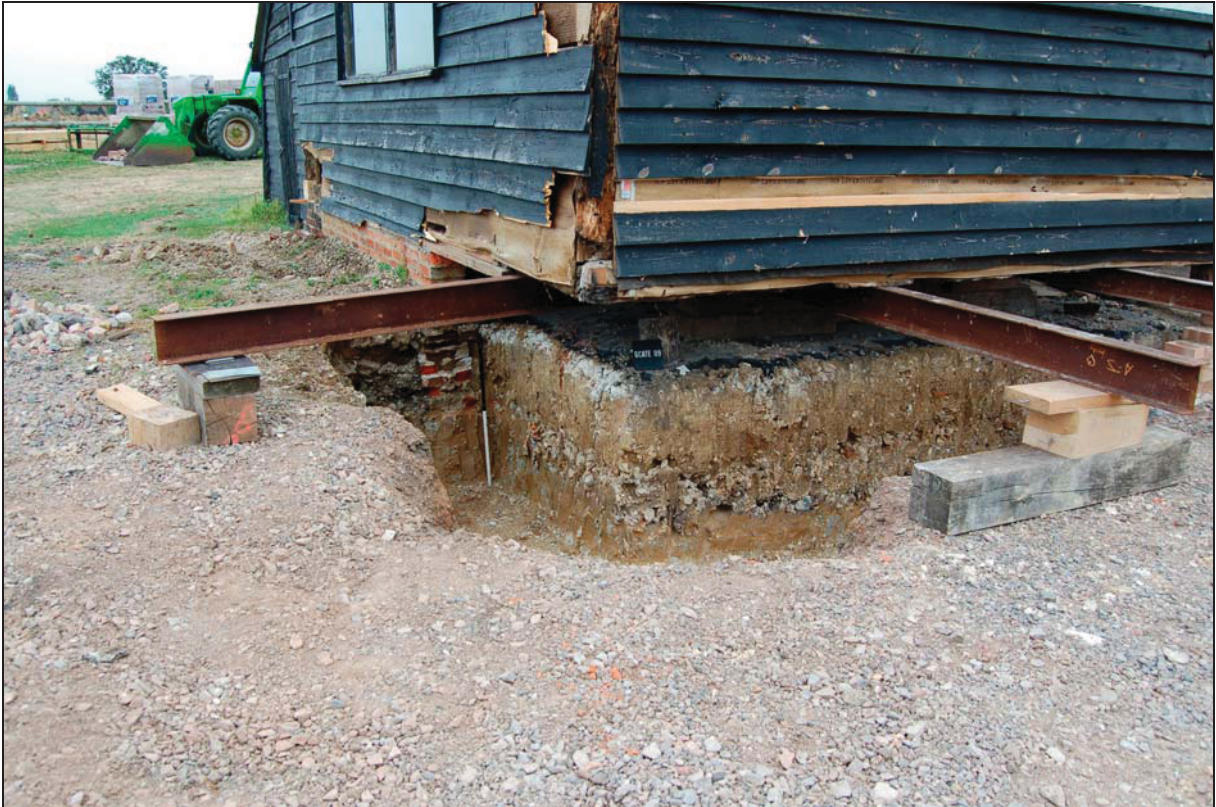
Plate 21 Flint and rubble spread under southern corner of barn 1

Underpinning trenches were dug to facilitate replacement of the brick plinth around barns 1 and 2. Further trenching for new internal wall foundations was carried out in barn 2 (fig. 12). All were dug by mechanical excavator fitted with a 0.85m-wide bucket to a depth of up to 1.2m into the natural chalky boulder clay below. Approximately 0.4m of silty clay topsoil was removed on the north side of the barns, straight onto natural deposits. The other sides were cut through modern tarmac and gravel yard surfaces straight onto natural clay. A spread of flint, cobbles and brick rubble was recorded beneath re-deposited natural clay in the southern corner of barn 1. Its thin, unmade quality suggests it was laid down to consolidate the natural clay when the brick plinth was built in the 18th or 19th century (plate 21), rather than being a former floor or yard surface.
