**ROLLS FARM BARN, HASTINGWOOD ROAD
MAGDALEN LAVER
ESSEX**

HISTORIC BUILDING RECORD

December 2009

Document Ref.	1948rep
Report Issue Date	22nd December 2009
Circulation	Mrs R. Padfield
	ECC Historic Environment Management
	Essex Historic Environment Record

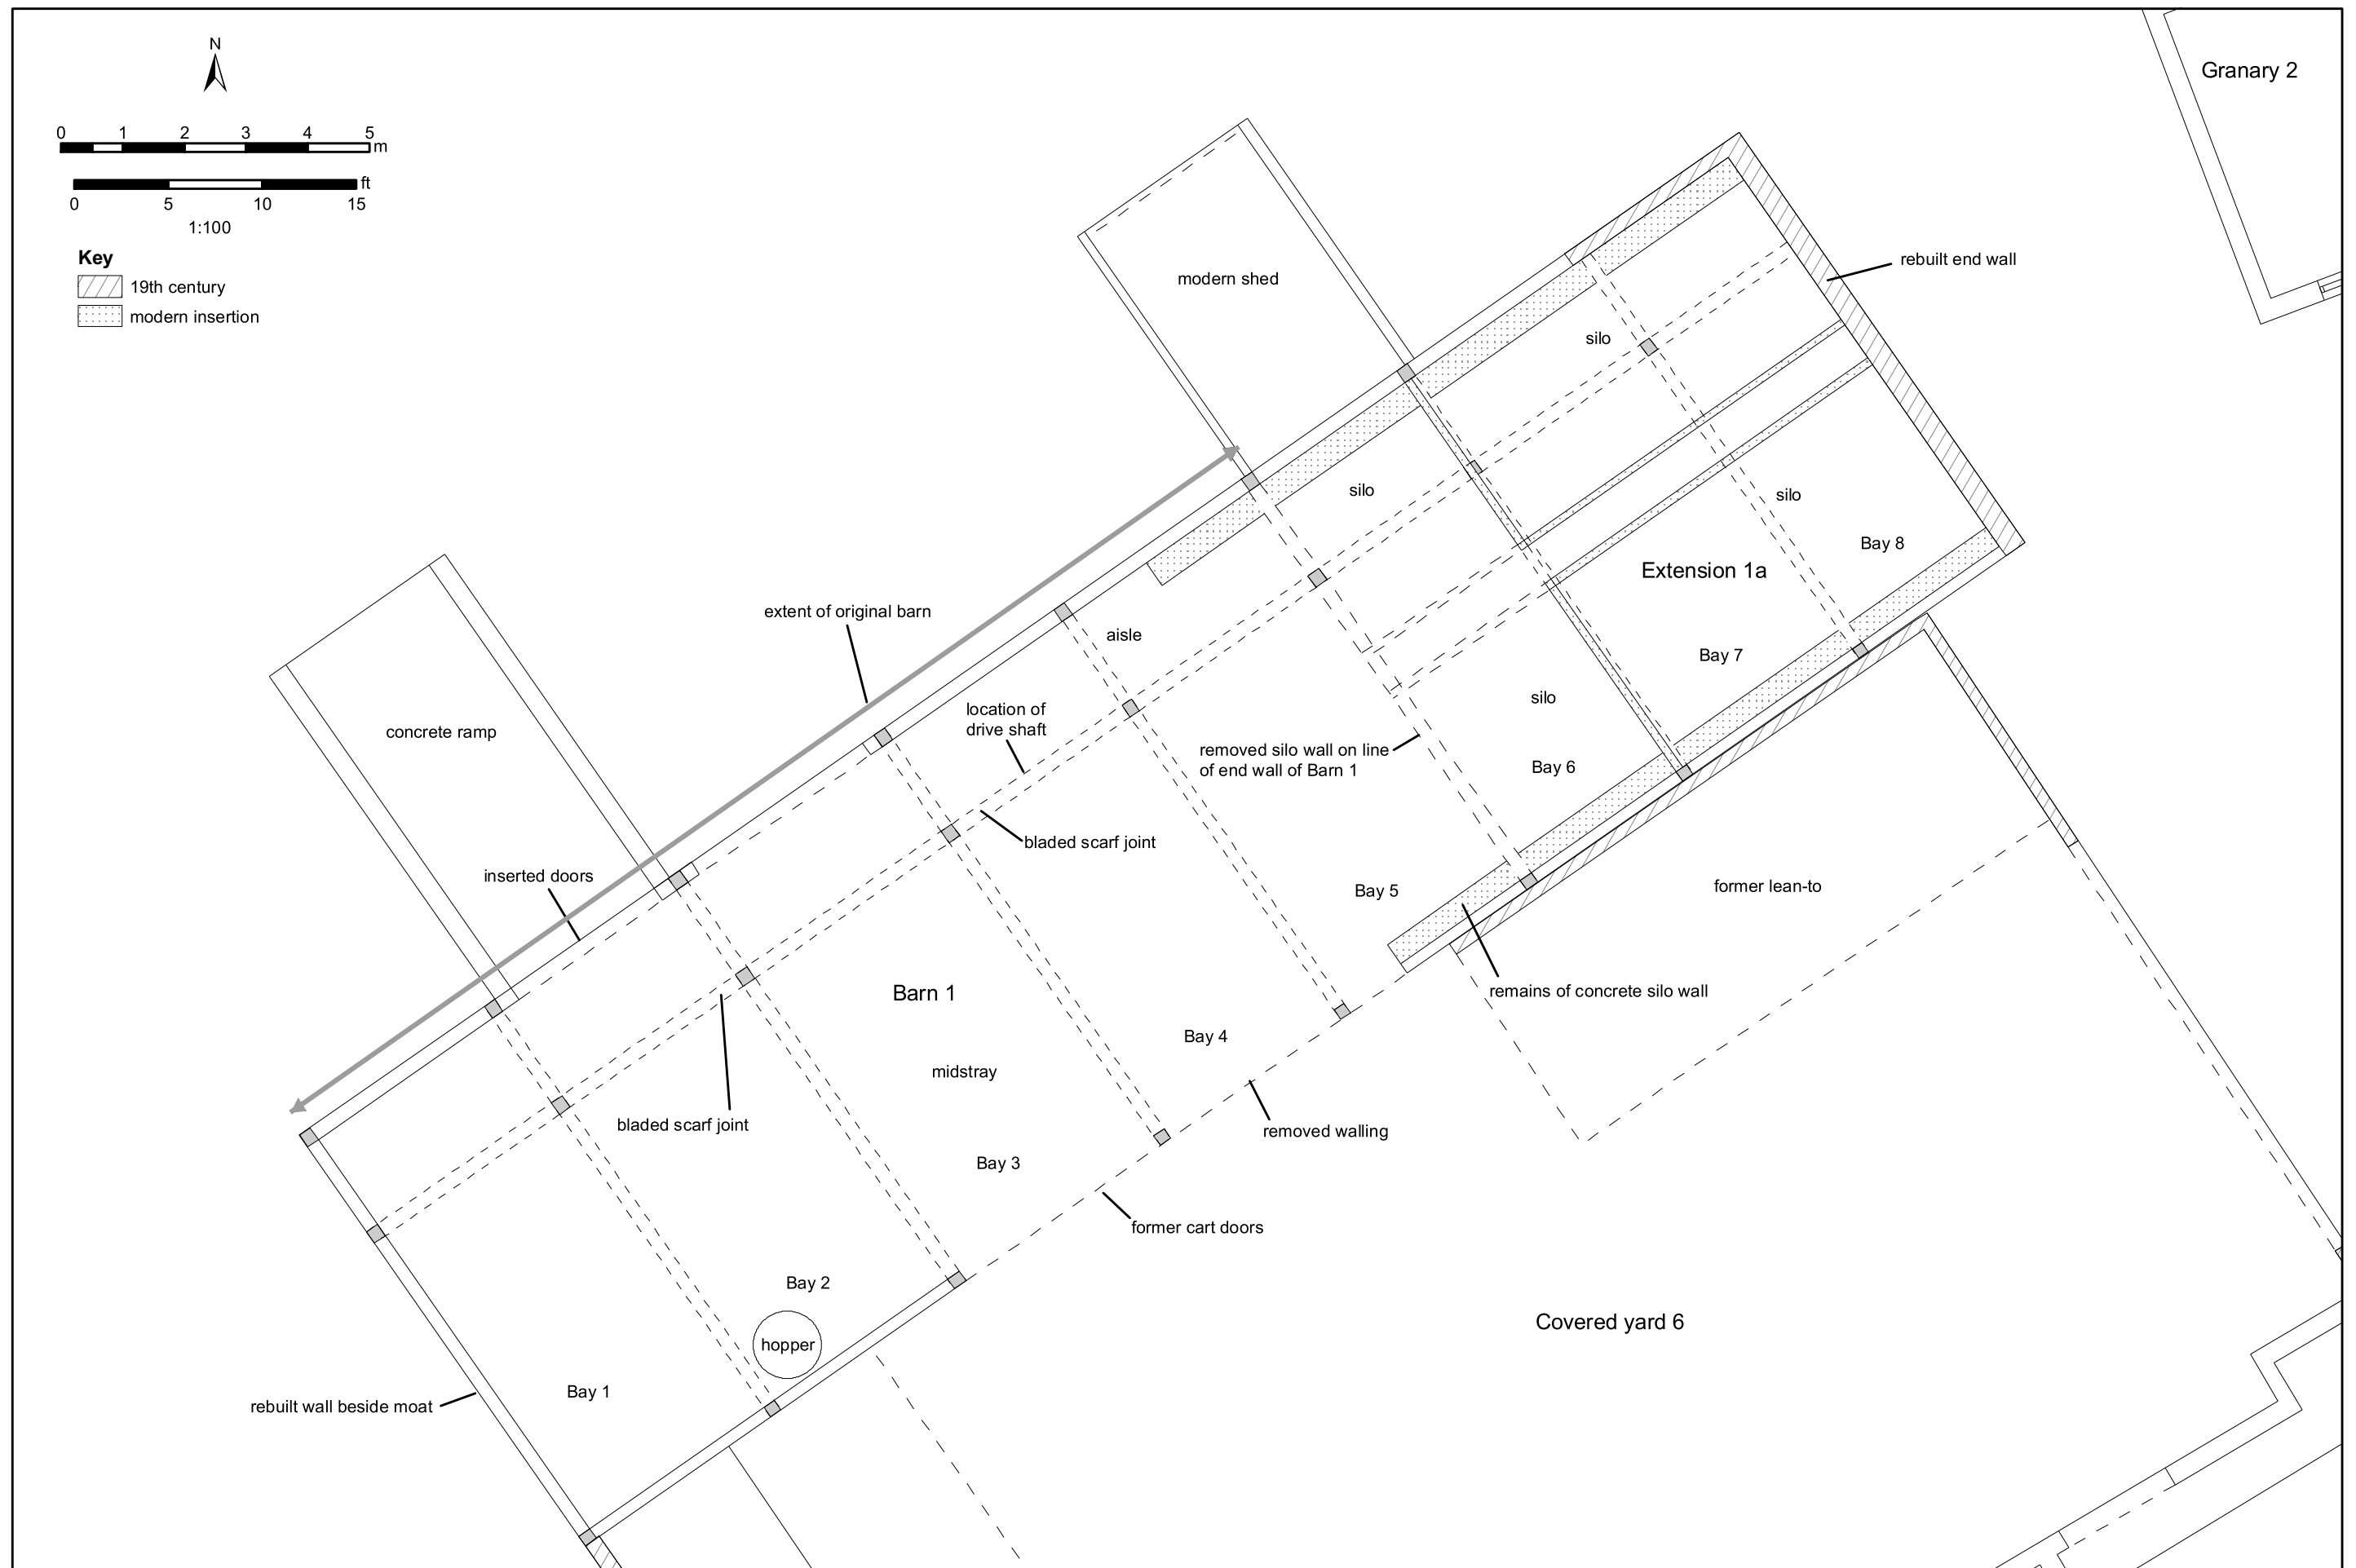
Fig.6. Plan of Barn 1

processing. The doorway to bay 2 is completely modern and has a ramp at the front so vehicles could unload grain straight into the barn (fig.6). The second doorway, on the barn midstre, has been refurbished with later cartdoors, held on the old strap hinges, but slots for 'leap boards' can be seen on the aisle posts either side to indicate the earlier cart entrance.

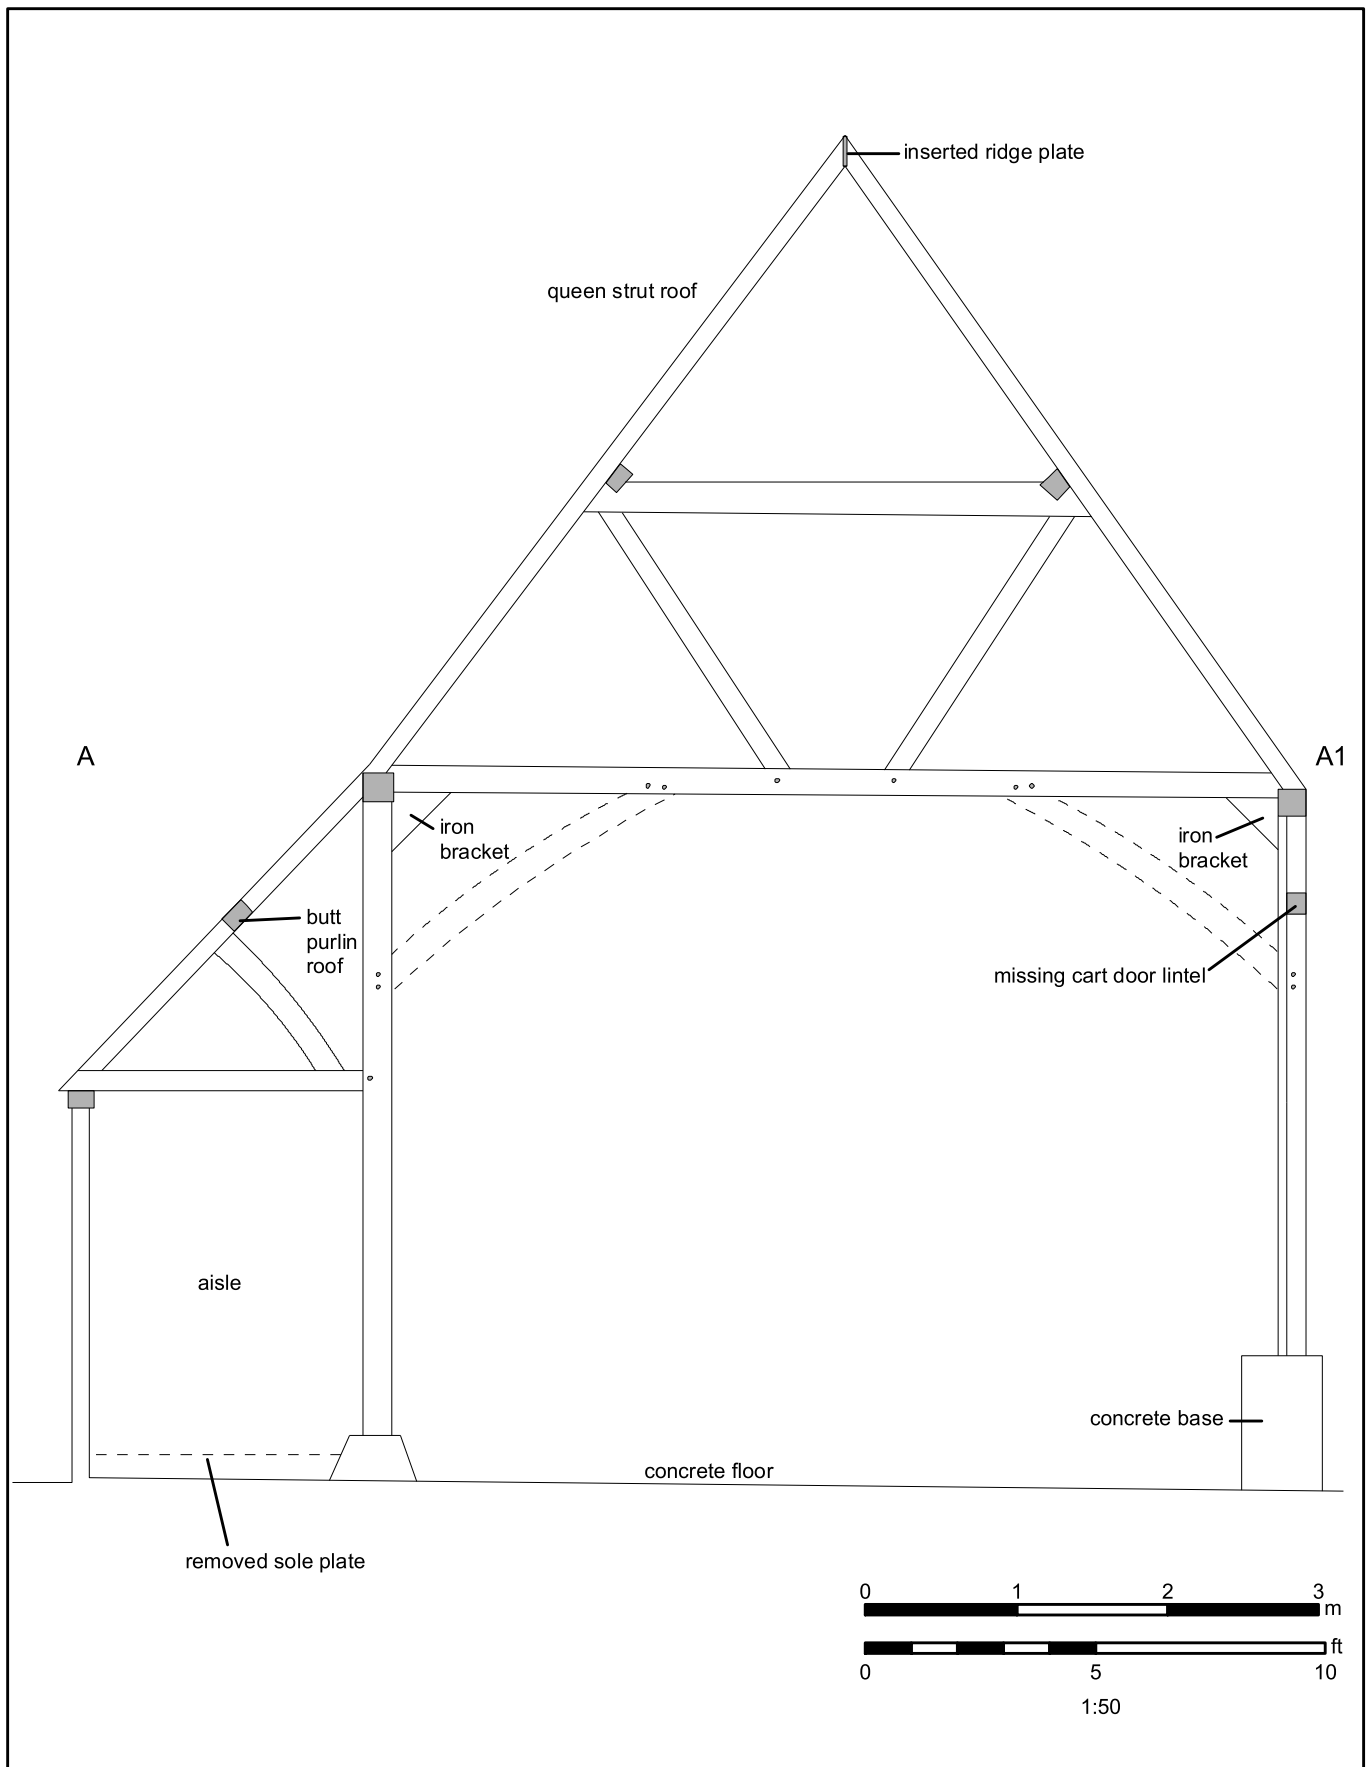
Fig.7. Section across barn

The north aisle is supported with thick rather elegant curved braces spanning outwards from the aisle tie up to the principle rafter (fig. 7, plates 9 & 10). They are tenoned to the tie but only lapped and nailed to the rafter (i.e. not pegged). Those in bays 2 and 3 are augmented with straight nailed pieces to hold the awning (plate 10) At the base of the frame none of the sole plates remain; which were probably lost when the bay post bases were concreted-in (fig. 7), if not before.

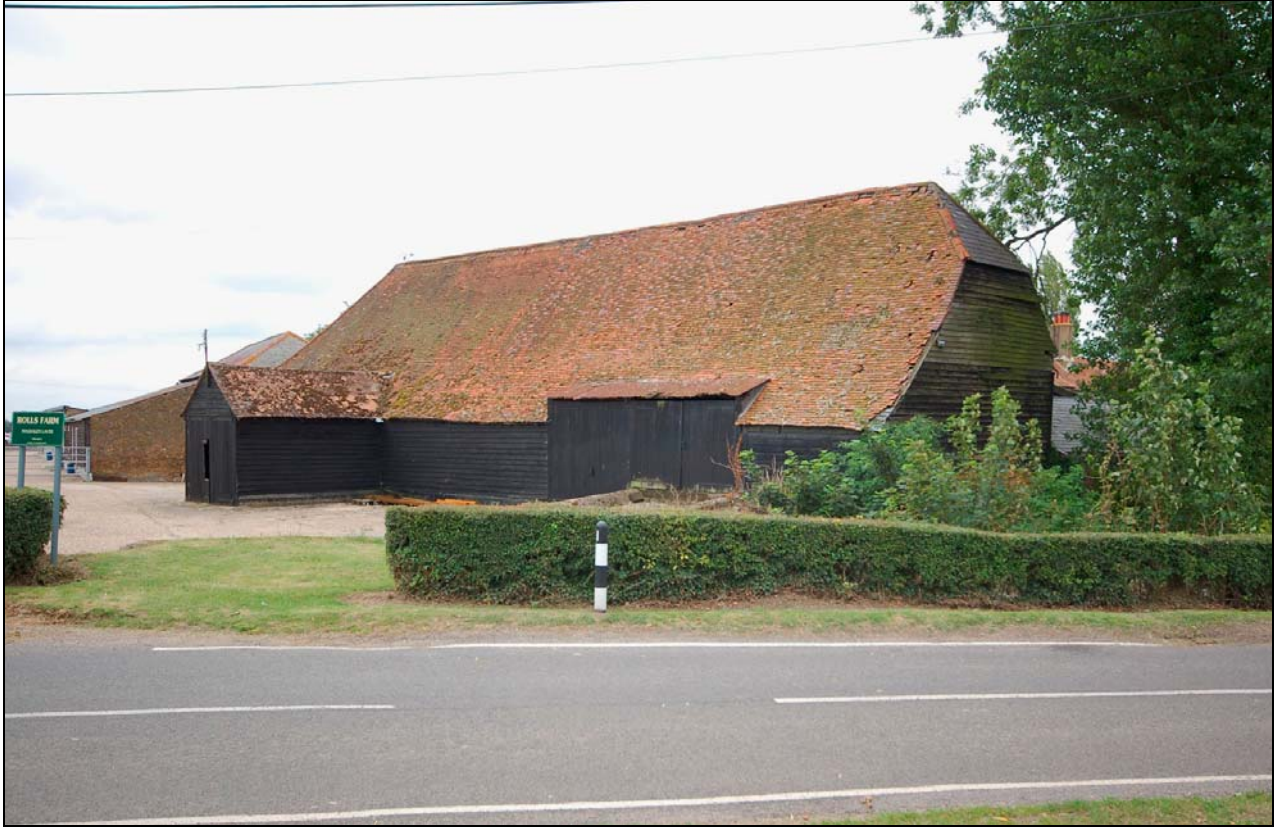
Plate 1 Barn viewed to south-east

The main elevation is on the north side with the aisle, which gives it the characteristic low eaves (plates 1 & 2). Boarding on this side is mainly in replaced softwood apart from those to bay 1 that are heavily tarred and appear more ancient in character.

Towards the west end of the elevation, over bays 2 & 3, is a modern corrugated tin 'awning' or short porch, built into the aisle roof (plate 1) inserted during the era of mechanised grain

The end gables are hipped to the east and half-hipped to the west and slate-covered like the Victorian farm buildings. The eastern end has been under-built in yellow brick and the pitching hatch reused as a grain conveyer passage between the barn and granary (plate 2). The western end remains unaltered from the outside, apart from some replaced boarding to top and bottom (plate 1).

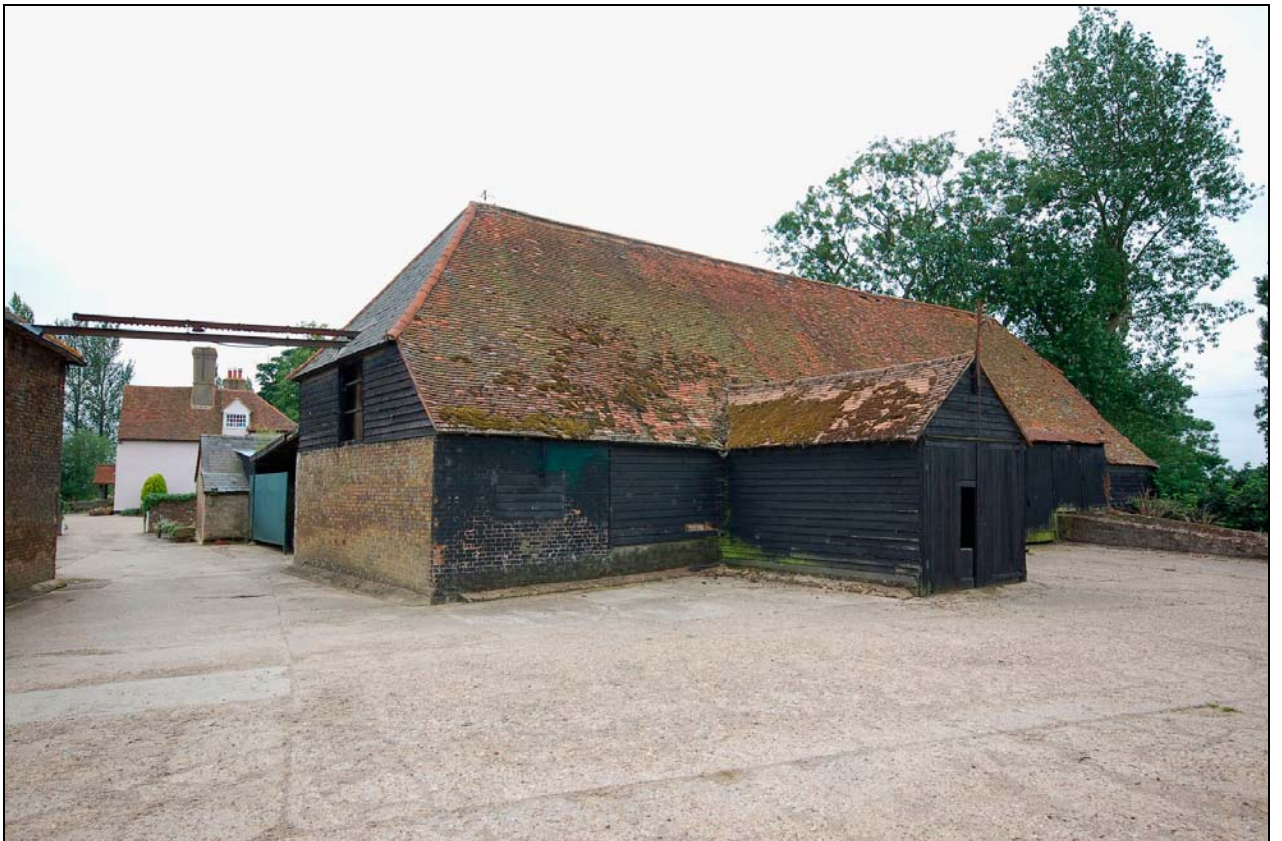
Plate 2 Barn viewed to south

A narrow 20th century shed is attached to bay 6 on the barn extension (1a) that resembles a porch (plate 2), though there it has no access into the barn. The interior contains wooden shelving most likely connected to the later function of the barn.

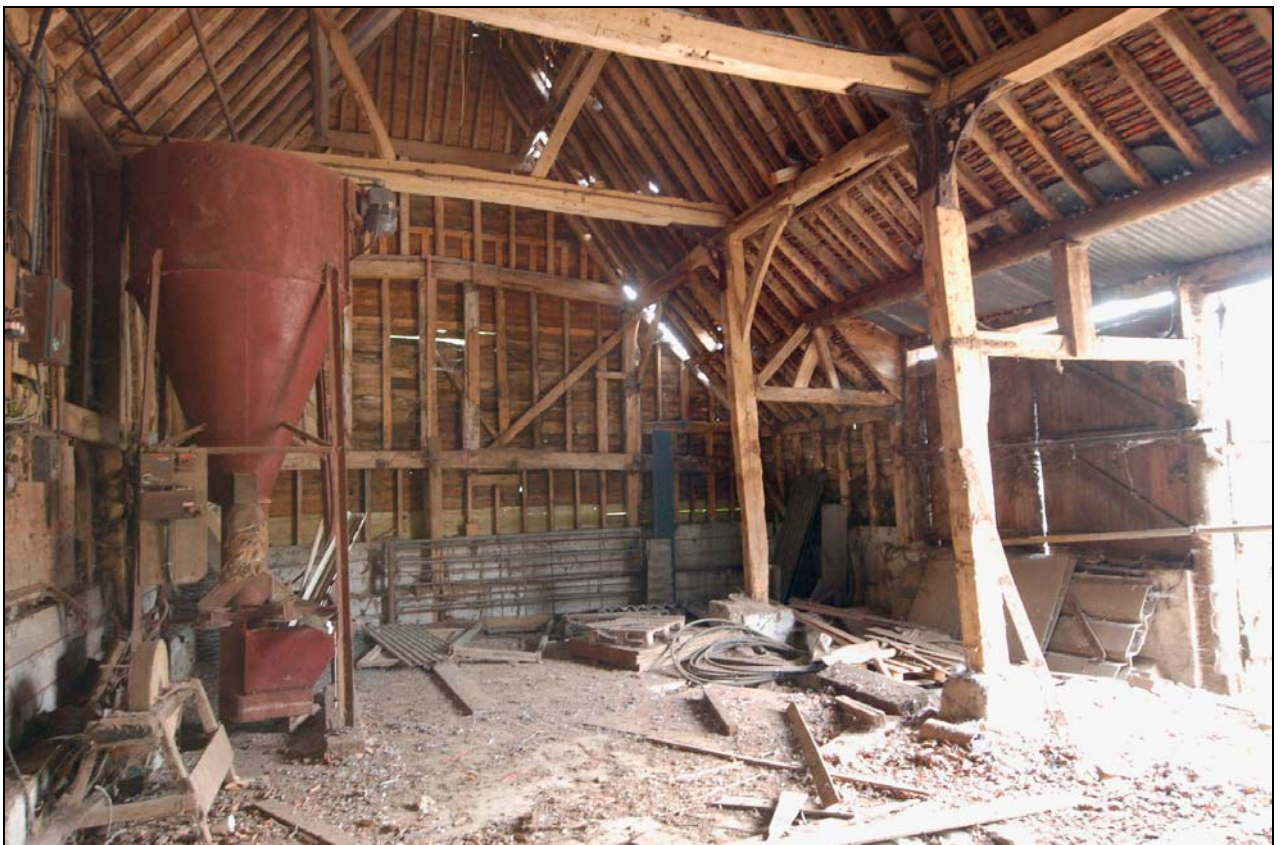
Plate 10 Partially-rebuilt western wall

The western wall has a high proportion of replaced modern timbers, mainly in the lower register, presumably due to subsidence/damp from the moat on the outside of the wall. A secondary midrail and post have been bolted onto the frame to stabilise this end of the building (plate 10).

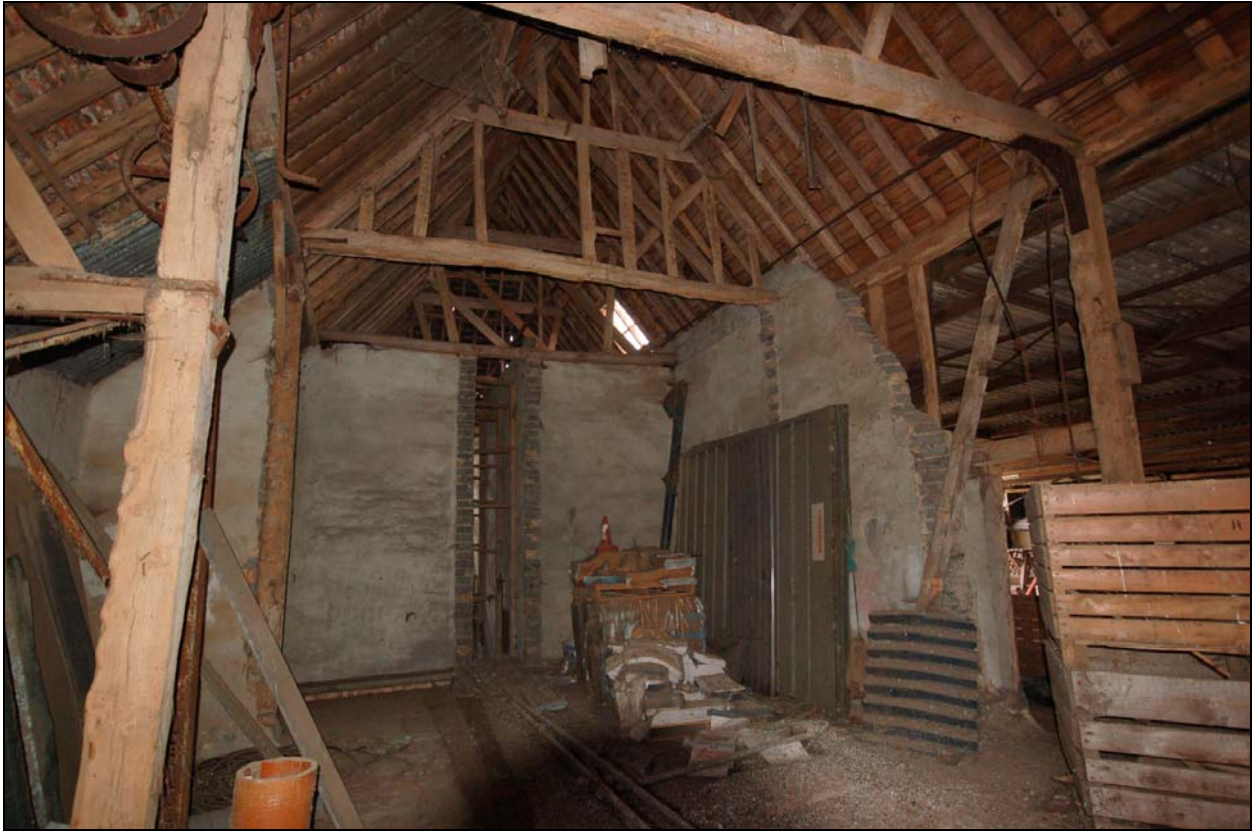
Plate 11 Original internal east wall and remains of concrete grain silos

The original eastern wall, at the junction of bays 5 and 6 (fig. 6, plate 11), retains studwork in the gable stud and stud rebates under the wall plate, where the lower part of the wall was removed. There is a profusion of nail holes on the outer face of the studs and end framing (plate 12), indicating the original gable was lath and plastered. Somewhat strangely there is no suggestion of there being a hip this end to match the opposite one, though there is no such consistency in the present gables either. Above the wall plate is the outline of an old pitching hatch (plate 12). The studs of the gable are in-line and tenoned at the base but lapped and nailed at the top, which is often a feature of post-medieval structures where these details would have been covered up on the outside.

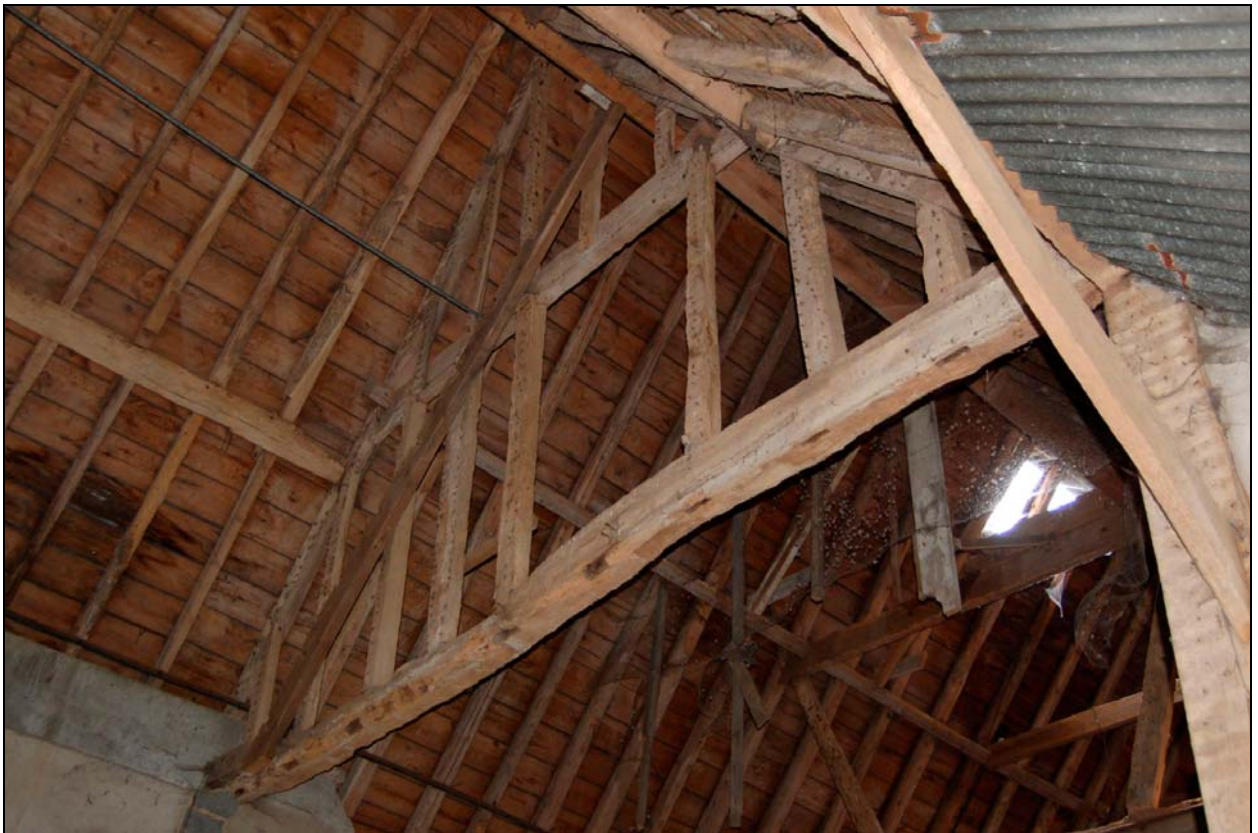
Plate 12 Original east wall viewed to south-west

The barns have two separate roof frames that meet at bays 5 and 6 (plate 12). The roof in the main part has a raking queen strut form with birdsmouth collars on the half bays (fig. 7), while the roof in the three bay extension is of butt-purlin form (plate 12), as is the aisle (plate 8), perhaps rebuilt when the extension was added. This butt-purlin roof is of basic form, where the principle rafters are pegged and tenoned to the purlins but the secondary rafters are only tenoned. The rafters have similar scantling to the studs but are closer together, with between 6 and 7 per bay. Additional, narrow, rafters have been added between the original ones along the north side and all those in bay 5 are replaced (plate 6). Some rafters in the extension have not been properly finished and still retain bark, though their scantling is comparable with the main build.

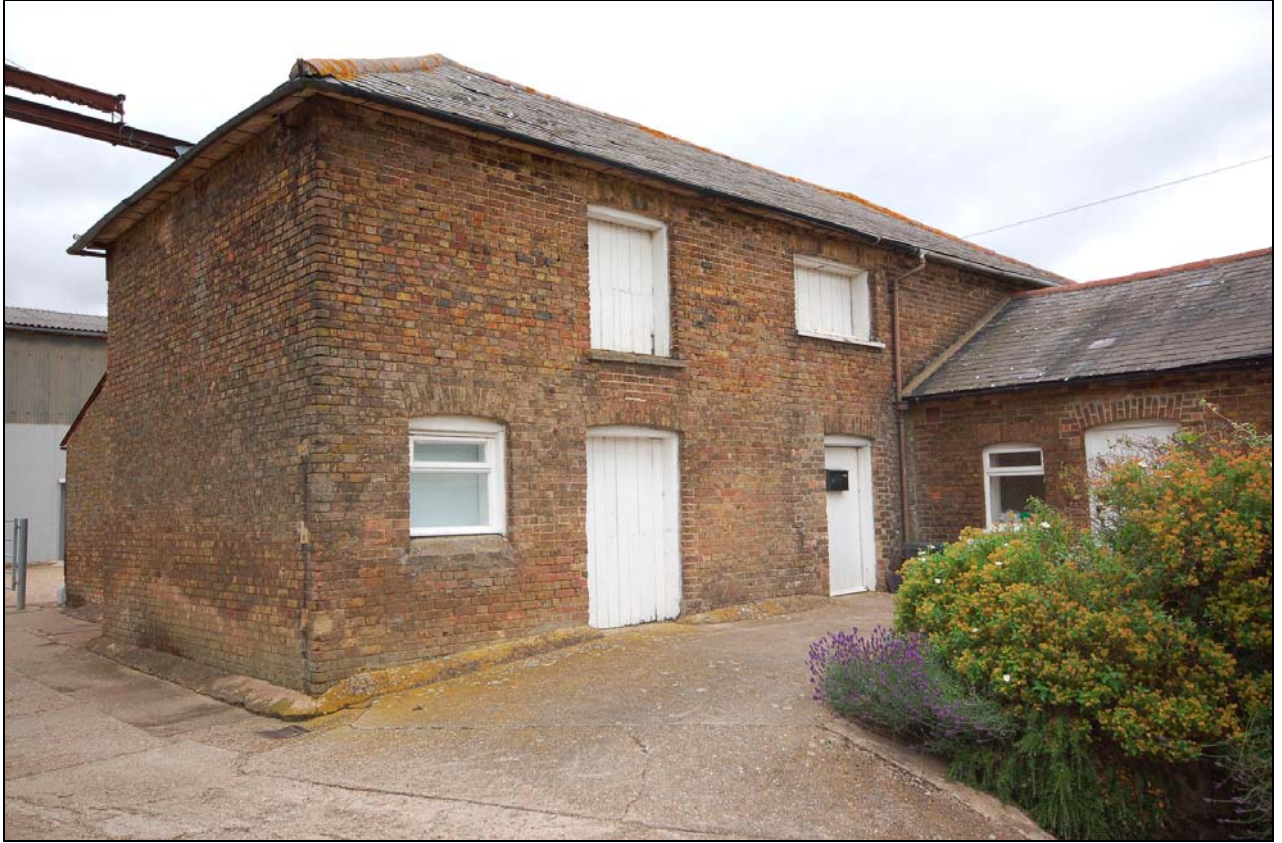
Plate 15 Granary viewed to north-east

In the latter stages of the working farm grain was conveyed to the granary from the barn for storage but originally it would have been hoisted up through the taking-in doors at the front (plate 15).

The main elevation faces the yard to the south and includes two doorways and a window on the ground floor and a taking-in door and hatch on the first floor (plate 15). The eastern part is attached to the stable range. The ground floor window has been replaced and the eastern doorway was narrowed when the interior was re-partitioned (fig. 8). Otherwise, the rest of the fixtures are original. The doors are ledged, braced and battened in a traditional form and all such features are topped by cambered yellow brick arches on the ground floor and flat arches on the first (plate 15).

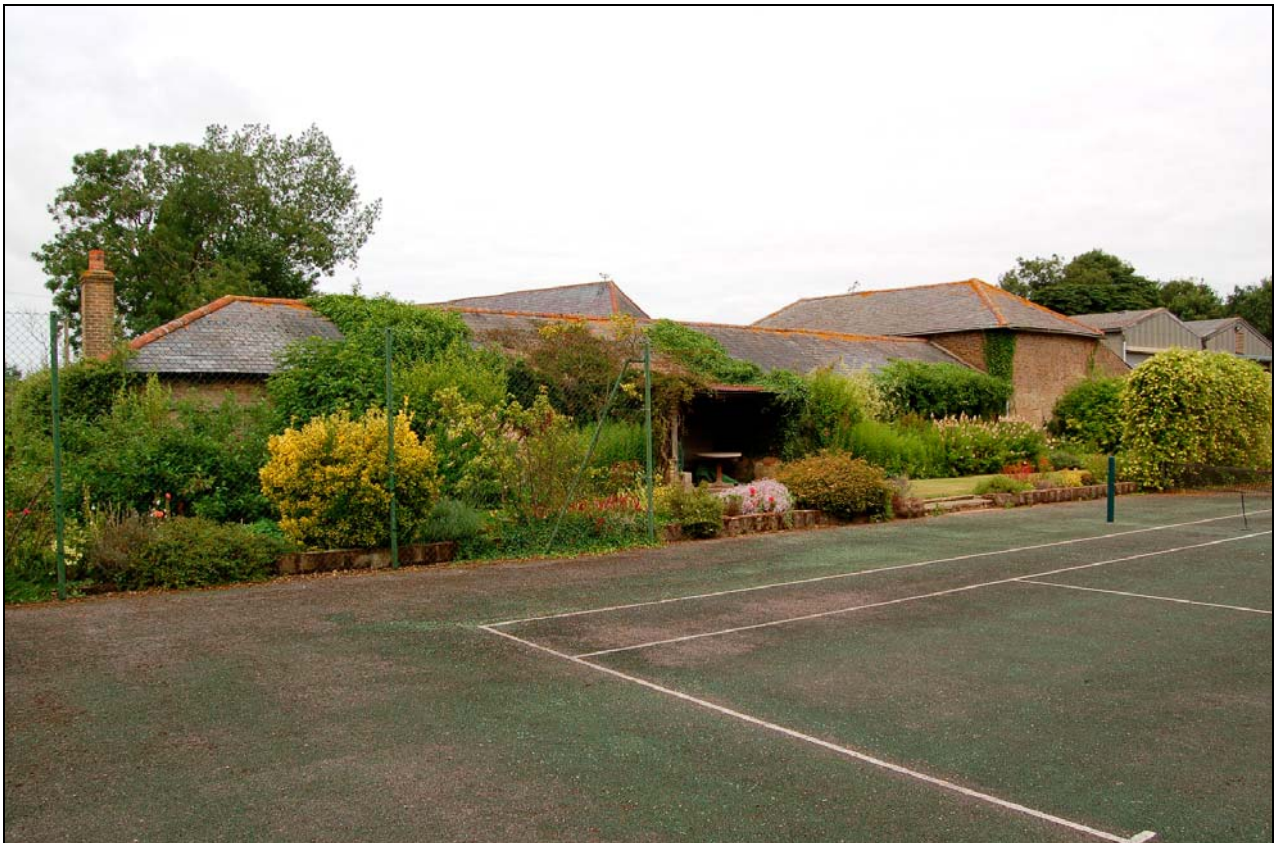
Plate 18 Rear of eastern range viewed to west

Much of the eastern elevation on the tennis court side is obscured by shrubs and other plants (plate 18). The only features are two replaced windows inserted into existing openings (fig. 8).

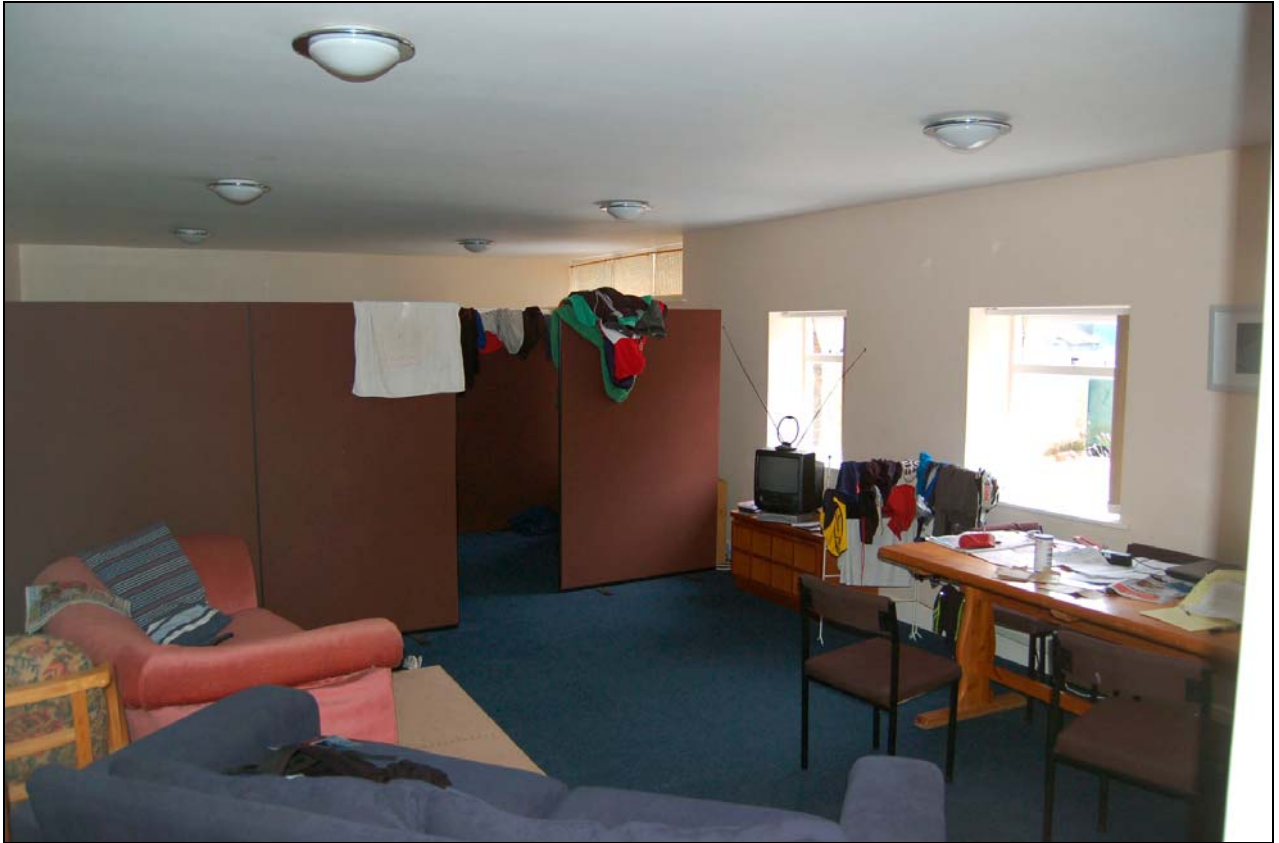
Plate 19 Interior of bed-sitting area inside stable

As mentioned previously, the former stalls had already been converted, so there was no information for internal layout and features to record. As part of the conversion it would appear the interior was lined out in studwork and plasterboard to provide proper insulation, bringing the walls out from 35 to 50cm. Modern carpets and other fittings were inserted and sleeping, sitting and utility areas demarcated (plate 19).

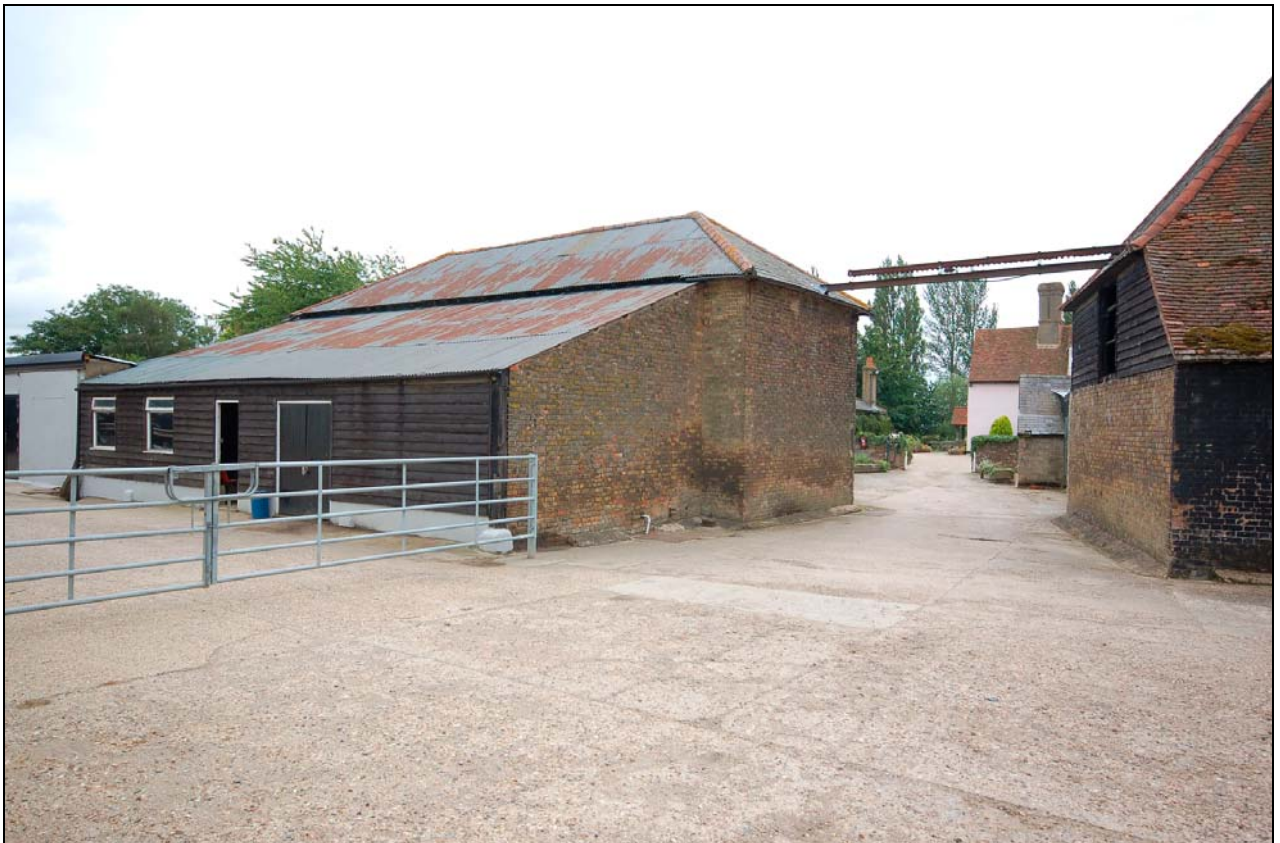
Plate 22 Former cart shed 4 viewed to south-east

There are no features on the hipped elevations to west and east and the north elevation is occupied by building 4, which, like the granary has been re-roofed in corrugated iron (plate 22).
