**THE PLANTATION, MILL ROAD  
STOCK, ESSEX**

**LEVEL II HISTORIC BUILDING RECORD**

**May 2010**

**FAU Project No.:** 2178

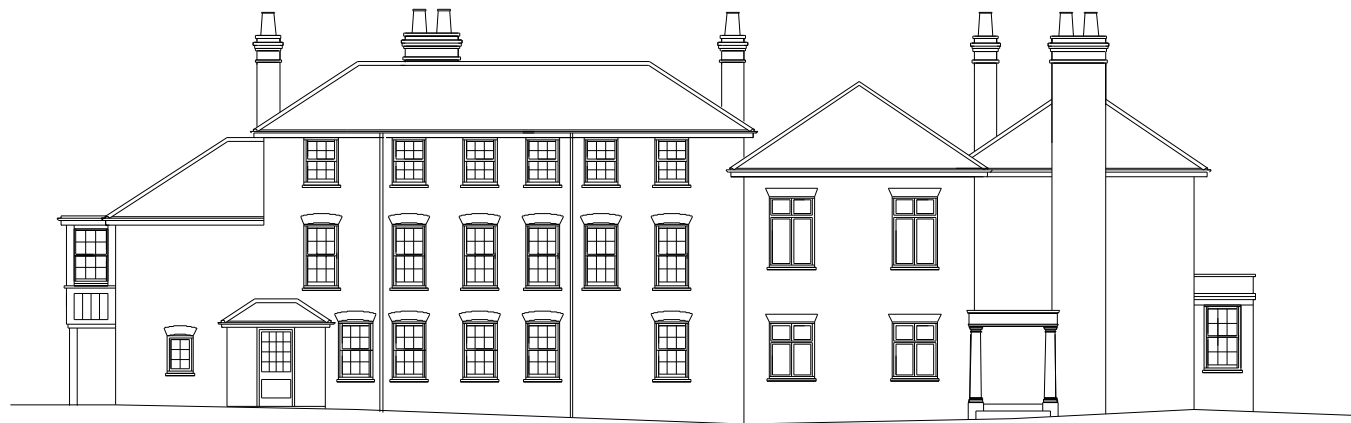
(a) Front (north) elevation

The central three-storey part has six bays that contain service rooms to the east and entertaining rooms to the west, behind a uniform façade (fig. 7a) Fenestration is provided by six-over-six sash windows which on the top floor are smaller to suit the position of the rooms within the eaves (plate 1). Windows on the far western bay have been replaced with horned one-over-one more modern sashes, though it is interesting to observe that there are horns on the six-pane windows too, which indicate these are copies rather than early sashes (Hall 2005), as horns were only introduced with the introduction of larger window panes.

To the east lies part of the service wing, access into which is provided by a side door contemporary with the third phase (fig. 7a). It stands within a slightly projecting brick porch with a pent, slated roof. The door is semi-glazed with a flat projecting hood held on plain, carved brackets (Gibson 2009) and leads into a small service hall and stairs. To the left side is a fixed cloakroom window. The rest is blank. The bedroom upstairs is lit by an enclosed veranda partly seen from the side (plate 2).

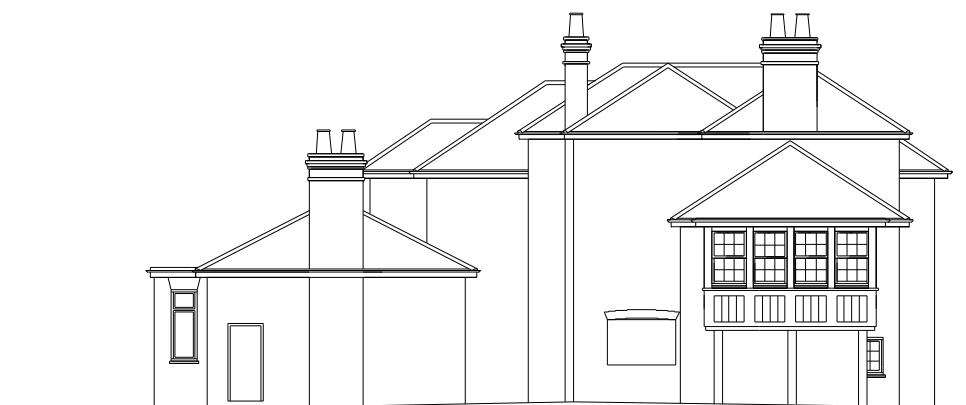
(d) Side (east) elevation

This elevation faces onto a group of multi-phase service buildings, some of which were removed in preliminary site works. With regard to the house, the most interesting feature is the enclosed timber veranda attached to the end bedroom (plate 6). It is supported on square wooden columns and has a panelled surround and six-over-six sash windows (fig. 7d) to admit daylight into the darkest side of the house.

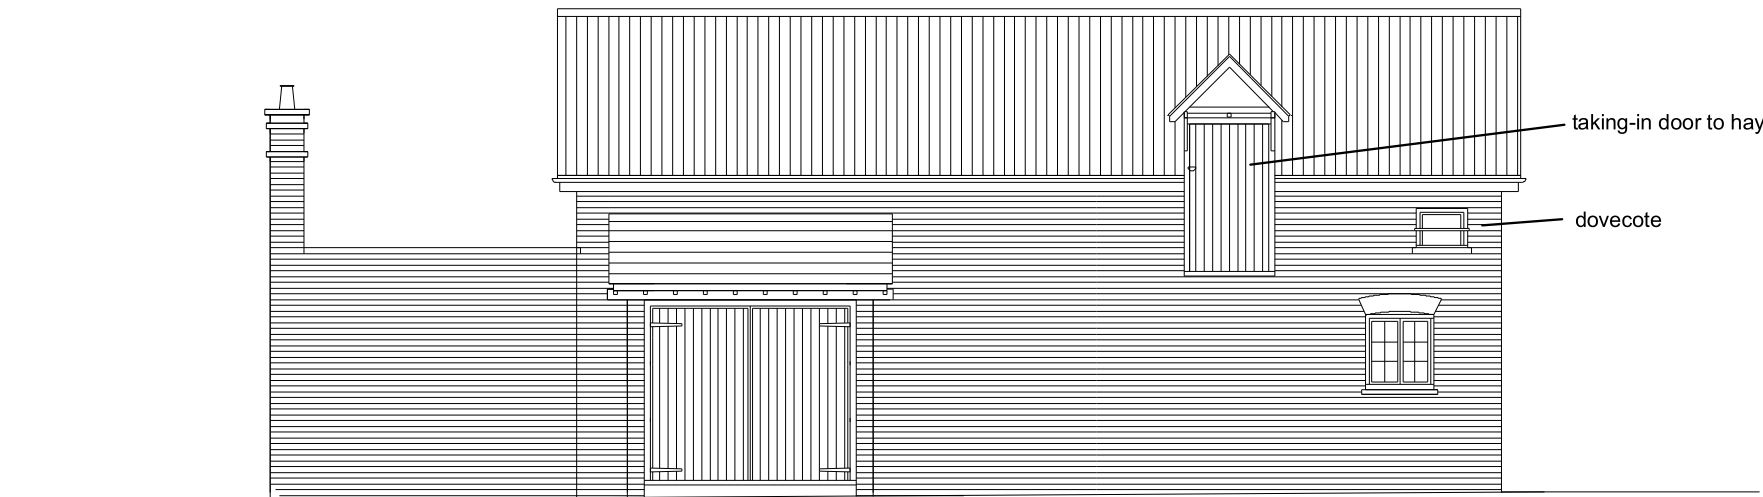
d) West elevation

The most interesting aspect of the west elevation is the first floor taking-in door to the hay loft over the stable (fig. 9d, plate 28). The door is enclosed within a gable projecting from the roof that probably housed a winch. It is of timber construction with curved braces plus moulded ridge plate and barge boards, and roofed with plain red tiles rather than the pantiles seen on the rest of the stable roof. Sawn off wooden guards either side are obscured by vegetation. On the same level to the south of the taking-in door is the entrance to the dovecote, with five doveholes on two ledges (plate 28). Below is the horizontal sliding sash window to stall 1, and an old riveted iron water tank, still in use. A second, narrower, window formerly lit stall 2 but this has been blocked so well that the only giveaway is the surviving head to the right of the coach doors (plate 28).

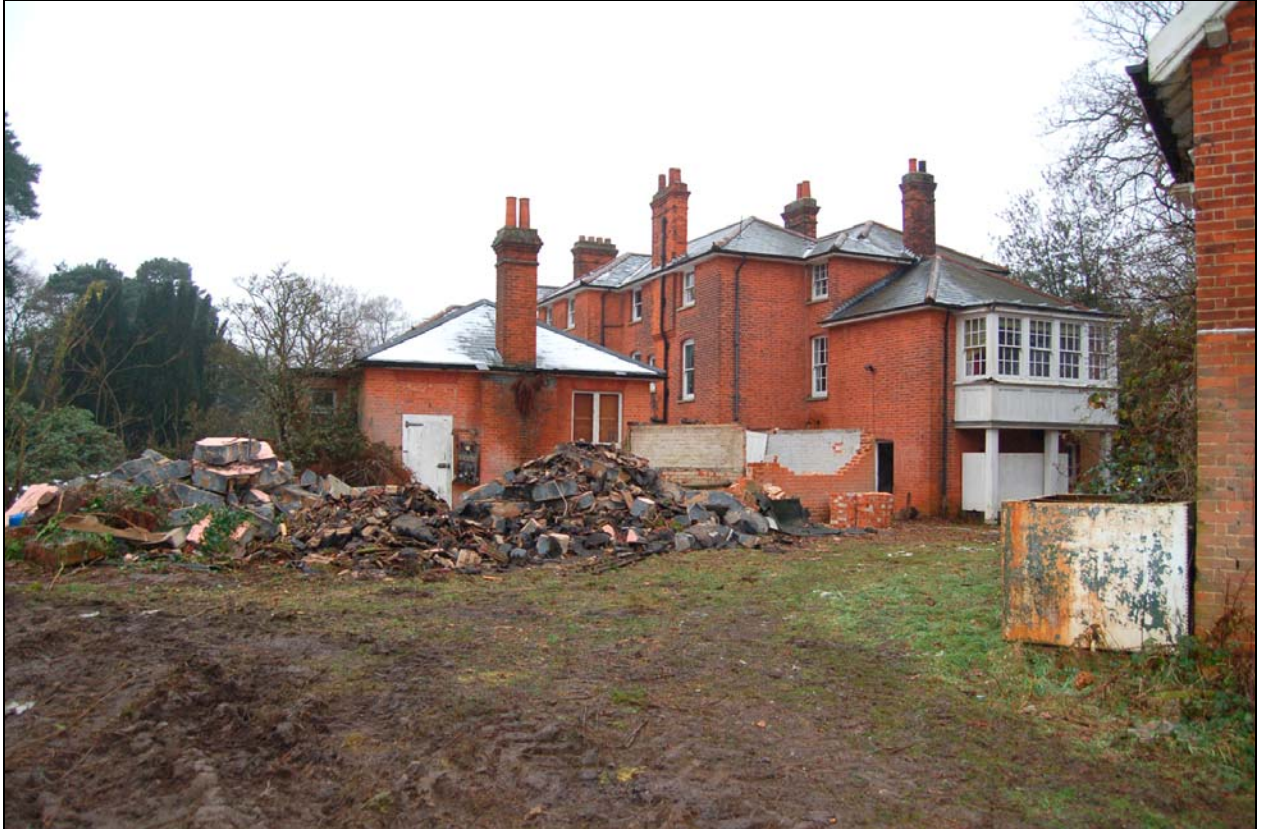
Plate 6 East elevation

One of the two games room windows on this side has been opened-up to create a modern doorway (fig. 8a, plate 6). The door is of the heavy refrigerator-type, indicating that apples were kept in here.

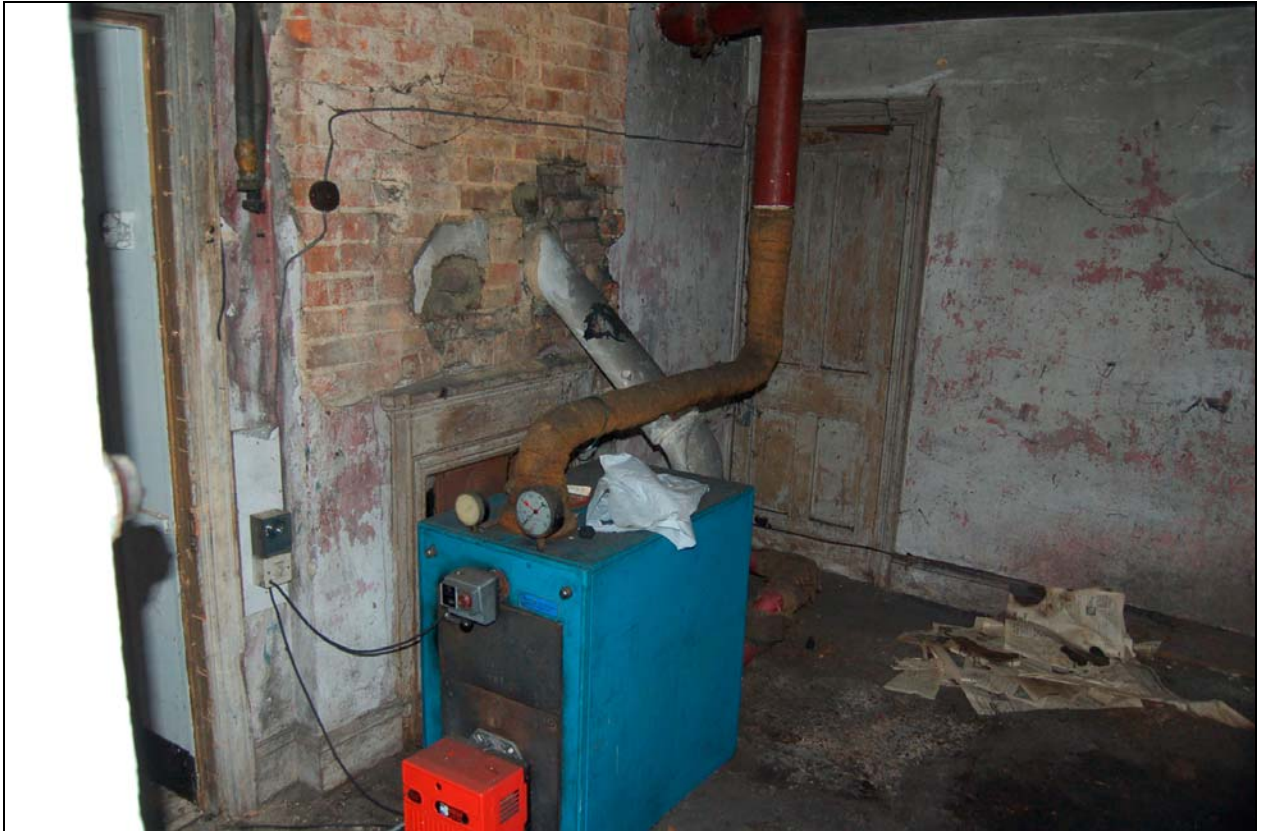
Plate 7 Interior of boiler room

There are currently two entry points into the service wing, one at the back of the house and a more formal one at the front. The first leads directly into the kitchen/preparation area, while the second gives immediate access by stair to the first and second floors. There was originally a third route, through the **boiler house** that originally linked to the entrance **hall** opposite, but the doorway is now blocked (fig. 8a). This and the fact that there is a fireplace behind the boiler, which is relatively modern suggests this room originally had a different function (plate 7).

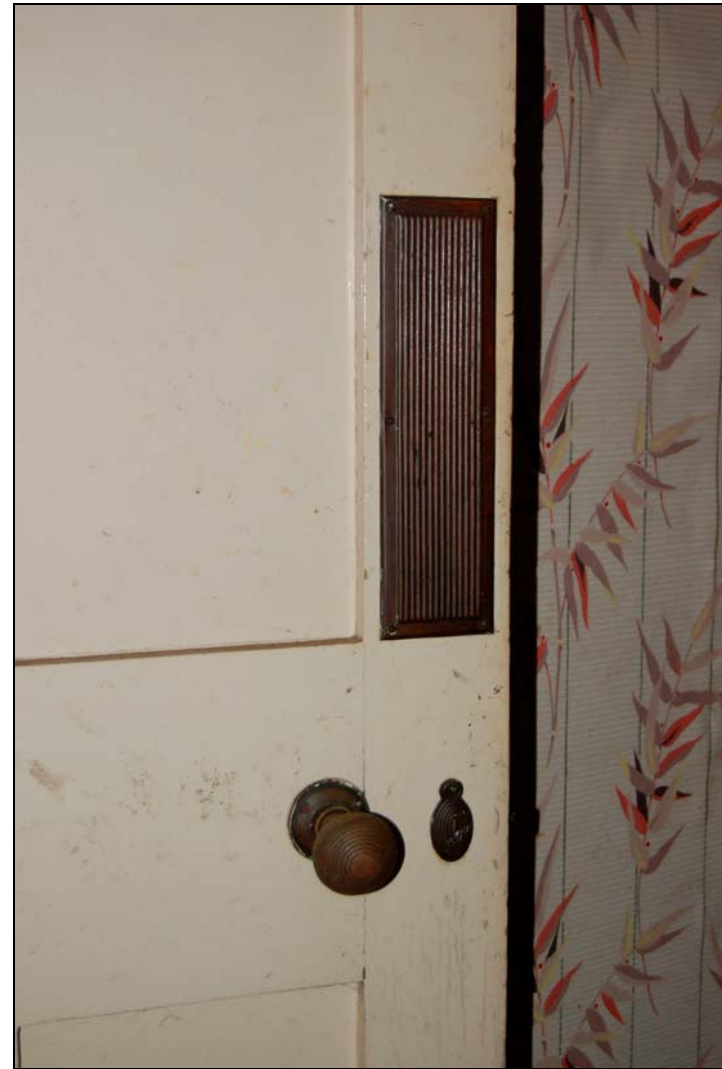
Plate 14 Door furniture

As already stated, the service area is also entered from the staff entrance on the north side of the house. From the staff **hall**, there is access to the cloak room, study and staff stair. The **cloakroom** has what may be termed 'Art-Nouveau style' coat hooks and the window fixtures have curled ends which are used in most of the casement windows (plate 13). The plain dog-leg **stairs** are arranged in three flights up to the second floor. The **study** is assumed to be the administration area and reflects the general type of fixtures seen in the less utilitarian rooms: cast iron fireplaces (removed), torus moulded skirting boards and plainly moulded architraves. The four-panelled doors are fitted with 'honeycomb' brass door knobs, and one in particular (to the hall) is unique to the house in retaining its escutcheon over the keyhole and scratch plate above, forming a 'matching set' of early 20th century door fixtures (plate 14).

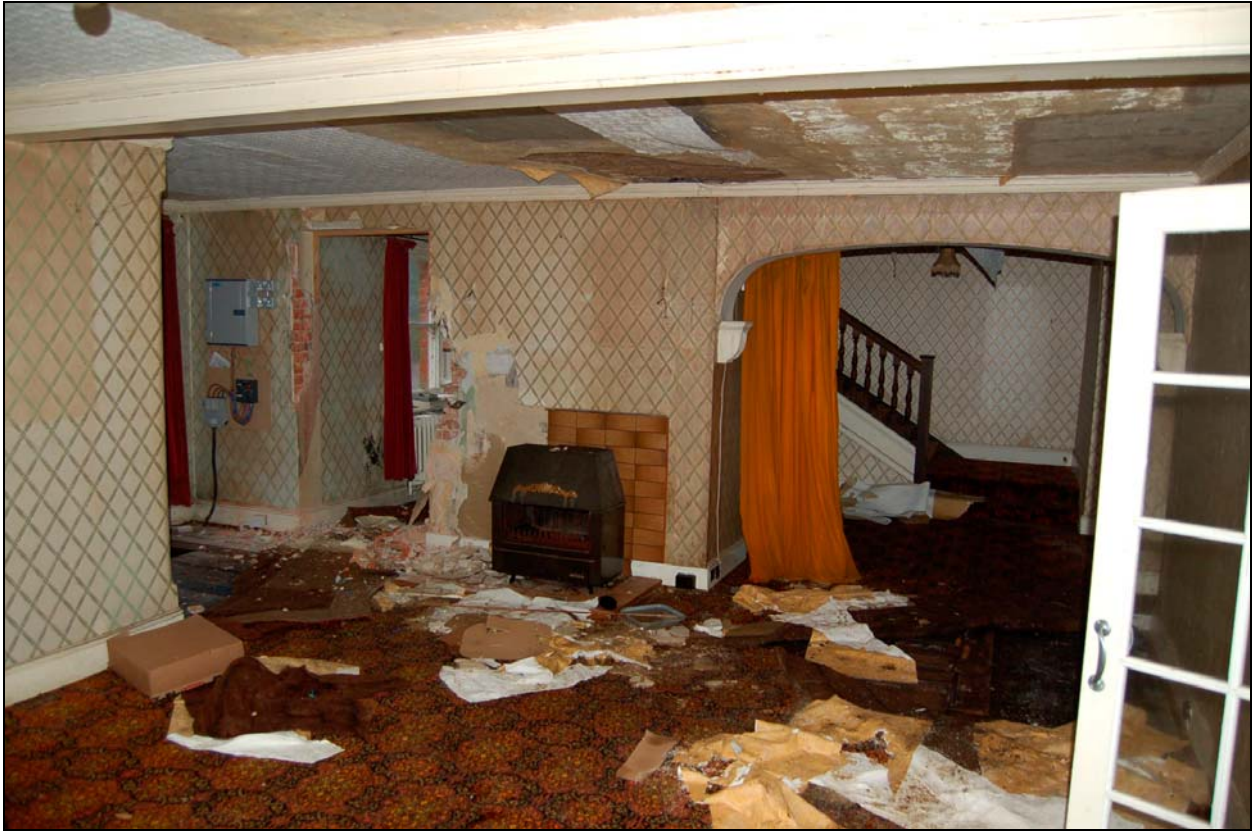
Plate 15 Sitting room viewed to east

There are three main entertaining rooms for guests, each quite large and with more modern décor than the service rooms. Generally, apart from the skirting boards and windows with their elaborately curled fittings, all the features (doors, carpets, etc) are modern. The **sitting room**, probably the lounge and bar area seen on the service board in the breakfast room, is in a very poor state, with soggy carpet and peeling wall and ceiling paper (plate 15). It lies broadly on the boundary between the early (phase 1 and 2) and later build and is divided into two areas by modern hardboard arches either side of the chimney breast (fig. 8a). The modern dog-leg **stairs** (plate 15) are of no architectural interest.

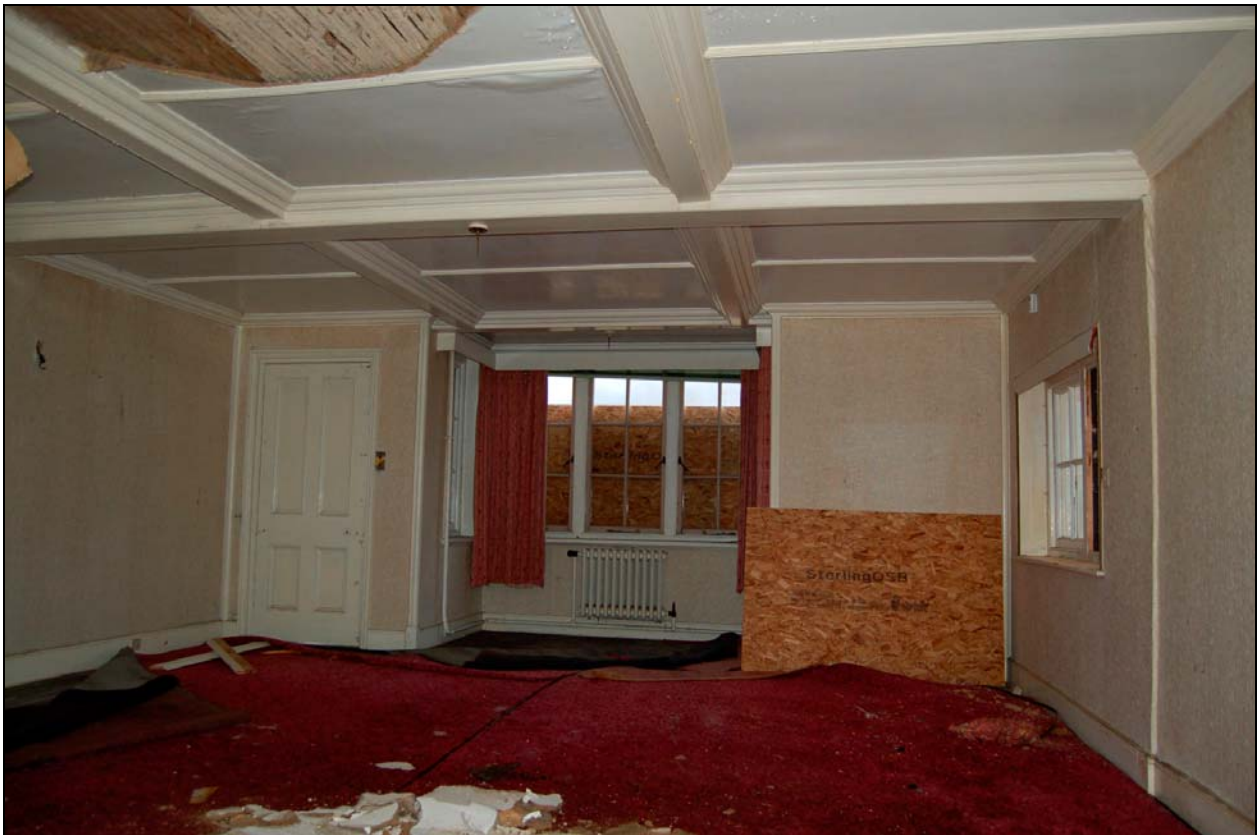
Plate 16 Dining room viewed to south

The **entrance hall** behind the portico has no features of note apart from a substantial oak door and red 'brick' tile floor. The **dining room** has a coffered ceiling (plate 16) and access to the conservatory link that joins this to the service end of the house. The **ballroom** (fig. 8a), complete with parquet dance floor, is decorated to a high standard, though it is all modern, designed with Classical-style panels, dado rail and cornice over gypsum plaster (plate 17). The wallpaper is modern and the fireplace is an elaborate reproduction; if it were not it would surely have been stolen with the rest. The bay window was probably added in the second phase, but has been fitted with plain 20th century handles, despite the room's obvious status. A pair of double doors leads out into the conservatory, which has been built over what was originally the main formal entrance into the house. This is demonstrated by the dentilled cornice that remains above the present external doorway (plate 18). The **conservatory** stands where the Tuscan porch originally stood and is contemporary with the main house enlargement phase. Parts have been replaced over time, particularly the roof which is UPVC.

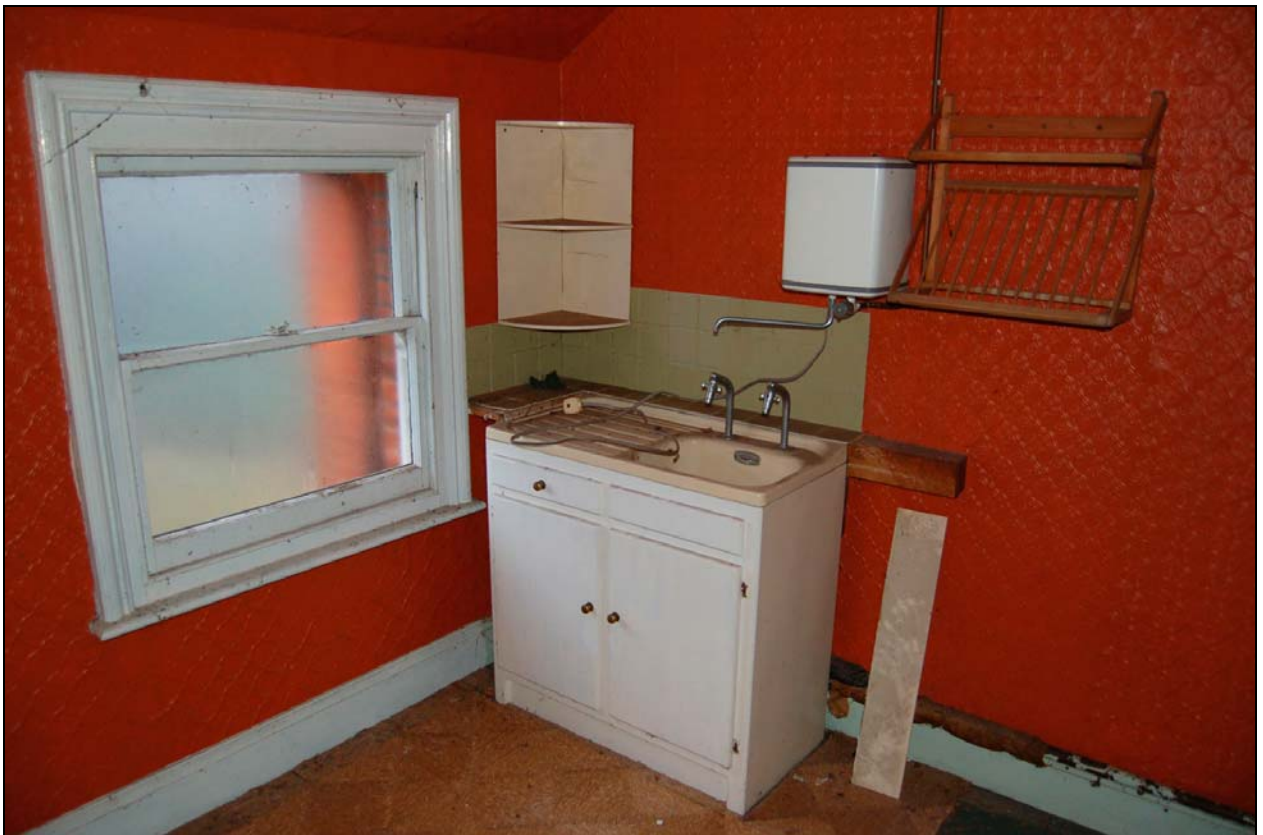
Plate 26 Staff kitchen

The bedrooms are simply furnished and built into the eaves of the roof. Most are painted in shades of green, red and blue, some rather bold. They all retain small cast iron fireplaces and some fitted cupboards. **Bedroom 9** is interesting in having a higher quality door than the others, with moulded panels that appear decorated in textured wallpaper (plate 25). **Bedroom 11** at the far end retains a cupboard in the alcove that was probably standard in all the rooms. The **kitchen** still has the sink, heater and plate drying rack for off-duty staff to use (plate 26).

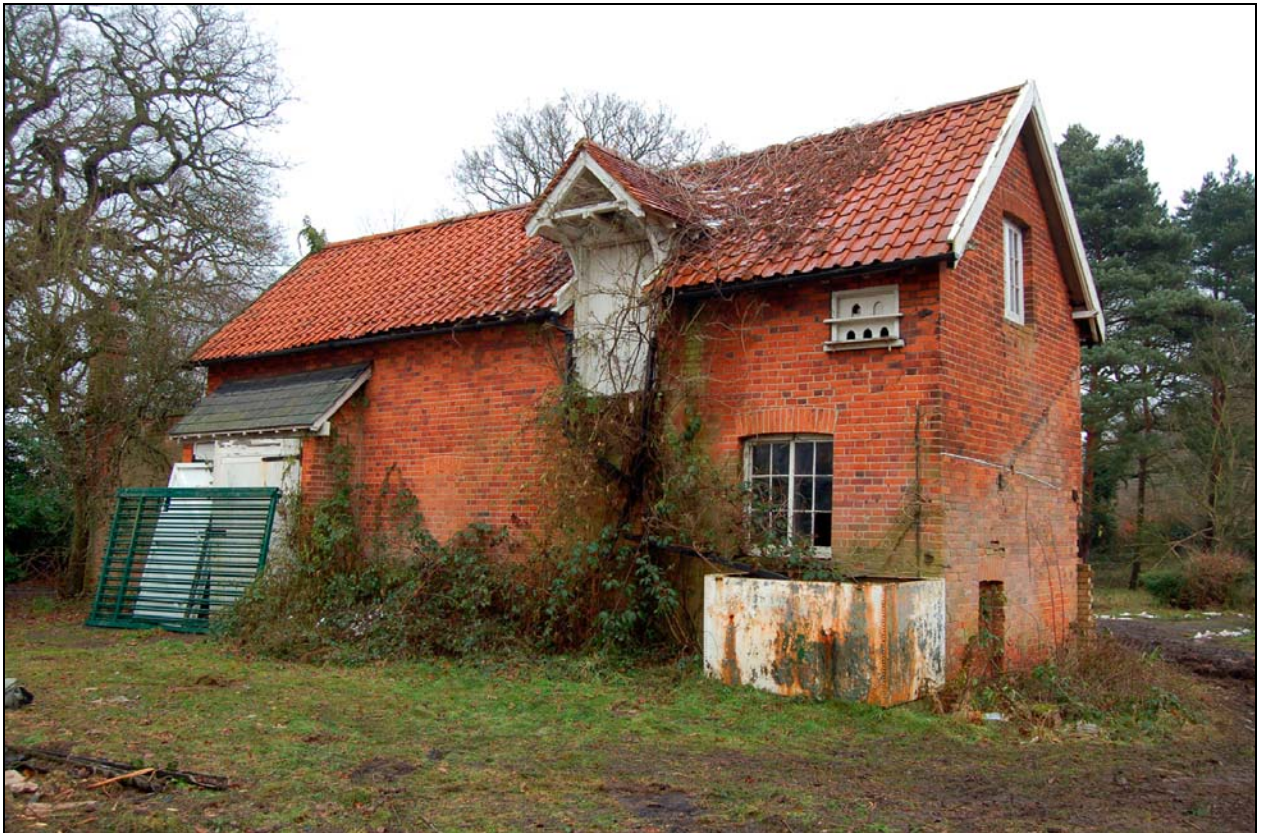
Plate 28 Stable viewed from south-west

The gables have horizontal sliding sashes high up at either end to light the hay loft (figs 9b & c); the south-facing one of which is replaced. At ground floor level on the south side is a blocked segmental-arched aperture that was likely associated with a machine pit inside the first stall (fig. 10a) and the line of an old rainwater pipe can be seen running into the tank on the south-west corner (plate 28).
