**'MILKWOOD', TILBURY ROAD
OVINGTON
ESSEX**

HISTORIC BUILDING RECORD

**Essex County Council
Field Archaeology Unit**

June 2010

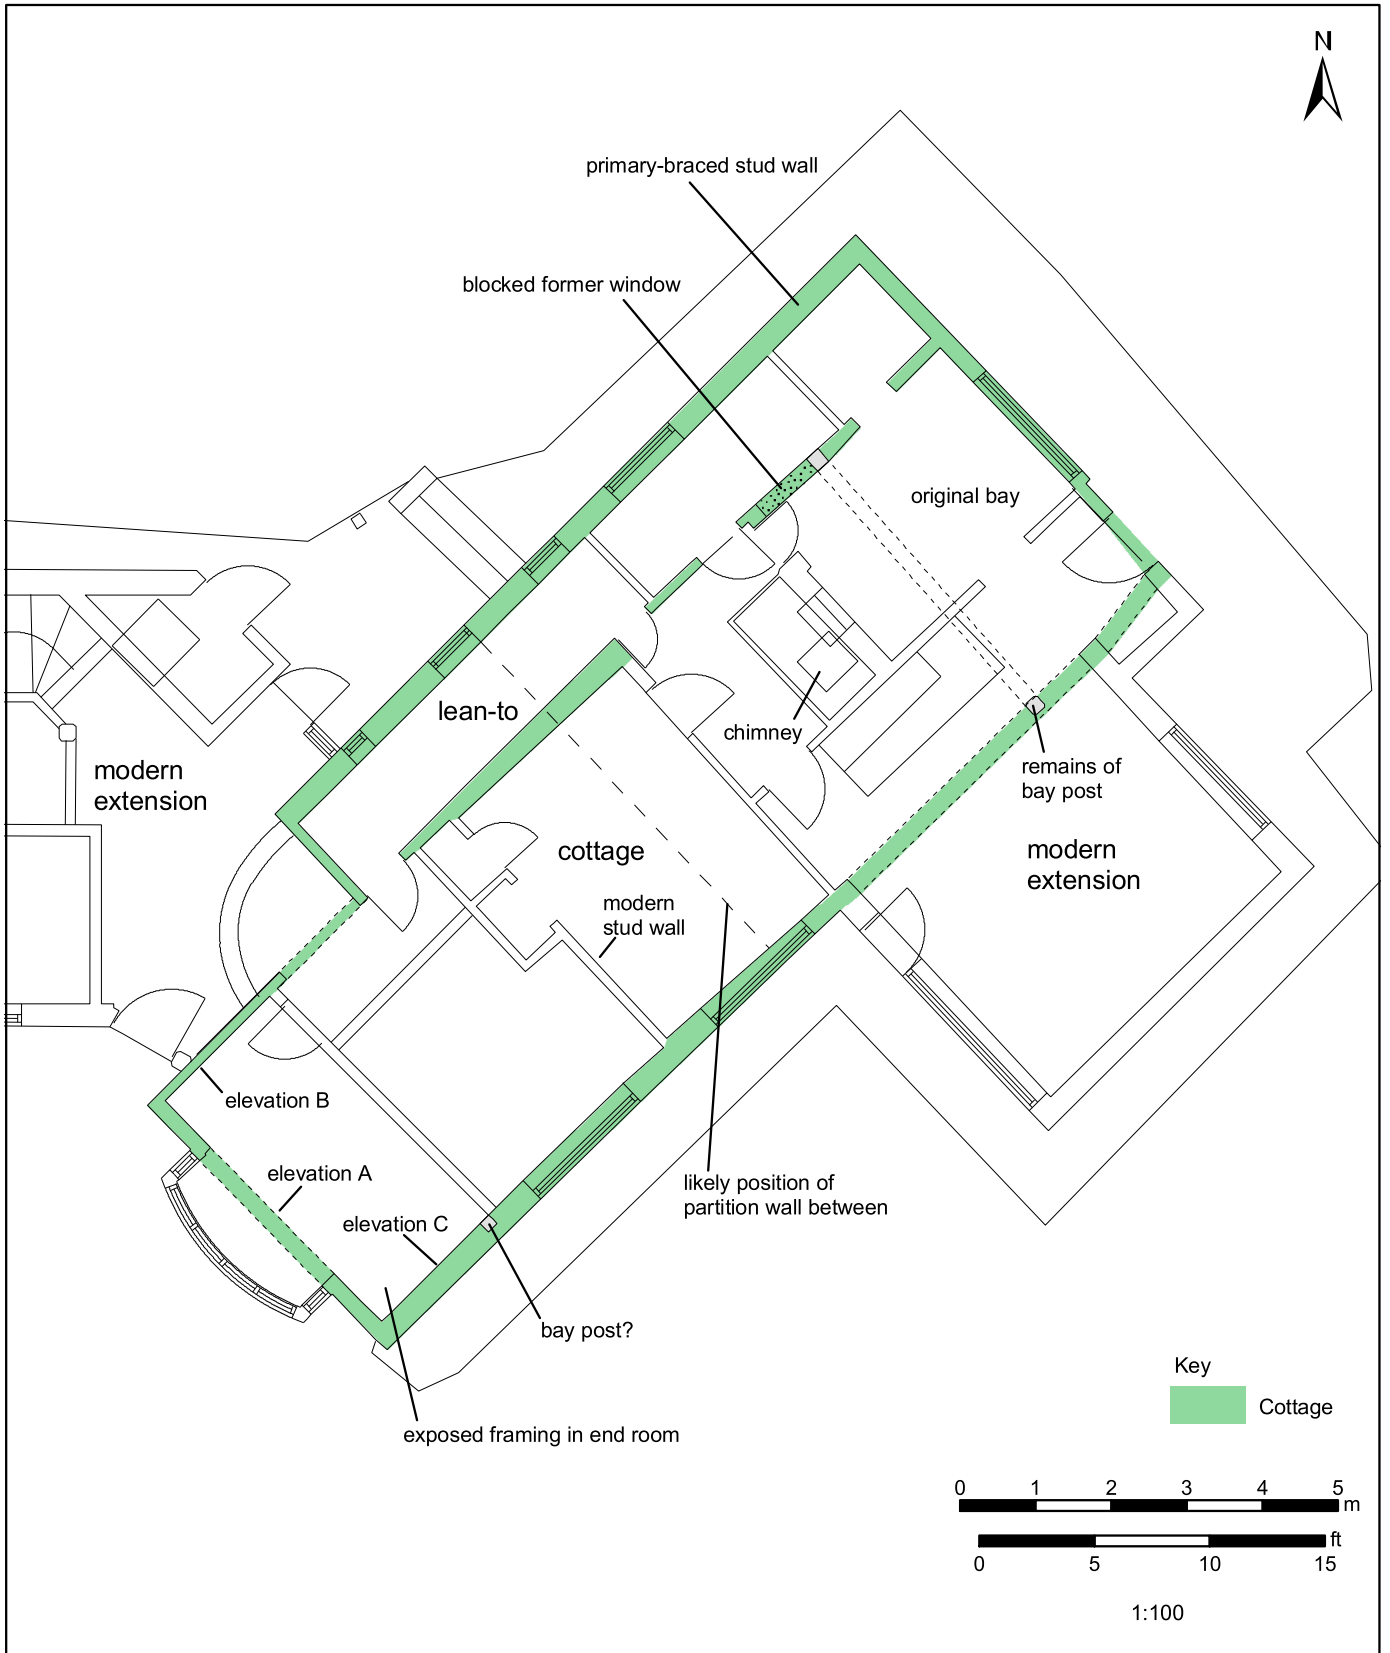
Fig.6. Ground floor plan

When the interior was gutted by the fire all the internal walls were lost, leaving a single modern stud wall as the only survivor (fig. 6). Taking this into account and the relative survival of the earlier outer walls, the room layout in figure 6 probably reflects the modern rather than historic floor plan. In particular there is no evidence of the central dividing wall between the cottages, added to figure 6 from the 1897 OS map.

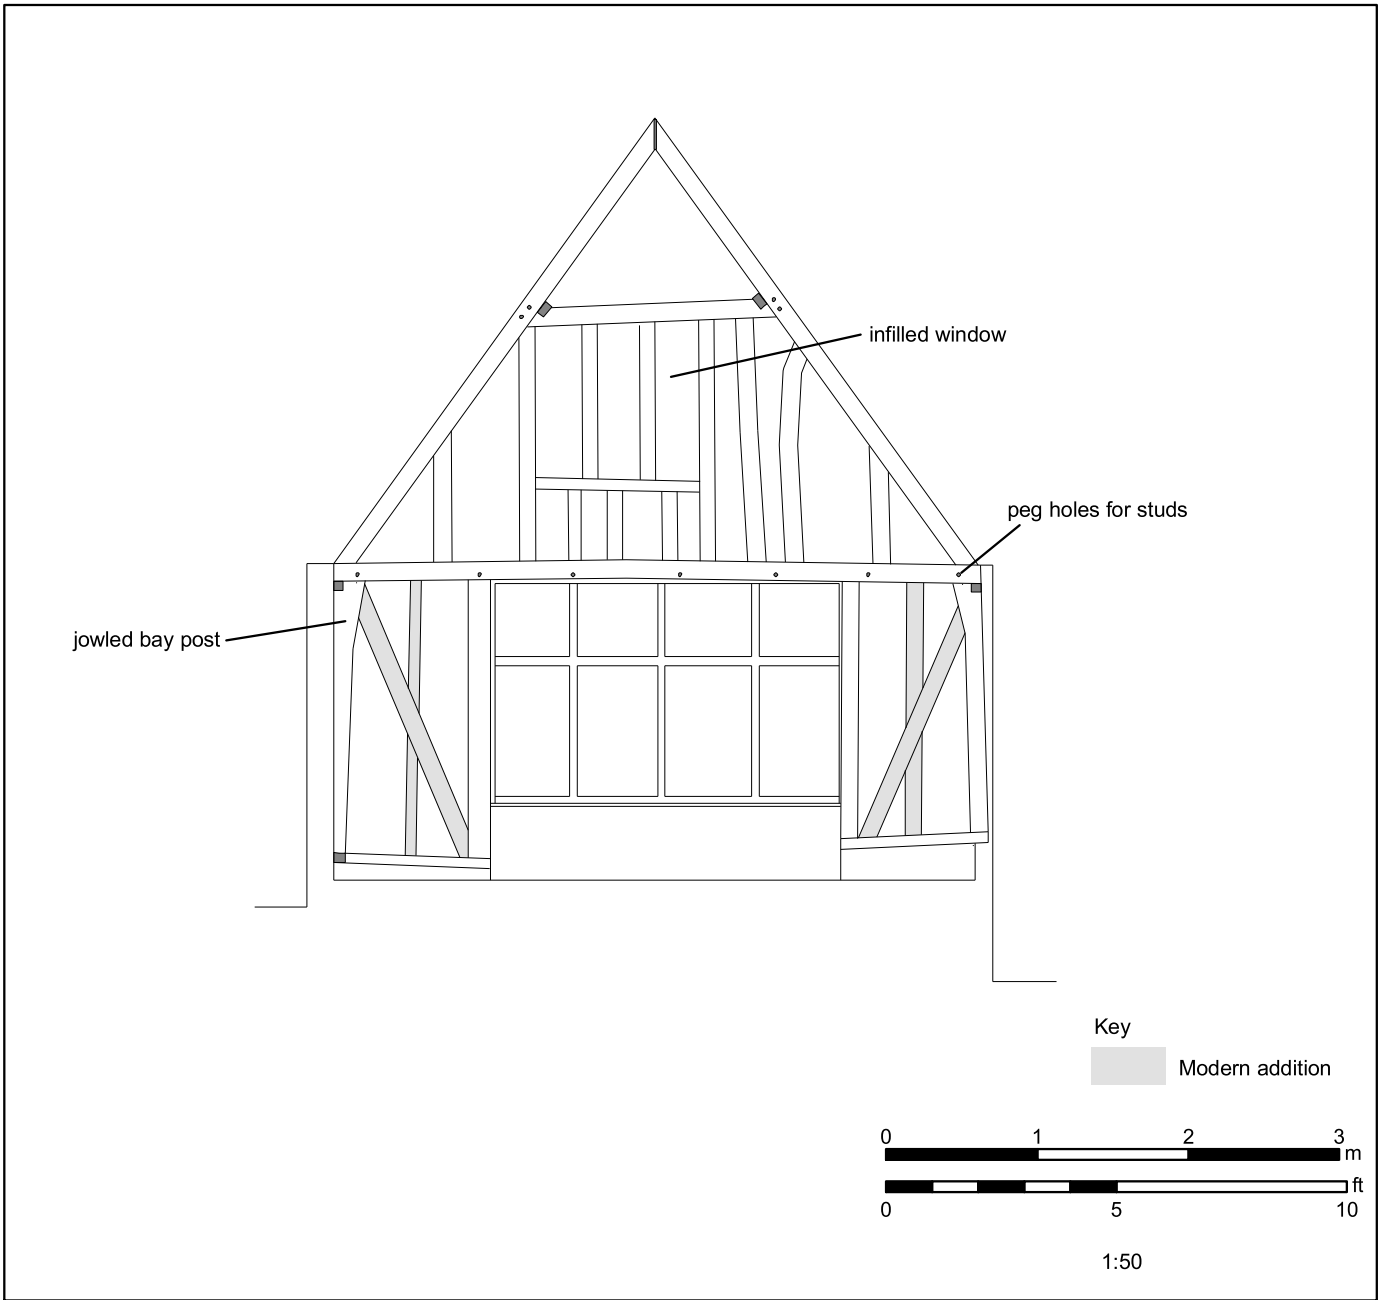
Fig.7. Elevation A

The most prominent area of framing is on the gable wall (fig. 7, plate 4), whose framing is more typical of the first half of the 17th century, with jowled-headed bay posts and fairly straight and wide studs, between 10-15cm wide (c.5 inches). Not all the studs are pegged, but those in the lower register are pegged to the wall plate (fig. 7) and tenoned to the sill. Studs have been removed in the lower register to insert the bay window but their positions can be inferred from the pegholes along the wall plate, quite wide at c.60cm. Extra studs and steep primary braces have been added either side to support the open area behind the window, none of which are pegged to the frame (fig. 7). The upper register is different. Here the studs are only tenoned rather than pegged and their spacing is much closer, although their overall form and dimensions are similar to those below. A three-light window, built to hold iron frames, has been blocked in the gable (fig. 7). It is likely there was another on the opposite wall facing the road.

Virtually none of the roof survives, but remains in the south-west gable indicate a common form, the collar clasped purlin type. The collars are double pegged to the rafters, whose ends are butted rather than pegged (fig. 7). Butted rafters are generally a later form, usually nailed to a central ridge plate that may have perished in the fire.

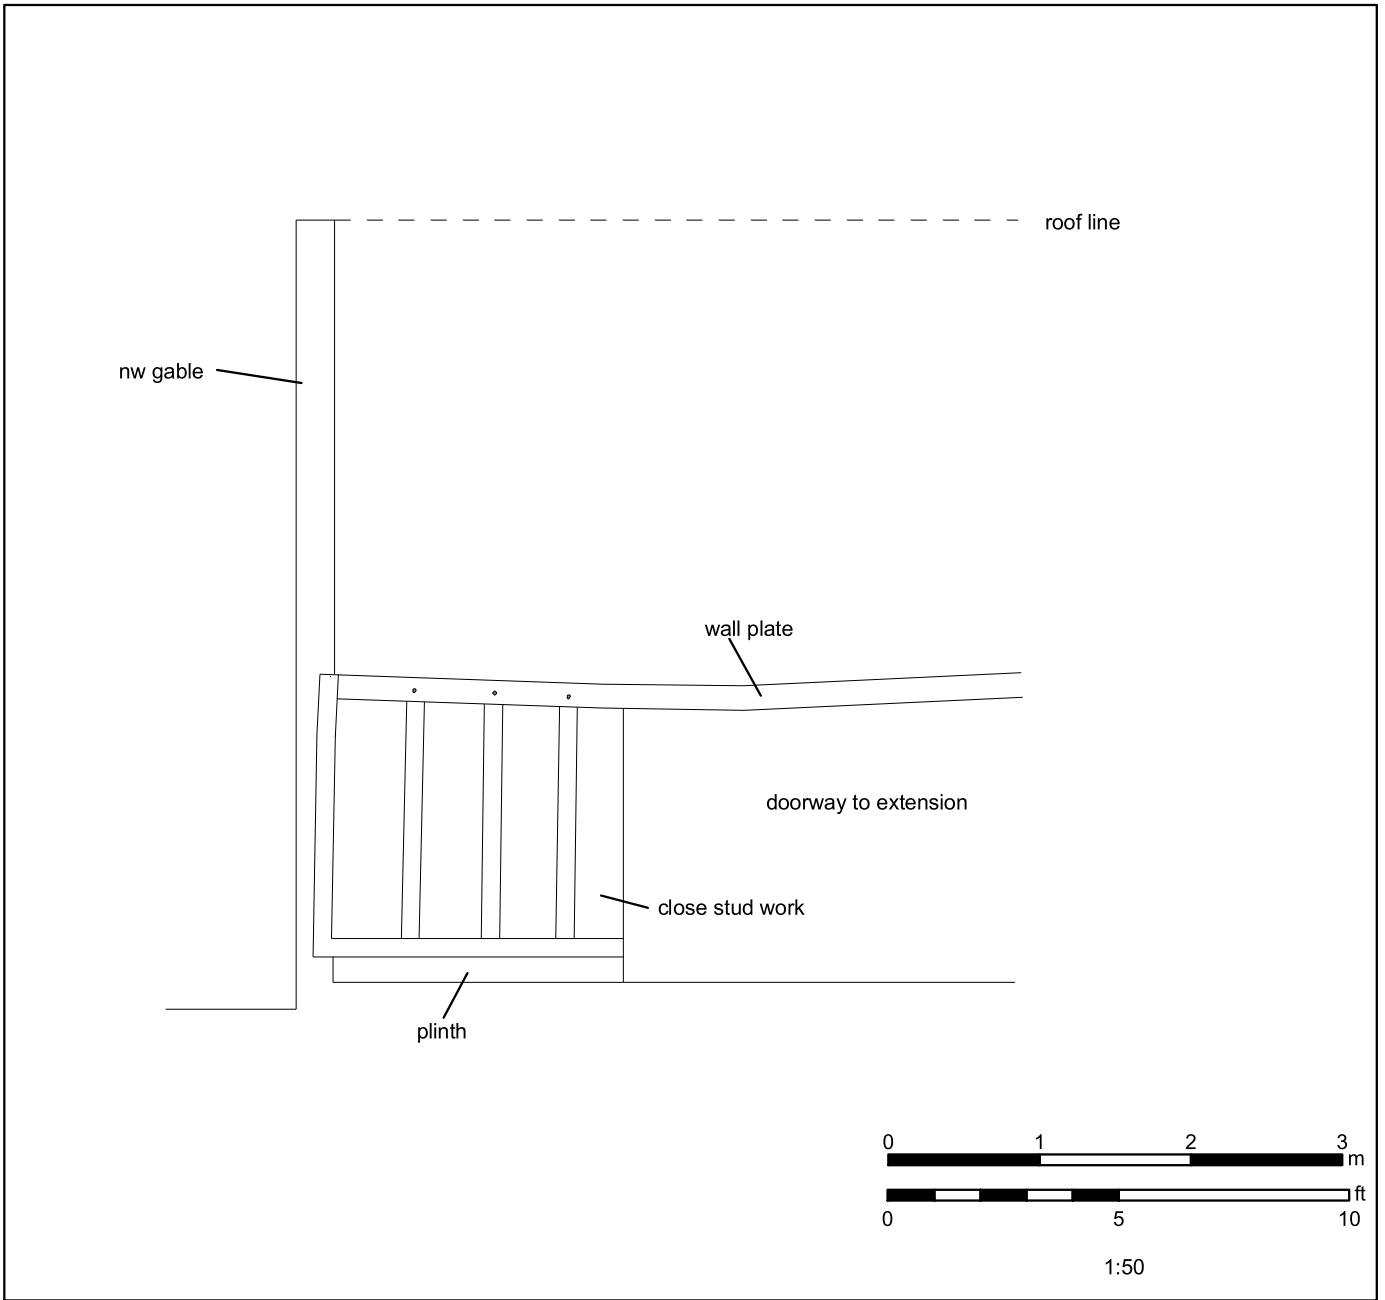
Fig.8. Elevation B

Similar pegged close studwork is evident on the north-west wall (elevation B, fig. 8). Three studs remain, whose line is broken by a wide modern opening into the extension, where the wall plate is covered by later timber (plate 5), hiding any pegholes here. The studs are similar in size and neatly-spaced with wide gaps of c.40cm and attached to a replaced sill.

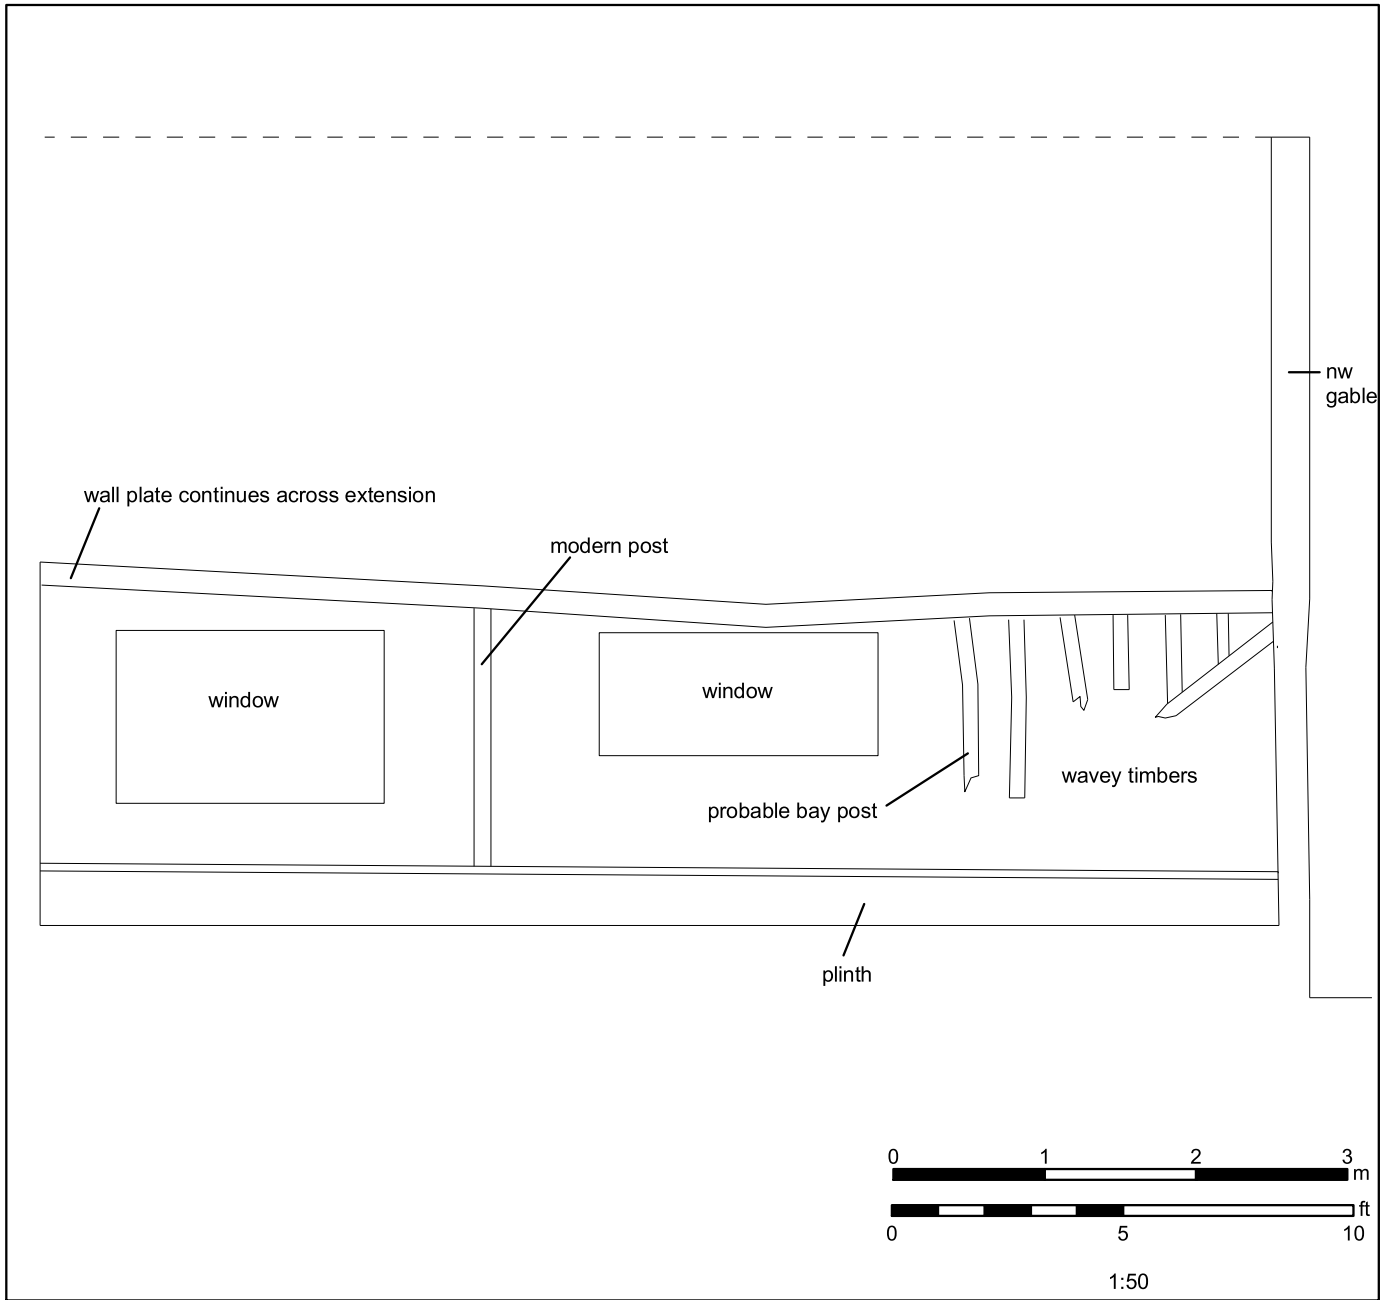
Fig.9. Elevation C

The south-east wall (elevation C, fig. 9) is totally different in form to the two other walls, having a 'waney' primary-braced frame, more typical of the late 18th or early 19th century when good wood was scarce. The frame is largely unpegged and the studs, badly burnt in the fire are simply nailed to the brace (plate 6).

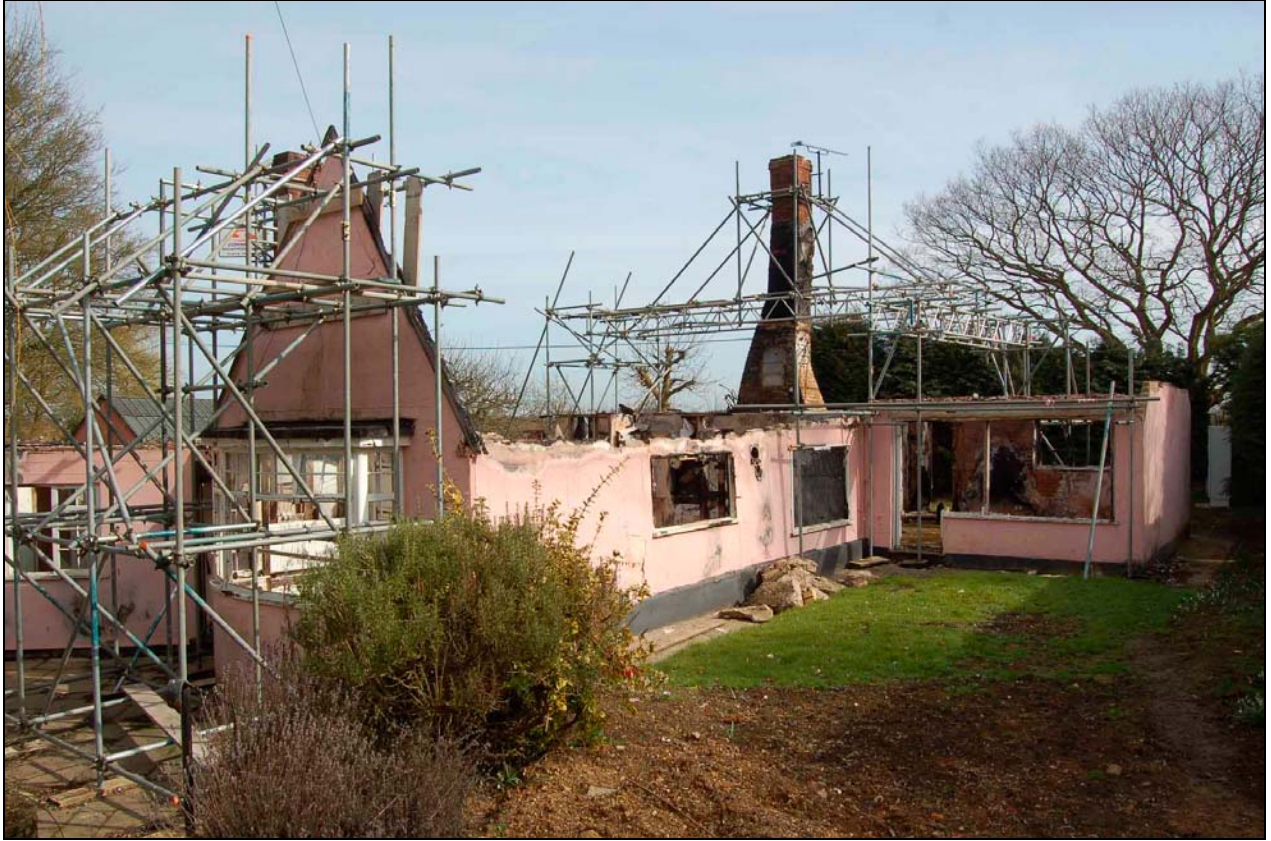
Plate 1 Cottage viewed to north with extensions either side

Since the fire, the cottage is little more than a shell. The roof was completely lost and only the outer walls, the chimney and the south-west gable remain (plate 1). Later extensions, also thatched, fared no better. The cover plate shows the cottage as it formerly appeared.

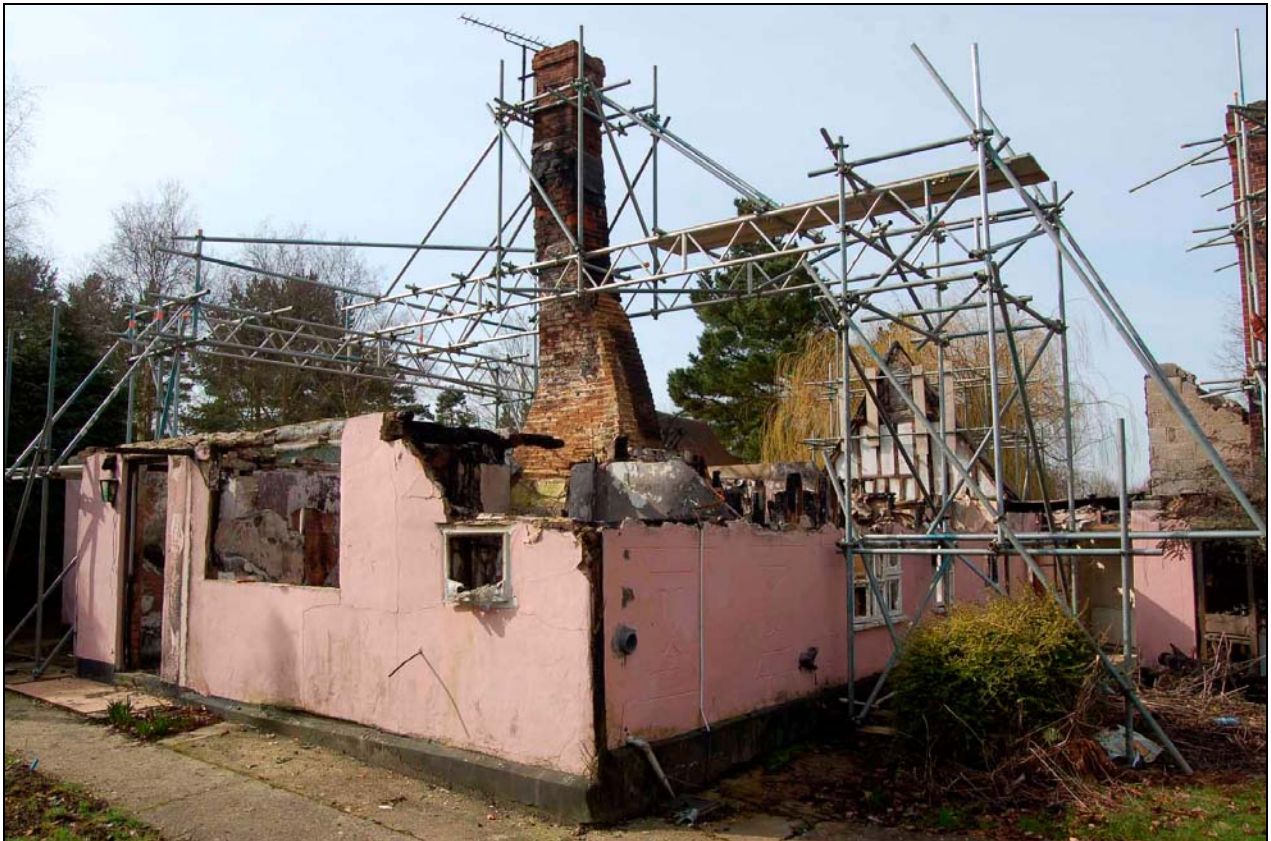
Plate 2 Cottage viewed to south with lean-to in foreground

The lean-to (fig. 6, plate 2) is probably a later addition (1839-81) and is built from a mixture of fairly substantial primary-braced timbers towards the east end and machine-sawn timbers towards the west, which are more typical of a later 19th century date.

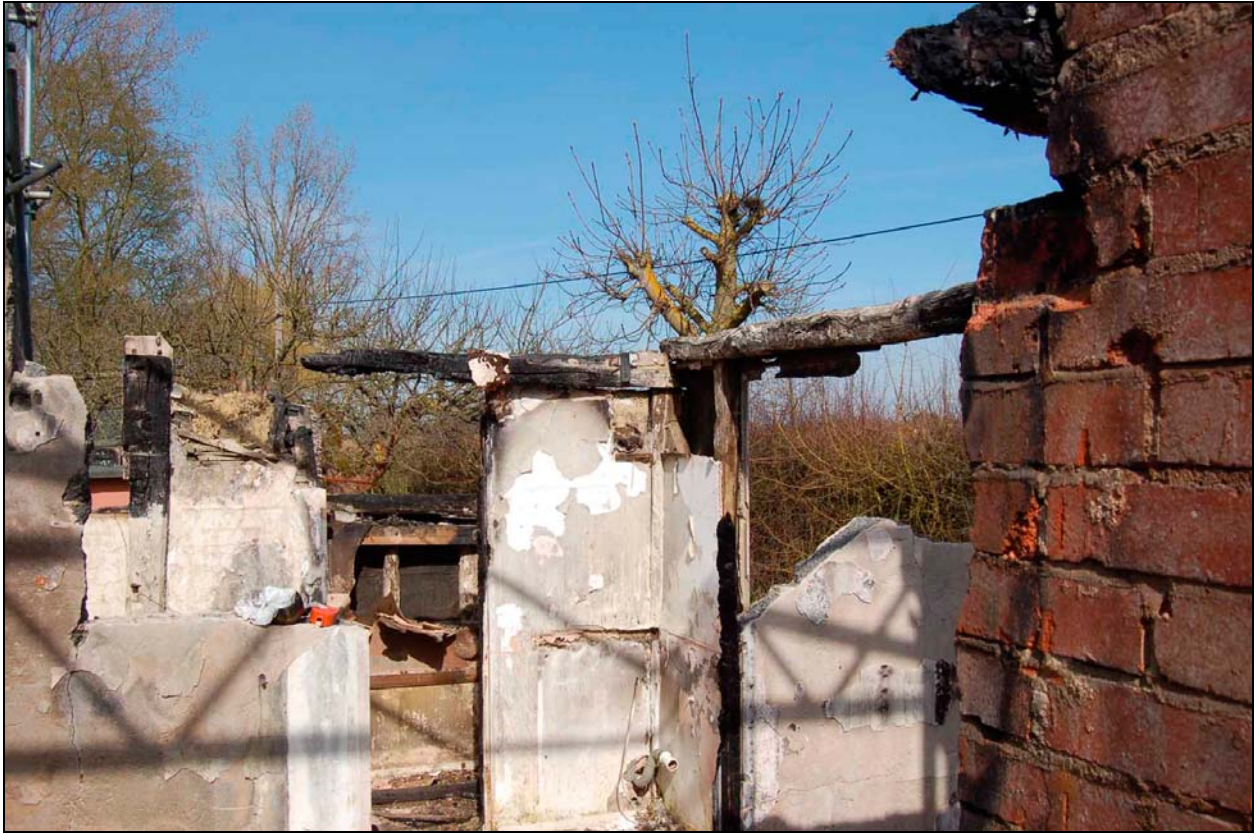
Plate 3 North-east bay viewed to lean-to showing bay post to left

A single bay remains at the north-east end, which is quite narrow at 2.2m, inferring that the cottage was built of six bays. The bay is represented by two posts. The one on the south-east side is a charred stump, but the other survives to full height (fig. 6, plate 3). In their original form they would have carried beams that held the roof frame and ceiling above, of which nothing remains. Close inspection of the intact but charred north post shows the beams were supported by double-pegged braces sat on short ledges. The tenon joint with its three pegholes for the original wall plate survives virtually intact (plate 3).

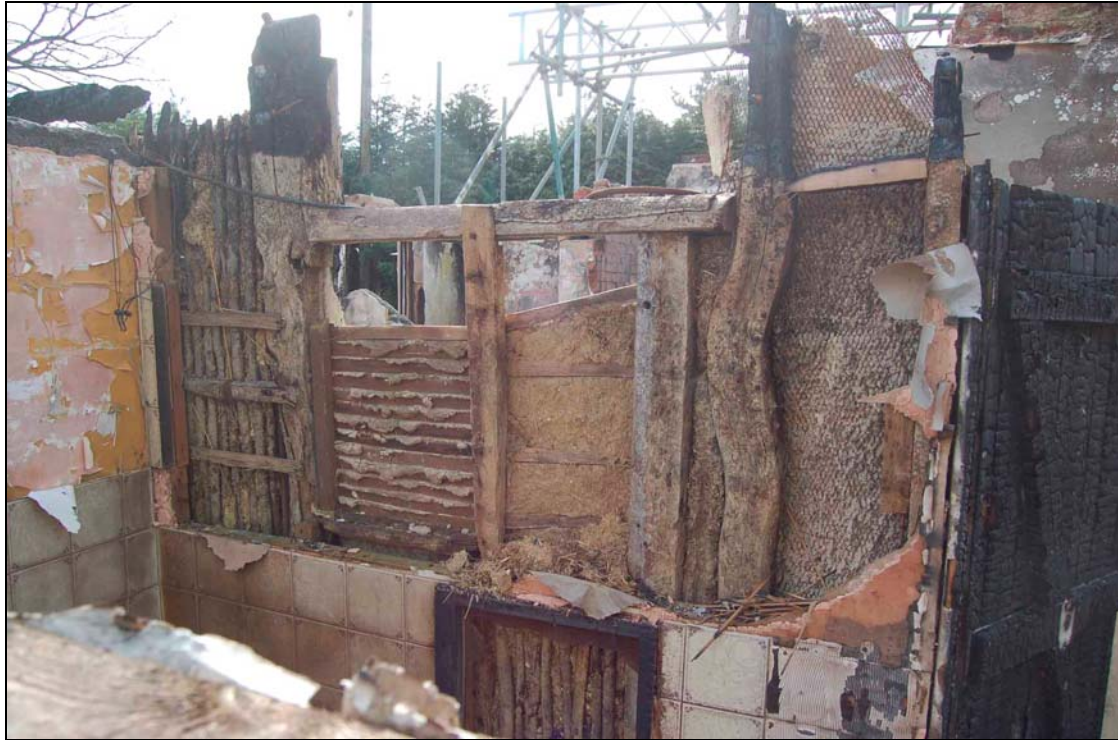
Plate 7 Exposed features on north-west wall of cottage

Part of the external wall frame of the cottage was exposed after the fire on the north-west side of the cottage, viewed from the bathroom of the later lean-to (fig. 6). An un-braced and waney timber is evident in the build (plate 7) and more is likely to exist along the wall. This section of rarely-exposed wall fabric is important in containing a rather rustic two-light plain timber window frame (fig. 6). This feature probably pre-dates the cottage and was likely blocked, in daub with lime plaster over, when the lean-to was built. The window (plate 7) is built onto one of the few remaining bay posts. On the other side of the window, past the extant bay post, is some exposed wattle and daub. The daub has been pressed from the inside onto staves that are held in place by nailed laths. Bark binding is still attached to the central stave (plate 7). Further along the room, at the north-east end of the lean-to, rudimentary split staves have been used across the wattles and there are the remains of a

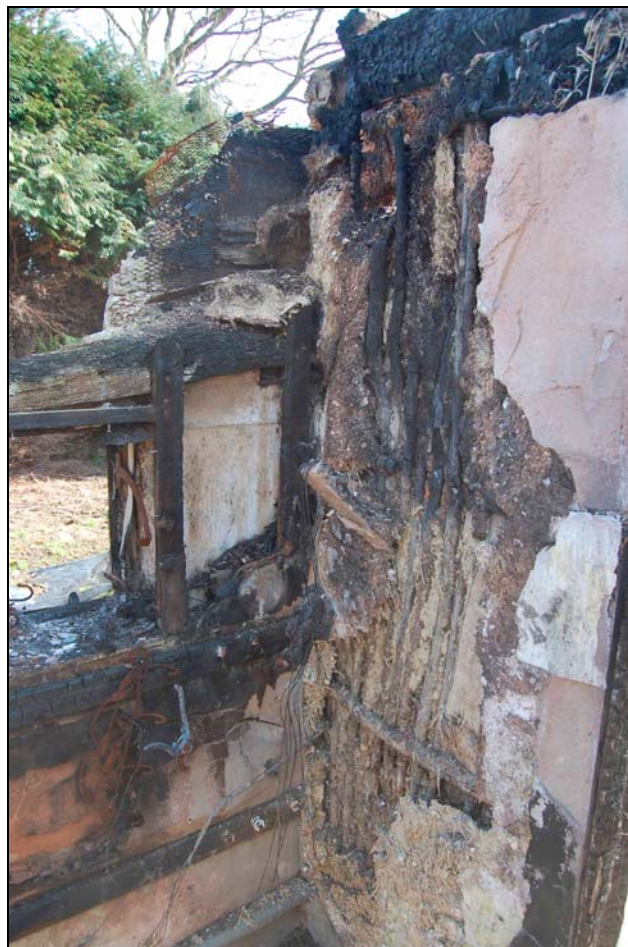
Plate 8 Detail of wall fabric on north-west side of cottage

thick daub/lime render with a high level of straw (fig. 6, plate 8), a very rustic element that would probably have covered the whole of the cottage originally.

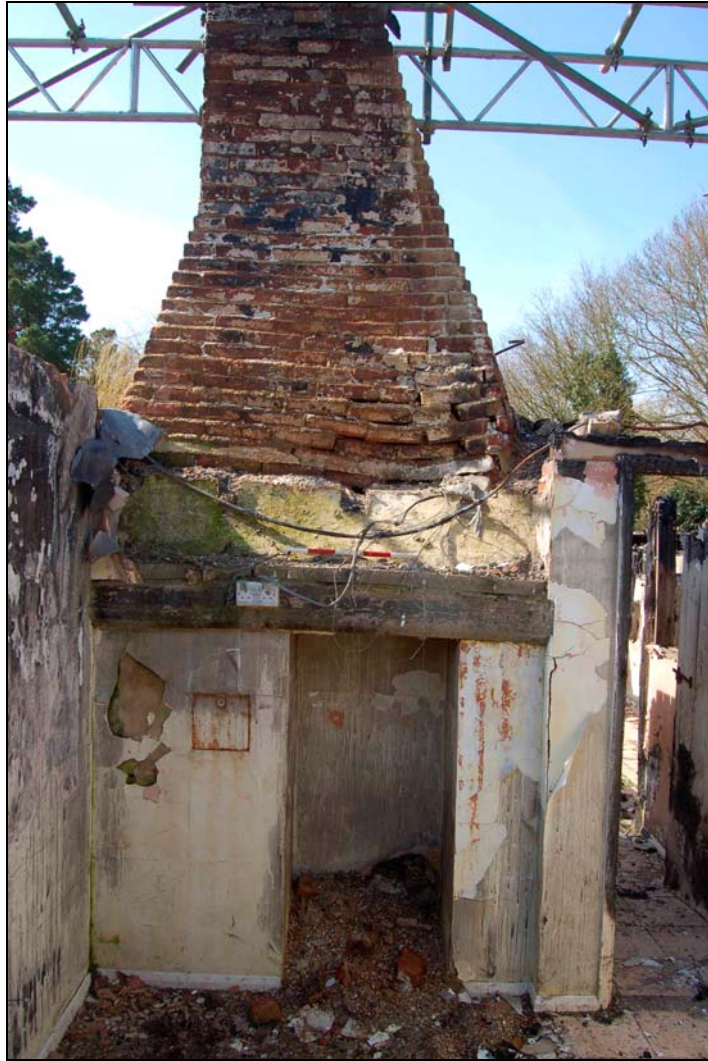
Plate 9 Chimney stack viewed to south-east

The most obvious surviving internal feature is the chimney, which would have stood along the west side of the middle bay, supporting the truss. With the roof missing it is only the scaffold that keeps it upright. In form it appears earlier than the cottage, perhaps rebuilt from the previous structure. For its construction, red, very gritty bricks have been used for the chimney breast, topped by 19th century soft reds in the stack (plate 2). The breast bricks are much shallower than the 19th century bricks and their fabric and size (240 x 50 x 110mm / 9 x 2 x 4 inches) suggests a 15th to 17th century date (Ryan 1996, Appendix 1). Again, this can be seen as an example of reused materials from the earlier building, but it seems odd the new cottage was not simply built around the old chimney, unless the old chimney had collapsed. The earlier bricks are bonded in an earth mortar, made from lime and clay probably dug from the site; another interesting, more vernacular, element. The flue for the kitchen range is located below the chimney, topped by a timber bressumer (plate 9). Above the bressumer is a coat of daub plaster, the remnants of internal décor that contains the impressions of former ceiling joists along the top (plate 10).
