**FORMER CHAPEL AND SCHOOL BUILDINGS
AT CHURCH HOLLOW
PURFLEET
ESSEX**

HISTORIC BUILDING RECORD

May 2010

FAU Project No.: 2207

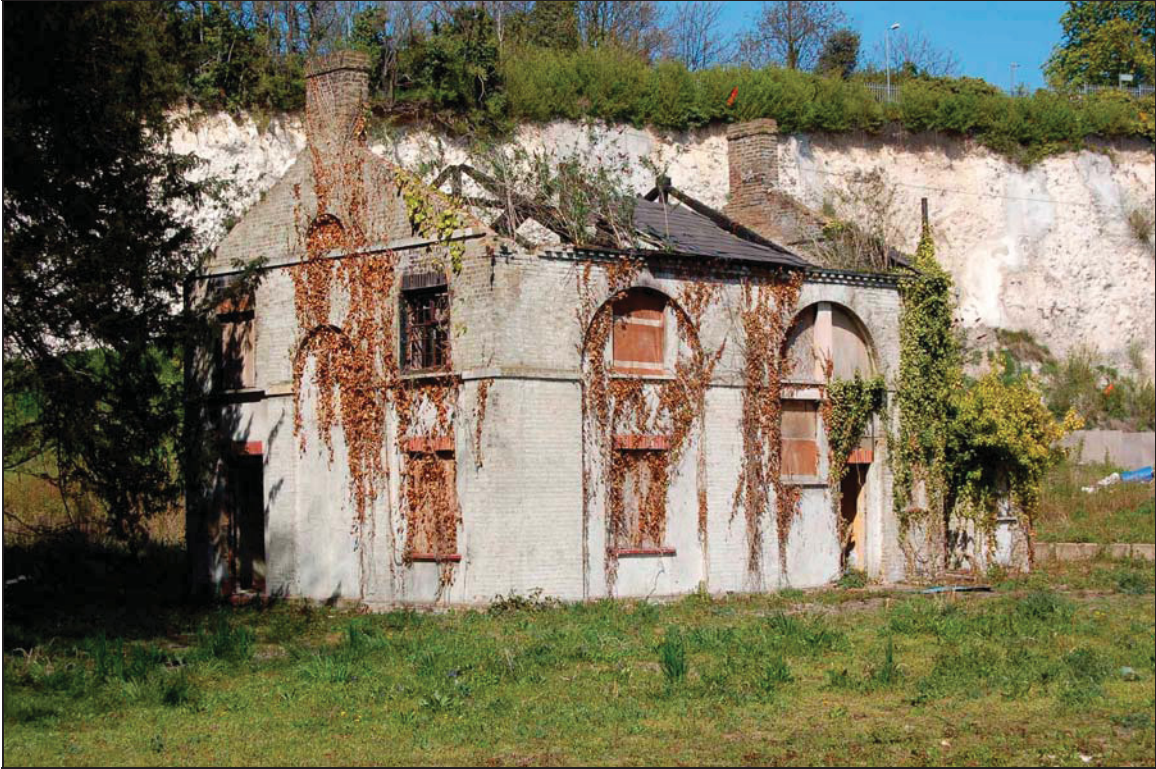
Plate 3 Church House viewed to north

The **south elevation** (plates 3 & 4) became the main elevation to the house in the 1920s when a front doorway was inserted into the eastern arch (fig. 8a). Above it, the top panes of an earlier window remain, which is only visible internally (see internal description). This window probably belongs to the repair phase of 1855 when larger windows, occupying the whole arch, were added to admit more light into the building. The windows in the western arch are both replaced and look entirely out of place.

The **west elevation** (plate 3) contained the original entrance into the chapel. The entrance was located centrally within a narrow recessed arch with steps leading up to it and a flat door hood (fig. 3). The doorway has been blocked-in and a fireplace inserted on the inside (fig. 9) but the original plaque above the door remains, though partially covered in ivy. It reads '*Purfleet Chapel MDCCXCI Rebuilt 1855*' (plate 5). Either side are piers capped with stone and surmounted by the arch, with a smaller arch above resting on a stone eaves string course. Metal windows have been inserted into the recessed arches either side of the former doorway, into which the upper ones cut into the tops of the arches. A burnt-out window is shown in plate 6, typical in style and materials, metal windows in wooden frames, to those in the school buildings. At ground level, in the north panel, is an open doorway onto the 1920s veranda (fig. 8a).

The **east elevation** (plates 3 & 4) contains the 1920s kitchen. Much of it is heavily covered in ivy, but closer inspection aided by elevation drawings supplied by the client, show a single storey projection with metal windows below flat brick heads (rather than soldier heads) and a back door to the north (fig. 8d). The roof is gabled to the east, hipped to north and south (fig. 9) and clad in grey slate. Those windows above, in the main building, are the same as the rest and obviously inserted. Internal inspection suggested this wall was rebuilt, as the brick bond is different (English rather than Flemish), but this would perhaps seem unlikely.

The **roof** was seriously damaged by the fire; most of the rafters and slates were lost. Three charred trusses to a king post strut roof remain (plate 3).

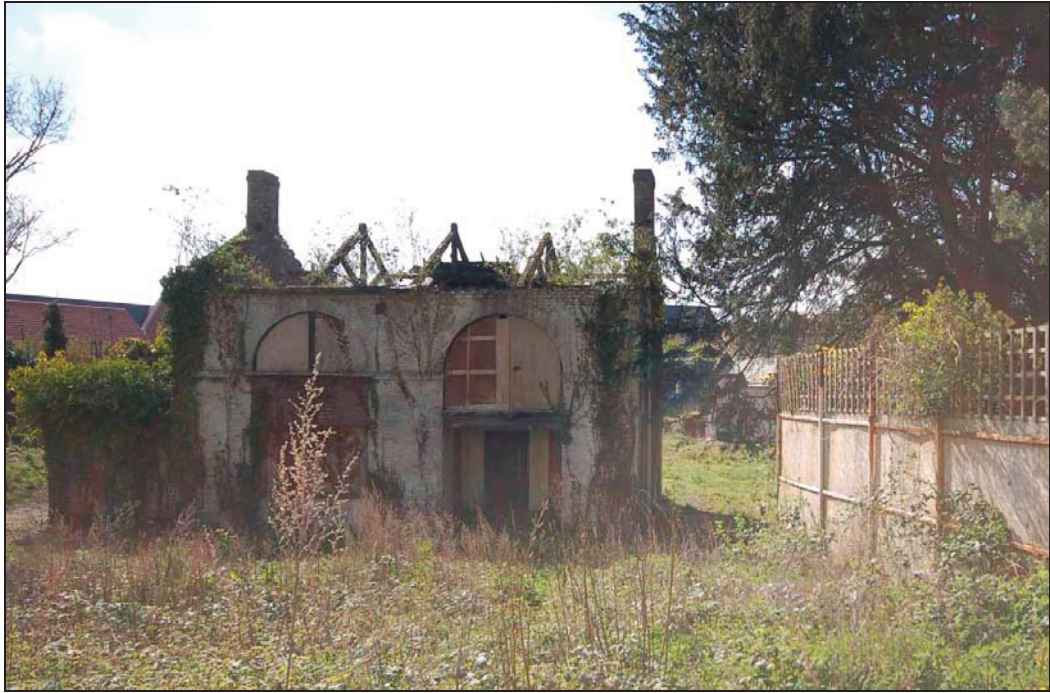
Plate 7 Church House viewed to south

The **north elevation** (plate 7) probably faced onto the 1920s garden and the whole of this side of the building was quite brutally altered at this time, mainly in the formation of a crude

veranda in the north-west corner of the chapel. Here the lower part of the panel has been knocked through to create an open area attached to the interior by metal French doors. Above it on the first floor appears to be a Juliet balcony, or at least interpreted as such from the elevation in figure 8c, as its detail is hidden from view. On the second panel (to the east), a tiled feature, presumably a form of 1920s décor, is located above the later ground floor window. Interestingly, the arch above it appears not to have been disturbed and may still contain part of its 1850s window.

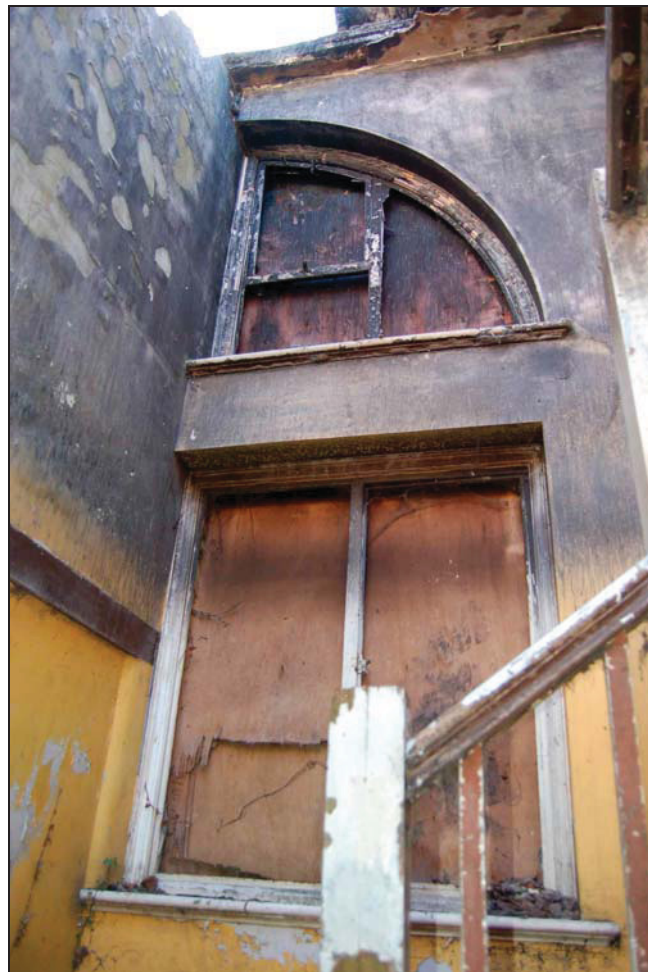
Plate 8 Presumed 1850s chapel window inside Church House

The front door of Church House leads onto a hallway that provides access to all rooms as well as the stairs to the first floor (fig. 9b). Looking up the stair can be seen the window head of the presumed 1855 replacement that has survived to light the stair (plate 8). Brass fixtures show the top pane tilted open by a cord operated from below and the part on the other side (largely hidden from view) would have done the same. None of the lower frames survive.

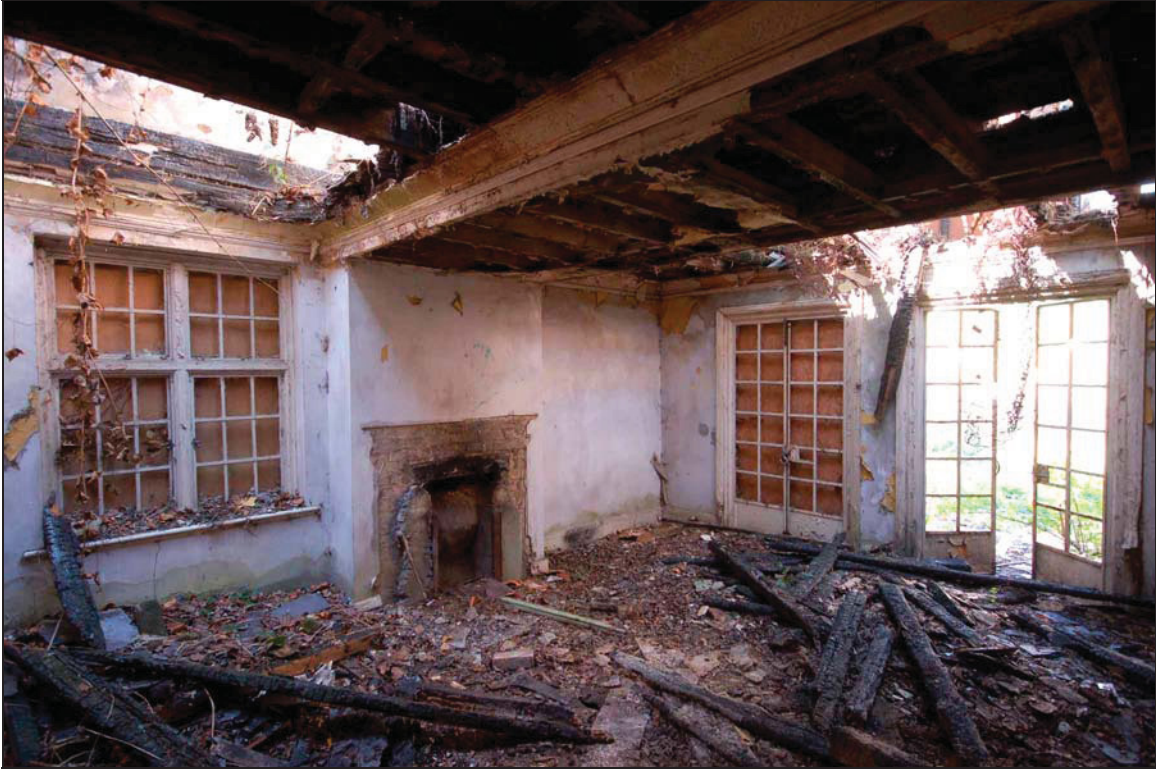
Plate 9 View to veranda and former entrance inside Church House

The fireplace across the blocked former chapel entrance is shown in plate 9, which also shows the French windows to the veranda. There is perhaps a blocked doorway into the former vestry at the east end of the dining room (fig. 9a, plate 10). Quite often there were two rooms off the chapel, one for robing and the other for meetings or Sunday school. The kitchen has largely 1920s fittings, mainly panelled doors and built-in cupboards (plate 11).

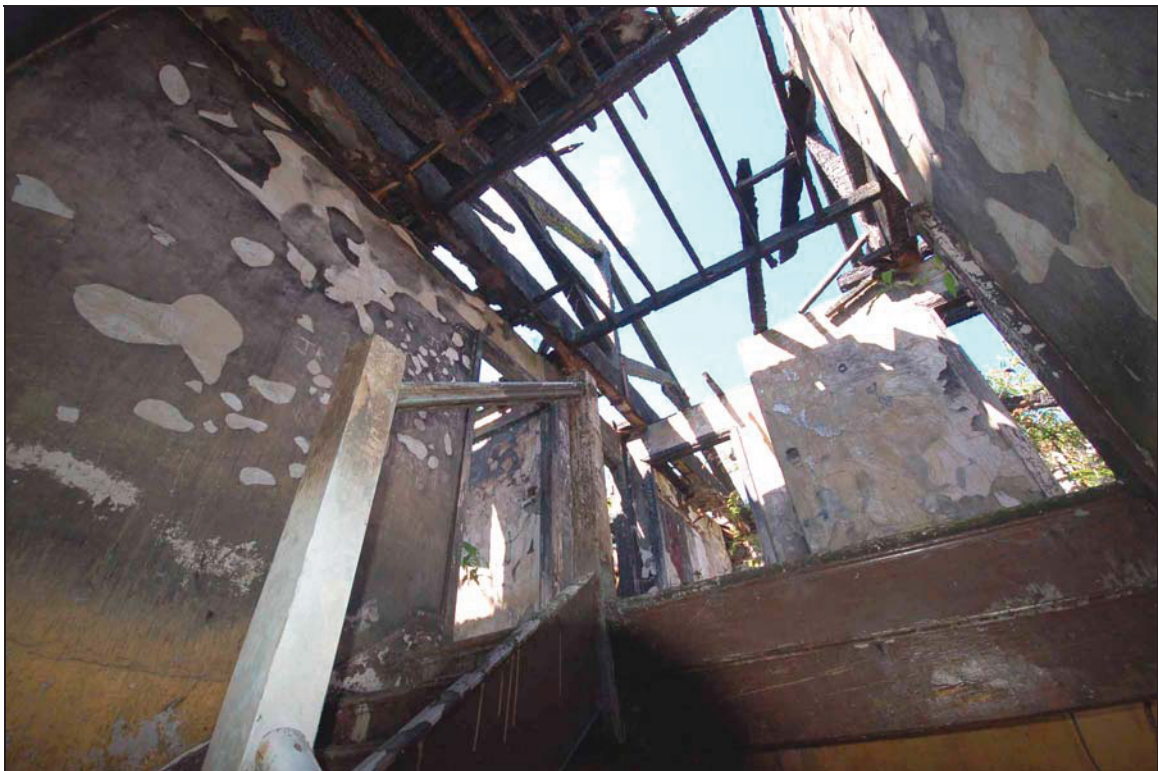
Plate 12 View up to first floor of Church House

The first floor would appear to have provided four bedrooms, two of which were quite small (fig. 9b) leading off the landing, as well as bathroom and toilet. Plate 12 and figure 9b provide the only record of this part of the house, fire damage preventing entry.

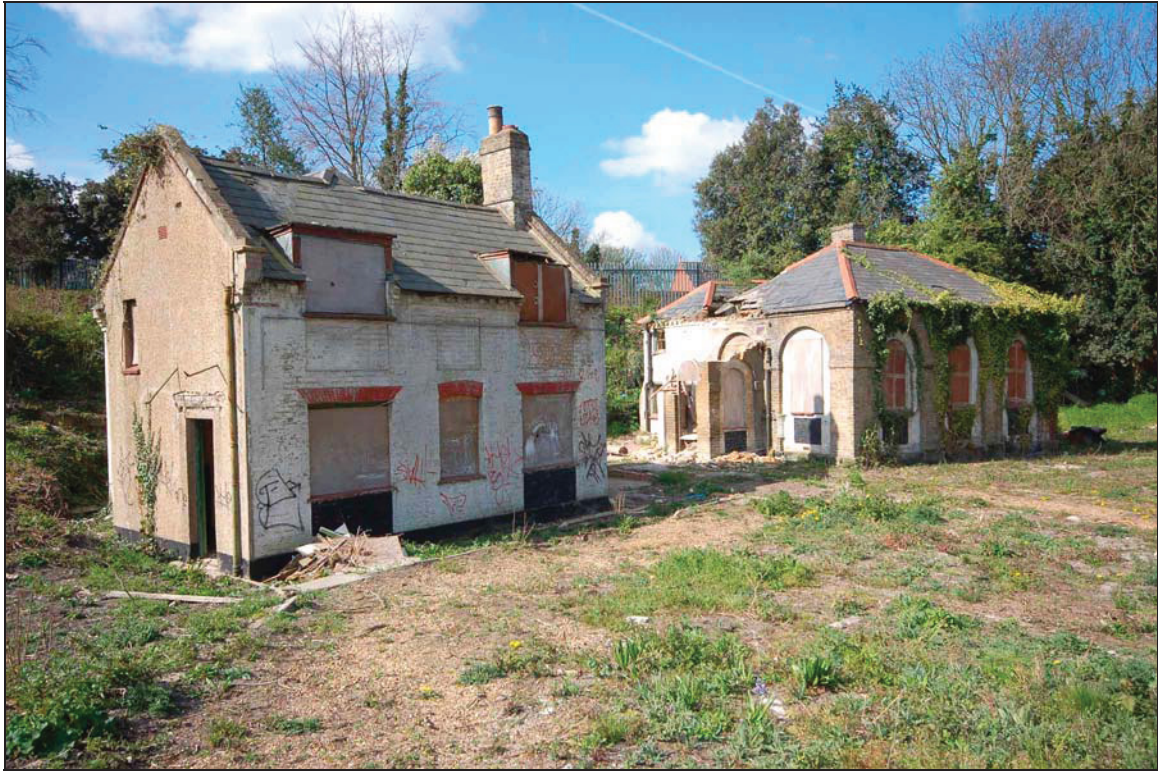
Plate 13 Church Cottage and Church Bungalow viewed to south-west

The **east elevation** (plates 13 & 14) has a small porch with a good 1920s or 30s door from its second phase of use, making an attractive feature (fig. 10a). Much of the porch roof has collapsed along with part of the main roof this side, but entry inside was possible. The south extension is certainly a separate build and has none of the significant features of the main building.

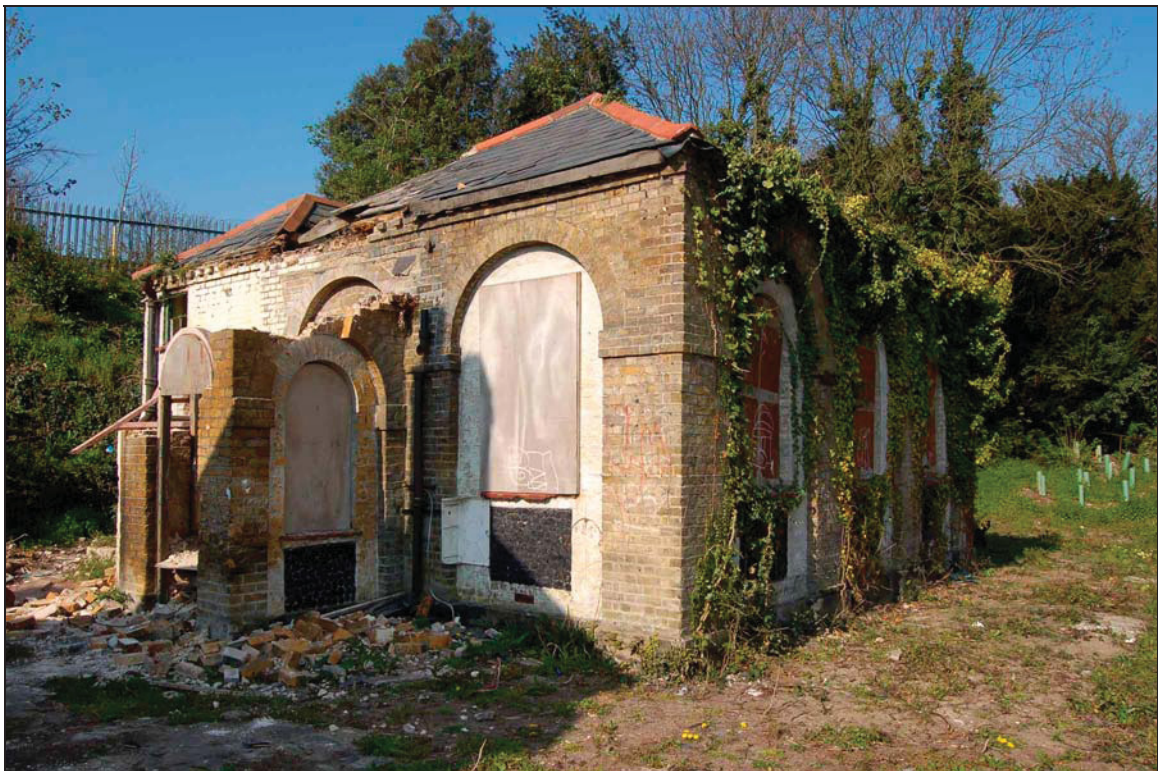
Plate 14 Church Bungalow viewed to south-west; school entrance

The **north elevation** (plates 14 & 16) formed the front of the building, with its large windows to let light into the classroom and is largely unaltered. Though overgrown with ivy, this side properly shows the character of the building, its row of three arched window panels in the main body of the building as well as a smaller arched window on the entrance porch (fig. 10b). There is also a round leaded window on the flat-roofed toilet annex, now boarded up, but photographed internally (plate 23).

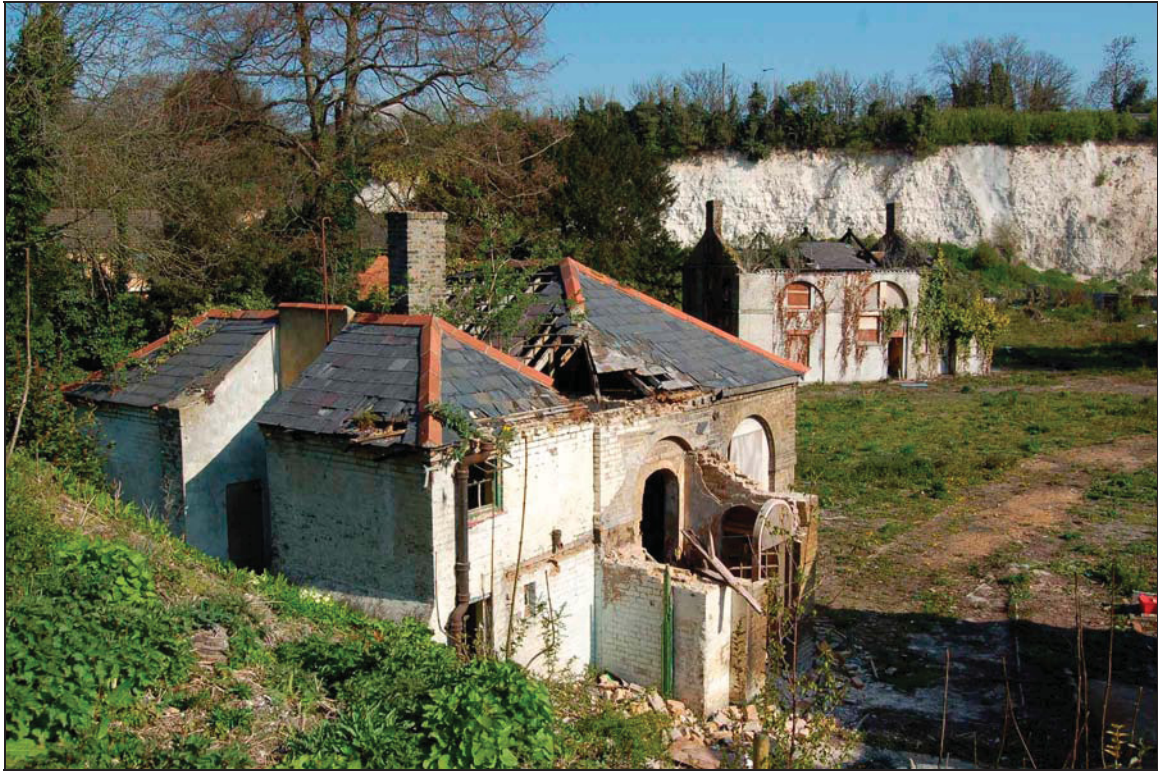
Plate 15 Church Bungalow viewed to north-west with Church House in background

The **south elevation** (plate 15) comprises the 19th century extension built up close to the quarry pit edge. There is a small yard contained in a recess with entry from the back door and a single central window above. The lower walls are rendered in cement. There was formerly a small chimney on the south-west corner of the recess (fig. 10d), probably for a kitchen range.

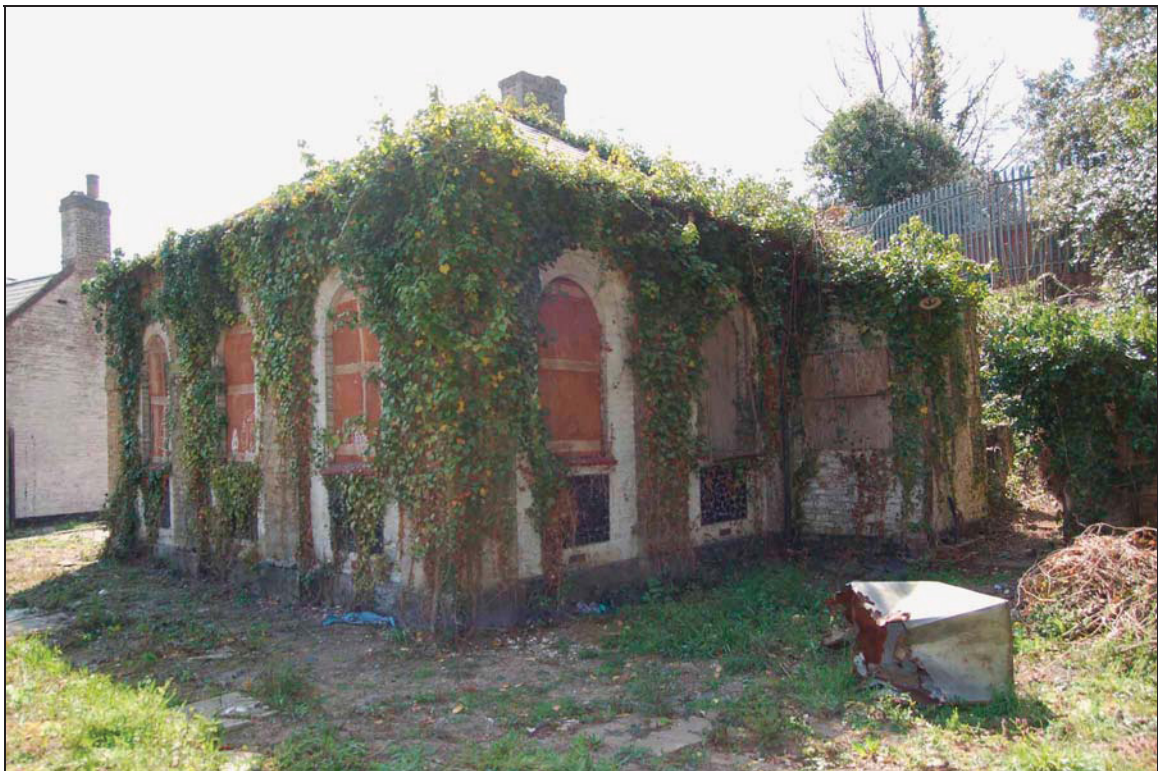
Plate 16 Church Bungalow viewed to south-east

The **west elevation** (plate 16) also remains much the same as the painting, but has suffered from the addition of the bland 19th century extension and toilet annex, though the arched panels have not been affected (fig. 10c).

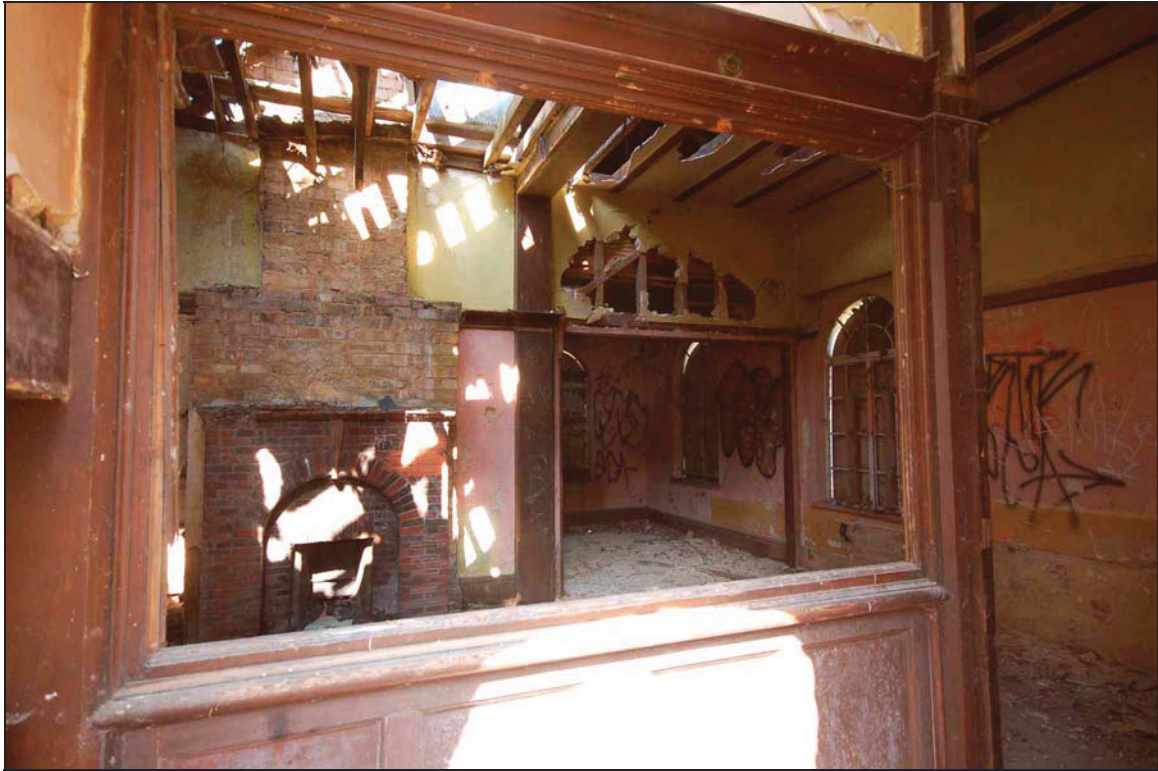
Plate 17 View from entrance to Church Bungalow into former classroom

Entry into the schoolhouse was through the porch and past a semi-glazed wooden screen (plate 17), then through a door and into the classroom (fig.11). A second room to the west was probably used as the teacher's office. Current 19th century décor is primarily in dark-varnished woodwork comprising posts, picture rails, skirting boards and ceiling panels. Posts and beams have been boxed in apart from those framing the doors (plate 18). All are chamfered and the posts have shoulders level with the picture rails. The picture rails have elaborate mouldings and survive around the north-east corner (fig. 11, plates 19 & 20). They are complimented by tall 8½ torus-moulded skirting boards, which are also found in the room beyond (plate 17), which was probably partitioned off with panelling (fig. 11). It is likely all the walls were once panelled, but probably became rotten and removed during the emergency works. The 'Tudor brick' fireplace (plates 17 & 18) is probably late 19th century too, though

The ceiling is suspended from the original joists to create ribbed panels (plate 17), now plasterboarded. The original joists are connected to a thick beam that runs across the classroom south to north, bearing number 14 (XIII, plate 21) as a carpenter's mark. There is likely to be another beam along the fireplace wall to represent the third bay. From limited inspection of the roof, it appears to be in queen post strut style, with some machine-sawn timbers indicative of later repair.

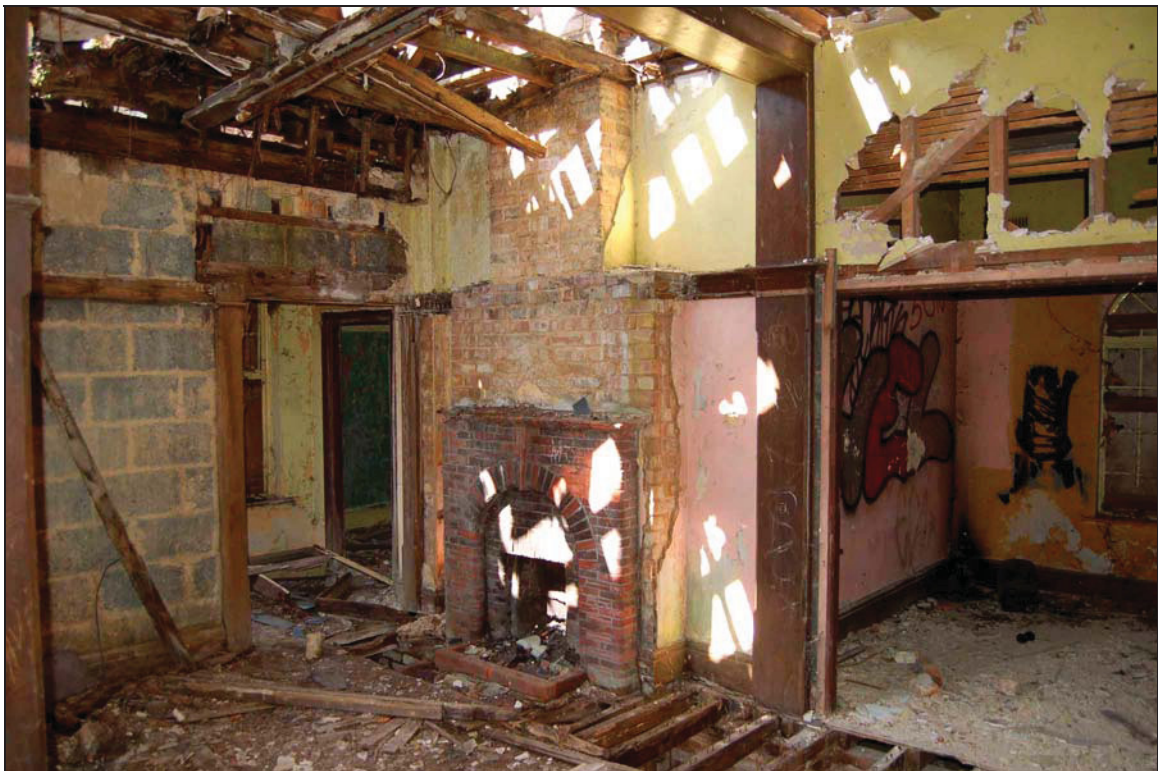
Plate 18 View across classroom into extension and other room

the breast and stack are rebuilt. The dividing wall with the extension has been rebuilt in concrete blockwork (plate 18).

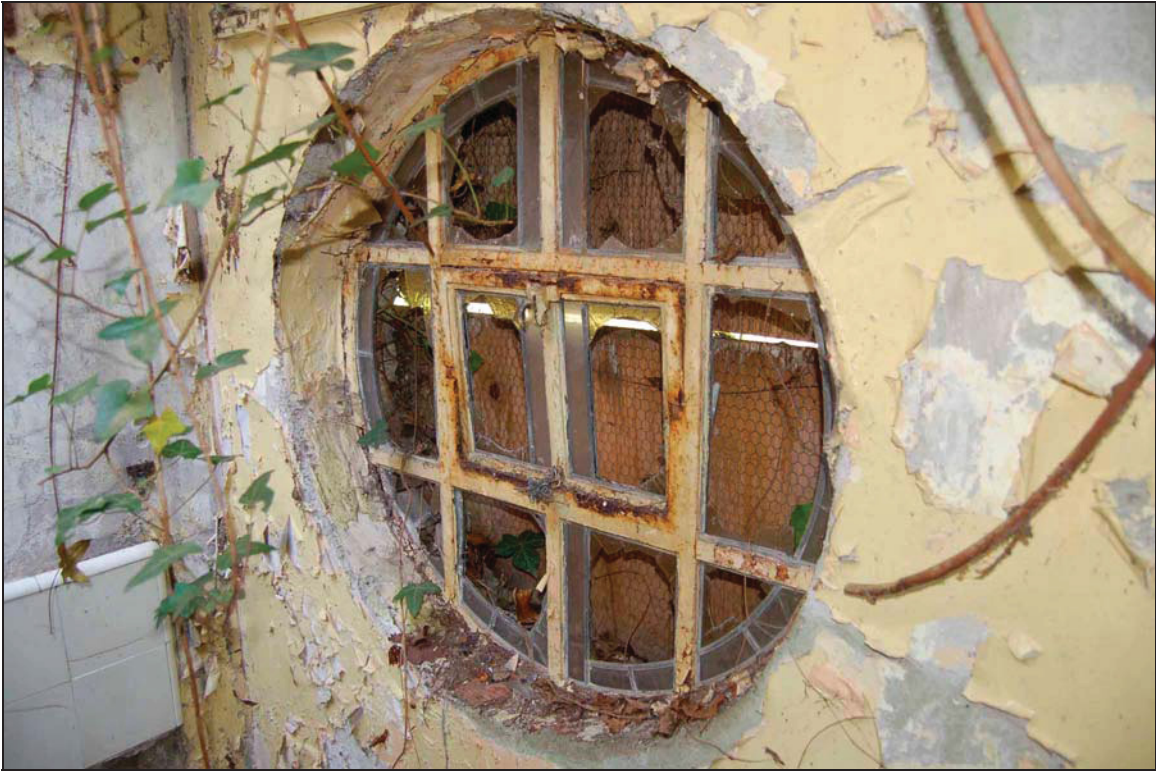
Plate 23 Round leaded window in western annex

Only limited inspection was carried out in the extension due to the roof collapse in the south-east corner. The stairs have collapsed but formerly led up to a small room, which is the only room on this level (fig. 11). If this was used as lodgings, then the two rooms downstairs perhaps functioned as kitchen and living room by the late 19th century. The only fixtures and fittings to remain are moulded picture rails and skirting boards (plate 22). The small annex at the west end contains fitted cupboards with long narrow-panelled doors indicative of the 1920s/30s and toilet fittings (plate 22). The round leaded window on the north side is a nice historic feature (plate 23).

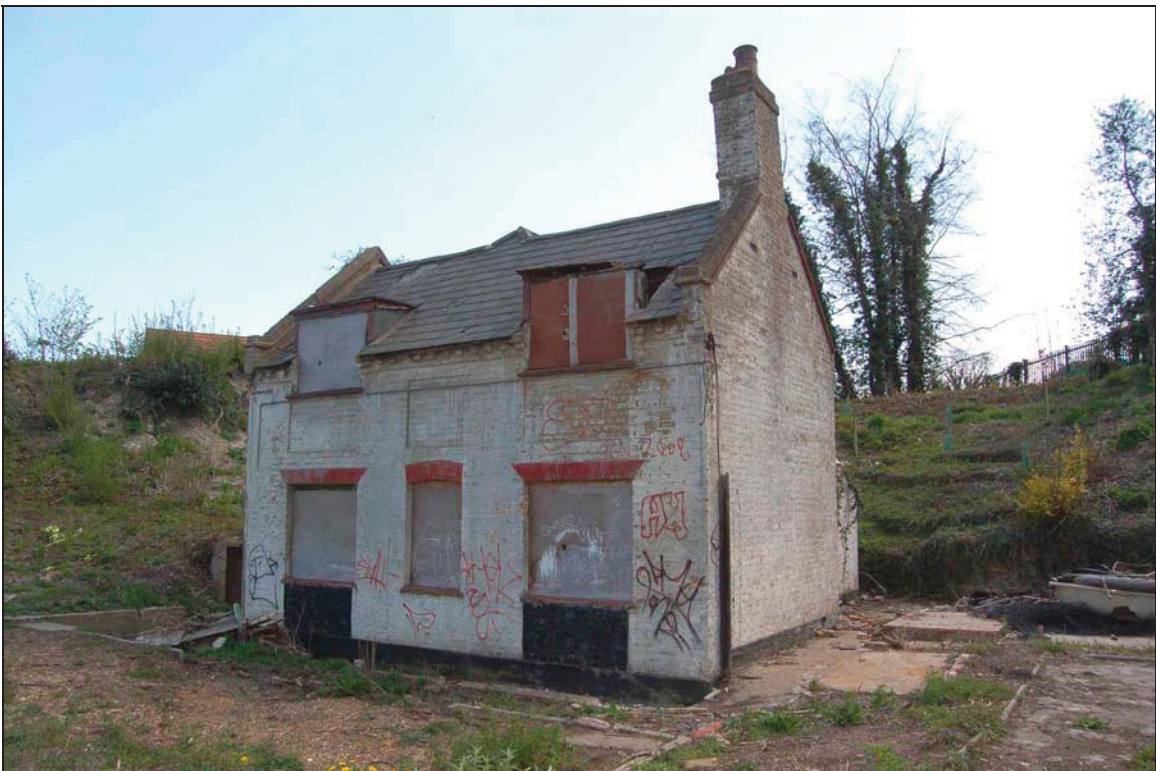
Plate 24 Church Cottage viewed to south-west

Bungalow and a subterranean concrete structure on the east side of Church Cottage (fig. 1, plate 24 left), most likely an air raid shelter (now flooded).
