**HISTORIC BUILDING SURVEY OF
HULL'S MILL FARM, HULL'S MILL LANE
GREAT MAPLESTEAD
ESSEX**

June 2010

HISTORIC BUILDING SURVEY

FAU Project No.: 2182

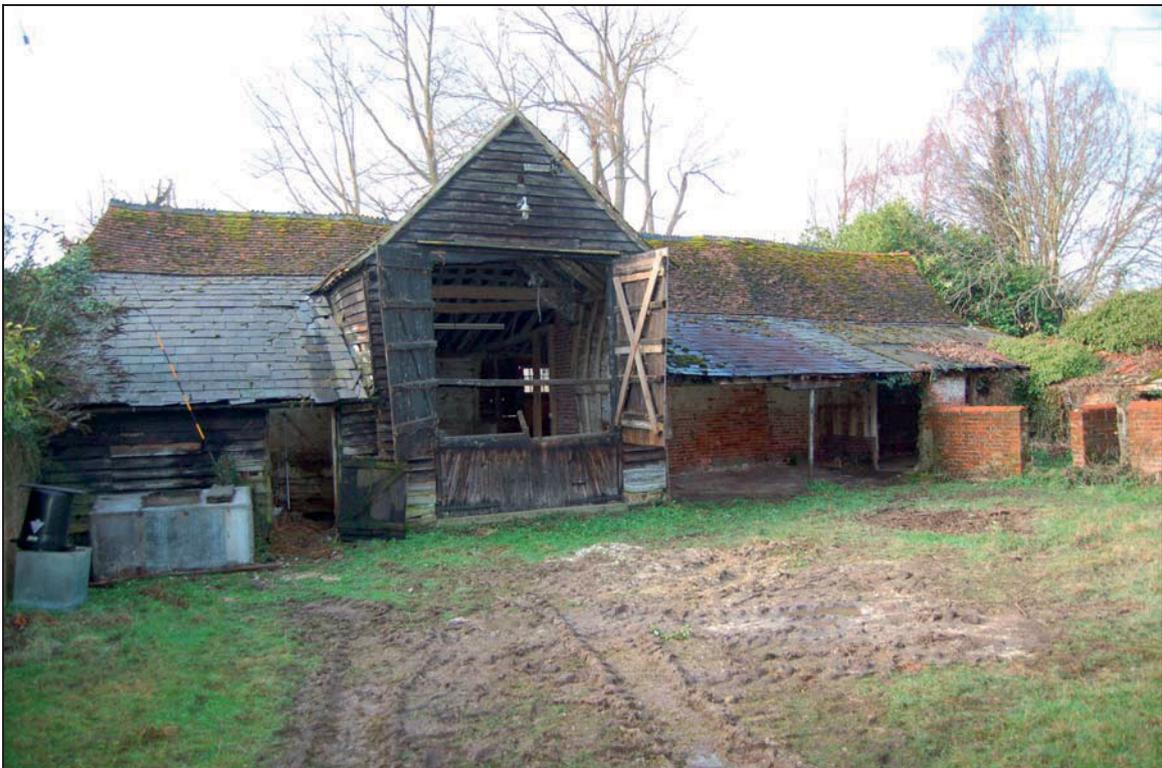
Plate 4 Barn viewed to west

The porch on the **eastern elevation** (plate 4) is set centrally to the barn and retains its tall cart doors intact; ledged battened and braced, with iron strap pintel hinges. To close, the doors are attached by iron chains to link on the central bar (plate 4). Modern bracing has been fitted to the inside of the north door. The lower leaves have radiating boards (plate 4) that form the threshold leap, plus wooden locking bar. A threshold leap was a low partition for keeping muck and straw in the yard from getting inside the barn and to contain grain and deter livestock during threshing. A second door is inserted into the north side of the porch.

Outshots 3 and 4, positioned either side of the porch, are Victorian additions with slate roofs. **Loose box 3** has a single-pitched roof of only 25° and entry by a half-heck boarded door (plate 4). On the other side of the porch is the open-sided **cow shed 4**. The bays are divided by a plain cast iron column under a shallower single-pitched roof of 20°. Through the open bays can be seen the wall of the barn, which was rebuilt in brick during the 19th century improvement.

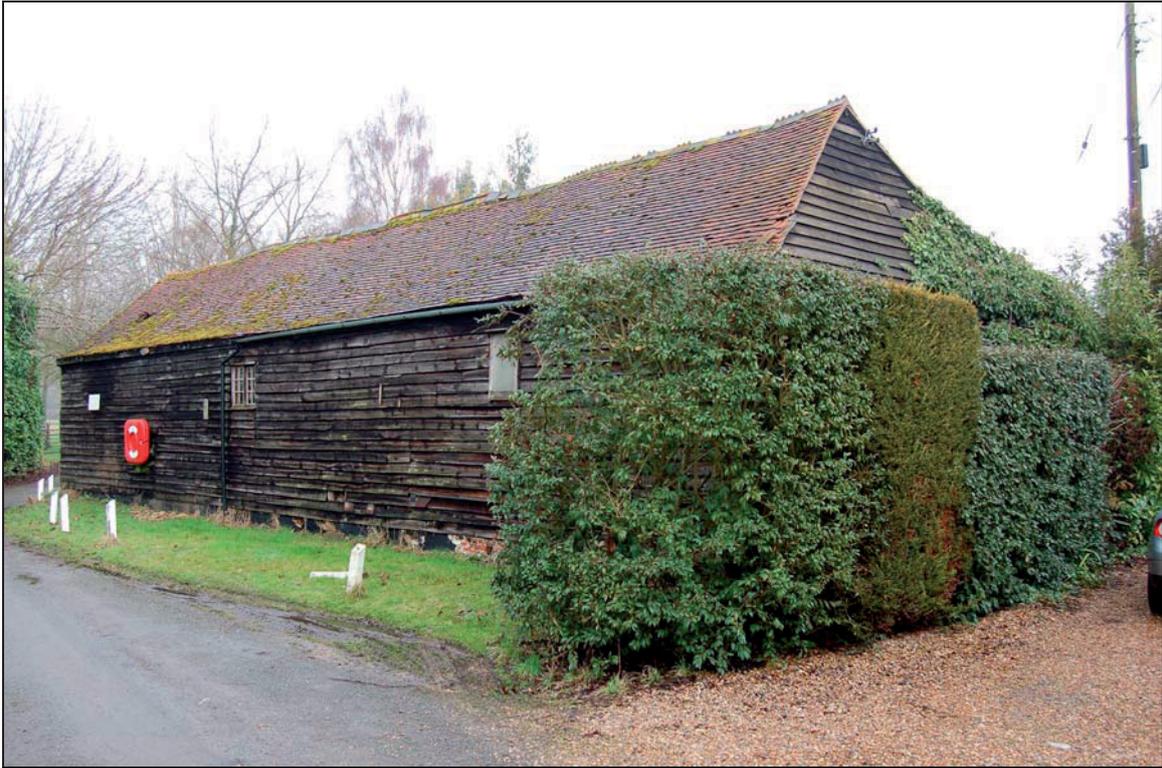
Plate 5 Rear of barn viewed to north

The southern elevation is screened by a tall hedge (plate 5) that hides the rebuilt south wall of the barn, entered by a central ledged battened and braced door, and a pair of short ledged and battened cart doors face the former farmhouse in loose box 3.

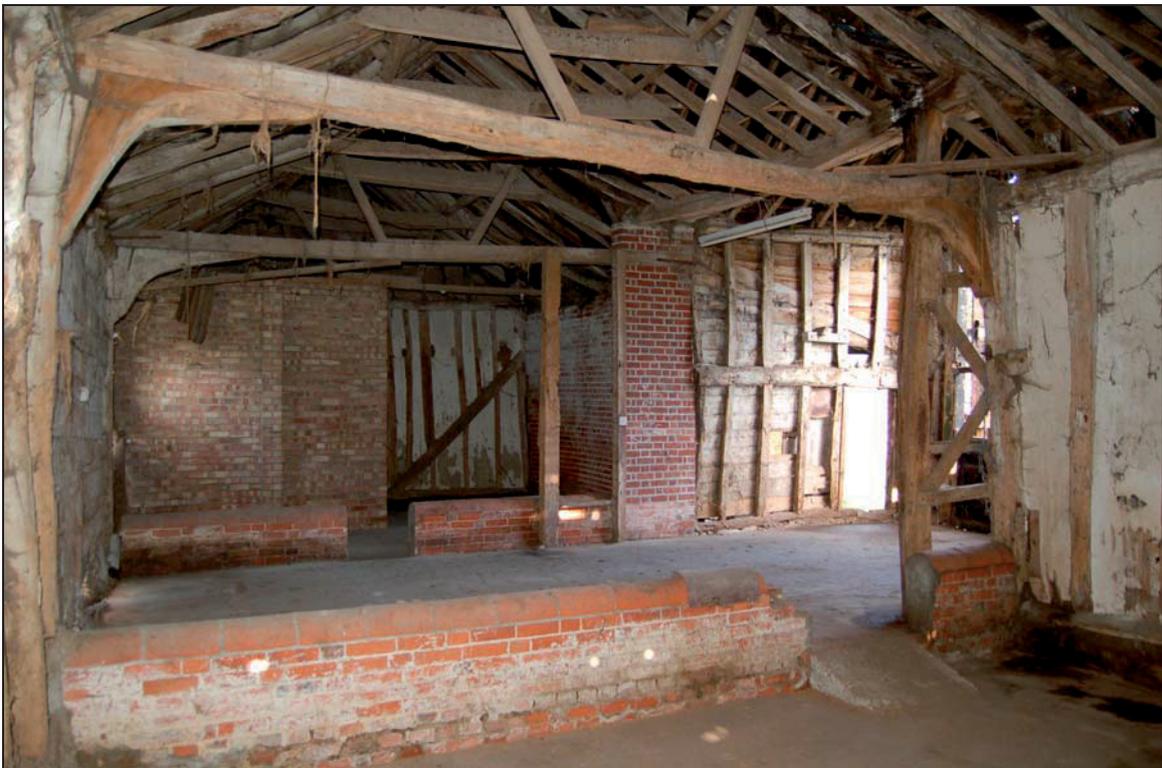
Plate 8 Interior of barn viewed to north

Main framing appears to be of oak or elm and largely intact with few reused pieces. All main members are single-pegged to one another. Jowled posts define the bays, supporting strapped tie beams on pegged and bolted knee braces, which were added in the 1781 building phase. Empty slots and pegholes exist for earlier braces. The main timbers are slender and consistent in size, typically c.16cm². The tie beam in the frame north of the midstrey (plate 8) was replaced when the east wall was rebuilt in brick but the frame on the south side of the midstrey is largely intact (plate 9), though failing as a structure. This is most likely due to the weight of the porch, whose wall frame is higher than the barn and attached to the rafter rather than the wall plate, bending the east bay post inwards (fig. 7). This has happened over some time and may be the reason why the knee braces were added in 1781, a date carved into the knee brace here (fig. 8). To stabilise the area between barn and porch a secondary post and wall plate have been added to support the feet of the rafters (fig. 7, plate 9). Minor pieces of wood have been nailed to brace the two posts in more recent times. The north wall of the porch is sagging from the weight above (plate 8).

The north bay of the barn has lost a considerable amount of wall-framing. The entire east wall, up to the porch, was probably rebuilt in Flemish-bonded red brick beneath the wall plate with the new farmstead, probably to correct similar structural problems to the other side of the porch. In addition, half the north wall was removed when the wagon lodge was extended into the barn the early 20th century (fig. 7), resulting in modern studs being added to the surviving end wall providing extra strength (plate 8).

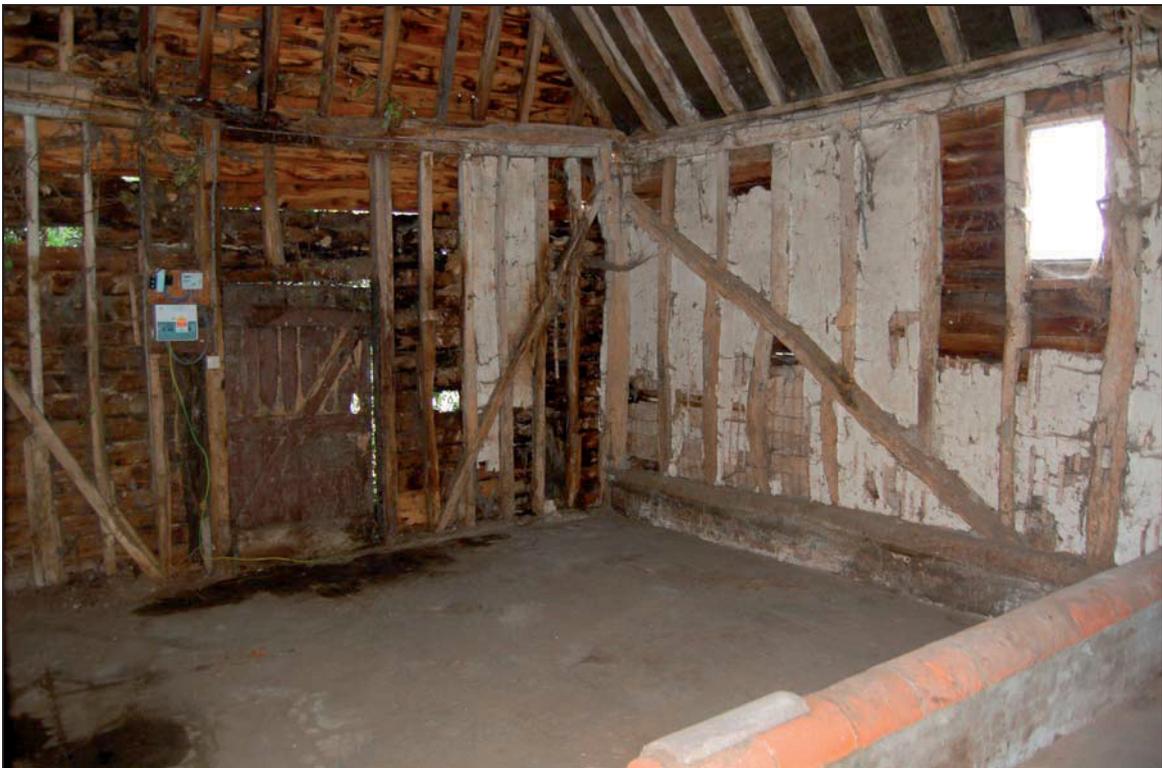
Plate 10 Wall-framing detail viewed to south

The southern bay survives the best, with long braces falling from the corner posts along the side walls (plates 7 & 10). In contrast, the south end wall (plate 10), is replaced; built from narrower timbers that have stronger 18th or early 19th century characteristics more like the other structures. In the centre is a wide ledged and braced door, perhaps for livestock, as there is a good deal of historic plaster surviving between the panels to act as insulation.

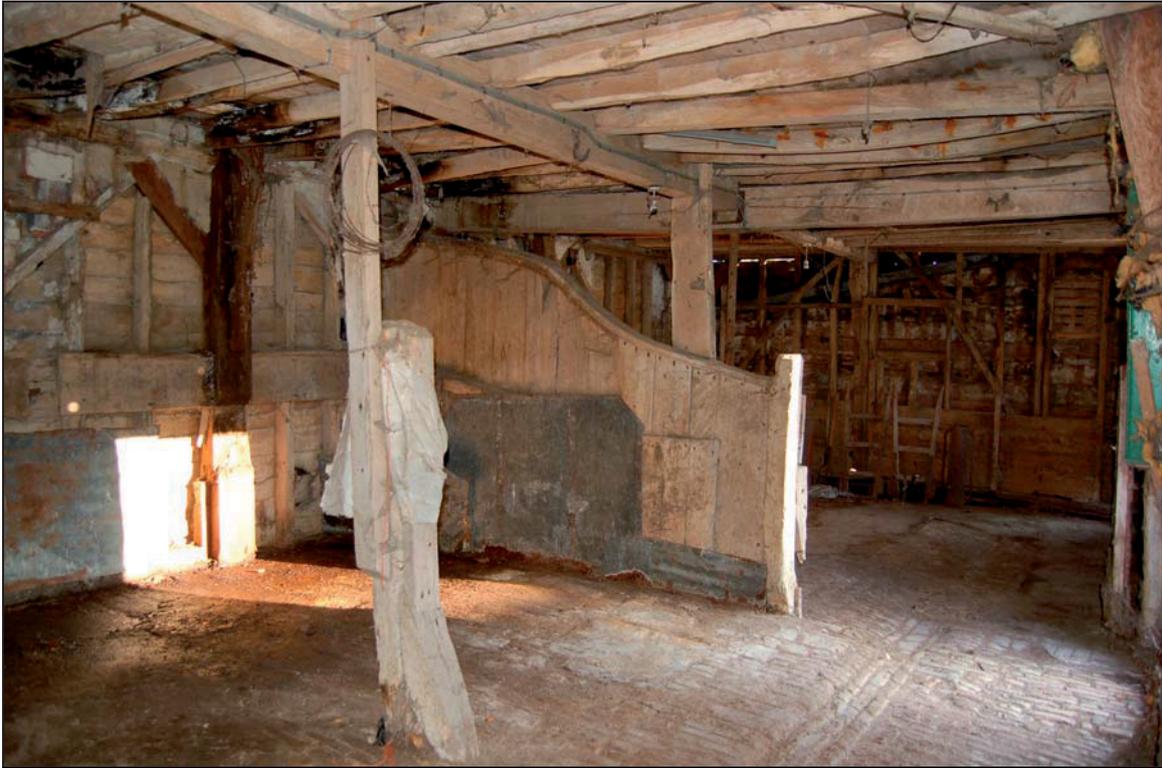
Plate 21 Interior of stable viewed to south

The first floor chaff store is carried on a 23 x 20cm-thick central lateral joist, jointed to thinner bridging joists continuing to each end (plate 21). This is quite a span to carry, and since the floor has started to rot, the central joist is now acro-propped (plate 23), with additional modern posts added to support the joists in the northern bays. 9 inch floorboards are attached to minor joists lapped between the bridging joists and wooden clamps nailed to the studwork.

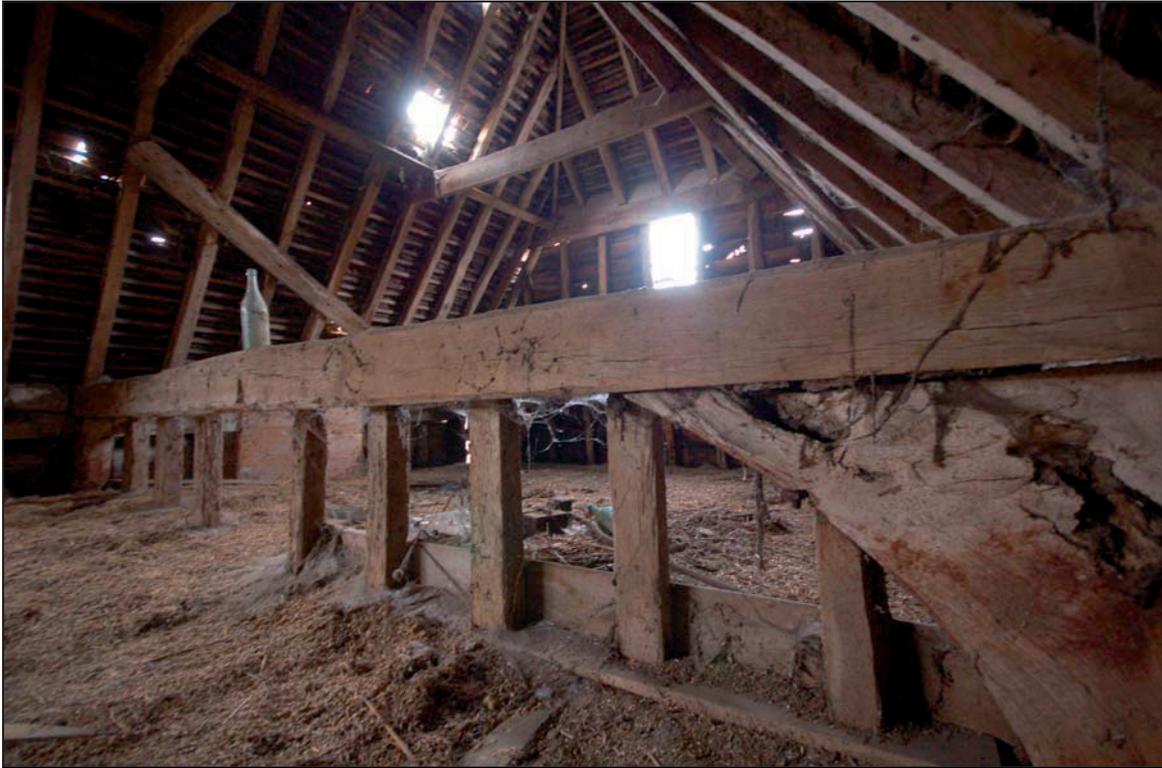
Plate 25 Chaff store viewed to south, showing low partition

Entry to the first floor is by a small ladder hatch beside the doorway on the western wall (fig. 7a). The third bay of the loft is divided by a low studded partition attached to the tie beam (fig. 7a, plate 25). Behind the partition is the only chaff chute to remain, feeding down to the stall below via a hatch (removed). Closer inspection was not possible due to the unsafe nature of the floor.

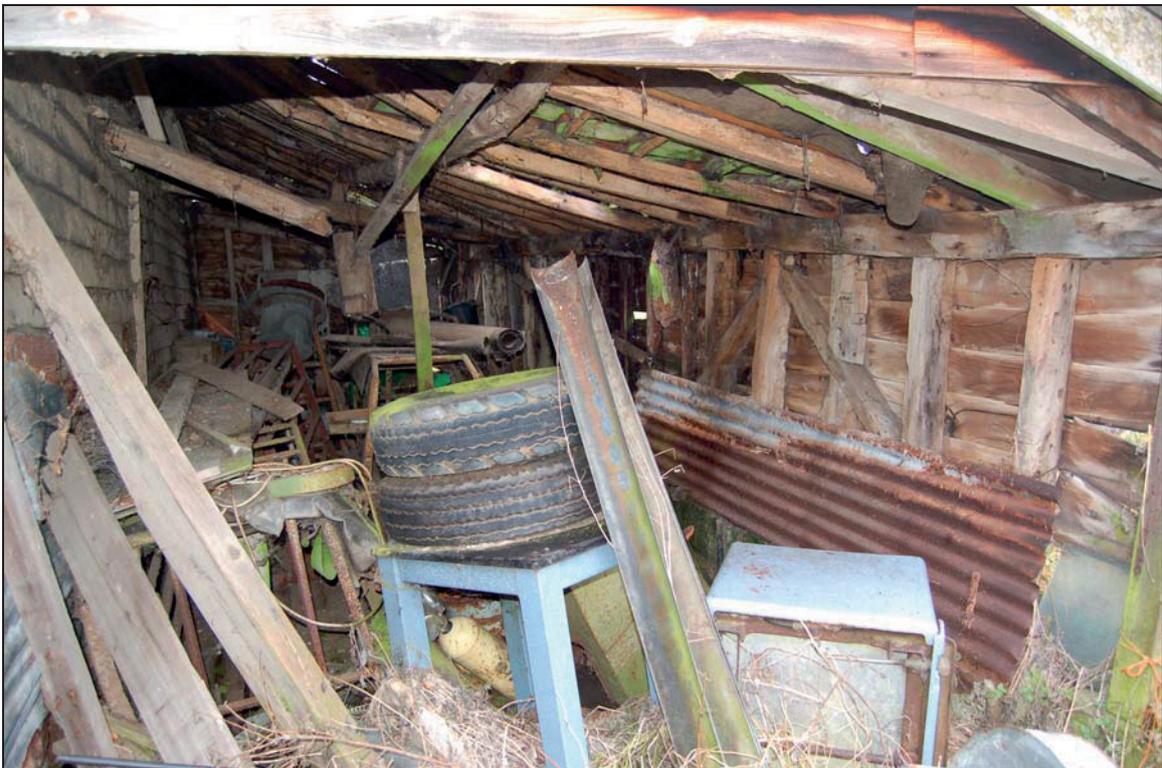
Plate 26 Interior of lean-to 8 viewed to north

The lean-to is linear in form and attached to the rear of the stable, open-sided to the traditional trackway (fig. 7, plate 1). A doorway on the north elevation has later T-hinges and is therefore likely to be an original insertion (plate 20). The boarded primary-braced frame is a slightly more robust version of the framing observed around the Victorian farmstead, but some of the roof timbers have snapped or are on the verge of snapping through damp and the weight of the pantile roof above (plate 26).
