**BARNS AT LITTLEBURY FARM
FAIRSTEAD ROAD
WHITE NOTLEY
ESSEX**

HISTORIC BUILDING RECORD

July 2010

FAU Project no.: 2141

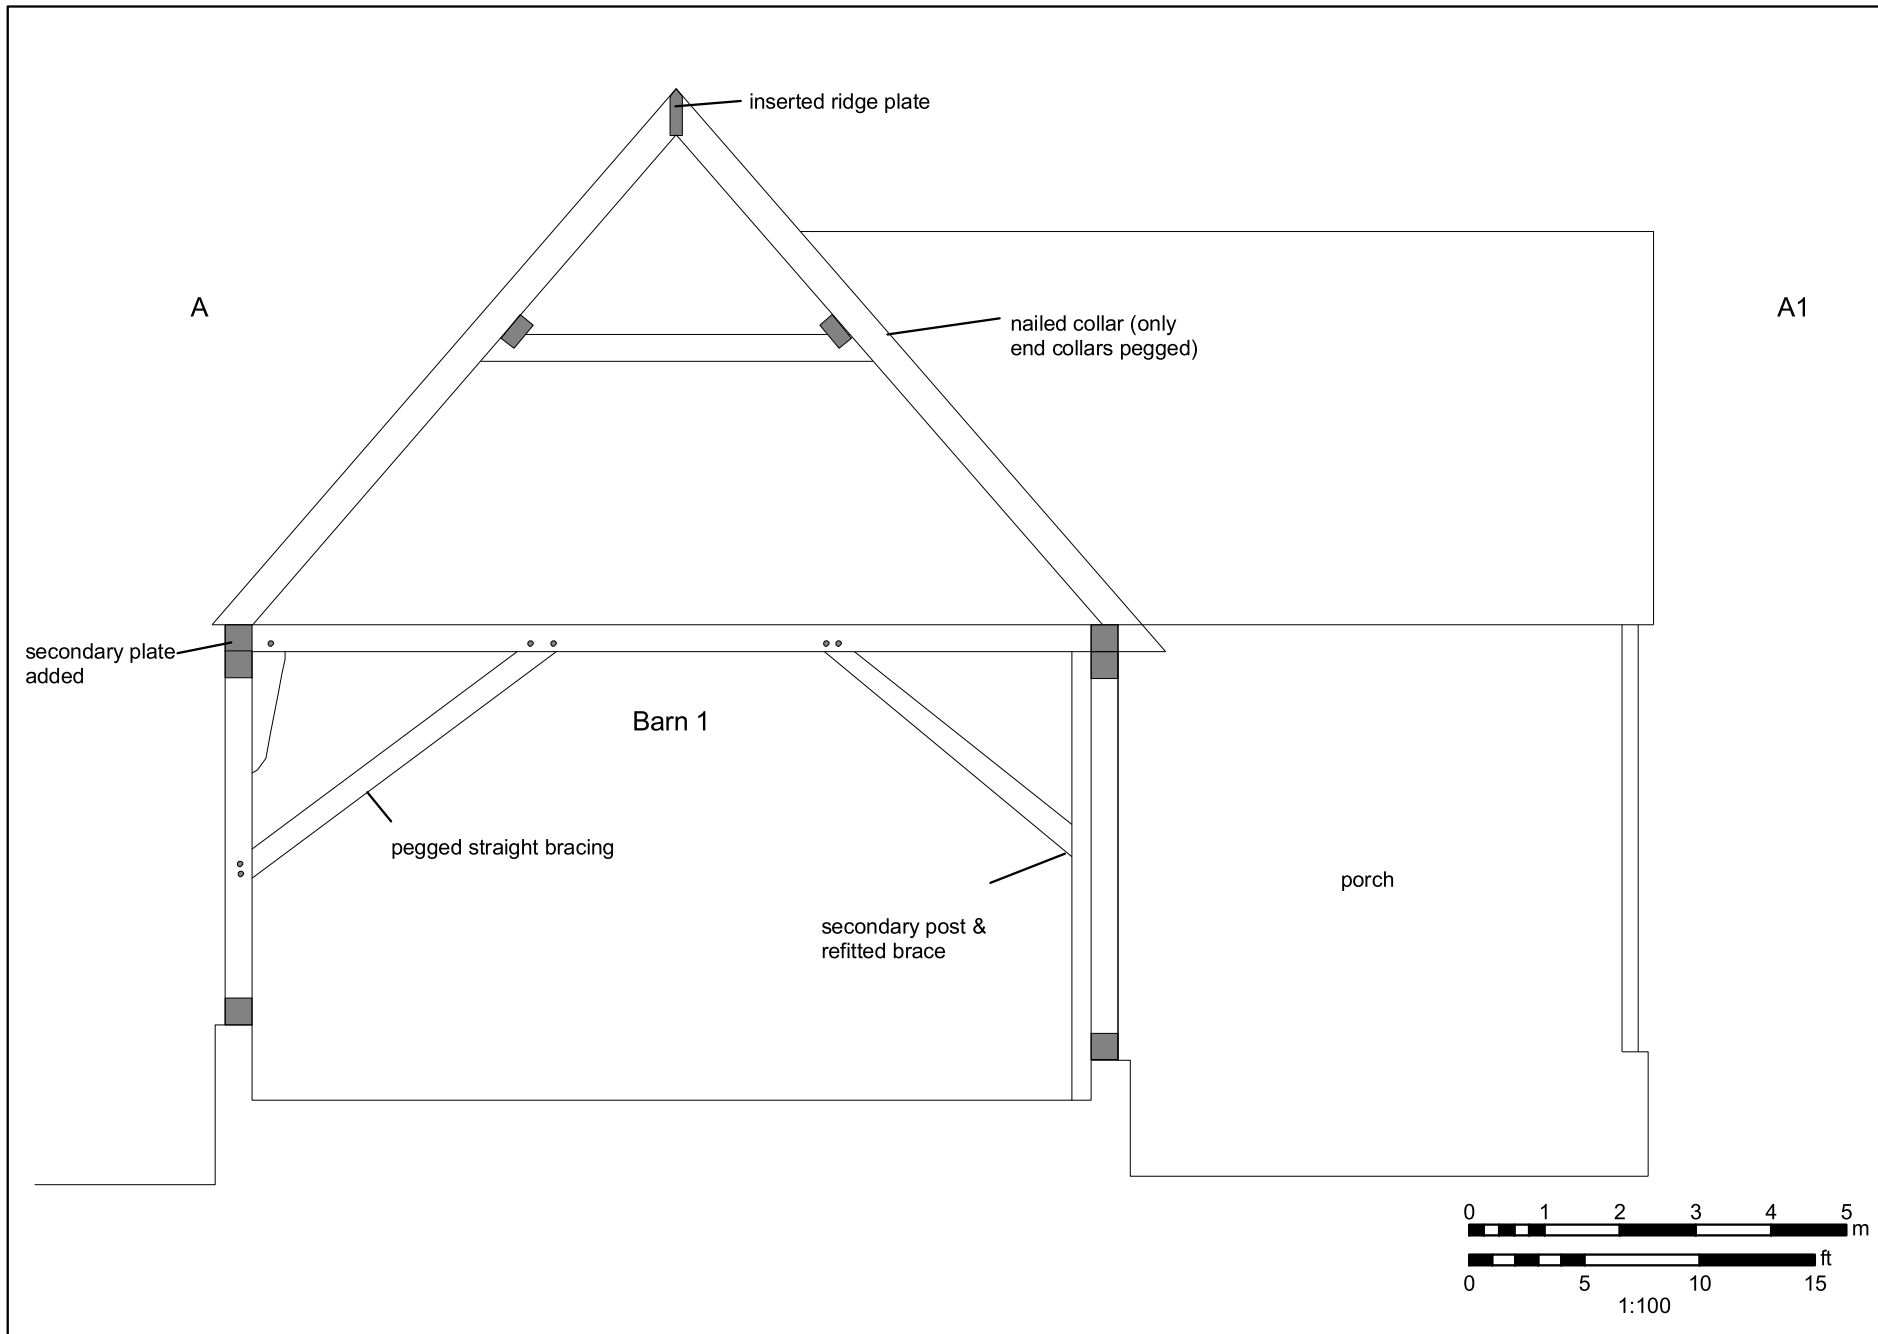
Fig.7. Section A - A1

Main-framing consists of good-quality jowled-headed bay posts that define the bays and carry the tie beams, each of which is supported on straight double-pegged braces (fig. 7). Dimensions of the main timbers are c. 20 x 18cm, between 7 and 8 inches. All are cut square. Wall plates of similar scantling extend either side and carry the studwork. Wall frames are of one bay lengths without the need for scarf joints. No scarf joints were observed on the sill beams, that rest on the brick plinth, either. Some of the plates are strapped to the tie beams, a later insertion to prevent the roof 'spreading'.

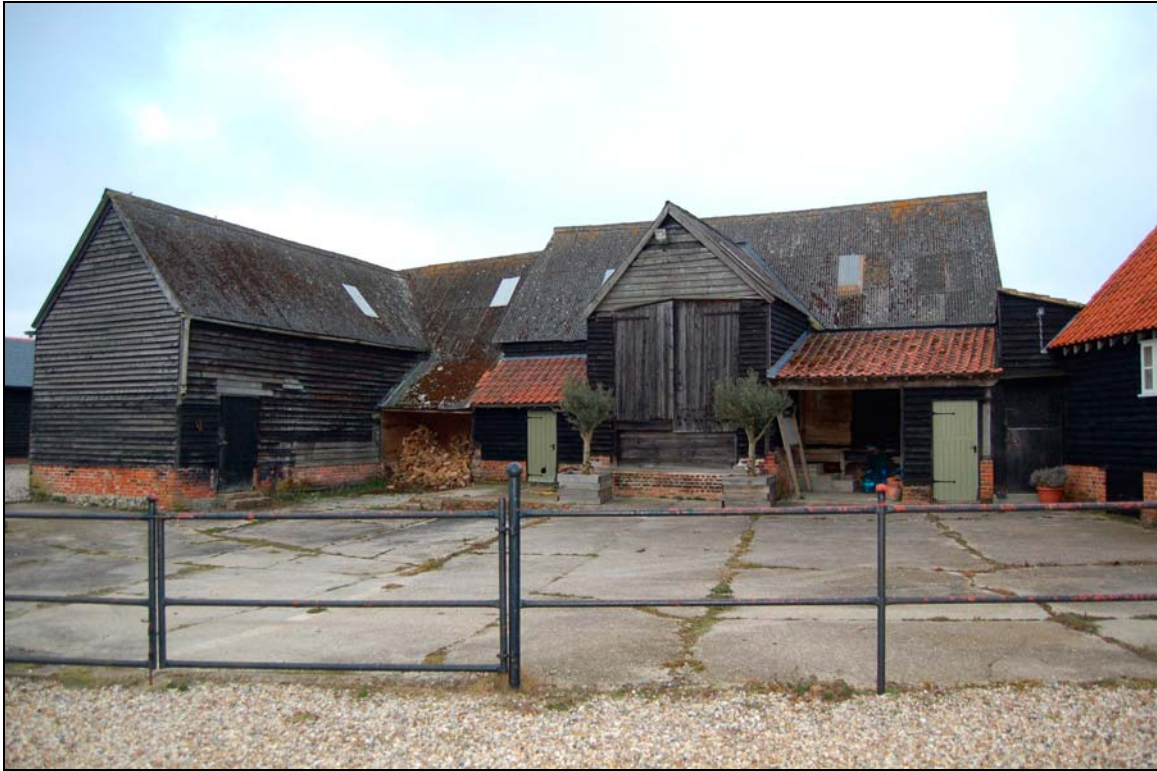
The main barn elevation faces the yard, with a porch with high cart doors and former pig sty and byre either side (plate 1). The threshold still retains its 'leap boards' (numbered 1-4), which were used to keep the muck from the yard from entering the barn and prevent animals straying in during threshing. Above the leap are large two-leaf cart doors likely to date from the late 18th or 19th century (plate 2).

Plate 1 Surveyed farm buildings viewed to north across yard

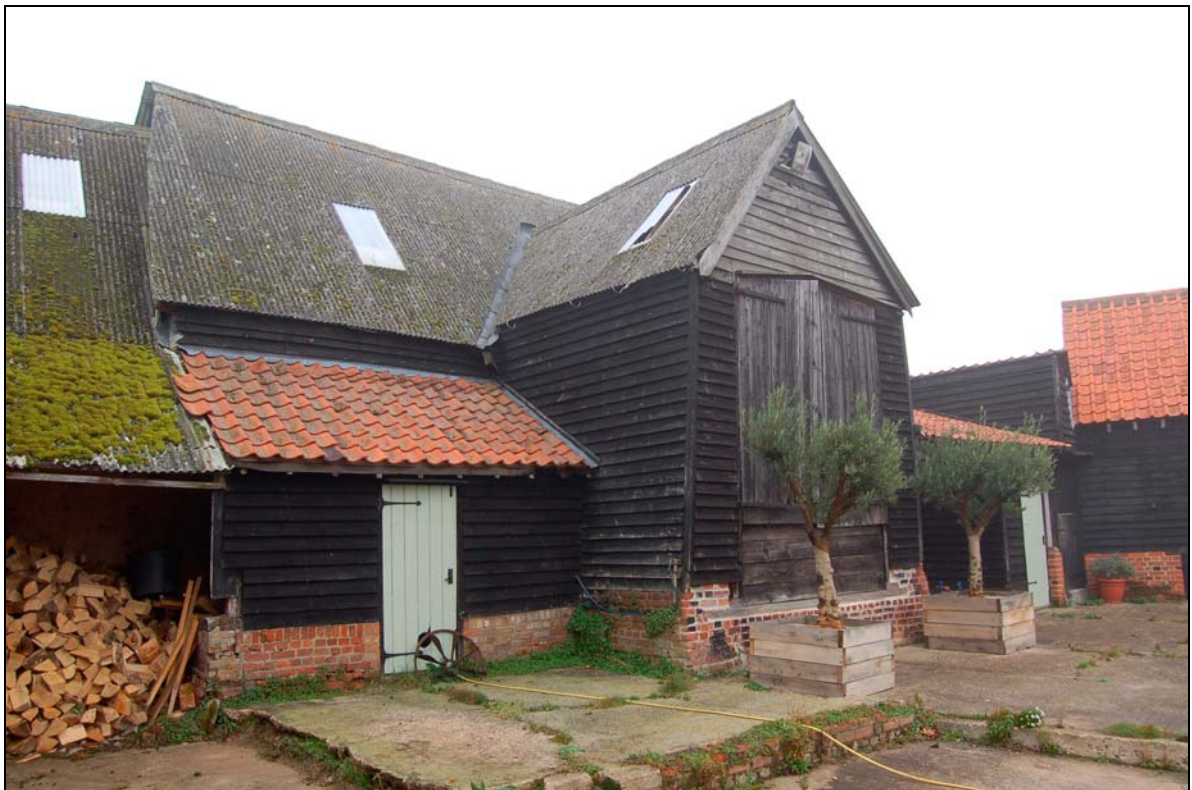
Plate 2 Barn and converted pig sty and byre to north

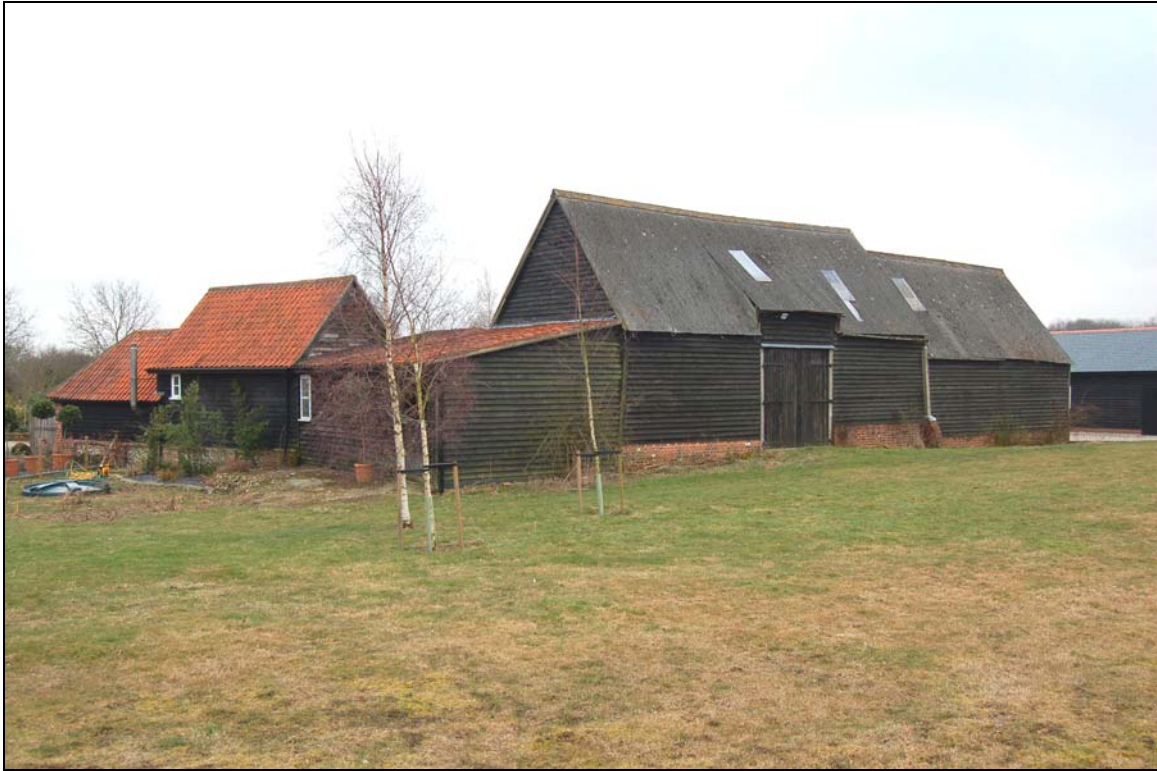
The north elevation comprises the rear of the barn and cartlodge at the back. Modern cartdoors provide entry this side into the barn, which are under a canopied roof (plate 3). All the boards have been replaced this side, probably when the modern stables were built between the north and east ranges (plate 3). There are no openings for windows on the north elevation of either the barn or cartlodge, though there may have been formerly.

Plate 3 North and west ranges viewed to south-west

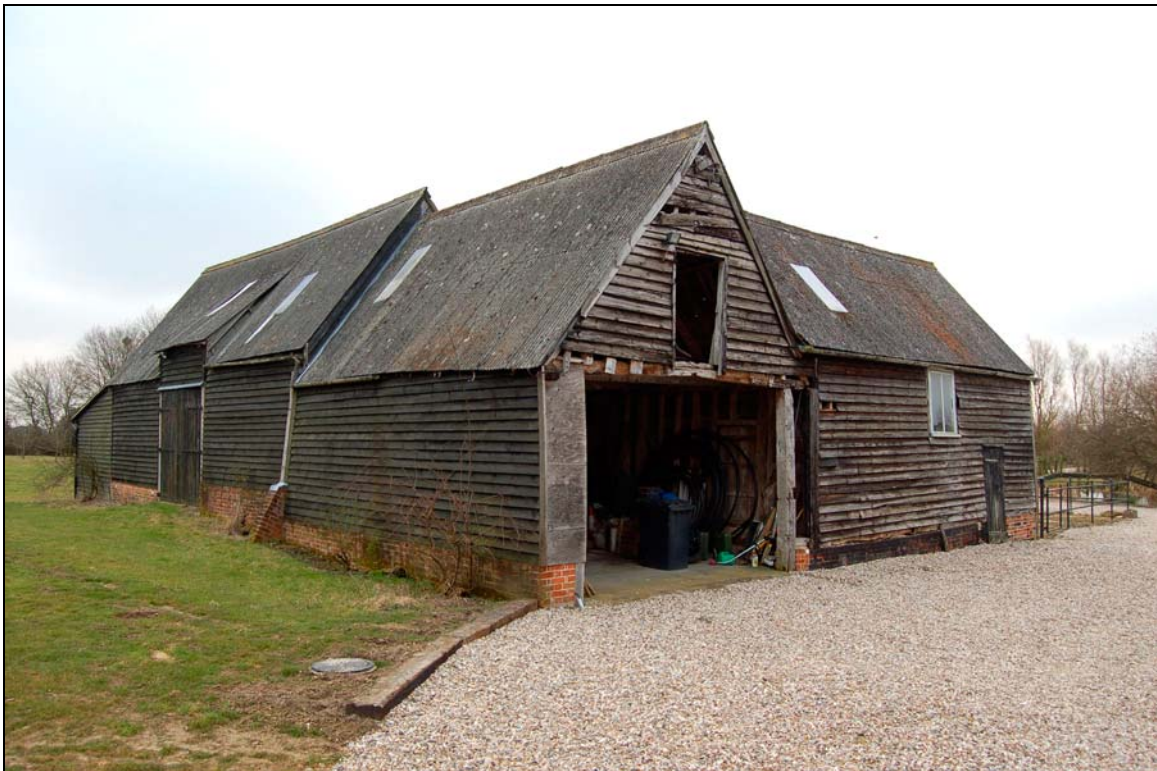
The gable wall of the cartlodge contains the wide cart entry facing onto the gravel driveway (plate 4). Boards are missing over the entrance and on the sides and there is no evidence for doors, nor studwork to show this was ever enclosed. The doorway posts either side are inserted (one reused and the other being modern). A disused pitching hatch in the gable (plate 4) suggests there was a hay loft inside.

Attached to the south are stables 3, the main features of which are a fixed 2-light modern window and a half-heck doorway at the far end on this side (plate 4).

Plate 4 North and west ranges viewed to south-east

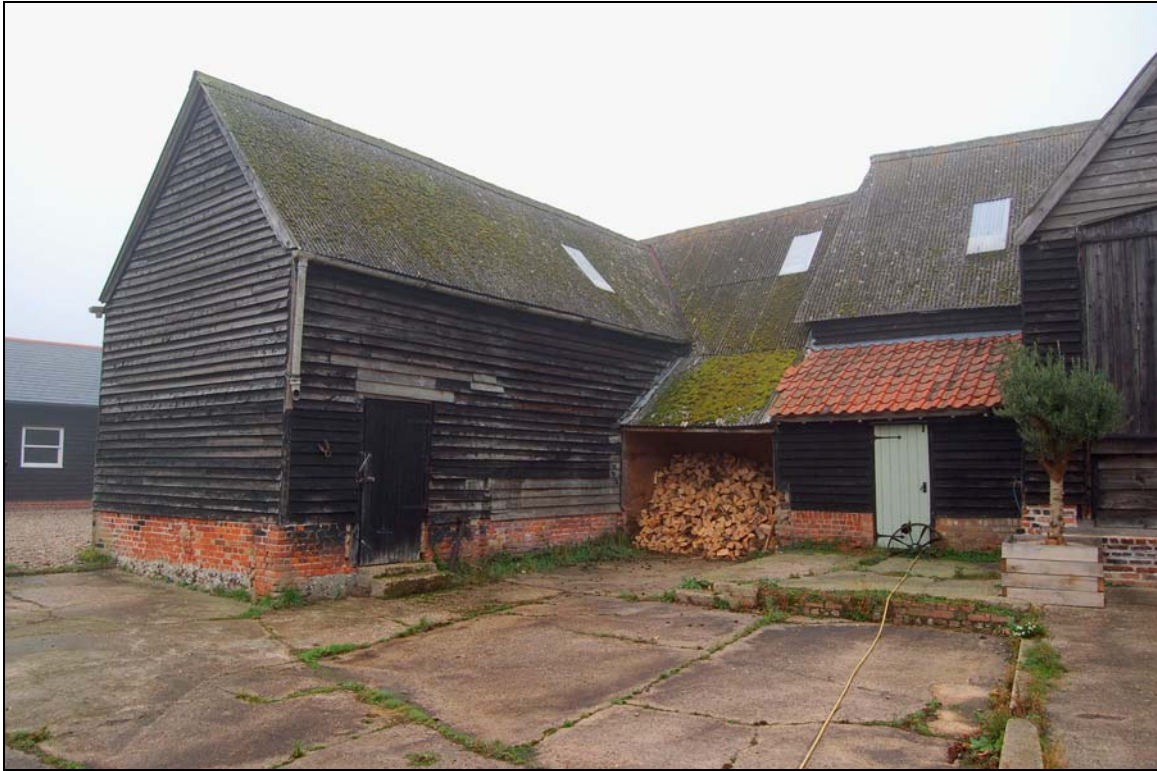
A single door provides access from the yard via concrete steps (plate 5) that retains historic door fasteners.

Plate 5 Stables and former pig sty viewed to north-west

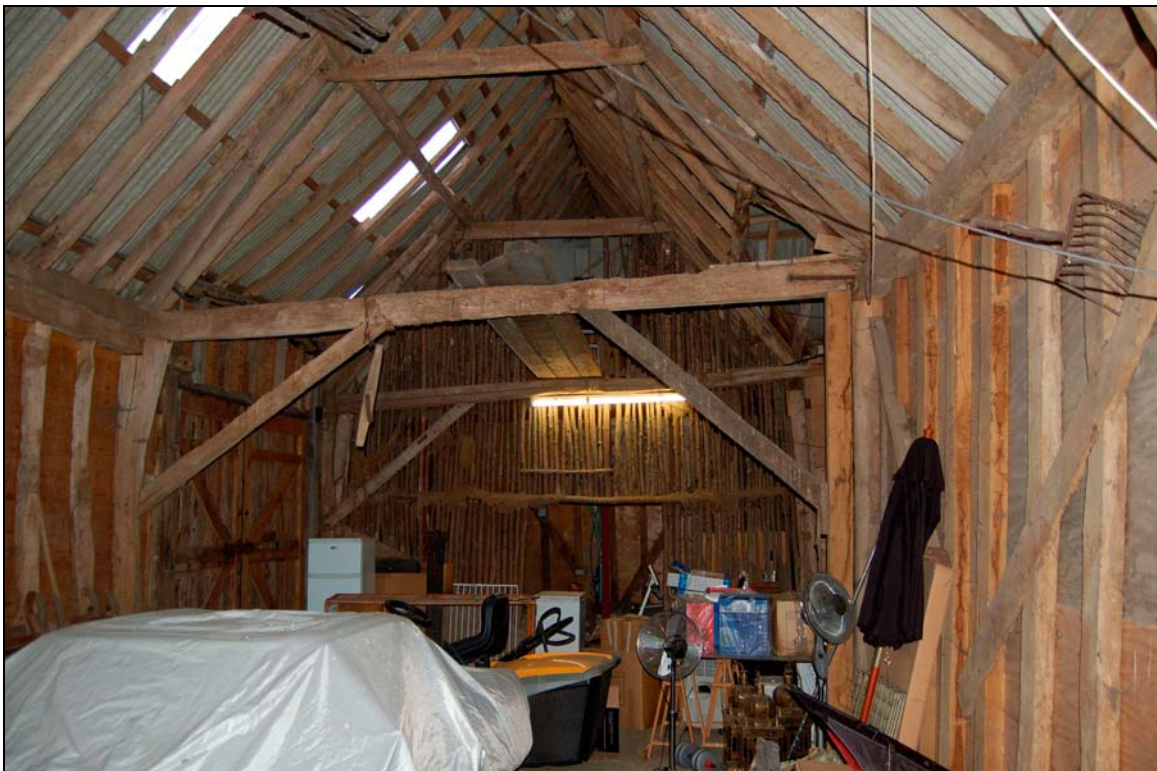
Recent repair works have been carried out on the roof which is of the clasped purlin form (fig. 7, plate 6). The ridge plate is inserted and all but the end collars are nailed rather than pegged. Possible mortice holes for queen struts were seen on the western end of midstrey, but no pegholes were observed, so this beam may be reused. Quite heavy rafters are set in line with the studs below.

Plate 6 Interior of barn viewed to east

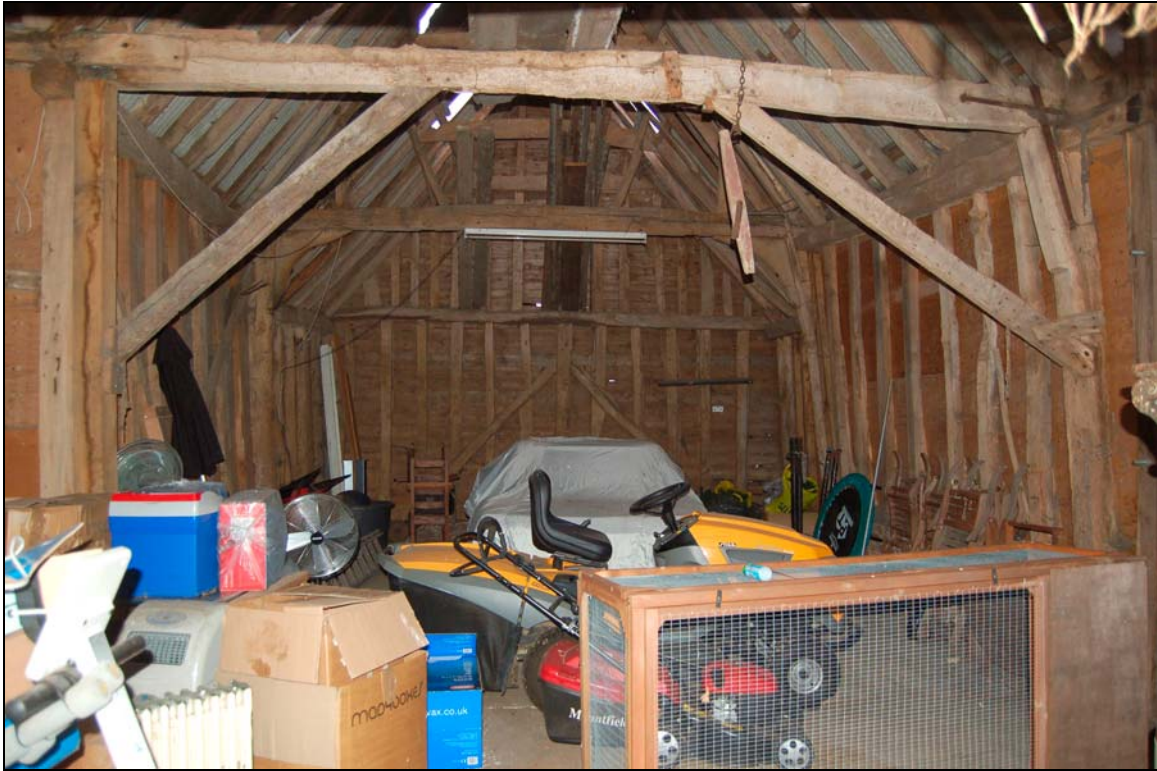
The porch is a contemporary fixture of the barn and has the same internal nailed bracing seen in all other parts, though planks have been nailed across the porch wall plates and midstrey tie beams (plates 7 & 8), suggesting problems in the past. It would seem the door and studwork above the lintel (at least) was replaced in the 18th century as the porch door posts are built with bolted knee-braces rather than the jowled posts that remain in the corners (plate 8, left). The side door into the porch remains (fig. 10c) and possibly an earlier doorway facing it, though it seems not to have been used (plate 8). An additional post has been added in the south-east corner post of the midstrey resulting in the loss of its jowl.

Plate 7 Interior of barn viewed to west

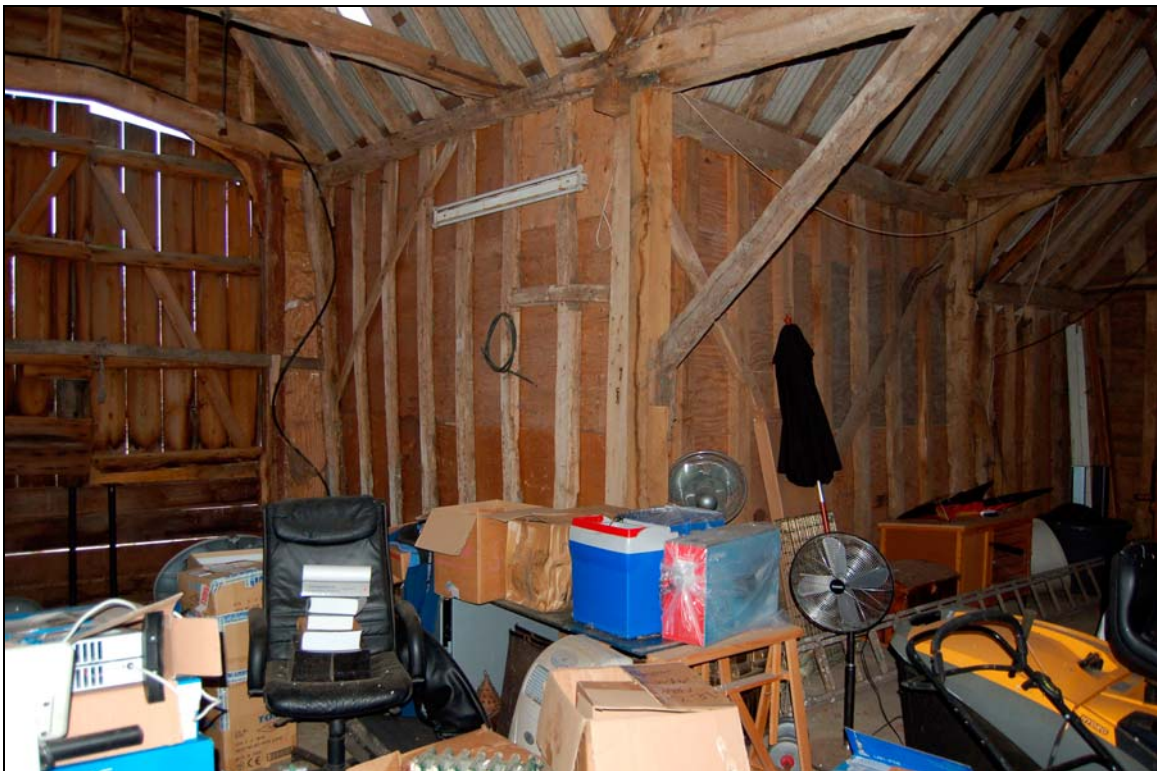
Plate 8 View across midstrey to porch (south-west)

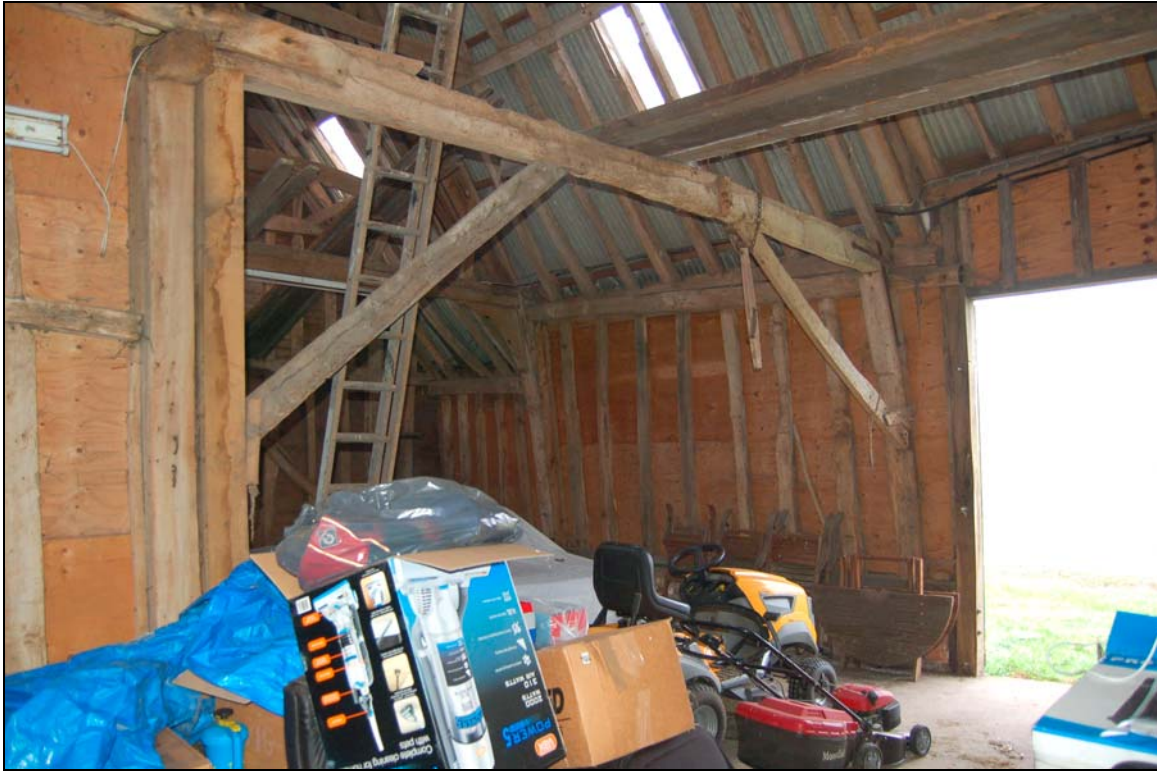
There has been some structural failure around the area of the cart door on the north side of the midstrey. Here the wall plate was cut through in the past, presumably to raise the height of the door, and the frame either side slumped in. Secondary plates have been inserted above the wall plates to correct this (plate 9). A lot of rebuilding has occurred around the door and the wall plates are now bolted to the door frame. Although the canopy over the door appears of some age externally, the studwork is secondary and simply nailed on, perhaps when the new door was fitted.

Plate 9 Open truss between midstrey and western bay and north door

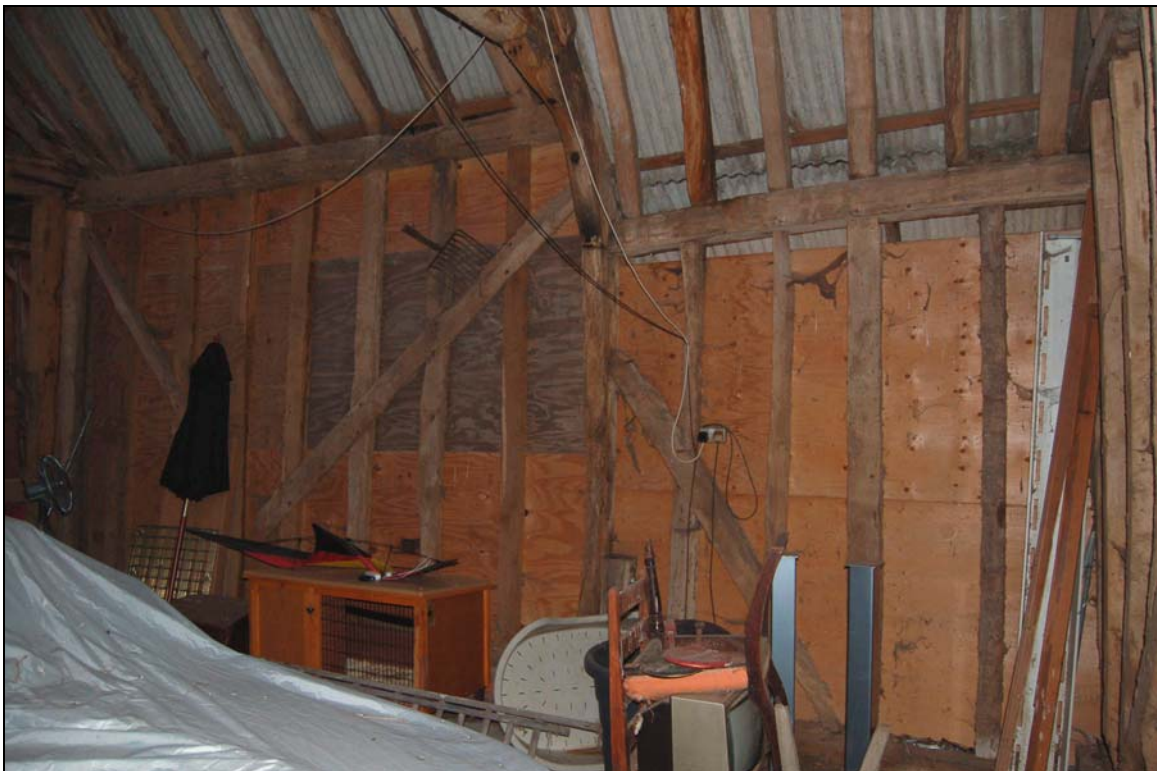
Evidence for the original west wall of the three-bay barn survives in the form of empty stud mortices on the western tie beam (plate 10). Bolted knee braces have been added to the bay posts either side. The new wall was built 2.5m to the west (fig. 6) with primary-braced timbers (plate 7), which is the predominant form of construction in the extension/cartlodge. Although obscured by the knee brace, the new wall plates are probably tenoned and pegged into the former corner post. The studwork butts onto the posts (figs. 10a & b, plate 10), providing extra stability rather than adding a new bay post, which is the norm.

Plate 10 Intersection of barn and extension, showing different bracing forms on south wall

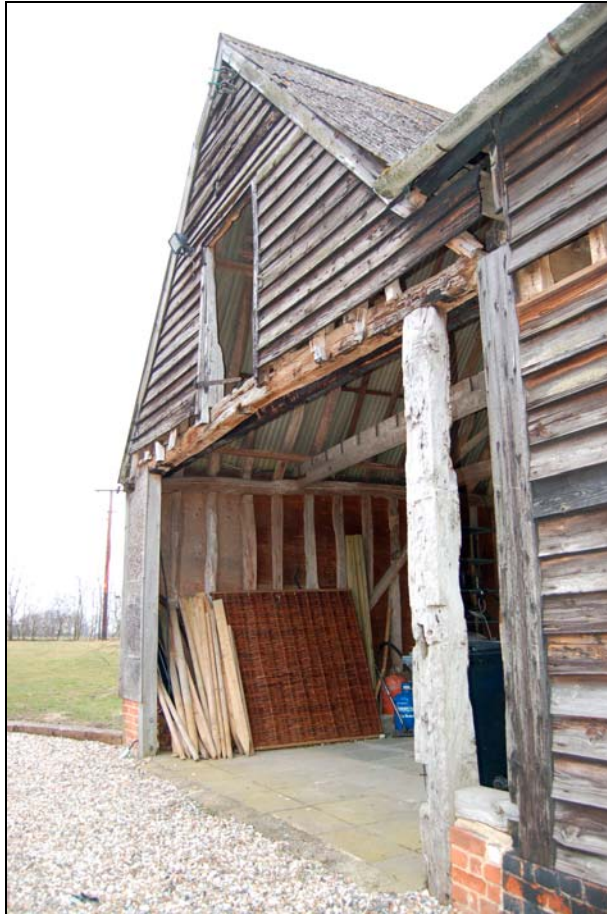
Because the stable is built over the southern edge of the cartlodge roof (plate 11), it signifies the final phase of the historic farmstead and its build typifies the late 18th and early 19th century style. It is built over three equal 2.8m bays (fig. 6), each equivalent to half a rod, and is therefore 1½ rods long and c. 1 rod wide (5m). Being slightly narrower, its roof is pitched slightly higher at 55° to reach the ridge of the cartlodge (fig. 9, plate 5 & 13).

Plate 11 Cartlodge entrance, with stable built up to it, viewed to north-east

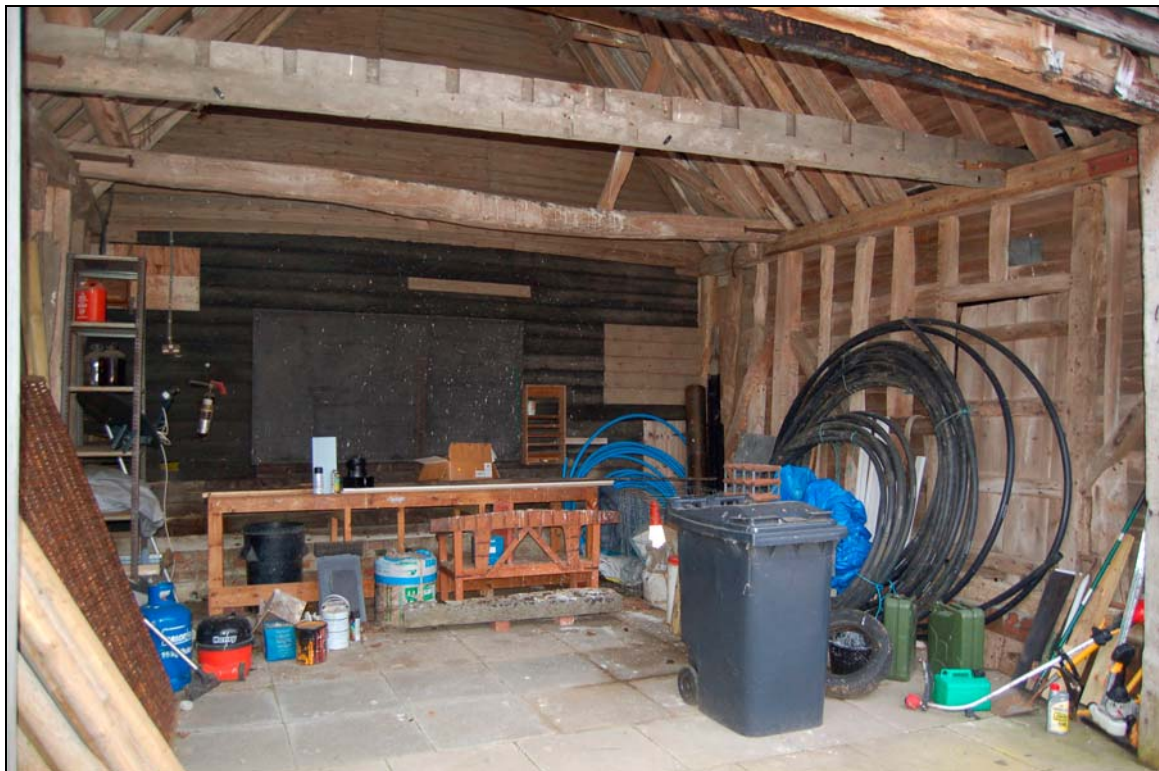
fire. The more prominent one between the charred beam and tie beam is a floor joist (plate 12). It is possible the two supported the hay loft above, even though their form is very different. A gap in the studs above the mid post on the barn-side gable may represent a former pitching hatch into the barn, in which case the loft was built across the whole of the cartlodge.

The cartlodge has a similar roof construction to the barn, utilising the clasped-purlin form. Being unaffected by modern repairs, it retains its pegged collars and rafters (fig. 8). An inserted strut is on the south side and short windbraces are nailed to the rafters (plate 12).

Plate 12 Interior of cartlodge viewed to east

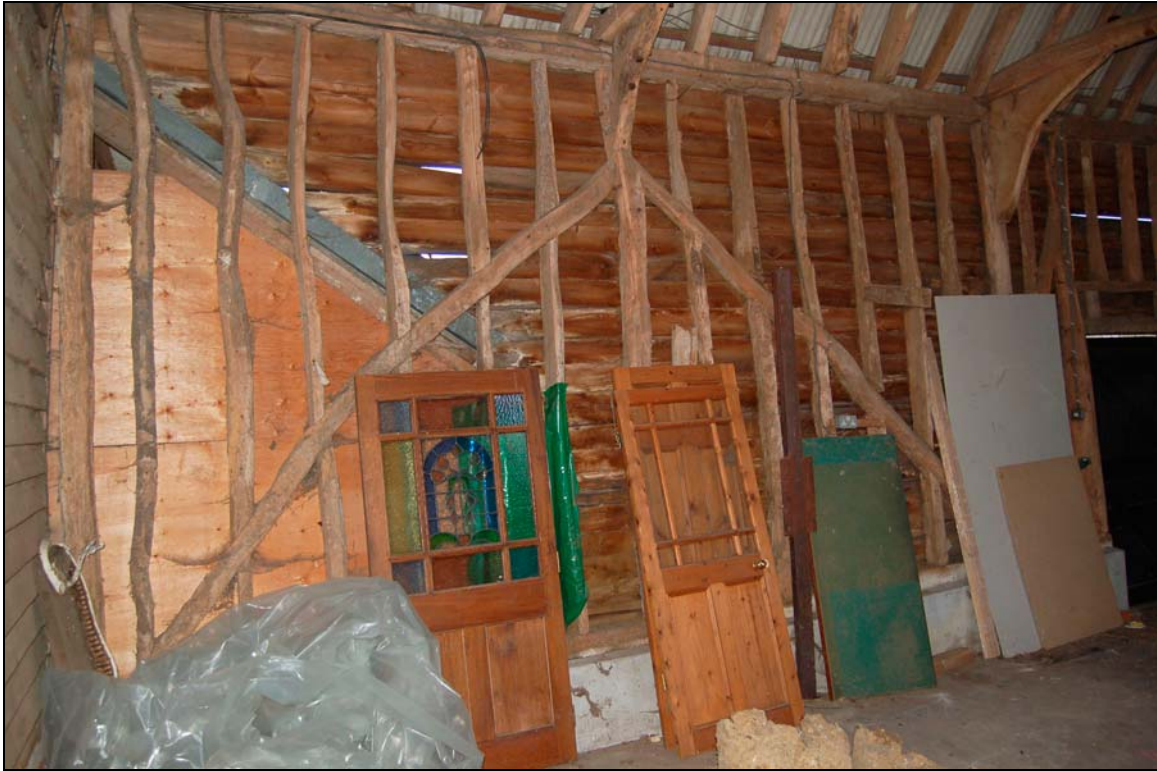
The floor is laid in concrete and the internal walls are built from waney primary-braced timbers (plates 14 & 15). The braces on the west wall are particularly long and waney (fig. 10e, plate 15). Studwork is close together at between 26 and 32cm and the studs themselves, whilst having a fairly consistent depth (c.12cm), are quite narrow, between 7 and 11cms, mainly the former. None is pegged, not even to the bay posts. As shorter bays, there are 6 per bay with gaps typically of 0.32m between them. Some still have bark attached. Some of the studs are pegged to the plate, but generally they are only tenoned in.

Plate 15 Wall-framing on west wall of stables

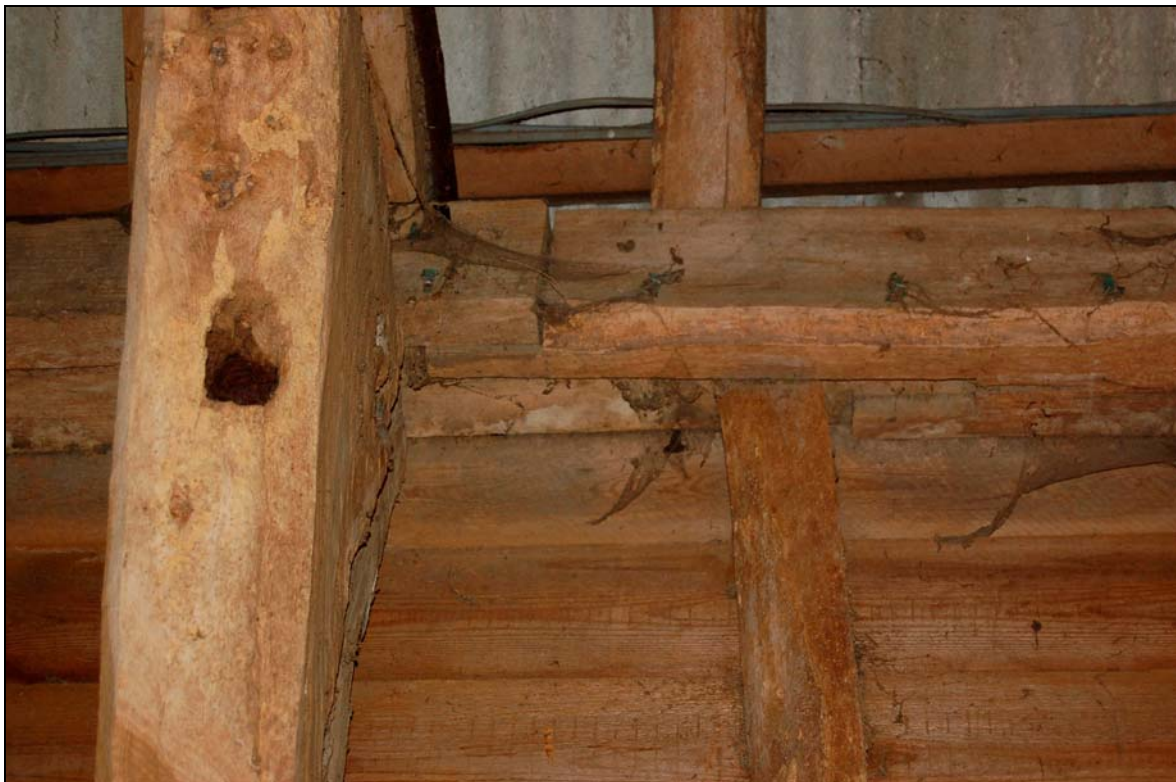
Wall plates are connected in two places by four-pegged face-halved and bladed scarf joints (figs. 10d & 10e) the clearest example being in the southern bay close to the yard-side door (plate 16).

Plate 16 Bladed scarf joint on east wall of stables

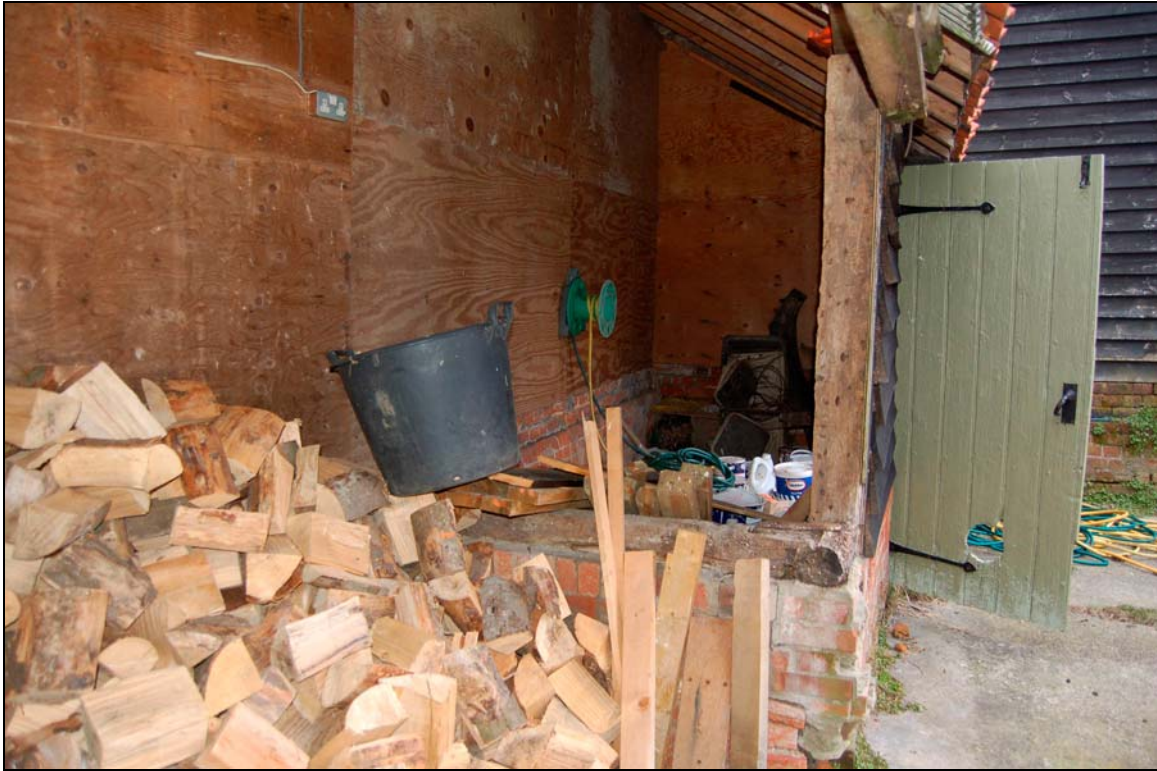
stores paint (plates 5 & 17). As the log store retains its asbestos roof, it is assumed this is the remnant pig sty, though there are no features to confirm this. The other side appears to have been built from reclaimed timbers with a new roof and door. Both are lined-out in pine boarding.

Plate 17 Converted pig sty viewed to east

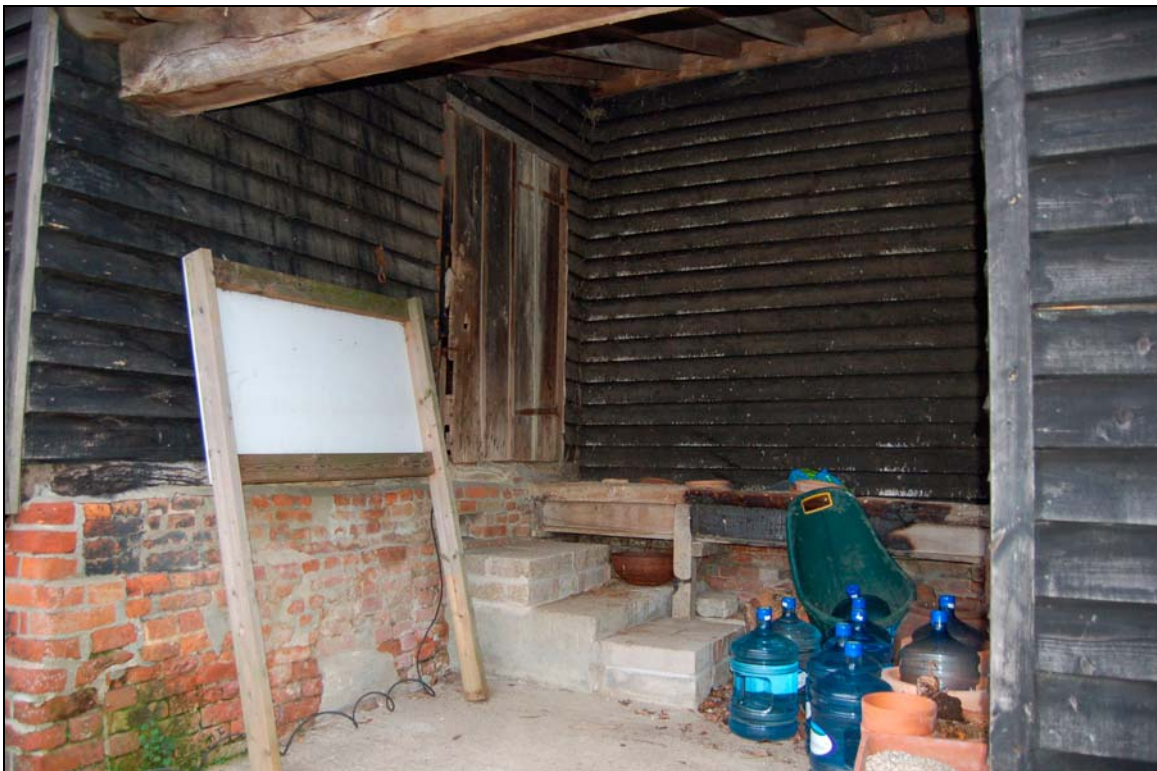
The byre retains much of its earlier form and also retains its feeding trough beside the porch door (fig. 6, plate 18). The interiors of the gardening store are boarded-out although the partition wall may have some historic significance.

Plate 18 Feeding trough inside converted byre
