**GAYNES PARK MANSION AND STABLE BLOCK
THEYDON GARNON
EPPING
ESSEX**

DESK-BASED ASSESSMENT AND HISTORIC BUILDING RECORD

October 2010

FAU Project No.: 2166

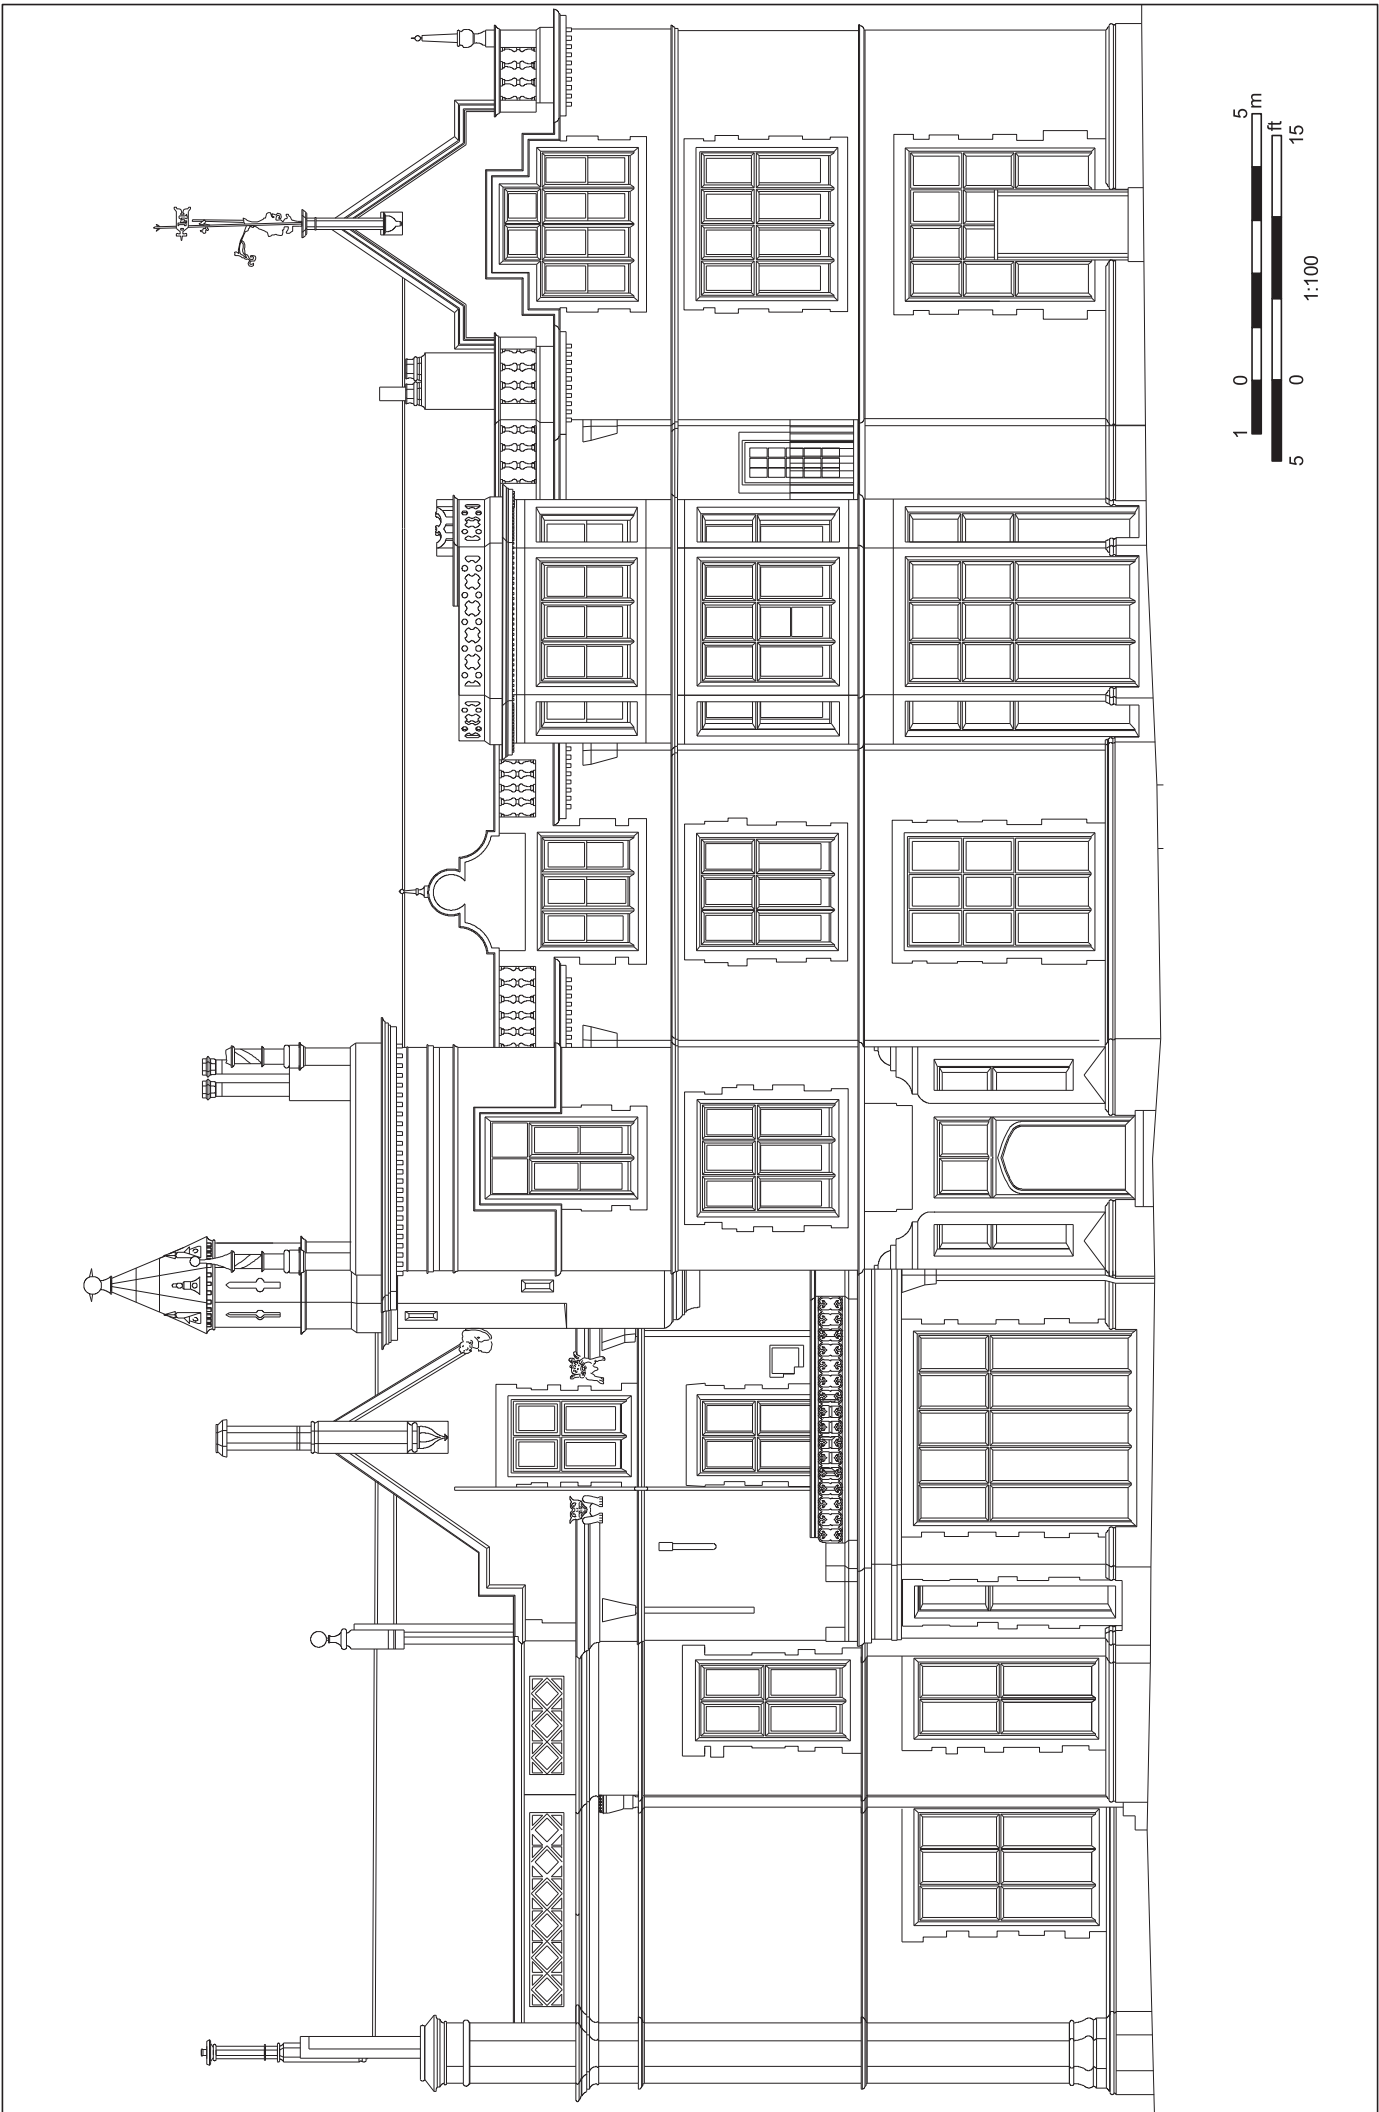
Fig. 10b. South elevation

The end bay returns to the pointed gable dominant on the first bay and west elevation (fig. 10b). A doorway is cut into the window here, and between bays four and five, a small window is missing (fig. 10b). A balustraded stone parapet links the bay window to the bays either side. A foundation stone laid on this side bears the inscription 'CM Sept 7 1868'.

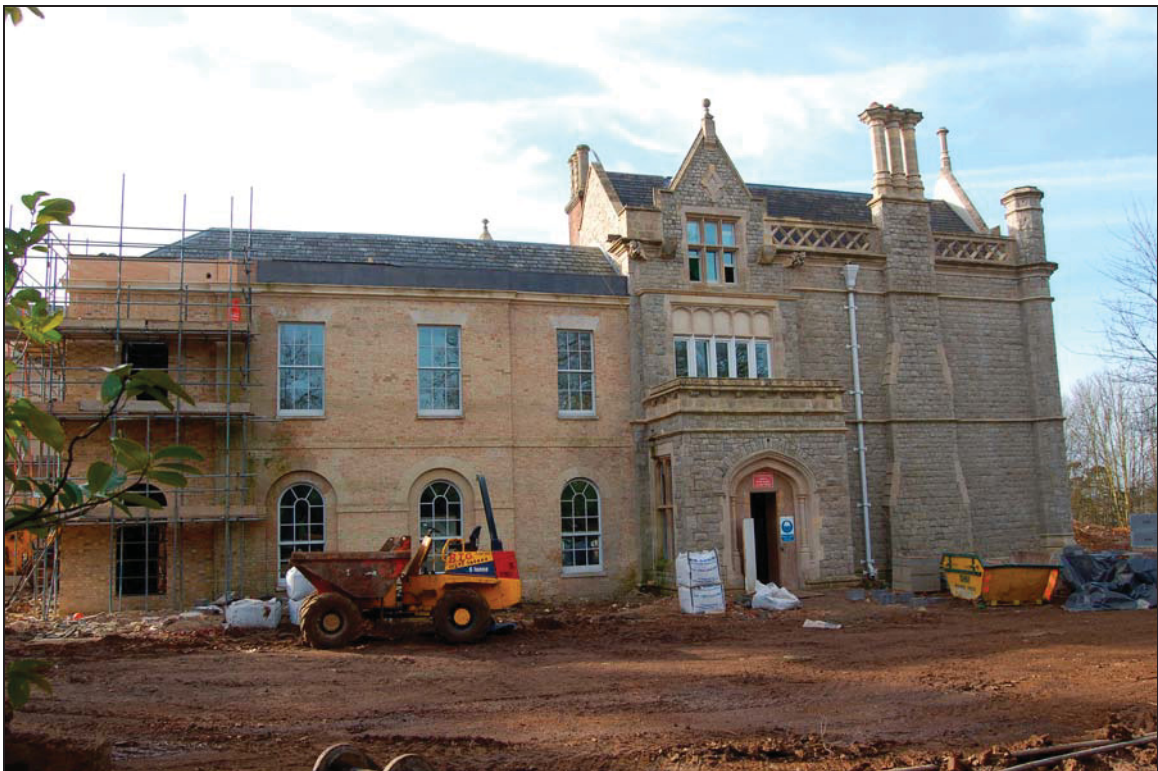
By contrast, the main **north elevation** juxtaposes the two styles of Georgian and Victorian gothic (fig. 10c, plate 6). At the time of the survey the demolished early 20th century extension was being replaced by a shorter extension built over the hip of the Georgian elevation. The Georgian part remained unchanged in 1870 because of its utilitarian function, housing the kitchen and main service rooms. The exterior is faced in creamy stock brick (re-faced between 1805 and 1867, appendix 1) over an English-bonded red brick core and, given that the west end was extended in 1870, almost three-quarters of the early elevation is exposed. The exposed three bays of the service range display sash windows with stone sills and gauged brick heads rather than the Venetian windows seen on the front in the 1818 print (fig. 5), which were more decorative and probably saved for the more prominent elevations. Those on the ground floor are arched nine-over-six windows in recessed panels, connected by a brick band. The two floors are separated by a second brick band; those windows above are six-over-six sashes with flat arches below a moulded stone pediment (plate 6).

Plate 6 North elevation during survey

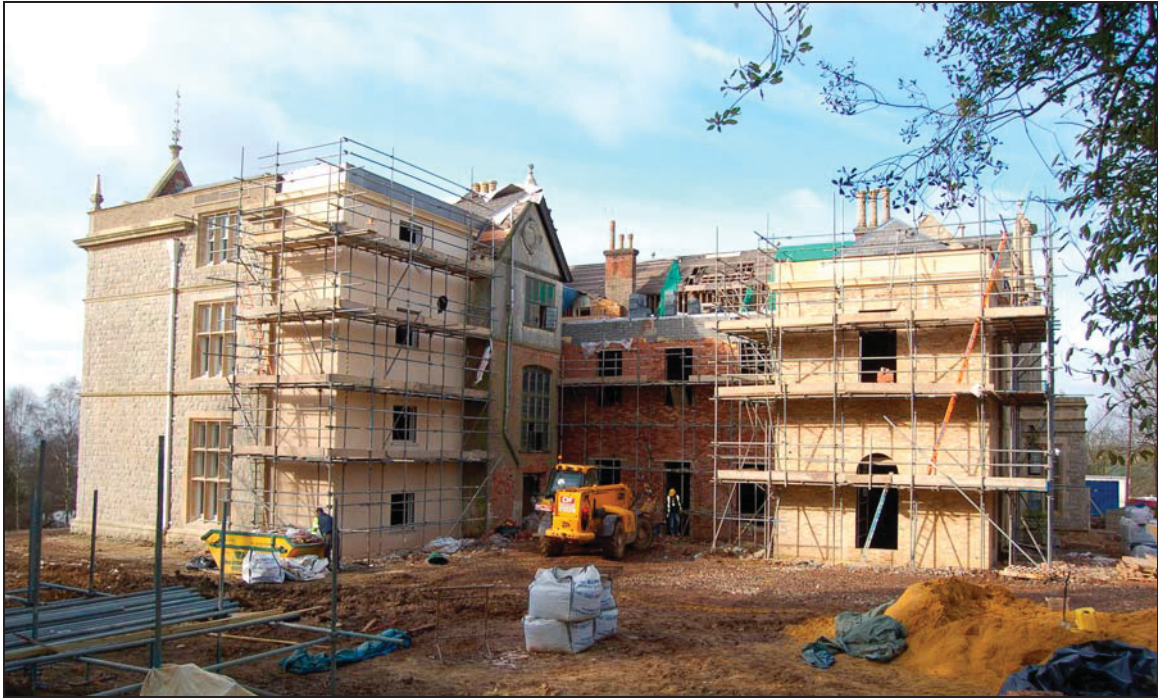
The **east elevation** (fig. 10d, plate 7) has received less architectural treatment than the other sides because of its location at the rear of the house. It is clear from the mainly low architectural standard of the courtyard (apart from the stair tower) that this was a service area. It is also the most affected by the current building works, which comprise extensions to the north and south wings and a replacement structure at the back of the west wing, seen in progress in plate 7. The only surviving historic part of this elevation is the east end of the south wing (fig. 10d), which has stone cross transome windows set on three levels offset to the centre. A parapet runs around the top on a dentilled cornice and stone bands run between the floors to match those on the other elevations. The new extension on the north side will improve the window imbalance in this part of the building but will also hide the east

Plate 7 East elevation during survey

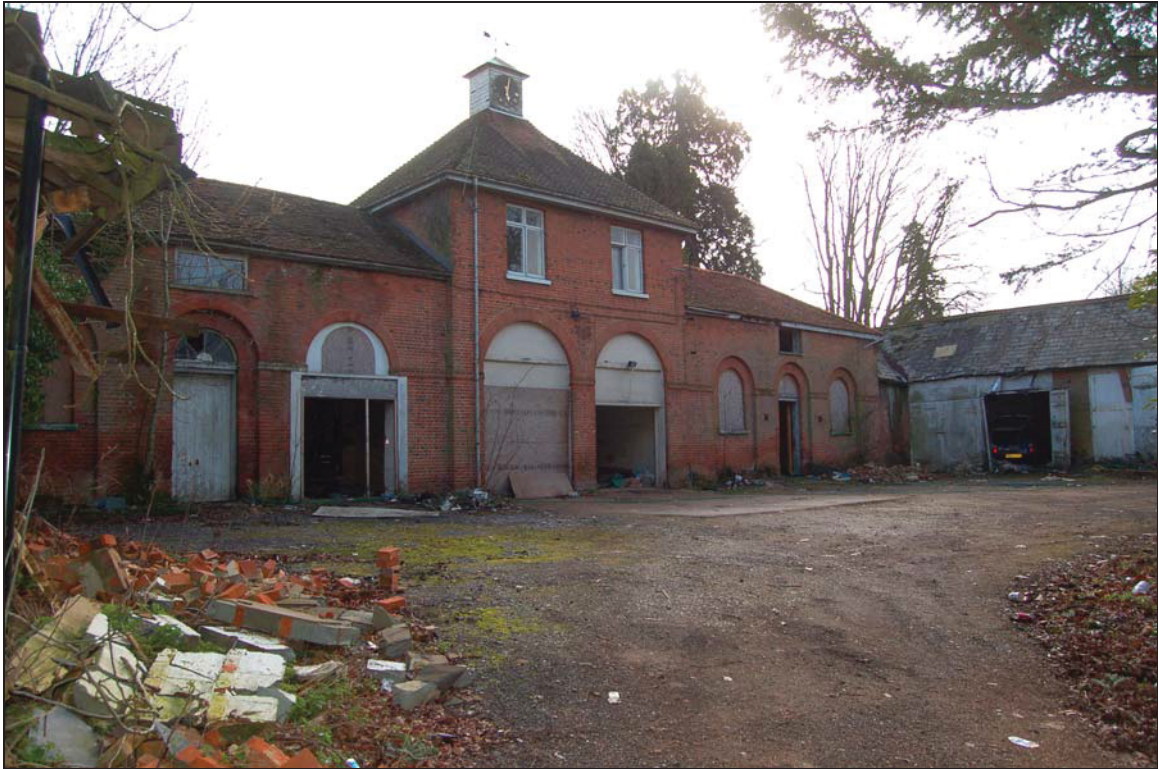
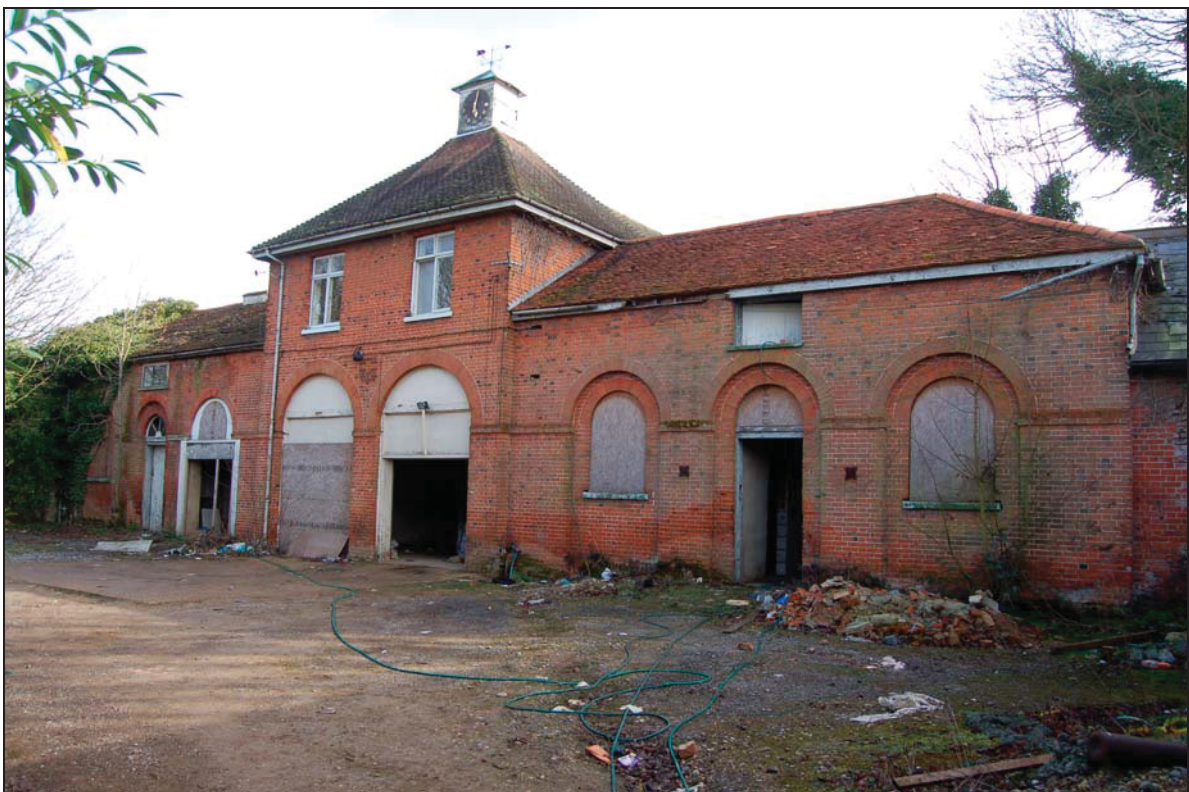
Carriages were admitted through two tall arched doorways on the main west elevation (plates 29 & 30). Brick bands extend to the recessed arches of the stable doors and windows either side (fig. 12a), formed from gauged brickwork. The doors and glazed fanlights in the arches above have been removed and boarded-up. On the first floor are inserted windows, probably dated to the 1960s or 70s when the house behind was built, cut into earlier ones shown on the 1818 print (fig. 5). The roof tiles are probably replaced.

Plate 29 Stable block viewed to south-east

Plate 30 Stable block viewed to north-east

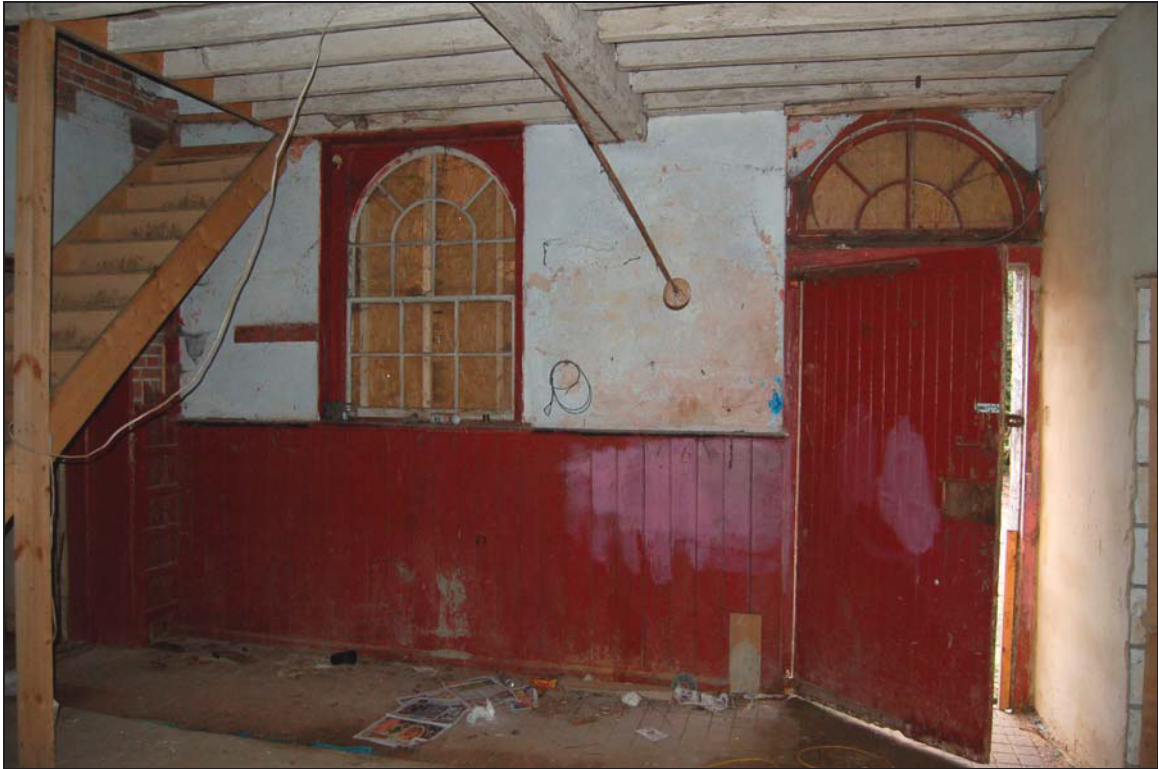
In the southern stable (2), the three bays are split by a modern wall. Good wall panelling survives south of this artificial division (plate 33), but has been removed and re-plastered to the north. Stall dividers have been removed throughout, but their outlines remain on the south wall beside the timber stair, which is a recent replacement (plate 34). Judging from the spacing of those in the stable extension, there are likely to be four stalls here. Access to the

Plate 33 Original panelling and windows in main stable 2

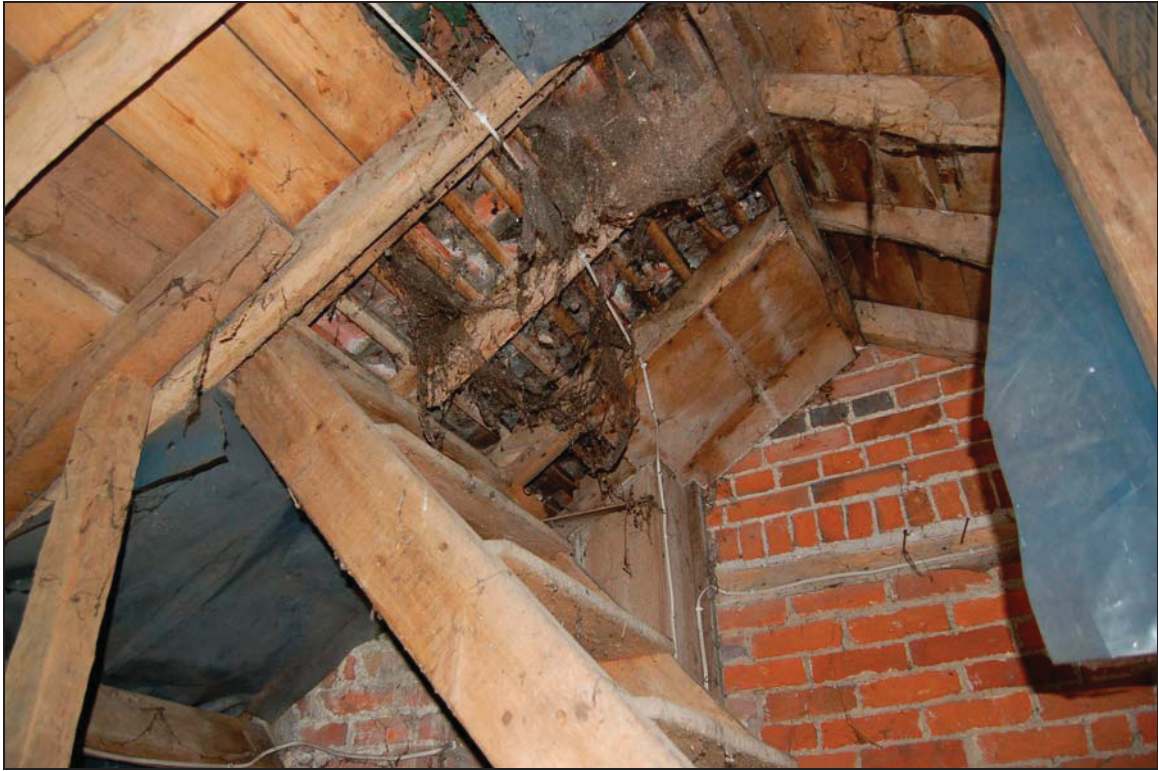
Plate 41 Blocked roof access in feedstore

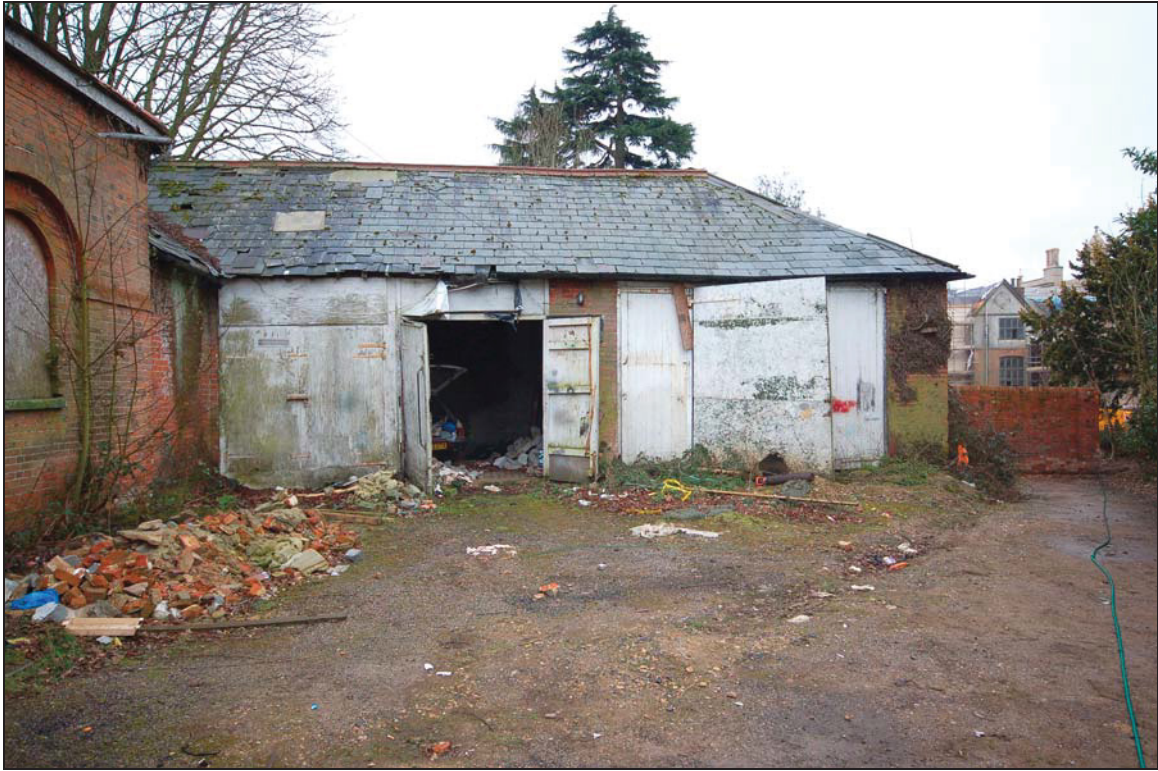
The main elevation facing the yard is in a poor state. Half the coach doors are modern replacements that lack the relative elegance of the original ledged and battened doors (plate 43). Two carriage doors are located on the garage in the corner, while the garage at the west end has a separate singular access and a tripartite carriage doorway that is mainly modern (fig. 13a).

Plate 43 South wing of stable block (6): north elevation
