**BARN TO REAR OF 17-19 BRADFORD STREET
BOCKING, BRAINTREE
ESSEX**

LEVEL II HISTORIC BUILDING SURVEY

**Essex County Council
Field Archaeology Unit**

October 2010

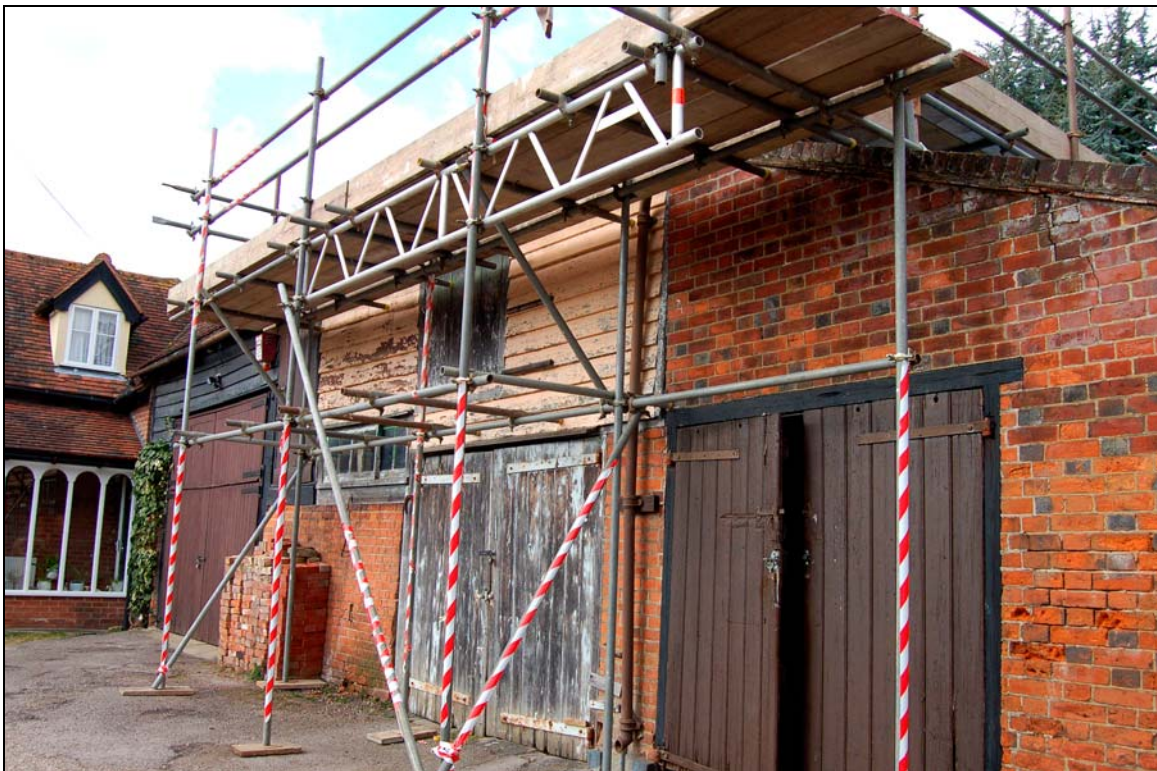
Plate 2 Workshop and barn viewed to north-west

The **south elevation** (plate 2) at the front of the building comprises a pair of carriage doors on the right-hand side and a horizontal sliding sash window set to the left, likely to be a 19th-century addition. The upper floor is reached by a first floor doorway stair set centrally to the structure, reached in the past by wooden steps. There is a sealed pitching hatch on the right for taking-in hay (plate 2), which may pre-date the doorway.

Access into the first floor storage areas was through the high door at the front, (plate 2) offering some degree of security. Despite later fixtures, the door itself is old and contains a wooden lock (plate 16). Judging by empty stud mortice holes on the wall plate soffit over the door, this feature is a later insertion, perhaps replacing the pitching hatch on the front elevation, which was sealed in the past. Through the door, a short flight of stairs leads into the hay loft (plate 15).

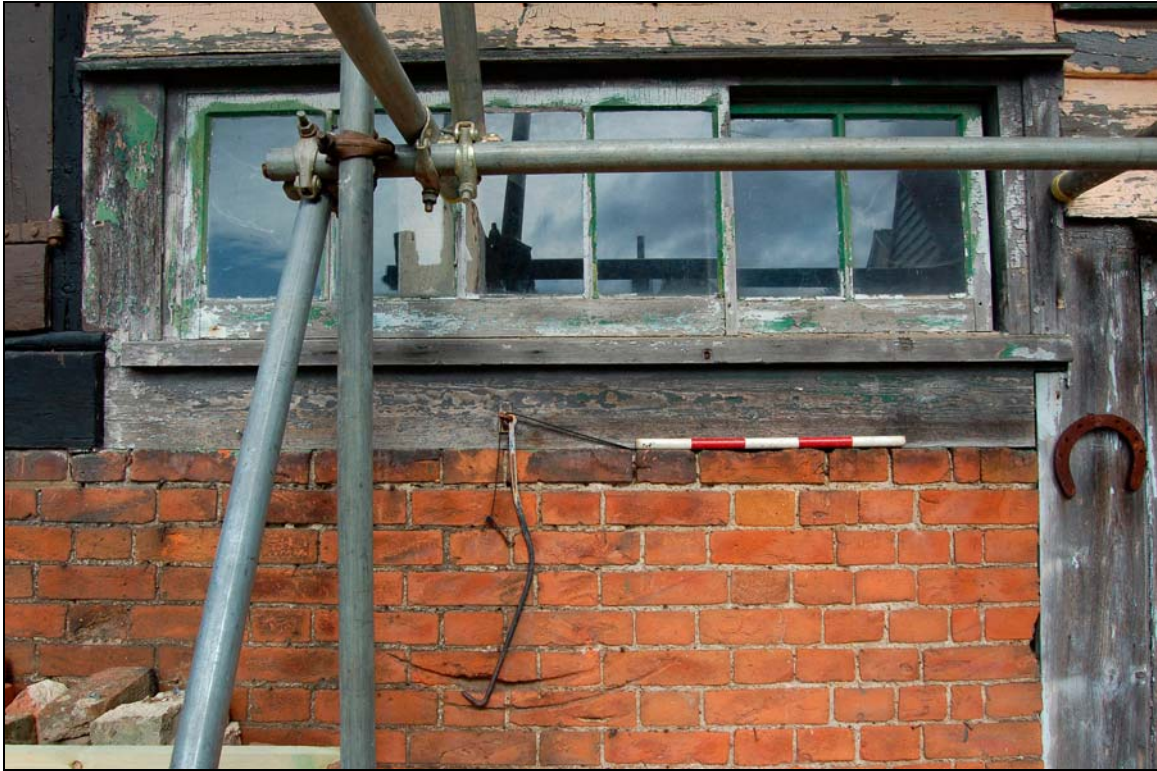
Plate 3 Horizontal sash window and cart door stay-rod

The carriage doors are ledged, boarded and braced and set on pintel hinges. Iron stays are attached to the brick wall for holding the doors back (plate 3). Door furniture (strap hinges and latches) are cast iron forms likely to be late 19th or early 20th century in origin and therefore replacements, perhaps contemporary with workshop 2, whose fixings are the same. The boundary wall is similar in build to the barn and likely to be contemporary, but heightened above the workshop door in later brick when the workshop was added (plate 2).

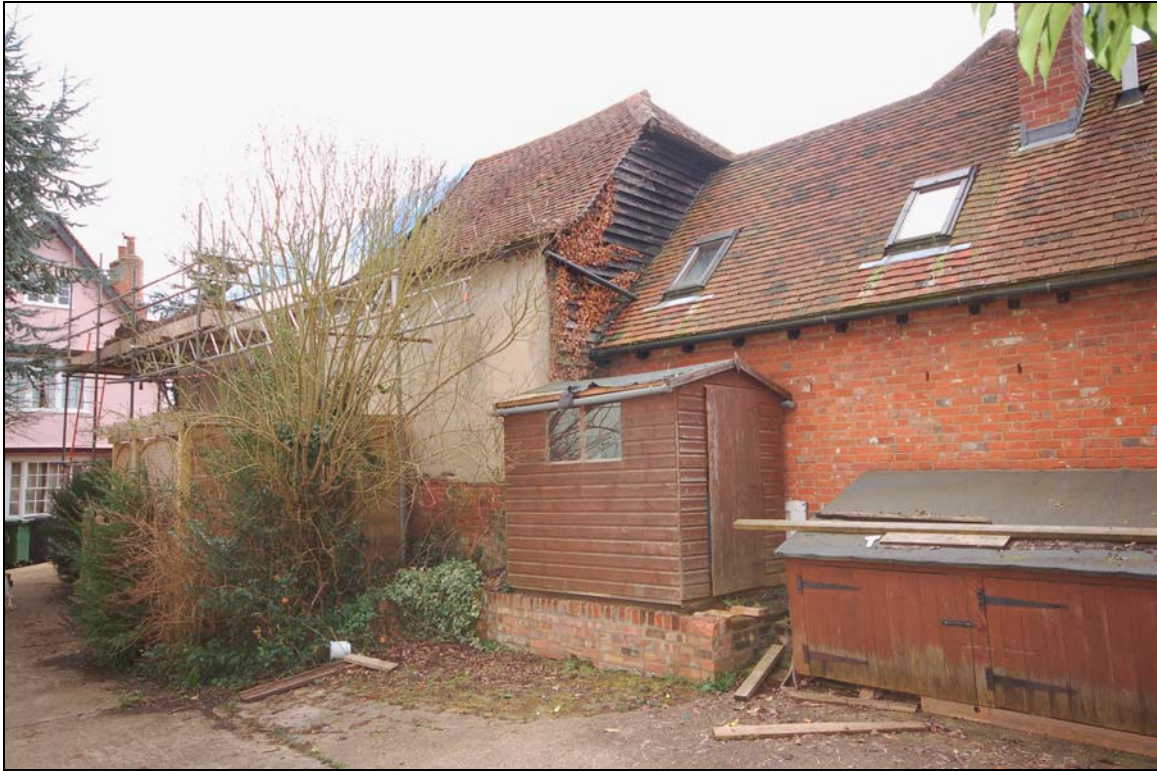
Plate 5 Rear (north) view of barn, with Ostler's Cottage

The rear **north elevation** is largely hidden by later features (plate 5) and access was limited, being within the garden of no. 19. The boarding on this side is now plastered and the brickwork below is supported by small buttresses. Towards the east end there are 18th-century air vents to the stables that have been plastered over.

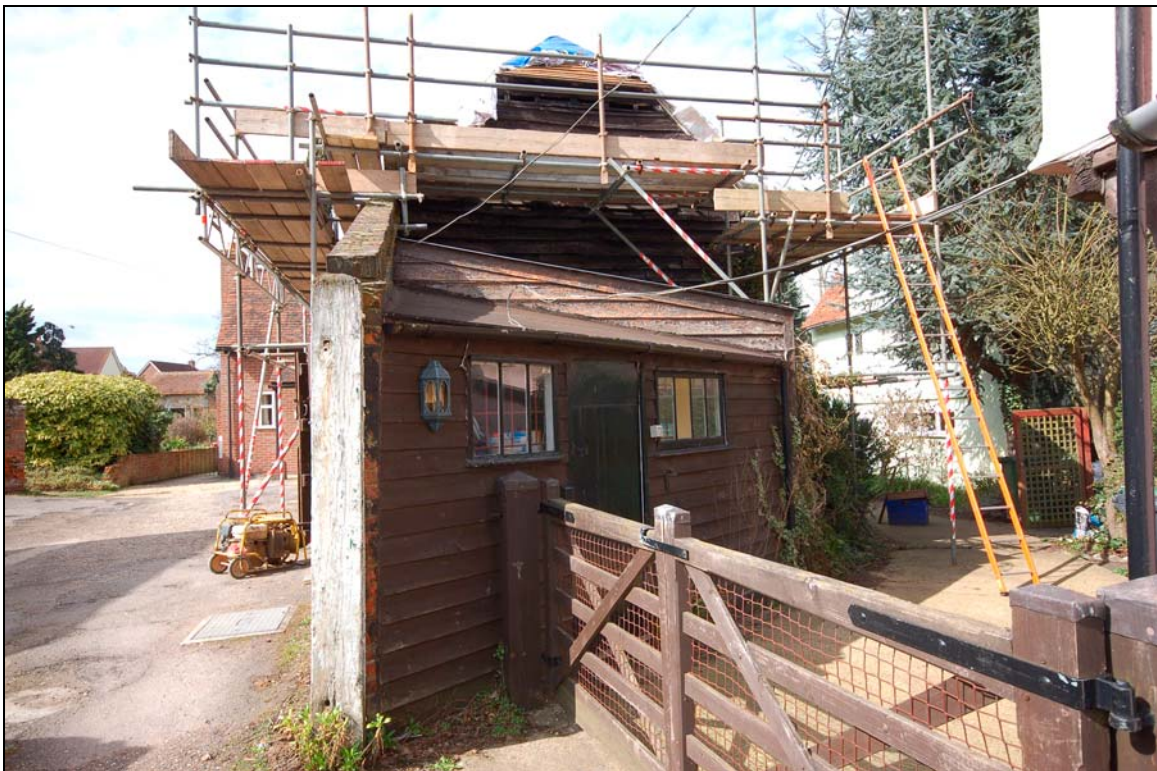
Plate 6 Eastern gable of barn and modern shed

The **west and east gables** are obscured by later structures (Ostlers Cottage and workshop 2). Both ends are boarded but the eastern side (hay loft) has ventilation slats below the hip (plate 6).

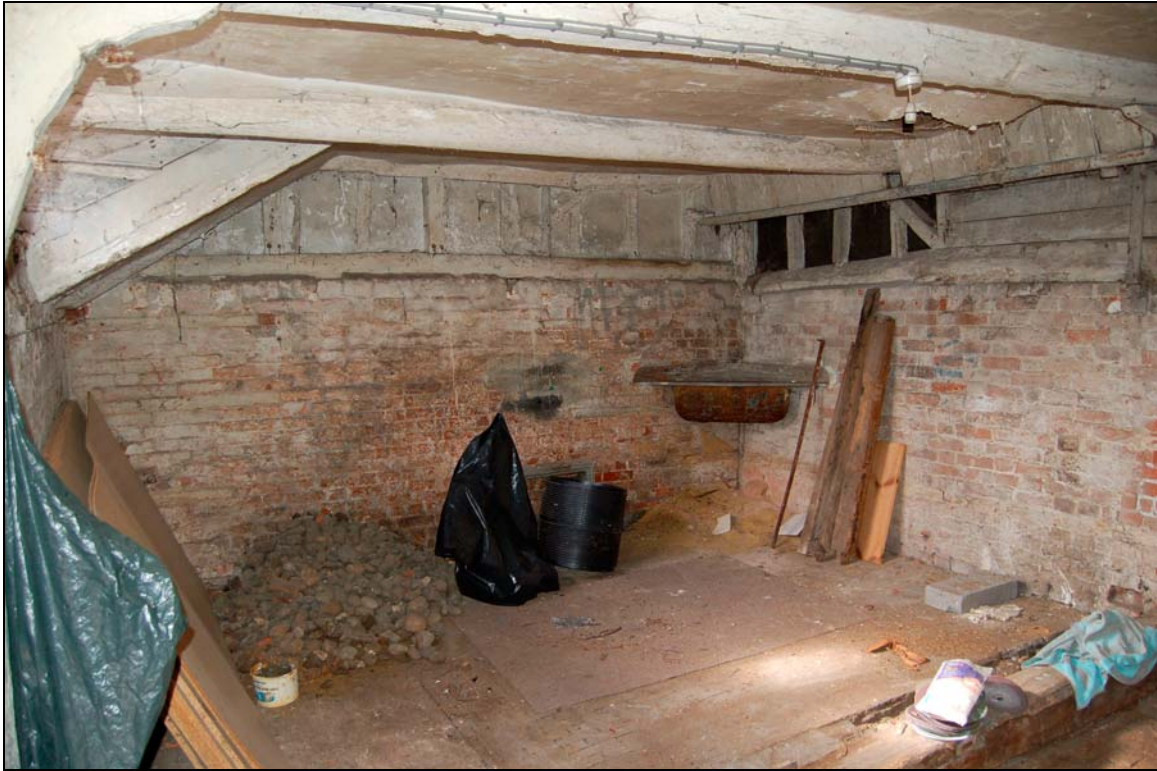
Plate 7 Interior viewed to north-west (stall)

On the floor are the remains of a brick dwarf partition (plate 7) aligned with the bay that once supported a timber dividing wall, probably a stall for the horses (fig. 5). The floor is laid in 8 inch brick setts, raised in the area of the stall, with a gully that leads to the doorway (fig. 6, plate 8) terminating in a 'Doulton'-manufactured cast iron drain of 19th-century date.

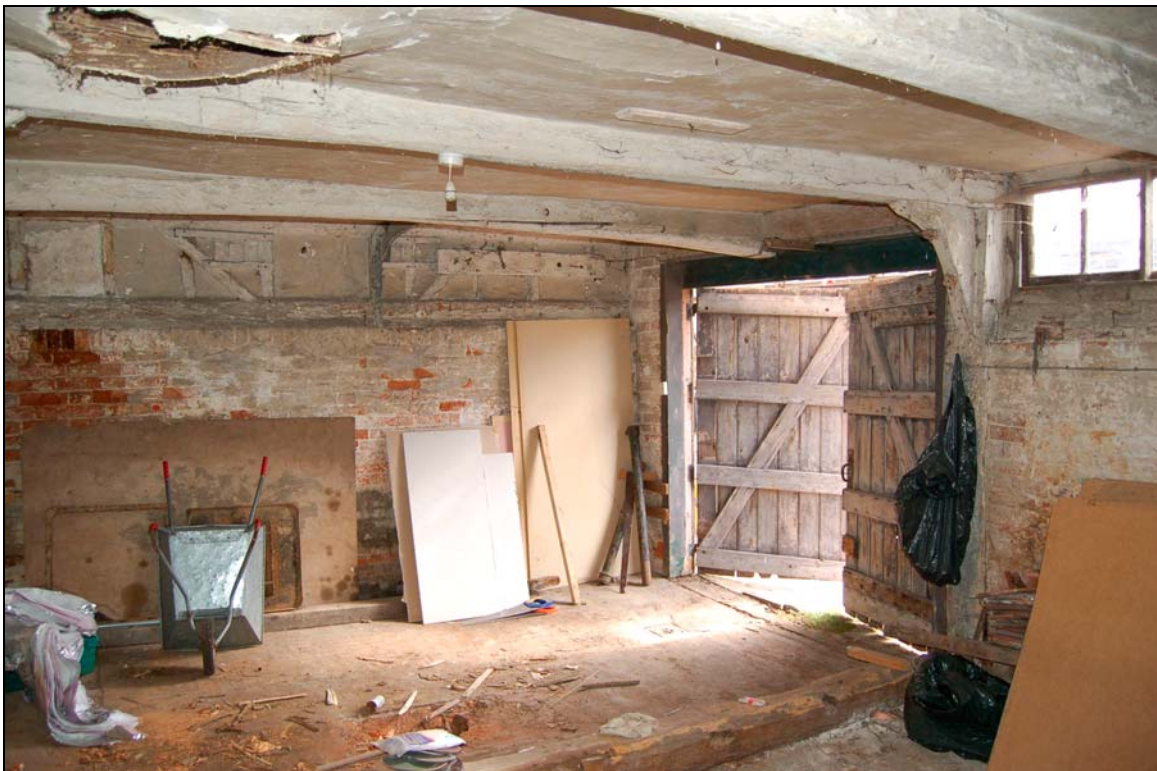
Plate 8 Interior viewed to south-east (cart doors)

Three beams span the ceiling and support the first floor, the central one of which defines the bay and is supported either side by bolted knee braces (plate 8). The ceiling is plastered like the walls, providing insulation for the horses inside.

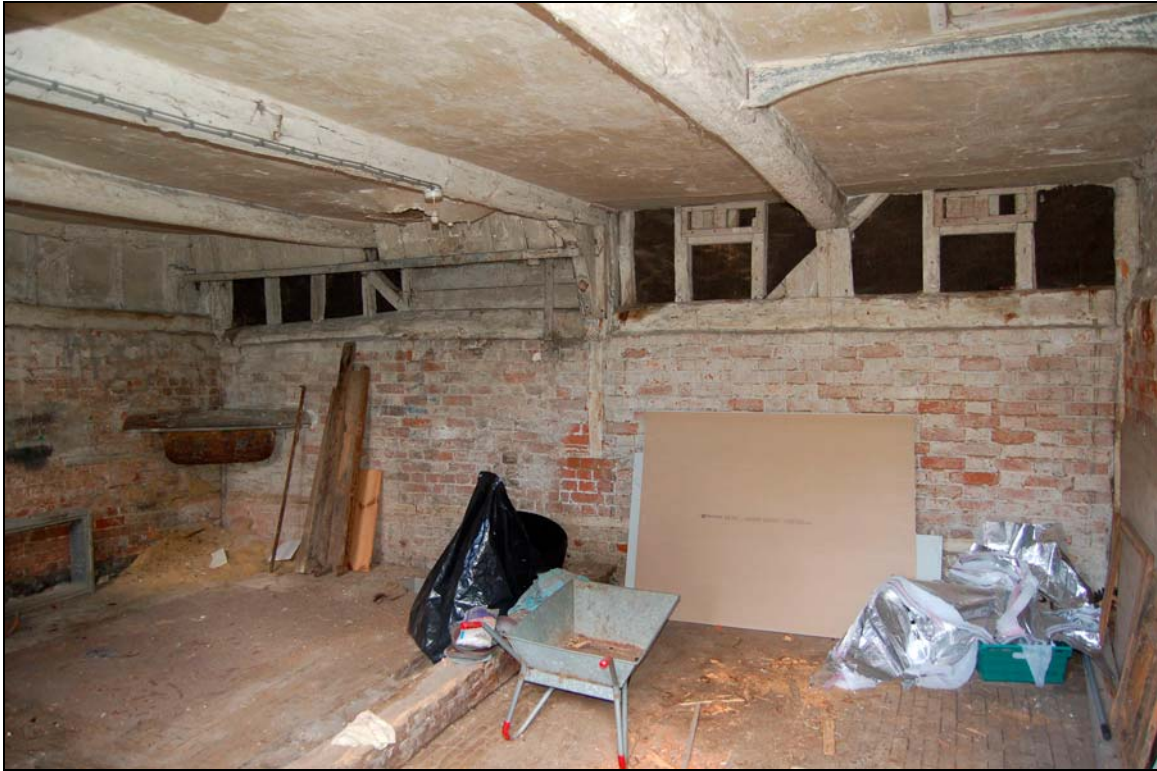
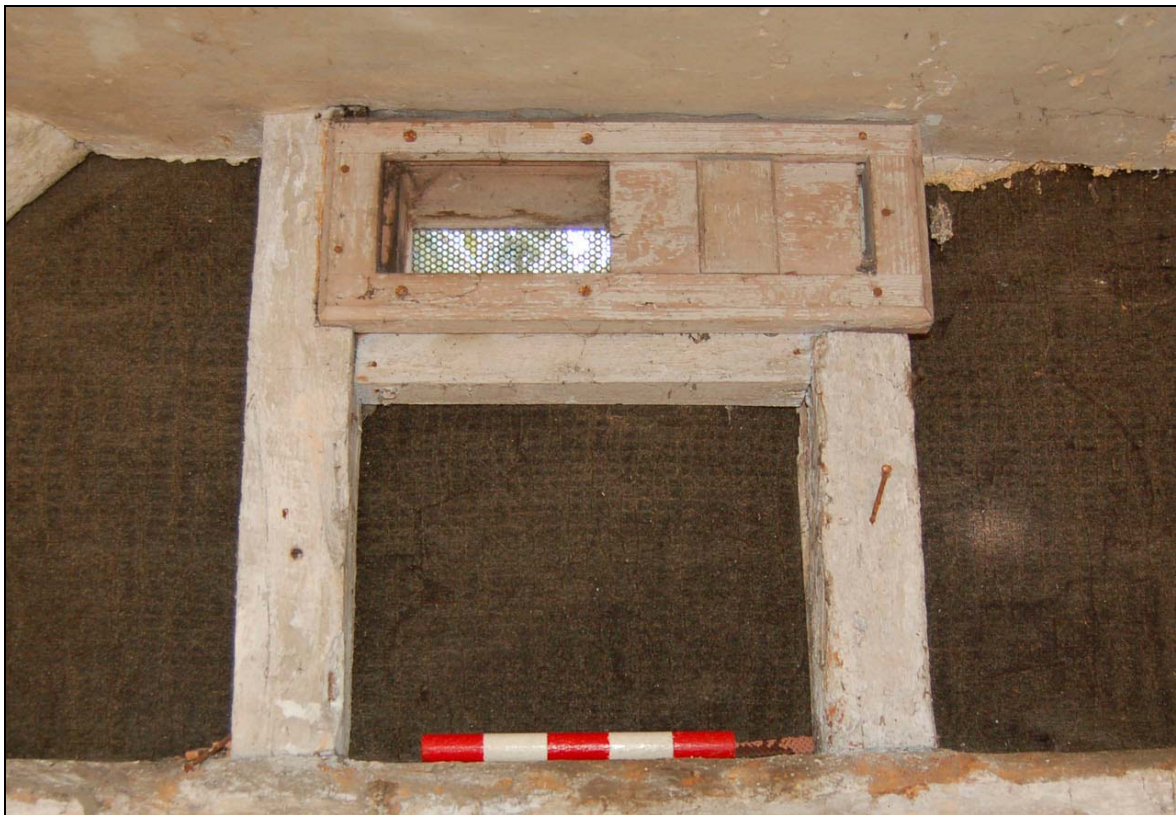
There are several interesting fixtures and fittings on the ground floor. On two of the sides are wooden air vents that retain their wooden shutters that regulated the air flow (fig. 5). Those on the north wall are largely intact although the outer parts are covered with steel plastering mesh (plates 9 & 10). Those on the eastern wall have a different form of shutter that have been blocked (fig. 5, plate 11). There is evidence for an old hay rack against the north wall (plate 12) supplied by a 'hay drop' in the ceiling, lined on the wall side with boarding (fig. 5, plate 9). Another ceiling aperture survives on the eastern cart bay, perhaps for internal access to the loft (fig. 5). It is partially supported by a carved beam (plate 13).

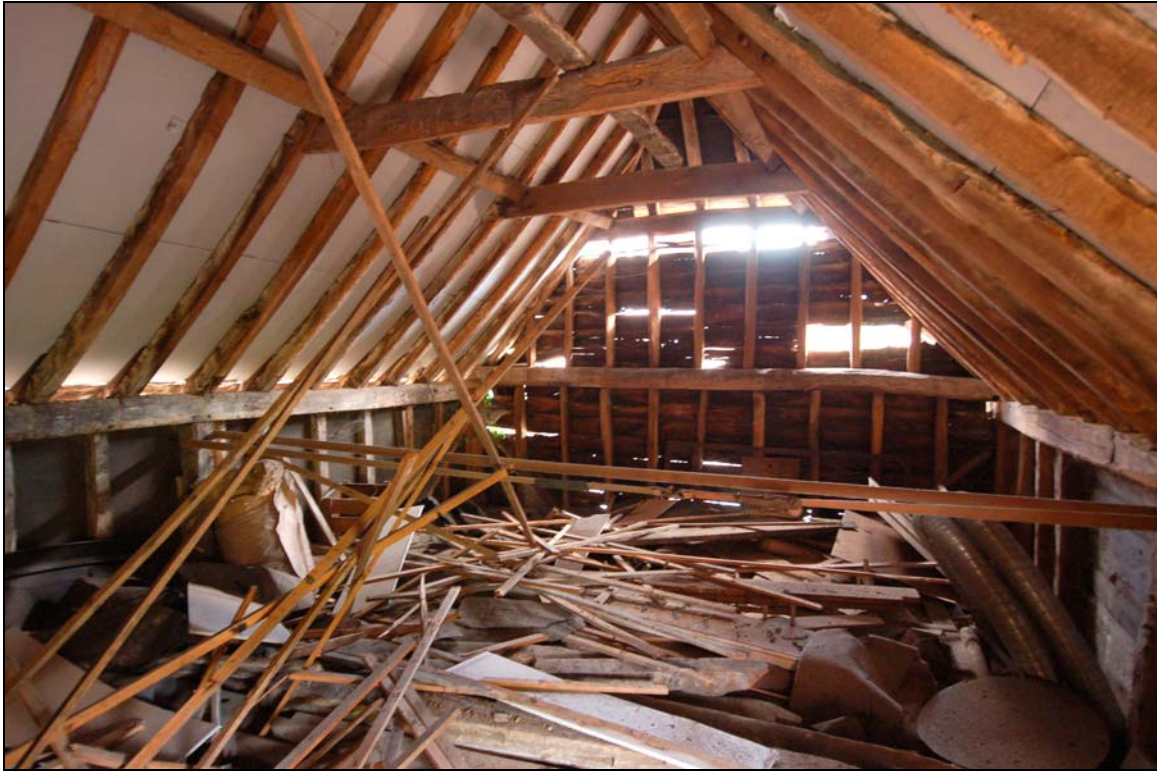
Plate 17 Hay loft viewed to east

The tie beam that separates the two bays of the hay loft has been removed and the two ends are currently strapped (plate 17). Wall plates extend the length of the two bays and are attached by simple lapped and scarf joints over the western bay posts, but are largely hidden behind the boarded partition that separates the two stores (plate 18). Rising from the floor below are six studs per bay, primary-braced at the ends. The bay posts are double-pegged to the wall plates, but there is generally a lack of pegging, apart from in the roof.

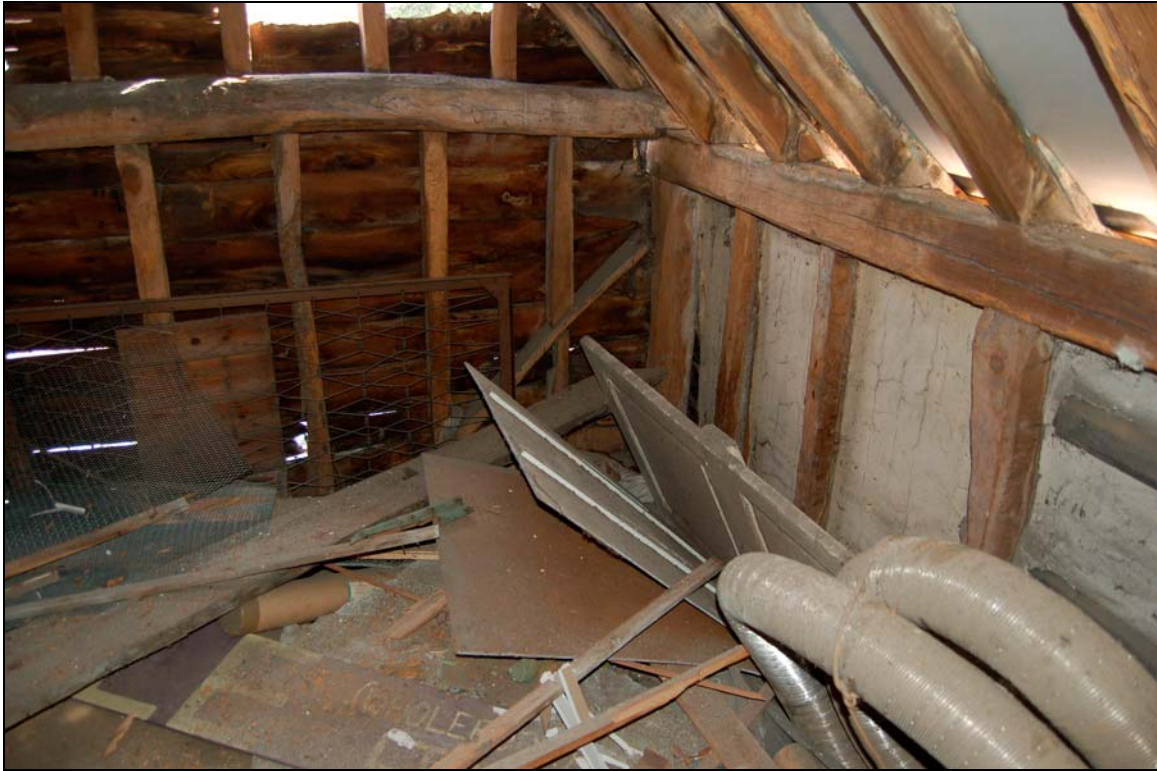
Plate 19 Infill panels and former pitching door on south wall

10 Inch-wide floorboards are partially visible underneath the stored timber, which obscures the tops to the chute and floor hatch. The north wall of the eastern bay is plastered against the outer boarding, including the sealed former pitching hatch, (fig. 6, plate 19), and it is possible that the entire interior was originally treated in this way, which, combined with brick flashing under the eaves, would keep the upper floor draught-free.

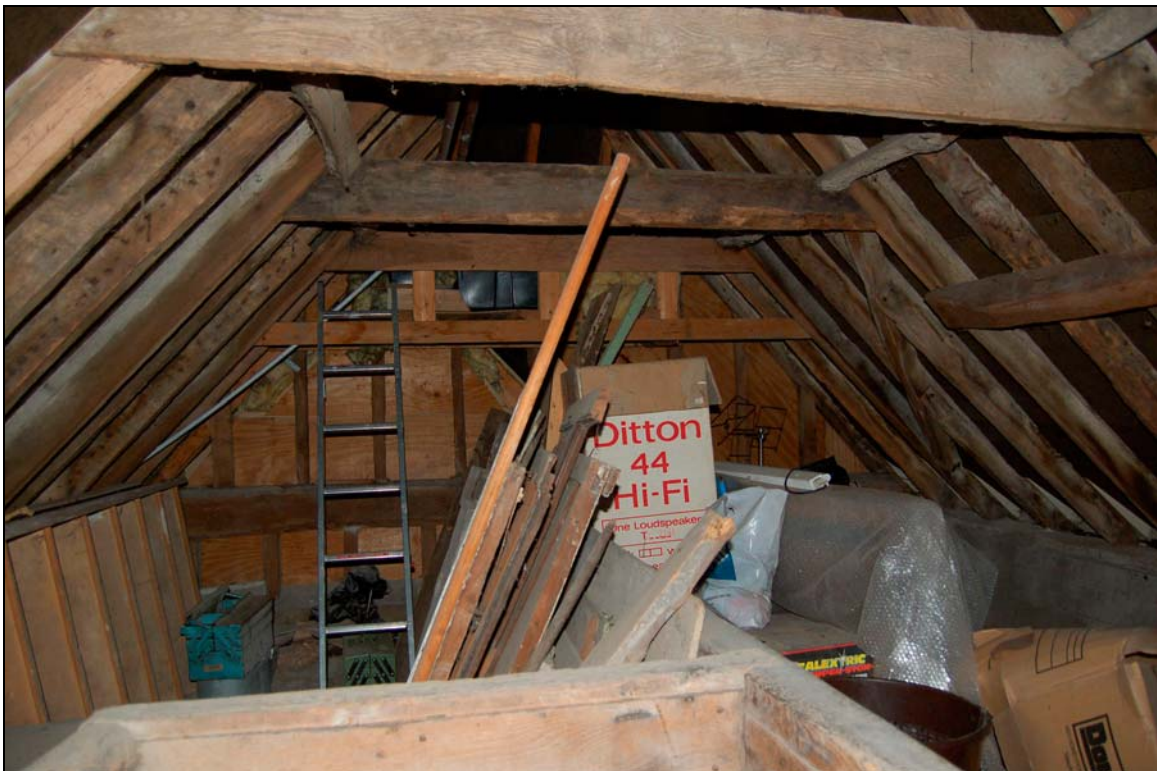
Plate 20 Feedbins above garage conversion

Short wooden steps lead to the grain bins on the west side, over the garage, which is essentially unaltered (plate 20).
