# OAKHILL FARM, COPPICE ROW THEYDON BOIS ESSEX

# LEVEL II HISTORIC BUILDING RECORD

Essex County Council Field Archaeology Unit

December 2010

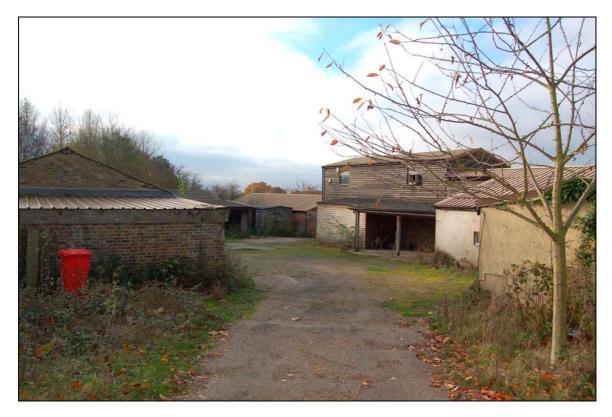
Plate 1 Entrance to farmyard viewed to south

Oakhill Farm is located on the western side of Theydon Bois on the eastern boundary with Epping Forest at TL 4396 9929 (fig. 1), close to the manorial site of Birch Hall (EHER 4041). Access is by a narrow tarmac track that leads southwards off Coppice Row past the farmhouse and down the slope of the hill to the former farm (plate 1).

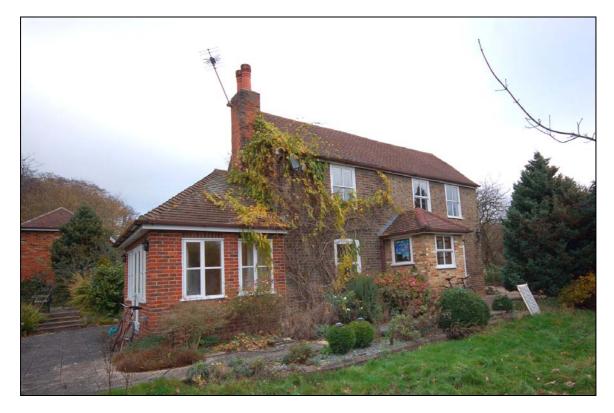
Plate 4 Farmhouse 1 viewed to north

The farmhouse is four bays long and brick-built on two levels in Flemish bond beneath a pitched plain tile roof. The two long elevations are built in yellow stock bricks while the gables are built of red bricks. The south elevation (plate 4) is fenestrated with horned sash windows, indicating a date no earlier than the 1850s (Hall 2005). Much of the north elevation is hidden behind the 20th century extension (plate 5). The chimney stack is attached to the western gable and is now surrounded by a single-storey extension similar in character to the north extension.

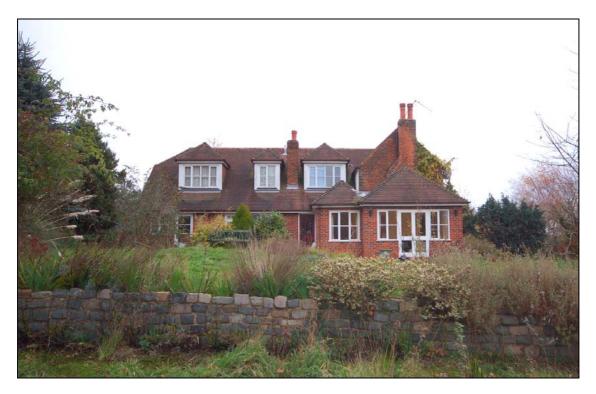
Plate 5 Farmhouse viewed to east

The north extension is built of red brick beneath a long half-hipped roof. Its proportions and plain wooden windows (possibly replaced) suggest a modern date, though the tiled roof and dormer windows are typical of the inter-war chalet bungalow (plate 5), which, if it is the same building depicted on the early 20th-century map, suggests it was built in the 1920s (fig. 4)

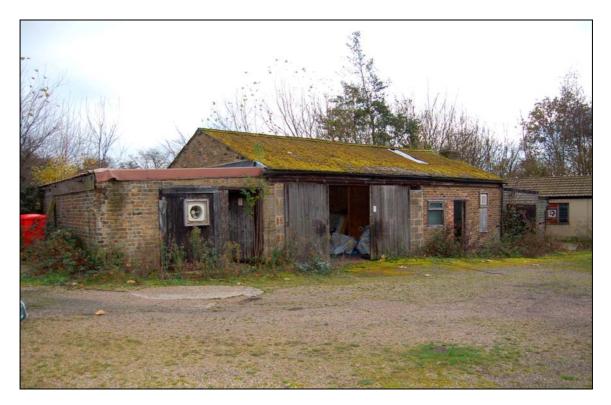
Plate 6 Building 2 viewed to east

The front elevation (west) has areas of modern infilling reducing the size of the large garage doorway and smaller one at the southern end (plate 6). The remaining window is modern and likely to be original. The pitched asbestos roof is laid on a modern machine-sawn timber frame. A short red-brick chimney stands at the south gable (plate 6 & 16), though any internal fixtures no longer remain.

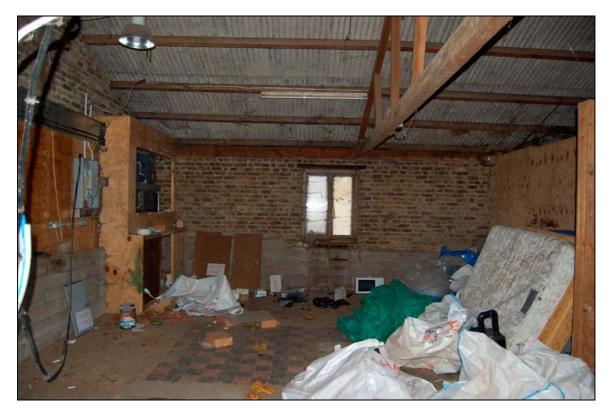
Plate 7 Interior of building 2

The interiors have no fittings or fixtures of interest (plate 7).

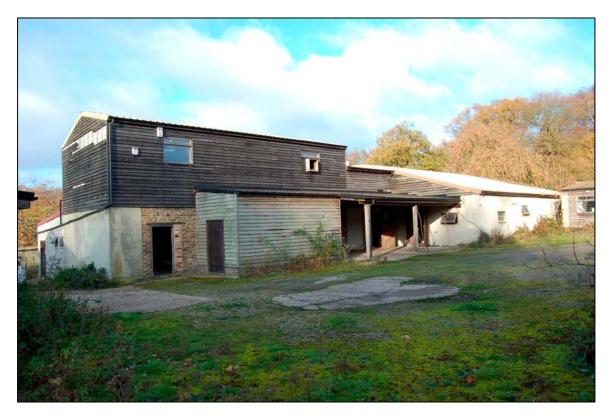
Plate 8 Building 3 and modern structures viewed to west

A second, post WW II structure stands on the west side of the farmyard, roughly where the farmyard shelter shed once stood (plate 8). This building was extensively modified when the farm was converted by extending the building to the north and adding a second floor. In addition, the warehouse was built to the west and a shed and canopy to the east (plate 8). The original eastern doorway has been narrowed from 1.2 to 0.9m.

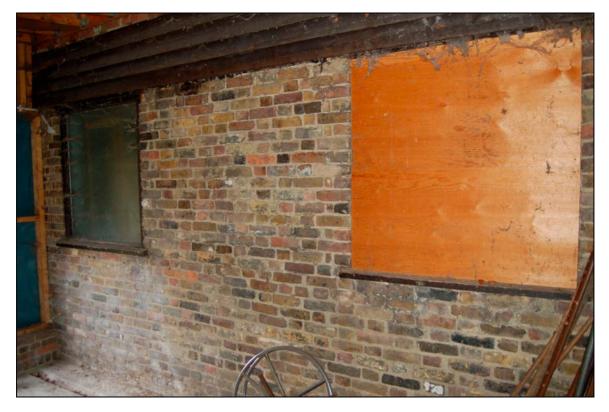
Plate 9 Detail of brickwork of building 3

Brickwork similar to building 2 can be seen on the east elevation beside the doorway and within the later shed (plate 9). The walls include a variety of hues and sizes derived from earlier brickworks structures, but are predominantly standard 9 inch yellow stock bricks. These walls are again built with cement but in this case appear to have been built directly onto an earlier lime/concrete floor perhaps contemporary with the farm, rather than with proper foundations. All windows are modern and there is no sign of earlier apertures.

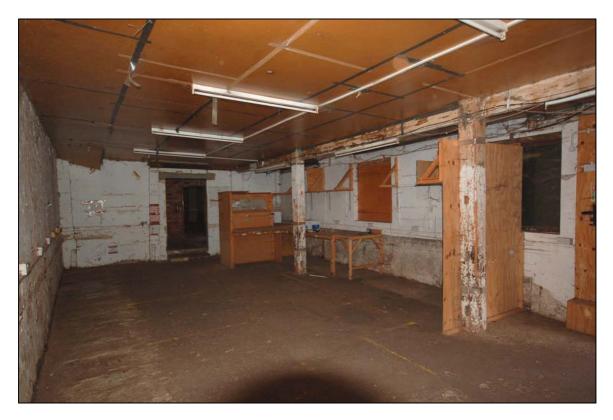
Plate 10 Interior of building 3 viewed to north

The interior is whitewashed and the modern first floor partly supported on long oak planks and posts that have sockets for railings and are therefore likely to have been reused from the 19th-century shelter shed (plate 10). There are no other significant features.

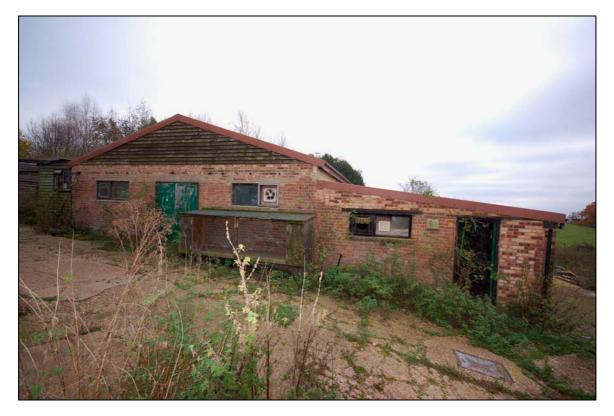
Plate 11 Dairy building 4 viewed to east

Two large cow doors on the north elevation provide access into the dairy. These are flanked by plain windows, one of which has a later fan inserted into it. Some of the side windows have been blocked. The gable has been rebuilt with a modern steel roof (plate 11). Inside (plate 13) the concrete floors slope to a wide gully in the centre. All the stalls have been removed and a ceiling added.

Next door the lean-to roofline has also been altered and the southern corner rebuilt (plate 11). Inside the cattle area is screened by a concrete block wall onto a side passage (plate 14).
