**MANOR FARM  
CHURCH LANE, BARHAM  
SUFFOLK**

**LEVEL II HISTORIC BUILDING RECORD**

December 2010

Document Ref.	2182rep
Report Issue Date	December 2010
Circulation	Wincer Kievenaar Chartered Architects
	SCCAS Conservation Team
	Mid Suffolk District Council

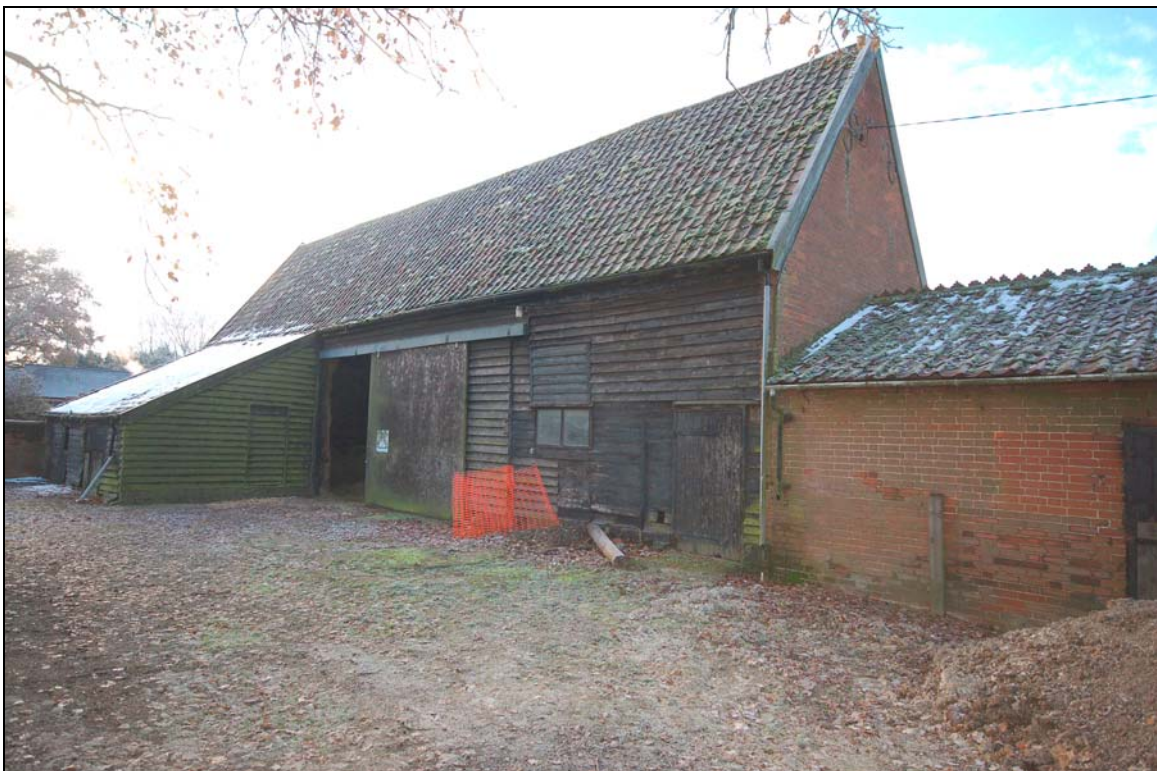
Plate 2 Barn, lean-to and cow house viewed to south

The main elevation is on the **east side**, facing onto the garden of Barham Manor (plate 2). Here the wall-framing is the most complete and clad in weather-board, a modern sliding doorway set across the midstrey. Boarding in the vicinity of the door has been replaced but older fabric survives on the northern bays, particularly around the door into the loft and the modern inserted window close by (plate 2), and covers an earlier mullion window which was seen internally (fig. 4a). At the opposite end, the external wall of the two southern bays is obscured by lean-to 2.

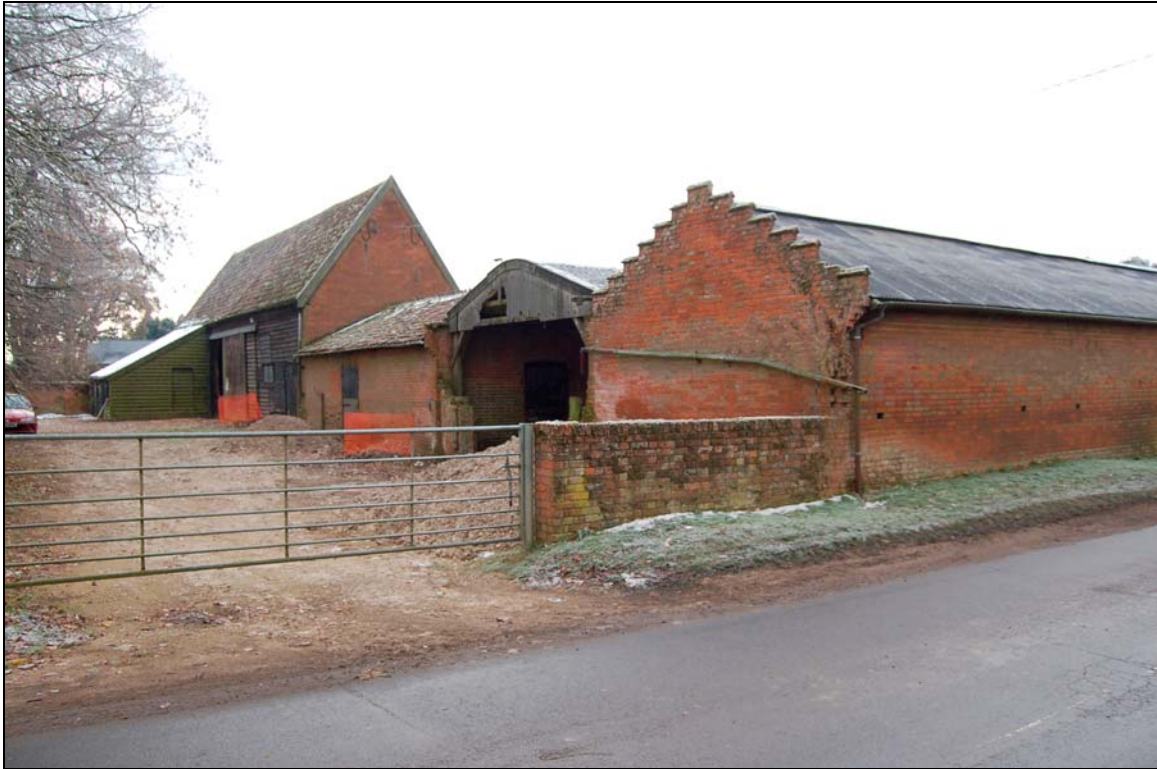
Plate 3 Farm group viewed to south from Church Road

The gable of the **north elevation** was rebuilt in brick in the 19th-century, probably when cowhouse 3 was built. Like all the later structures the bricks are of variable size and laid in monk bond, a variation on Flemish bond favoured in farm buildings. Two S-shaped tie plates brace the build onto the frame (plate 3).

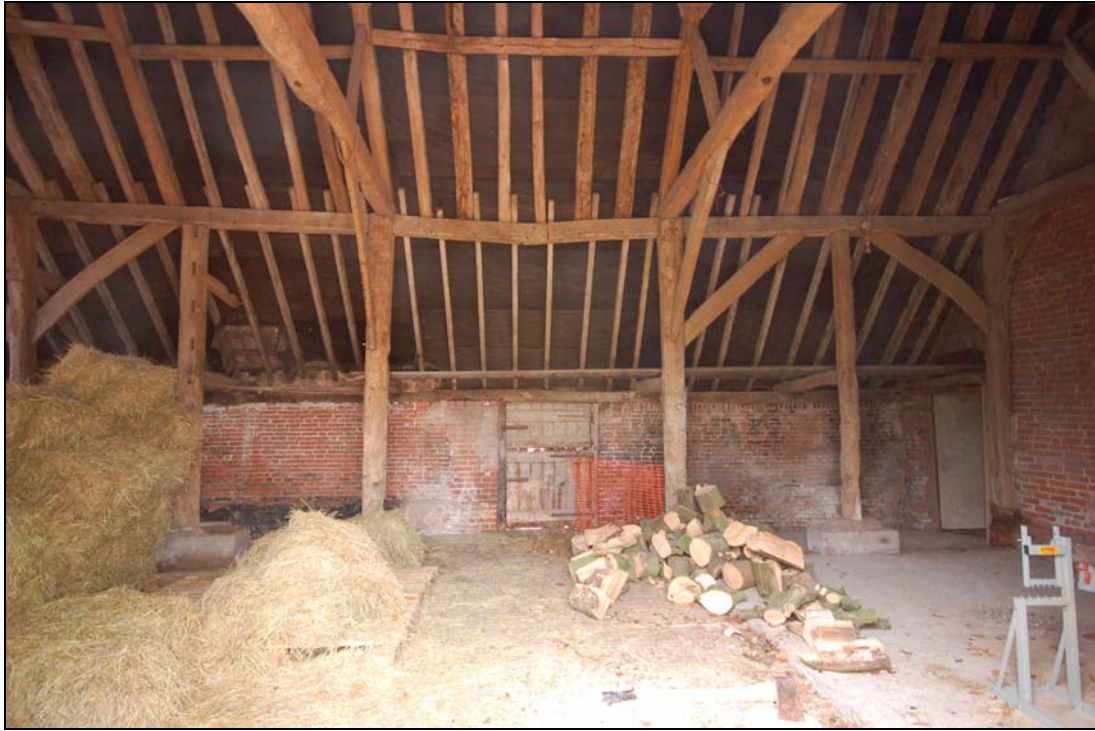
Plate 7 Midstrey and threshing floor viewed to west

**Main framing** appears to be mainly oak, consistent in scantling and fully-pegged. Heavy jowled posts define the bays, supporting the wall and aisle plates either side and the tie beams above. Most of the posts retain slightly-curved braces but some have been replaced by Victorian bolted knee braces. Straight-headed posts have been inserted in most of the wider bays at half-bay intervals, all of which are reused but carry the same aisle ties and braces as the bay posts, perhaps added to prop up the heavy roof when it was tiled. The aisle plate is reused and carries sockets for studs, though fewer than on the stud wall opposite. Counter-bladed scarf joints, a relatively late form, bind the aisle plates together in one or 1½ bay lengths. Most plates end on the jowl but the join over the aisle midstrey does not and as a consequence is failing (plate 7).

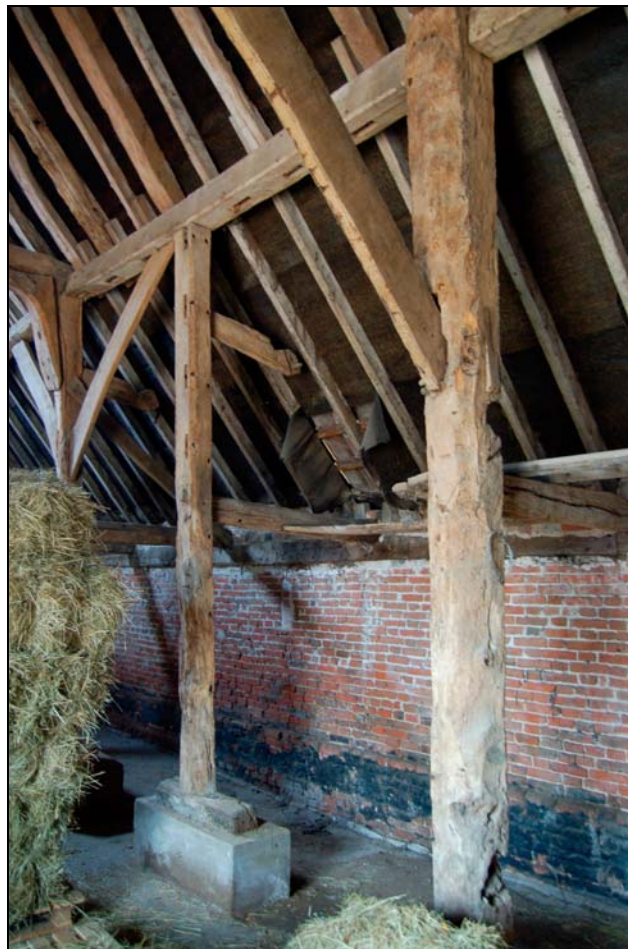
Plate 8 Aisle construction

**The aisle** appears contemporary with the primary build and is fully-pegged. The aisle ties appear contemporary and an aisle brace above tied the post and purlin together, though the aisle purlins were lost when the aisle roof was rebuilt (fig. 5, plate 8).

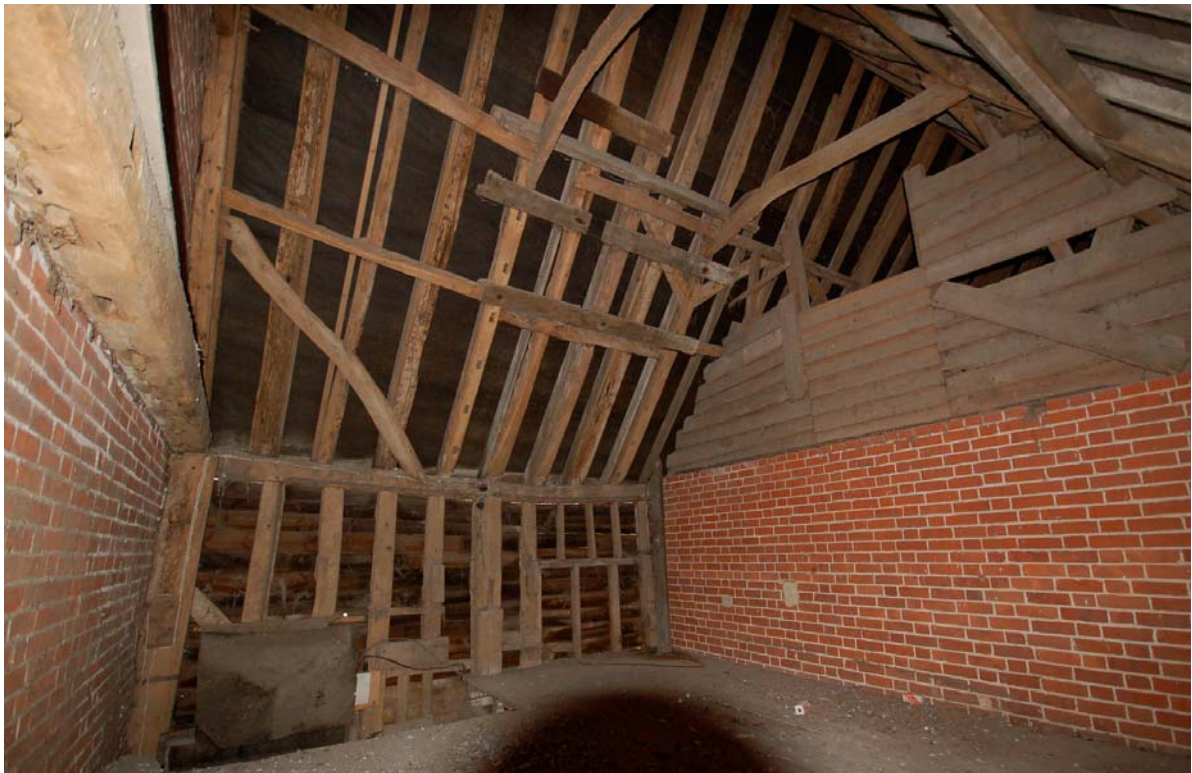
Plate 10 Hay loft

The **north bay** never contained an aisle but in the 19th century a corridor was built on its west side to connect the barn to the stock yard (fig. 4a, plate 11). Although the present loft (plate 10) is Victorian or later, a precursor loft was built integral to the barn judging from the pitching hatch in the T2 gable (plate 6) and presence of cut-outs and sockets in the jowl-heads for floor joists (plate 10). In latter use it appears the loft was lit by a crude window on the east wall (plate 10).

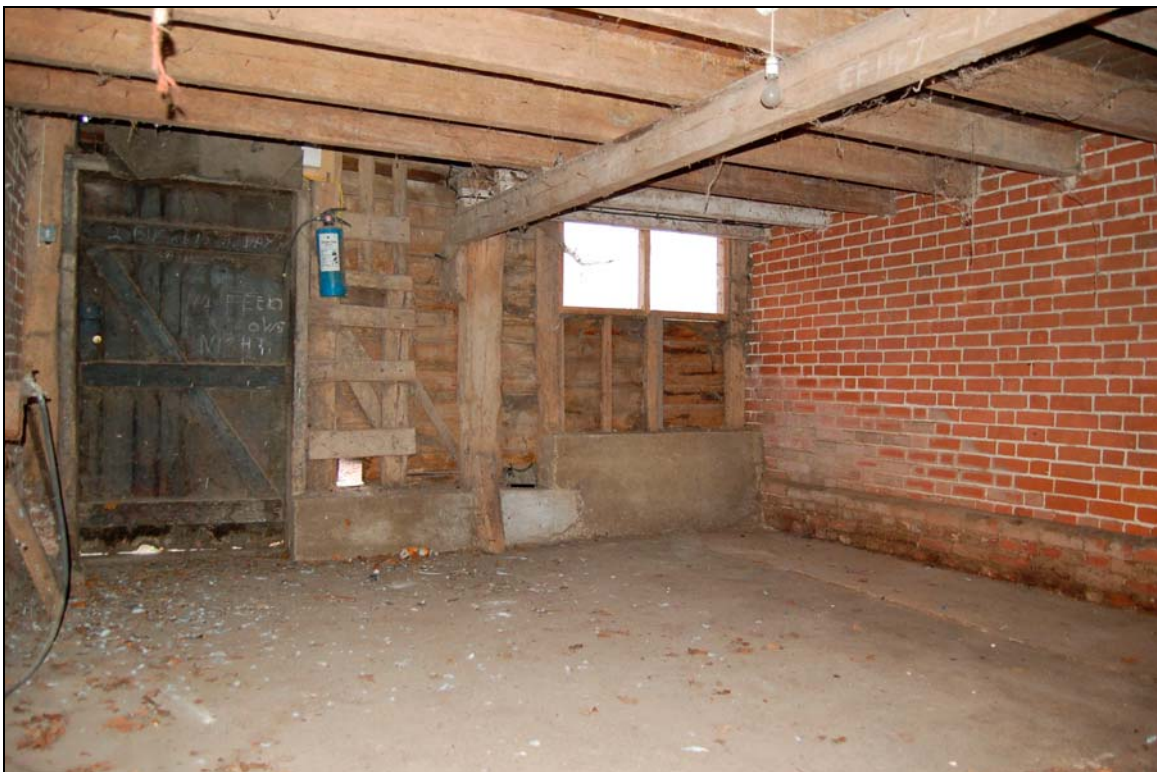
Plate 12 North bay beneath hay loft

On ground level, the fourth and fifth bays were divided off at T2 when the brick wall was inserted (plate 12), as the T1 wall plate soffit shows no sign of ever holding studwork. Studwork on the end north wall is entirely replaced in brick but the other walls in the end bay survive well and are in keeping with the main part of the barn (plate 12). One interesting feature is the remains of a heavy diamond mullion window behind the later addition of a loft ladder (plate 13).

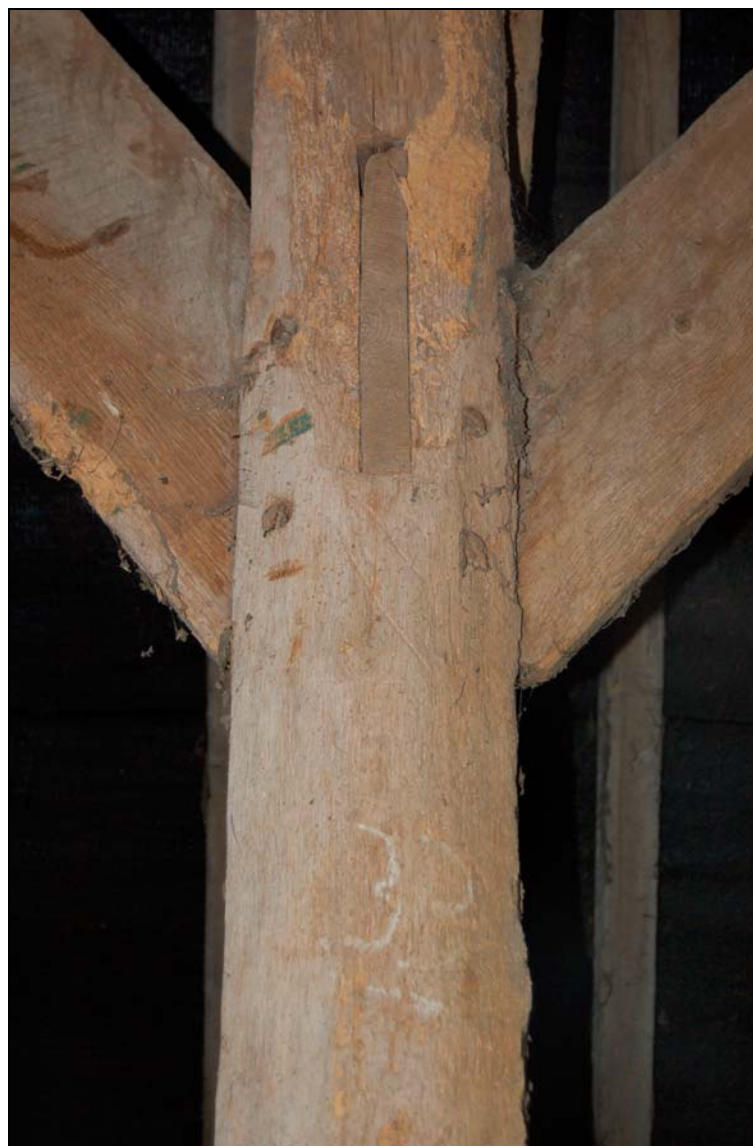
Plate 14 Scored carpenter's mark on T5 aisle post

**Carpenter's marks** are difficult to follow but tend to be scored onto the posts and 'tagged' on the western side (fig. 4a). Some of the braces have chisel marks, which are a later form of identification, suggesting some are replaced. A Roman 'I' has been scored over a scribed circle in T5 (plate 14). Their locations are shown on figure 4a.

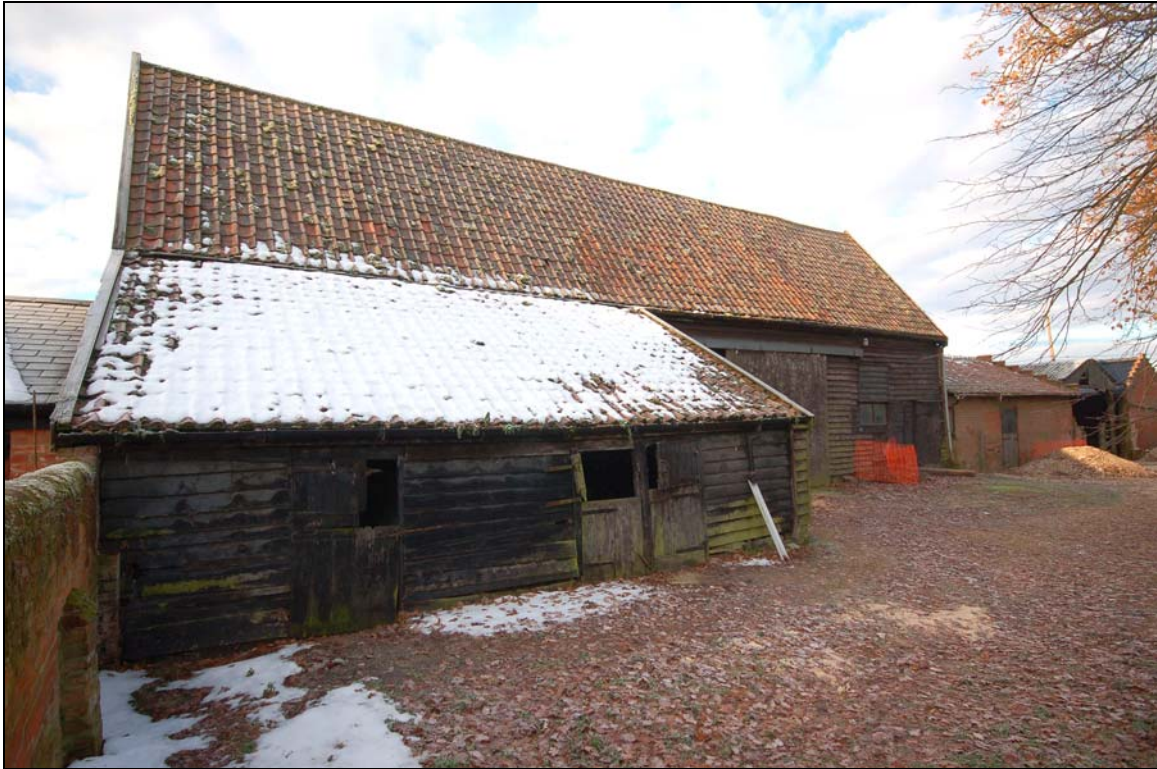
Plate 15 Lean-to and barn viewed to west

A timber-framed outshot (plate 15) is attached to the east side of the barn (fig. 1) that was probably built in the 19th century for pigs, but is now used as a wood store. The framing is narrower than that of the barn and the beams that divide the three bays are roughly-hewn and inconsistent in size. The exterior is weatherboarded and the half-heck doors at the front are rather decrepit. The north wall and roof are modern.

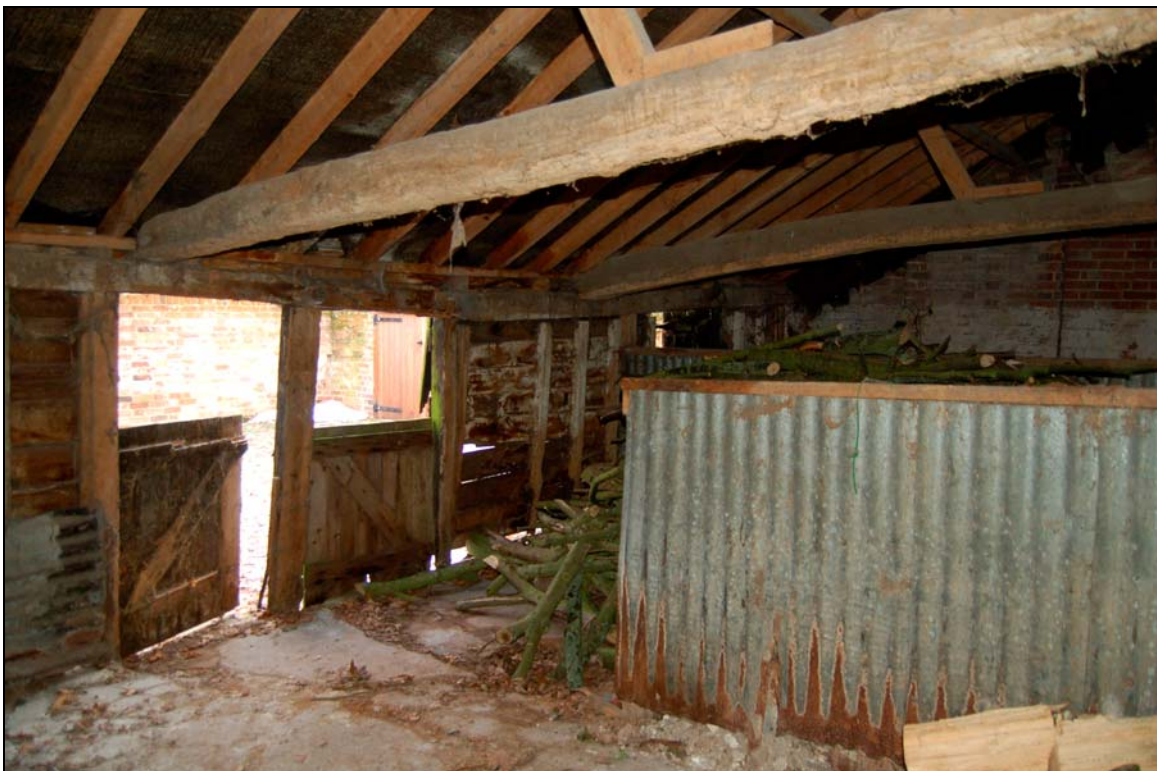
Plate 16 Lean-to interior viewed to east

The interior (plate 16) is divided into three stalls, now clad in corrugated iron and the concrete floor slopes down slightly towards the entrances at the front. On the south wall, which continues from the south wall of the barn, is the scar of an earlier outshot that is contemporary with the south wall of the barn and may feature on one of the historic maps. In the north-west corner are the remains of boards attached to the outside of the corner post of the midstrey that suggest there may have been a porch here originally.

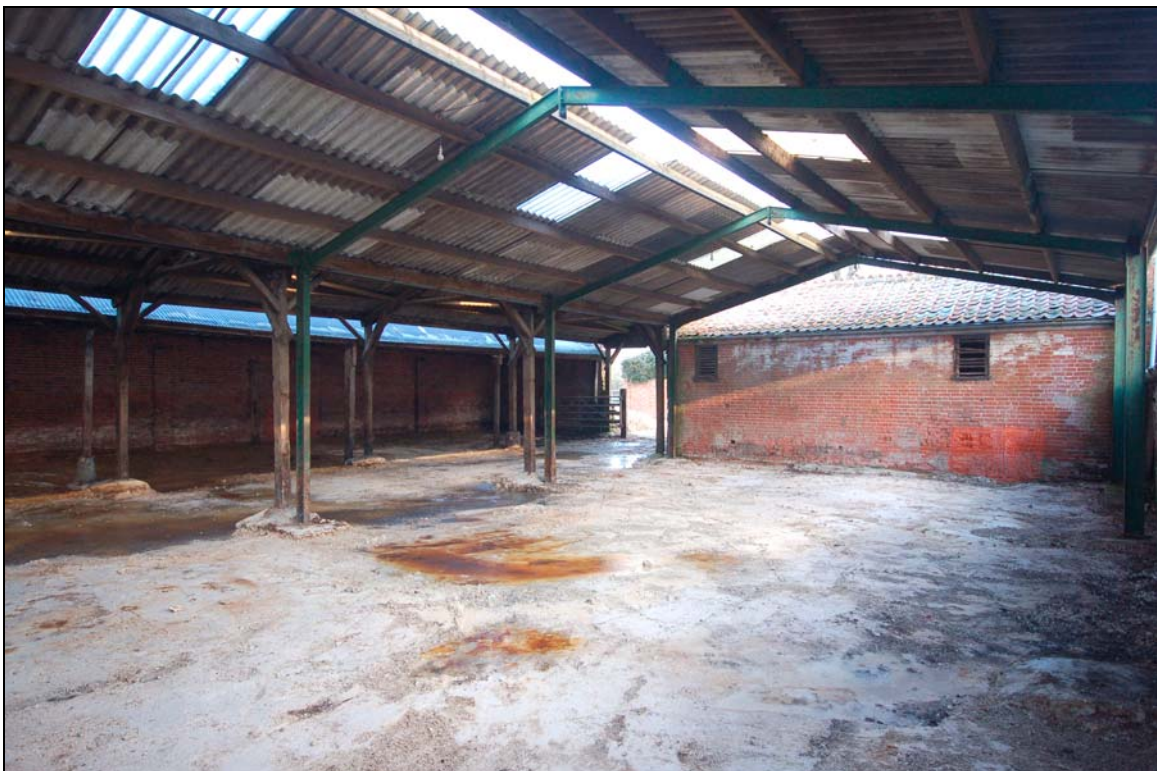
Plate 18 Covered stock yard viewed to east

Half-heck doors on the north and east elevations lead into each of two loose boxes inside. Over the north door is a stepped gable that is partially hidden by the modern yard entrance. Inside the yard, the west elevation contains two slatted air vents (fig. 4a, plate 18), which are a common feature of animal husbandry structures.

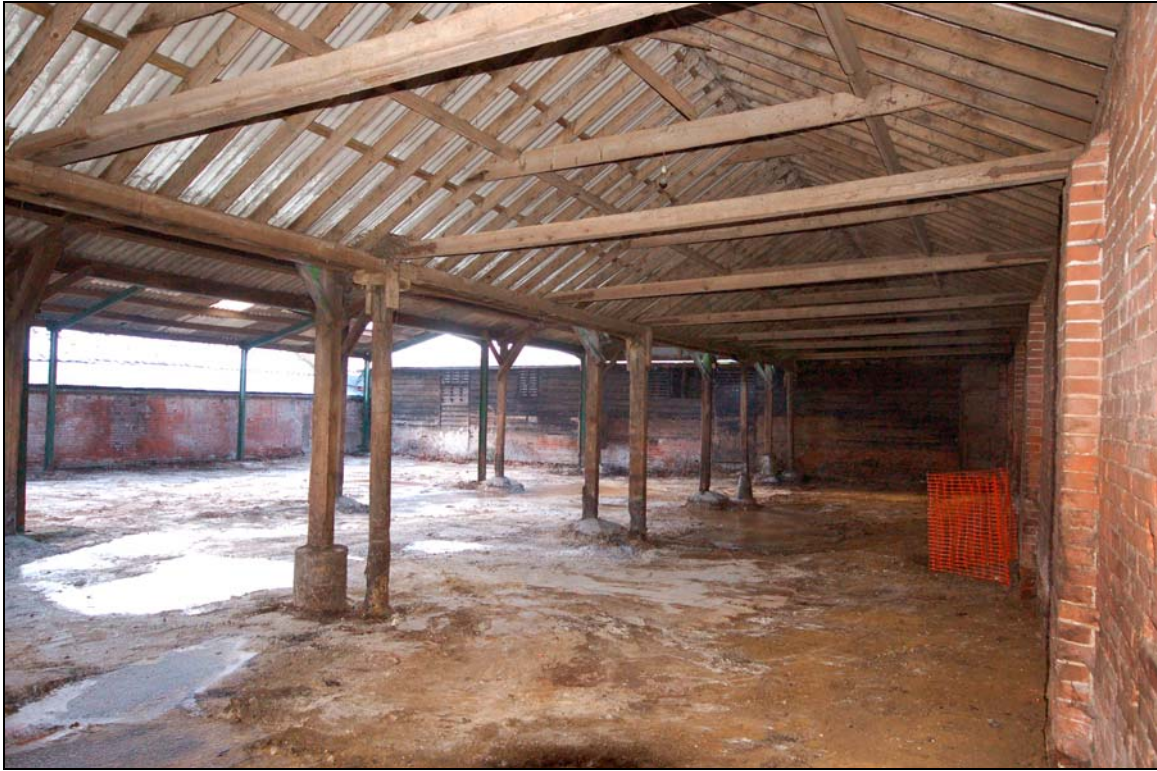
Plate 19 Interior of shelter shed viewed to west

The interior (plate 19) is divided into eight bays demarcated by strapped beams and basic nailed collars and purlins under a modern corrugated iron roof. Any earlier floor surfaces or other features were removed when the yard was cleared.

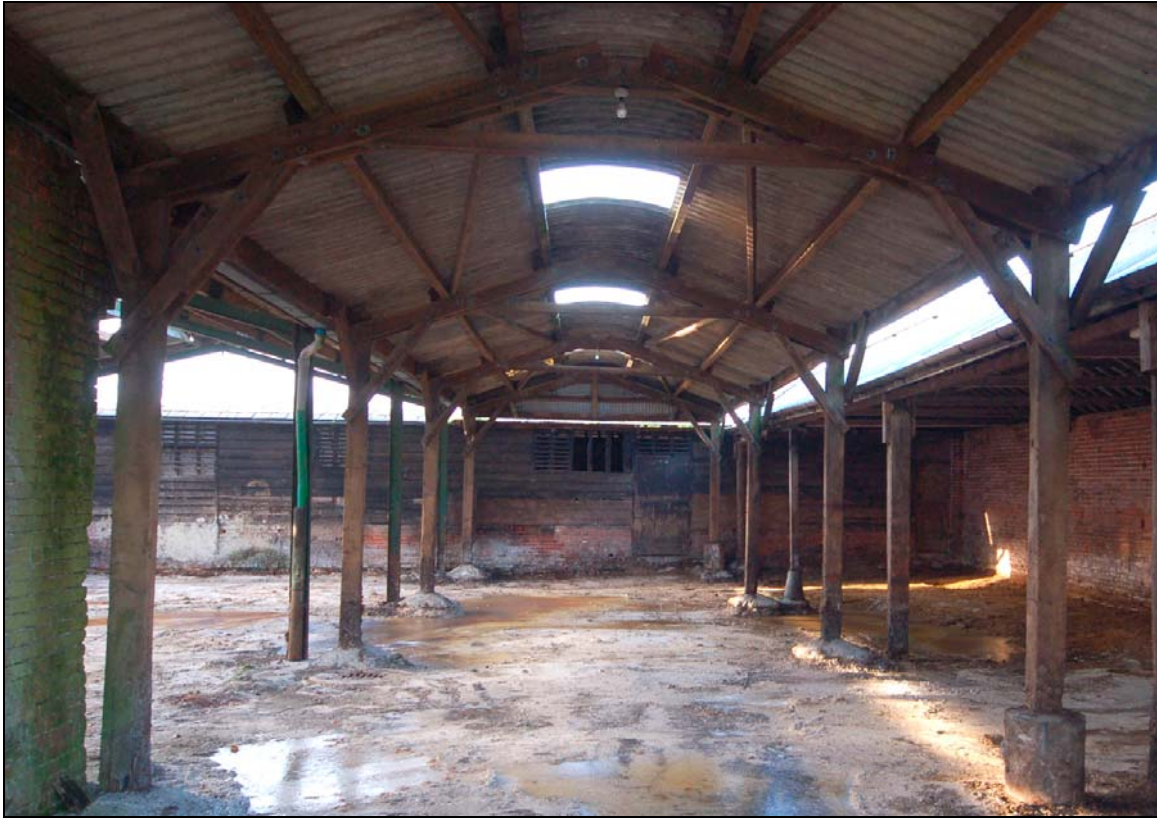
Plate 21 Stable viewed to west through covered yard

The stable is located in the north-west corner of the Victorian yard and retains some fixtures and fittings. While its walls along the road and farm entrance are of red brick, the wall facing onto the yard is built of timber, primary-braced with weatherboard cladding on a high brick plinth (plate 21) partly repaired in the modern era. Entry into the main stable area is gained from the yard by a half-heck door that has a slatted wooden vent above it and another to the south (fig. 4b). Further vents continue along the rest of the range (plate 21) but are beyond the scope of this survey.
