**ST ALBRIGHTS HOSPITAL  
(THE FORMER LEXDEN AND WINSTREE UNION WORKHOUSE)  
1 LONDON ROAD  
STANWAY  
COLCHESTER**

**HISTORIC BUILDING SURVEY**

**Essex County Council  
Field Archaeology Unit**

**April 2011**

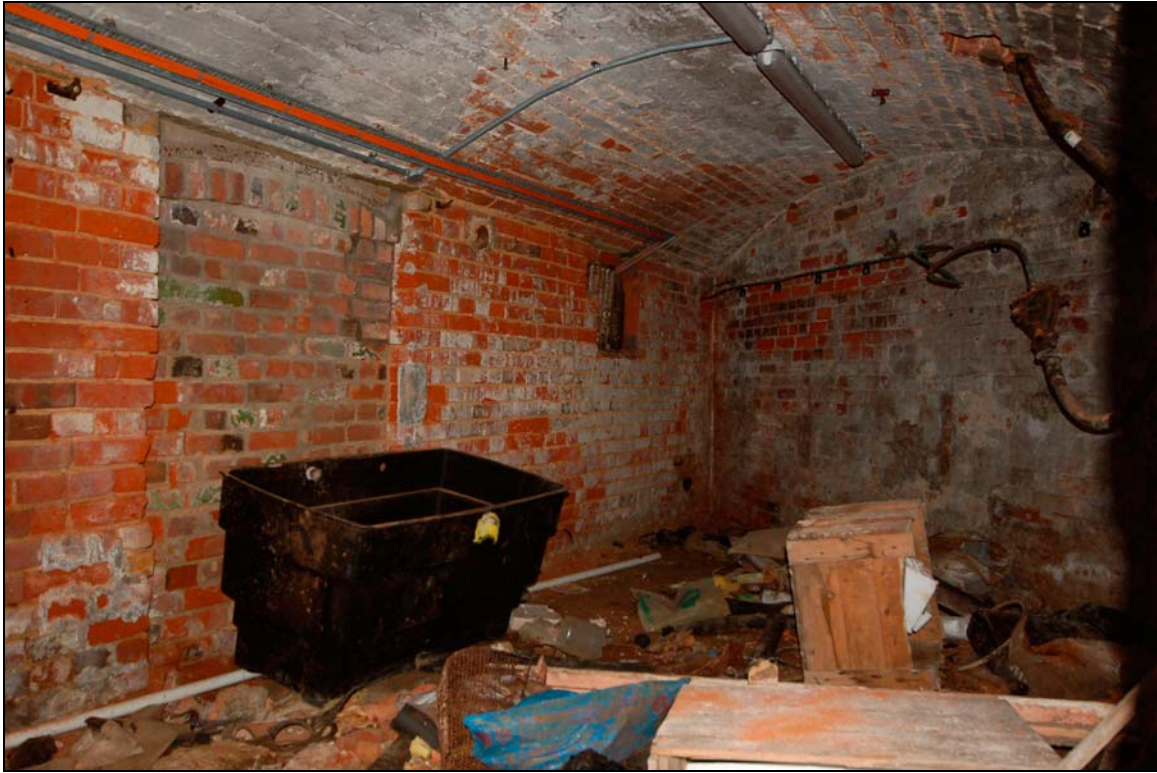
A basement exists under the hub, which is accessed from block C (fig. 9a). Stone stairs lead down into the interior, which comprises three rooms with a barrel-vaulted ceiling and red-painted bare brick walls. The interior contains modern boilers and pipework as well as an accumulation of assorted debris (plate 19). This was not included in the architect's survey and because of the poor conditions and low light levels no further recording took place

Plate 19 Basement underneath hub

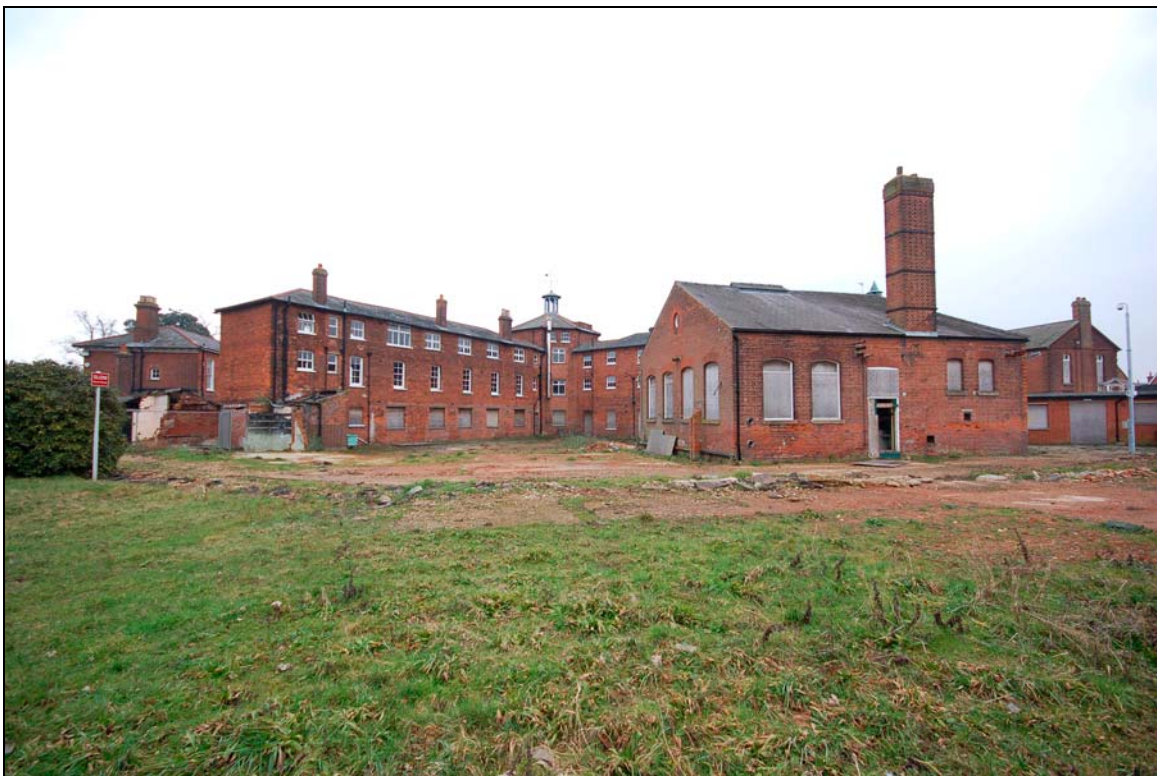
The north-east side of **block D** retains a small part of the former outbuilding range that was recently demolished after a fire (plate 24). Some of the windows have been replaced, although one original window remains on the ground floor, on the seventh bay. Two others are located on the first floor, on bays one and eight, the rest being refitted modern sashes. On the top floor, original windows occupy the sixth and eighth bays. Chimney stacks exist on this side between bays two and three and four and five, with another at the far end, suggesting there was at least three ground floor rooms originally.

Plate 24 West yard and laundry building viewed to east

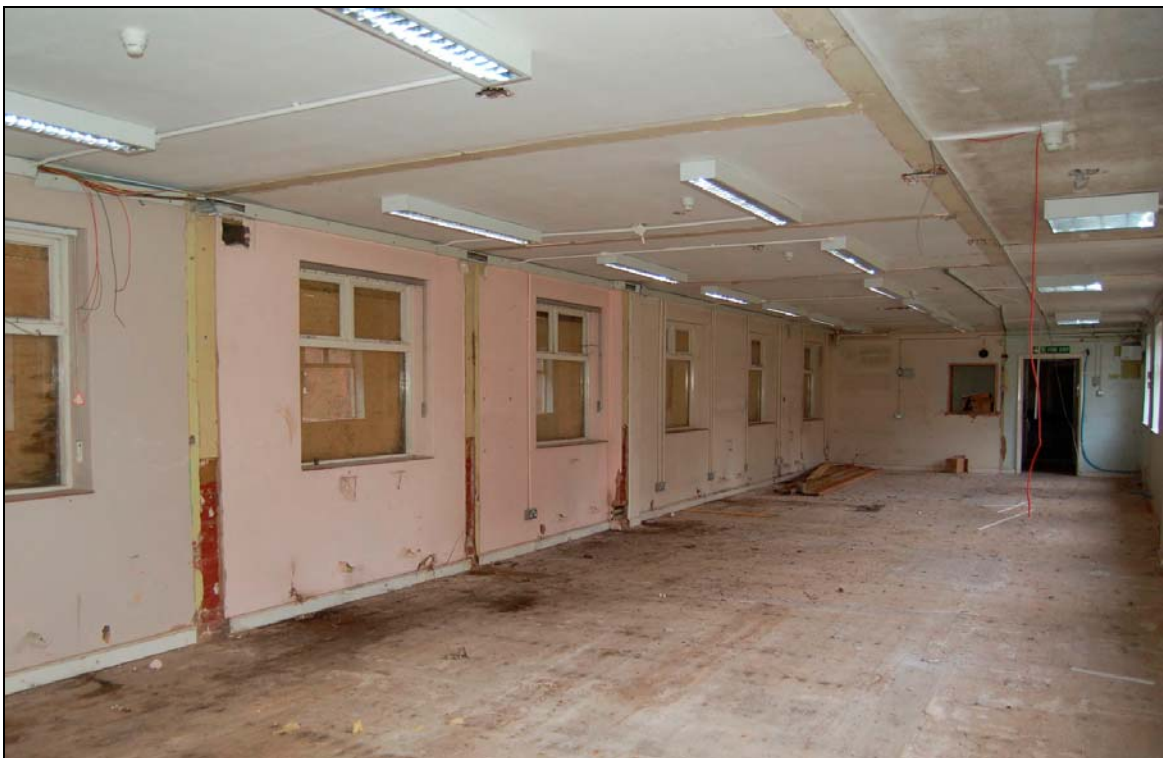
The ground floor of block C occupies one large room with the old ward partitions removed and 3½" pine floorboards exposed in the ceiling. The modern windows have tile sills. A hatch in the south-west wall (plate 28) shows where the original central doorway was, which was more fully observed in block D.

Plate 28 Block C, ground floor viewed to south

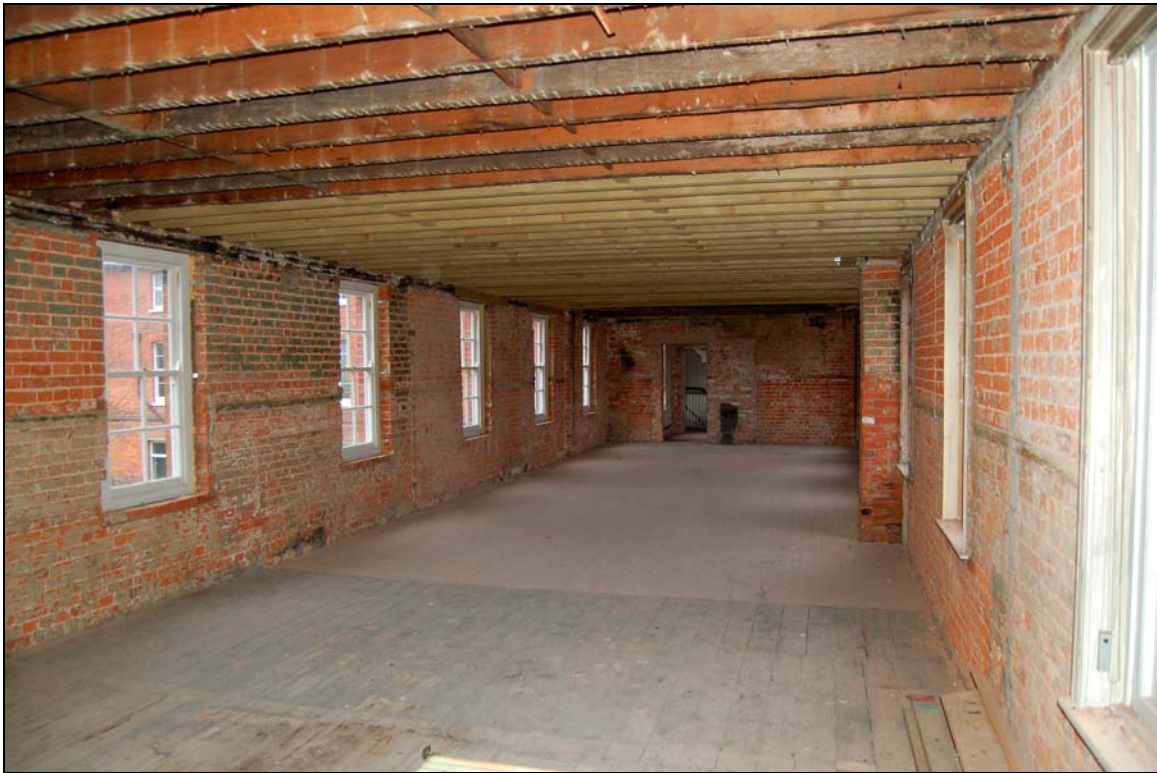
The first floor was stripped back to the brickwork after the fire, which has revealed a blocked central doorway into the main room (plate 36) but no further evidence of the original layout. A wooden rail set in the walls 1.4m above the floor provides evidence for a panelled interior of some sort, suggesting this was a room of some importance, perhaps the schoolroom or original chapel. Some traces of green paint were observed on the bare brick walls above, and it is worth noting that green was a common colour in Victorian institutions. This floor was refenestrated after the fire with modern sash windows.

Plate 36 Stripped-out first floor of block D, viewed to south-east

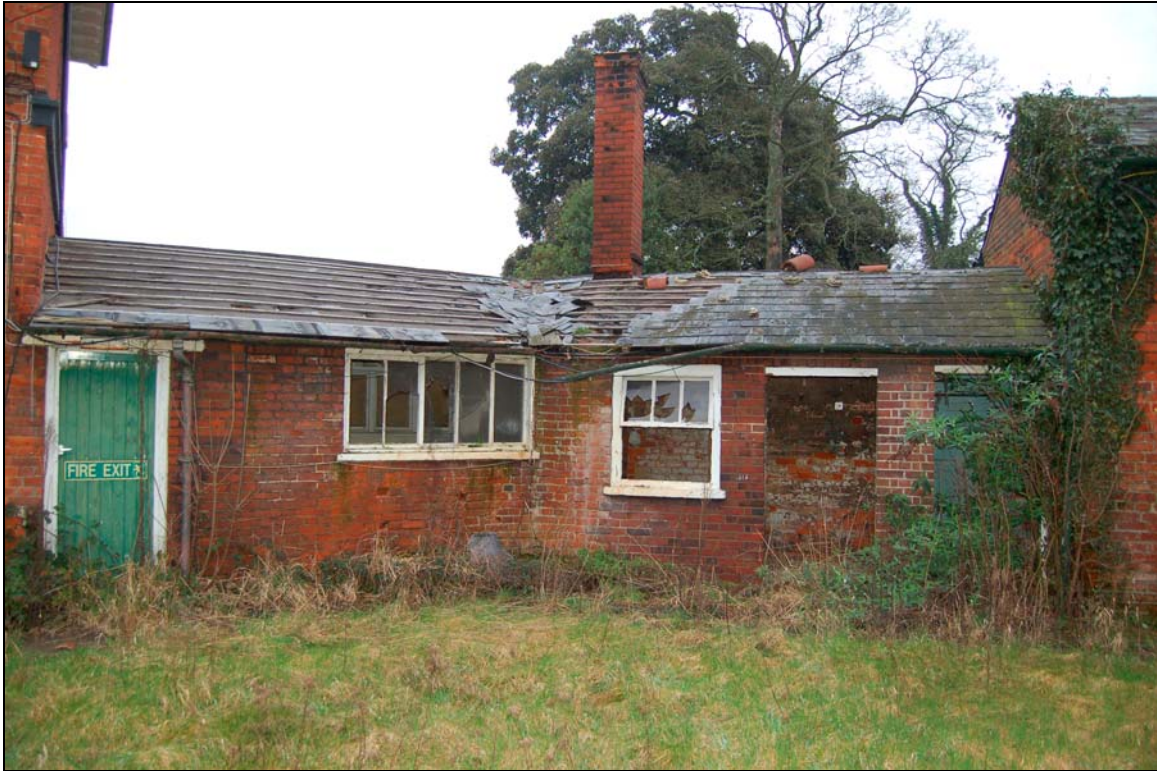
The south-west elevation is situated both sides of block C. The part in the north yard was largely inaccessible and in poor condition. The elevation (plate 39) shows doorways either side with a second doorway, leading into a small room (former WC). Both windows appear to be original, comprising a five-pane horizontal sliding sash and the standard vent window,

Plate 39 Outbuildings 3a viewed in north yard

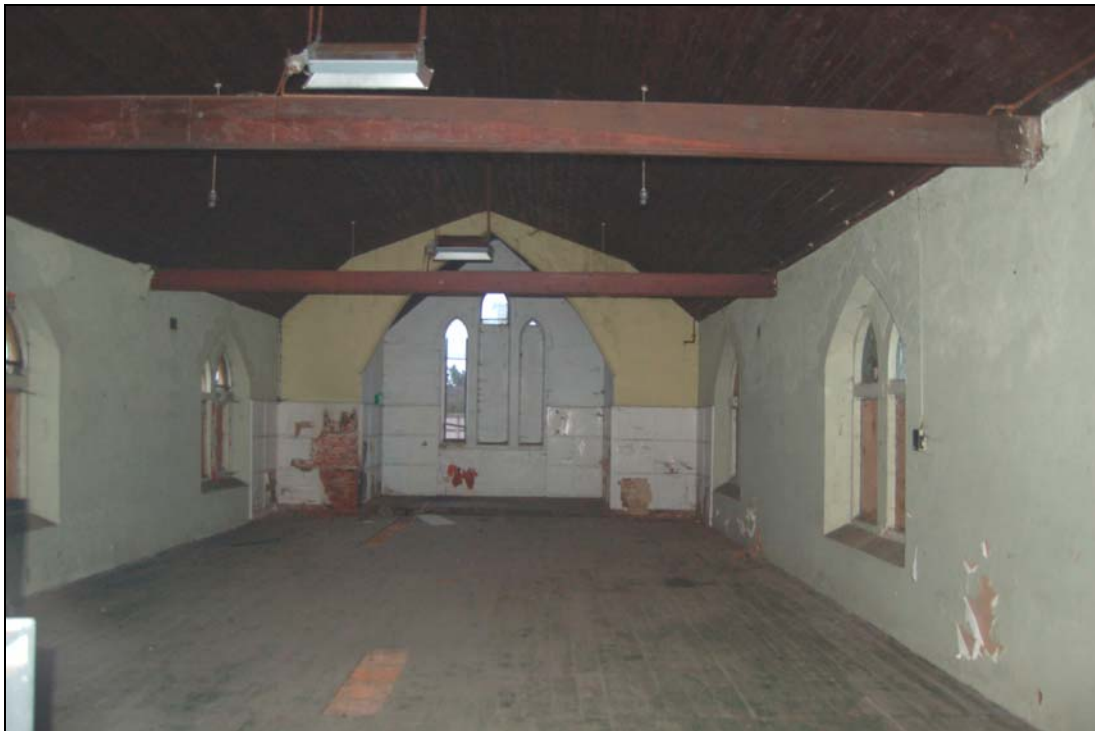
Entry is by a doorway set under a pointed arch at the west end. The floor is boarded and raised at the chancel end, where there is a chamfered pointed arch and also some square panelling (plate 58), partly fire-damaged. Vertical panelling survives in the north-west corner along with a coat rail. There is no other evidence of panelling and the rest of the interior is simply plastered. The windows have splayed reveals and sills and incised stonework around the heads (plate 59). The canted ceiling is built of stained pine boards and remains intact, divided by wooden tie beams.

Plate 58 Interior of chapel viewed to east

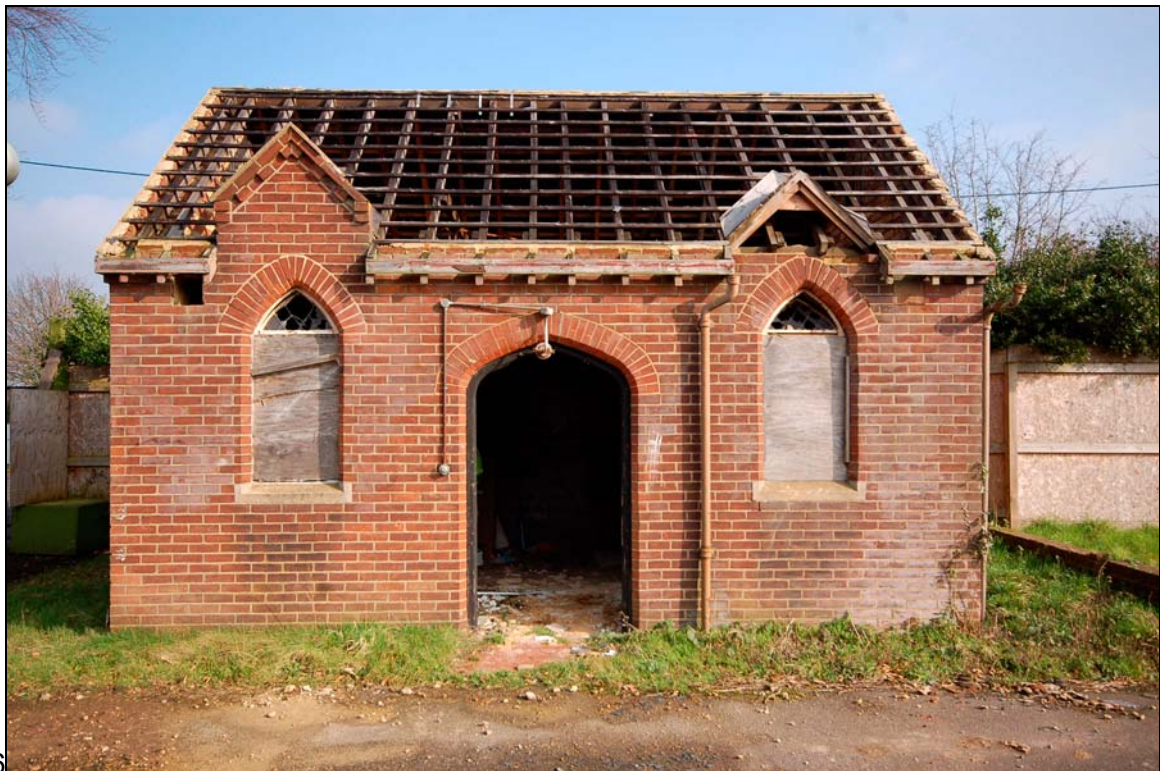
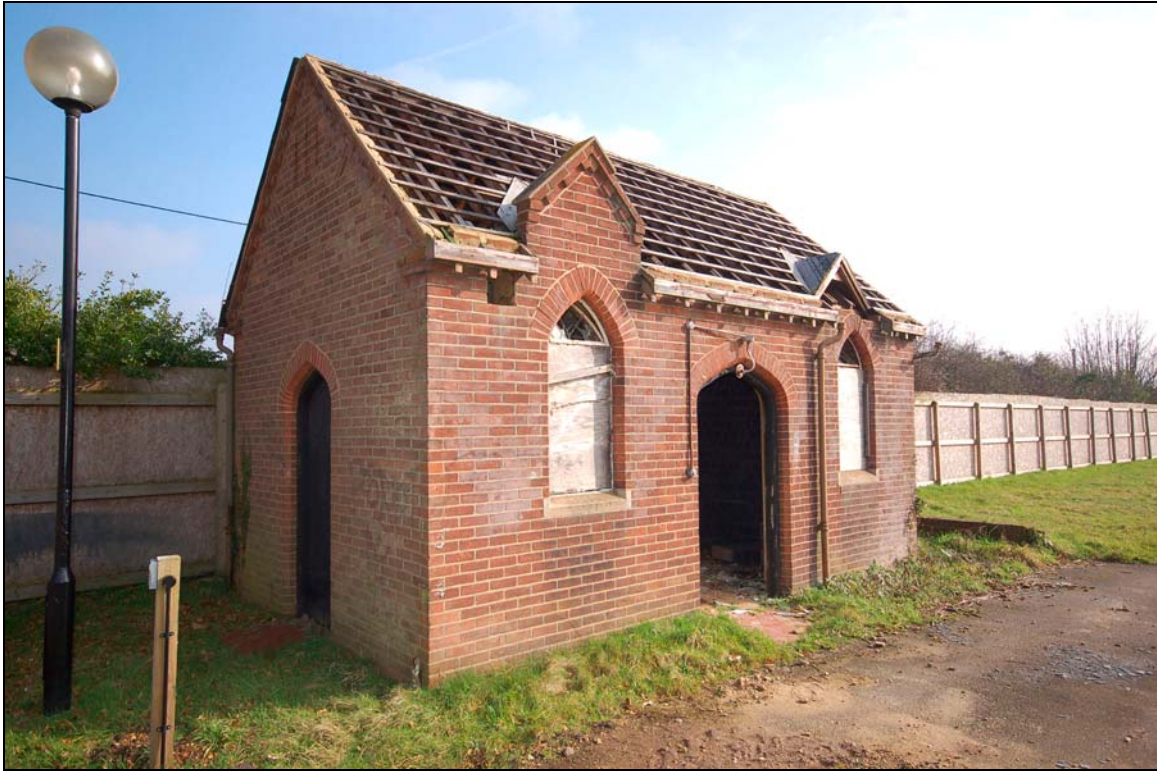
The original mortuary to the east of the workhouse (Morrison 1994) was replaced in the 1920s or 30s by a single-storey brown brick building, built in stretcher bond with vented gabled ends and a slate roof (that has been severely ransacked, plates 64 & 65). It is lit by two pointed leaded windows to the east and west, with codestone sills and brick arches and gablets rising above eaves level. There was a double doorway with a Tudor-arched head on the main west side that lead into the mortuary room, and a side entrance to the north which is largely intact, that led into the chapel (plate 65).

Plate 64 Mortuary viewed to east

Plate 65 Mortuary viewed to south-east
