All Saints' Church, Caddington, Bedfordshire.

Report No.1037

| Nature of work: | Building of a kitchenette, WC, meeting room and an external drain run | Present land use: | Church and churchyard |
| Project type, methods etc. | Monitoring and Recording | Archive Recipient: | Luton Museum |

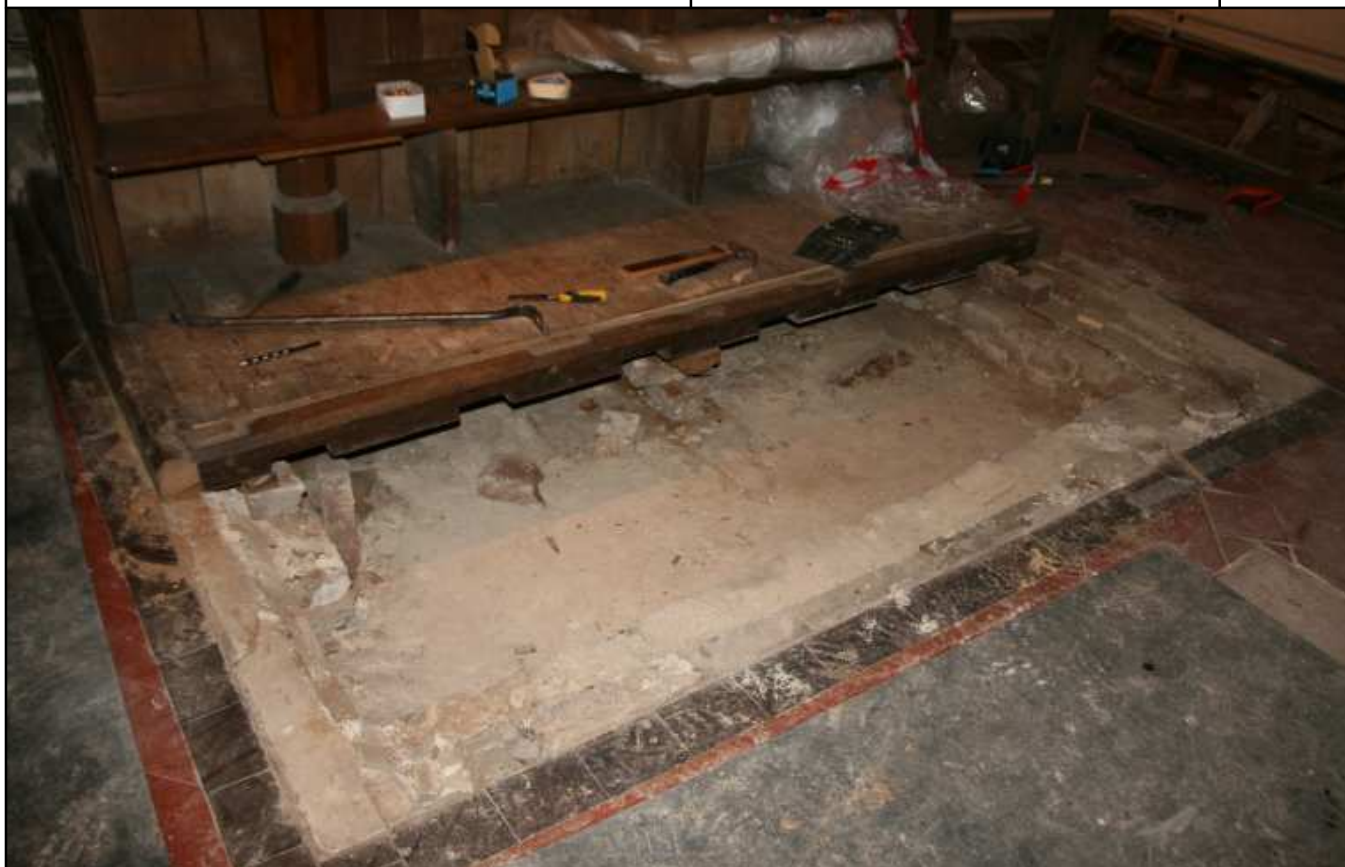
The groundworks programme included internal and external works (Figure 2). The internal works involved the excavation of three pad foundations (Test-pits 1-3), following the removal of pews within the footprint of the new construction (Plate1); the external works involved the excavation of a drainage trench to connect the new construction in the north-west corner of the church to existing services on Collings Wells Close to the north-west of the church.

Plate 1: Removal of the pews, looking north-west

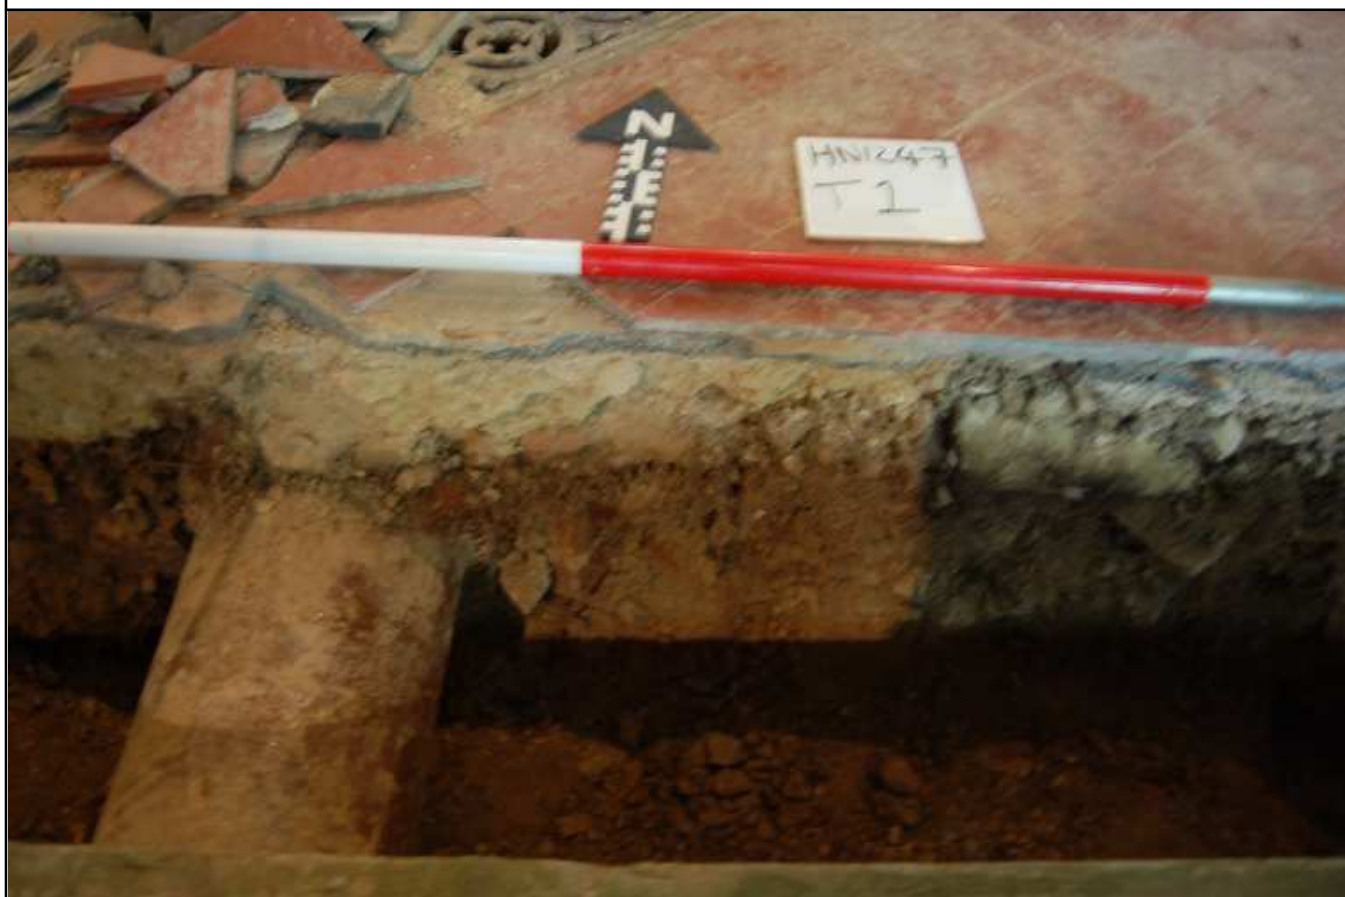
Test-pit 1 (Plate 2) was located in the north-west corner of the north aisle, between two pillars, and measured 2.8m in length, 0.4m in width and approximately 0.5m in depth. Test pit 2 (Plate 3) was located approximately 1m to the north-east of Test-pit 1 and measured 0.6m in length, 0.5m in width and approximately 0.60m in depth. Test-pit 3 (Plate 4) was located approximately 0.5m to the north-east of Test-pit 2 and measured 0.6m by 0.6m approximately 0.60m in depth. All three test-pits revealed the same stratigraphy, comprising a mixed rubble and stone make up layer for the existing floor surface, over 0.6m deep. Test pit 1 had a rubble and mortar layer, 0.2m thick overlying this.

Plate 2: Test pit 1, looking north

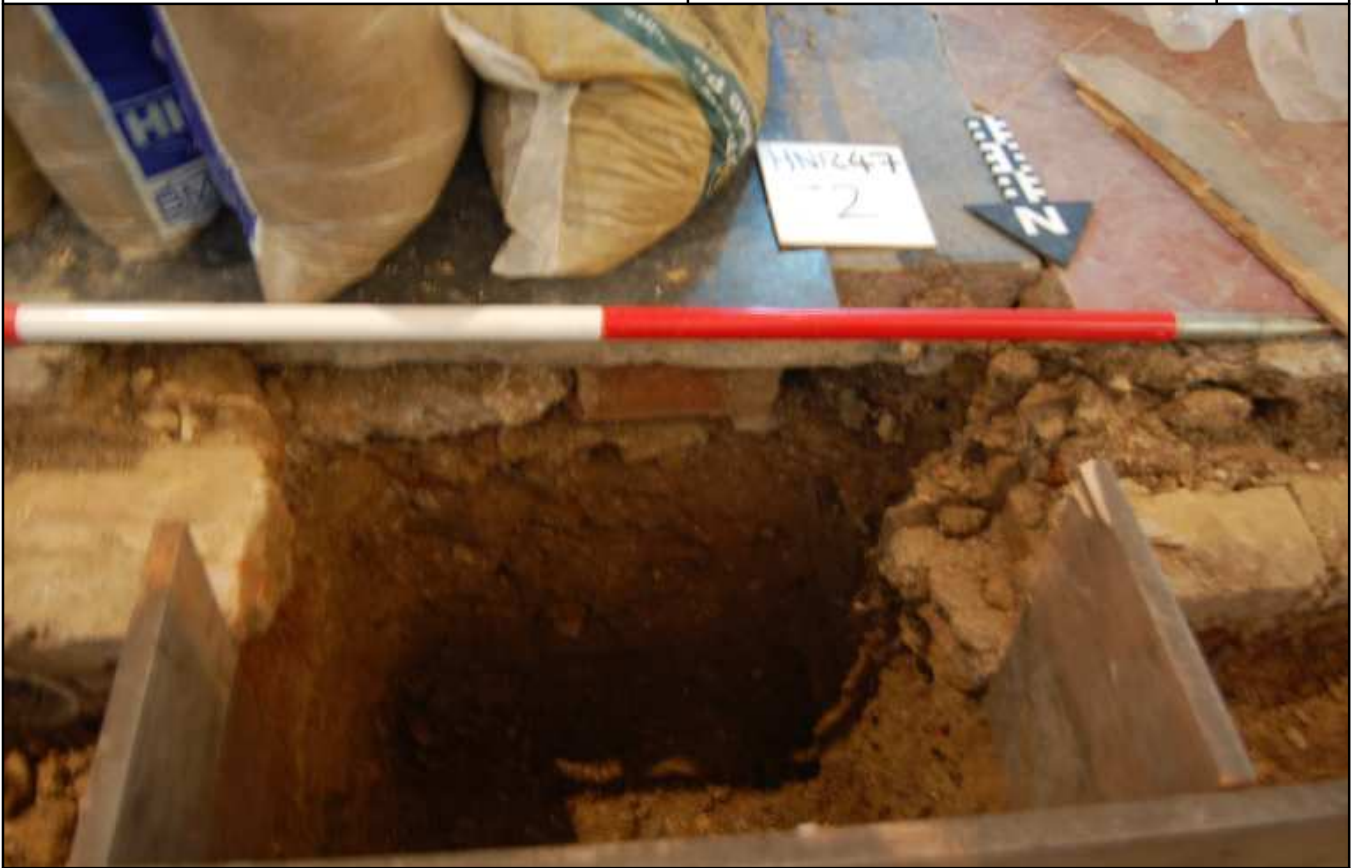
Plate 3: Test pit 2, looking south

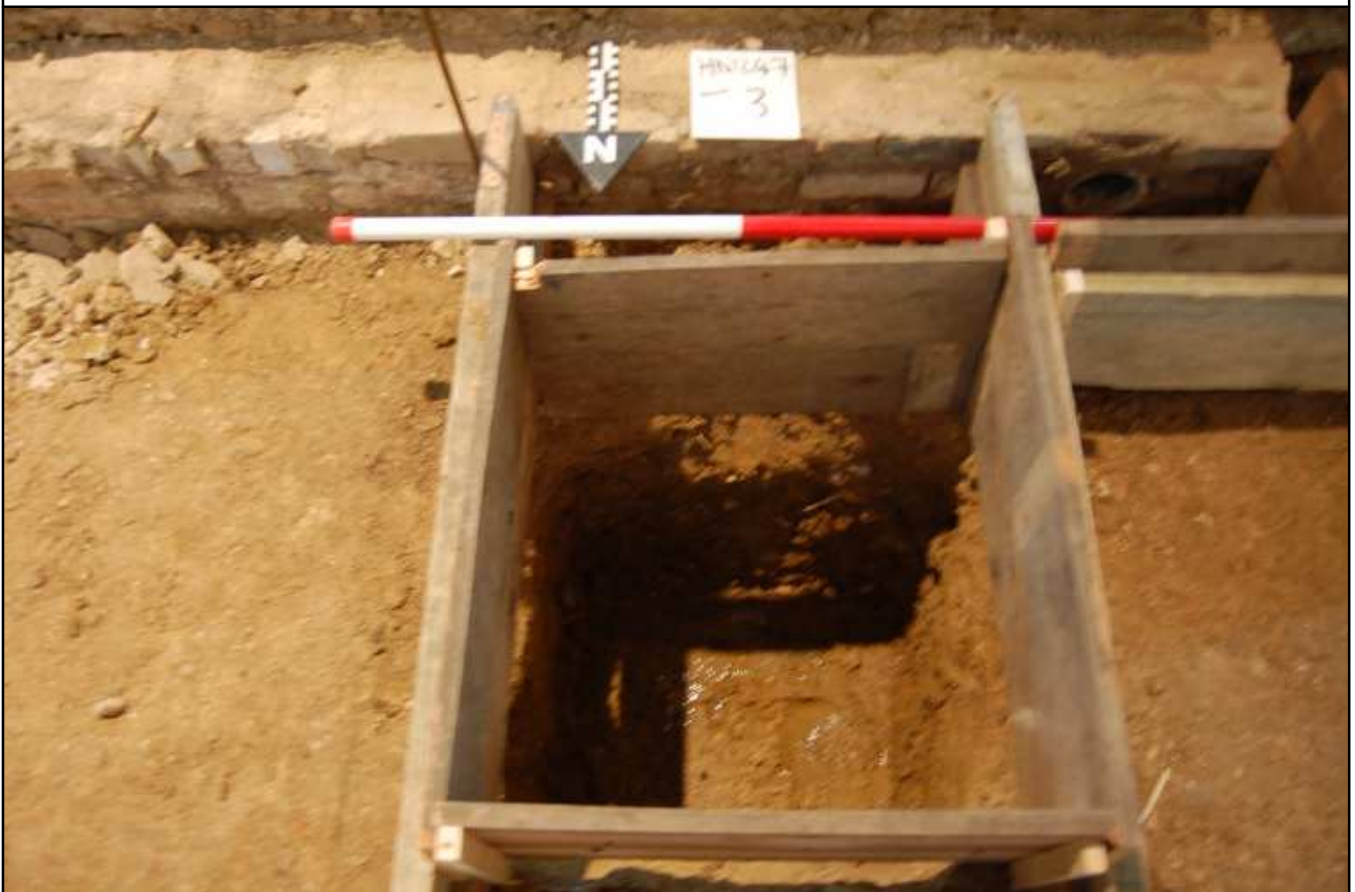
Several fragments of disarticulated human bone were recovered during the excavation of Test-pit 3. The remains were handed to the vicar for reburial. The risk of encountering disarticulated human bone was expected and no articulated remains were exposed.

Plate 4: Test pit 3, looking south

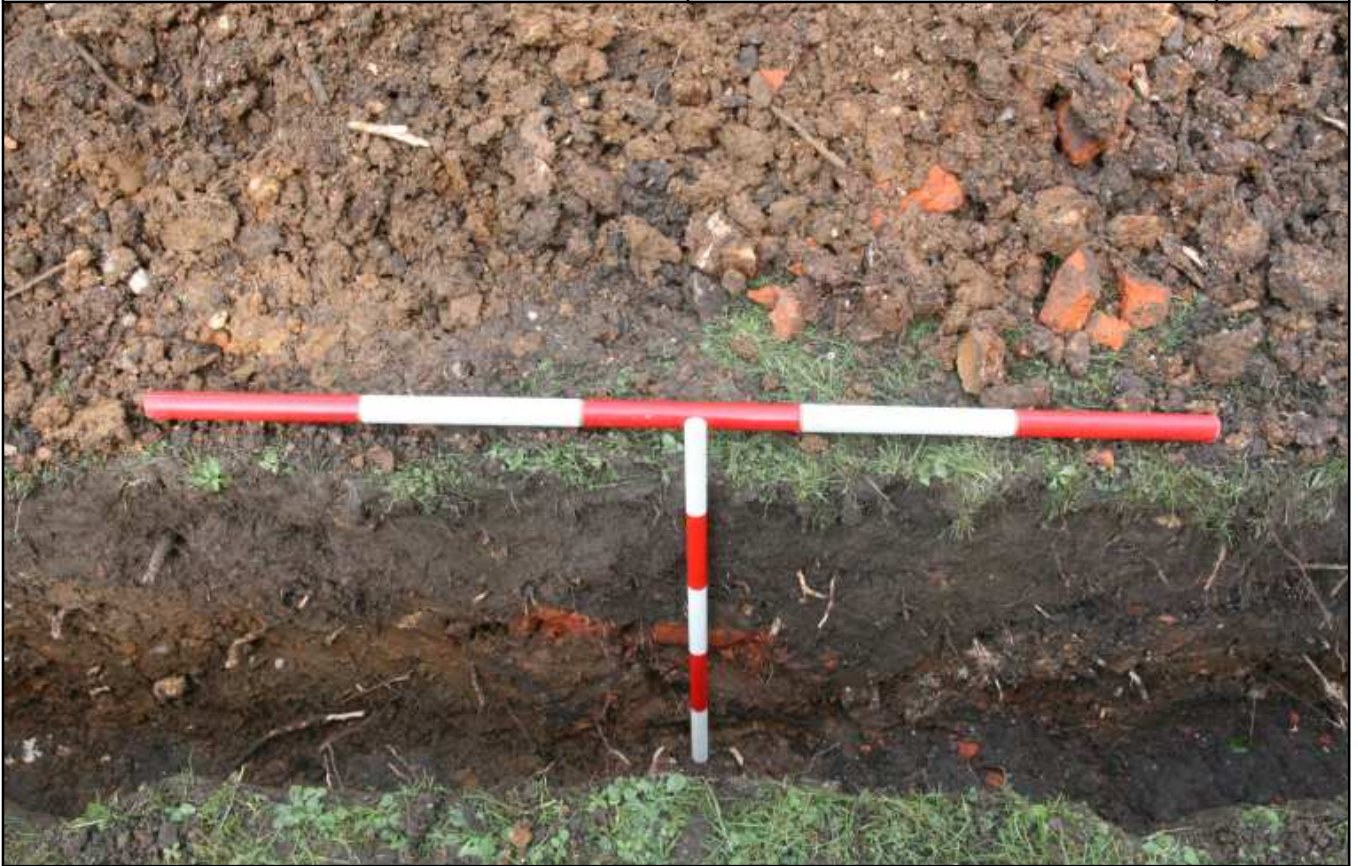
The drainage trench was approximately 28m in length with a width of 0.5m and a depth of 0.4m. The stratigraphy in the trench was uniform, consisting of a black (10YR 2/1), soft silty clay topsoil overlying a yellowish brown (10YR 5/8) soft, sandy clay subsoil. At the north-west corner of the site the drainage trench cut through a bank defining the edge of the churchyard, which consisted of a disturbed topsoil and a redeposited natural containing modern material.

Plate 5: Section of drainage trench, looking north-west

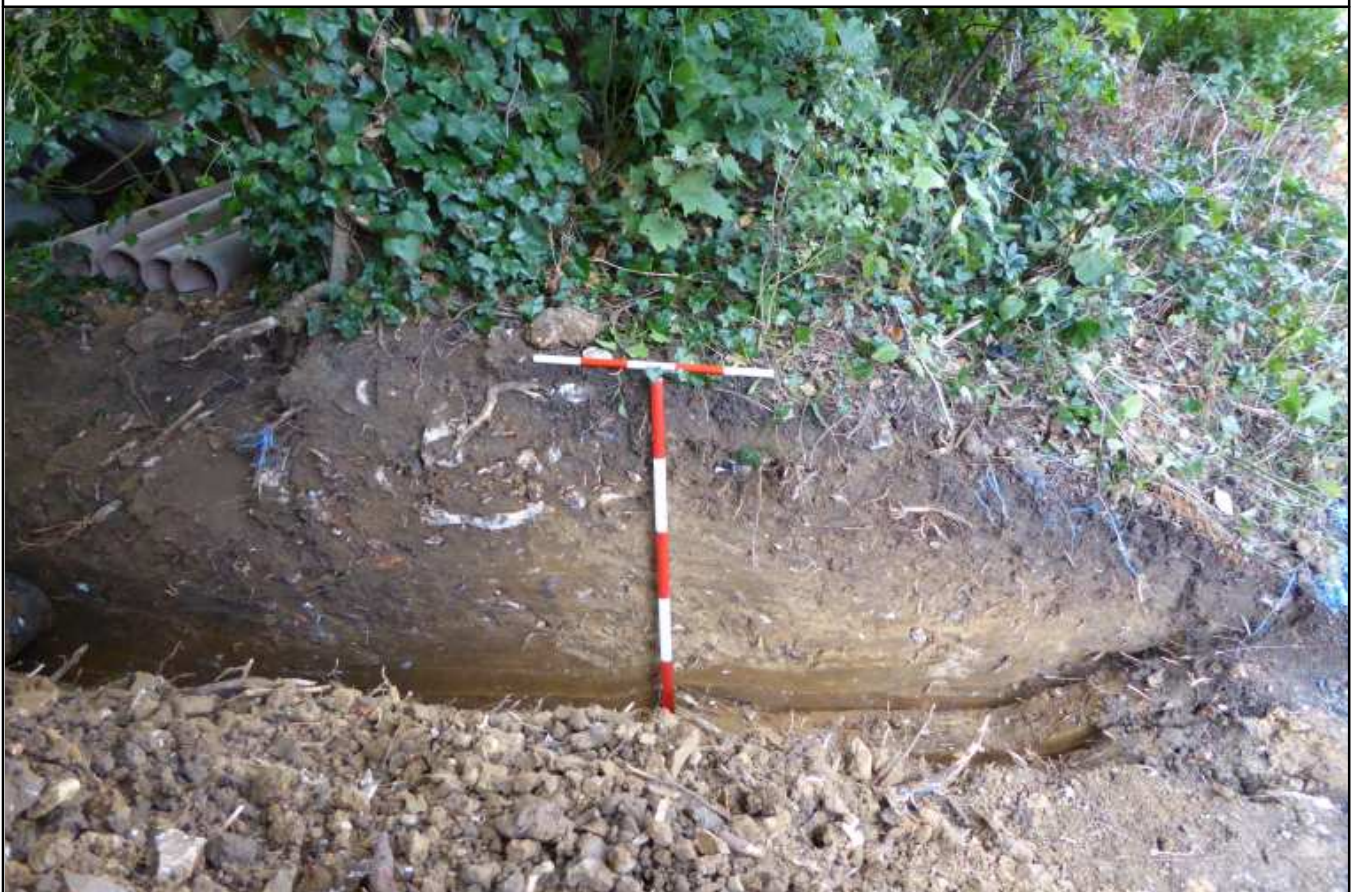
Plate 6: Section of bank at site boundary, looking north-east

The bank is formed of very compact light yellowish brown silty clay with occasional flint and chalk inclusions which appears to represent a redeposited natural. To the south of this, topsoil has built up, providing bedding for sycamore, holly and other trees that demarcate the boundary. Within the topsoil were fragments and whole bricks, and other modern items including a fragment of bone china and a plastic bowl (!). No clear debris for the bank itself was observed.
