**'FANCY HALL'**  
**7 Church Street, Buntingford, Herts.**

HN1366

***HISTORIC  
BUILDING RECORD  
& ARCHAEOLOGICAL  
MONITORING***

Report no. 1175

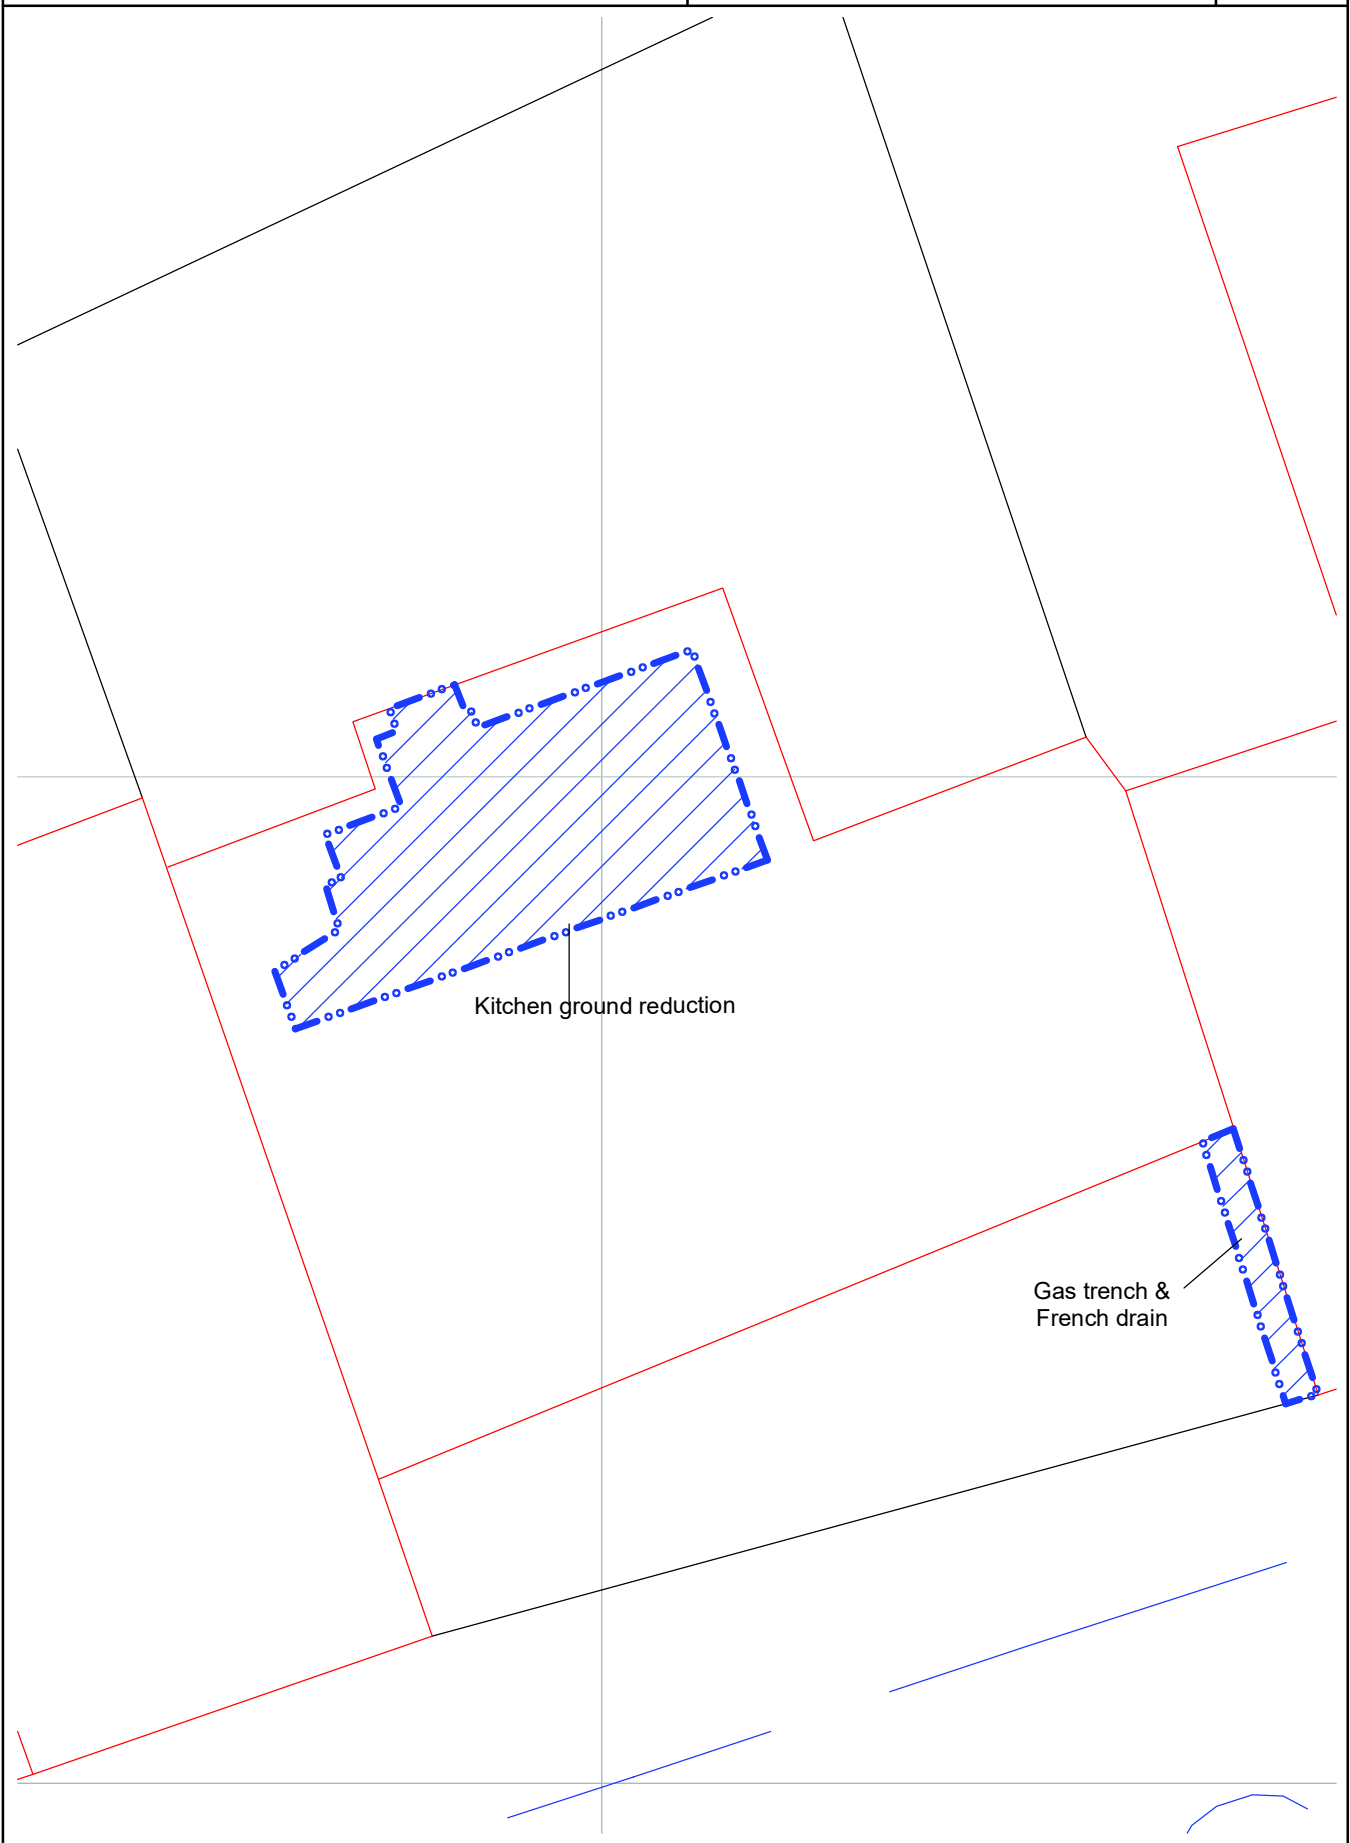
Figure 5

**3.47** Ground reduction within the kitchen covered an area with a maximum length of 5m and a maximum width of 2.7m (Figure 5). This area was reduced by 0.33m, revealing a general stratigraphic sequence comprising concrete, 0.15m thick, above a layer of light greyish brown loose silty clay, 0.08m thick, with frequent brick fragments (Figure 6, Section B, Plate 26). This overlay the natural reddish brown firm sandy silty clay with occasional small flints and chalk fragments.

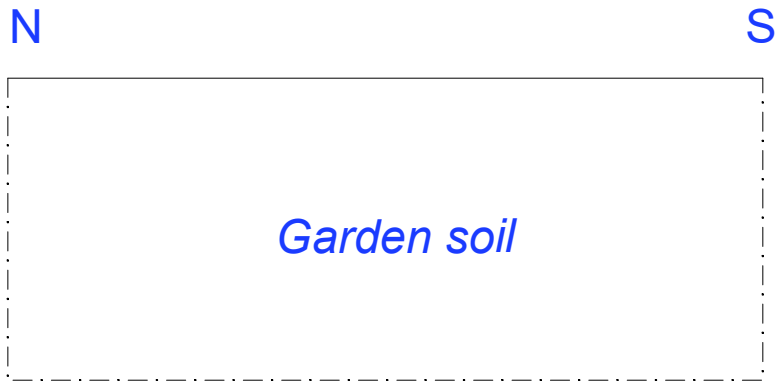
Section A: Gas and drainage trench - E facing section

and measured 2.8m in length, 0.40m in width and 0.40m in depth (Figure 5, Plate 25). The eastern section revealed the brick foundations to the neighbouring house, while the western section revealed a very dry, friable dark greyish brown silty clay garden soil with frequent rooting and tile, red brick and glass fragments (Figure 6, Section A).

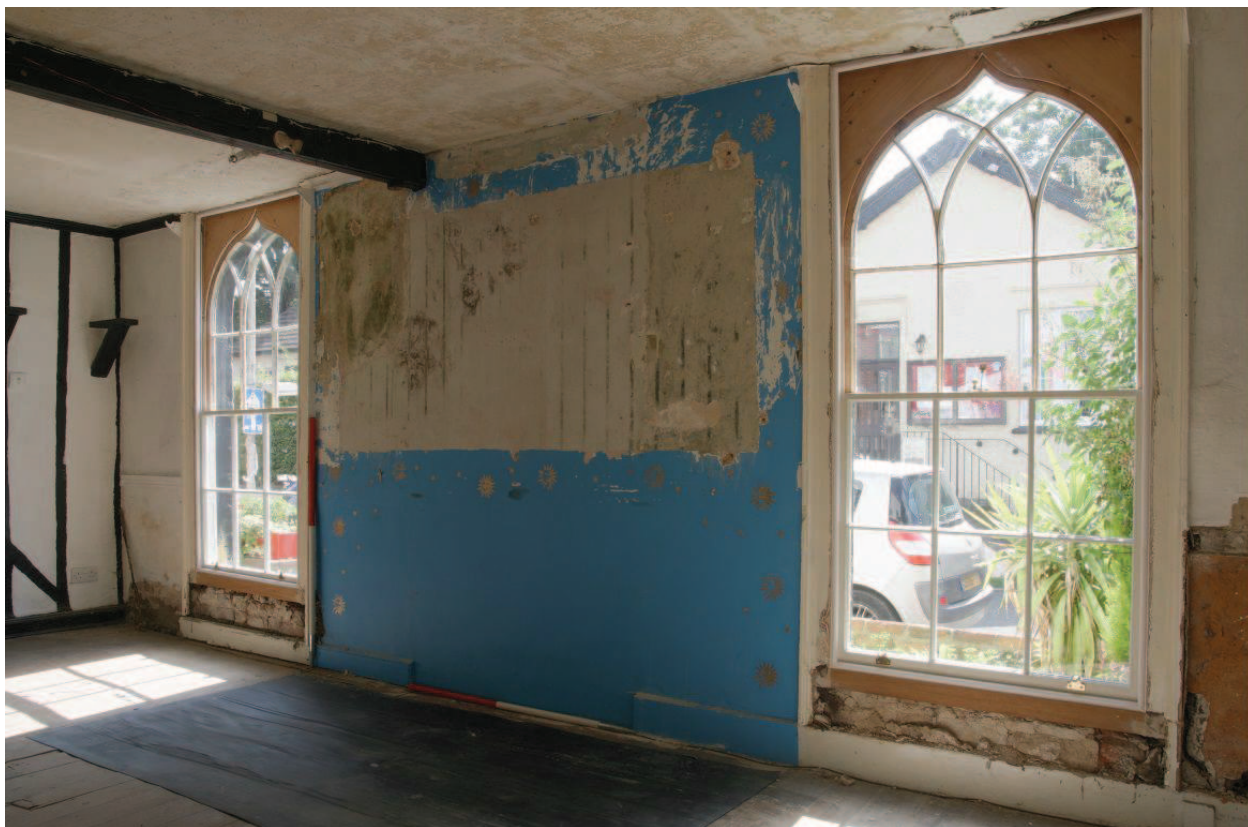
Plate 06 - Living room, south elevation, looking SE

**3.23** The south elevation has two ogee-headed sash windows to east and west (Plate 6). The bottom sash and beading have been replaced, though the top sash appears to be original in

**3.23.1** Remains of a similar moulded cornice to that observed in the east elevation survives immediately to the east of the eastern window. Remains of a dado rail survive on either side of the windows, and possible traces of a dado rail can be seen between the windows, up to the break.

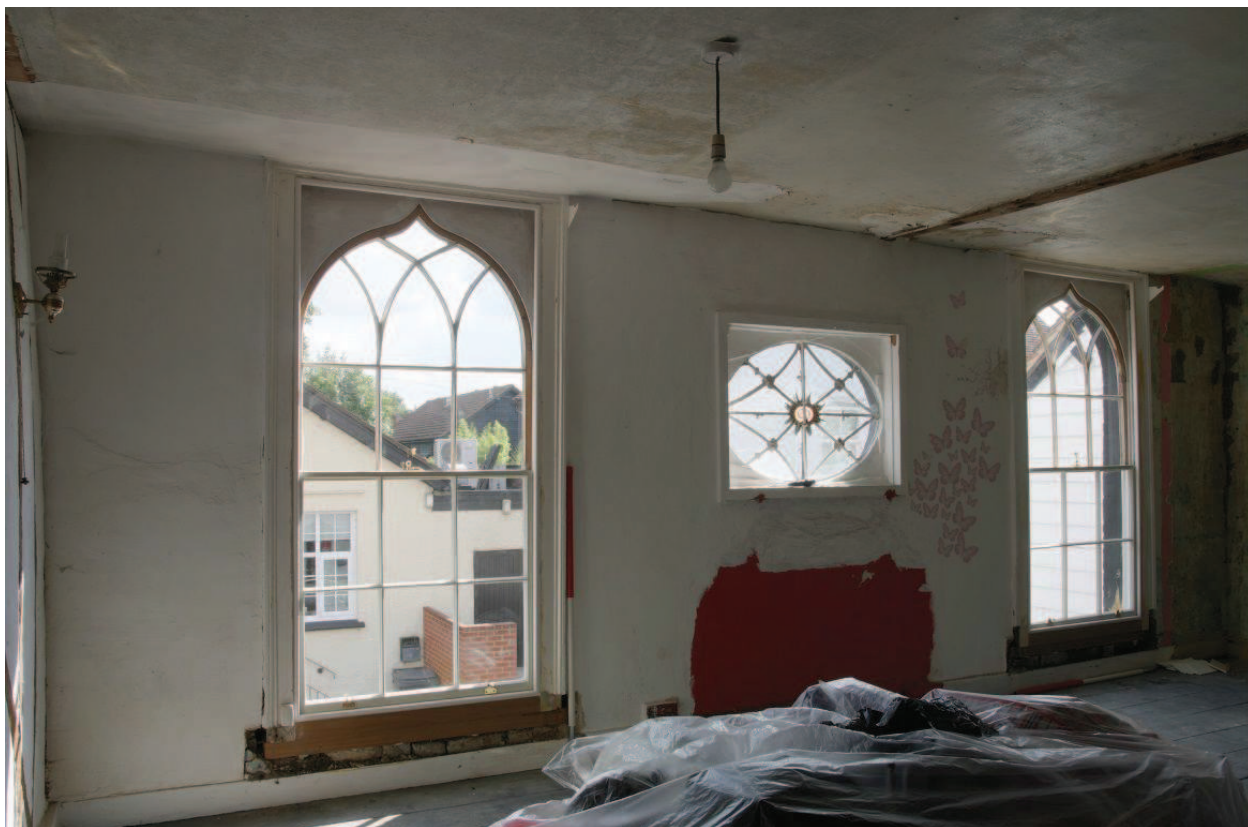
Plate 14 - Bedroom 1, south elevation, looking SW

**3.30** The south elevation of the first floor room (Bedroom 1) is plastered, with a simple square skirting, and is occupied by three window openings (Plate 14). Two ogee-headed sash windows, similar to those on the ground floor, are located at the eastern and western ends of the elevation. As with the ground floor windows, the lower sashes have been replaced. They flank an oval Regency window in the centre of the elevation. This has been mounted on a horizontal axis, but was possibly intended to be vertical. It has an orange stained-glass centre decoration with an etched spiral design (adapted to fit the space) set in a sunburst mount with leaded tracery (Plate 15). The frame to this window is of machined timber and the whole appears to be a later addition, although possibly set in an original opening.

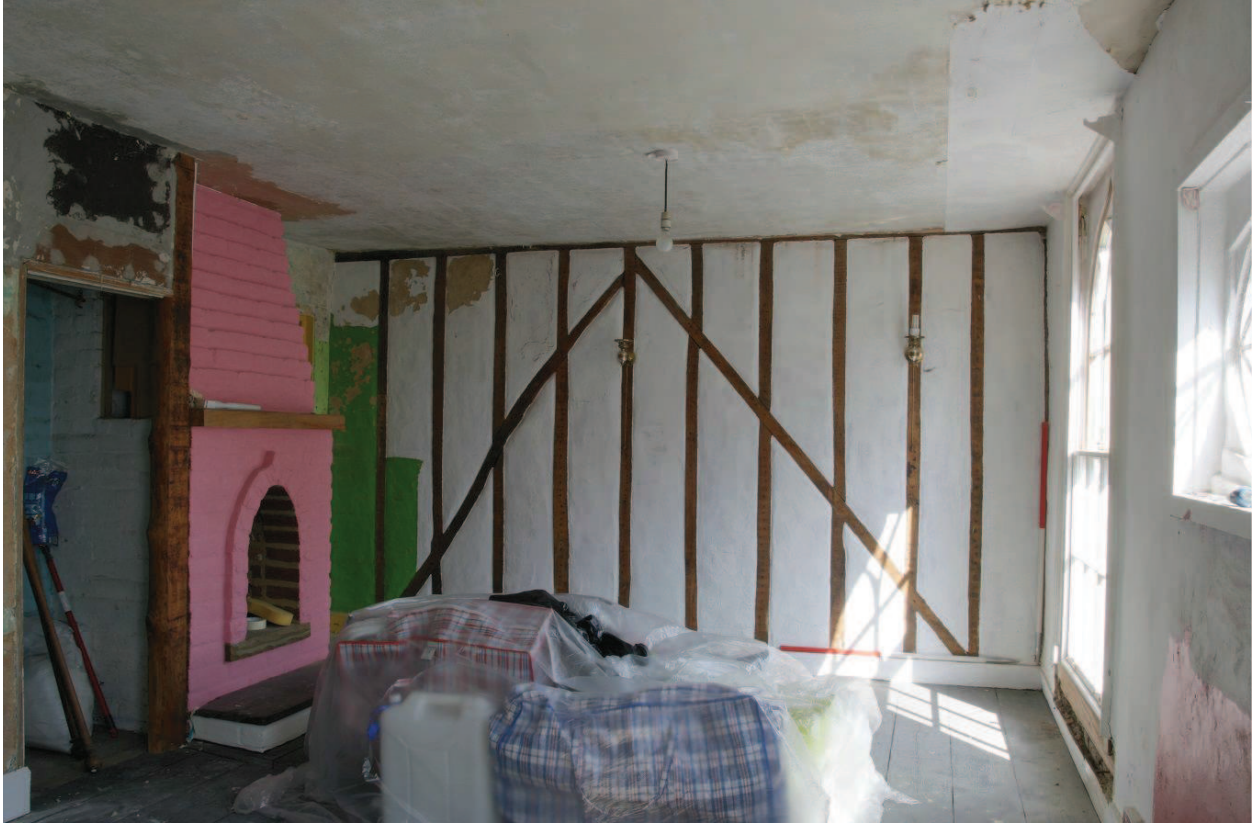
Plate 16 - Bedroom 1, east elevation, looking NE

**3.31** The east elevation has exposed framing with primary bracing, as noted in the same elevation downstairs, and clearly defined nail holes to support laths which have been stripped away (Plate 16).

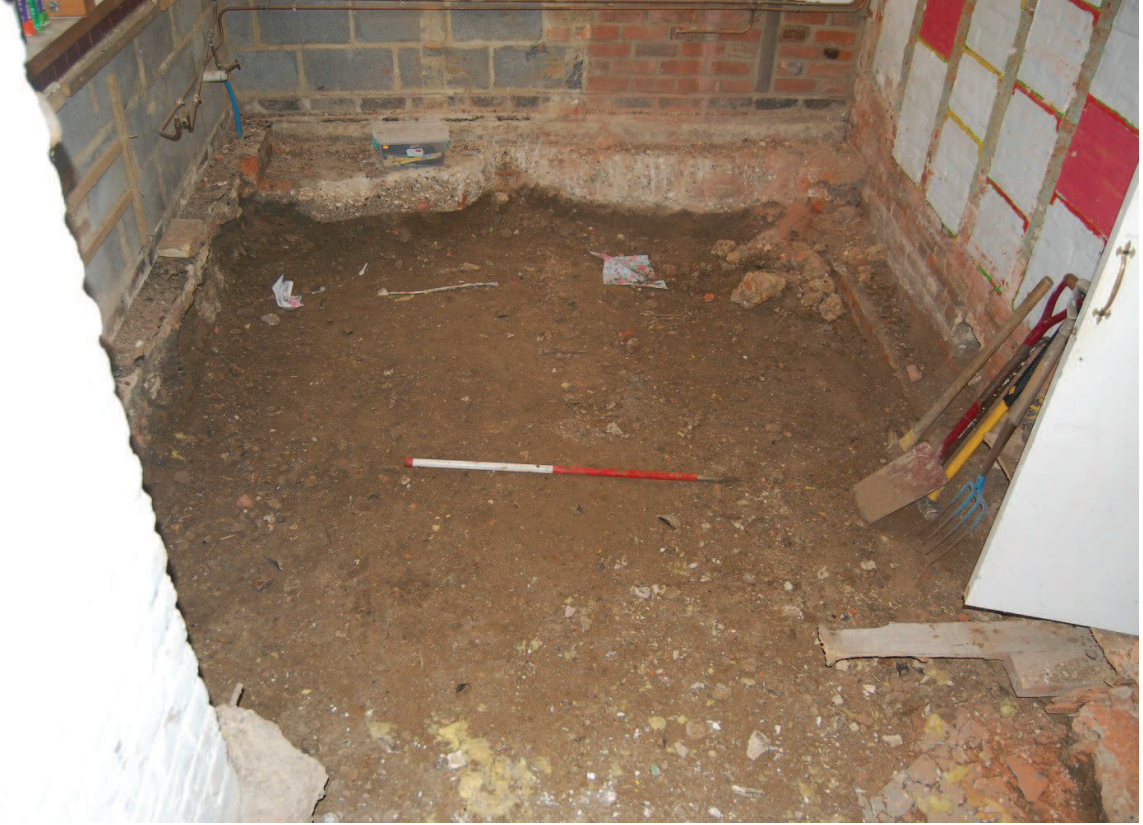
Plate 26 - Kitchen ground reduction, looking E

**3.48** The ground reduction exposed part of the brick foundation to the original north wall of the house, which stepped out by approximately 0.10m at a depth of approximately 0.20m below the modern concrete floor surface. No evidence for a foundation trench was observed and the brickwork continued below the impact depth of the ground reduction.
