## **35-41 SILVER STREET Enfield, Middx.**

(HN470 / SVS04)

*Historic Building Record &  
Archaeological Evaluation Report*

Report No.248

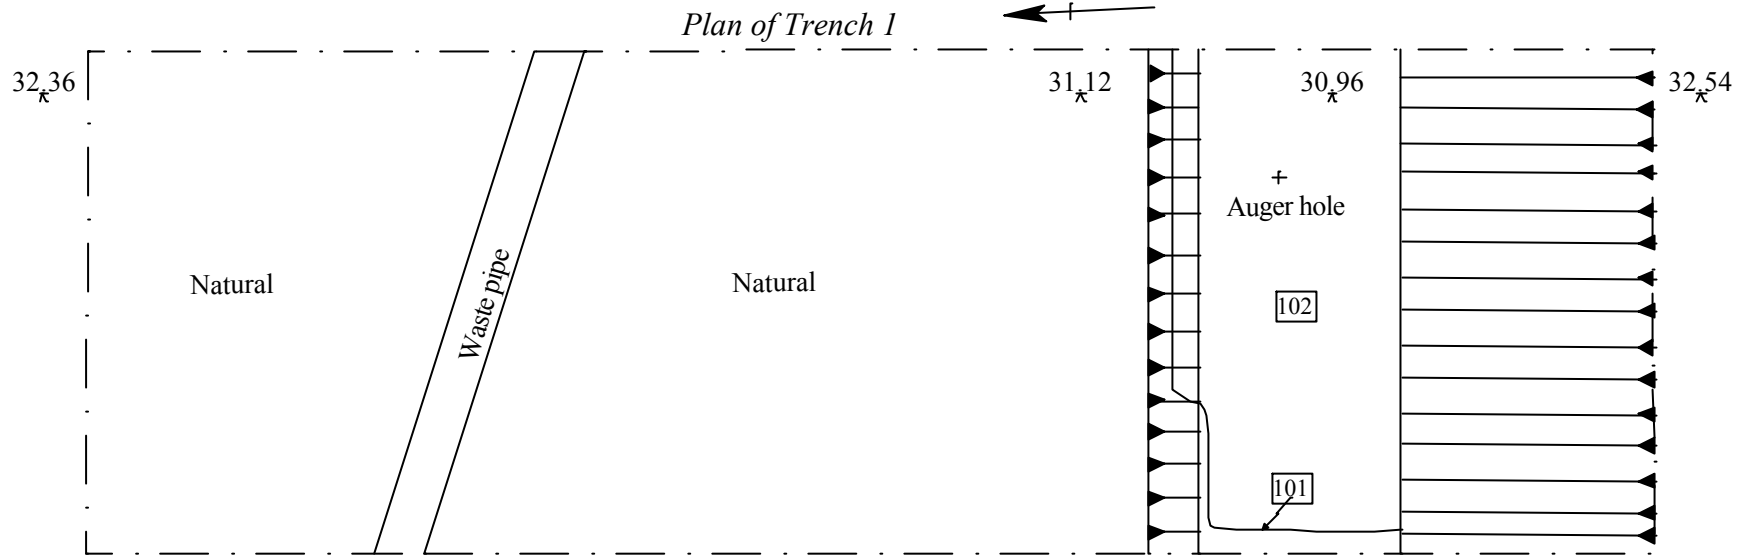
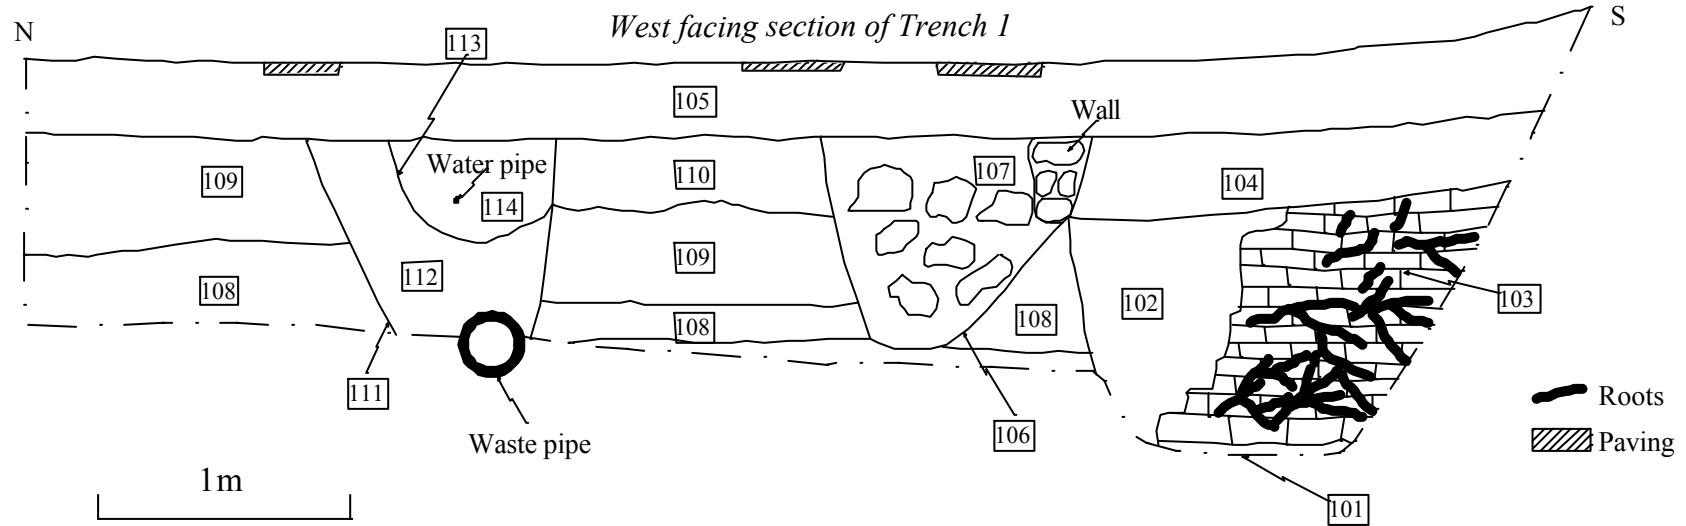
Figure 7

**3.13** The wall [103] was orientated north to south extending from the southern baulk of the trench. It was approximately 0.90m high (13 courses), had a maximum length of 0.95m and was 2 courses deep. It was heavily damaged by root action and had slumped along its length at an angle of approximately 30° and was truncated. The bricks were red clay 0.24m x 0.11m x 0.06m (9.5 x 4.25 x 2.5 inches) in size, bonded with a lime mortar.

Plan and section of Trench 1

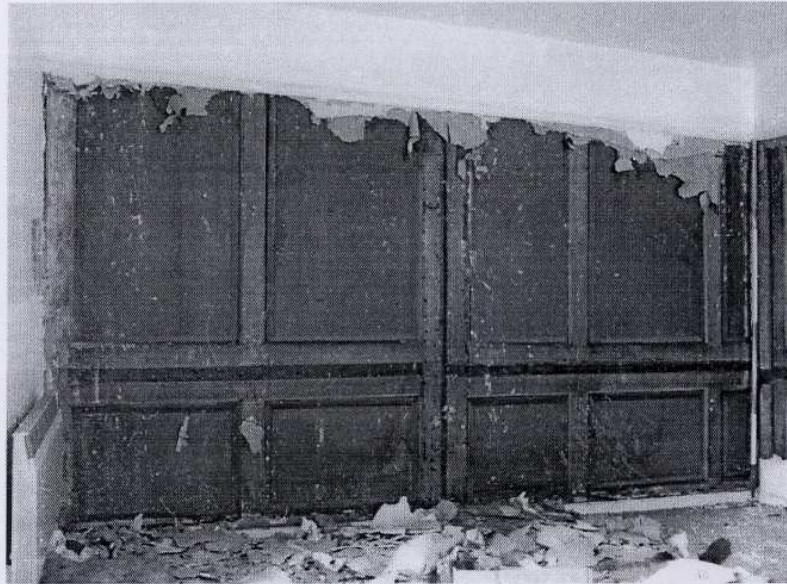
Plate 1a

**2.12** The living room overlooks Silver Street. Original panelling has been revealed underneath later plasterwork on the north and east walls. The panelling is full height with a chair rail just below the mid point. The panelling is of pine, which has been painted a number of times. (Plate 1a)

**2.14** The panelling and the fireplace appear to be of early to mid 18<sup>th</sup> century date.

Living room panelling

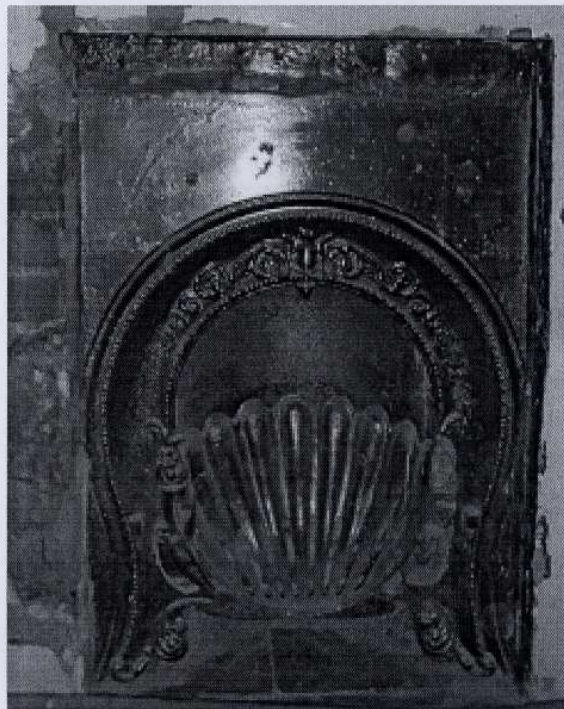
Plate 1b

**2.13** The blocked fireplace was opened to reveal a cast iron fire. Both the opening and the grate were based on the form of a scallop shell. Actual oyster shells were found mortared into the wall to the top left of the fireplace. (Plate 1b)

Living room fireplace

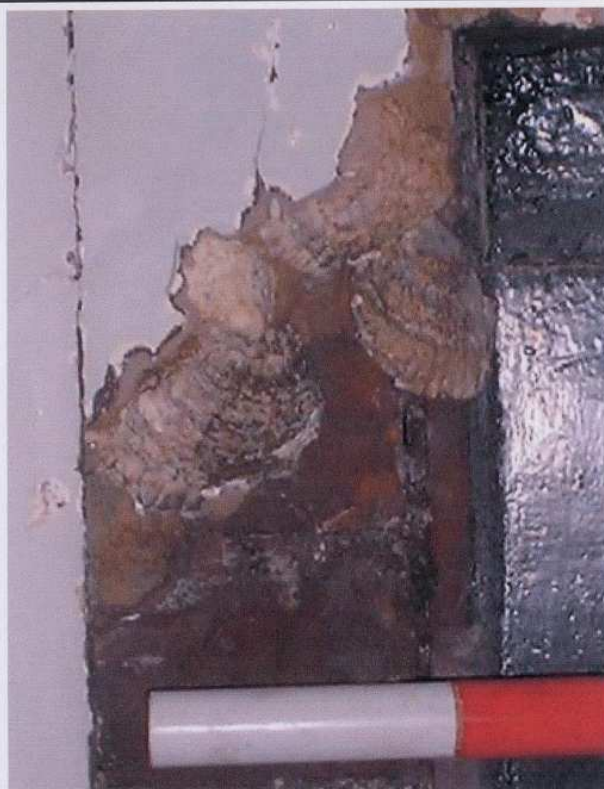
Plate 1a

Oyster shells set into living room fireplace surround

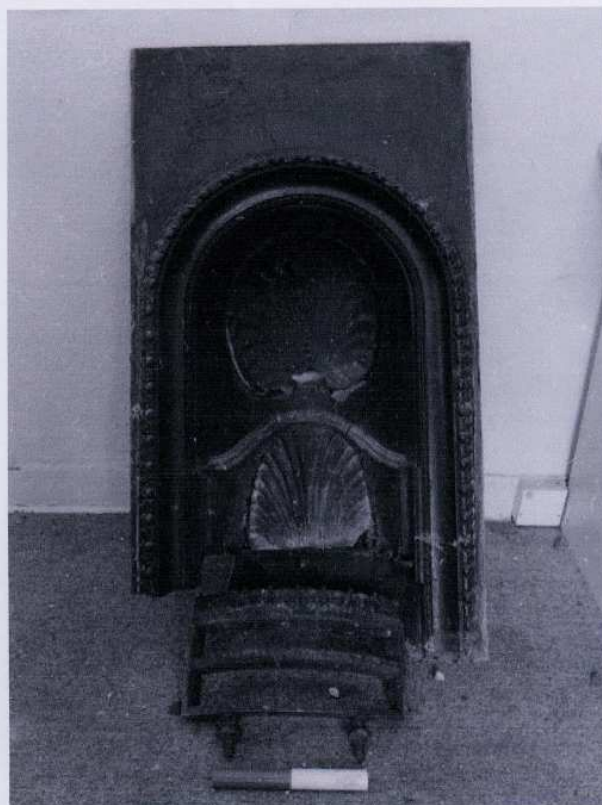
**2.18** Bedroom 3 lies at the rear of the building with a 12-light sash window in the north wall and access to the modern bathroom in the east elevation. A fireplace was until recently located in the east elevation, next to the bathroom door. The broken remains of the fire surround were recorded (Plate 2a). Although sharing to scallop motif, this fireplace is likely to be later than that in the living room.

Bedroom 3 fireplace
