LODGE FARM Sandon, Herts.

HN479

Historic Buildings Record

Report no.254

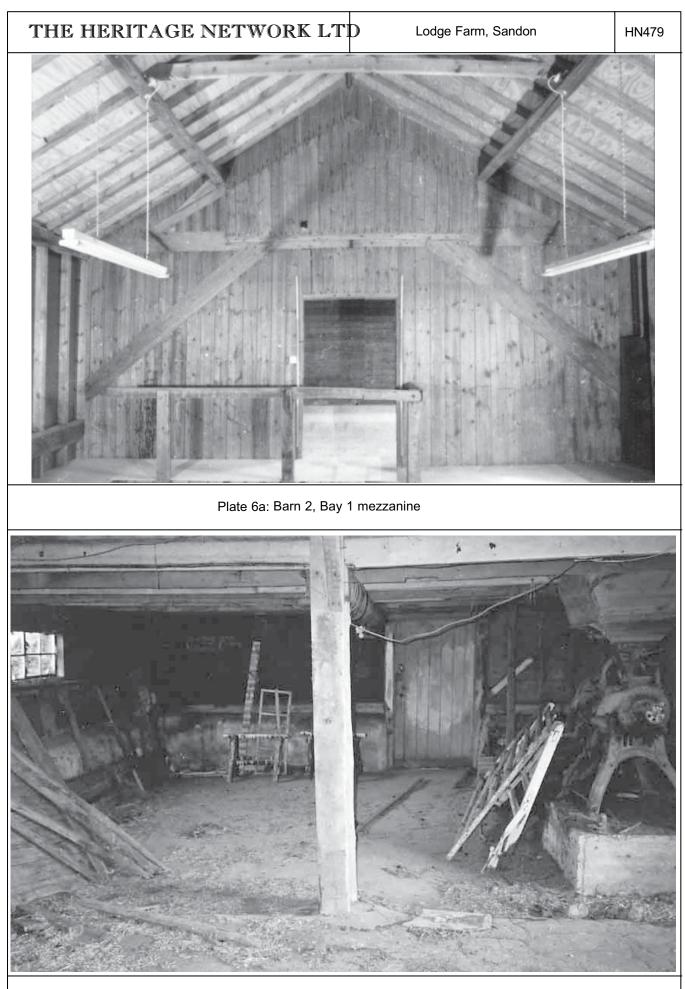
Plate 6b: Barn 2, Bay 1 ground floor before renovation
