89 TILEHOUSE STREET
Hitchin, Herts.

Historic Building Report

Prepared on behalf of K.F. Conroy Construction Ltd

Report no.256

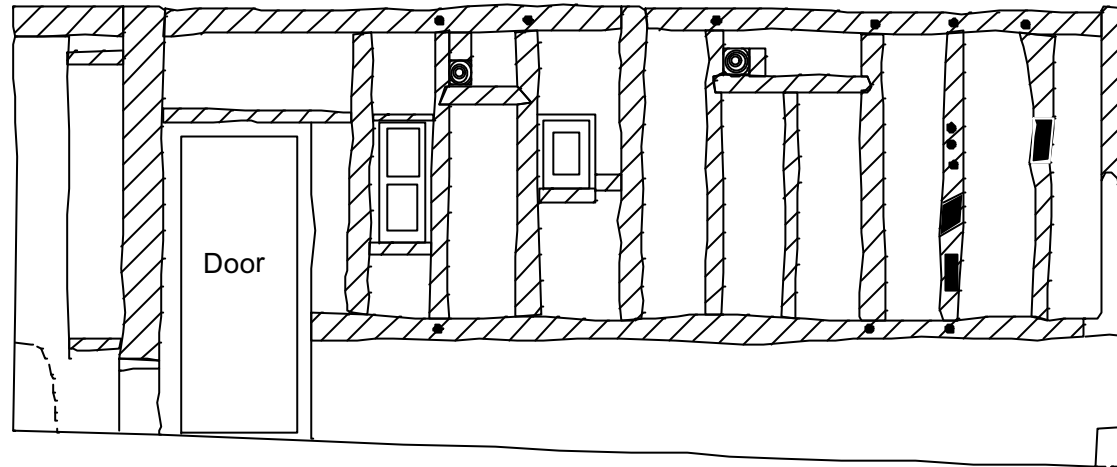
West elevation

2.5 The western elevation is timber framed and rests on a brick dwarf wall between 70 and 85cm high. The bricks in the dwarf wall are hand made, dark red in colour, with frequent stone inclusions, and measure c.22 x 10 x 5cm (8³/₄ x 4 x 2 inches). They are set in lime mortar (with some cement repointing) in an irregular English Bond.

2.7 The timber frame, which is of oak, has square corner posts. Most of the intermediate posts are pegged into the wall and base plates, suggesting that this is all part of the original structure. At least two of these are re-used timbers: there is a jowled principal post at the southern end of the elevation, and the next one to the north has a recess to accept a brace and a mortice below.

2.10 The dwarf wall shows signs of having been breached to accommodate the door, and two windows have also been inserted within the framing. The northern window is a 2-light fixed window and the southern one is a single light catchment widow.

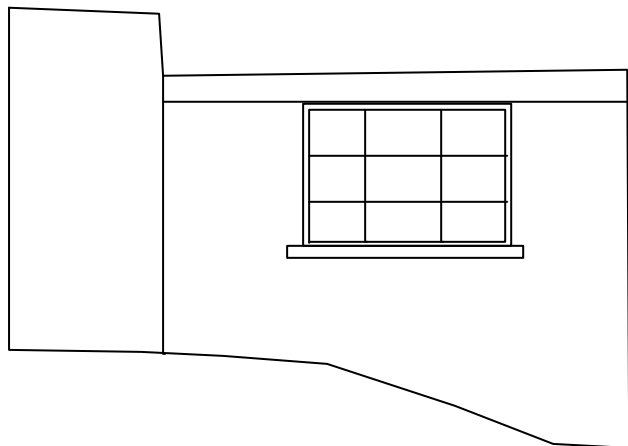
North elevation

2.12 The north elevation is of red bricks measuring c.20 - 26 x 6cm (8 -10¹/₄ x 2 inches) set in a Flemish Bond in lime mortar. Although the brickwork is all similar, there is a break in the build between the north western corner of the building and the remaining wall. The easternmost end of the wall is recessed and may mark the original extent of the north wall.

2.13 There is a modern 9-light window set fairly centrally into the wall, before it steps back.

2.14 A course of upright slates has been set against the base of the wall, possibly as part of a damp proof course.

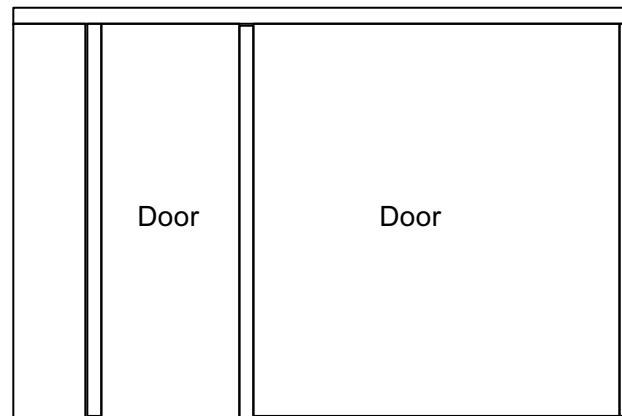
South elevation

2.15 The south elevation is modern and consists of three doors. The western one is a single door opening into a lobby leading to a WC, and the eastern one is a double door opening into a single room. An extension has been added to the roof to overhang the frontage of this elevation.

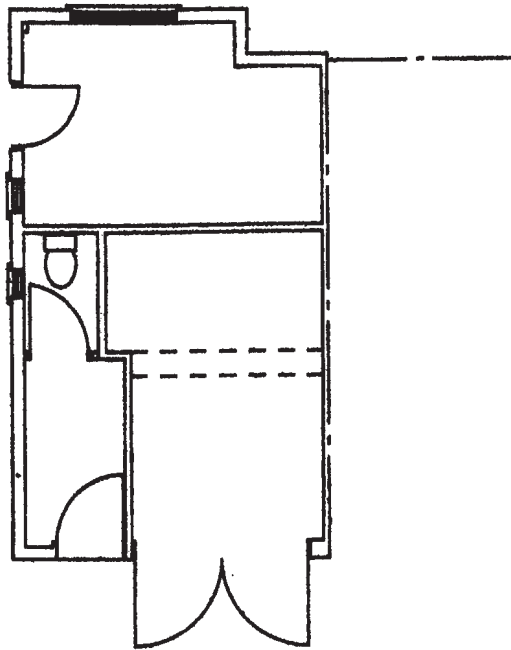
Ground floor plan

2.16 The interior consists of four separate areas. These comprise a single room at the northern end, which is wider to the west than to the east; a room at the south-eastern end of the building, which is wider at the northern end; a small narrow lobby; and a WC.

2.17 The floors in the two single rooms are of concrete and those in the lobby and WC are of quarry tiles.
