CHURCH OF ST MARY THE VIRGIN **Stanstead St Margaret's, Herts.**

HN542

Archaeological Monitoring Report

Report no.317

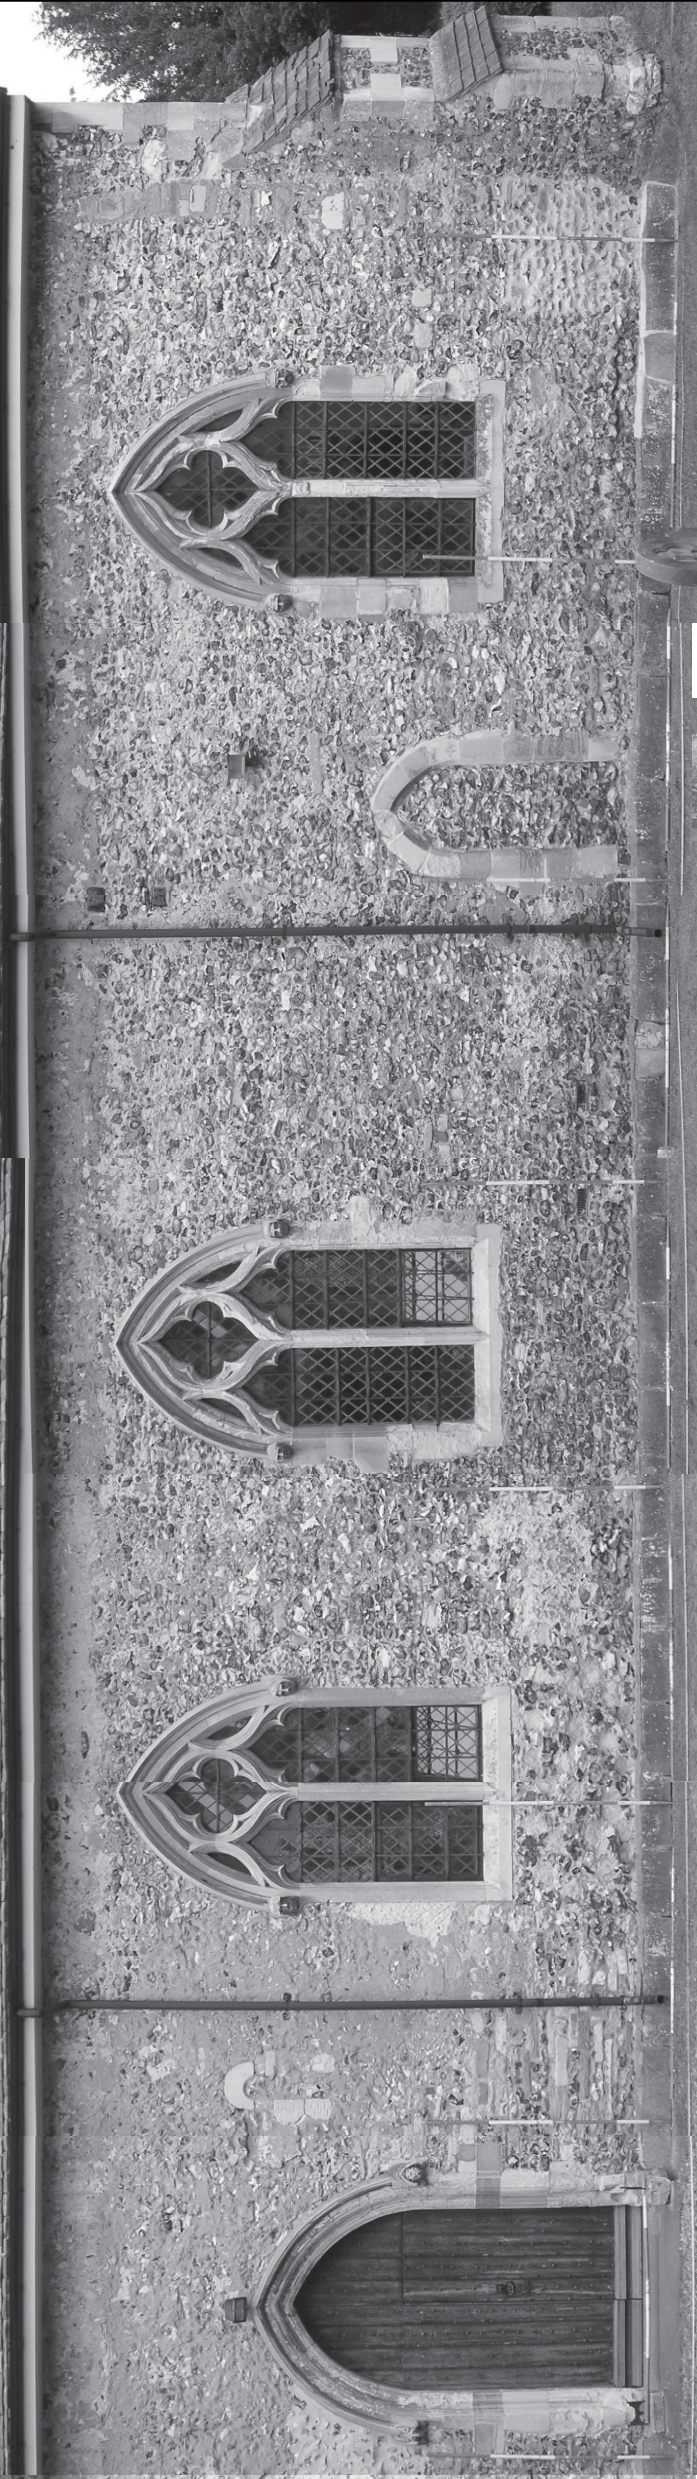
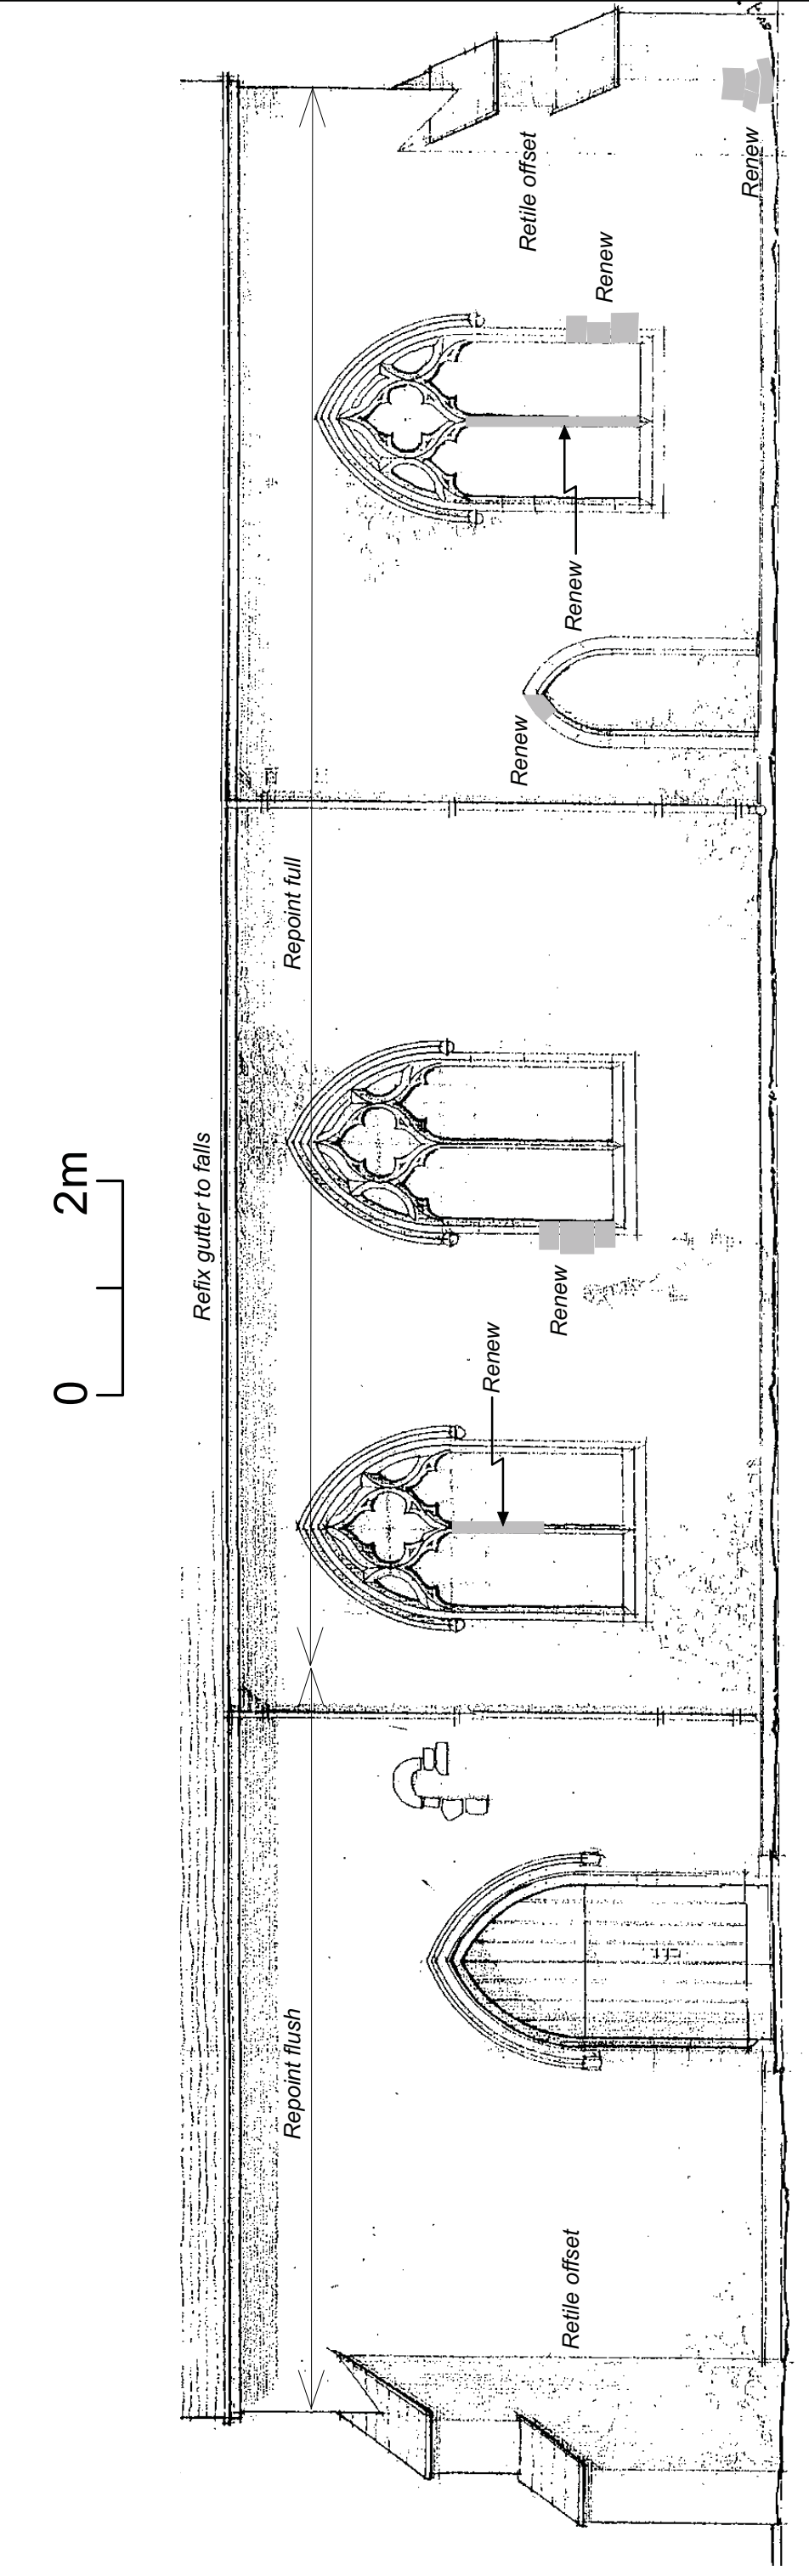
Southern elevation prior to repairs, and proposed repairs <i>(drawn elevation courtesy of Carden and Godfrey, Architects)</i>		Figure 2

2.8 The church is largely built of flint and fieldstones with limestone quoins and dressings. The refurbishment works included the repointing of the entire south elevation, the replacement of weathered and eroded stonework to the windows and buttresses, the repair and replacement of guttering and downpipes, the relaying of the stone gully at the foot of the wall, and the excavation of a new drain and soakaway.

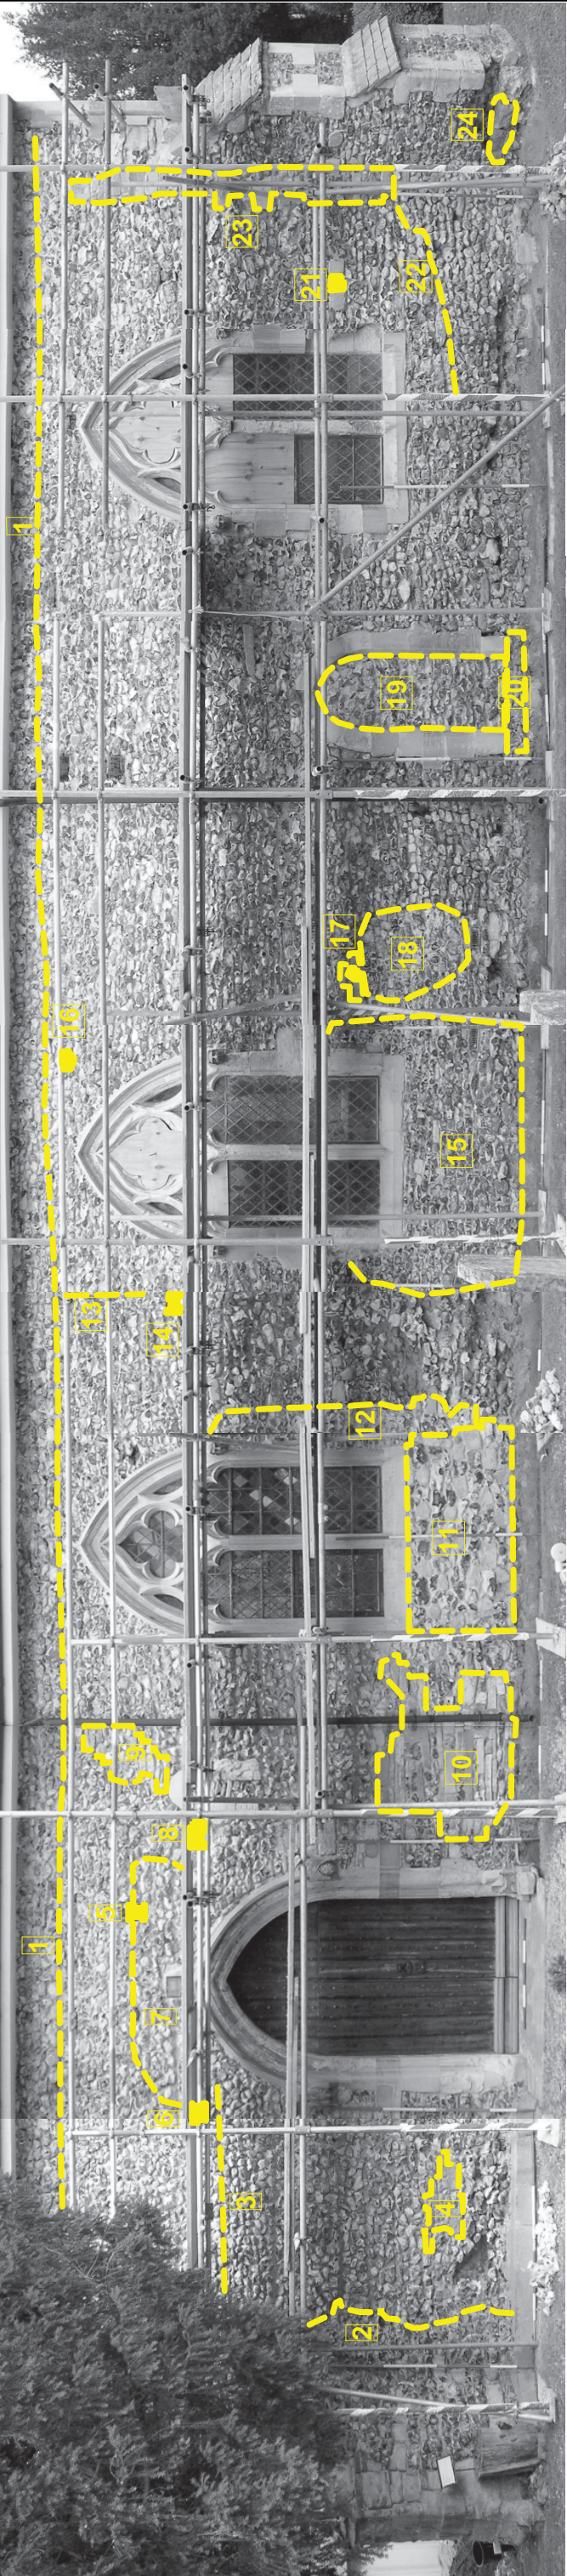
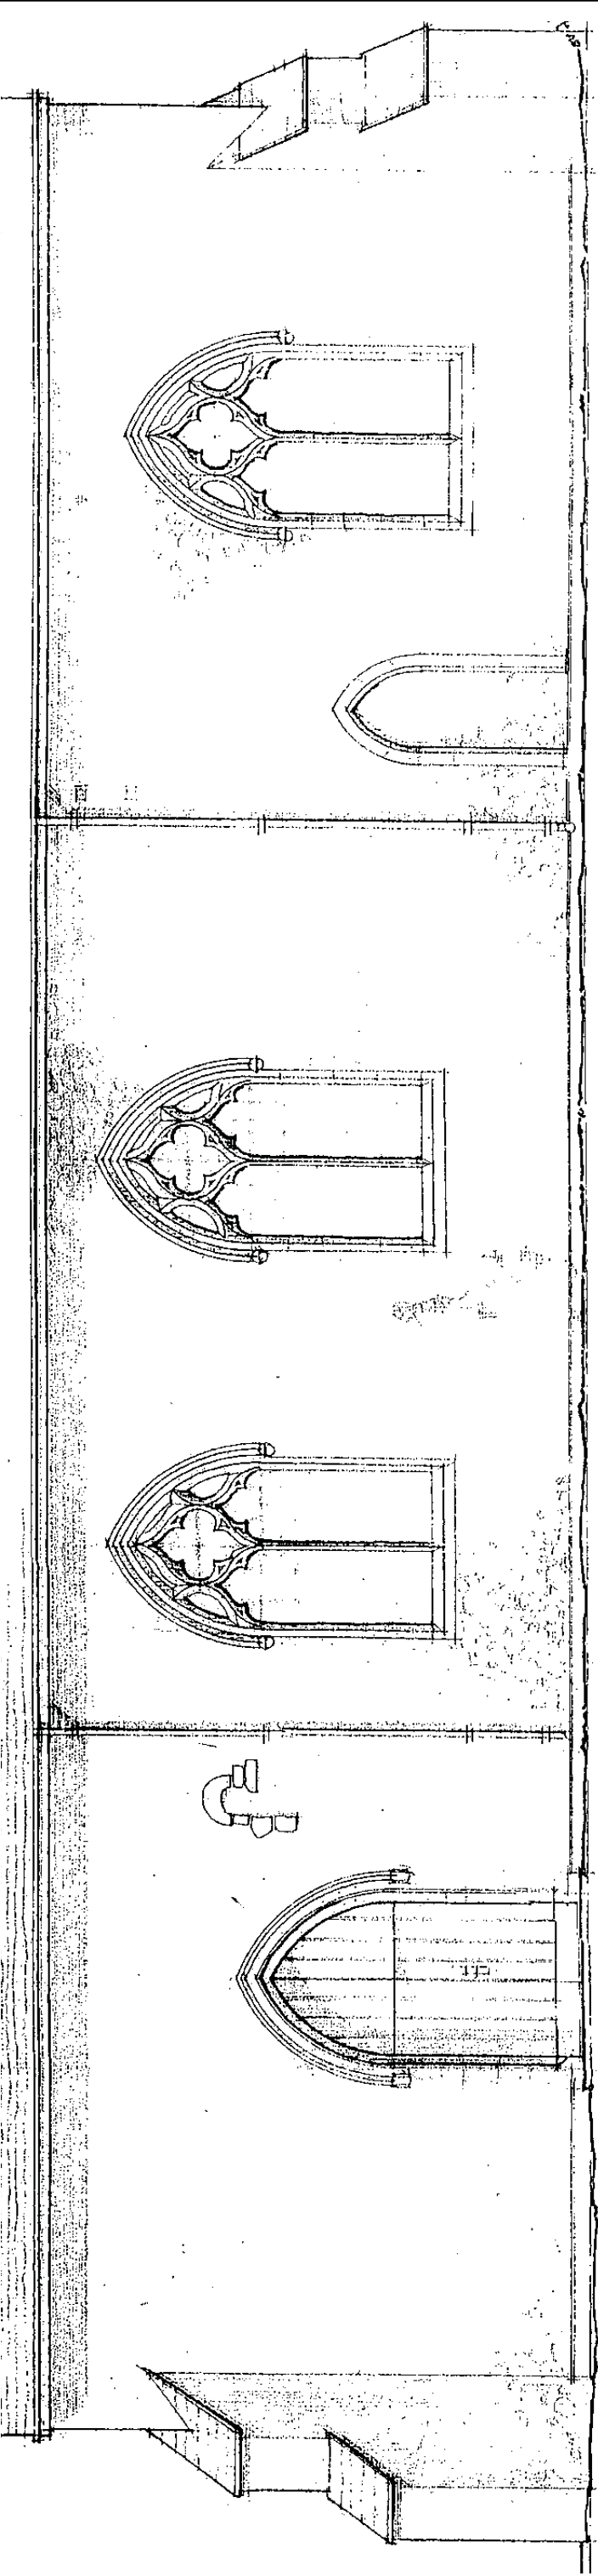
<p>Observed Structural Evidence</p> <p><i>(drawn elevation courtesy of Carden and Godfrey, Architects)</i></p>		
Figure 3

2.9 Following the raking out of the existing mortar and the removal of remaining patches of render, it was apparent that the wall facing had been subject to repairs on a regular basis. The chronology of the repairs was not generally apparent. The following features were noted:

- 1 Building lift running the full length of the building, approximately 0.30m below the eaves, suggesting that the roof has been raised
- 2 Repair, using knapped flint, running along the junction between the SW buttress and the nave

- 3 Building lift
- 4 Repair, using sandstone, limestone and brick
- 5 Putlog
- 6 Void, possibly associated with 7 and 8, possibly indicating location of earlier porch or canopy predating 1830

- 7 Area of repointing using a white lime mortar, possibly associated with 6 and 8
- 8 Void, possibly associated with 6 and 7, possibly indicating location of earlier porch or canopy predating 1830

- 9 Repair, using flint and limestone
- 10 Repair, using flint and limestone
- 11 Repair beneath the western window, using knapped flint and limestone, possibly contemporary with the repair or insertion of the window

- 12 Repair on the eastern side of the western window, using knapped flint, possibly contemporary with the repair or insertion of the window
- 13 Vertical joint, in the upper third of the elevation, at the junction between the nave and chancel

- 14 Putlog
- 15 Repair beneath the middle window, using knapped flint, possibly contemporary with the repair of the window
- 16 Putlog
- 17 Putlog with limestone dressings

- 18 Repair, using knapped flint
- 19 Infill of blocked doorway, using knapped flint
- 20 Infill below doorjambs of blocked doorway, in supposed location of sill

- 21 Putlog with limestone dressings
- 22 Repair lift
- 23 Vertical repair in limestone and brick
- 24 Exposed clunch blocks at base of buttress

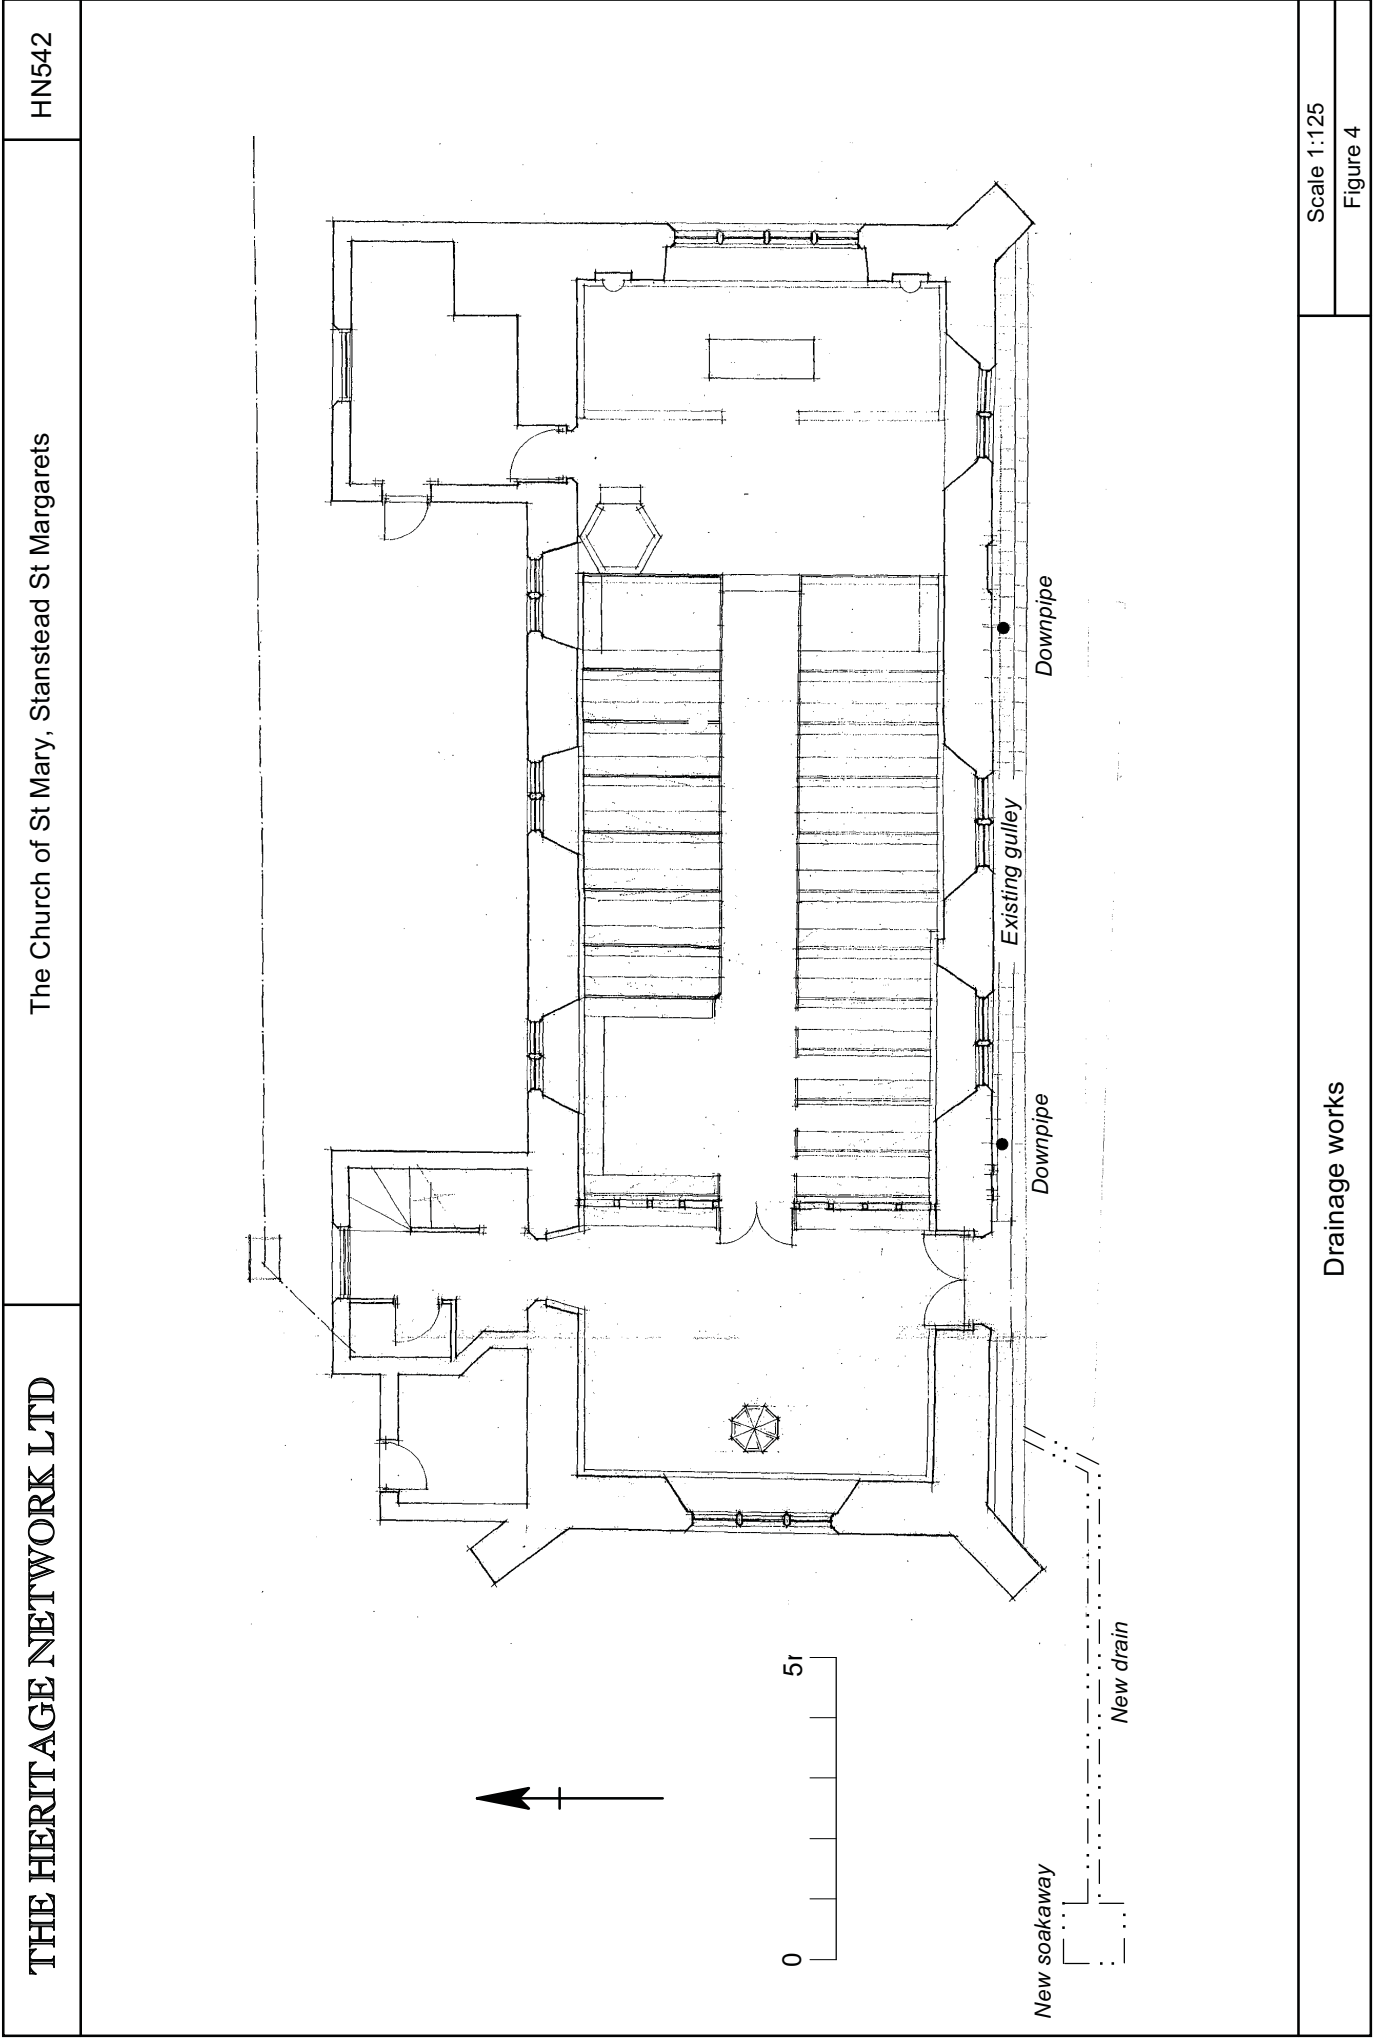
Figure 4

2.10 The gully running along the base of the wall was formed of limestone slabs laid to form a channel abutting the base of the wall. The bedding mortar was not removed and the slabs were lifted and relaid in the same positions.

2.11 The western end of the gully was linked into a new drain leading to a new 1m square soakaway located in the churchyard, 6m to the west. The groundworks were supervised but no archaeological features or deposits were observed. The stratigraphy consisted of 0.30m of gravel representing the bedding for an existing pathway, overlying an undifferentiated subsoil 0.70m in depth.

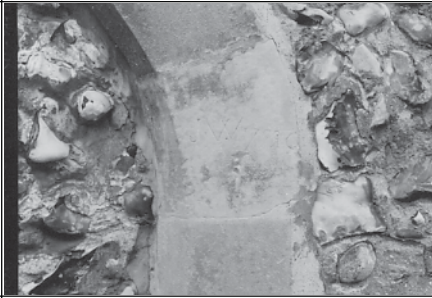
Frame 5: Graffito on jamb of priest's door
