THE GREAT BARN, Rectory Farm, Pirton, Herts.

HN976

HISTORIC BUILDING RECORD

February 2011

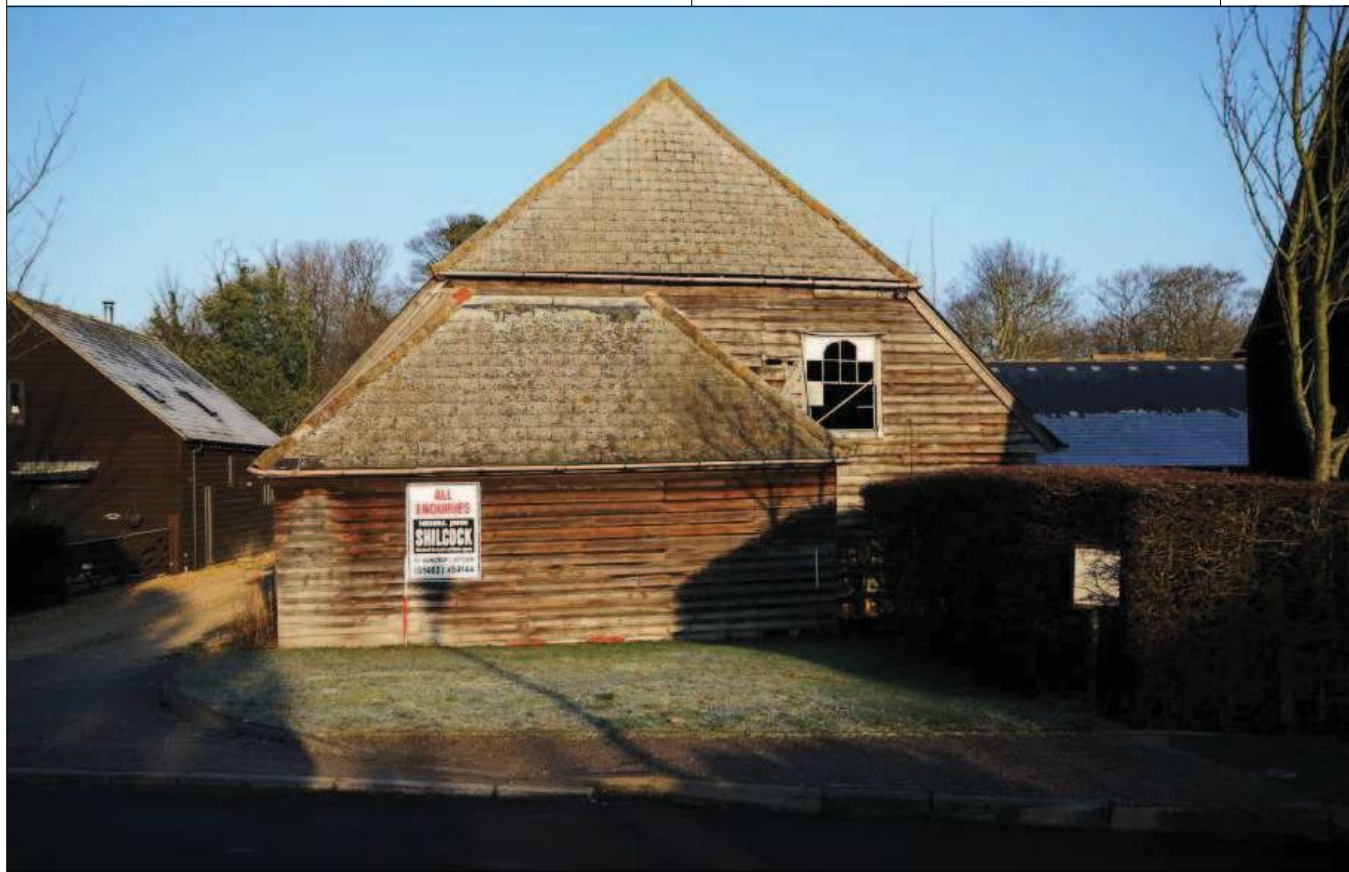
3.3 The southern exterior elevation is dominated by a lean-to extension, offset to the west, faced with weatherboard and roofed with slate (Figure 6; Plate 1). The main barn is also weatherboarded in modern softwood, above a plinth formed of Arlese white bricks laid in English bond with a lime mortar. Just to the east of the end of the lean-to roof, a modern 8-over-8 sliding sash window has been inserted. The horns of the arcade plate project below the hip, and those of the aisle plate project at the eaves. Within the lean-to, the elevation of the Tithe Barn preserves some earlier weatherboarding, above a plinth consisting of six courses of modern Arlese white brick (Plate 2).

Plate 1: South exterior elevation, looking N

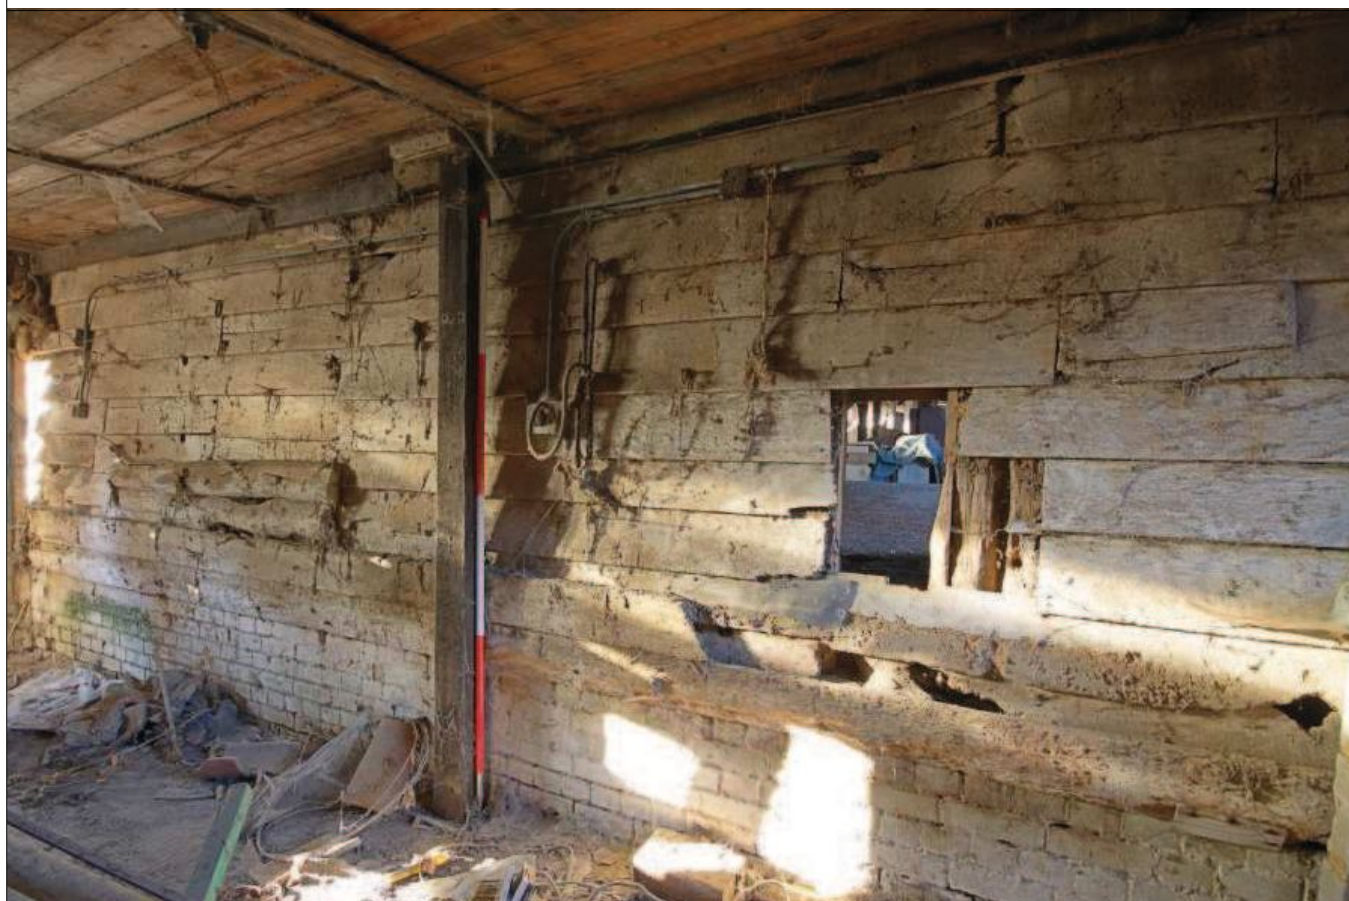
Plate 2: S elevation of main barn from interior of lean-to

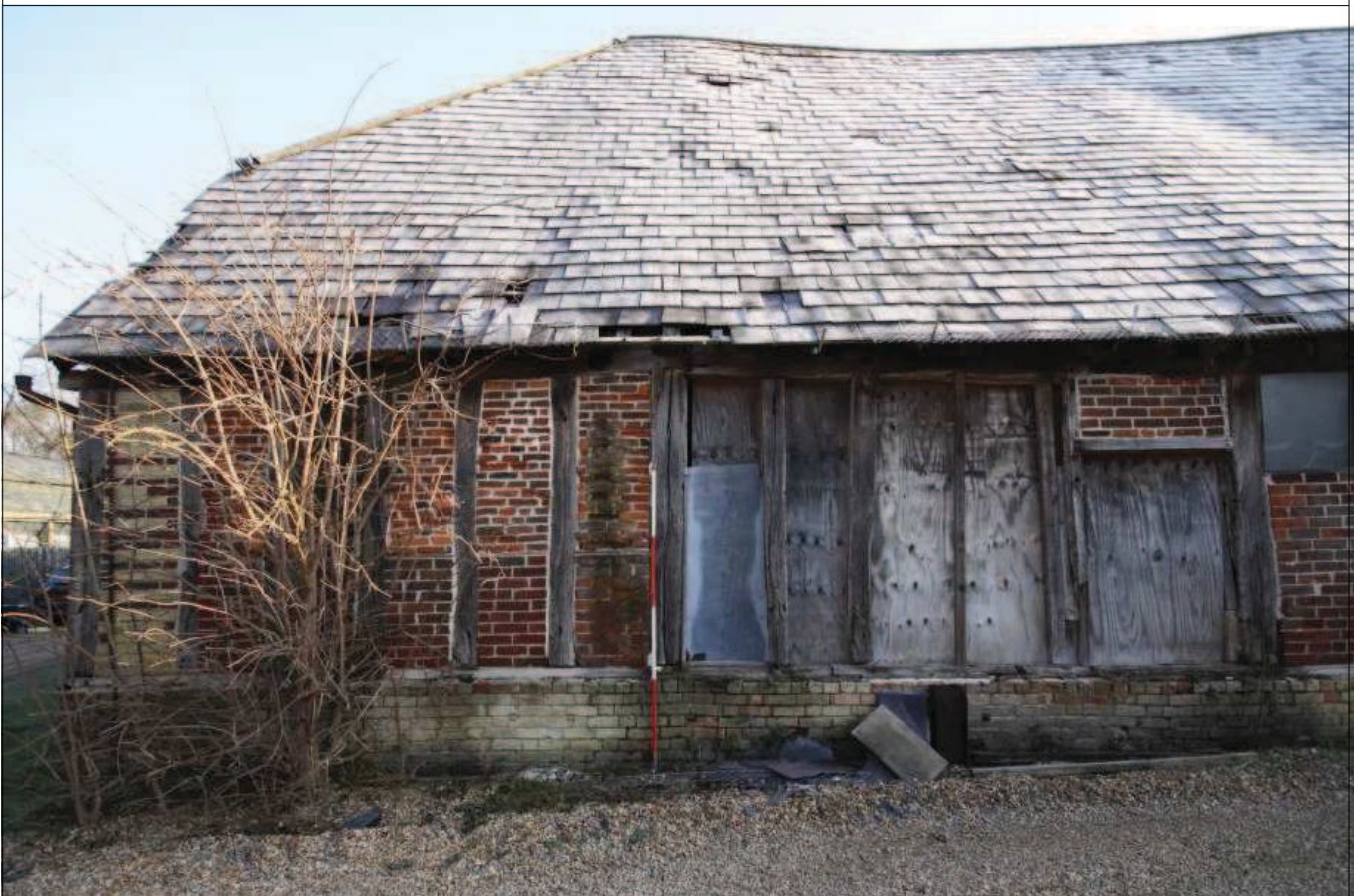
much decayed but survives in Bays 1, 2, 6, 7, 9 & 10. This rests on a brick plinth, formed of Arlesey white bricks measuring 8½” x 2¾” x 4¼” (216mm x 70mm x 108mm) in Bays 1, 2 & 3 and the southern end of Bay 10 (Plates 4, 5 & 9), and narrow red bricks measuring 8½” x 2” x 3½” (216mm x 51mm x 89mm) in Bays 6, 7, 9 and the northern end of Bay 10 (Plates 7 & 9). Bays 4 and 5 are supported on modern shuttered concrete (Plate 6). Bay 5 has two rows of holes punched through the upper half of the brick nogging, possibly intended for ventilation (Plate 6). The underside of the aisle-plate in Bay 2 shows drilled dowel holes to house wattle-and-daub infill that would have pre-dated the brick nogging (Plate 10). A modern personnel door with glazed light above the transom has been inserted at the north end of Bay 3; a modern sliding hatch has been inserted at the north end of Bay 6; and modern double doors have been inserted in Bay 8.

Plate 4: Detail shot - Bays 1 - 2, west exterior elevation

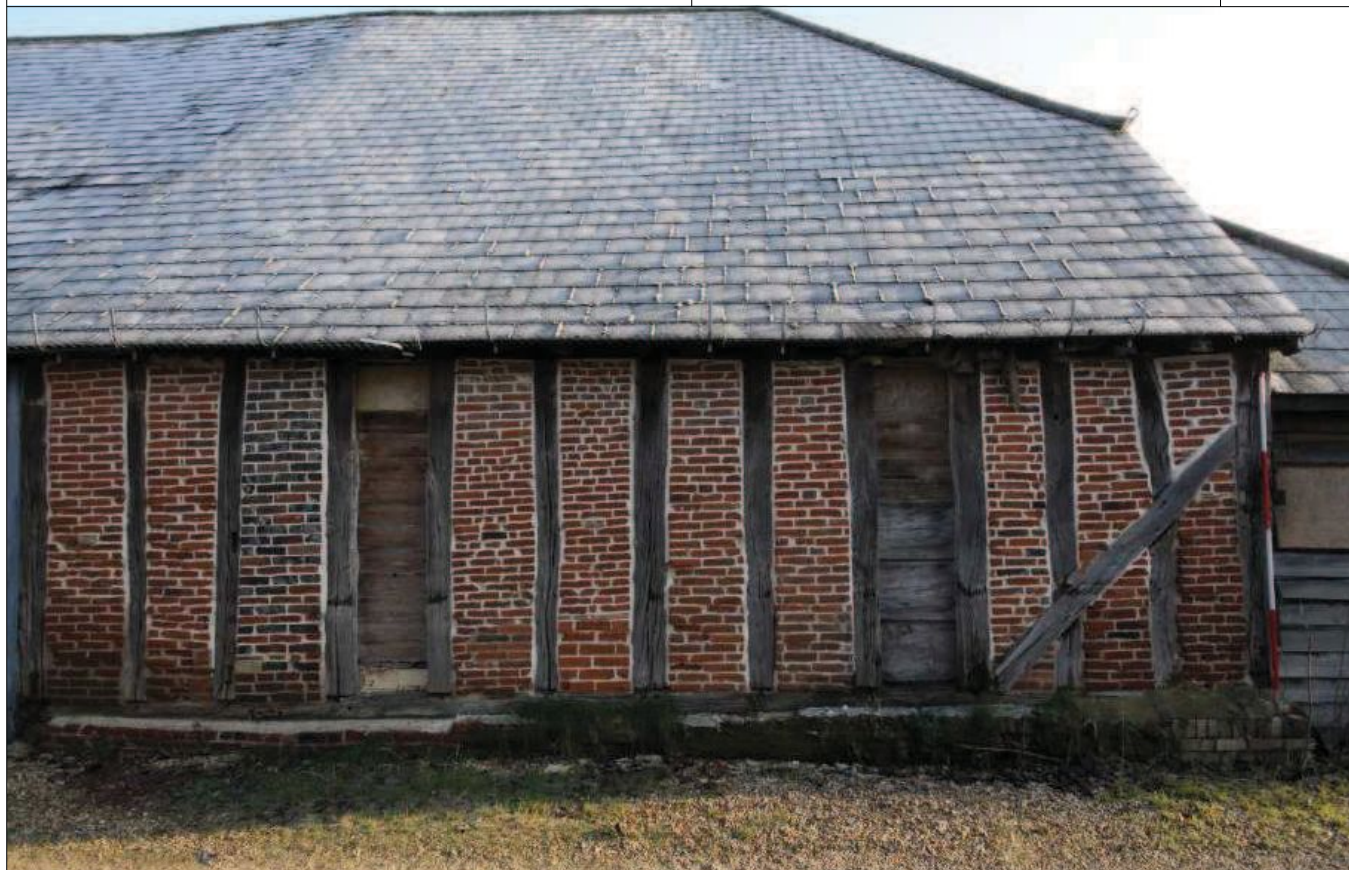
Plate 9: Detail shot, Bays 9 - 10, west elevation

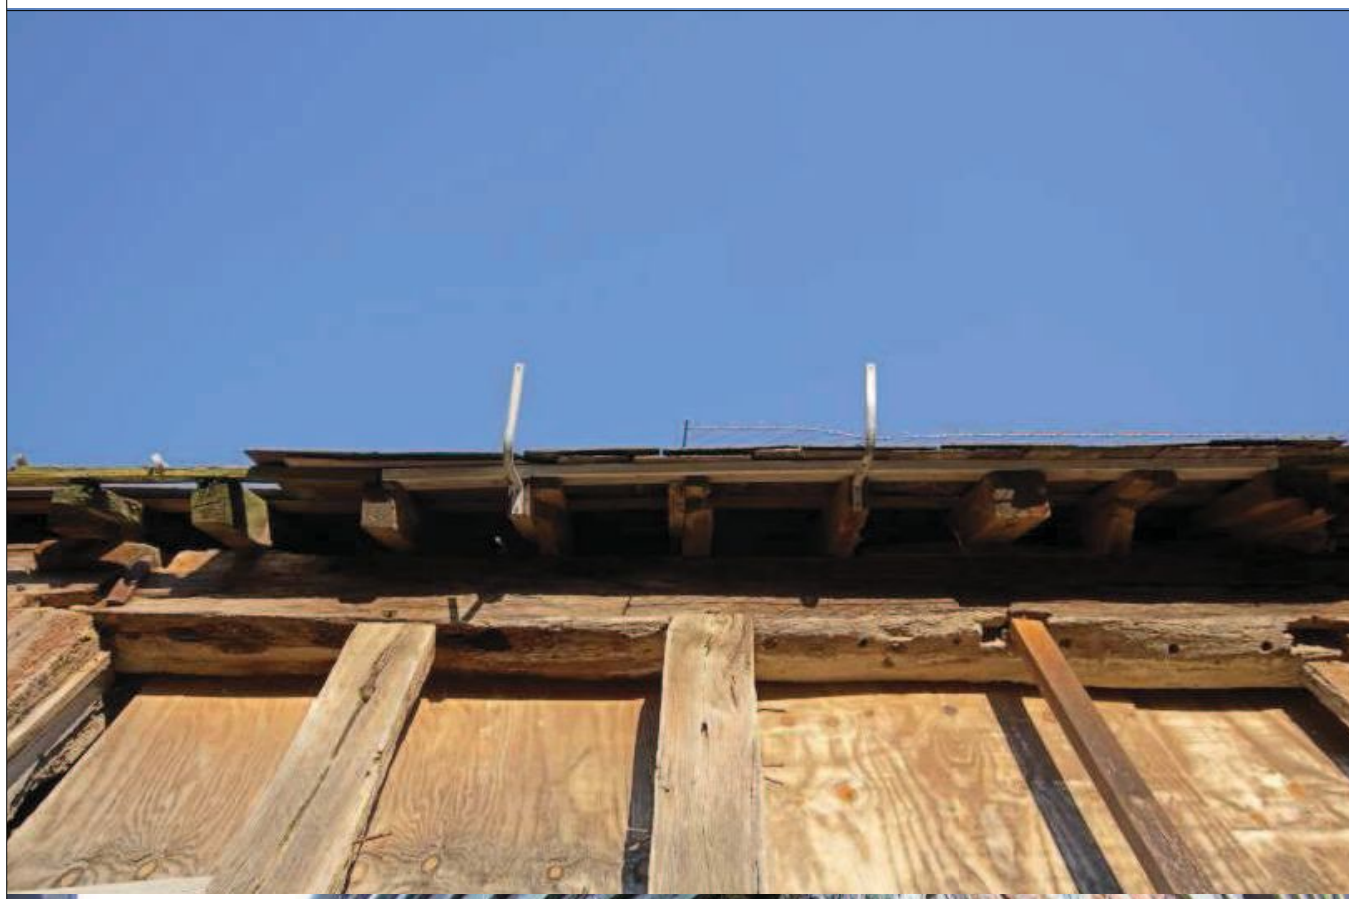
Plate 10: Detail shot, underside of wall plate in Bay 2, west elevation, showing dowel holes

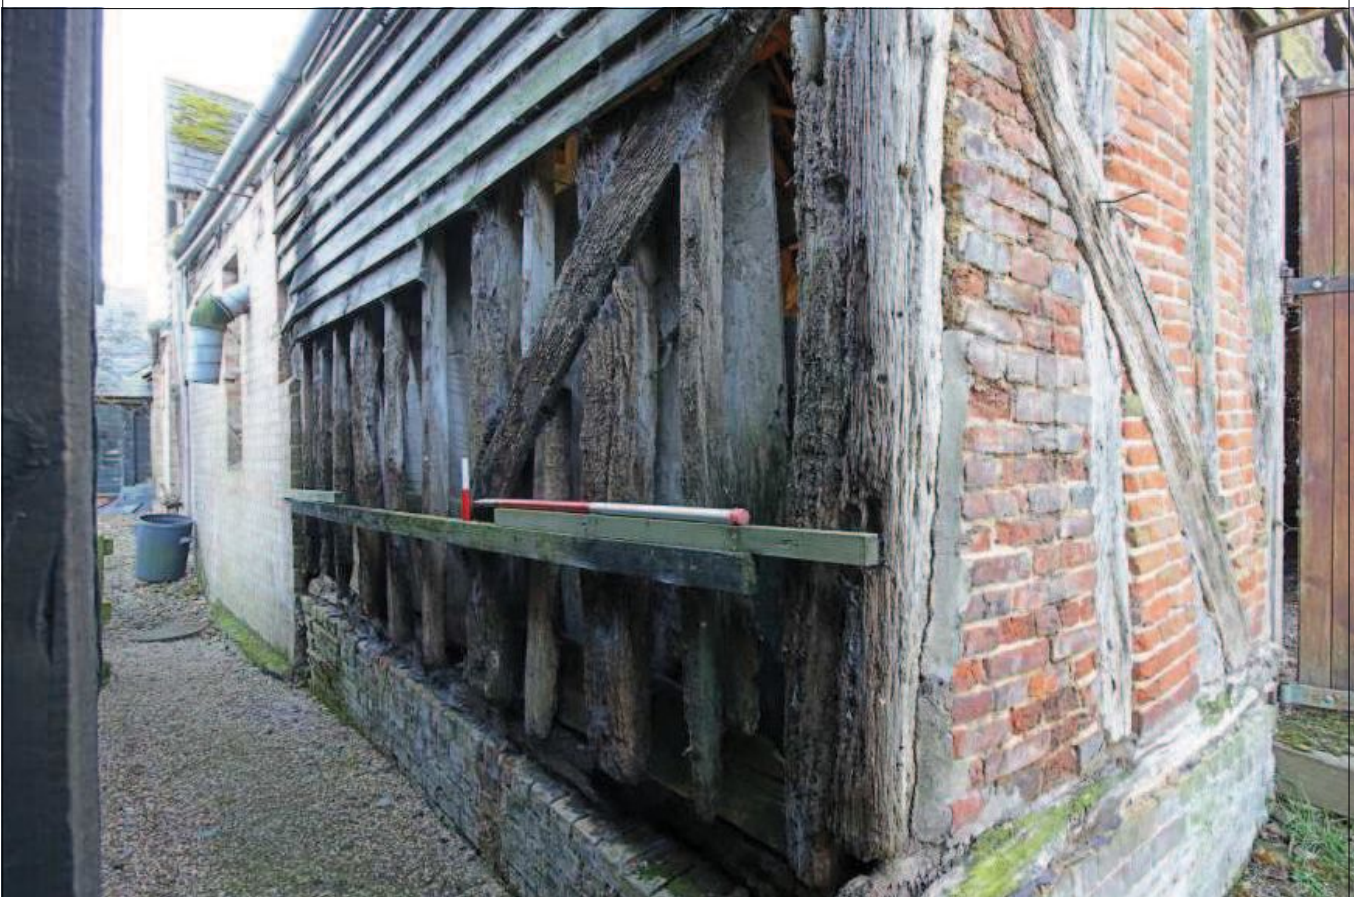
3.7 The eastern exterior elevation is bisected by a remodelled 19th century barn, the western end of which forms part of the present property (Figure 6). To the north of this, Bay 1 retains its original studwork and primary bracing, very badly weathered where the modern weatherboarding has fallen away, resting on a decayed white brick plinth of indeterminate bond (Plate 12). From Bay 2 to the northern end of Bay 5, the elevation has been completely rebuilt below the aisle plate in modern Fletton brick with metal framed windows inserted in Bays 2, 4 and 5 (Plate 13). A string course marks the line of the sill in Bay 4. Bay 3 has been provided with a gabled midstrey that appears to be a completely modern addition, though possibly on the site of an original opening. Modern double doors, offset to the north, extend above the aisle-plate to the level of the arcade plate, and a three-light window occupies the gable above, which is otherwise weatherboarded.

Plate 12: East exterior elevation, Bay 1, looking SSW

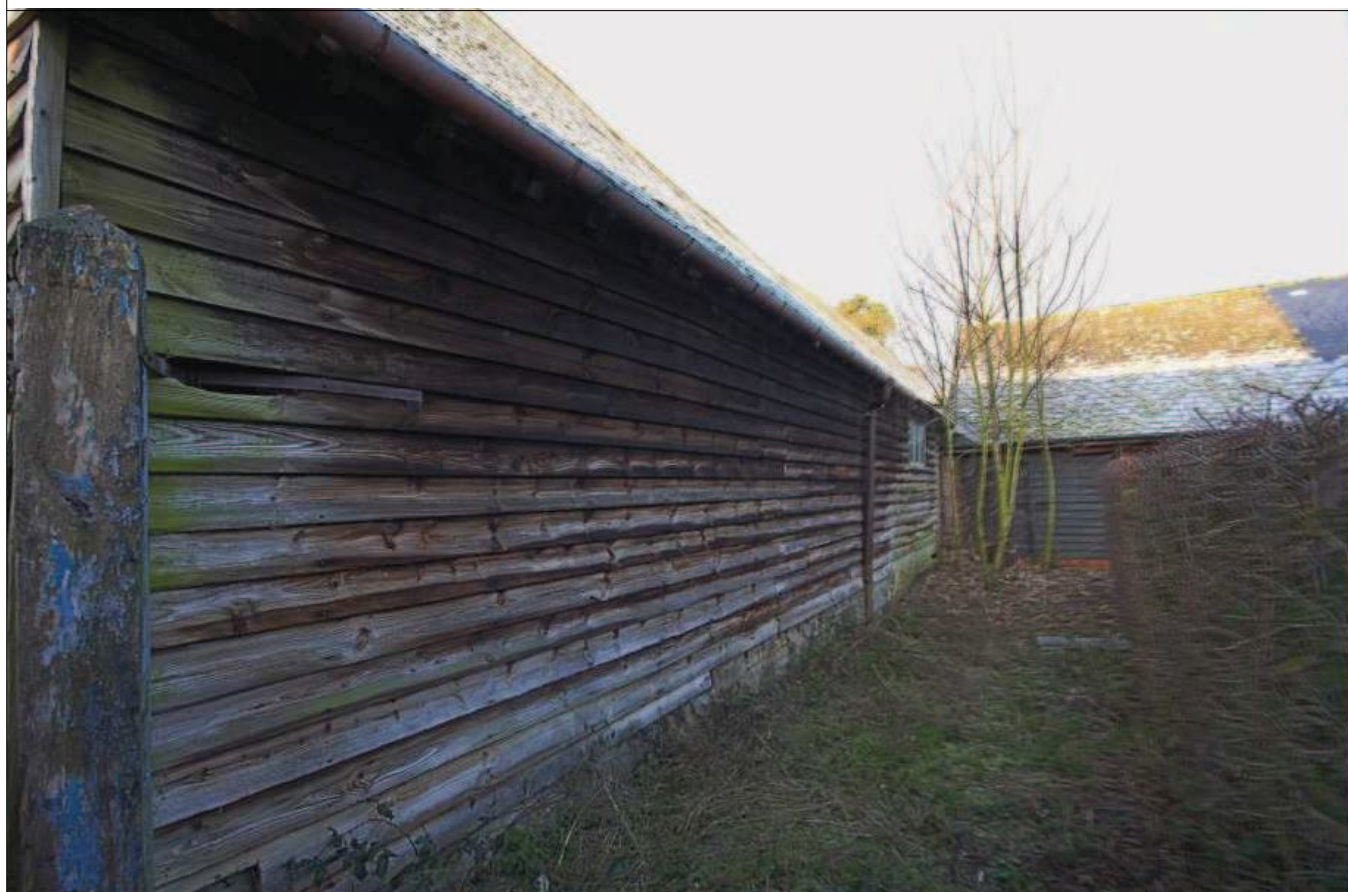
3.8 To the south of the 19th century barn, the elevation is faced with modern weatherboarding (Plate 14). Bay 8 sits on a concrete plinth, with a modern three-light casement inserted below the eaves. Bays 9 and 10 sit on a plinth of Arlesey white bricks measuring 8¾” x 2¾” x 4¼” (222mm x 70mm x 108mm). A modern door has been inserted at the junction of Bays 7 and 8.

Plate 14: East exterior elevation, south end, looking NW

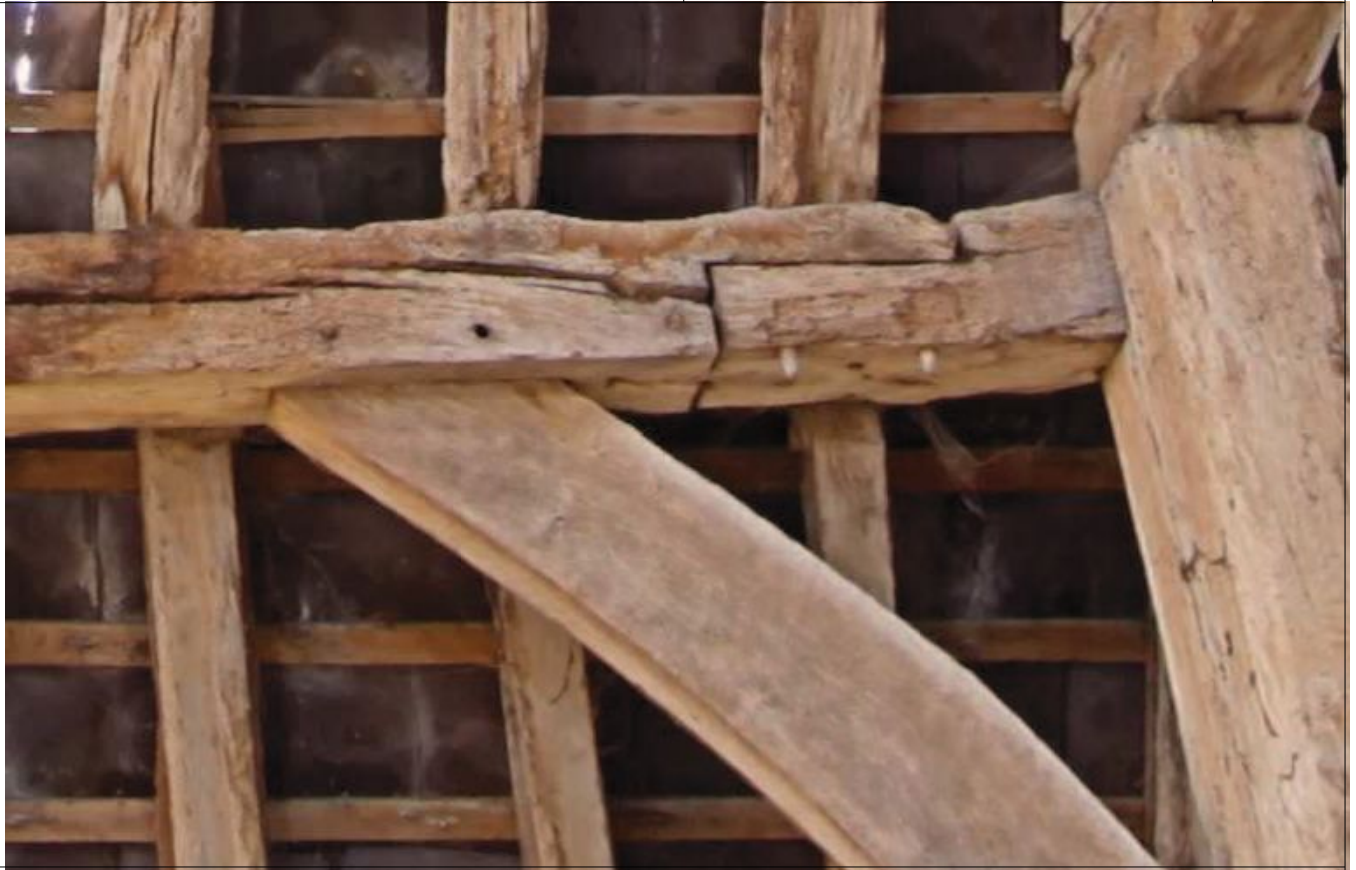
3.13 The arcade and wall plates are formed of lengths of wood of around 27 feet, each extending across approximately two bays, and joined together by edge-halved and bridled scarf joints (Plate 17).

Plate 17: Edge halved and bridled scarf joint to W arcade plate, Bay 7

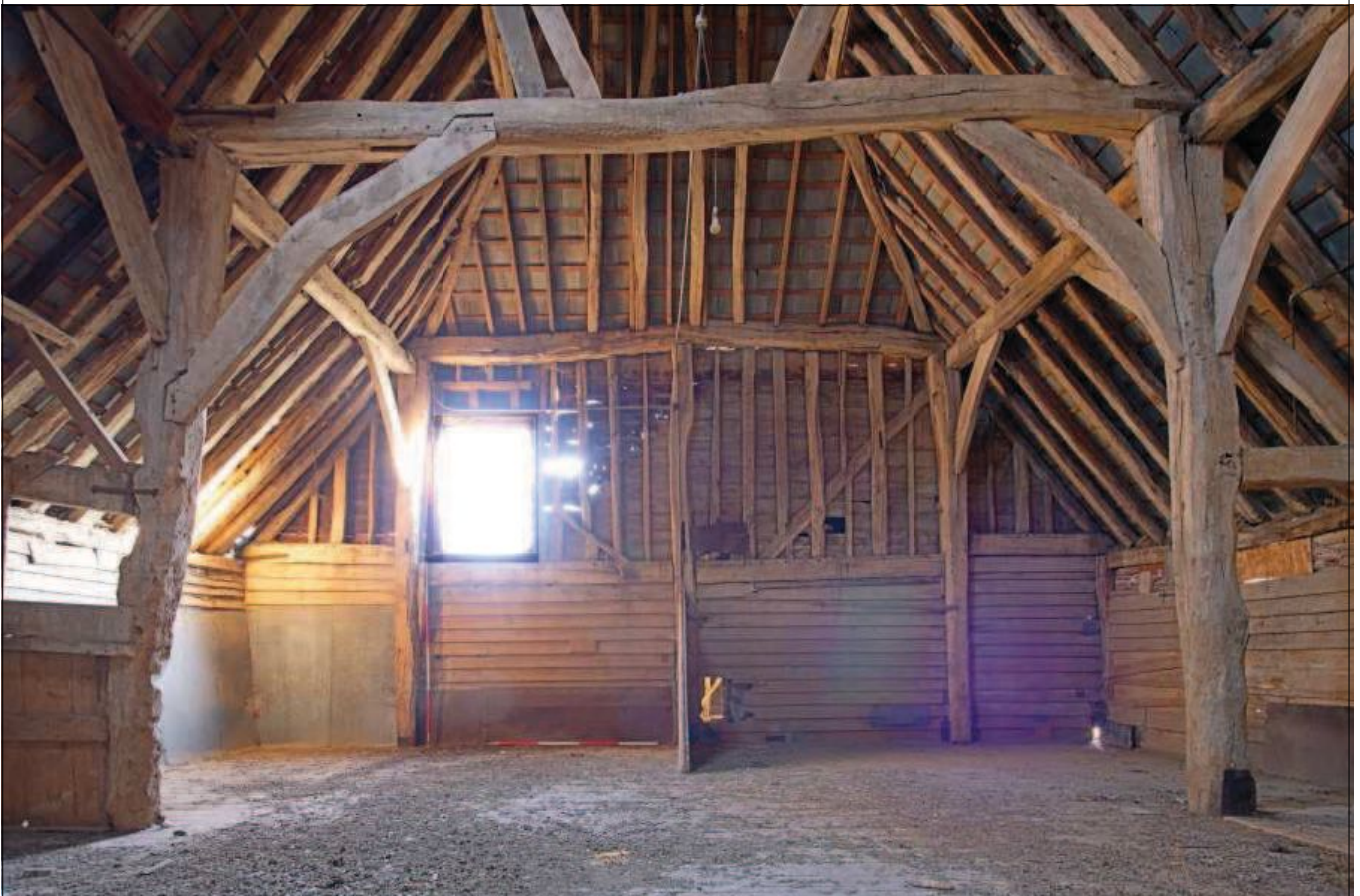
3.15 The southern gable end exhibits peg holes indicative of a similar original layout to that found in the northern gable, but replaced with narrower and more closely spaced studs at a later date, possibly to support the later weatherboarding (Plate 20). Some original rafters to the hip survive (Plate 21).

Plate 20: South gable interior elevation

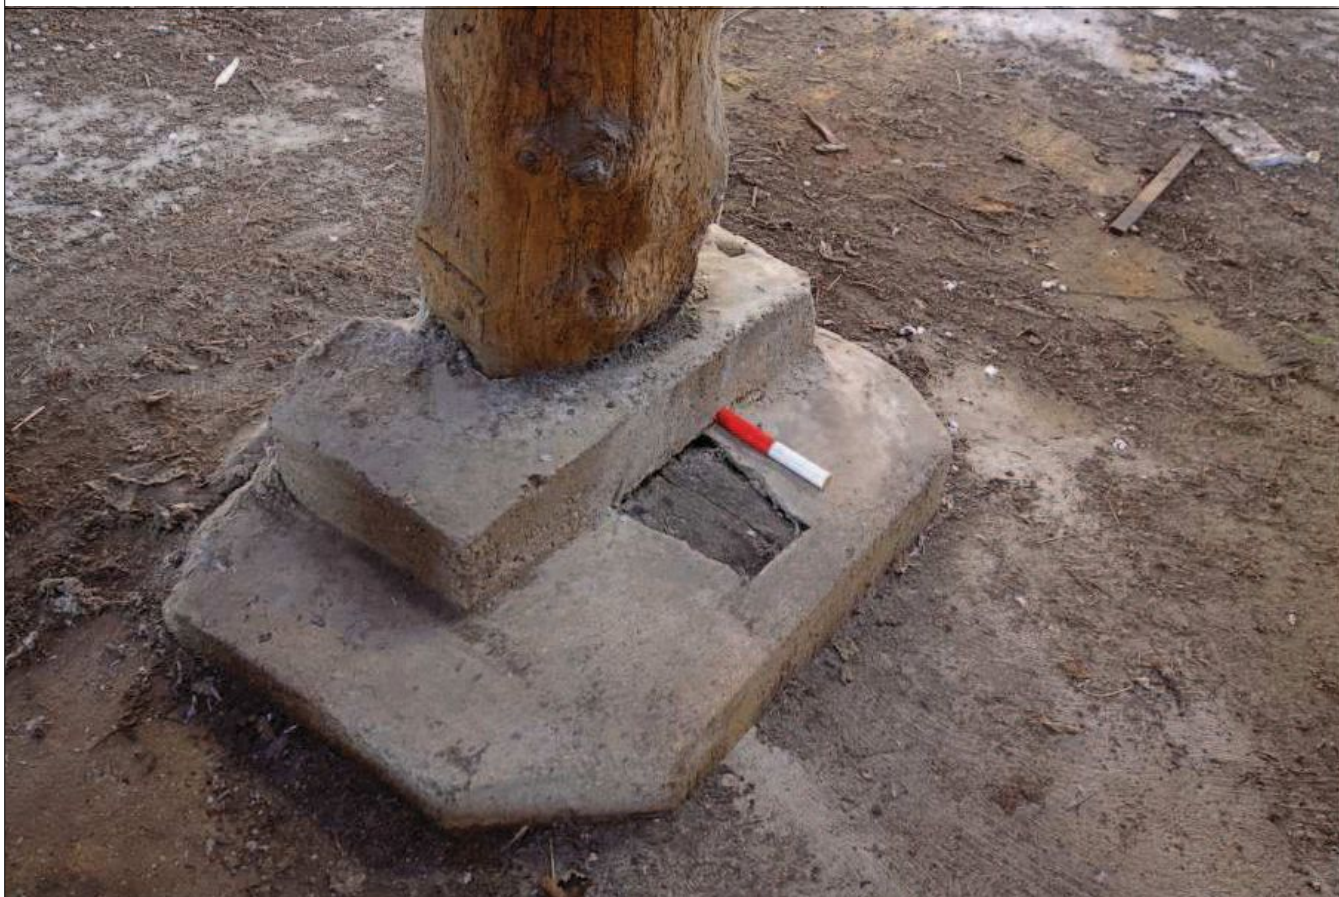
3.16 The arcade posts would originally have rested on peninsular sills running back to the main sill, but these have been replaced in all cases by a concrete pad (Plate 22). A fragment of decayed wood does survive on the east side of the eastern arcade post between Bays 5 and 6, and the listing description suggests that peninsular sills and brick plinths were extant in 1968. Since then the floor of the barn, between Bays 1 and 8, has been replaced in concrete. Evidence may survive in Bays 9 and 10 where a raised wooden threshing floor is still extant, and the elevations are lined with wooden slats to retain the threshed grain (Plate 23).

Plate 22: Detail of concrete pad below arcade post and remains of peninsular sill

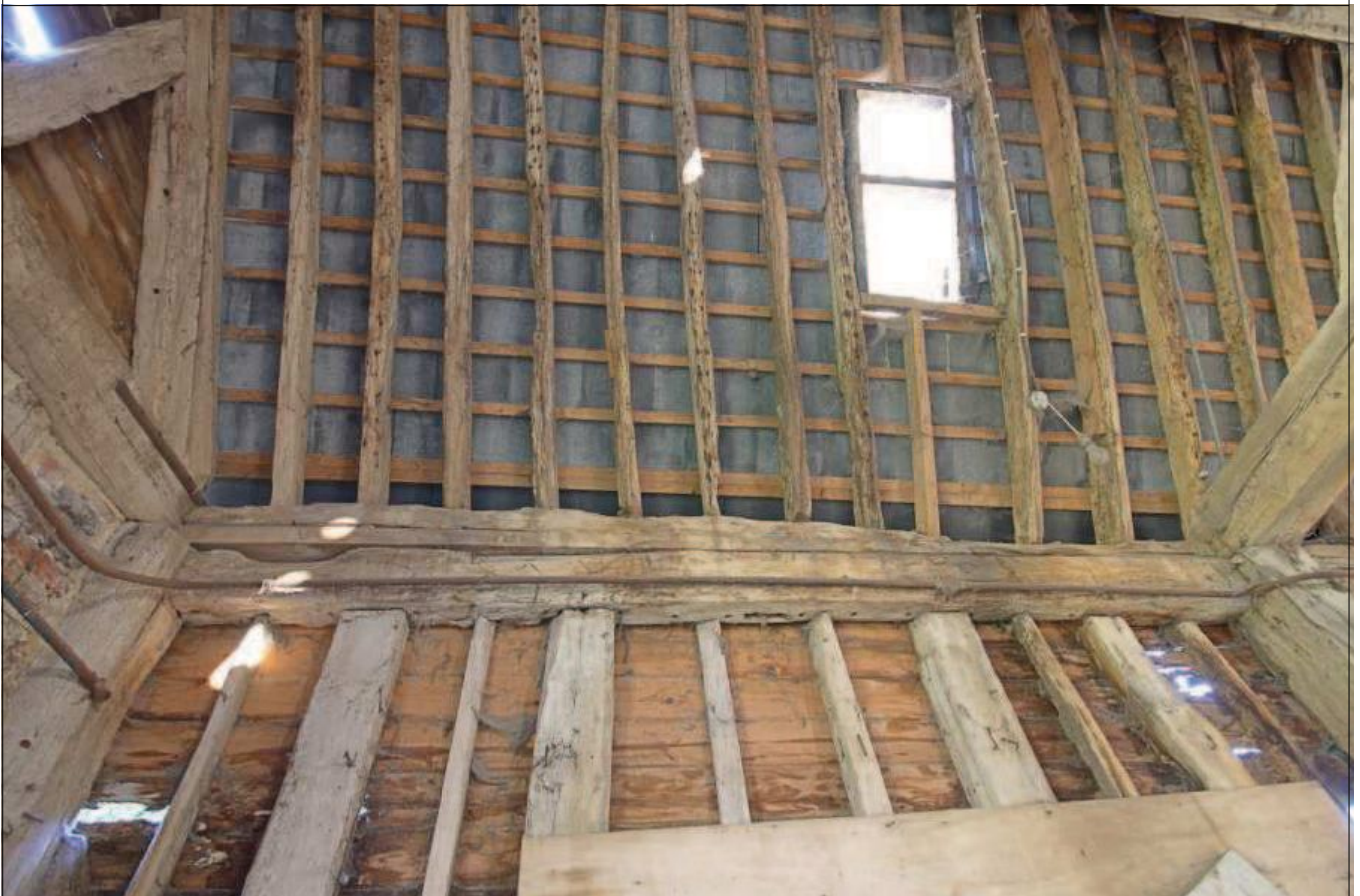
studs, each 7” in width and set on 28” centres, and mortice, tenoned and pegged into the wall plate and sill. Between each stud are groups of three drilled dowel or wattle holes on 8” centres, separated by 10” across the stud and demonstrating that the nogging on the western elevation, and the weatherboarding on the east, were preceded by wattle and daub in-fill at the time of the construction of the barn (Plate 24).

Plate 24: Bay 1, east elevation, underside of wall plate showing dowel holes
