MANOR HOUSE **21 High Street, Baldock, Herts.**

HN503

Historic Building Record

Report No.278

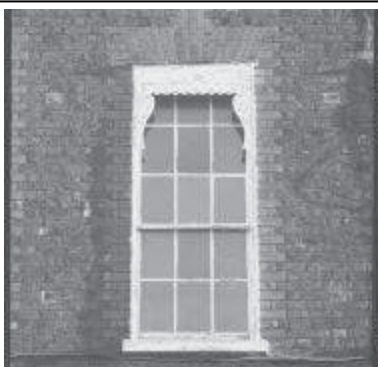
1/5

3.10 The first floor windows are similar to those on the ground floor, but the centre three have shaped wooded casings for blinds fitted to their upper section (Photo 1/5).

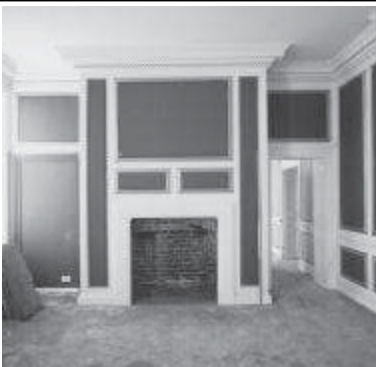
2/5

3.30 The entrance hall is roughly square, having a projecting stack with fireplace on north side (Figure 8). The fireplace has a square chimney piece in stone, having rounded corners with bead moulding (Photo 2/5).

Entrance Hall, North elevation

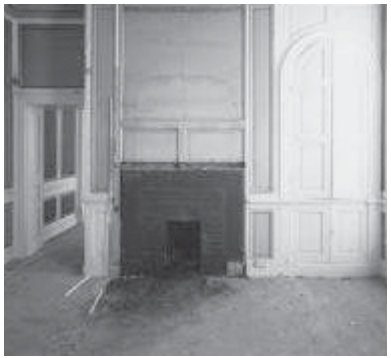
2/12

3.36 To the south, the projecting stack incorporates a modern 20th century chimney piece, with good paneling surviving above (Photo 2/12). To the west of the stack, an arch-headed cupboard with panels in the room style appears to have been built into the alcove at a later date (but still during the 18th century) (Photo 3/1). The upper cupboard has two leafed doors, with interior doors of formed of flush panels. Both the inner and outer doors are lockable suggesting the cupboard's use as a safe. The lower cupboard has a simple two leafed door.

North front, South elevation

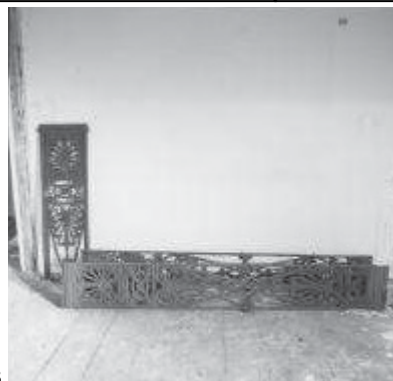
3/3

3.43 A cast-iron gate pillar noted by Pevsner and shown in a photo dated 1950 (HALS AA50/7235), formerly positioned on the street frontage and one of four similar, with honeysuckle decoration in Adam style, was temporarily stored in this room (Photo 3/3).

Cast iron gatepost : detail

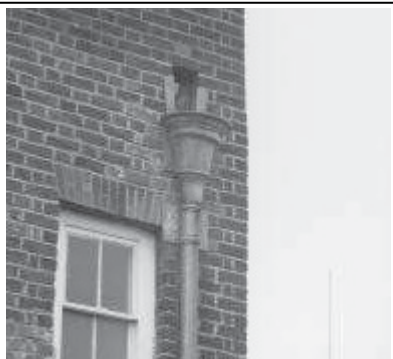
3/9

3.23 At second floor level, to the north of the window noted above, is a four flue chimney stack. To the north of this is a double hung sash window of 6 panes in the house style, a 20th century fire escape door adapted from an earlier window opening in similar style, and a similar window converted to modern glazing. At the northern extent of the second floor, and matching a similar window at the southern extent, is a small double hung sash window of 4 panes with exposed framing. Rising adjacent and to the north of this is an original lead hopper and rainwater down pipe serving the roof (Photo 3/9).

Rainwater Hopper, northeast corner

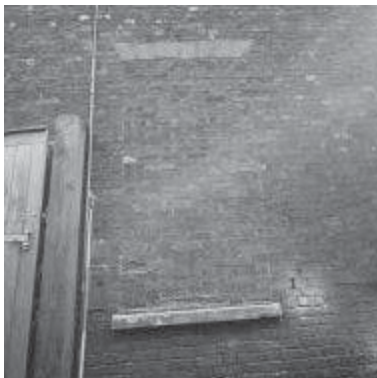
7/2

3.13 At the western end of the ground floor, there is a blocked window with a sill of Portland stone and a slightly segmental voussoired header (Photo 7/2). To the east of this is a small inserted 20th century casement, next to a double hung sash window of 8 panes (arranged 2 x 2 below 2 x 2) with thick framing in earlier 18th century style (Photo 7/3).
