TANKARDS BARN **Tea Green, Offley, Herts.**

HN446

*Historic Building Record
& Archaeological Monitoring Report*

Prepared on behalf of the Kings Walden Estate

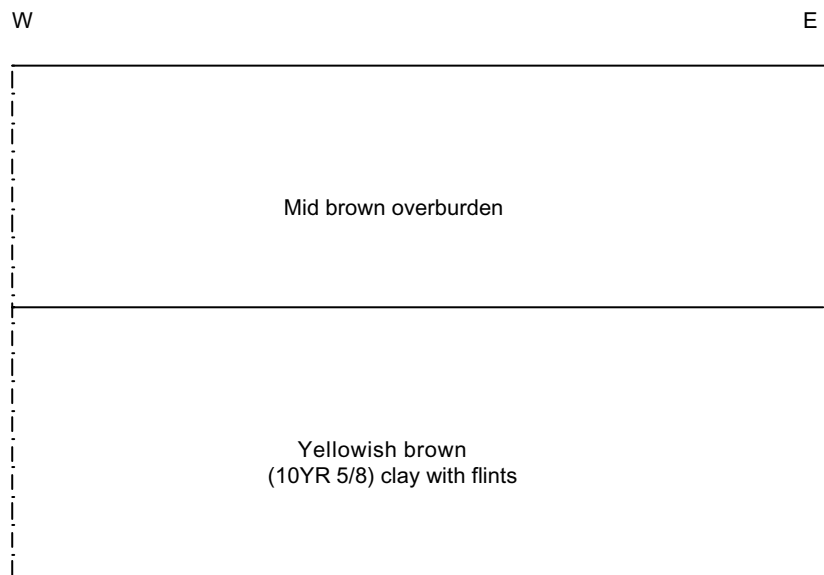
Barn footings

4.4 The underpinning pits demonstrated that the dwarf wall on which the timber frame of the barn rests has only very shallow foundations and in places is built directly onto the natural geology.

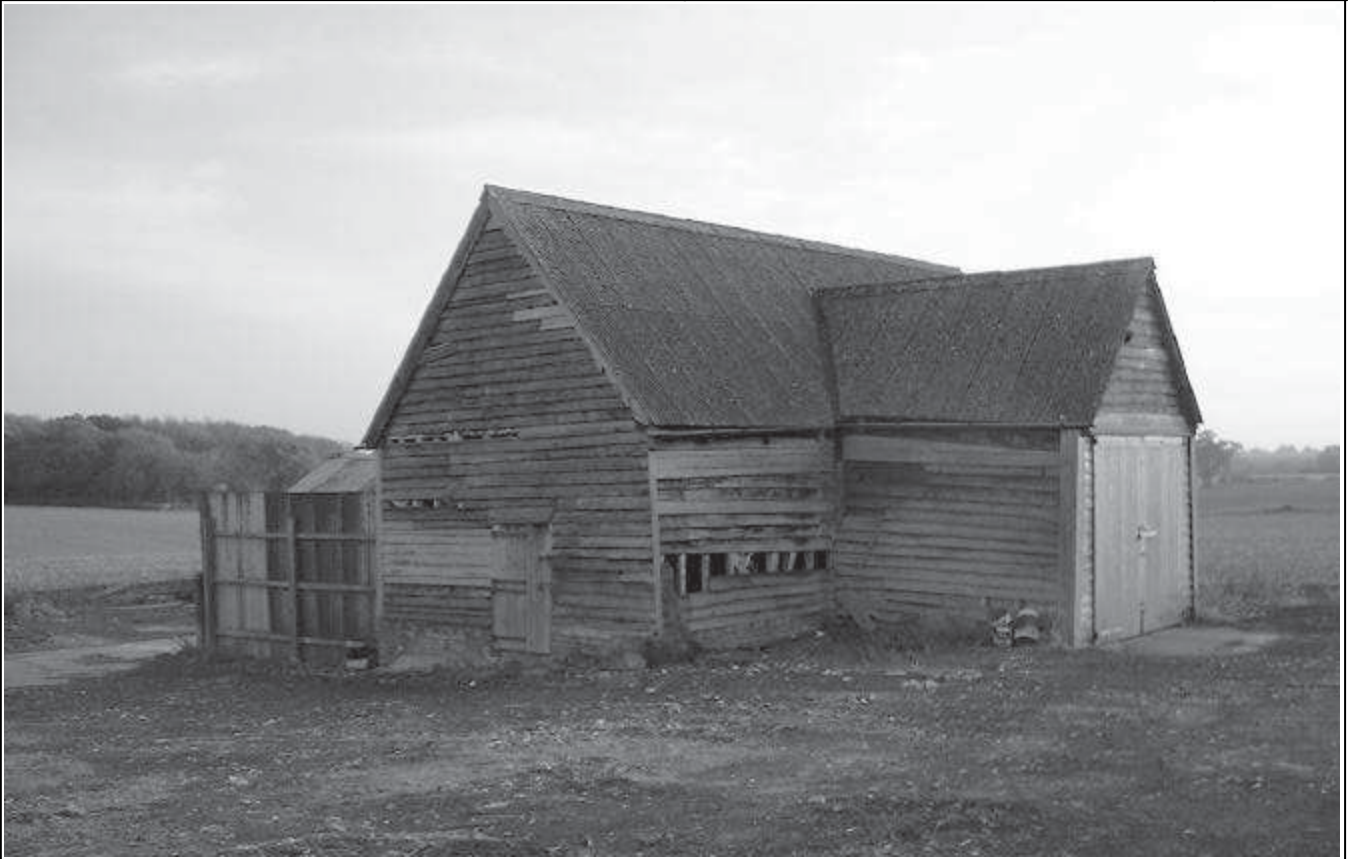
Plate 1a

2.1 The main barn (Building 1) is a 3-bayed, timber structure set on a dark red brick dwarf wall under a corrugated asbestos roof. There is a porch to the north and a livestock shed has been added to the south west corner of the barn (Plates 1a & 1b). The remains of a wall can be seen running northwards from the north east corner of the barn.

Barn (Building 1)

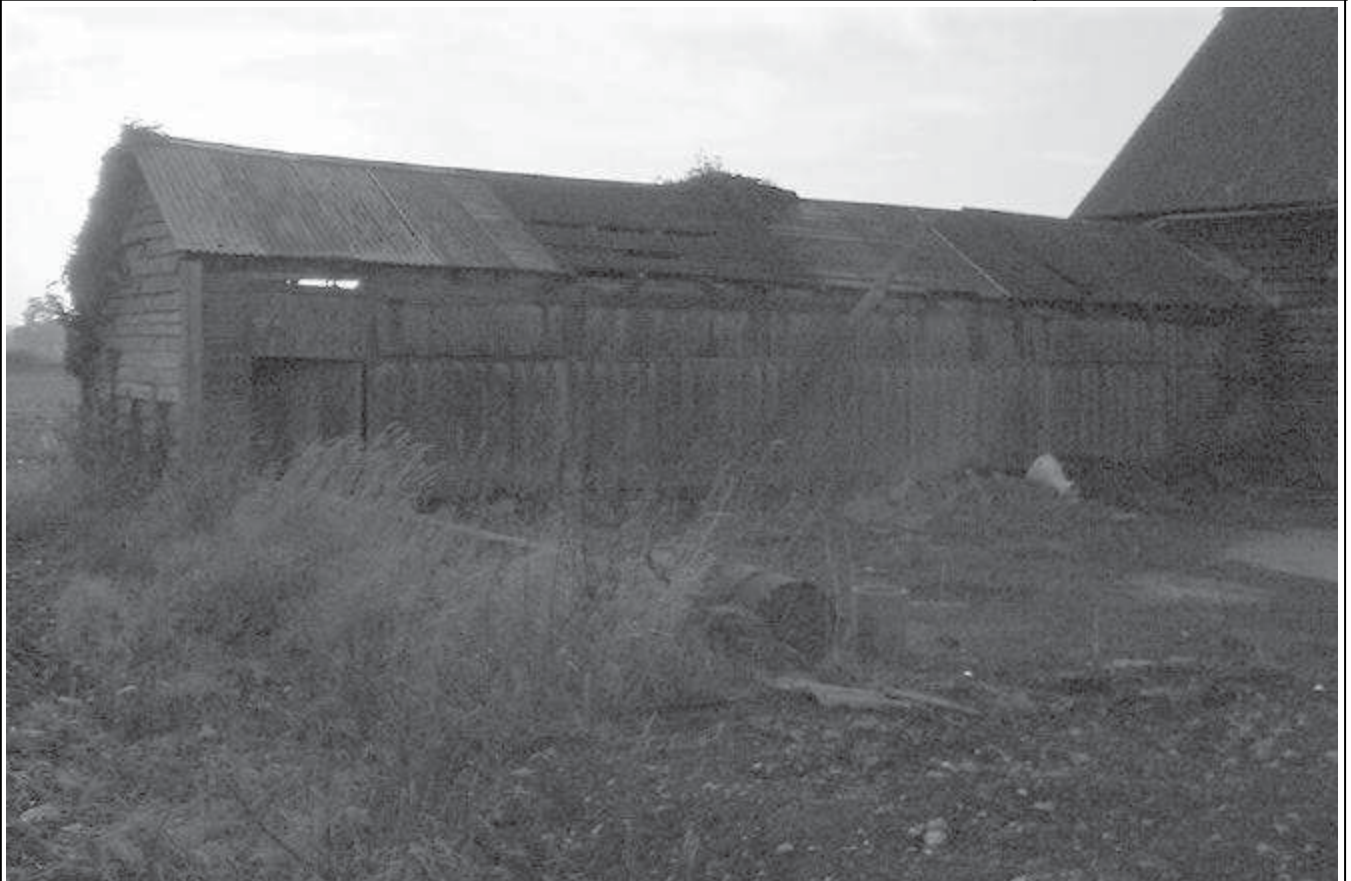
Plate 1b

2.18 This building is orientated north to south and abuts the western end of the south elevation of the barn. It measures 13.50 x 3.40 x 2.25m (h). Whereas the south and west elevations rest on a low dwarf wall, the principal posts in the east elevation are set in concrete bases, which may suggest that this was once open-fronted.

2.25 The shed gives every appearance of having been built at a fairly recent date using both new and used timbers. It may well originally have been an open-fronted building which was enclosed to house livestock. The height of the troughs and the presence of mangers, however, suggests that the name “The Piggeries”, which had been used for the building, does not refer to its most recent use.

Livestock Shed (Building 2)

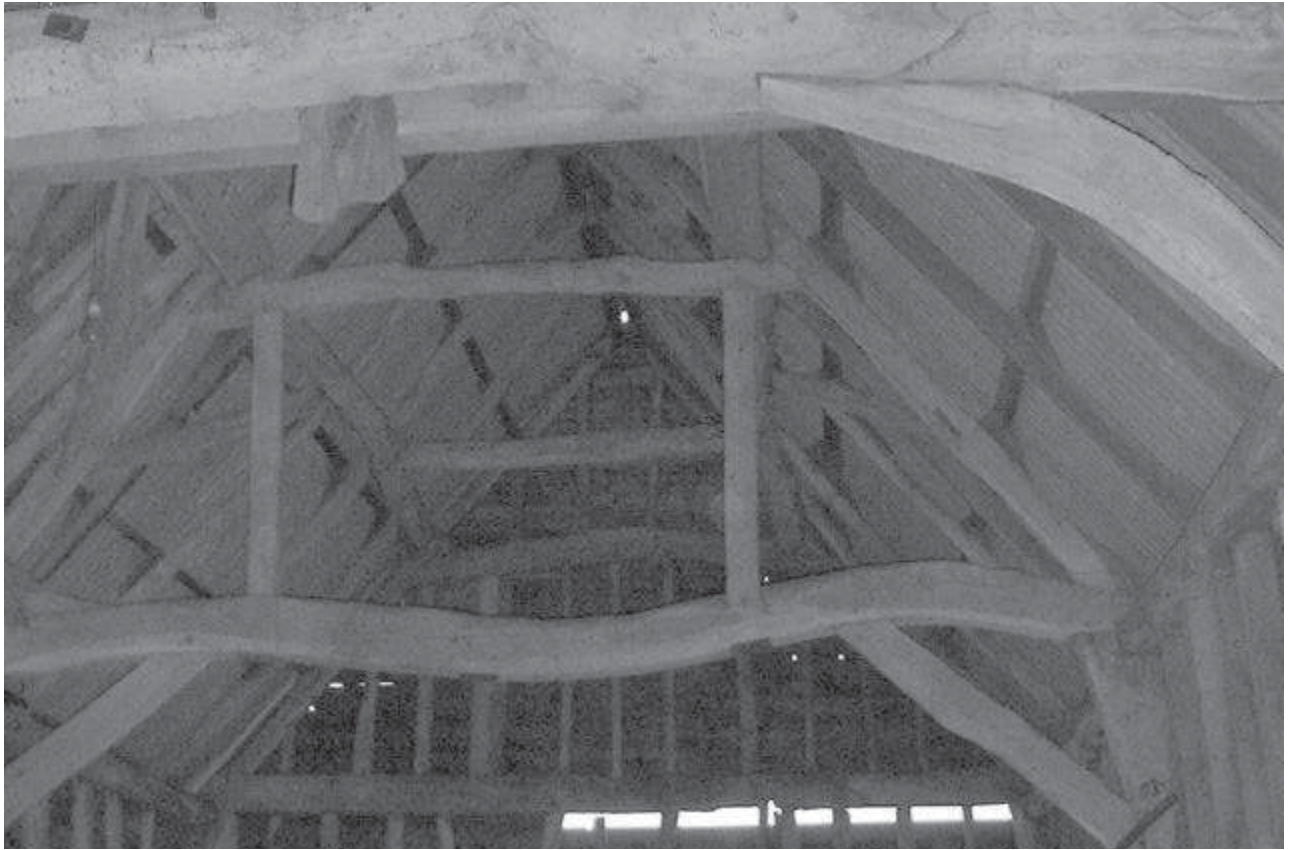
Plate 1a

2.4 The barn has a queen post roof with vertical posts, and was probably originally thatched (Plate 2a). This form of roofing is indicative of a 16th or 17th century construction date. The curved wind braces suggest a date of c.1600. The present roofing material is supported by recently inserted rafters with cleats. Although most of the rafters are generally waney-edged, six on the south elevation are squared timbers, which may suggest that they are replacements. They all have additional braces at the bottom, which gives a stepped effect.

Building 1: queen post roof, looking east

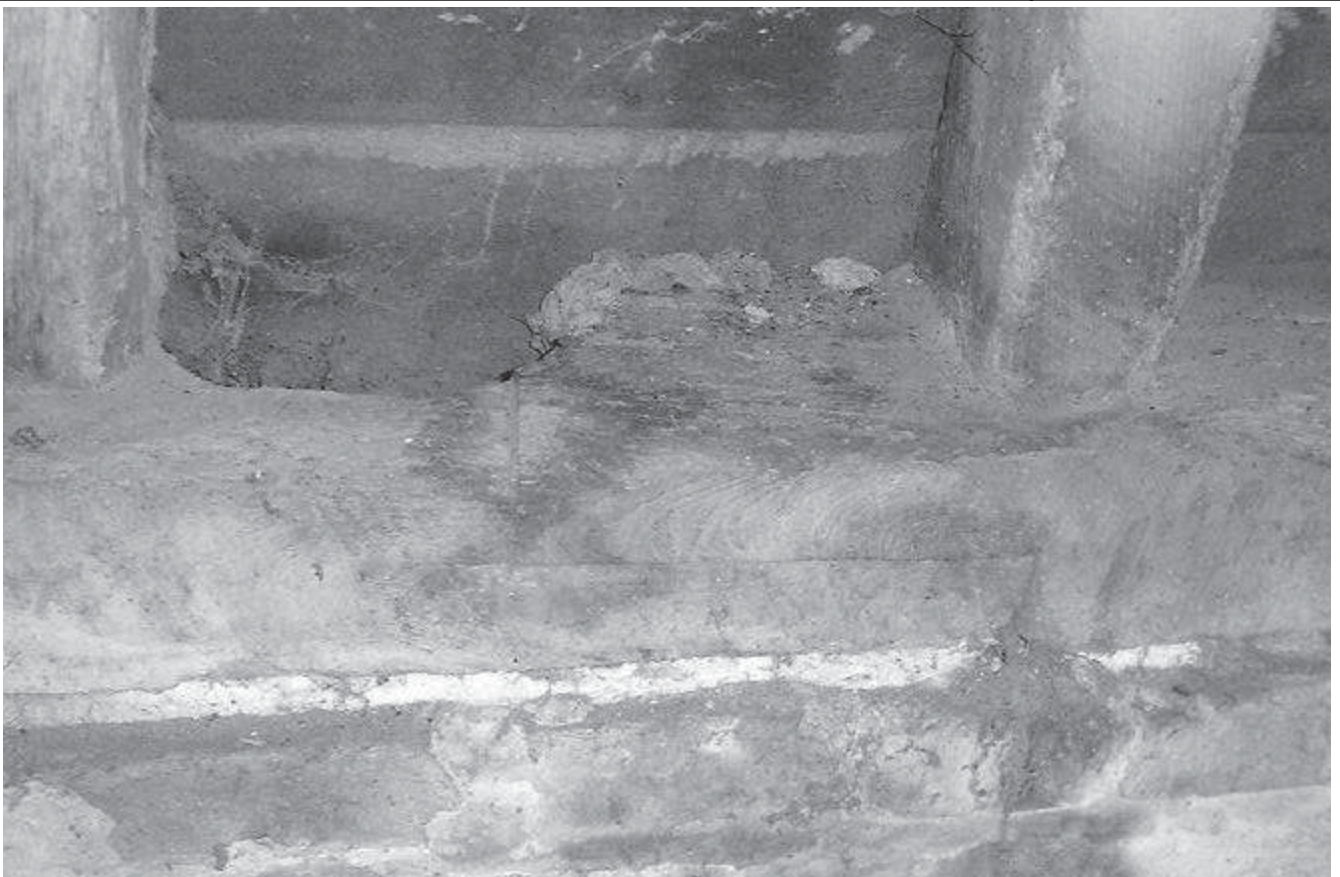
Plate 1b

2.7 The south and west elevations have primary bracing, which suggests a date of no earlier than c.1600. The wall plate and sill beam, however, have rudimentary scarf joints. The edge-halved joint in the wall plate west of the door and the edge-halved scarf joint with square abutments in the sill beam east of the door (Plate 2b) suggest a date prior to the end of the 16th century when face-halved scarf joints became more commonly used. Although two face-halved joints are also present in this elevation,

Building 1: edge-halved scarf joint with square abutments

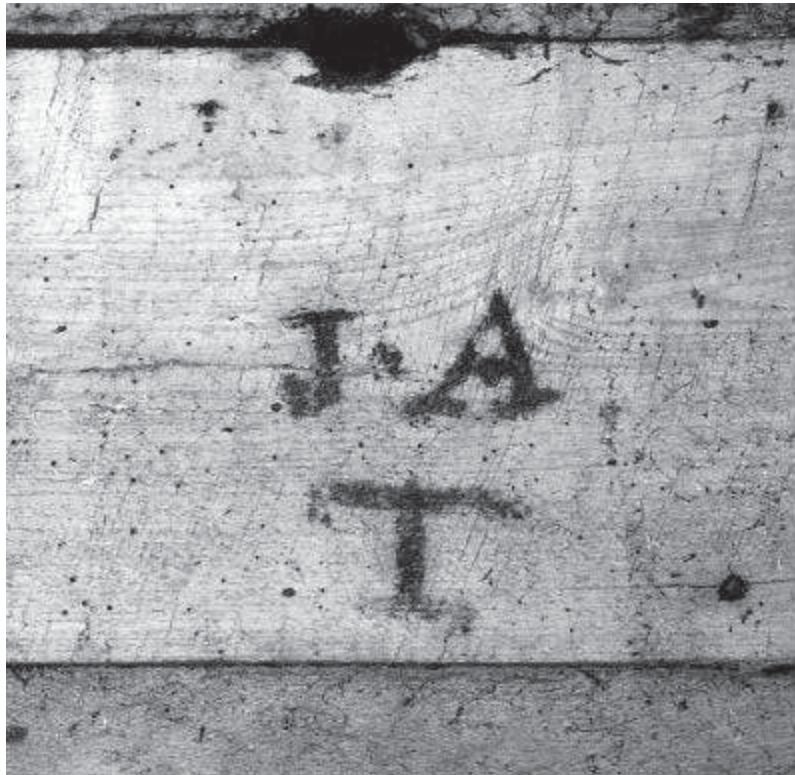
Plate 2a

2.17 Graffiti is present on both sides of the porch. The initials *JAT* have been carved into the panelling on the west elevation whilst the initials *MM* on the south east principal post have been formed by a series of circular indentations (Plates 3a & 4b). The initials *MM* were frequently scratched into posts near to the entrances of buildings in the 17th century to ward off witches.

Graffiti on the west elevation of the porch

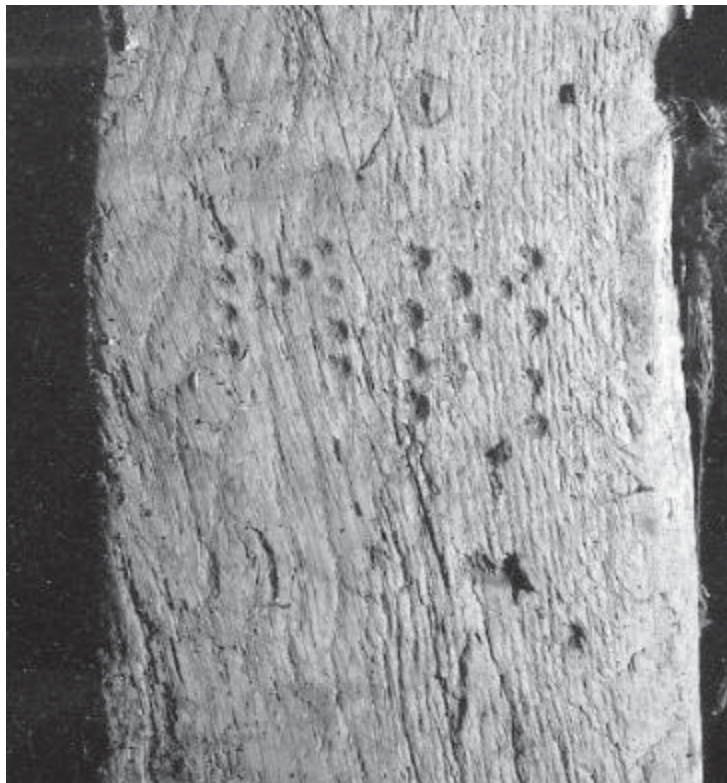
Plate 2b

Graffiti on the south east principal post of the porch
