LETCHWORTH HALL HOTEL
Letchworth, Herts

HN520

Archaeological Monitoring Report

Report no.320

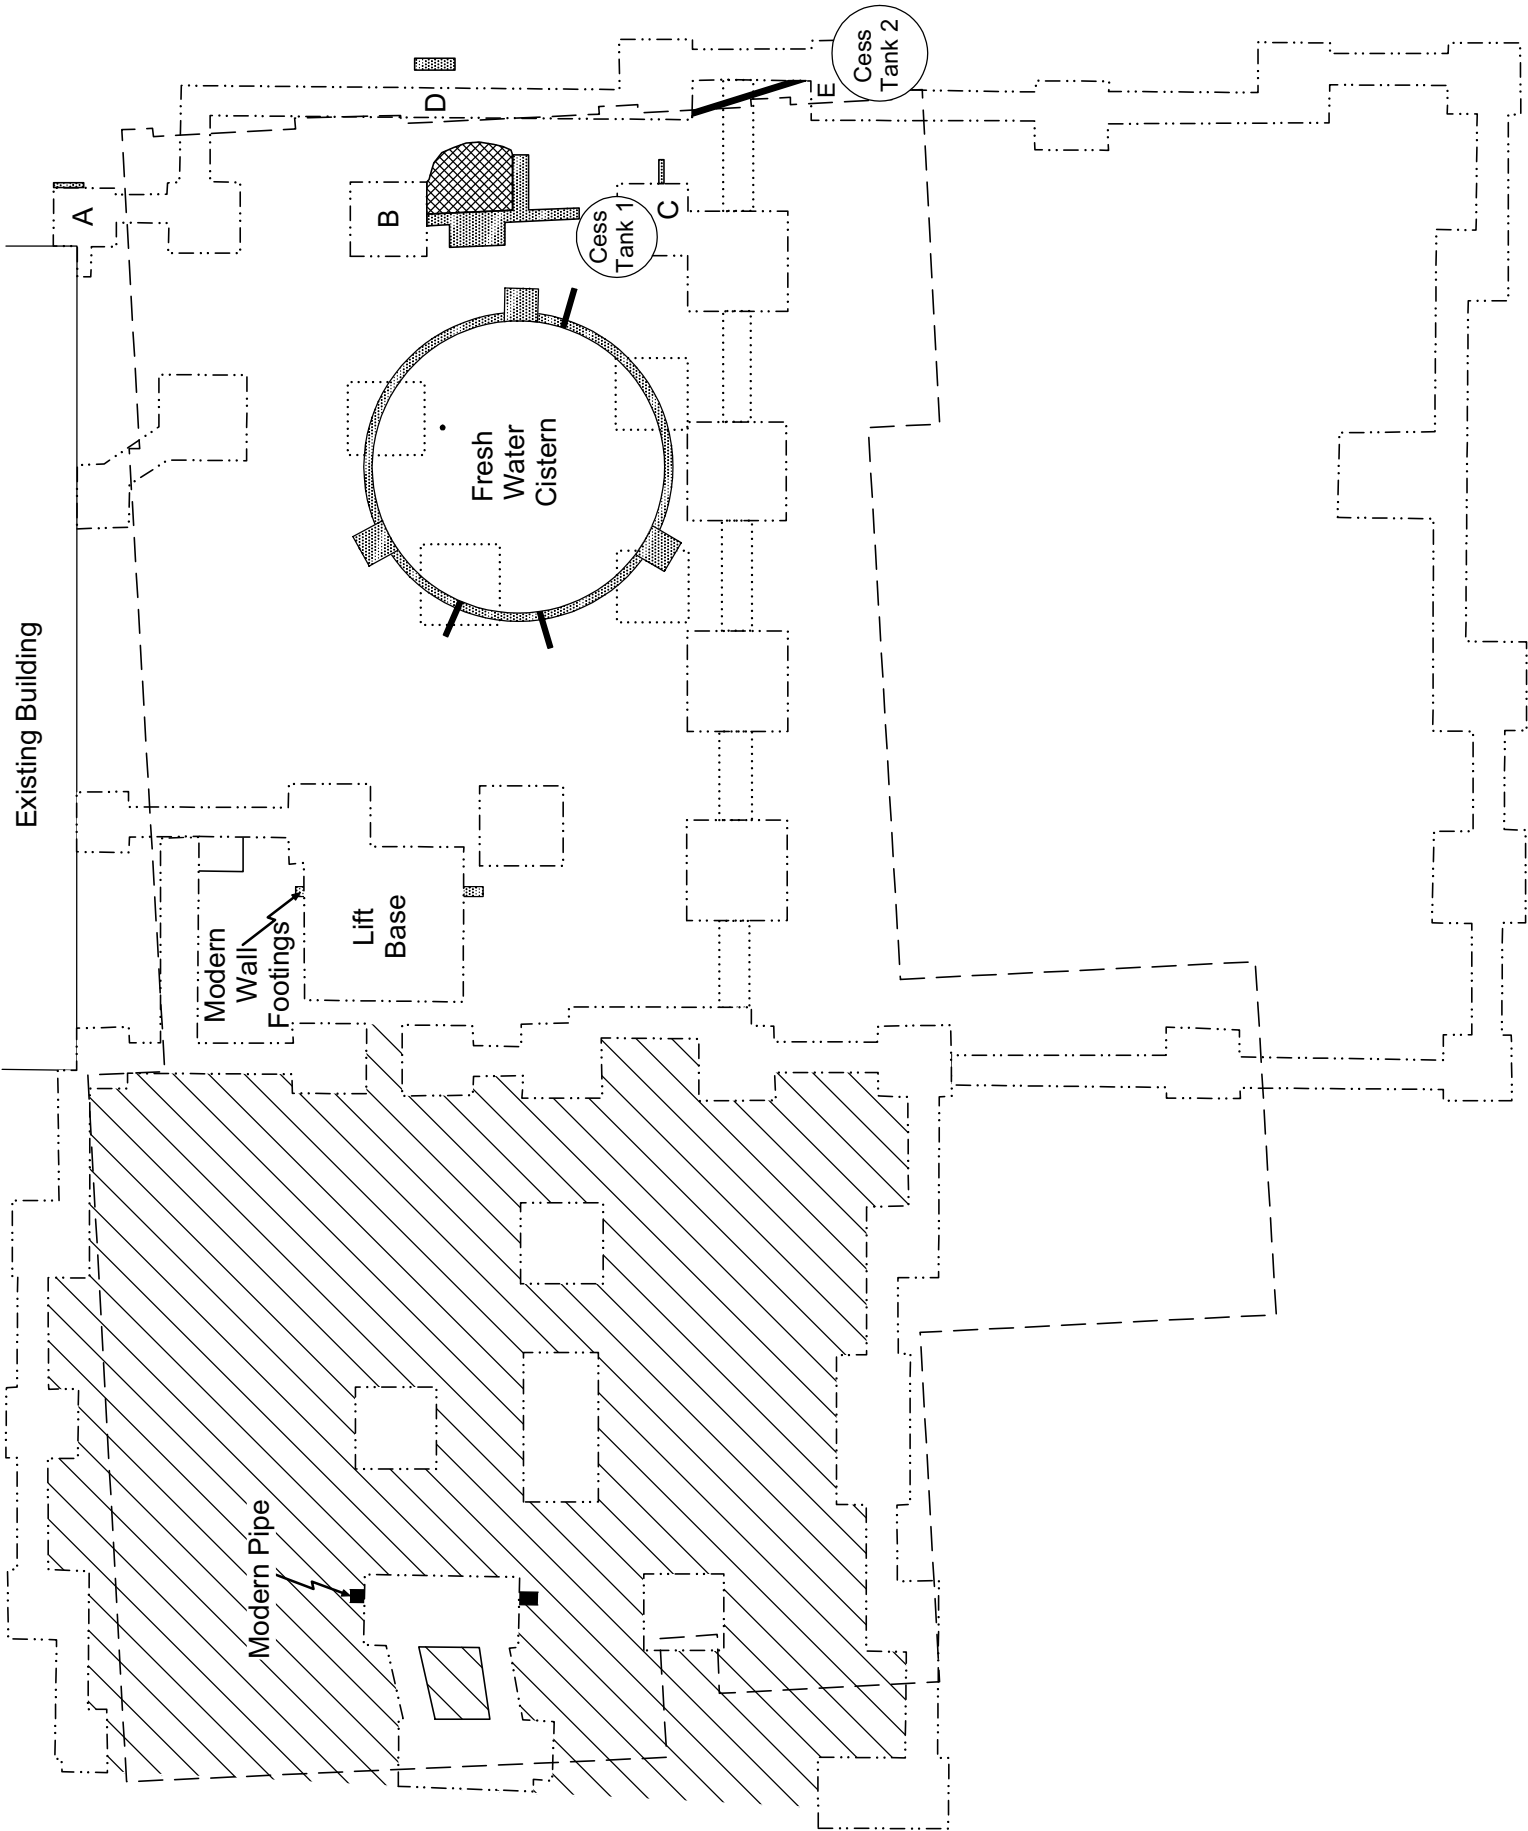
Figure 2

2.9 The remaining area of approximately 538m² was reduced by 0.6m through the made-up ground associated with the Alington Suite. During this process a number of structures were exposed including a large brick built tank, two cess tanks, a number of wall fragments and a floor surface (Figure 2).

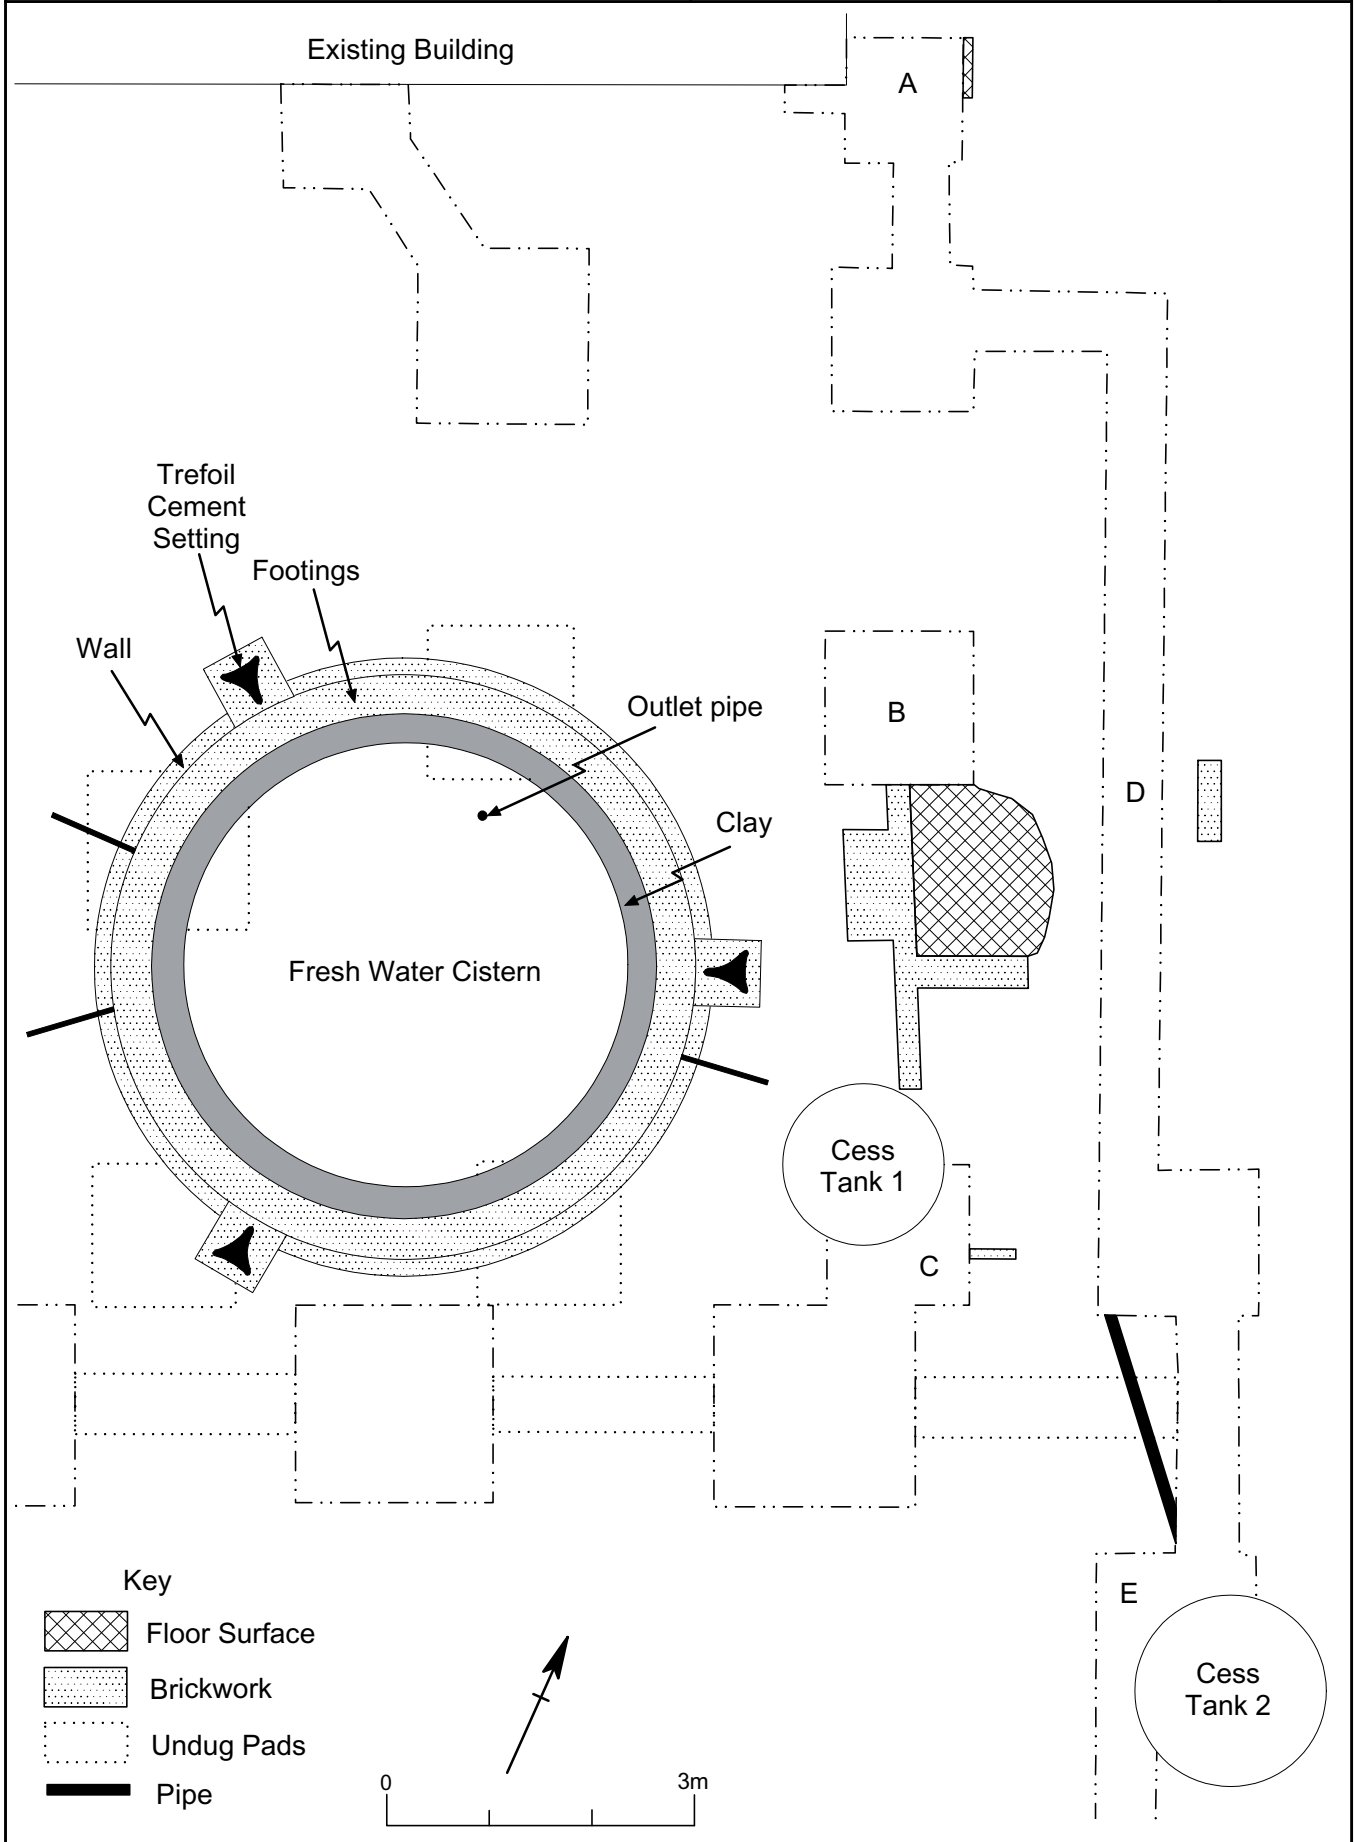
Figure 3

its perimeter. Set into the top of the piers were the remains of trefoil cement settings, each supporting three metal uprights that appear to have formed a superstructure to the tank. The floor was 0.5m thick and consisted of three courses of brick underlying two courses of tile. Below the floor level the walls were 0.4m thicker and stepped into the body of the cistern. These wall footings were built directly onto a layer of grey clay that extended a further 0.3m into the body of the tank and was 0.15m thick. The whole of the inside of the structure appears to have been coated in a bitumen-like substance (Figure 3).

2.16 Two cess tanks were exposed in pads C and E (Figure 3). Tank 1 was 1.6m in diameter and approximately 2m deep. It was domed and brick built with a cement mortar bonding and a cement render lining. Tank 2 was of identical construction though slightly larger, measuring 1.9m in diameter and 3m in depth. There was also a 0.1m diameter ceramic pipe running northwest from this tank towards some footings exposed between pads B and C.

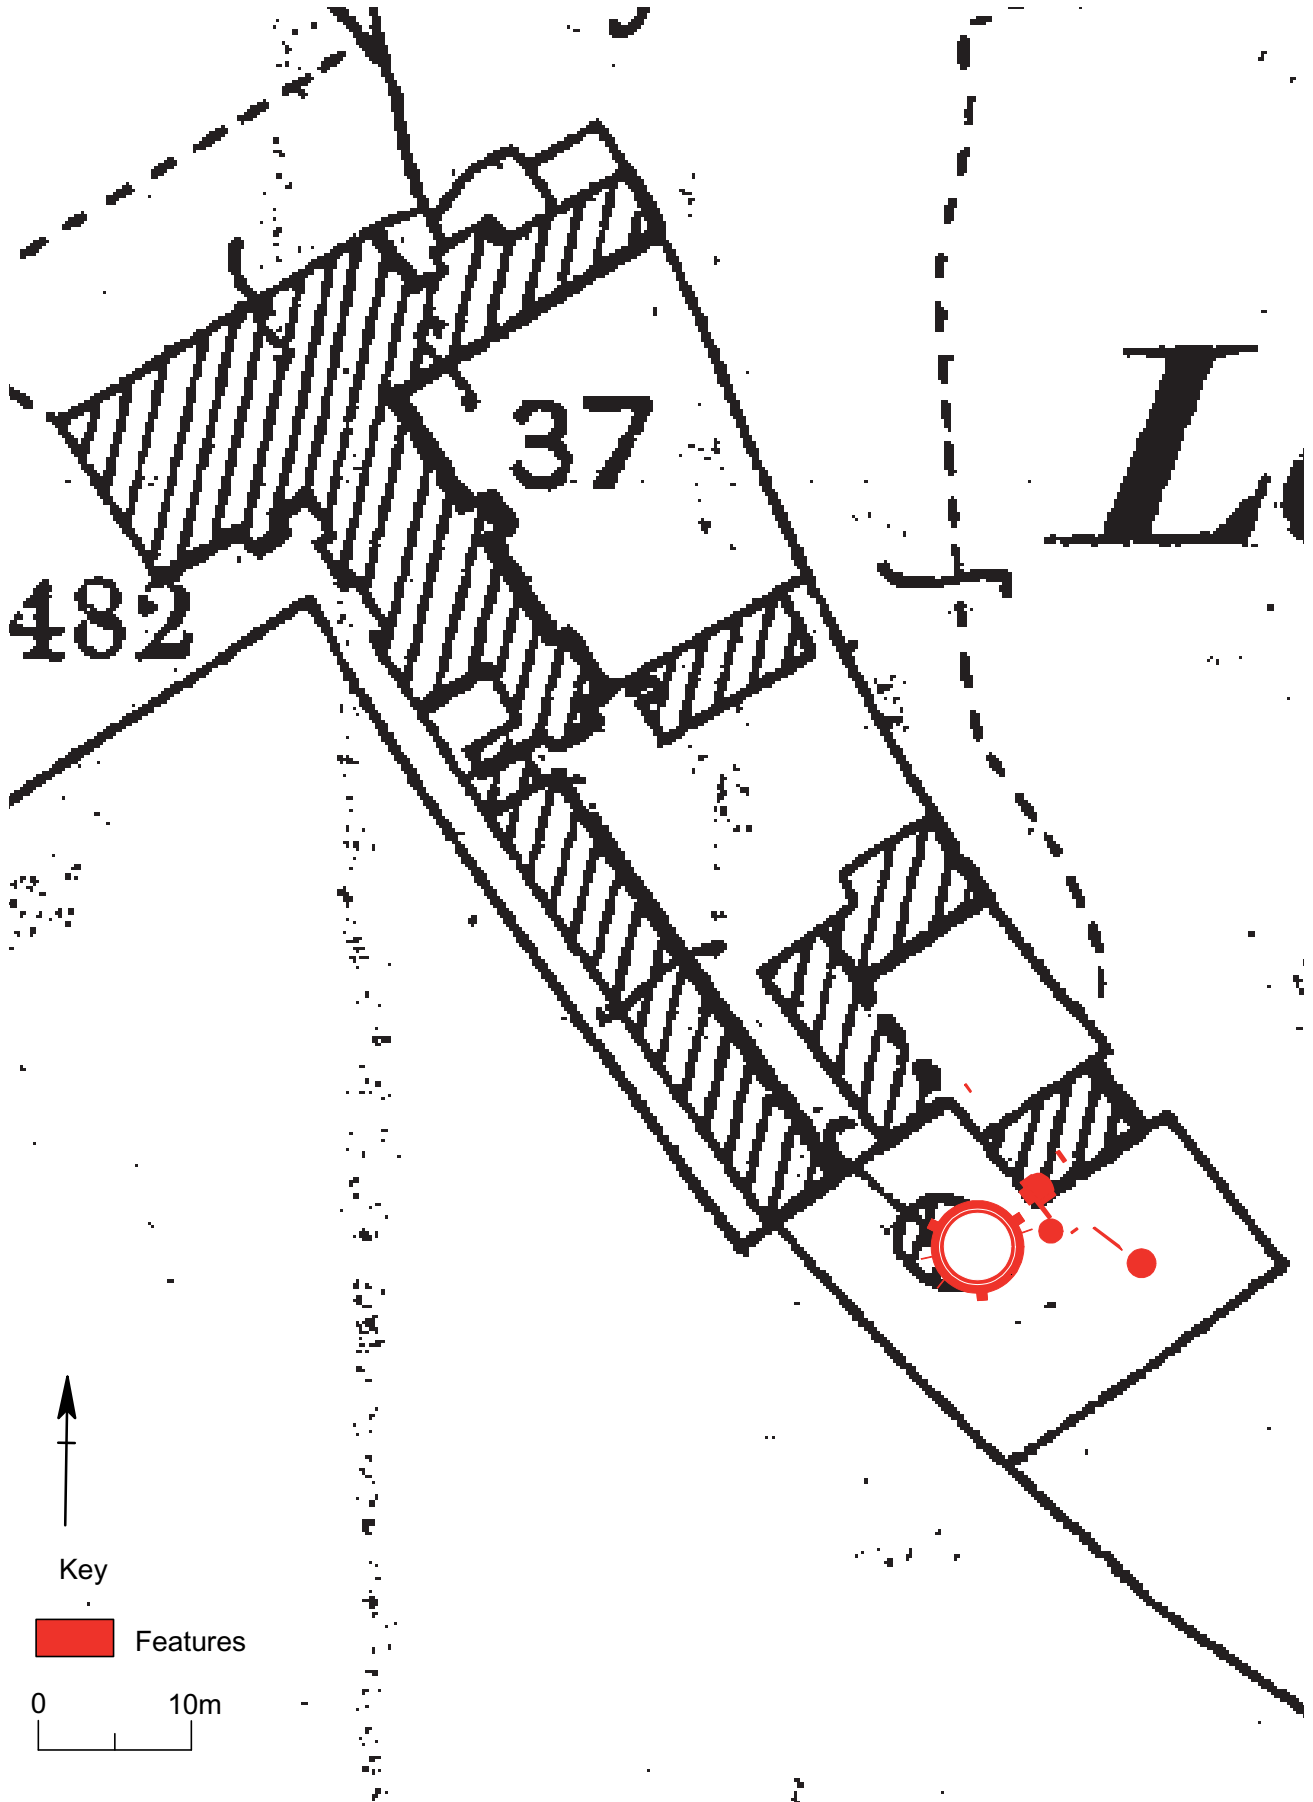
Scale 1:500
Figure 4

3.2 The archaeology is concentrated in the northeast quadrant of the present development area. The vast majority of it appears to be Victorian in date though the wall fragment in Pad A is probably mid 18th century (Figure 4). Due to the small size of the fragment it not possible to say what the original structure was.

3.6 The 2nd edition Ordnance Survey map shows what appears to be the cistern within a walled enclosure, probably a garden. To the north and northwest is what may be stables, feed stores and cart sheds. The outlet pipe was orientated towards these buildings.

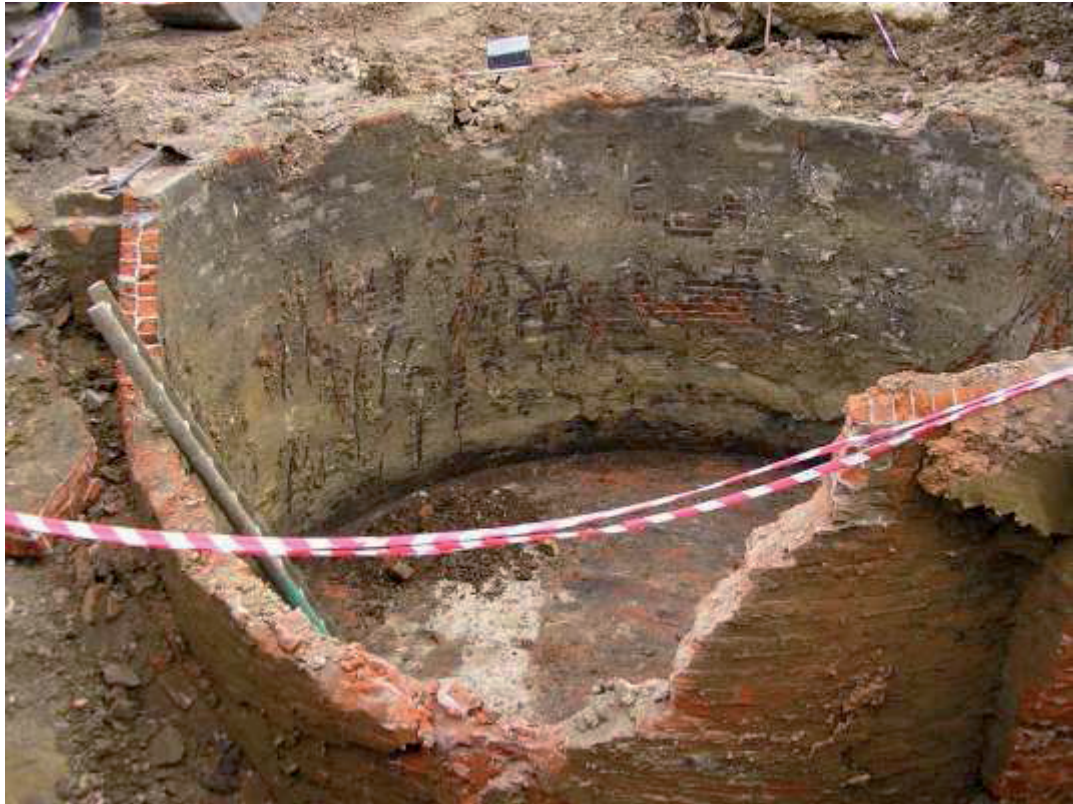
2.10 The large cistern measured 5.8m in diameter and was approximately 3.1m deep and was situated in the proposed location of four column pads. It was constructed of brick with cement mortar, two courses thick with three 0.65m square, stone capped piers situated equidistant around

3.3 The large cistern was probably intended to collect rainwater with inlet pipes at the top and an outlet pipe at the bottom. The piers may have supported a roof structure or formed part of a float mechanism to indicate the water level within. The function of the metal collar at the base of the tank is unclear though conceivably it may have formed part of a filtration system. This was a substantial structure possibly designed to provide water for the gardens and stables. It was capable of holding an estimated 15,000 gallons of water. Although not well documented, similar structures are know to exist at Wimpole Hall in Cambridgeshire and Kew Gardens, Surrey.

Plate 1a: General view of tank facing south

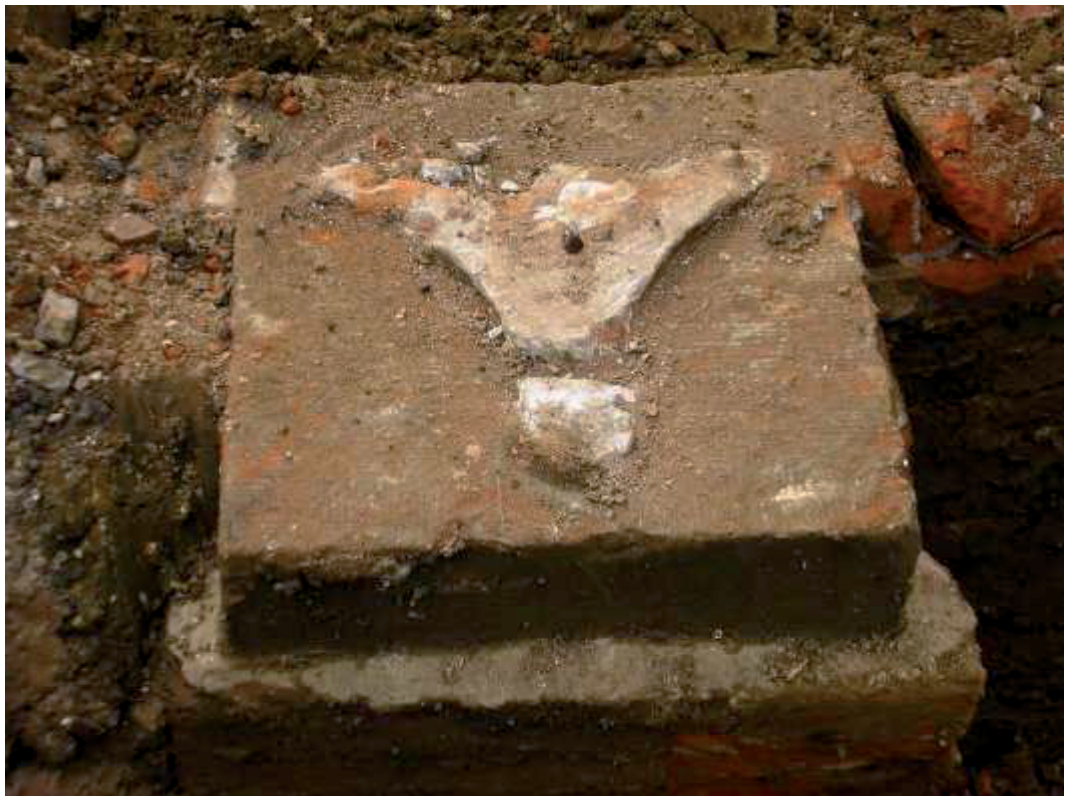
Plate 1b: Top of pier

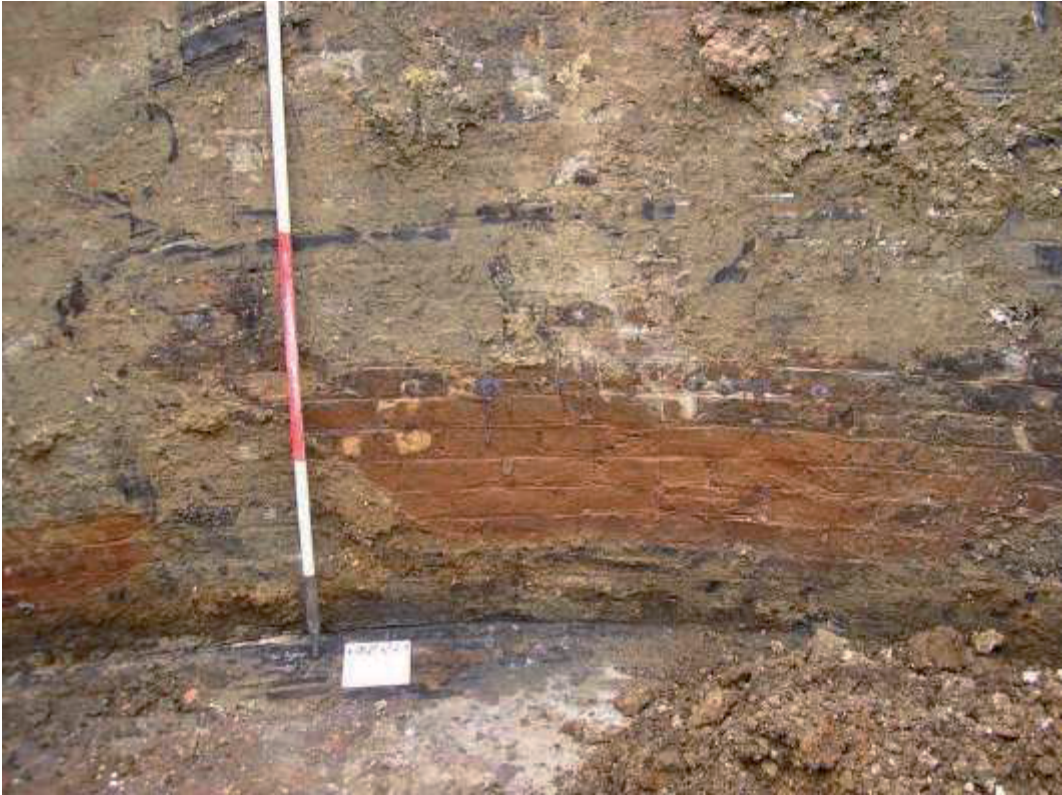
2.12 Inside the tank there was evidence of a metal collar that once lined the bottom of the wall to a height of 0.75m from the base. It was constructed a series of ferrous metal plates held together with 12mm rivets and secured to the wall with a ring of 6mm metal rivets or studs approximately 10cm below the rim. There was no evidence that this collar extended to line the base of the tank.

Plate 2a: Rust line left by iron collar

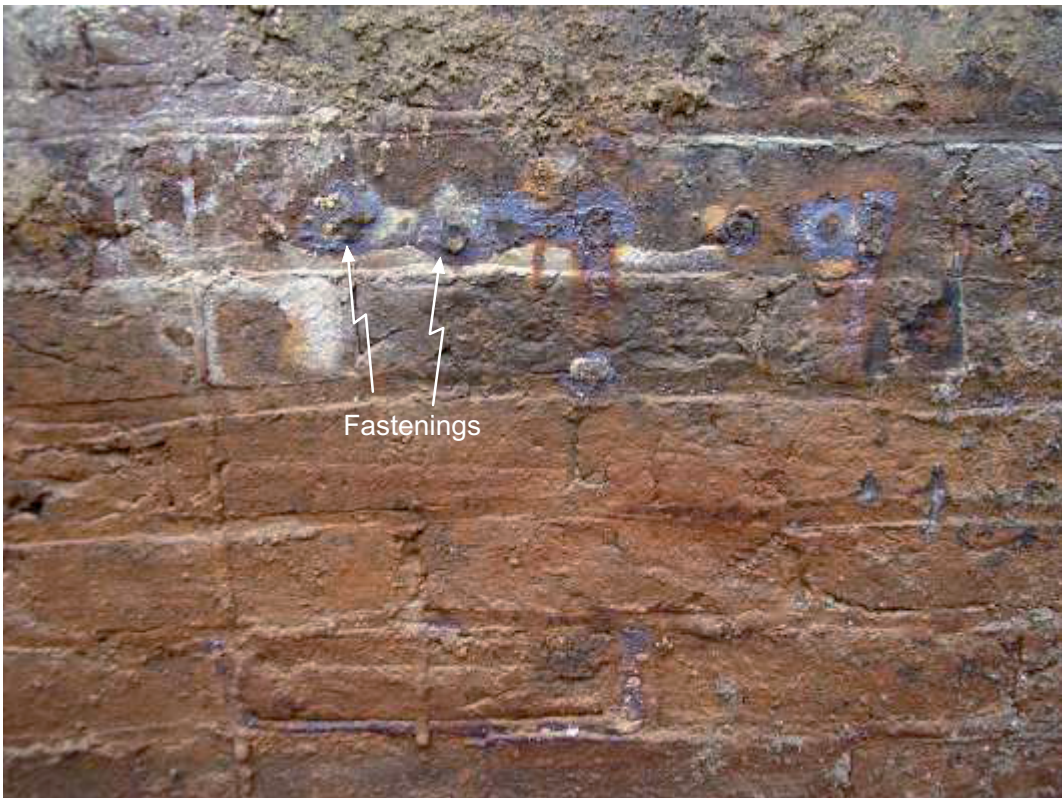
Plate 2b: Close up of fastenings for collar
