## 'SHIPWRIGHTS COTTAGE' Cottered, Herts.

HN530

*Historic Building Recording  
& Archaeological Monitoring Report*

Report no.332

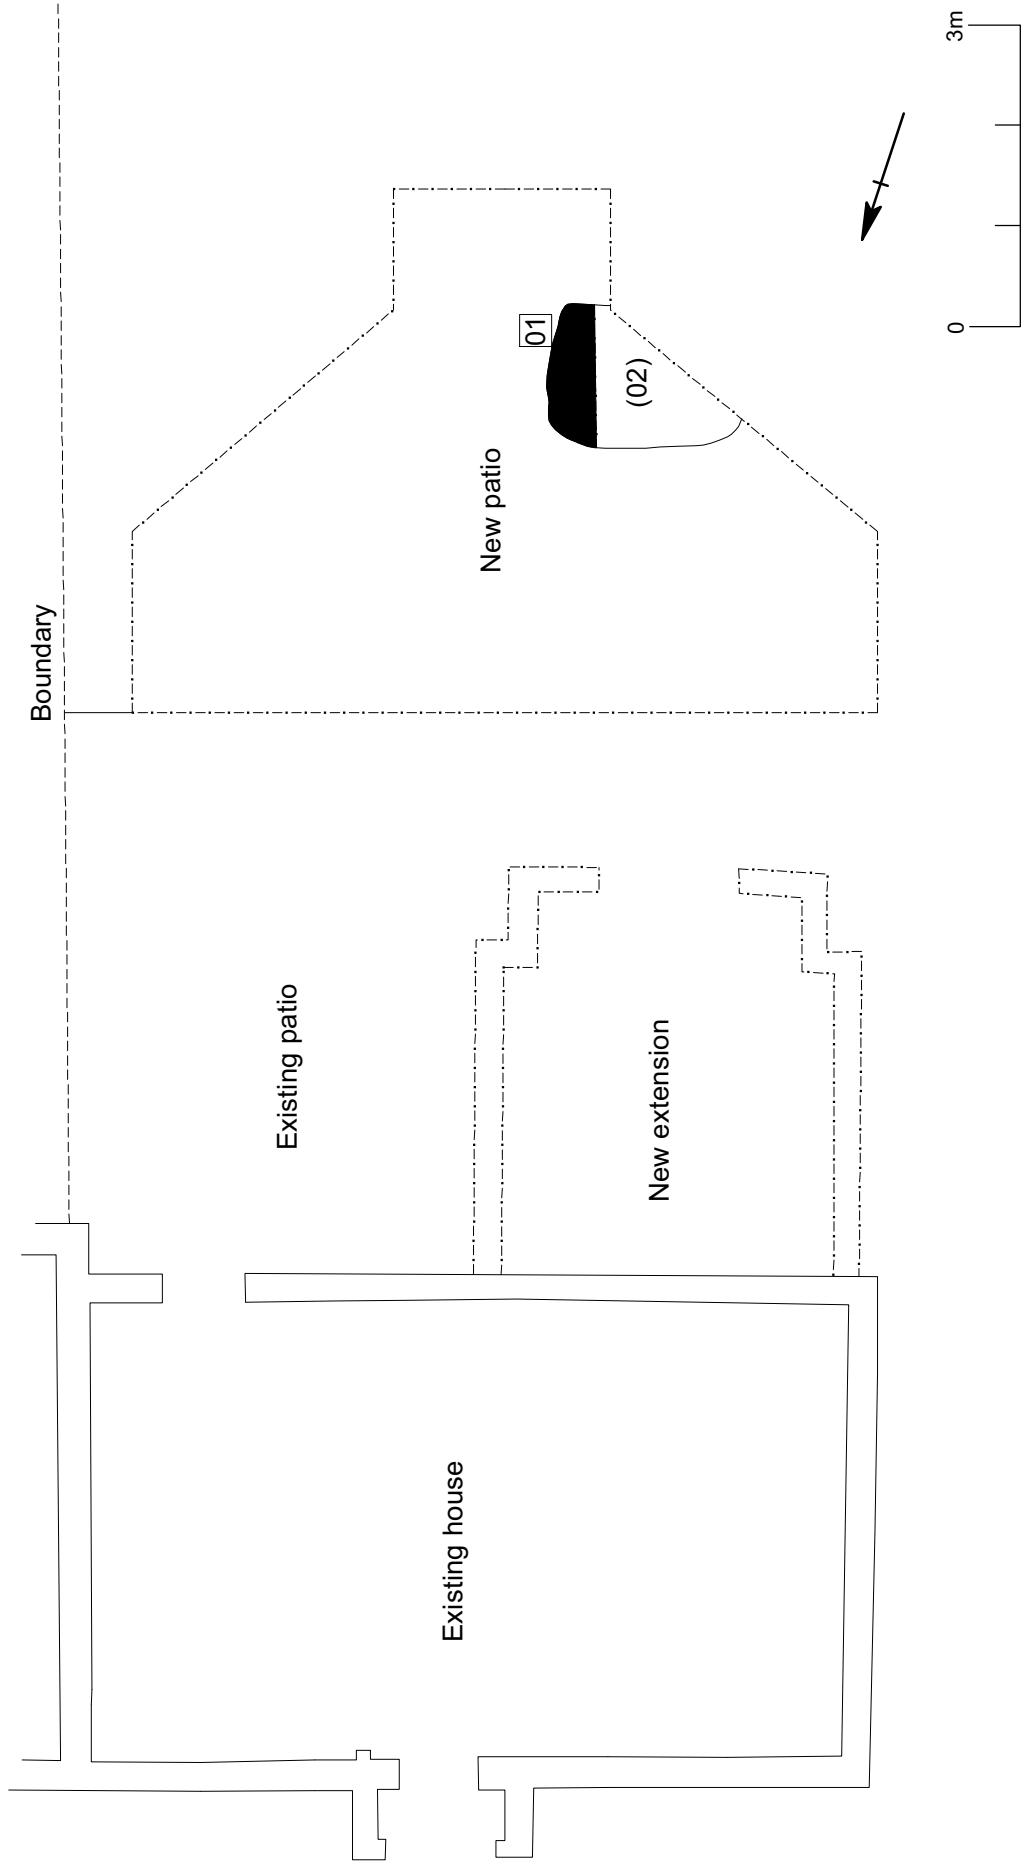
Figure 5

**2.14** The new extension crossed an existing paved area to the rear of the house, that had been terraced into the natural ground slope. The terracing was extended southwards, to a maximum depth of approximately 0.92m, to allow for a new patio (Figure 5). The natural geology was encountered in this area at a depth level with the existing patio.

**2.18** The footings trenches for the new extension measured approximately 0.45m wide by 1.0m deep. The footings were located within the area of the existing patio, and the stratigraphy in the trenches consisted of natural clay only, demonstrating that the ground level within the area of the existing patio has been reduced previously (Figure 5).

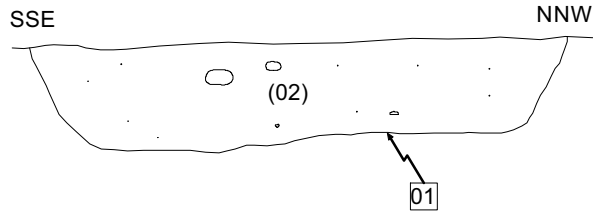
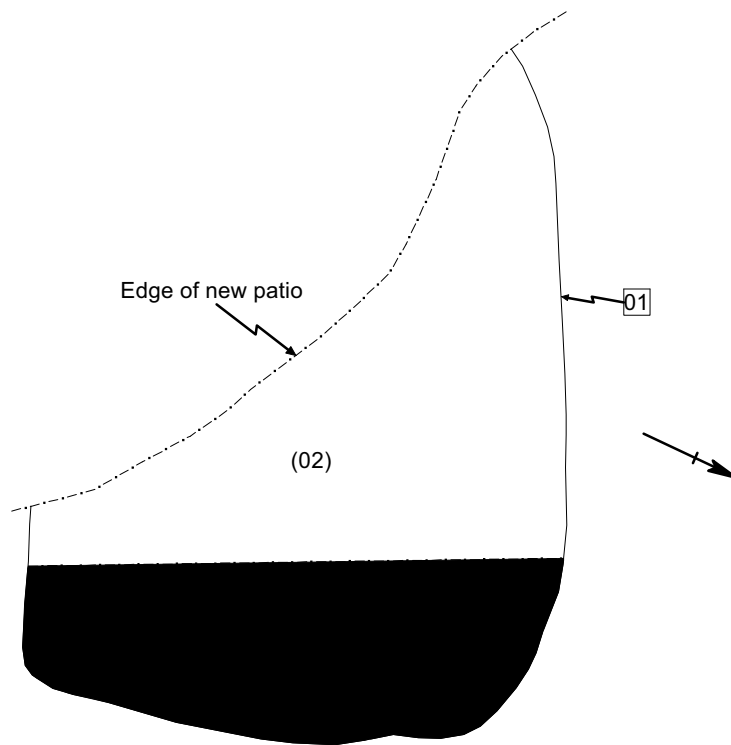
Figure 6

**2.15** A sub-rectangular pit [01] was observed cutting through the natural clay on a west-southwest – east-northeast alignment (Figures 5 & 6). The full dimensions of the pit were not apparent as it extended beyond the limit of excavation, but it had a maximum depth of 0.29m. The pit had steep very slightly concave sides and a flat base. The single firm, olive brown (2.5Y 4/4), slightly silty clay fill (02) yielded 3 undiagnostic bodysherds of probable 10<sup>th</sup> – 12<sup>th</sup> century date. Groundwater was encountered in the base of the feature. The function of the feature is unclear.

**2.22** Three undiagnostic bodysherds of 10<sup>th</sup> – 12<sup>th</sup> century date were recovered from the fill of pit [01]. One of the sherds was coarsely sand-tempered, the remaining two were finer but also sand-tempered.

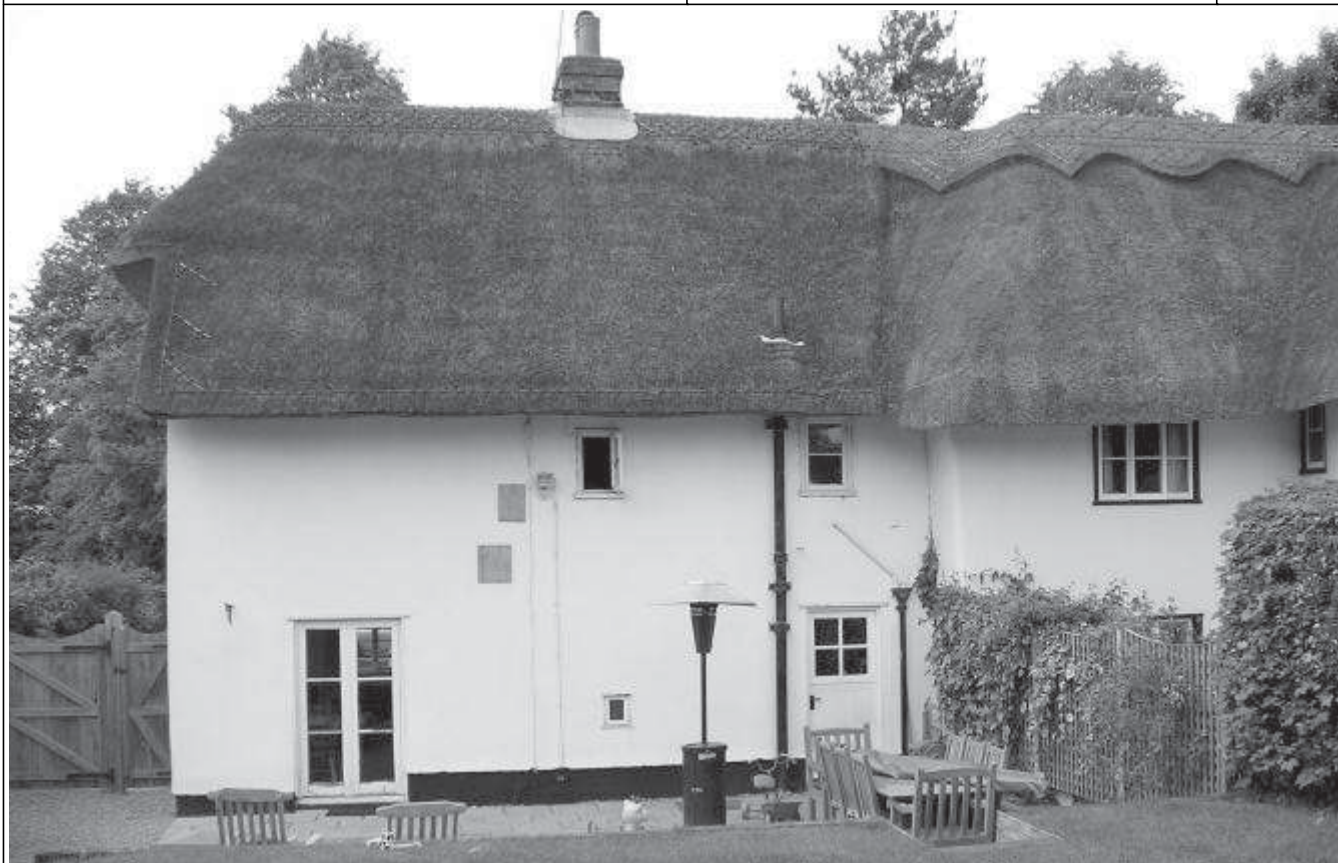
**2.10** The southern (rear) elevation has French windows at the western end of the ground floor, and a half-glazed door at the eastern end (Plate 1). A low set small one-light casement window is placed between the two doors, serving a cupboard beneath the staircase. A one-light casement is set in the middle of the upper floor, serving the staircase, and a further one-light casement is set at the eastern end.

Plate 1: 'Shipwrights Cottage' rear elevation looking N

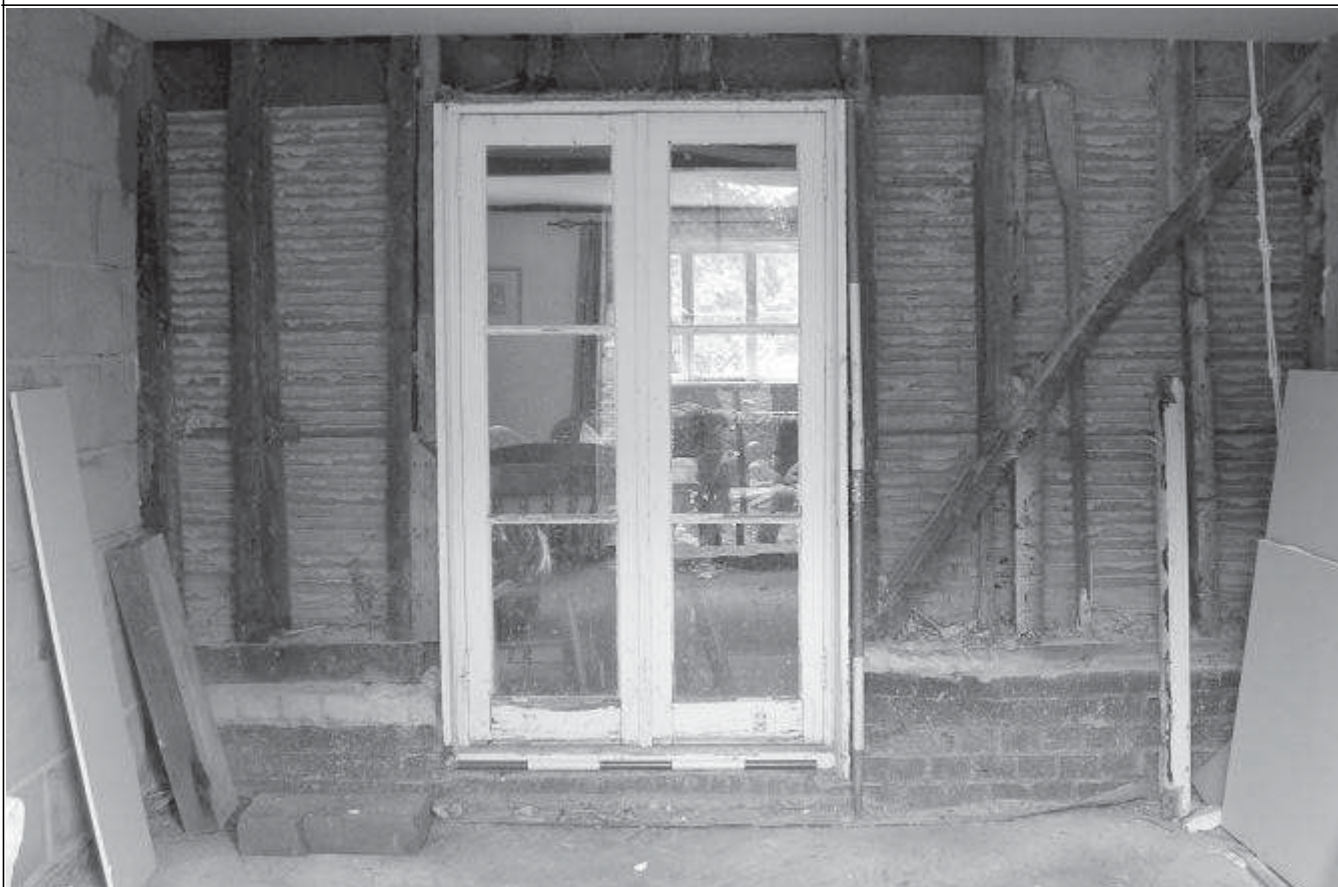
**2.12** The render was largely stripped away from the ground floor revealing a modern brick plinth, modern sill and middle rail, and reused studs which are unlikely to pre-date the Victorian period (Plate 2). The principal post was not observed in the section available. The internal plaster was modern and supported on modern laths. Some apparently original floor joists were visible above the middle rail (Plate 3).

Plate 2: External southern elevation after removal of render

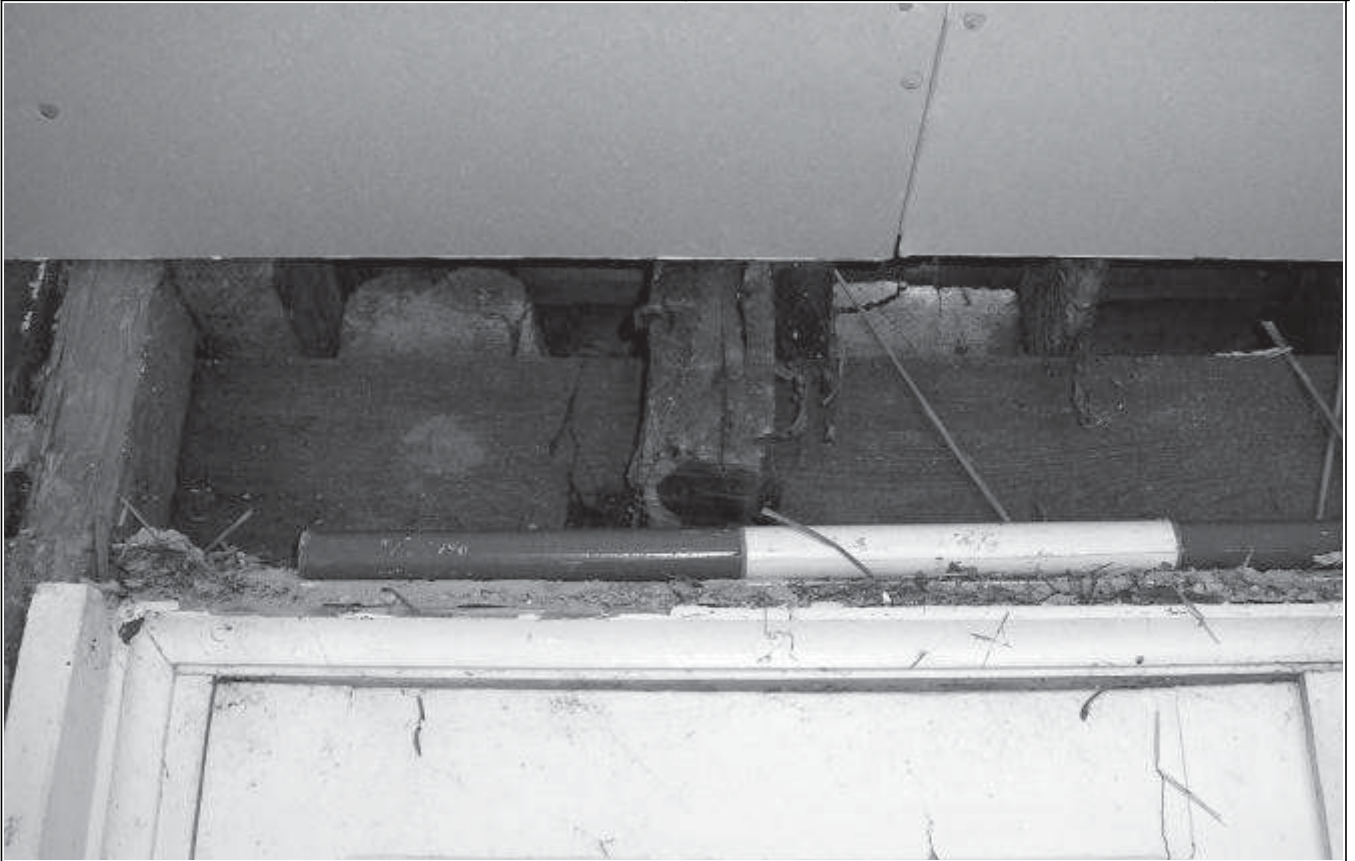
Plate 3: Floor joists visible above the middle-rail

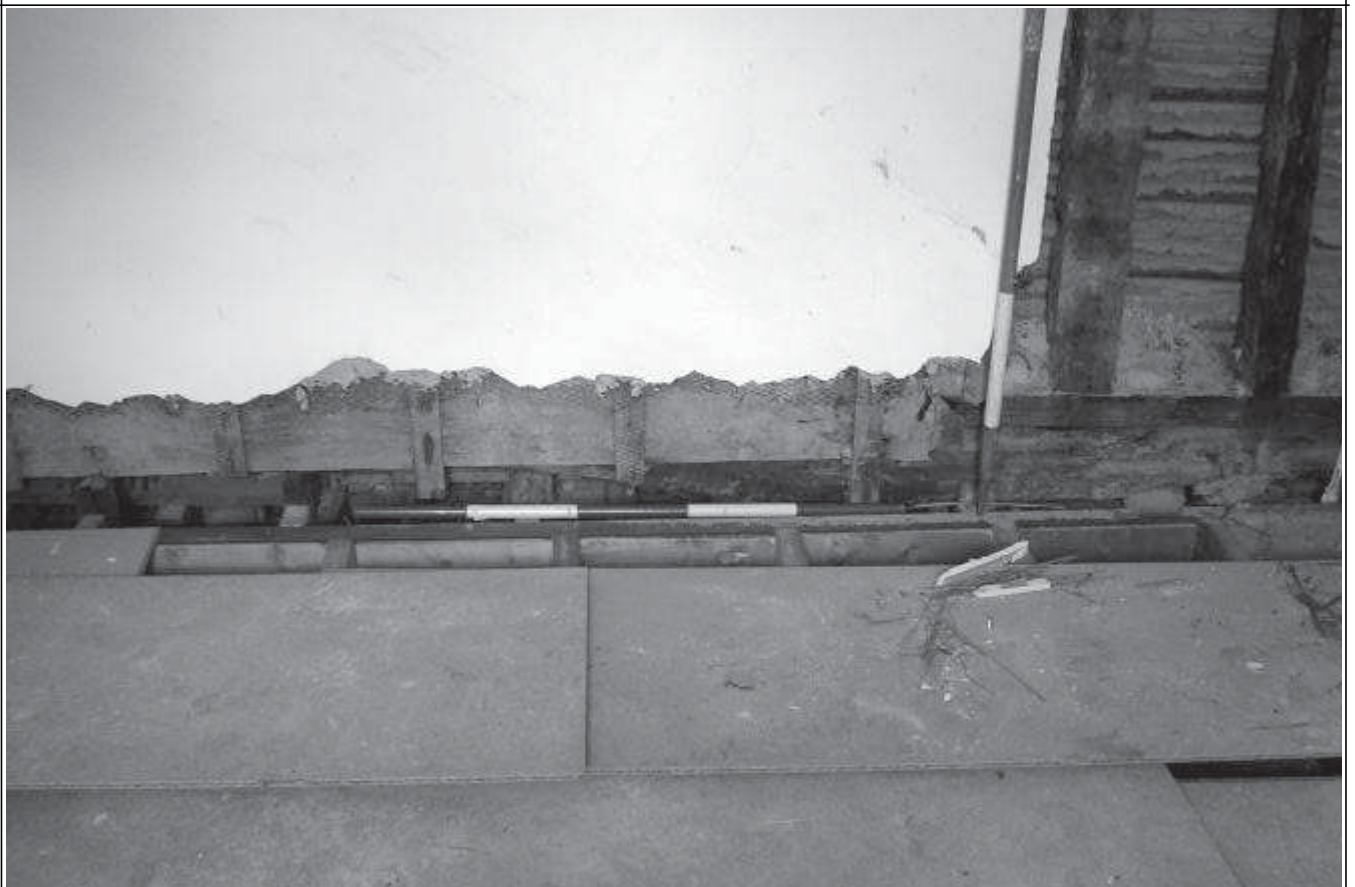
**2.13** The render was partially stripped from the upper floor revealing a modern wall plate and roof timbers, and reused studs. The exterior render was modern and supported on metal mesh, and the internal plaster was cement-based and supported on modern laths. An original beam was observed above the level of the middle-rail, extending from the east and finishing approximately half way along the elevation (Plate 4). No indication of its current or original structural purpose could be ascertained.

Plate 4: Original beam observed above the level of the middle-rail
