## St Helen's Church, Wheathampstead, Hertfordshire

Report No. 731

<b>Site name and address:</b>	St Helen's Church, Wheathampstead, Hertfordshire		
<b>County:</b>	Hertfordshire	<b>District:</b>	St Albans
<b>Village/town:</b>	Wheathampstead	<b>Parish:</b>	Wheathampstead
<b>Planning reference:</b>	N/A	<b>NGR:</b>	TL 17664 14020
<b>Client name and address:</b>	Wheathampstead PCC, c/o Rev. Brian Gwinn, 32 Warwick Avenue, Wheathampstead, AL4 8QB		
<b>Nature of work:</b>	Maintenance	<b>Present land use:</b>	Churchyard
<b>Site Status:</b>	Grade II* listed	<b>Reason for investigation:</b>	Advice of DA
<b>Position in planning process:</b>	N/A	<b>Project brief originator:</b>	N/A
<b>Size of affected area:</b>	3.5m <sup>2</sup>	<b>Size of area investigated:</b>	3.5m <sup>2</sup>
<b>Site Code:</b>	HN995	<b>Other reference:</b>	n/a
<b>Organisation:</b>	Heritage Network	<b>Site Director:</b>	David Hillelson
<b>Project type, methods etc.</b>	Observation and Recording	<b>Archive Recipient:</b>	St Albans Museums

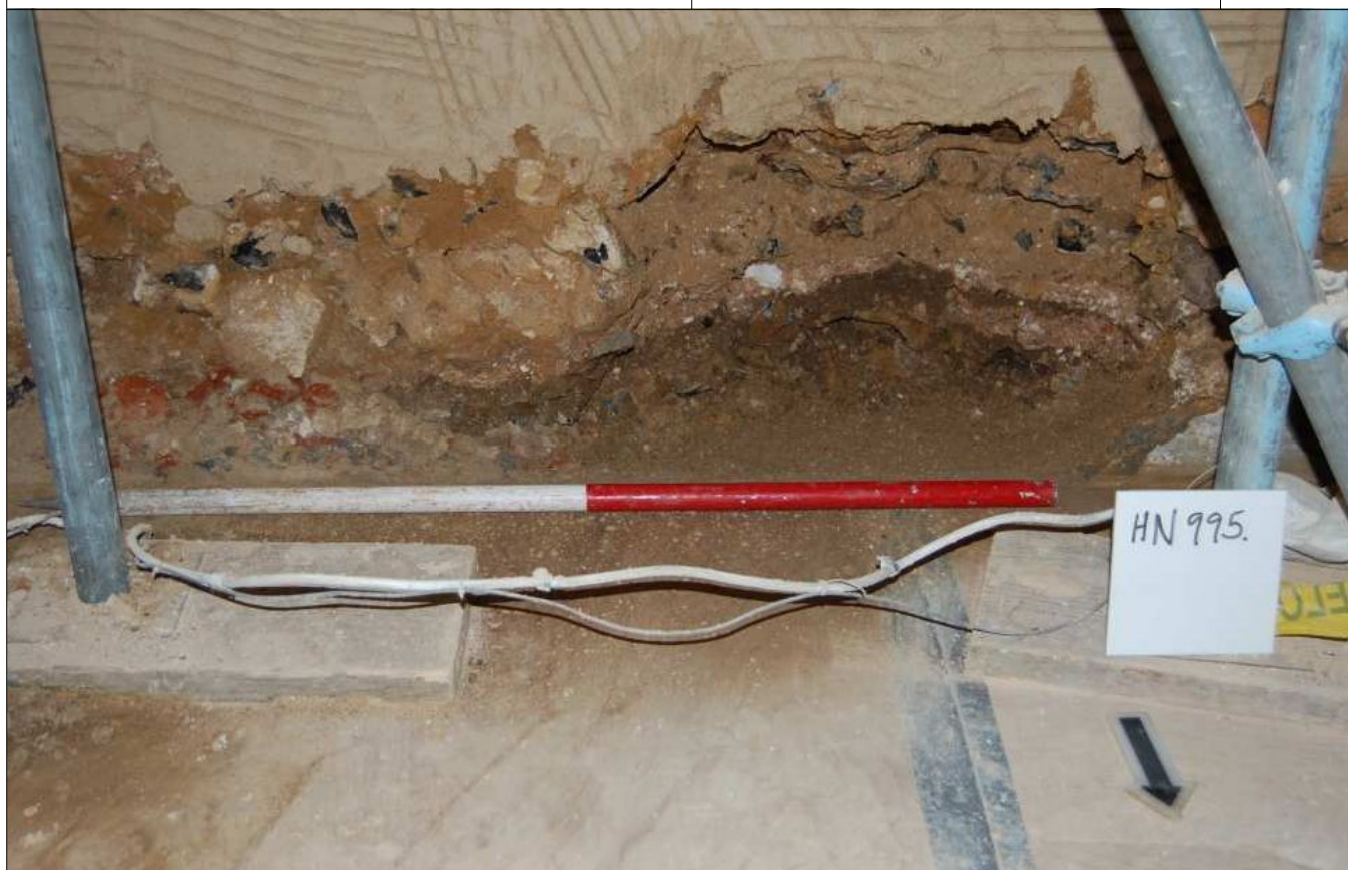
The underpinning works initially consisted of a 0.5m wide excavation by hand into the base of the south wall of the south transept to expose the wall makeup and show the form of any wall footings. This trial excavation revealed that the wall (001) was formed of irregular un-coursed flint nodules set in a sandy lime mortar matrix and resting on a 0.05m thick levelling layer of mortar (002). Below this was a foundation of black soil and flint rubble (003). The base of the wall stood 0.05m above the existing internal floor surface.

Plate 1: Trial hole, looking north.

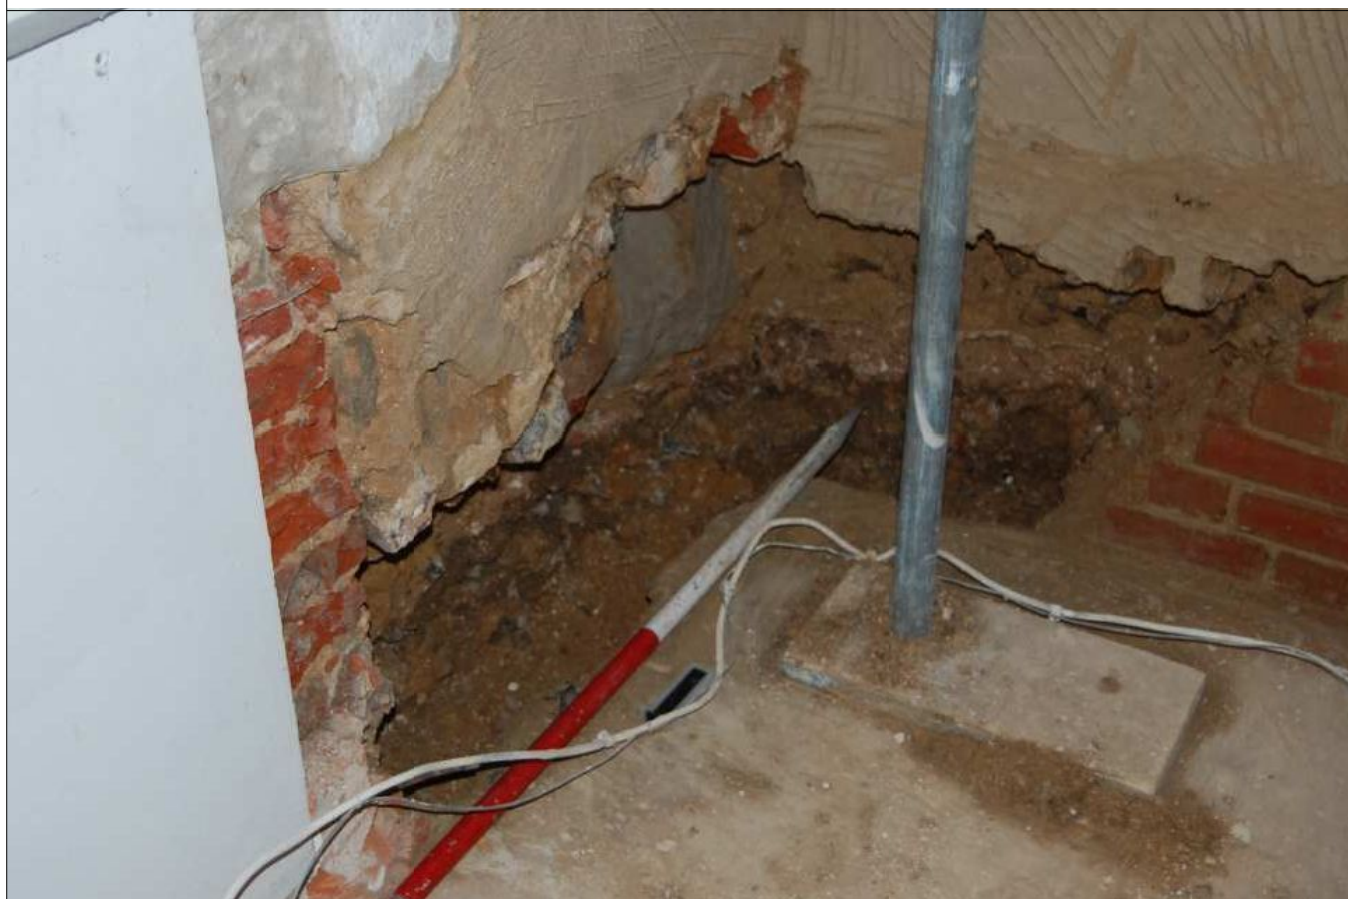
Following the trial excavation, the decision was made that the base of the wall required support. This was achieved by cutting the wall and its foundation back by 0.30m, to a height of 0.50m above, and a depth of 0.20m below, the existing floor. A limecrete foundation was then introduced above which a brick plinth was built. The construction sequence along the length of the wall was similar to that revealed in the trial excavation, with the exception of a small area at each corner where clunch stonework was revealed.

Plate 2: Underpinning east corner, looking southeast.

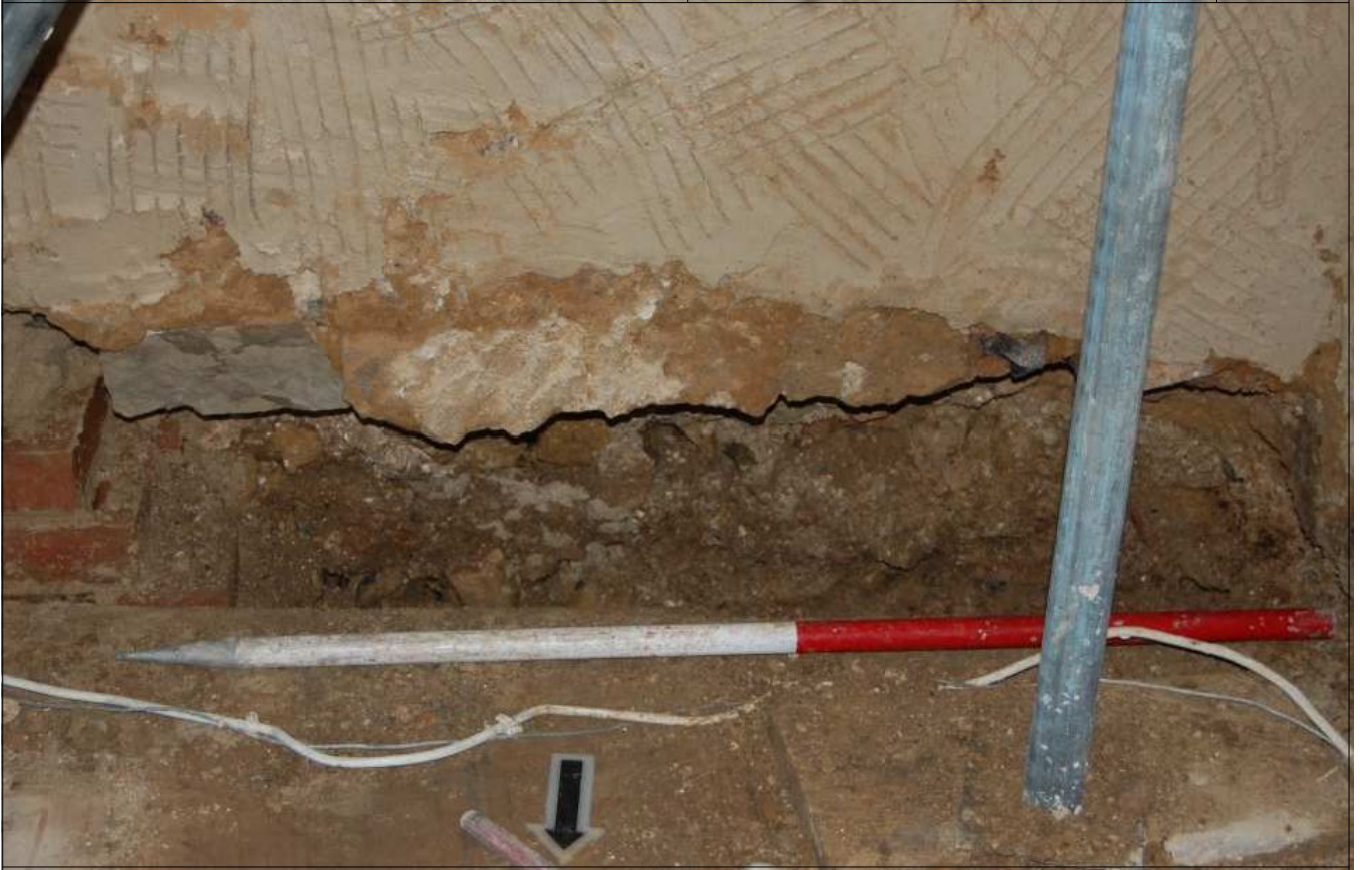
Plate 3: Underpinning west corner, looking south.

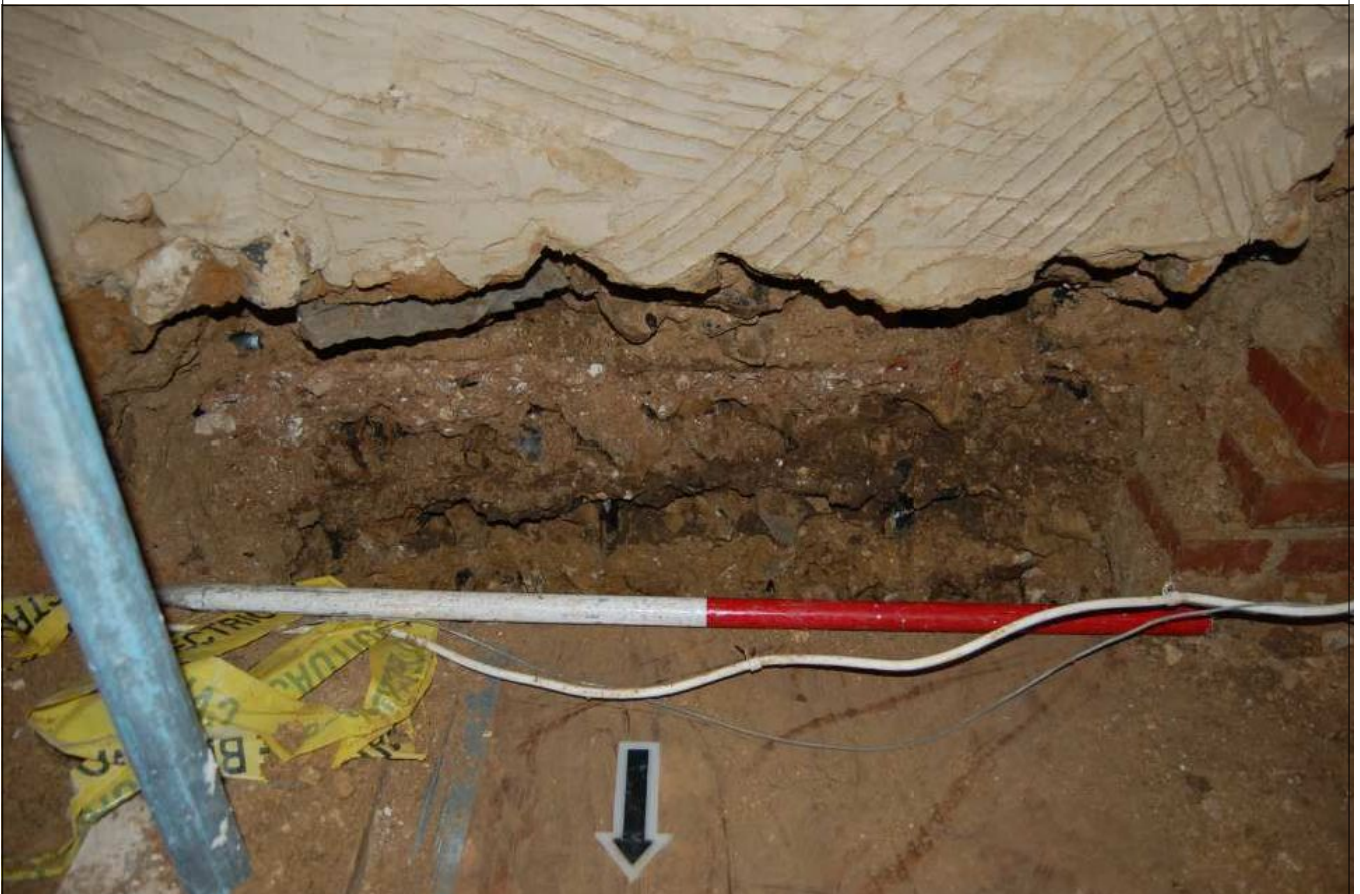
In the centre of the wall, where a stone archway below the window apparently marks a blocked doorway, the sequence continued uninterrupted and no evidence for the former doorway was observed.

Plate 4: Underpinning under stone arch, looking south.
